**Prudence Review of
Newfoundland and Labrador Hydro
Decisions and Actions
Final Report**

**The Board of Commissioners of Public Utilities of
Newfoundland and Labrador**

The Liberty Consulting Group

July 6, 2015

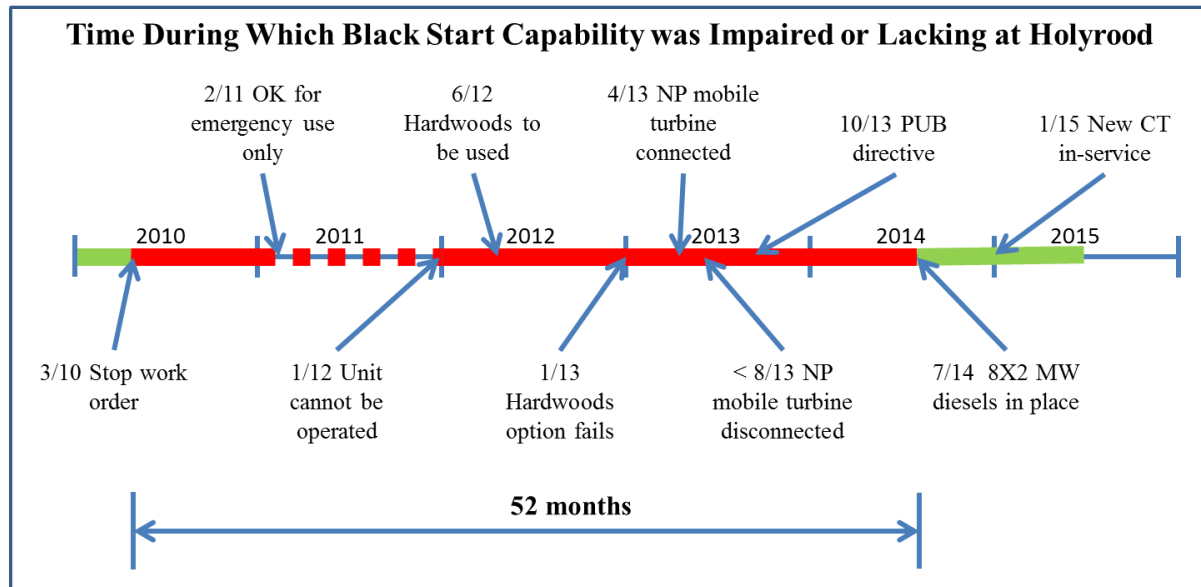
Illustration 10.1: Black Start Chronology

The next illustration shows the periods during which Holyrood lacked or had only impaired black start capability prior to completing installation of the eight diesel generators. The illustration shows how long it took Hydro to succeed in providing black start capability that could work.

Hydro has stated that it believes that the winter of 2010-2011 comprises the only time when it lacked black start capability at Holyrood. Hydro has also stated that:

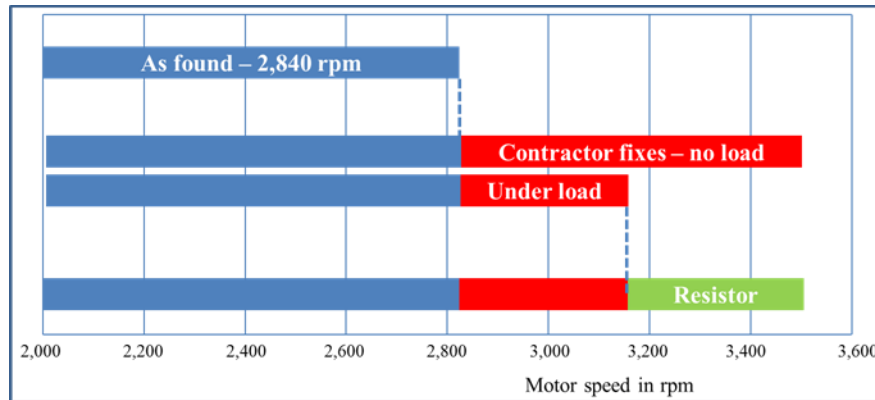
Diagram 11.1: Evolution of Motor Repairs

In an effort to determine the cause of the motor's inadequacy, Hydro sent it to a contractor for testing. The contractor also could not attain a speed of more than about 2,800 rpm. Further testing found that: (a) the motor's brush boxes were offset, and (b) the motor's neutral plane was misaligned. The accompanying insert explains how such flaws affected the motor. After the contractor corrected both items, the motor was able to reach its rated speed of 3,500 rpm under no load conditions. After its return to the Plant, Hydro connected the motor to the pump, but it again was unable to come to speed, reaching only about 3,100 rpm. Subsequent adjustment of a resistor setting allowed the motor successfully to reach rated speed under load. The next diagram illustrates this evolution.

The root cause analysis addressed the source of these problems, which appear about equally responsible for the motor's failure to perform. The root cause analysis attributed the misalignments to quality issues at a maintenance vendor, indicating that the resistor setting "was moved." Hydro has stated that the maintenance vendor operated under a standard that required speed testing of the motor before its return. Hydro also states that the vendor did perform the required testing. However, neither Hydro nor the vendor provided documentation sufficient to verify the conduct of speed testing. Hydro recently submitted a copy of the vendor's invoice, which under the description of the work, included the following notation:⁷¹

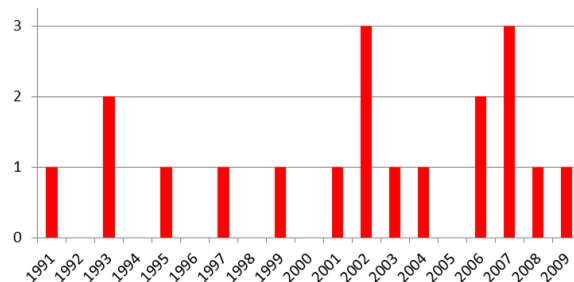
Chart 13.1: Reported Fires at Isolated System Plants

In 2011, Hydro commissioned a study by an external consultant to revisit its approach of not providing fire suppression for such systems.⁹² That study produced a risk matrix and plan for a long term effort to phase in fire suppression systems at the isolated plants. The study noted, as the next chart illustrates, a significant number of fires (19) at isolated systems since 1991.

Moreover, the study cited the possibility of others that may have gone unreported.⁹³ A rate of roughly one fire per year, with some producing catastrophic damage, would suggest that revisiting the fire suppression study was overdue. Hydro's root cause analysis of a 2008 event appears to have triggered the outside study. It is not clear why it came three years later. Liberty believes that it would have been appropriate for Hydro to have addressed the frequent rate of fires earlier. Its isolated systems had experienced 10 fires in the six-year period (2002-07) preceding the 2008 event that led to the 2011 study.
