Muskrat Falls Generation

Independent Dam Safety Review and Audit

Audit #1

January 29 to February 2, 2017

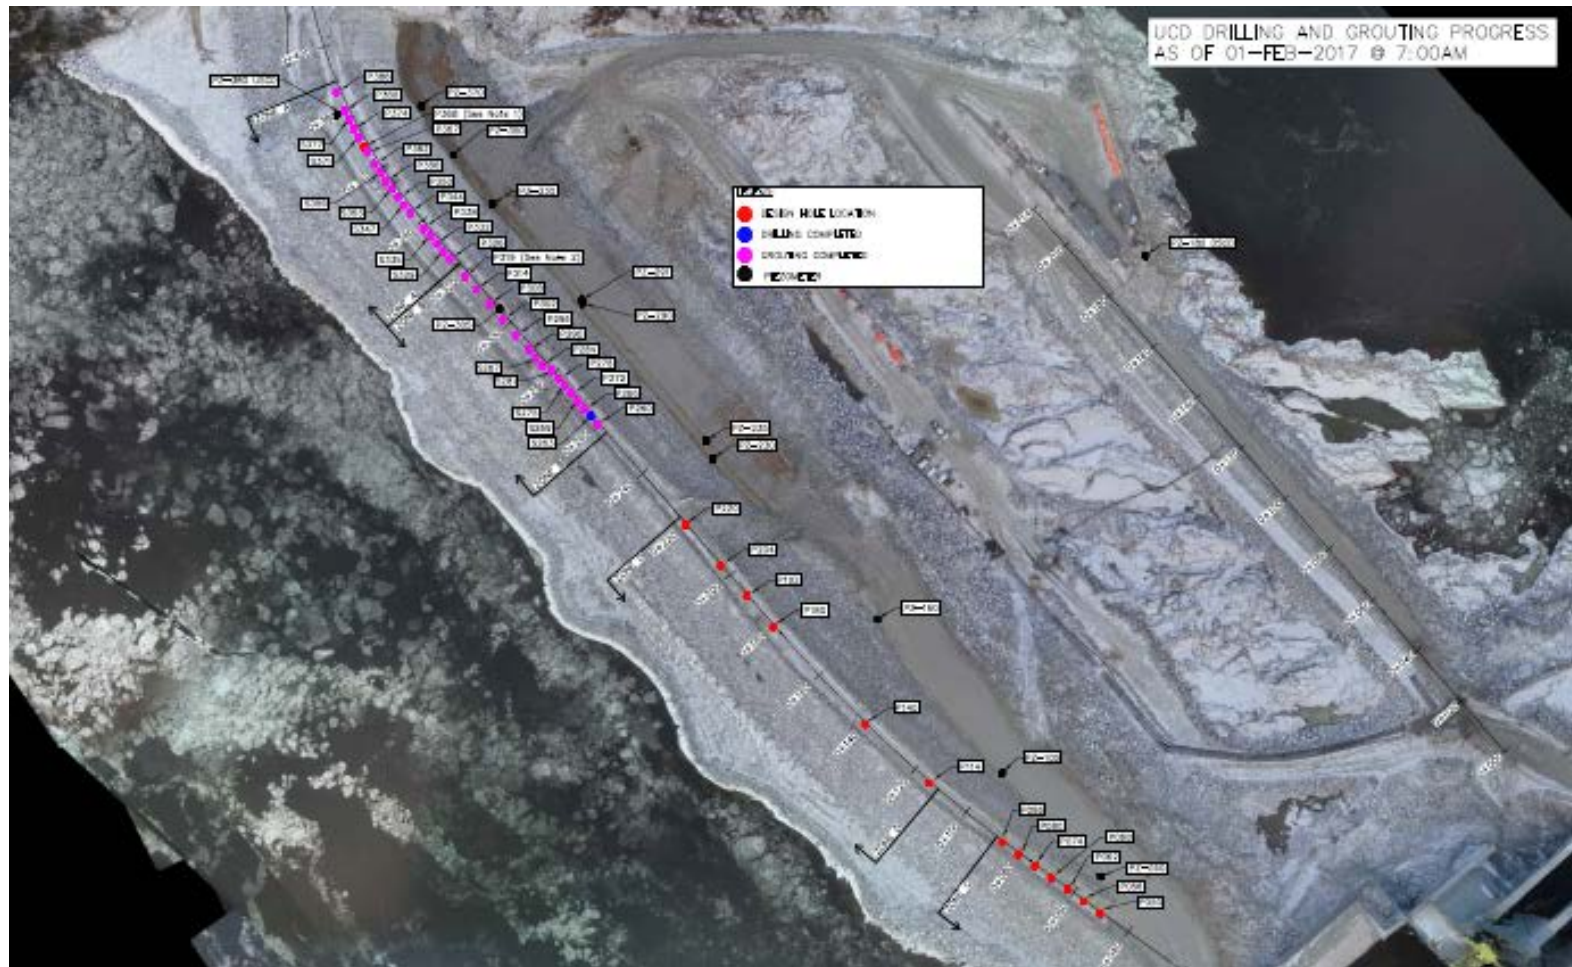
Current Areas of Leakage

- Upstream/downstream cofferdams
 - Current levels of leakage in line with what would be expected for a cofferdam of this type
 - Remediation program underway to deal with increased leakage that occurred on first impoundment
 - Measures are appropriate and appear to be effective
- Intake cofferdam (very minor leakage)
- Separation wall (very minor leakage)
- RCC cofferdam (minor leakage)

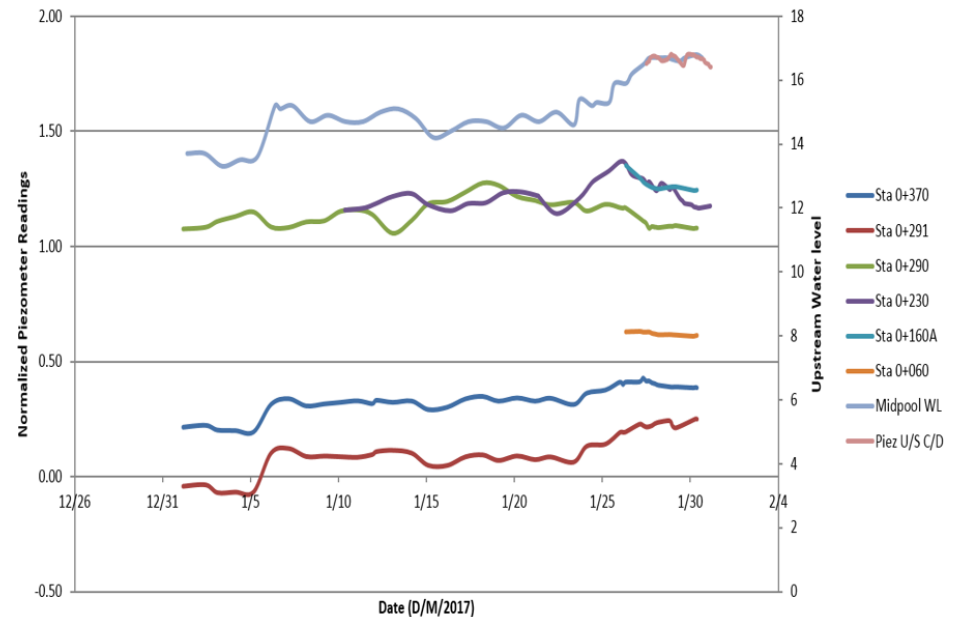
Actual Piezometric Response

- Actual piezometric response complex, affected by rising headwater

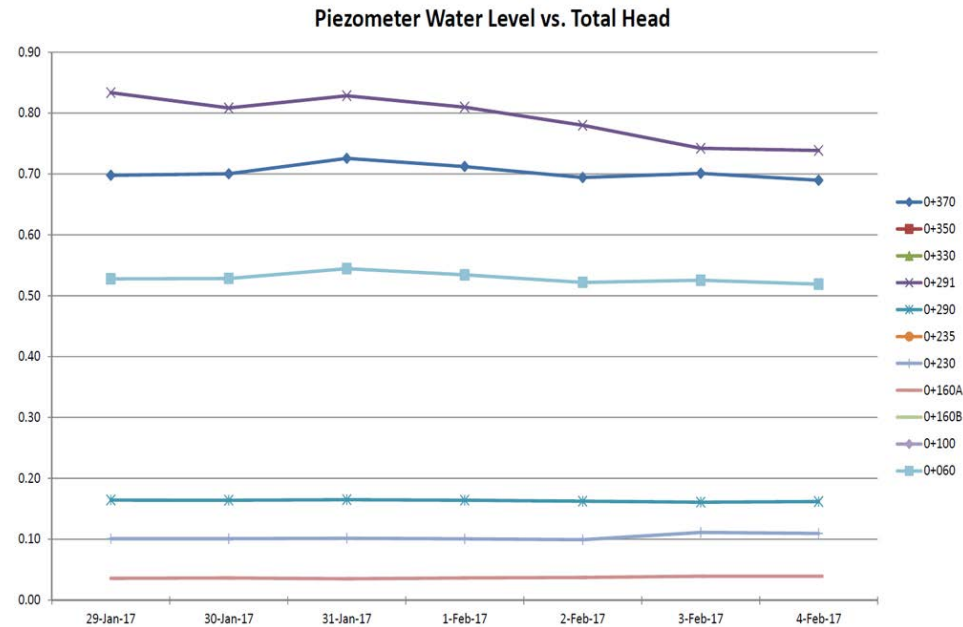
Normalized Upstream Cofferdam Piezometric Response

- Normalized piezometric response accounts for influence of reservoir rise on response
- Can be used to set alert levels
- P 291 is not responding to headpond
 - Consider replacement

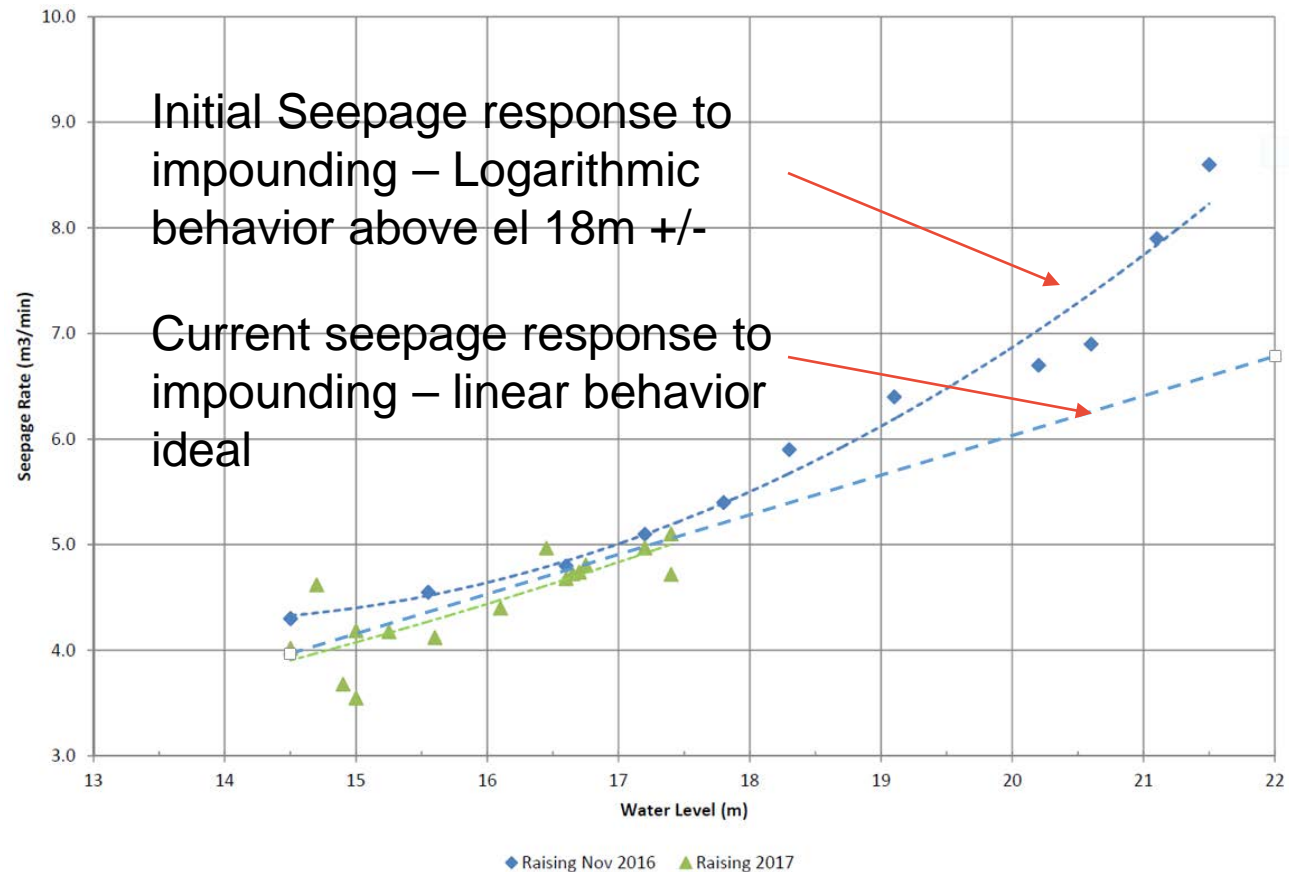
Review of Alert Levels - Seepage

- Comparison of initial impending and post remedial work seepage rates can be used to define alarm levels

- Current levels are appropriate up to about el 20
- Above that alert levels should be defined on the basis of deviations from observed trends in seepage and piezometric response to headpond
- Alert levels should be aligned with EPP alert levels (level 1, 2 and 3)
 - Appropriate criteria for each level should be defined and documented
 - Alert levels should be posted
