Muskrat Falls Generation

Independent Dam Safety Program Audit

Audit #2

April 16-20, 2017

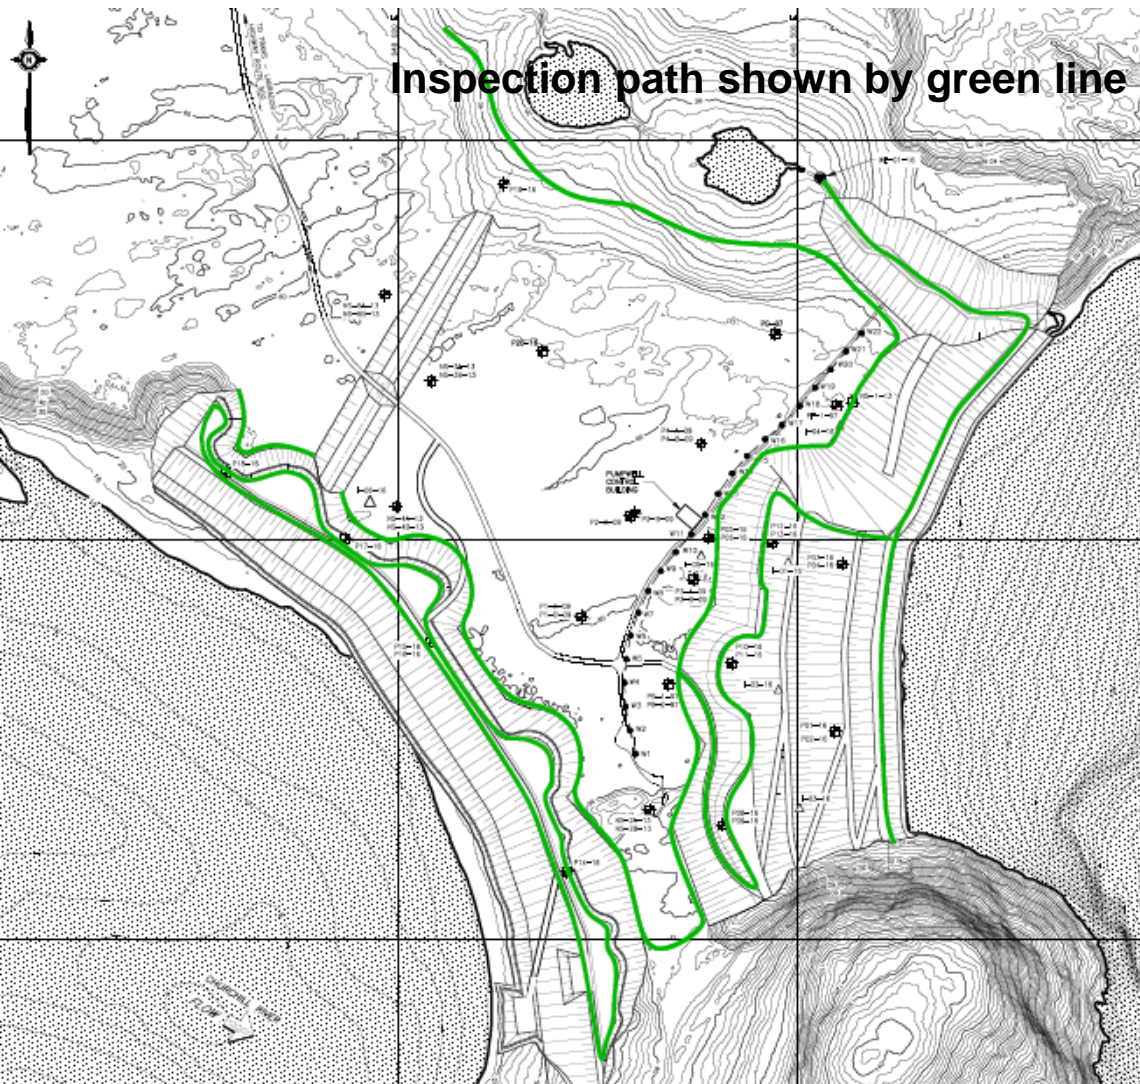
General Arrangement and location of Instrumentation

- 40 piezometers
 - 3 in lower aquifer
 - 7 upstream
 - 6 NW cow
 - 24 downstream
- 6 inclinometers
 - 5 downstream
 - 1 upstream
- 1 flow meter
 - Kettle lake outlet
