# UNCLE GNARLEY

Monday, 27 June 2016

## DESIGN ENGINEER BAFFLED BY EXTENT OF MUSKRAT TL FLAW REPORTED BY CBC

Guest Post Written by J. P. Schell, P. Eng (Retired)

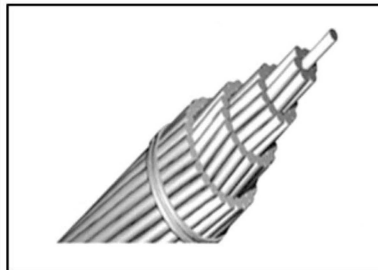
From the pictures included in the CBC News item it is apparent the outer strands of the line were squeezed too close together, causing one strand to "pop out" by an amount which is about half the strand diameter as shown in the photo. (Source: CBC)

There are three situations where a "popped out" strand could have occurred: a) during stringing, b) during transportation, and c) in the factory. The CBC item indicated that approximately 170 km of the DC transmission line had been strung before the work was halted, which represents about 340 km of conductor.

The only logical place for this to happen is in the factory during the stranding procedure.

caused this one strand to be incorrectly coiled and it continued, reel after reel after reel, without stopping until at least 340 km of conductor had been fabricated. Possibly it even continued for the full production run.

At the location of the clamps and dampers this strand will tend to be squeezed, distorted and flattened. As a result, the strand will be weaker than its companion strands; it will be more prone to breaking. If it breaks, the conductor's overall strength will be correspondingly weakened and the broken strand could slide or work its way out of the clamps. If that happens, it will unravel.

Because the strand has "popped out" of the conductor, it is probably very slightly longer than its companion strands and therefore will tend to act somewhat differently. Rain or dew or similar could get under the strand and freeze, thus pulling the strand even further from the conductor, thus allowing weather better access to the inner strands and isolating the strand even further from the conductor.

Is there a solution to the problem? First, I would state that I do not agree with a remedial action such as tightly winding an aluminum tape or equivalent around the conductor in a direction counter to the stranding. There are just too many things that could go wrong with it.

This line will be in service for more than 50 years — probably closer to 100 years — and under very severe weather conditions. This one odd-ball strand will be the one around which problems will tend to occur. For this reason, it would be my opinion that the conductor should be replaced. For major transmission lines, like those delivering power from Muskrat Falls, there is just too much at risk if they are not.
