LOWER CHURCHILL PROJECT

SITE VISIT REPORT JULY 14 TO 23, 2014.

Prepared for: Natural Resources Canada and Nalcor Energy

Date: September 19, 2014

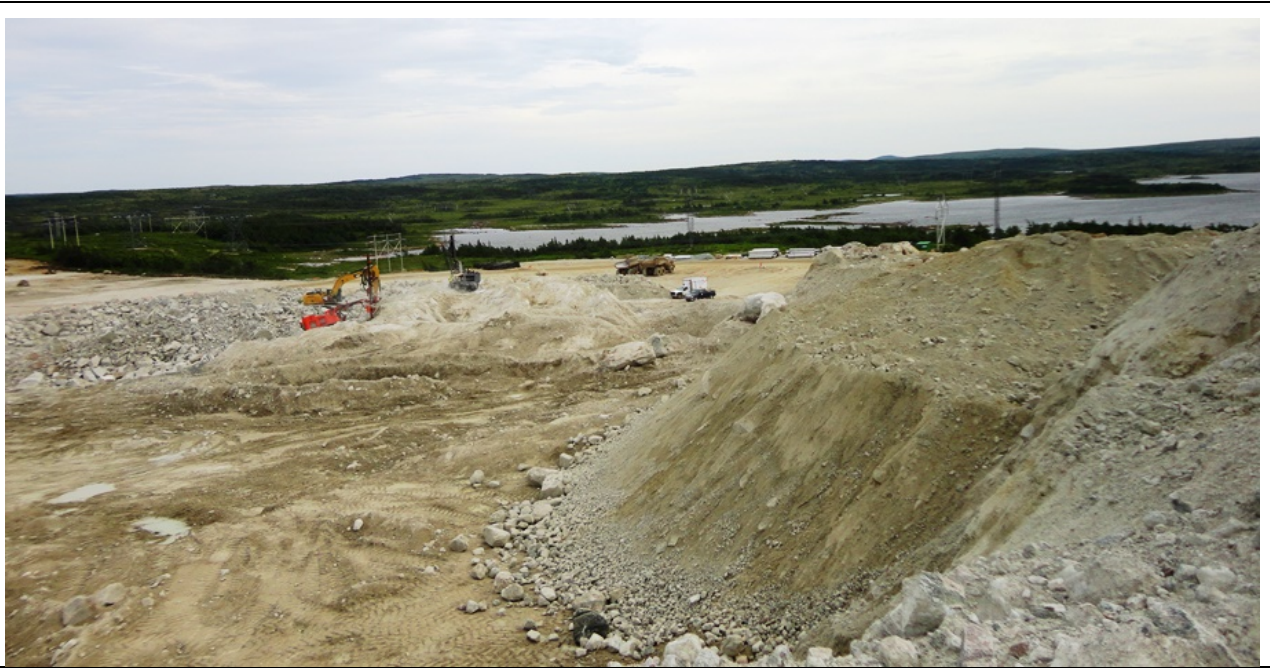
Photo 1.1: Soldier's Pond site; excavation work at the west end of the site. (July 14, 2014)

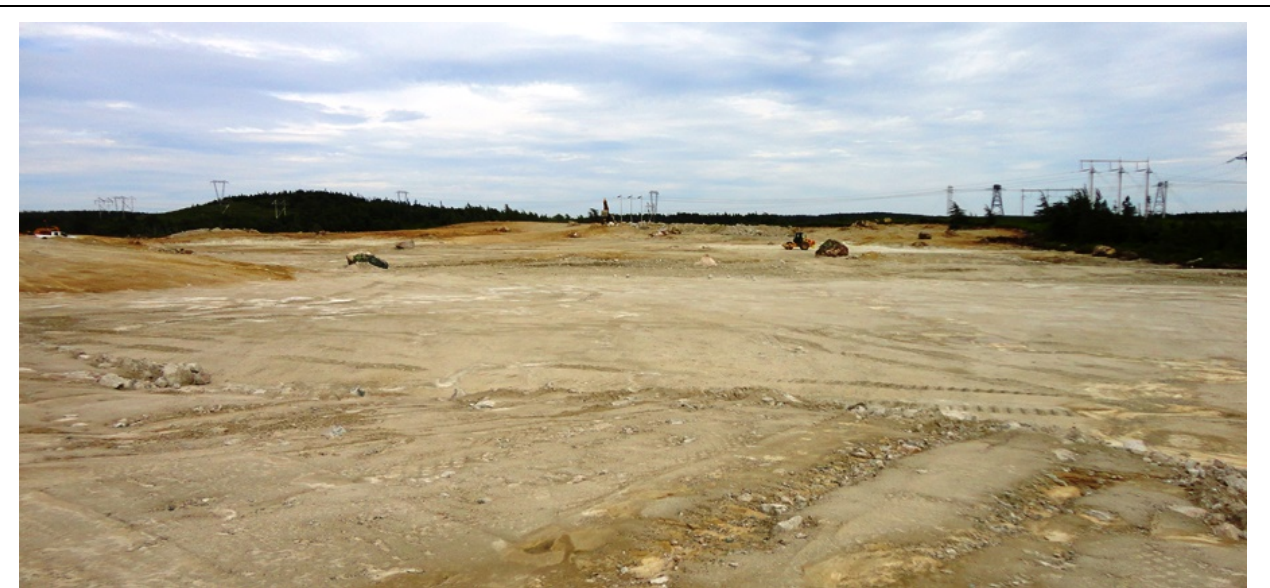
Bedrock and overburden materials are processed to remove boulders and oversized blocks to ensure their suitability for use as compacted fill. Fill is placed in 450 mm lifts and compacted to 98% Proctor with vibratory rollers. A rigorous quality control

The quality of the excavation and fill placement work is very good. All work is being carried out in a very safe manner, in accordance with Nalcor safety guidelines and regulations.

Photo 1.2: Soldier's Pond site; placing compacted fill to grade at east half of the site. (July 14, 2014)

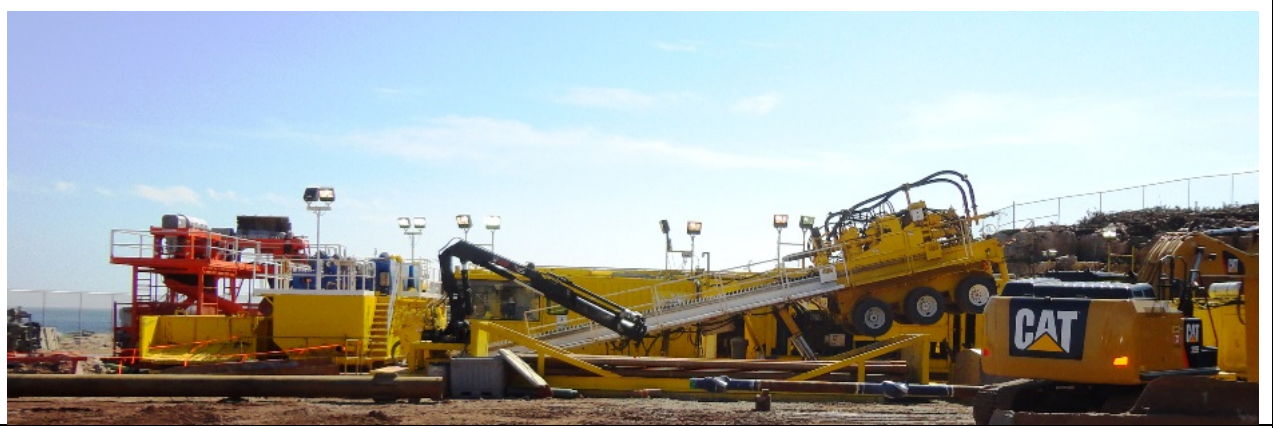
At the time of the site visit the directional drilling rig (Photo 2.1 in Appendix A), owned and operated by Direct Horizontal Drilling was set up on drill hole Forteau 2. The holes at this site are collared in competent, layered sandstone that has subhorizontal to gently inclined bedding (Photo 2.2 in Appendix A). As shown in Photo 2.3, the hole is collared near surface with 30 inch casing installed in a 36' boring. Inserts of 24" and 14" casing are telescoped into this and advanced in the hole as needed until sound bedrock is encountered. The main portion of the hole is drilled with a 14 3/4 " bit. The hole orientation and route are guided by a steerable bit that is oriented by compass guided instrumentation in non-magnetic rods (tool), 20 m behind the drill bit.

Photo 2.1: Forteau Directional Drilling. Inclined drill and equipment. (July 15, 2014)

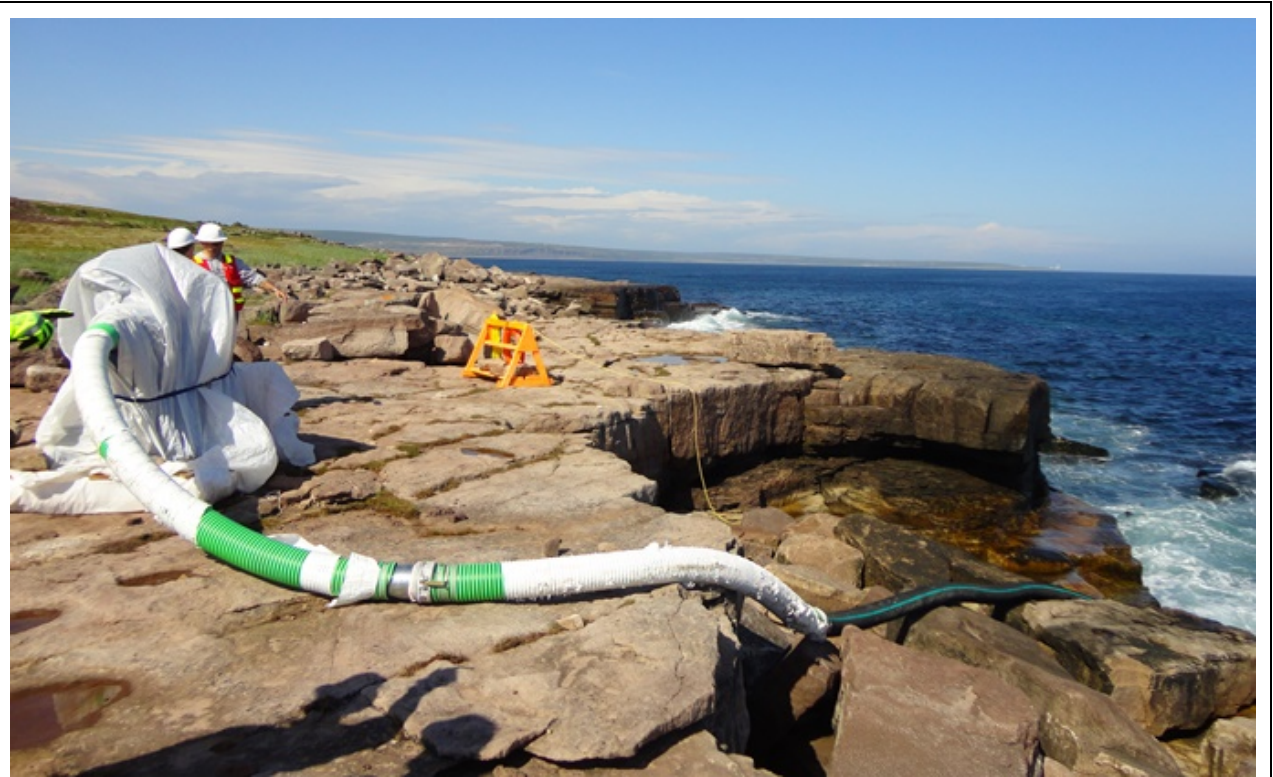
Photo 2.2: Forteau Directional Drilling. Subhorizontal bedded sandstone at the Forteau drilling site.

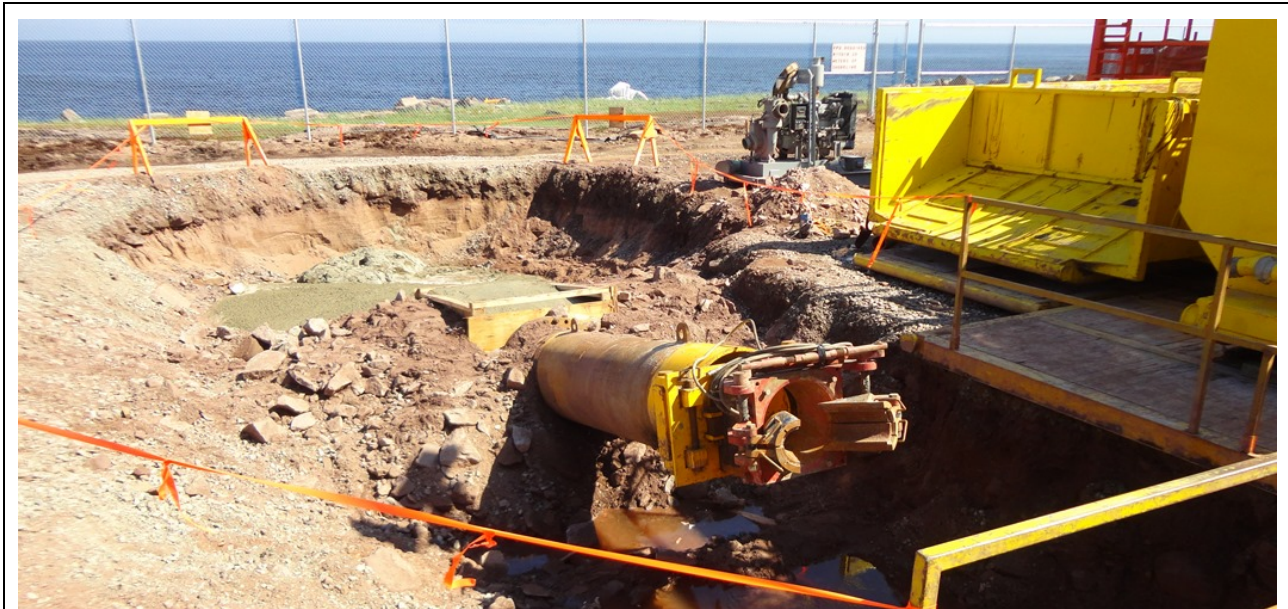
Photo 2.3: Forteau Directional Drilling. , Photo of borehole Forteau 2 showing the 30 inch casing collar. (July 15, 2014)

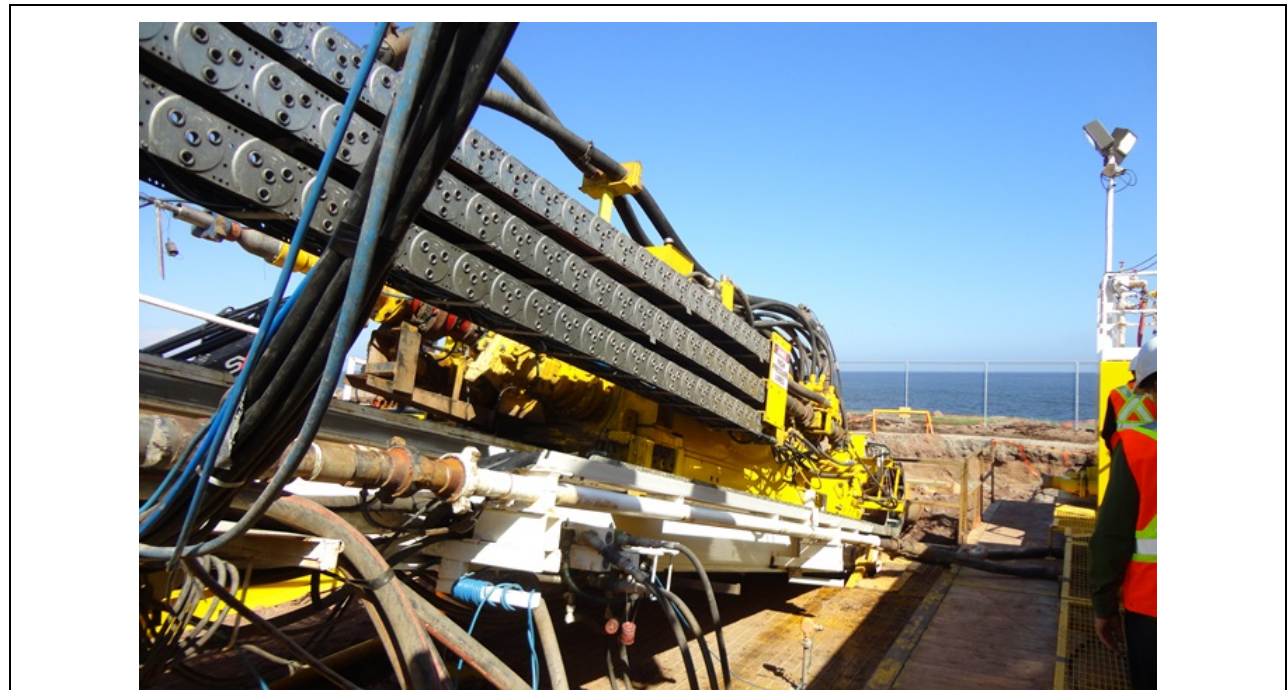
Photo 2.4: Forteau Directional Drilling. Drilling rig looking towards the drillhole Forteau 2.

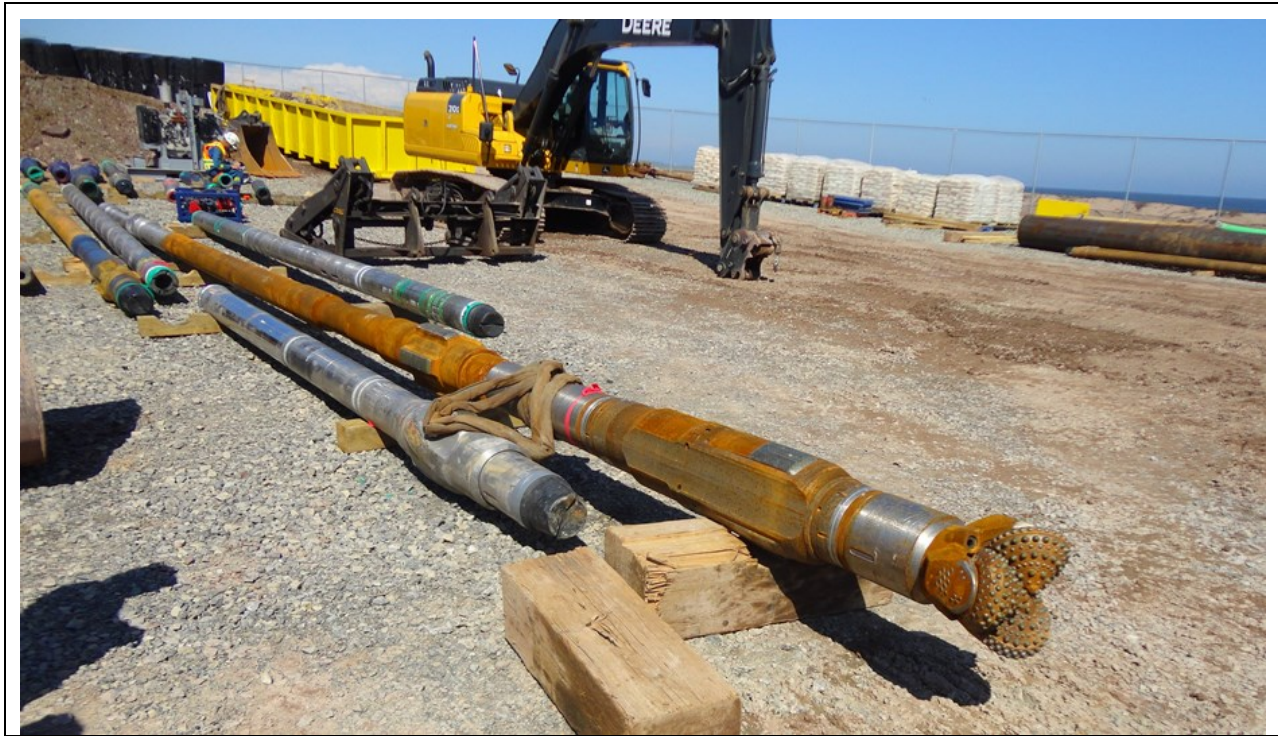
Photo 2.5: Forteau Directional Drilling. Drill bit and lower non-magnetic drill string components. (July 15, 2014)

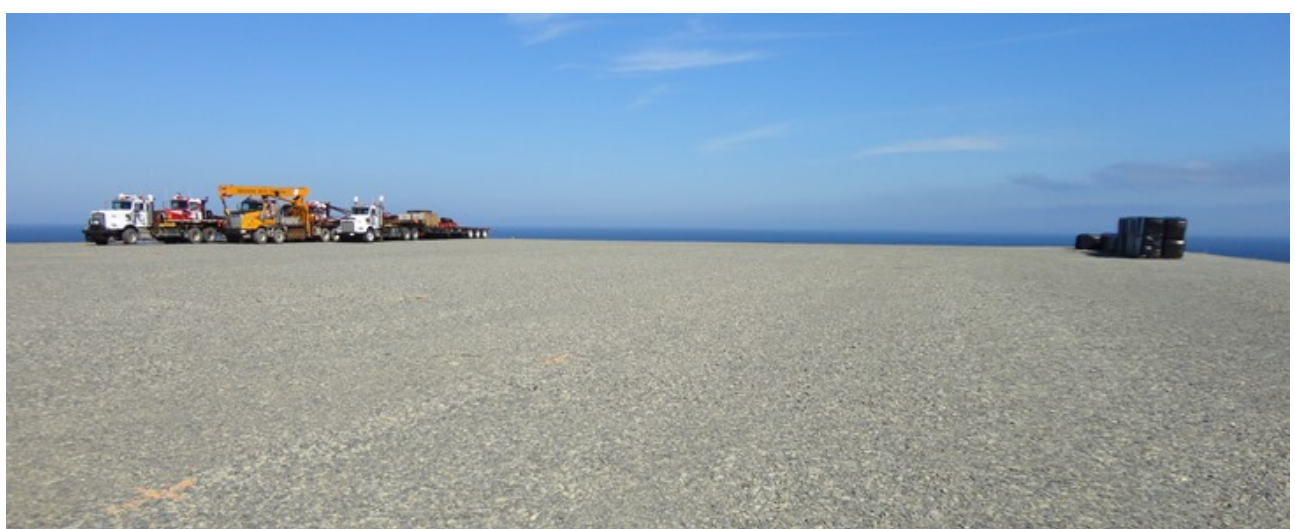
Photo 2.6: Forteau Directional Drilling. Graded fill at future transition compound site above the drilling site. (July 15, 2014)

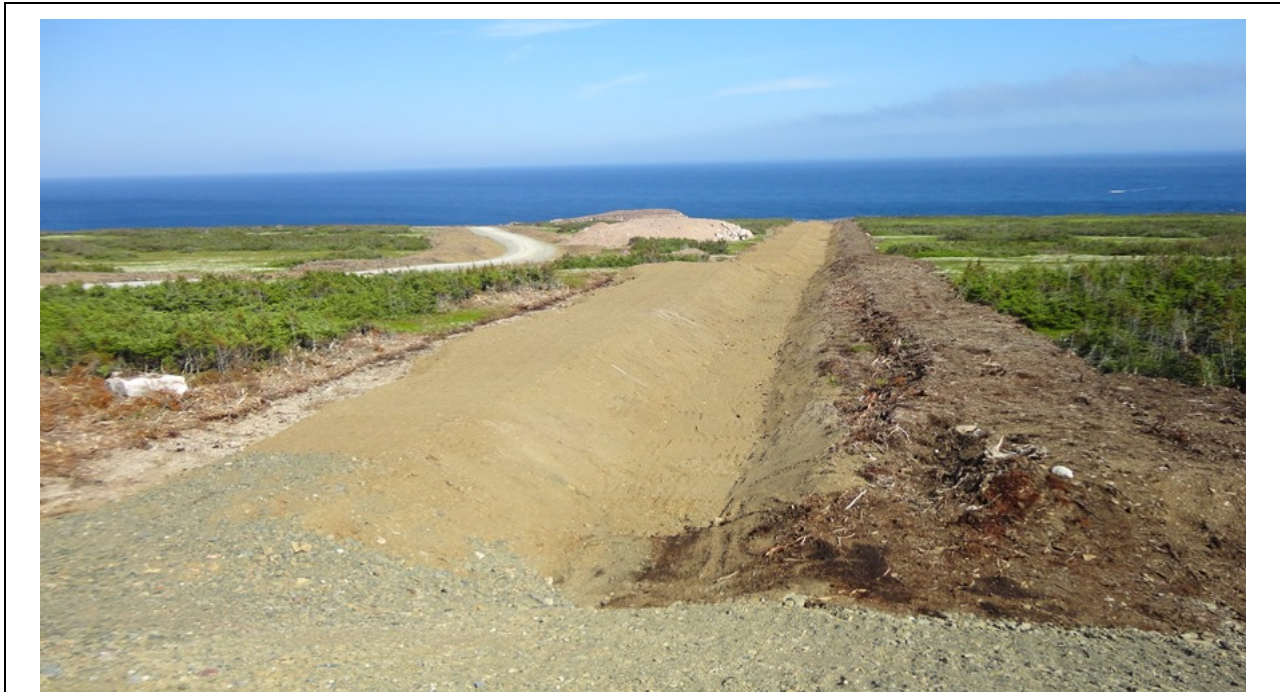
Photo 2.7: Forteau Directional Drilling. Excavated trench for the three cables between the transition compound and the drilling site. (July 15, 2014)

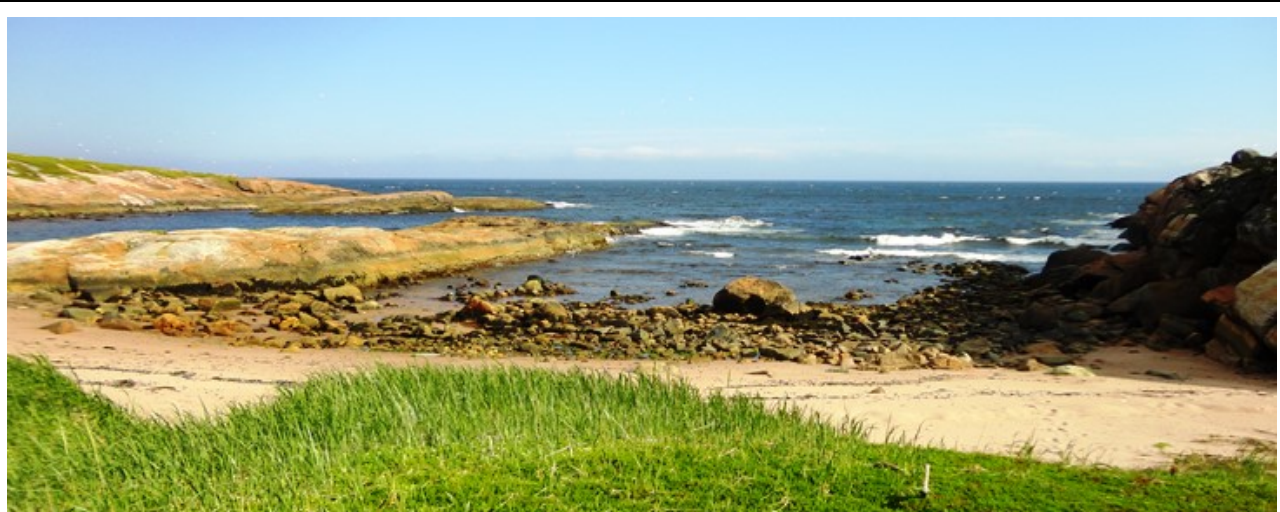
Photo 3.1: L'Anse au Diable Electrode Station site. The planned electrode pond site in a bedrock embayment. (July 15, 2014)

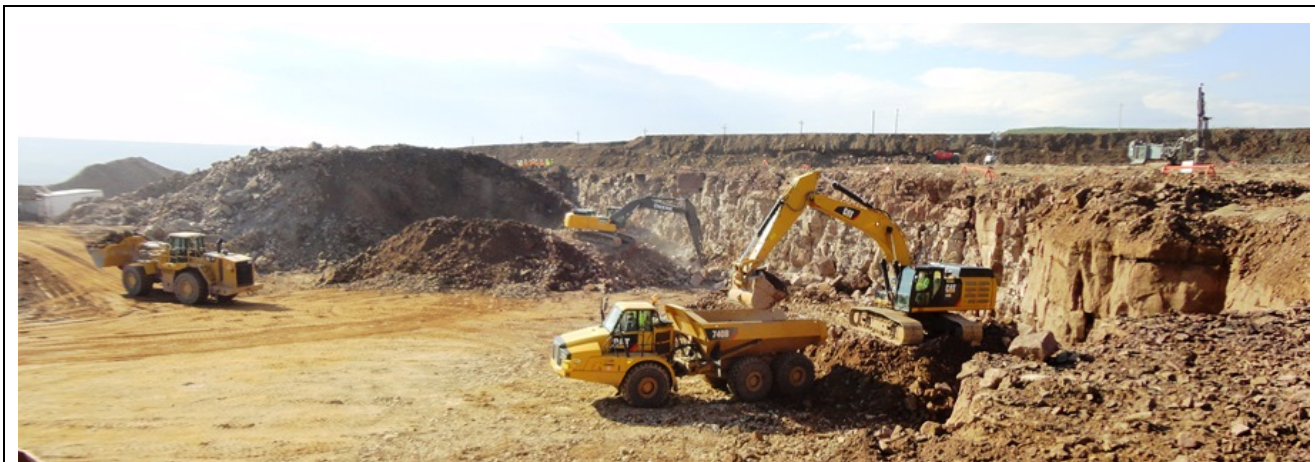
Work was progressing well at the time of the site visit. As can be seen on the photos in Appendix A, the quarrying operation has produced an 8 to 10 m high quarry face. The quality of blasting is good (Photo 4.1) and there is adequate equipment to blast, excavate and remove blasted rock from the face. The crushing and screening operation has produced a large stockpile of processed rockfill (Photos 4.2 and 4.3 Appendix A). The rock fill is made up of strong durable sandstone that is suitable for the intended use.

Photo 4.1: Forteau quarry. Principal quarry face on the right side of the photograph. Note stockpile of unprocessed rockfill in left background. (July 15, 2014)

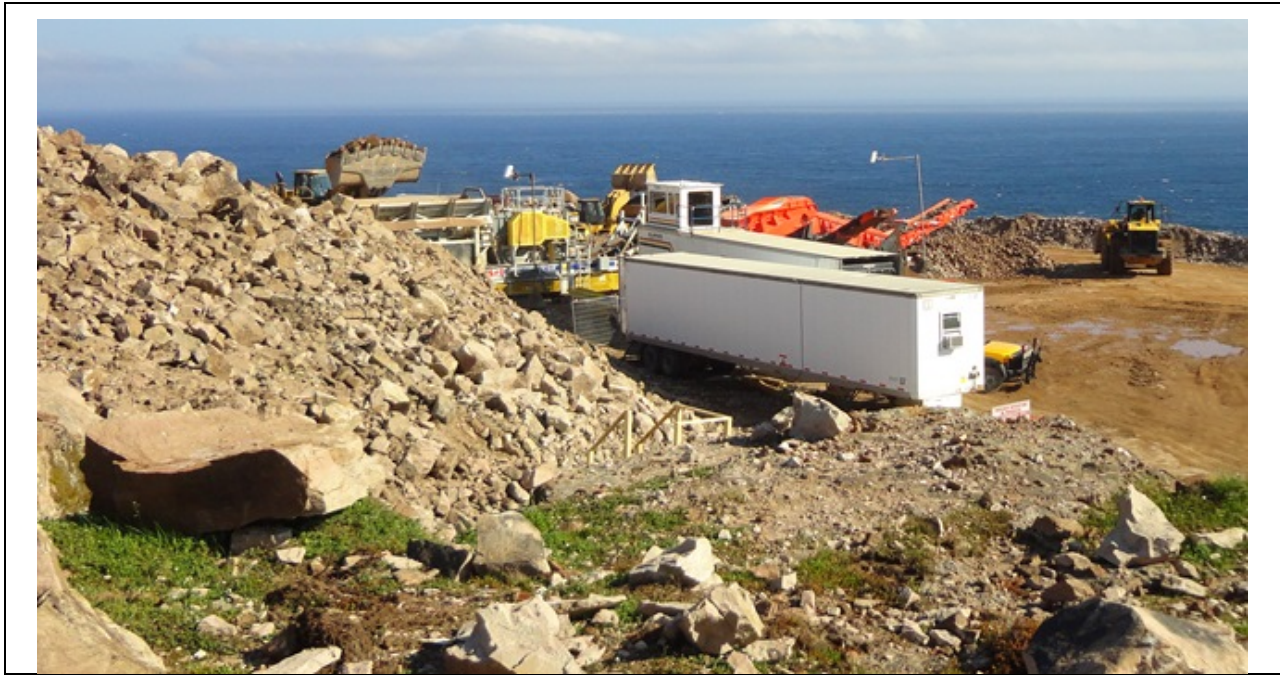
Photo 4.2: Forteau quarry. Crushing and screening plant in operation.

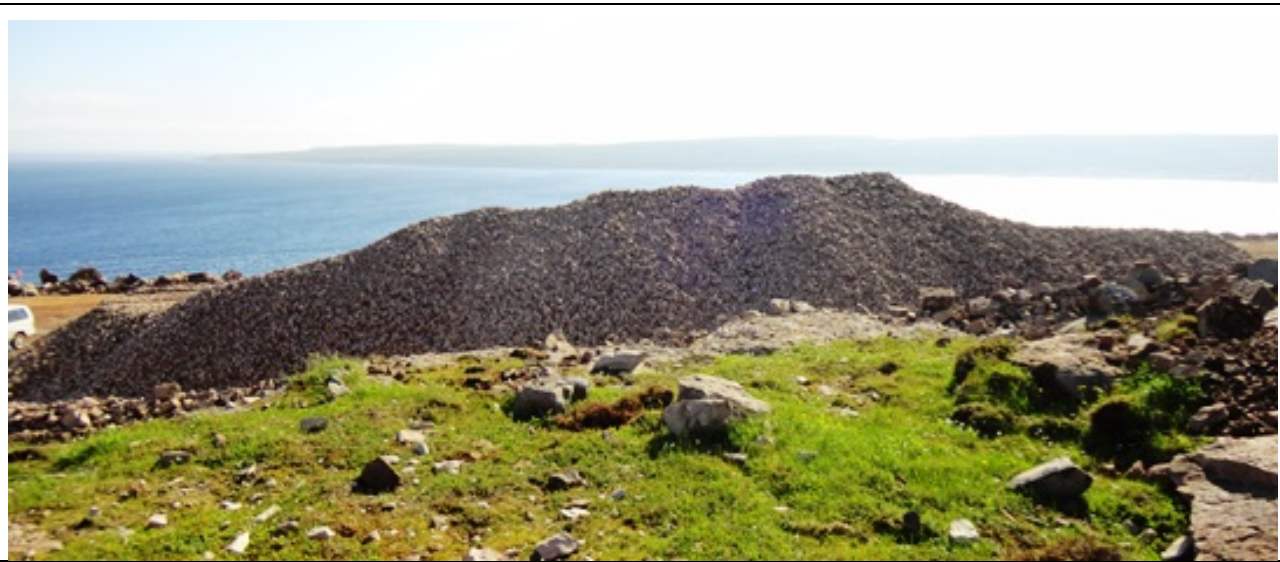
Photo 4.3: Forteau quarry. Stockpile of processed rockfill. (July 15, 2014)

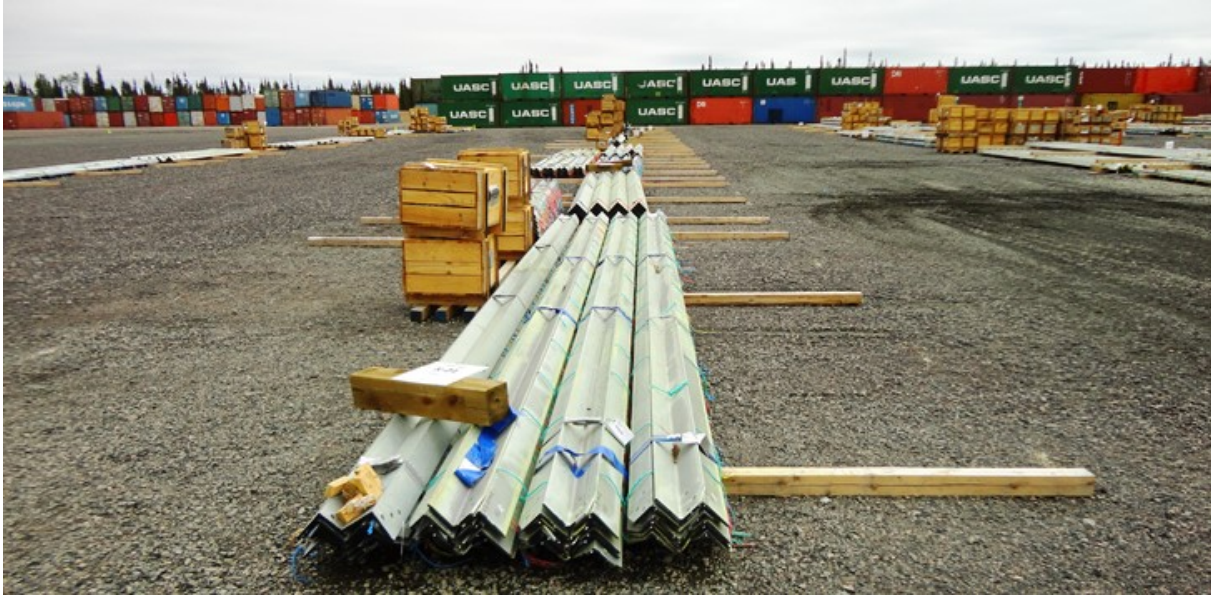
A main marshalling yard has been set up near Goose Bay (Photos 5.1 and 5.2). It is very well organized and has ample space for the planned quantities of construction materials for the various construction sites across Goose Bay, Muskrat Falls and the transmission lines.

Photo 5.1: Goose Bay Marshalling Yard (July 16, 2014)

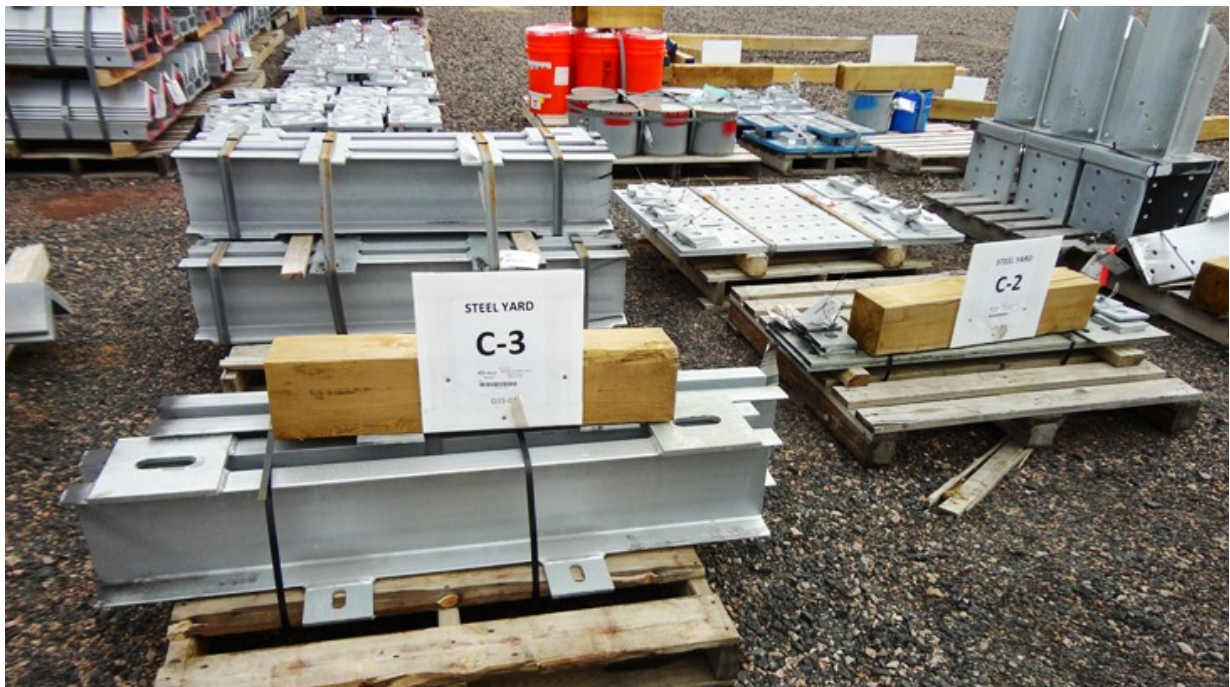
Photo 5.2: Goose Bay Marshalling Yard. Labeled transmission components for tower foundation (July 16, 2014)

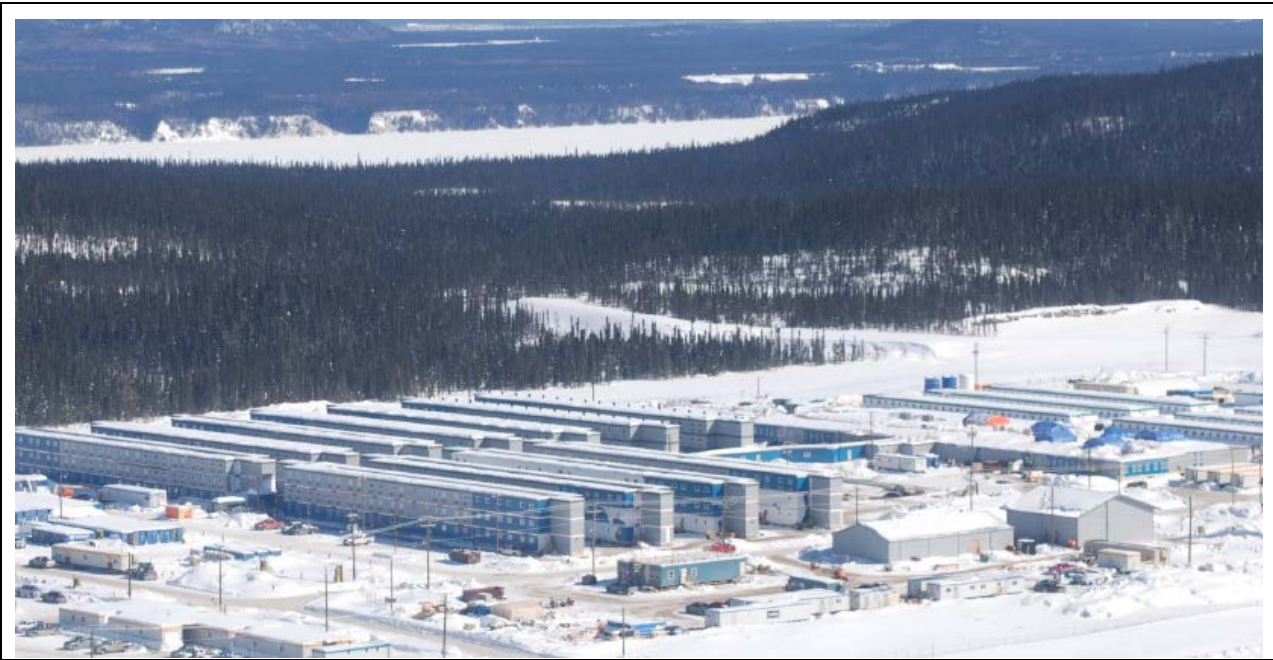
Nalcor is providing camp facilities for the various contractors. The new permanent camp is now completed (Photo 5.3 in Appendix A). Accommodations for approximately 1500 persons are available in the new permanent camp, supplemented by an additional 300 in the original "temporary" camp. The camps are of the accepted and even higher standard for northern work sites in Canada. The facility has adequate dining and recreation (a gym facility is still in construction) facilities for the residents. The main camp's kitchen and lounge for 500 single seating are very well organized and generally of a high standard. The kitchen layout accommodates a second (spare) serving bay that provides increased capacity during peak hours demand. The living quarters are with individual units, each one equipped with TV and wireless internet, individual toilet and shared (by two units) shower. Additional camps have been established at Churchill Falls and along the transmission line route, upstream of Muskrat Falls.

Photo 5.3: Muskrat Falls Camp, permanent and starter (Nalcor photo -Winter 2014)

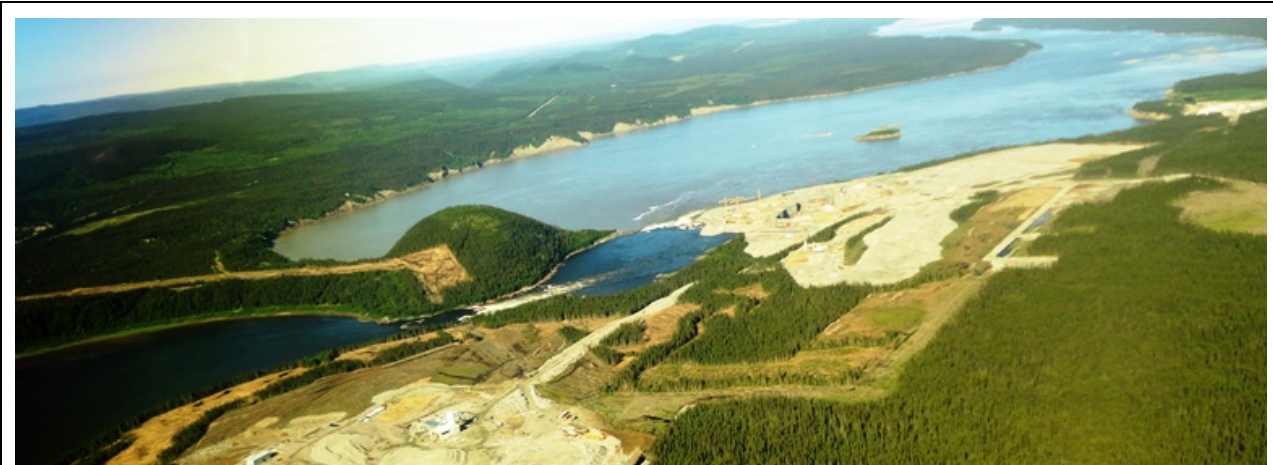
The North Spur is a 1000m long, 500m wide and 45 to 60m high ridge that connects the Muskrat Falls rock knoll to the north bank of the river (Photo 6.1). When the reservoir is impounded this feature will form a natural dam and become a major part of the river impoundment system. The feature is composed of unconsolidated mixed sand and marine silt/clay sediments. The depth to bedrock underneath the spur is in the range of 200 to 250 m. It contains a significant amount of glacio-marine silt/clay sediments, including horizons of highly sensitive clay strata, mixed with some sandy layers. The upstream and downstream slopes of this feature are subject to ongoing river erosion and mass wasting. This has contributed to local slope oversteepening of the slope, which triggers rotational sliding on both the downstream and upstream sides of the spur.

Photo 6.1: Panoramic view of the Muskrat Falls site looking towards downstream (July 18, 2014). The powerhouse/spillway site is visible on the upper right side of the photo. Transmission line clearing on the North Spur and reservoir clearing upstream of the falls are visible in the left side of the photograph.

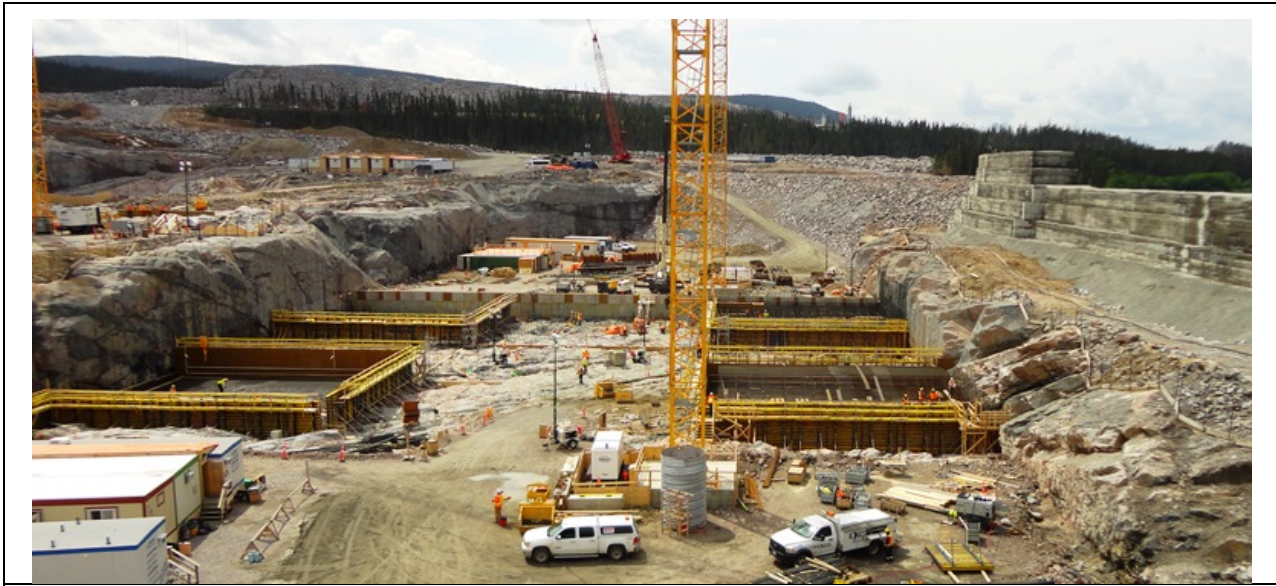
- During the IE site visit, work was underway at the first four base slabs of the spillway (Photo 6.2 in Appendix A). Foundation preparation had been completed, but could not be inspected by the IE on foot because of the limitations of the tour itinerary and heavy concentration of work at the foundation area.

Photo 6.2: Spillway base slab. Formwork for first four blocks of the base slab. (July 17, 2014)

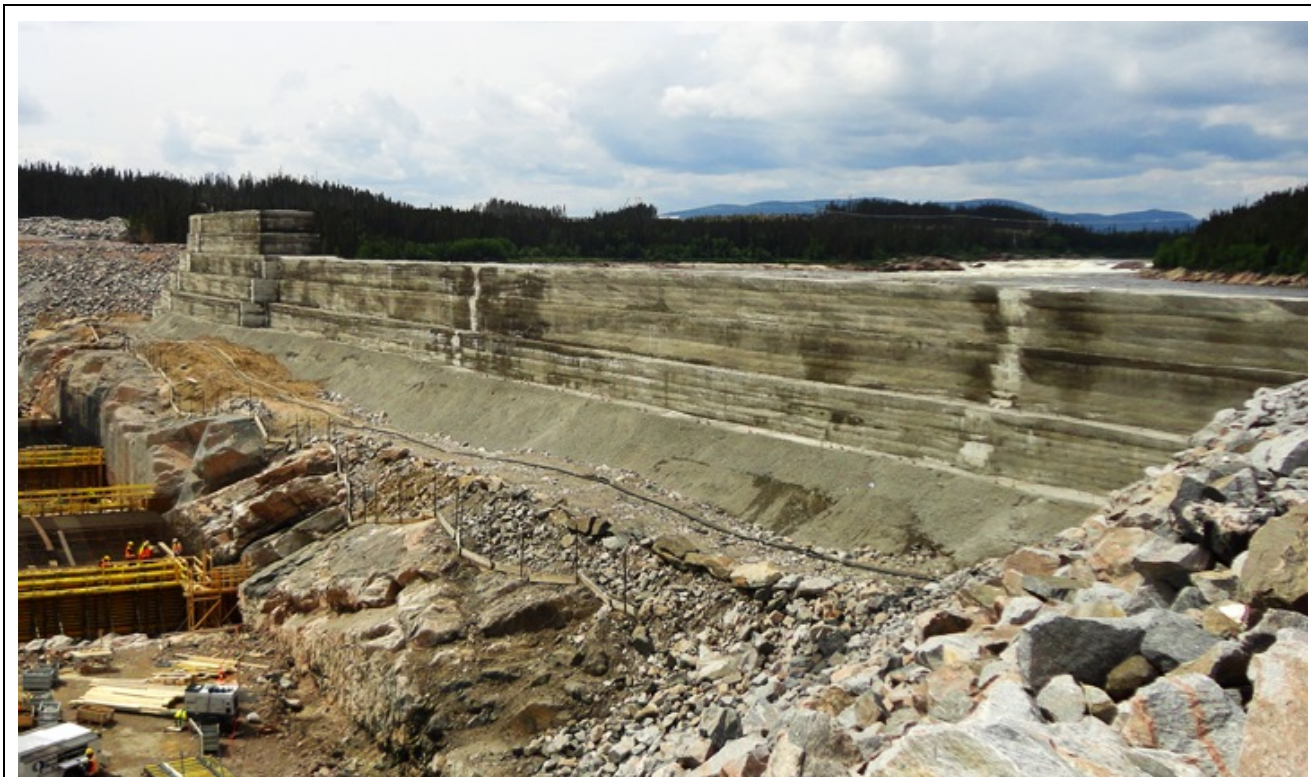
- The completed first stage cofferdams are shown on Photos 6.3 and 6.4 in Appendix A. These structures performed very well during the winter of 2013-2014 despite the unusual severity of the river ice conditions.

Photo 6.3: RCC cofferdam above the spillway left wall. Note the localized blasting overbreak of the spillway rock slope caused by block sliding along pervasive foliation planes. (July 17, 2014)

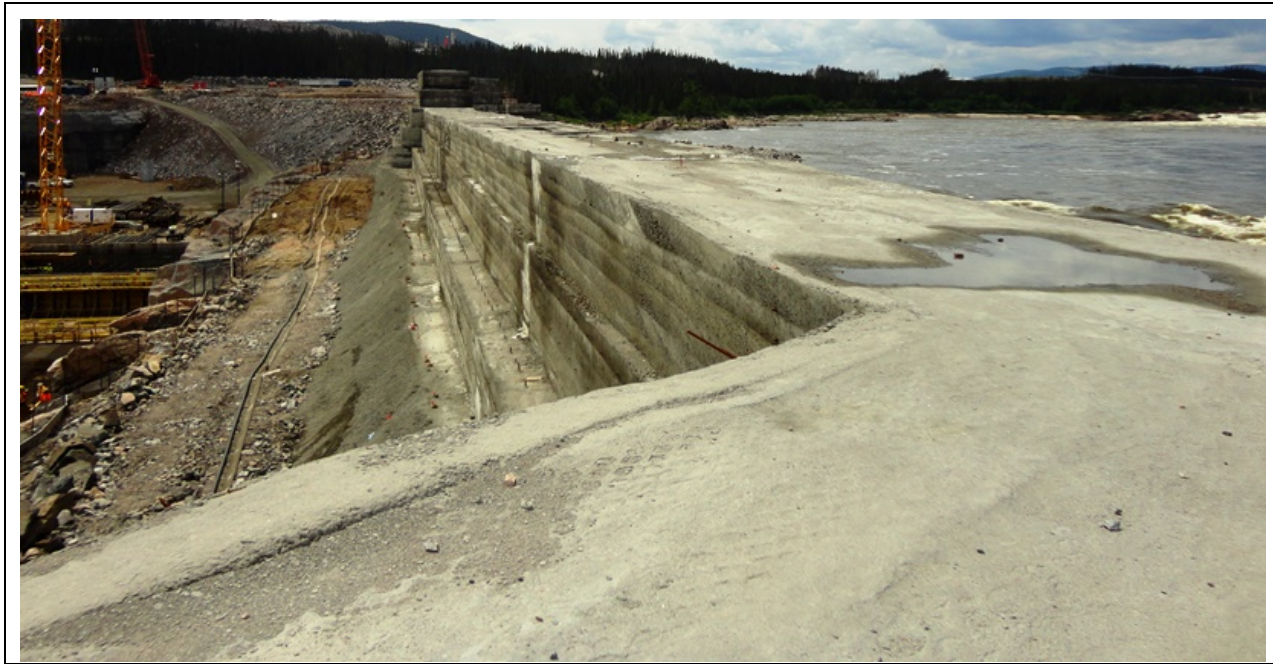
Photo 6.4: RCC cofferdam above spillway left wall. (July 17, 2014)

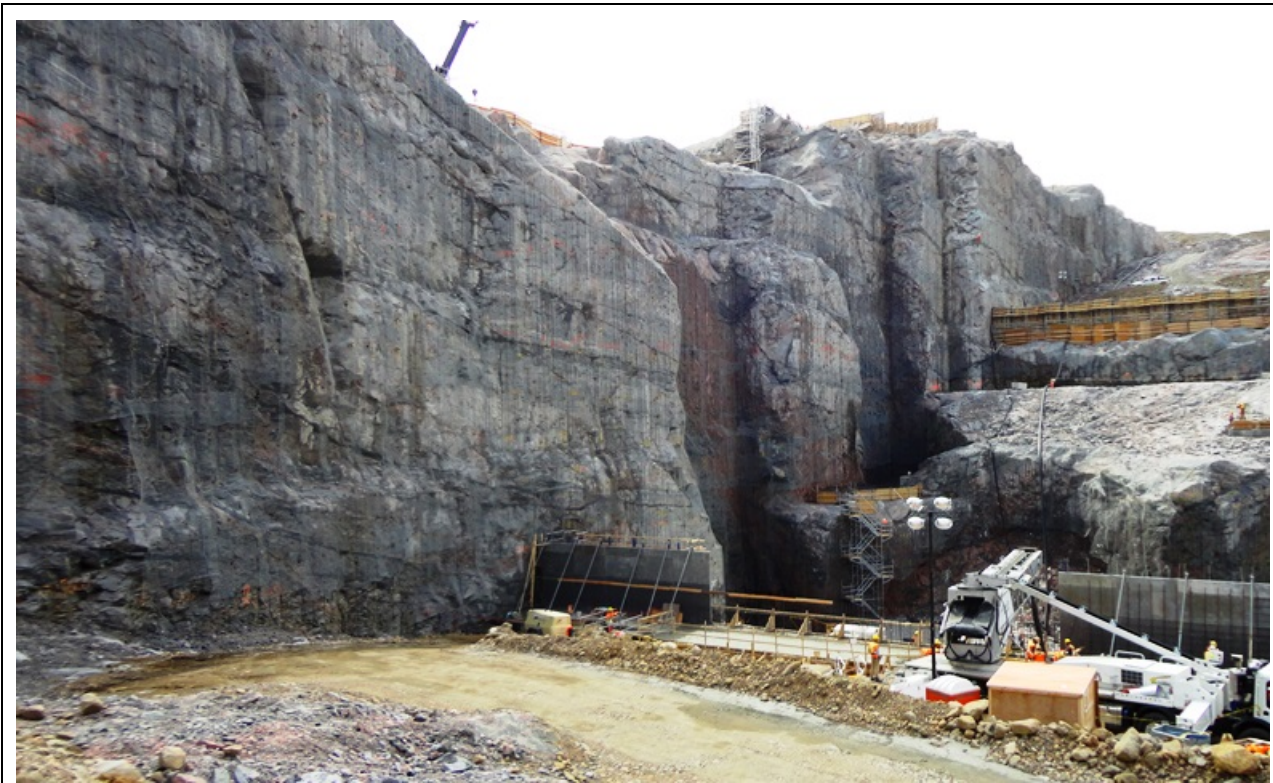
- Excavation of the Power Intake/Powerhouse/Tailrace channel is 100% complete. Controlled blasting techniques were used to form the final walls and the results are generally very good. Line drilling techniques (no explosives in the control line holes) were used in the concrete structures areas and presplit blasting is employed to form final walls in the open channels of the tailrace, intake and spillway. Rock support installations are adequate and significant rock slope stability issues have developed. The final excavated walls are in very good condition and there is minimal overbreak. There are a few cases of small localized overbreak that are triggered by shallow block sliding or toppling along natural discontinuities adjacent the face (Photos 6.3 and 6.5 in Appendix A). None of these features significantly diminish the overall integrity of the slopes or the quality of the slopes.

Photo 6.5: Right rock slope at powerhouse. Note the excellent quality of the line drilled excavated rock walls. A single fallout of a small wedges has caused a very localized overbreak feature. (July 17, 2014)

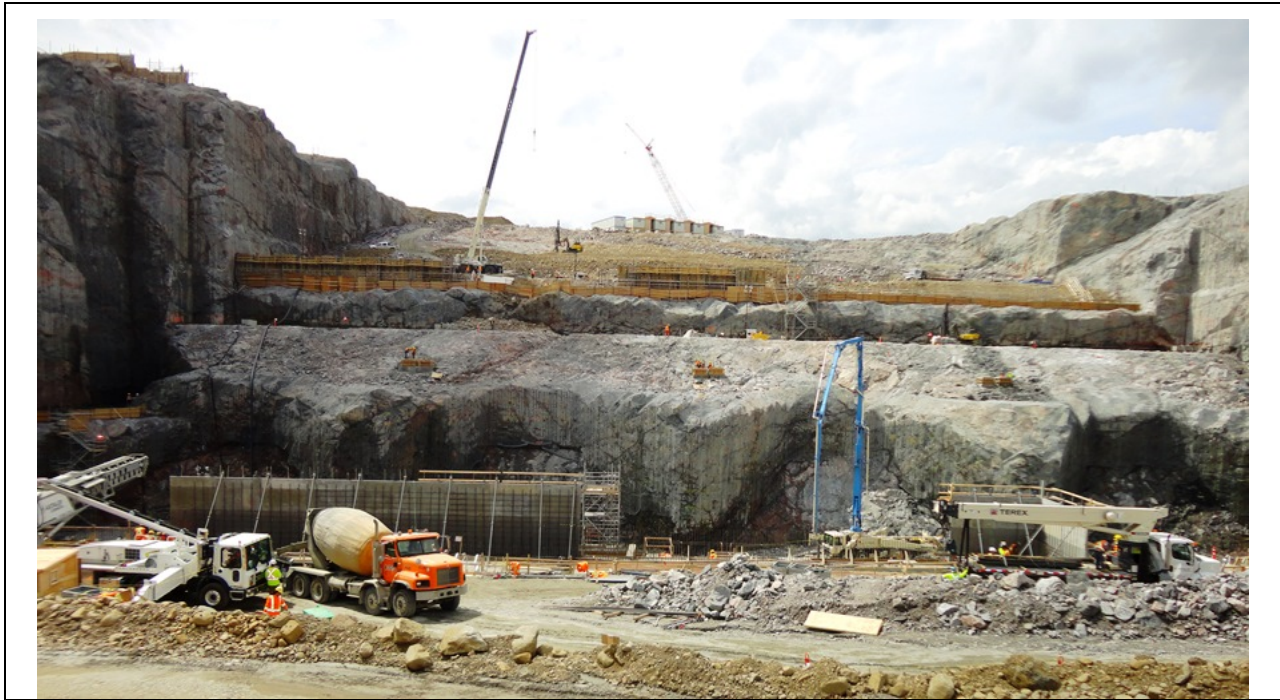
Photo 6.6: Powerhouse excavation, view looking upstream. The excellent control blasting results are visible in the rock noses between the unit cut-outs. (July 16, 2014)

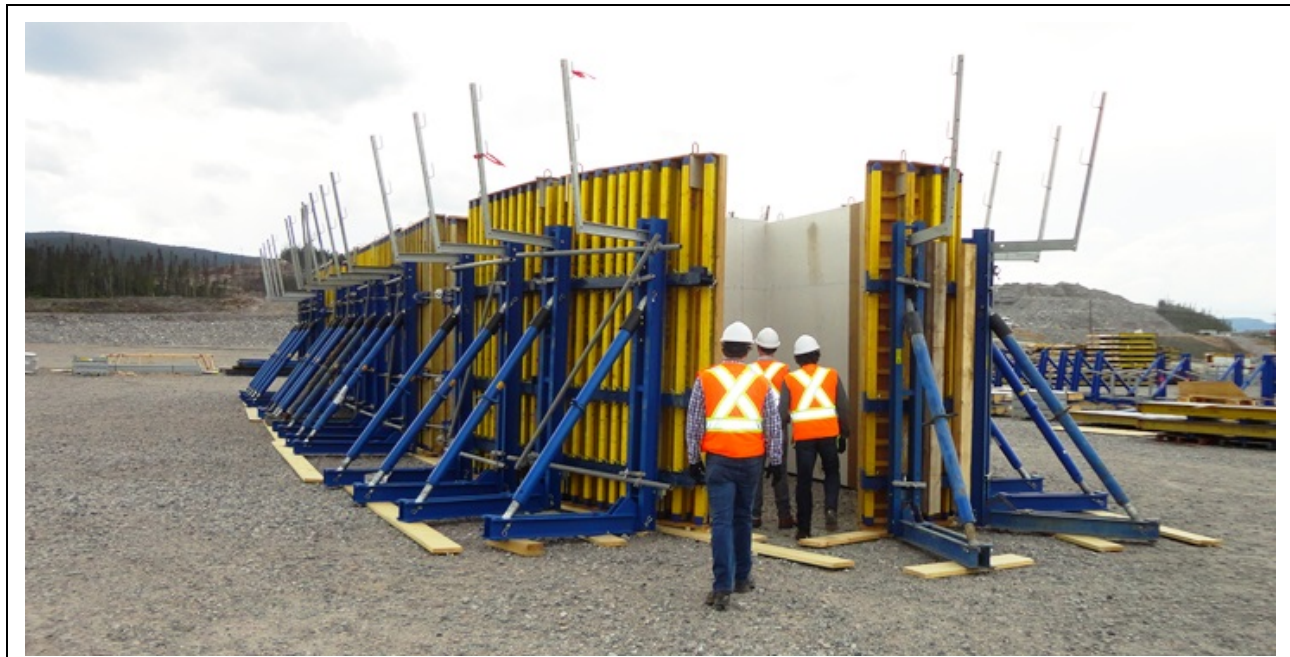
- Concrete works for the powerhouse and intake have commenced. Formwork was being erected at the time of the IE site visit (Photo 6.6 in Appendix A)
- A trial fitting of the pier formwork components was carried out (Photo 6.7 in Appendix A). The quality of the formwork was judged by the IE to be excellent.

Photo 6.7: Trial assembly of tailrace pier formwork. (July 17, 2014)

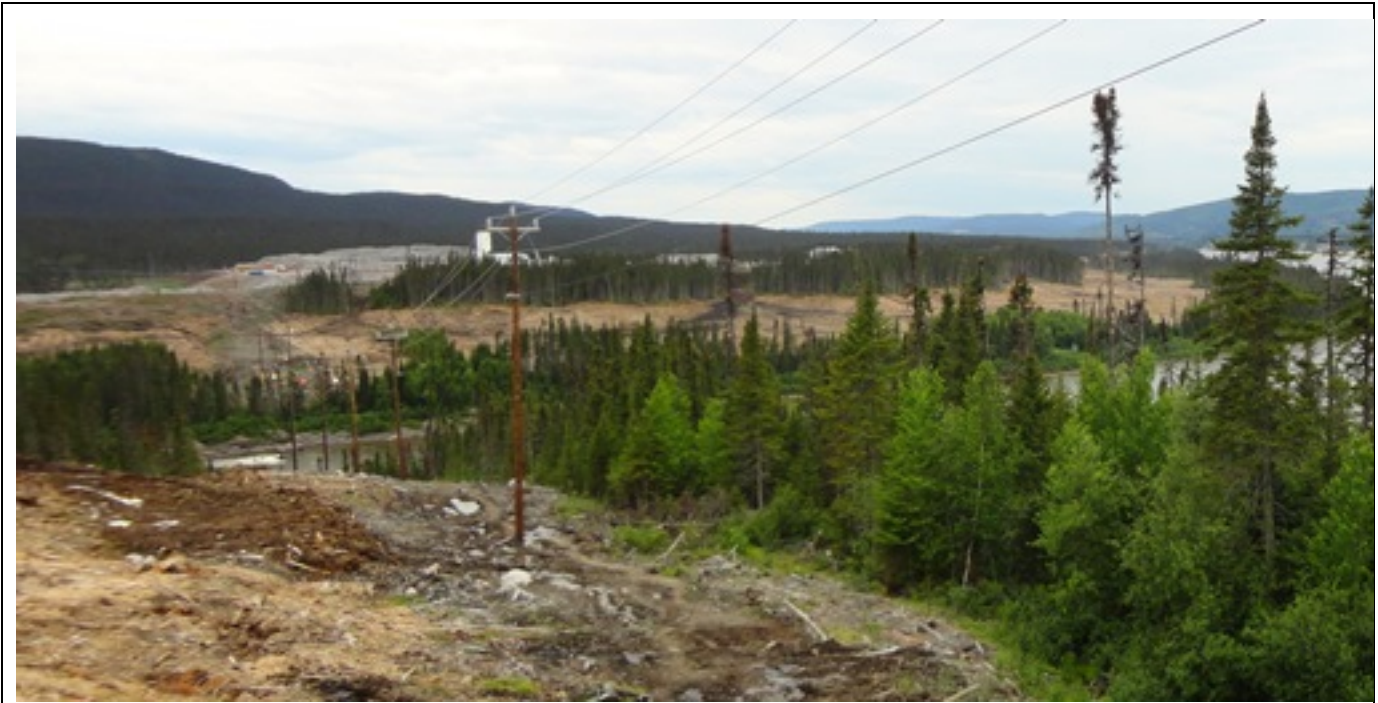
Photo 7.1: North Spur. View from top of North Spur looking towards the upstream Churchill River. Note reservoir clearing in center field and right bank quarry aggregate stockpile in background. (July 16, 2014)

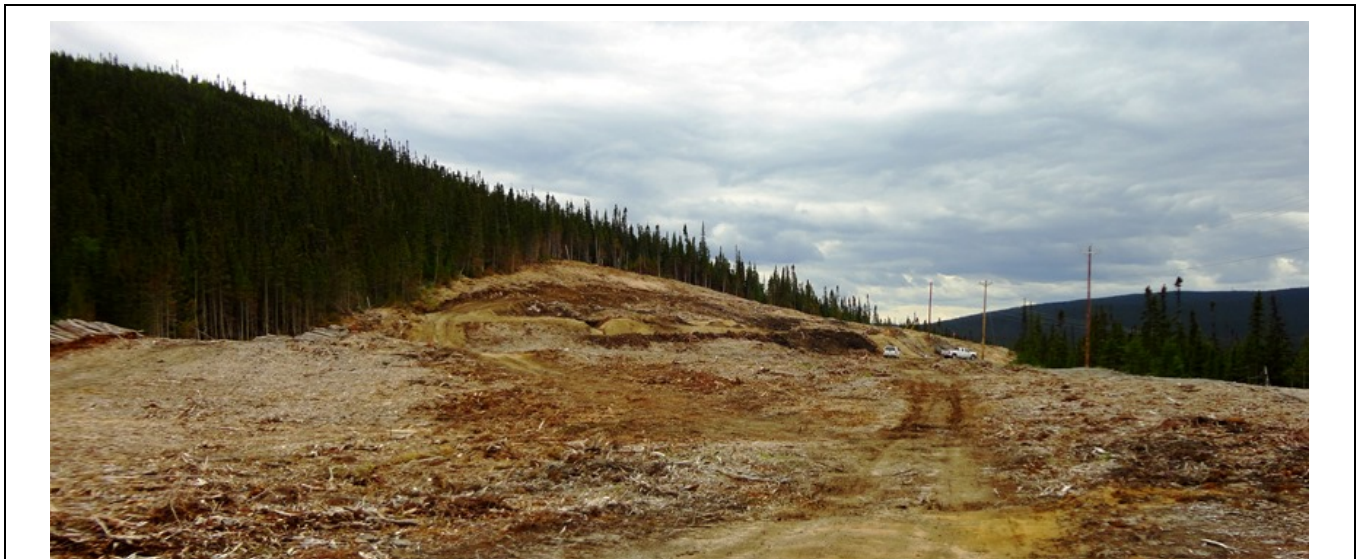
Photo 7.2: North Spur. Cleared transmission line corridor on top of the North Spur, looking northwest. (July 16, 2014)
