LOWER CHURCHILL PROJECT

SITE VISIT REPORT JULY 14 TO 23, 2014.

Prepared for: Natural Resources Canada and Nalcor Energy

Date: September 19, 2014

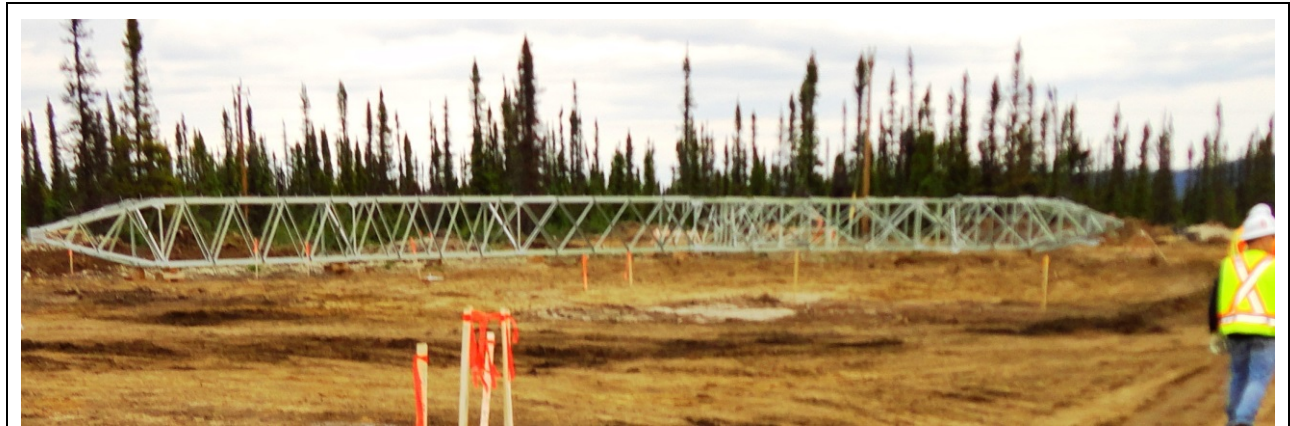
Photo 8.1: Transmission Tower Erection and Foundations. Assembled single HVac tower unit. (July 17, 2014)

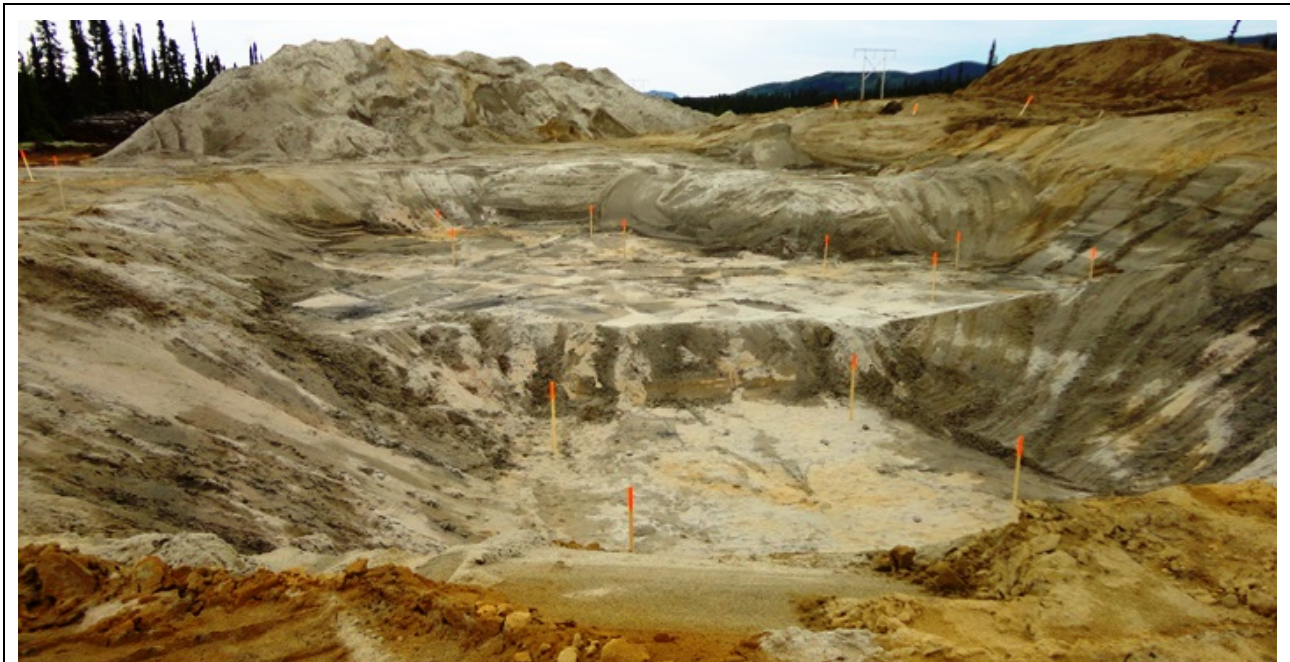
- Prepared foundations were viewed, as shown on Photo 8.2 in Appendix A. Work on the foundations examined has been carried out in accordance with good practice.

Photo 8.2: Transmission Tower Erection and Foundations. Excavated and prepared tower foundation (July 16, 2014)

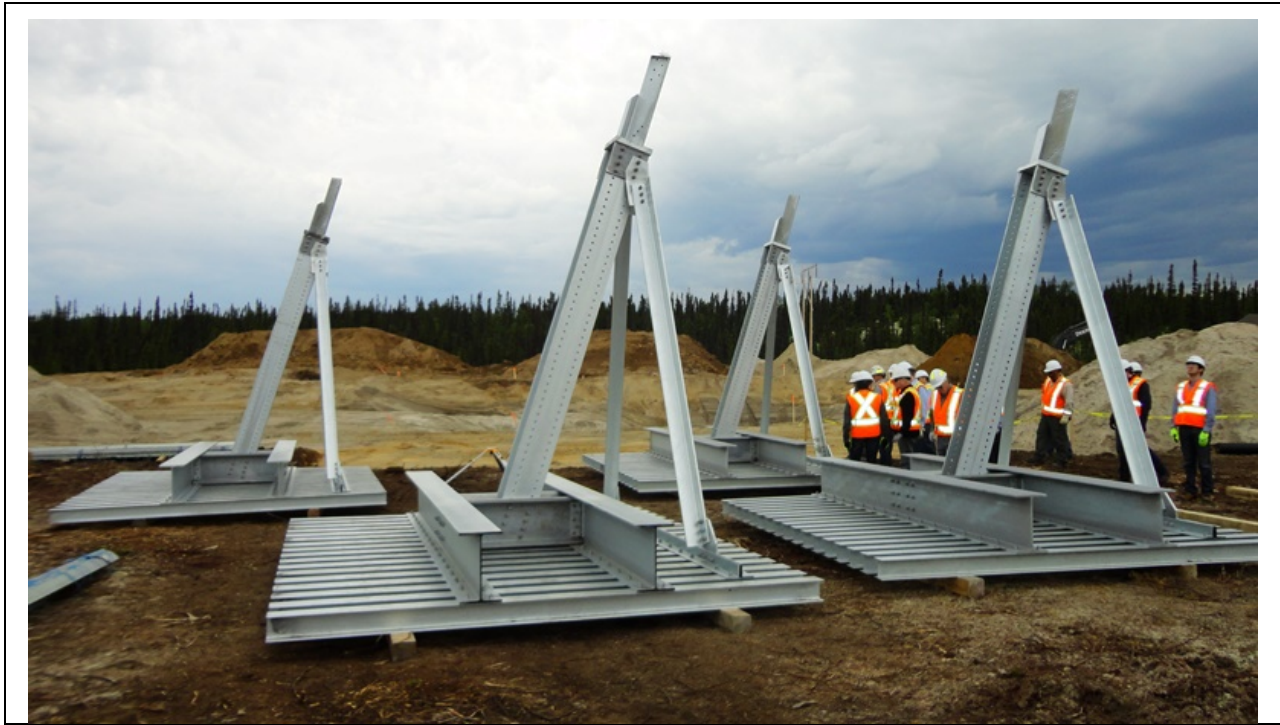
- Grillage footings (Photo 8.3 in Appendix A) are being used for overburden foundations. Two types of grillage footings were available for the HVac line; 100 kPa footing for loose to compact sandy foundations and 250 kPa footings for denser soils, including glacial till deposits. It is understood that there is a steel footing for competent bedrock foundations. Similar footings are used for the HVdc lines east of Muskrat Falls and on the island of Newfoundland. It is understood that footing types for various foundation conditions are chosen by qualified geotechnical personnel in accordance with a set of field guidelines prepared by the designers.

Photo 8.3: Transmission Tower Erection and Foundations. Assembled grillage footings. (July 16, 2014)

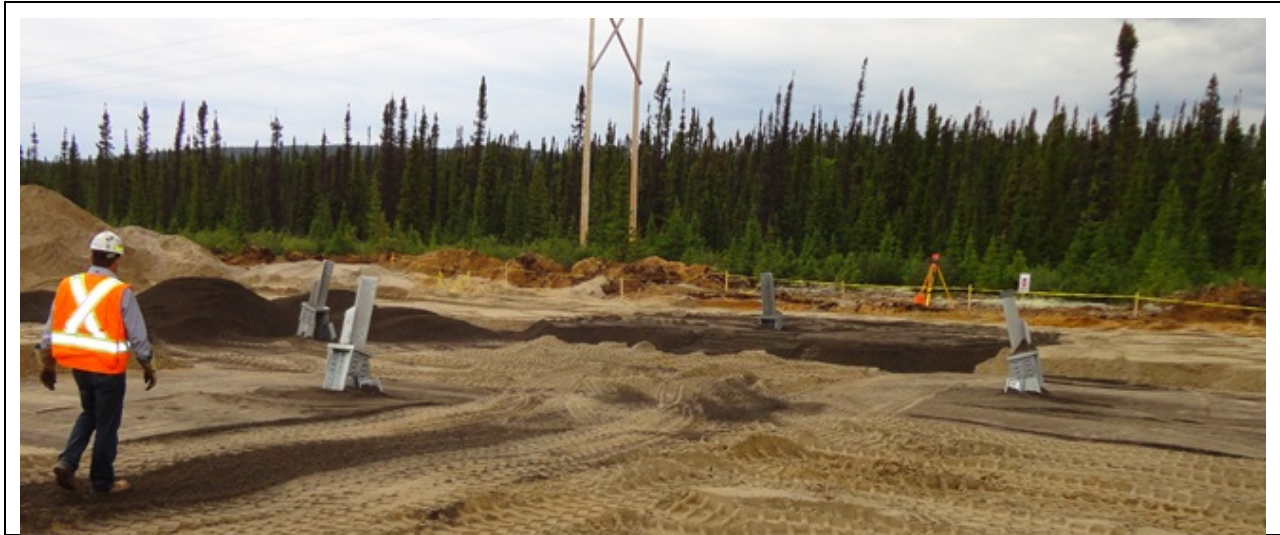
Photo 8.4: Transmission Tower Erection and Foundations. Tower footings installed and backfilled (four legged tower) (July 16, 2014)

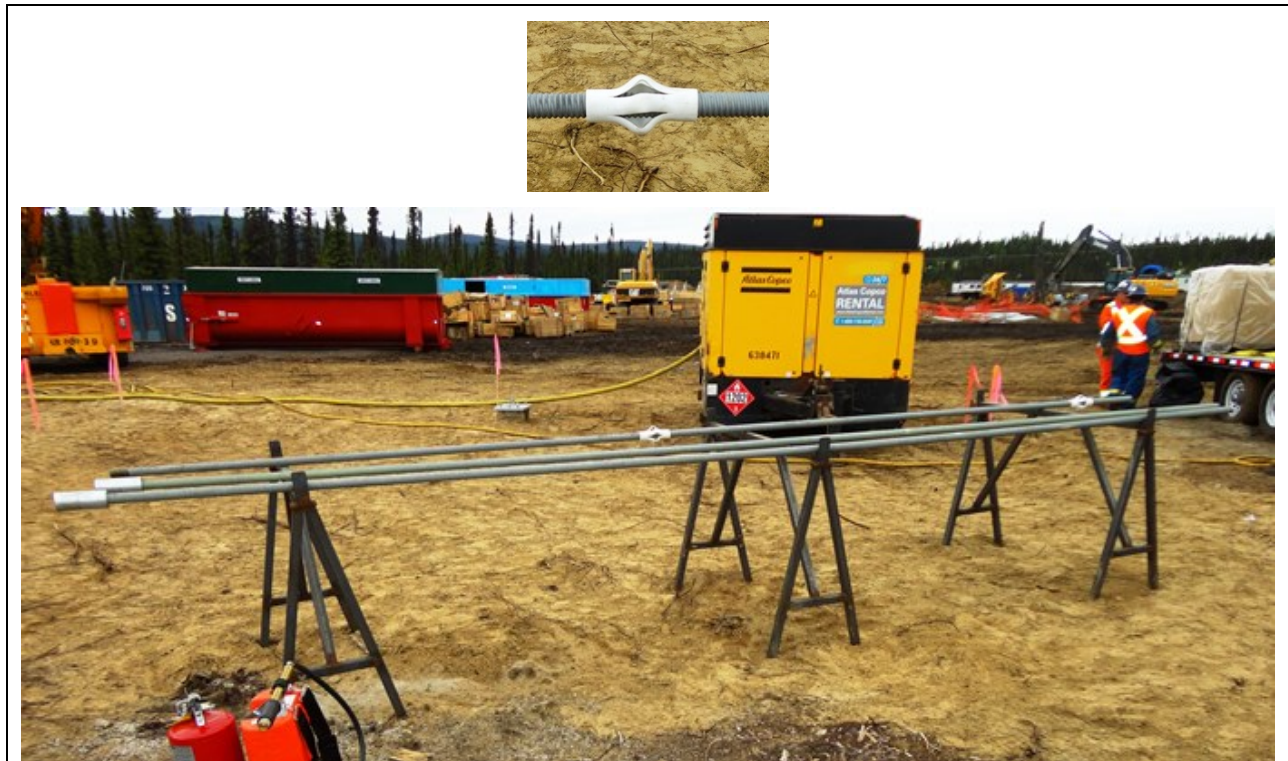
- Guy wires for towers are attached to fully grouted soil anchors. The IE team viewed installation work for one of these anchors on July 16, 2014 (Photos 8.5, 8.6 and 8.6 in Appendix A). The anchor details vary depending upon soil conditions and guy wire loadings. The following ground anchor design details apply:

Photo 8.5: Transmission Tower Erection and Foundations. Ground anchorage assembly, complete with couplers. Inset shows a typical plastic centralizer (July 16, 2014)

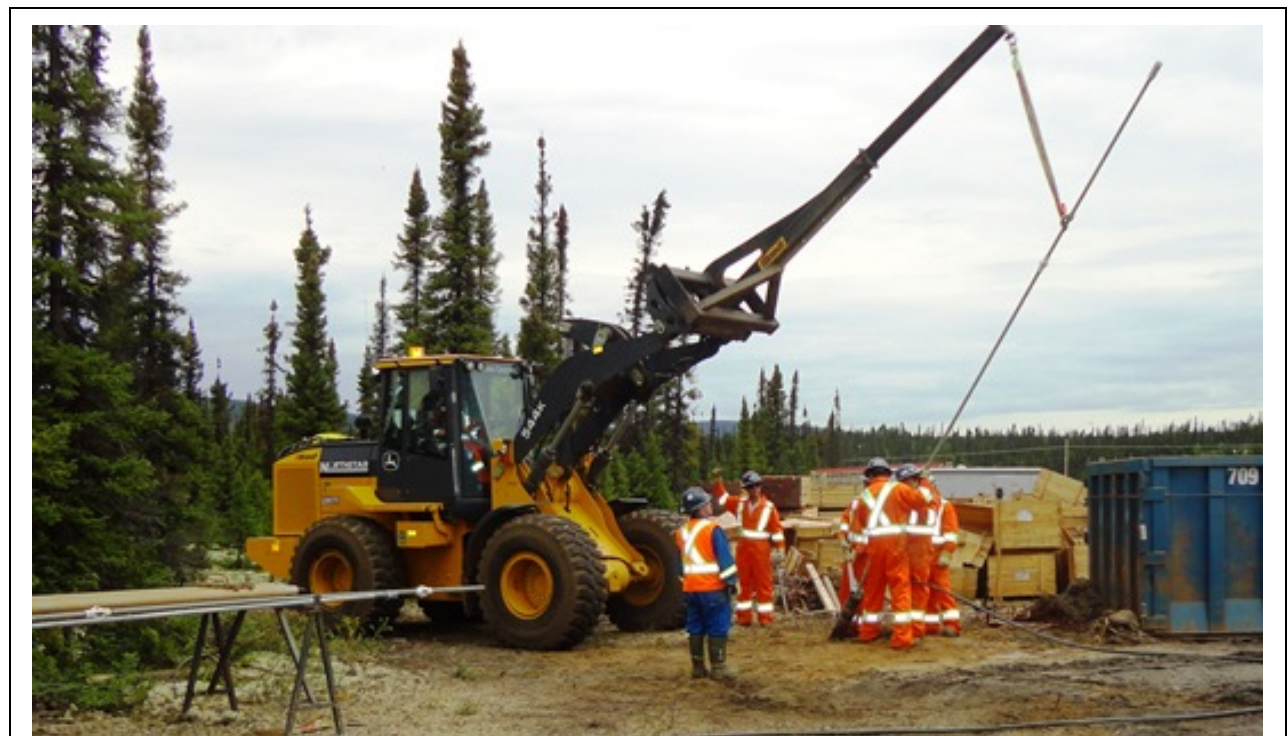
Photo 8.6: Transmission Tower Erection and Foundations. Installing a ground anchor. (July 16, 2014)

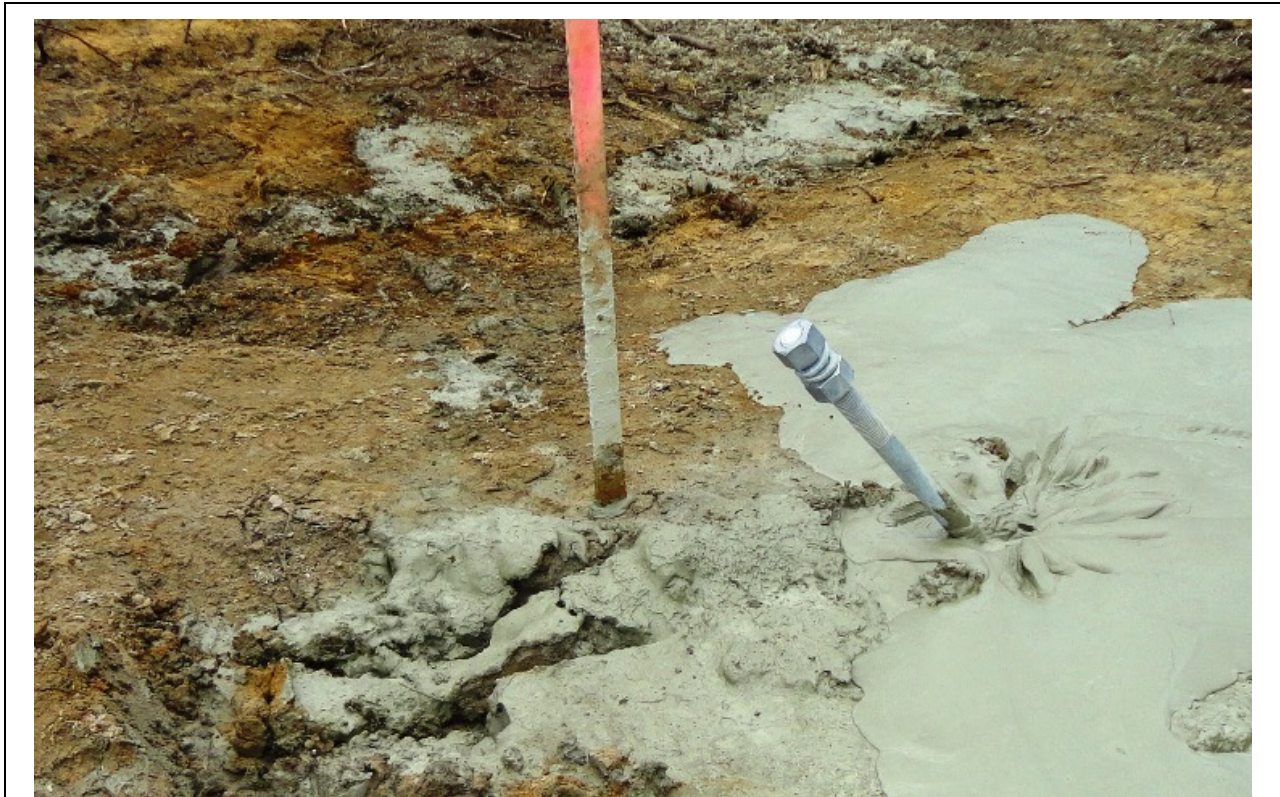
- Anchors are installed in cases and in inclined holes. They are tremie grouted through a plastic grout line as the casing is removed from the hole.
 - Performance tests are performed at 200% design load (DL) and proof tests at 100% DL. It is noted that the Nalcor proof test load is lower than normally accepted criteria (FWHA uses 150% DL and PTI recommends 133% DL for proof tests).

Photo 8.7: Transmission Tower Erection and Foundations. Installed, fully grouted ground anchor. (July 16, 2014)

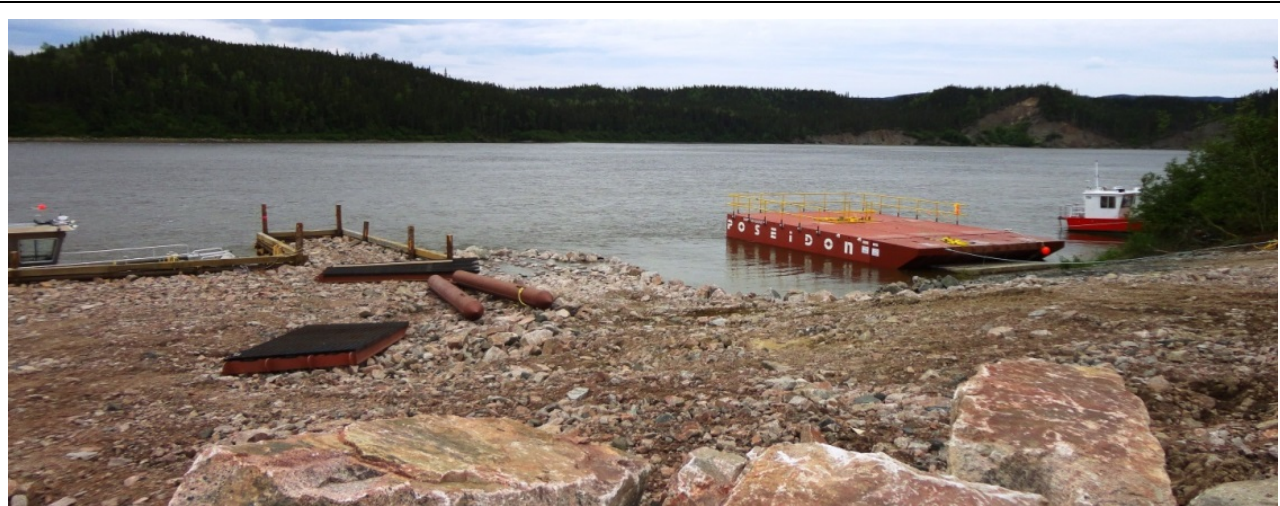
Photo 9.1: River crossing site in the upstream reservoir. (July 16, 2014)

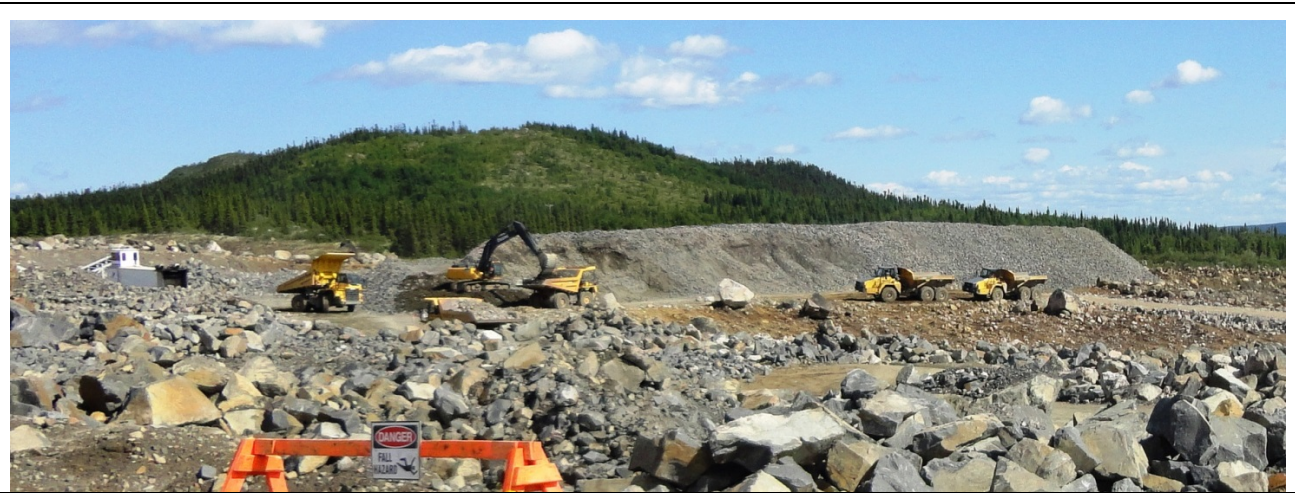
Photo 10.1: Churchill Falls New 315 kV substation and switchyard. Loading processed fill. Note stockpile of processed fill in the background and blasted rock in foreground. (July 18, 2014)

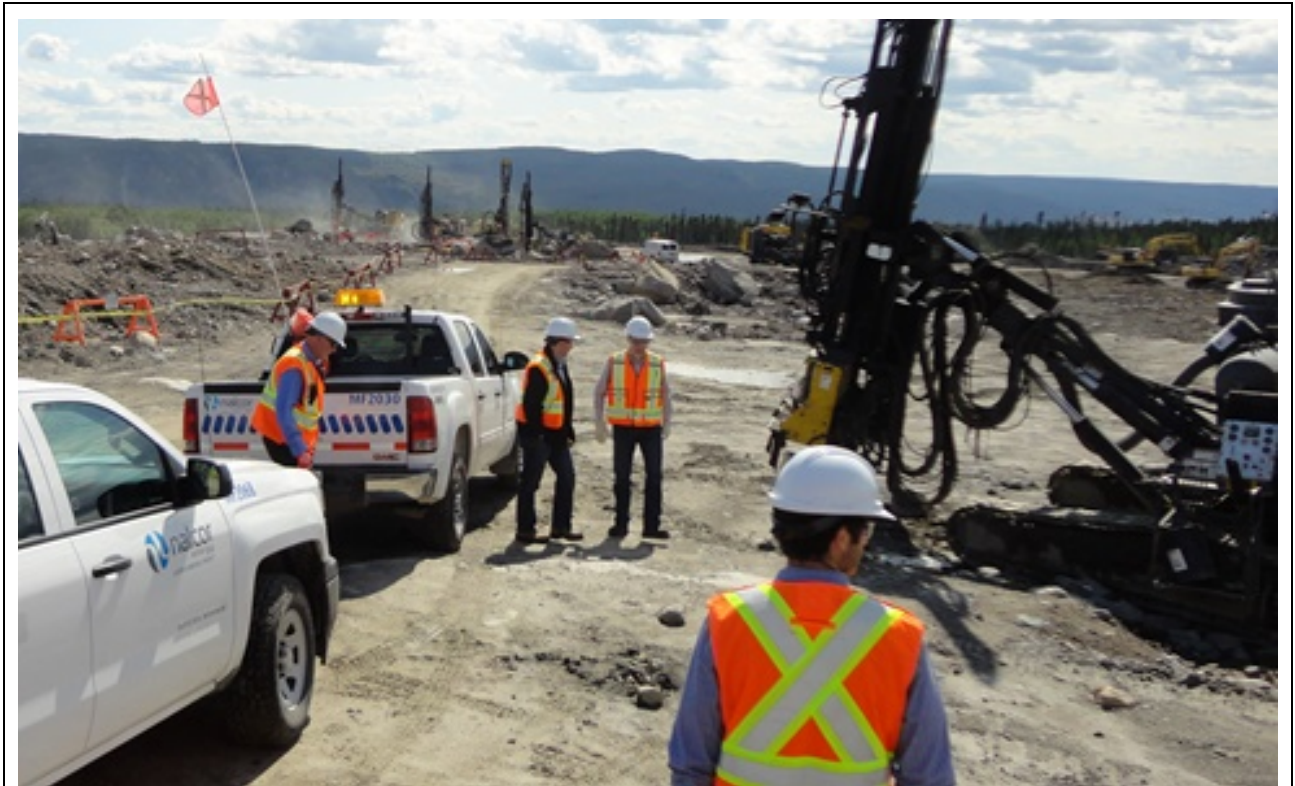
Photo 10.2: Churchill Falls New 315 kV substation and switchyard. Blast hole drilling in bedrock. (July 18, 2014)
