# MEETINGS IN ST. JOHN'S AND VISITS TO LOWER CHURCHILL PROJECT SITES, NOVEMBER 24 TO 27, 2014

Prepared for: Nalcor Energy

Date: January 28, 2014

Photos  
Muskrat Falls Site Visit - November 25 and 26, 2014

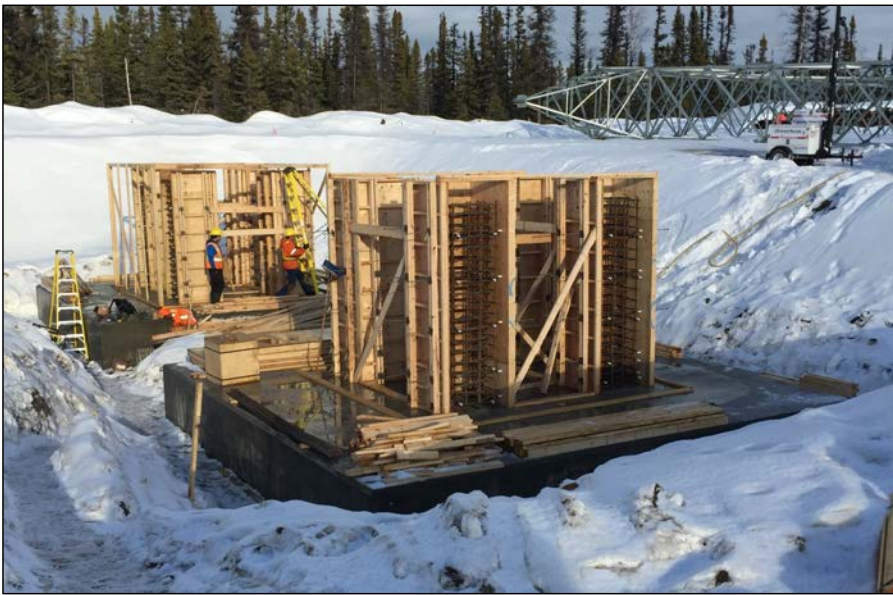
Photo 1.1 HVac transmission line foundation installation. (November 25, 2014)

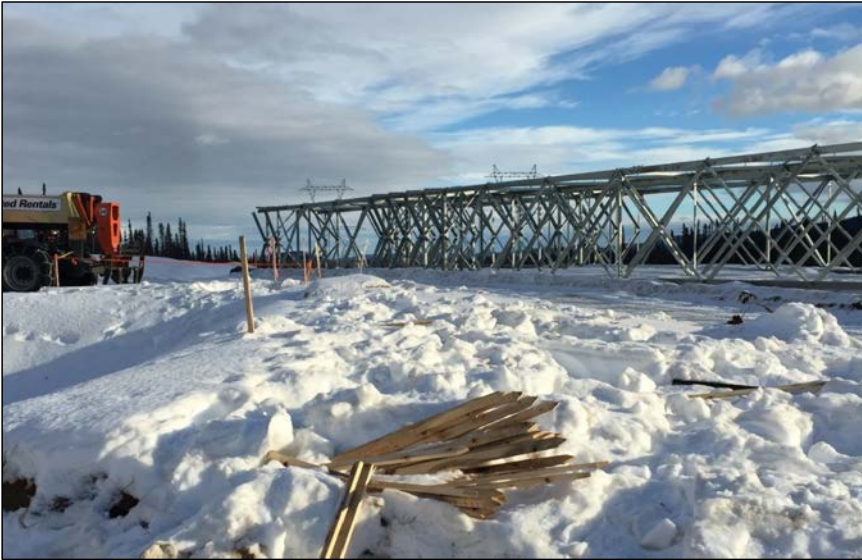
Photo 3.1: HVac transmission line structure assembly, November 25, 2014

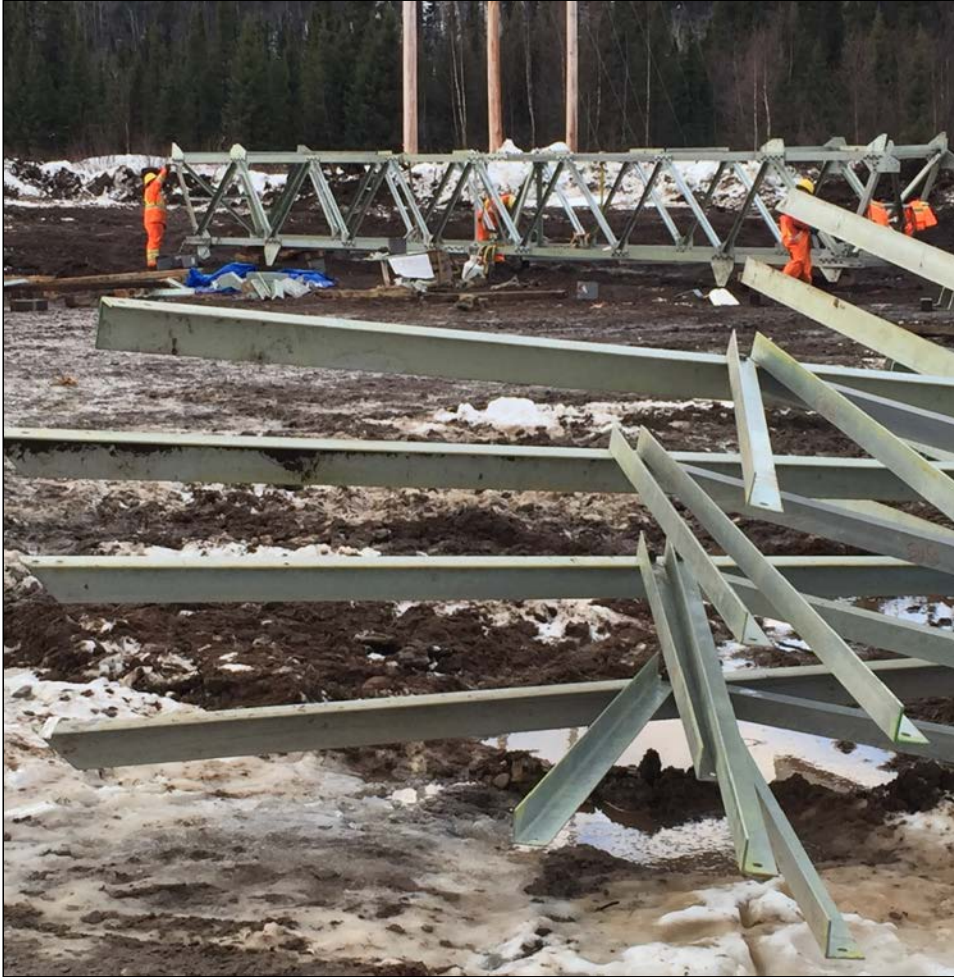
Photo 3.3: HVac transmission line structure assembly, November 25, 2014

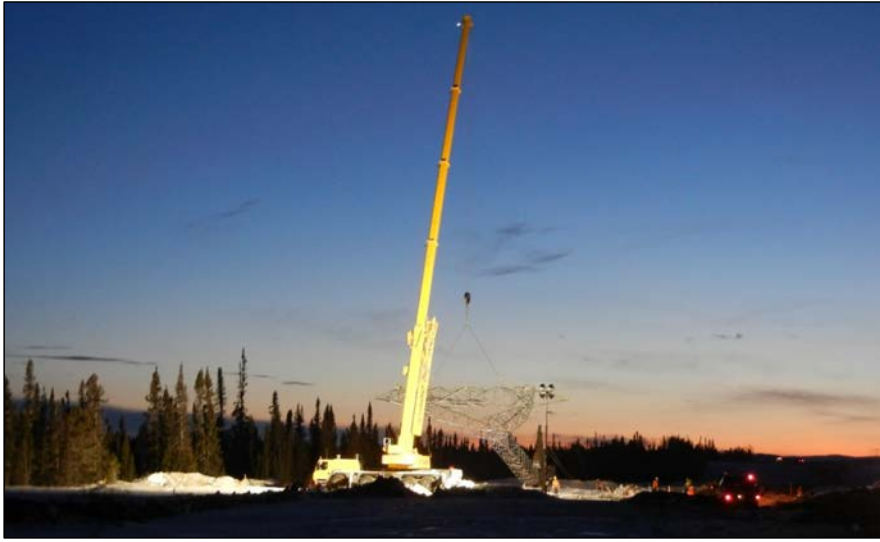
- No stringing or insulator/hardware has been installed yet.
- The IE witnessed the night time erection of a single foundation tower (Photos 4. 1, 4. 2a and b). The total time for the crew to move onto the site and erect the tower with a crane was just over one hour. When the IE team departed the site, crews were starting to secure to guy wires to the previously installed ground anchors.

Photo 4.1: HVac transmission line – structure erection, November 26, 2014

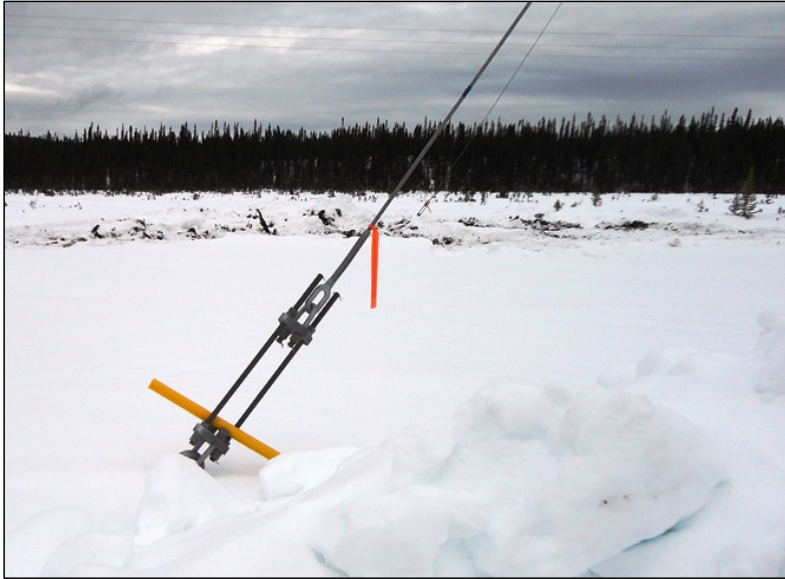
- A site visit was made to the guy wire assembly facility (Photos 2.1 and 2.2) and typical guy wire attachment installations were viewed (Photo 4.3).
- Tower assembly work (Photo 3.2) at each tower site was continuing at the time of the site visit. A significant number of units (approximately 300) have been completed and are ready for erection.

Photo 4.3: Lower connection of guy cable on single footing transmission tower

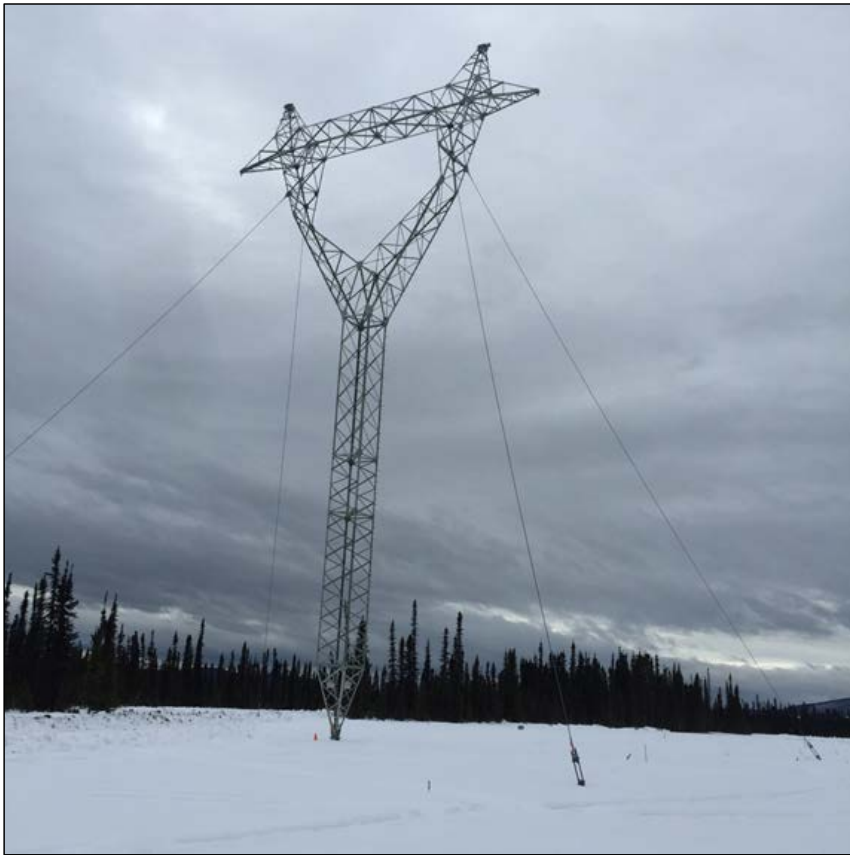
- A large number of foundations (approximately 300) have been completed.
- 56 HVac towers (Photos 5.1a, b, c and 5.1d) had been erected at the northern end of the line by the time of the site visits.

Photo 5.1a: HVac transmission line – erected guyed structure. (November 26, 2014)

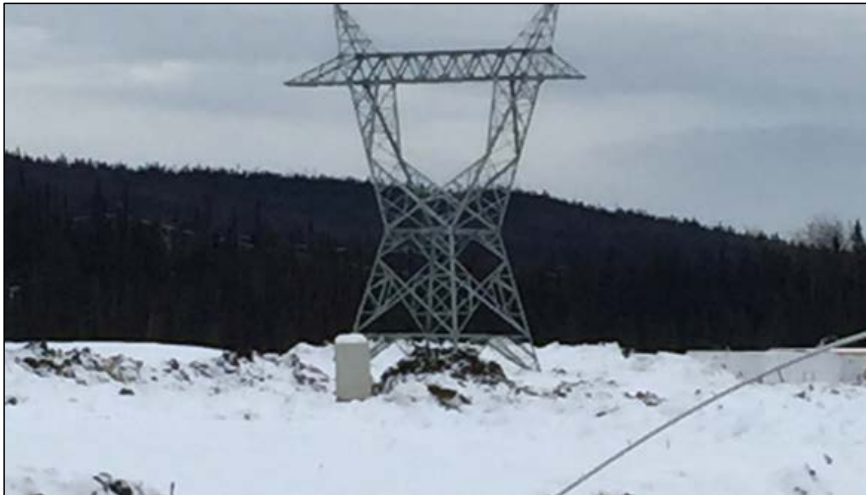
Photo 5.1b: HVac transmission line – erected Self Supporting Structure. (November 26, 2014)

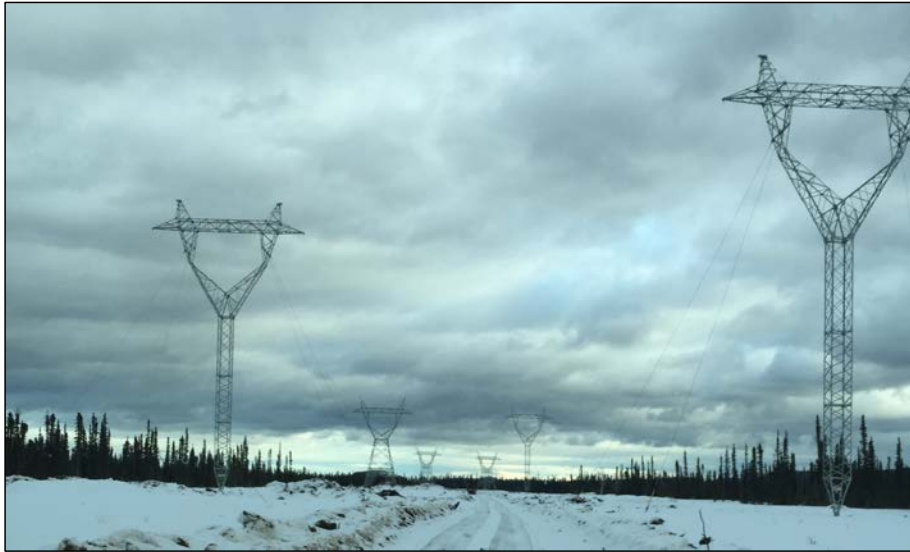
Photo 5.1d: HVAc transmission line – erected structures – Looking South toward both Lines, November 26, 2014

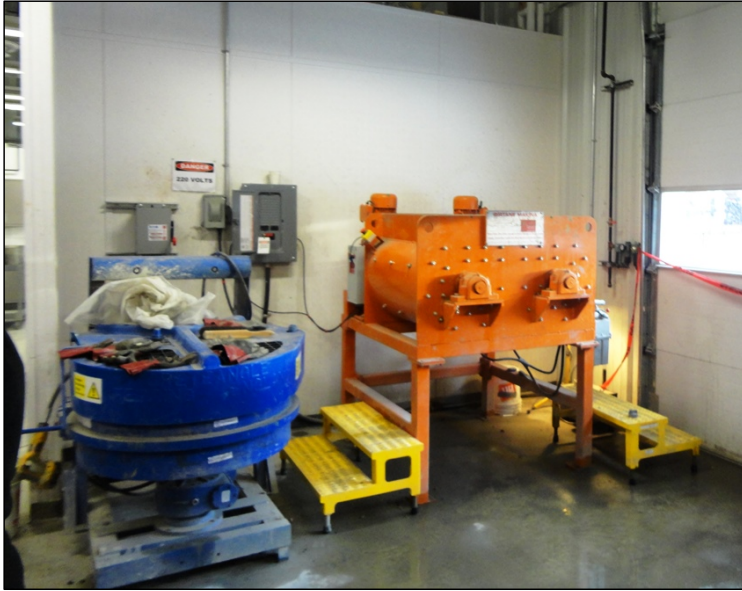
The IE inspected the soils and concrete testing laboratory on November 25, 2014. This facility is operational to carry out soil mechanics testing on fill samples and concrete testing. A program of concrete and RCC mix design is currently underway (Photos 6.1 – 6.5). A full range of soils mechanics and various concrete aggregate quality testing is carried out on aggregate and fill samples. It is understood that this facility is utilized by all contractors when confirming compliance with various technical specifications. The facility is well equipped, albeit a bit on the small size for a project of this magnitude.

Photo 6.1 Site laboratory; mixer for concrete mix design. (November 25, 2014)

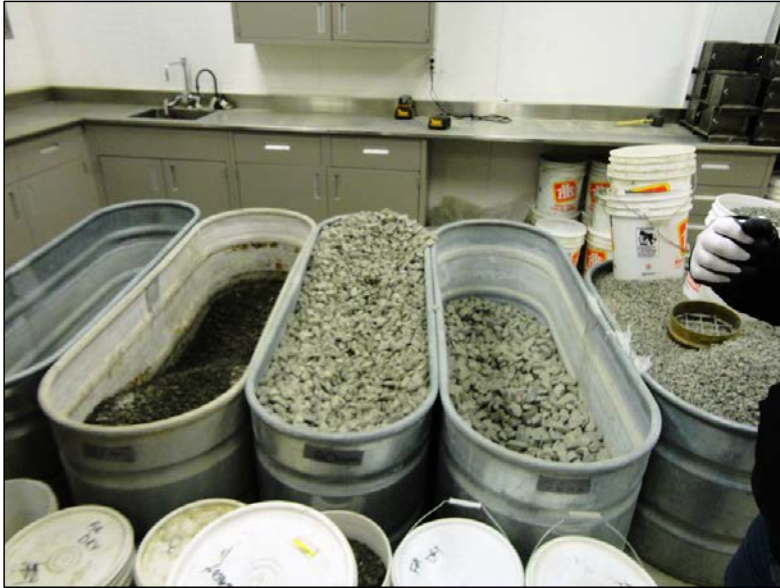
Photo 6.3: Site laboratory; graded aggregates for concrete mix design. (November 25, 2016)

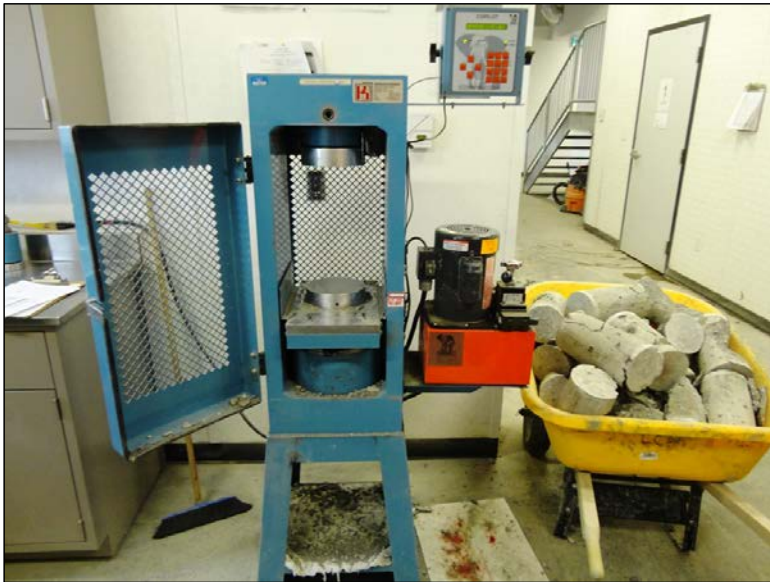
Photo 6.4: Site laboratory , unconfined compressive strength testing of concrete cylinders.

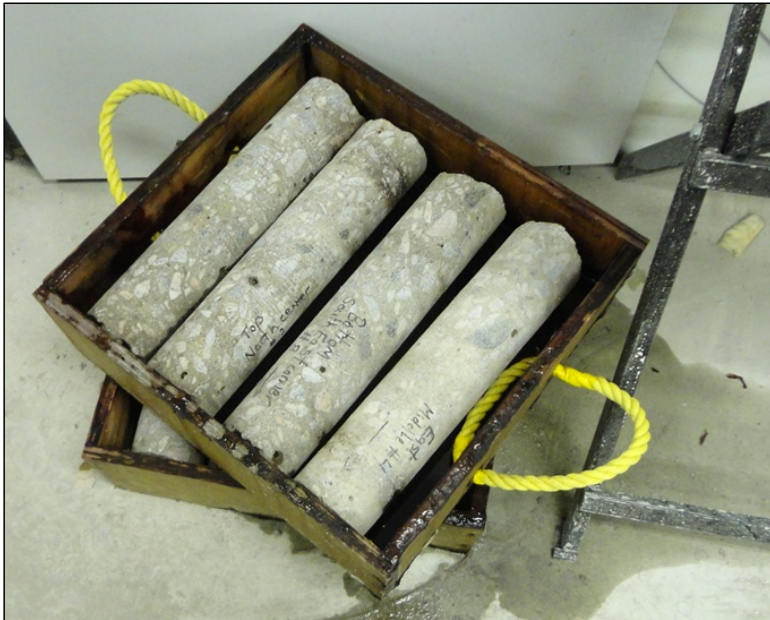
Photo 6.5: Drilled concrete cores from the field

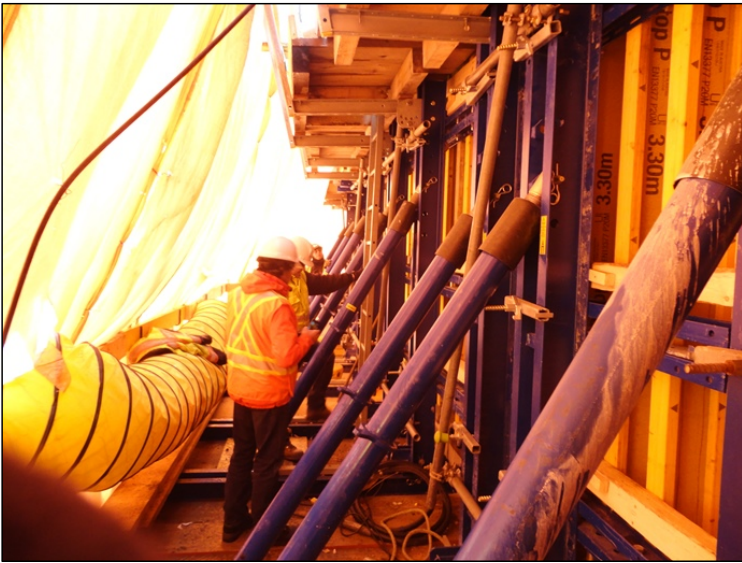
- Formwork erection and concrete placement work were underway in both abutments and all piers of the spillway structure (Photos 7.1 to 7.9). All works were enclosed in temporary shelters and heated with forced air heaters (Photos 7.6 to 7.9). This work is being carried out to a good standard and the shelter/heating arrangements are satisfactory for continuation of the work throughout the upcoming winter months.
- Steel rebar erections (Photos 7.5, 7.8 and 7.9) were observed in the various works and were of a good standard.
- A recently green cut horizontal construction joint was in Pier 3 as shown in Photo 7.9. This work was seen to be satisfactory.
- While it is understood that there has been schedule slippage, the activities and construction works observed during the site visit were all in accordance to good construction practice standards.

Photo 7.6: Spillway; shrouded and heated formwork. (November 26, 2014)

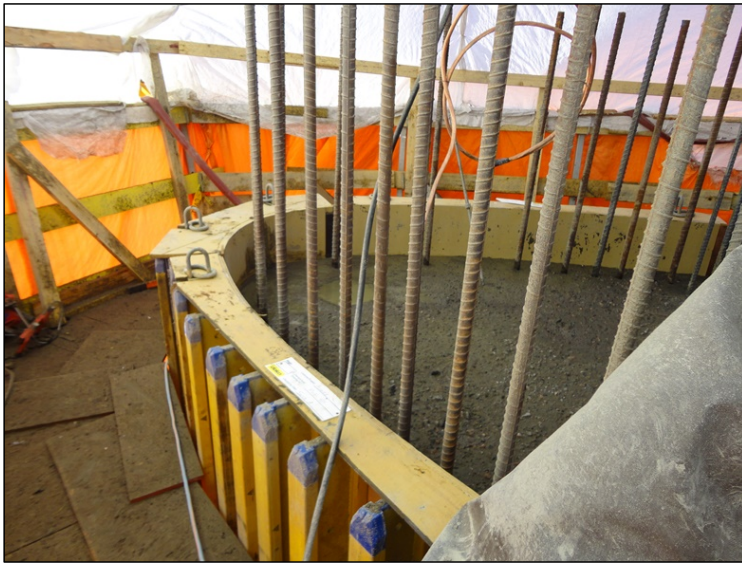
Photo 7.8: Spillway; Upstream nose of Pier 3. (November 26, 2014)

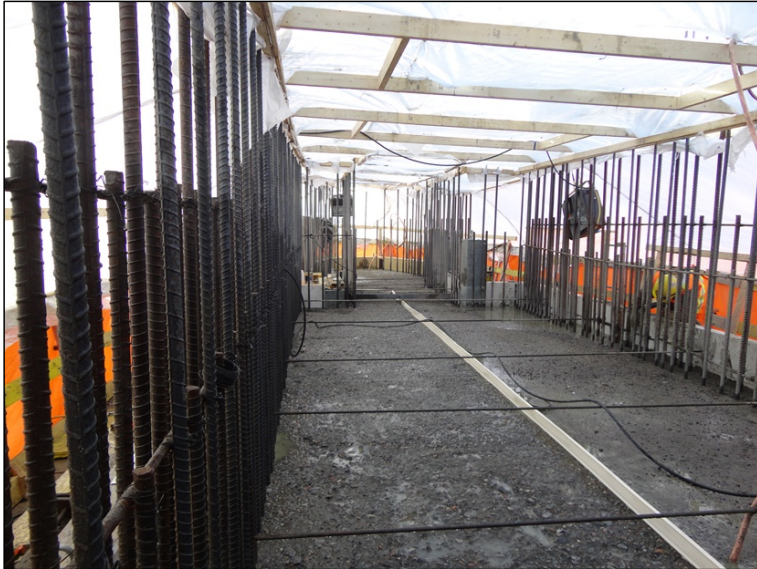
Photo 7.9: Current top of Pier 3 looking upstream. The concrete was green cut on the previous day and was currently being washed at the time of the photograph. Note the cut-out for the upstream stop logs in the background and the white water stop running down the centerline of the pier. (November 26, 2014)

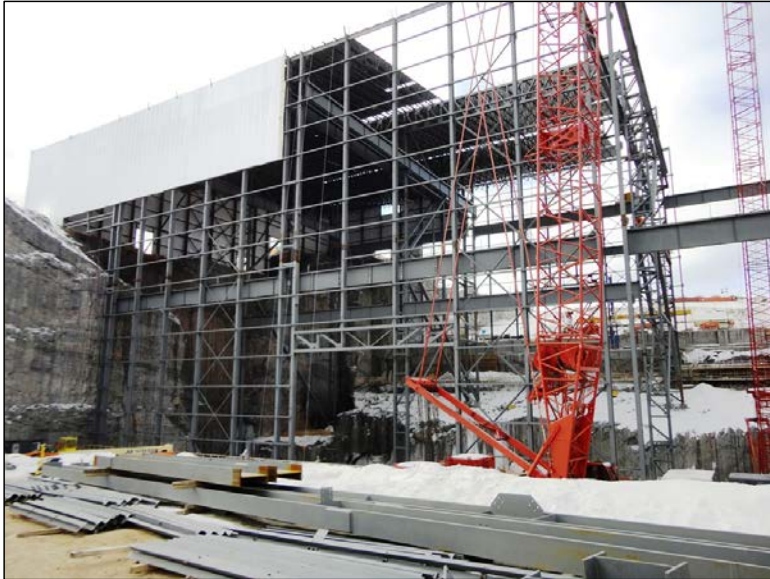
- Astaldi ~~Canada's~~ progress on the [Integrated Cover System \(ICS\)](#) (shelter structure) for the powerhouse construction is considerably behind schedule. At the time of the IE site visit the ICS structure was partially completed over two of the four bays (minus much of the wall cladding - Photos 8.1 to 8.5). It was understood that closed-in shelter will be provided for Bays 1 and 2 by January and additional shelter will be provided over Bay 3 shortly after. As seen during the site visit, it was assumed no shelter will be available for the Unit 4 area during early winter.

Photo 8.3: View looking upstream at the ICS construction over Units 1 and 2. (November 26, 2014)

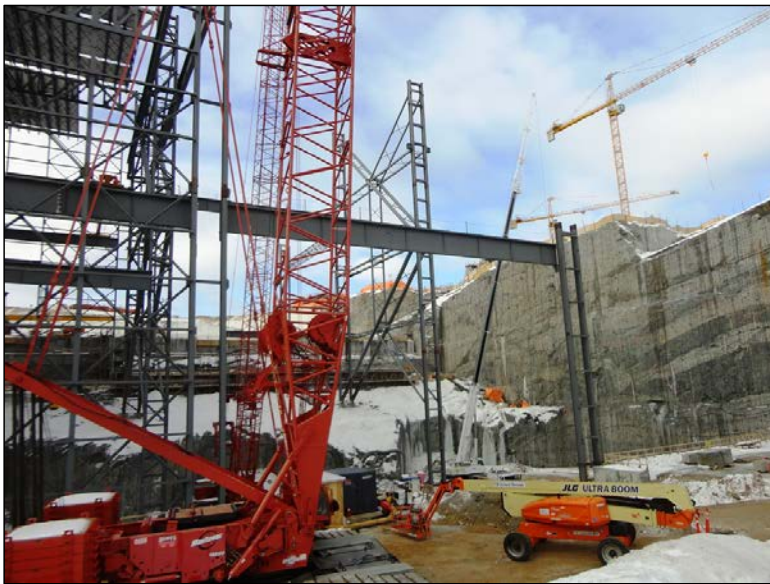
Photo 8.4: View looking upstream at the initial ICS framework erection over Unit 3 (November 26, 2014)

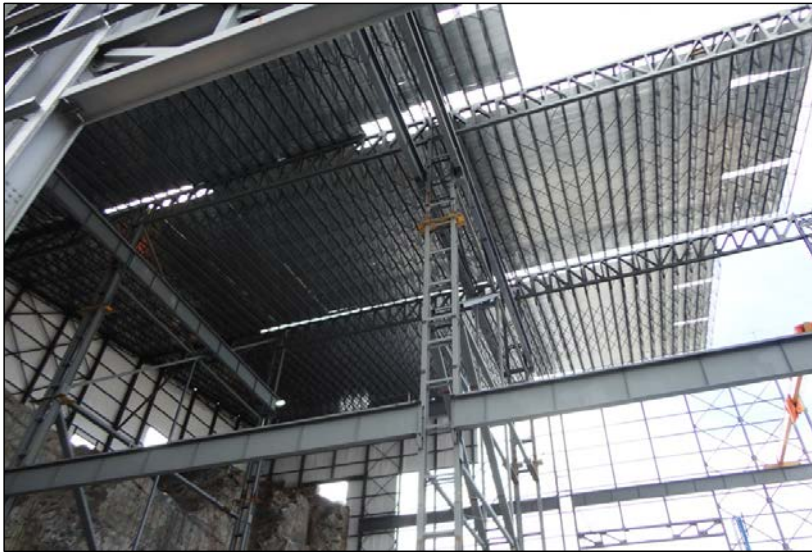
Photo 8.5: Powerhouse ICS Roof over Units 1 and 2. (November 26, 2014)

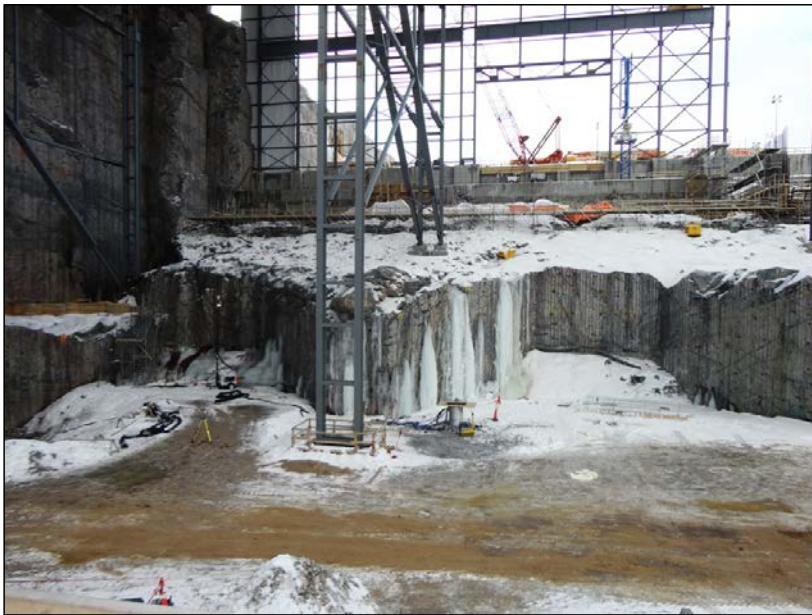
- The final rock excavation faces of each generator unit bays were inspected (Photos 8.6, 8.7 and 8.8). As shown on the photographs, the blasting at each location is excellent and the resulting rock conditions are suitable for the planned installations.

Photo 8.6: Final rock faces in Powerhouse bays 1 and 2. (November 26, 2014)

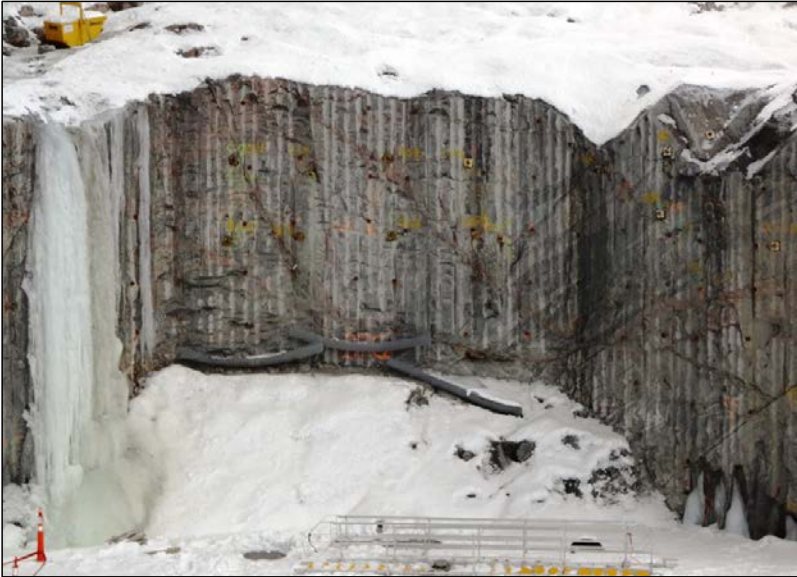
Photo 8.7: Powerhouse Bay 2. Photo shows the excellent quality of the blasting. (November 26, 2014)

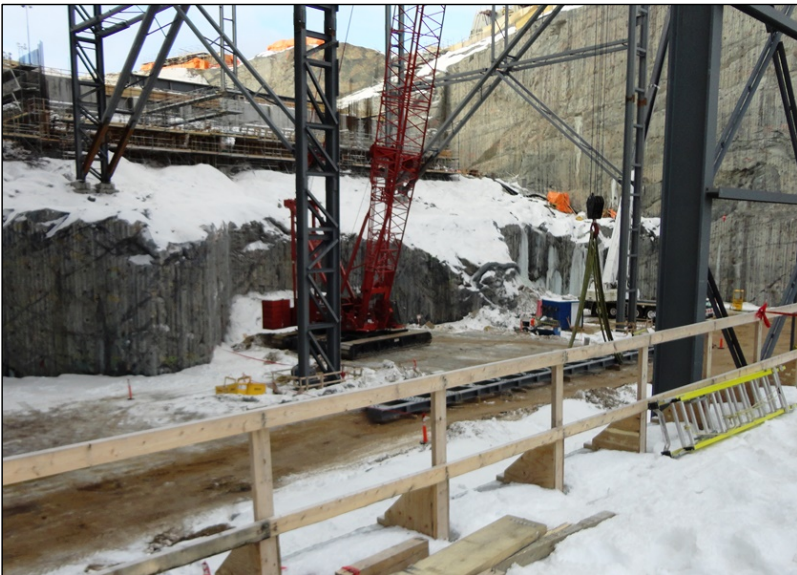
Photo 8.8: Final rock faces in Powerhouse at Bays 3 and 4. (November 26, 2014)

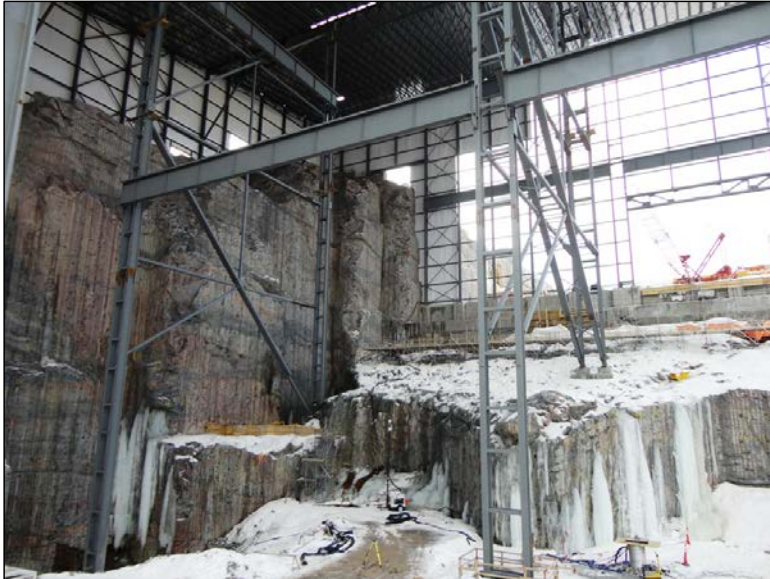
Photo 8.9: View looking upstream at the interior of the ICS over Bays 1 and 2. (November 26, 2014)

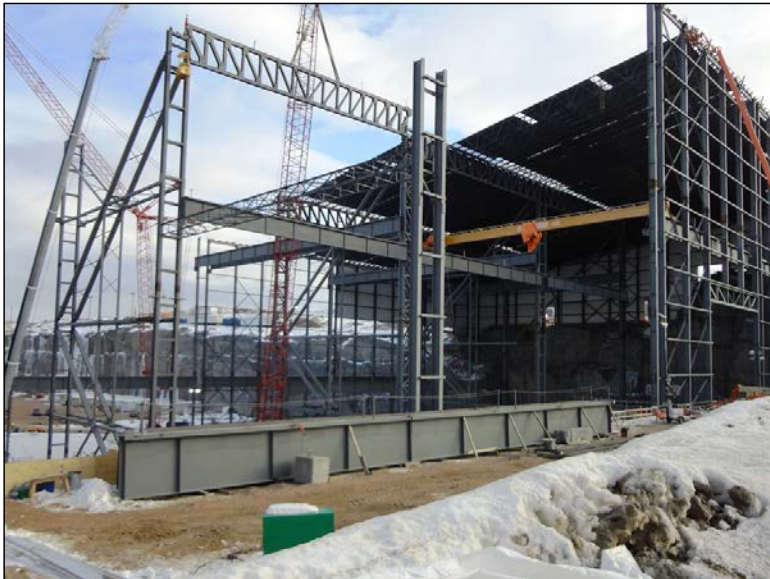
- Erection and concrete placement facilities are being installed. As seen in (Photos 8.10 and 8.12), an overhead crane and beam have been laced over the Unit bay. A Putzmeister concrete pump has been erected on a fixed swivel mounting between Bays 2 and 3 in the Powerhouse (Photo 8.13). Additional pumps and rail cranes will be installed throughout the ~~P~~powerhouse to make sure that all areas can be reached.

Photo 8.10: View looking downstream at the ICS framework over Bay 3. (November 26, 2014)

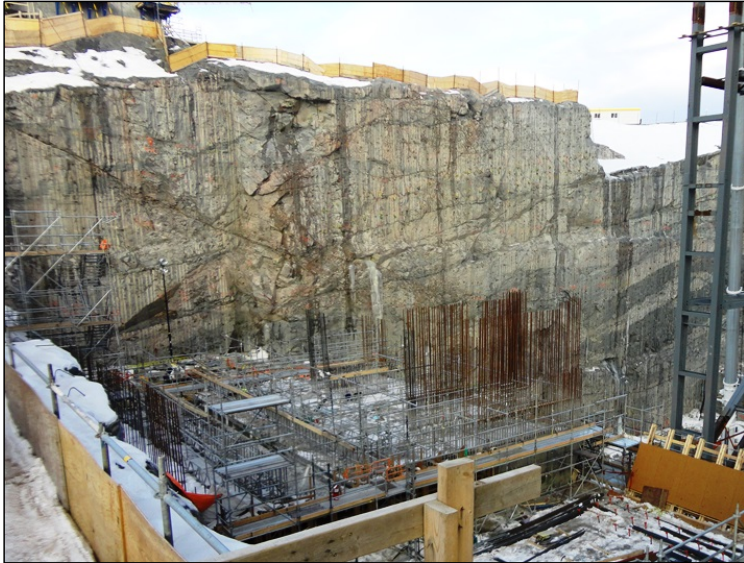
- A relatively small block of permanent concrete has been placed in Unit 4 of the intake (Photo 8.11). No further work is planned on the intake concrete works in the immediate future. Work on this structure will proceed in earnest when there has been more progress in the Powerhouse construction.

Photo 8.11 Powerhouse, Bay 4. Permanent concrete at base of intake structure at Bay 4. This is the only permanent concrete in the powerhouse/intake structures. (November 26, 2014)

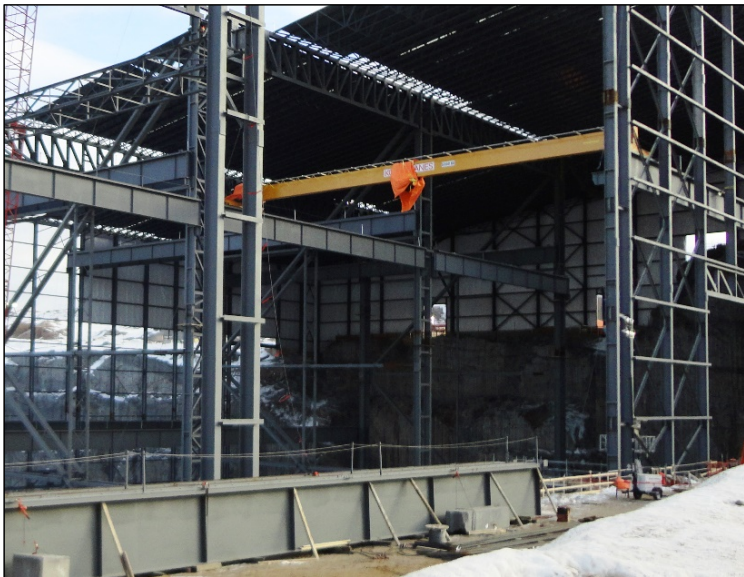
Photo 8.12: Powerhouse ICS. Beam crane above Unit 2. (November 26, 2014)

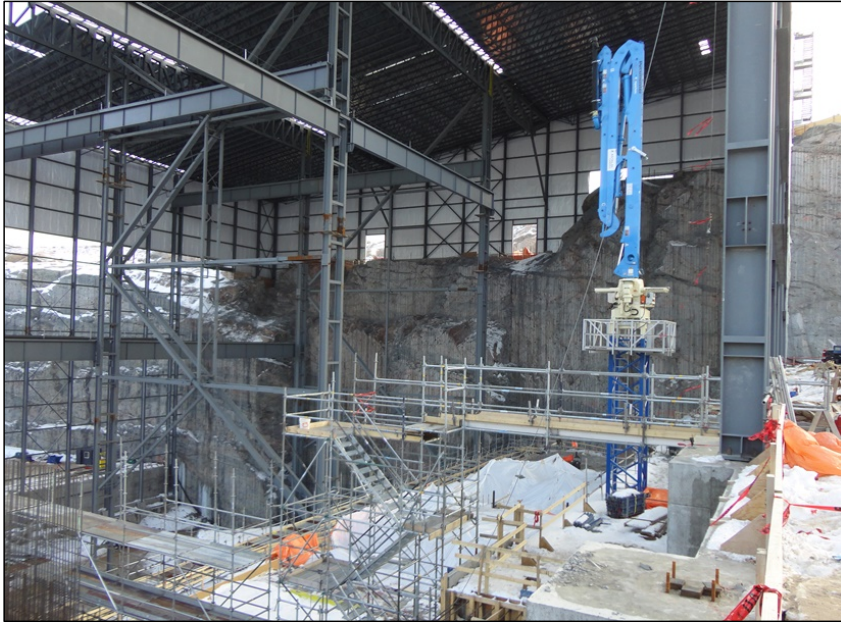
Photo 8.13: Putzmeister concrete pump on a fixed swivel mounting between Bays 2 and 3 in the Powerhouse. Additional pumps will be installed throughout the powerhouse to make sure that all areas can be reached. (November 26, 2014)

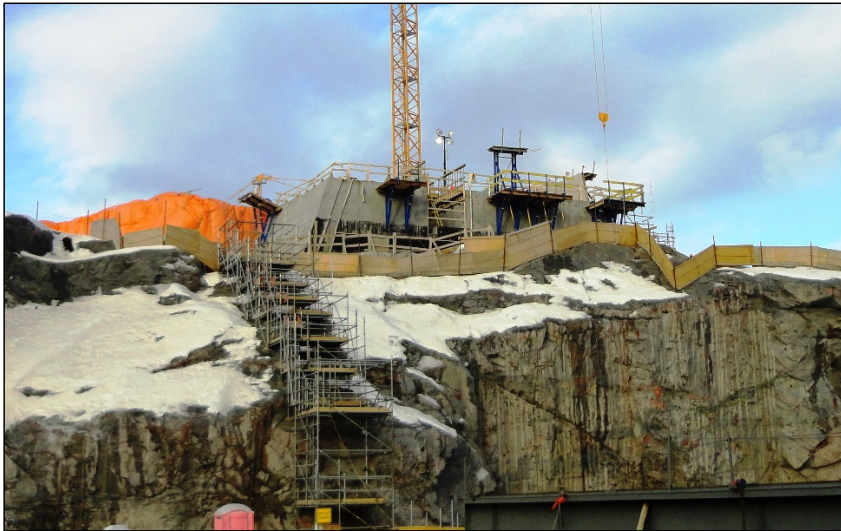
- Concrete placement for the transition dam between the Powerhouse excavation and the spillway was at an advanced stage (Photo 8.14). The left end structure was enclosed in weather protection shelter (Photos 7.1 and 7.2) and formwork erection/concrete placement work was underway at the time of the IE site visit.

Photo 8.14: Right end of transition dam adjoining the powerhouse intake. (November 26, 2014)

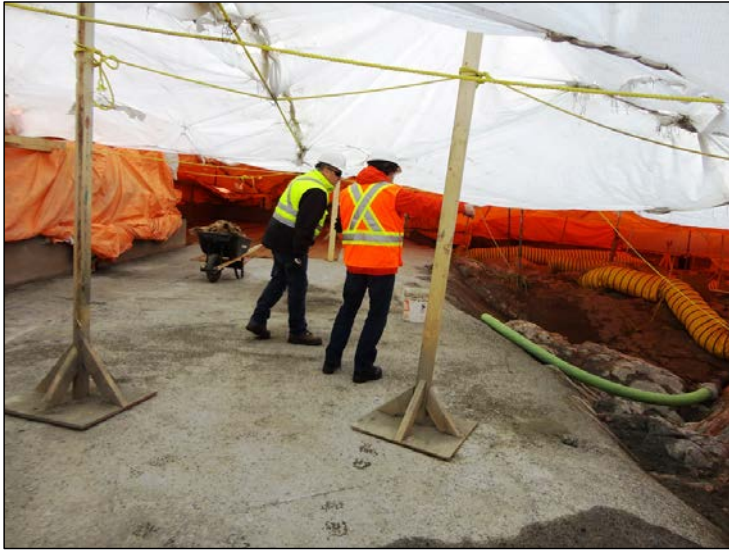
- Foundation preparation works in the Powerhouse North Service Bay were inspected (Photos 9.1 to 9.6). A concrete base slab has been placed in the upstream side (Photos 9.1 and 9.2) and foundation preparation work was underway at the time of the IE site visit. The rock mass in this area consists of competent, blocky granitic gneiss that is fresh to slightly weathered (Photo 9.4). The rock surface is being cleaned with water and with a large vacuum system in preparation for concrete placement (Photo 9.3). The work area is fully protected from the weather by a tarpaulin covering and heated with industrial heaters (Photos 9.5 and 9.6). The foundation preparation work is being carried out to an acceptable standard.

Photo 9.1: Powerhouse north service bay foundation. Recently poured base concrete. (November 26, 2014)

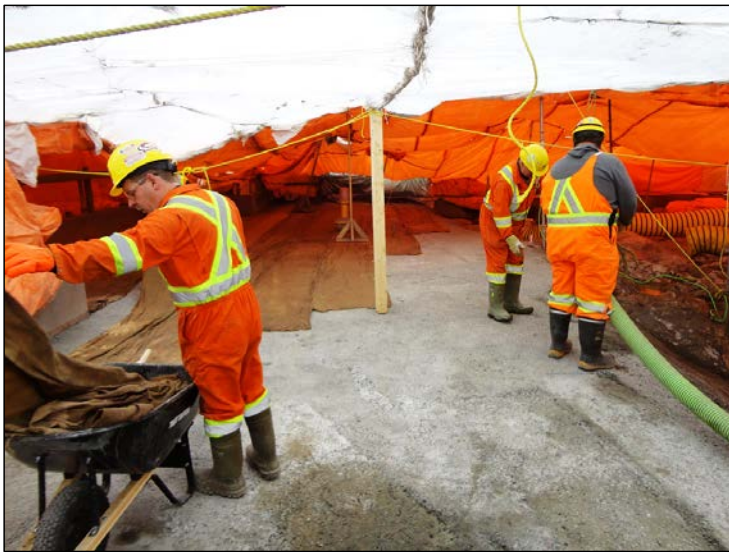
Photo 9.2: Powerhouse north service bay foundation. Note wetted burlap mats being placed on the surface of the base slab. (November 26, 2014)

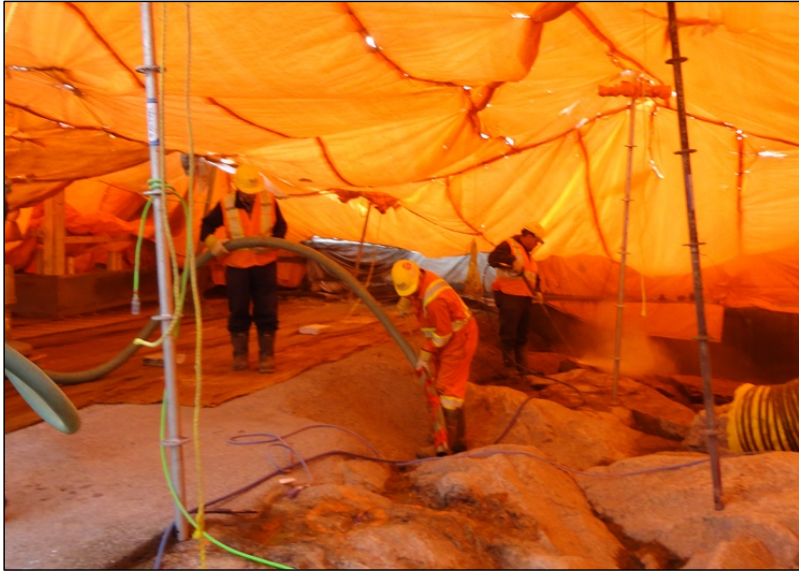
Photo 9.3: Powerhouse north service bay foundation. Cleaning the rock surface with an air vacuum and water jet. (November 26, 2014)

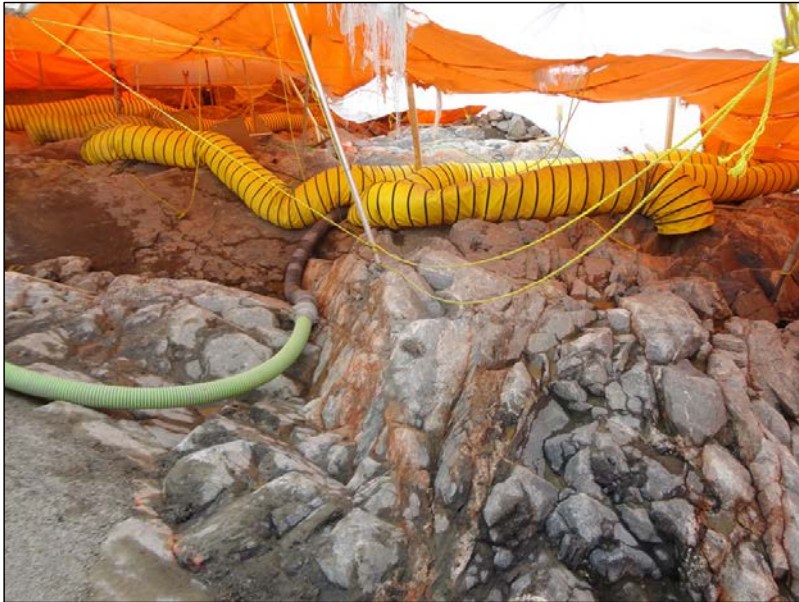
Photo 9.4: Powerhouse north service bay foundation. Cleaned surface in blocky granitic gneiss. (November 26, 2014)

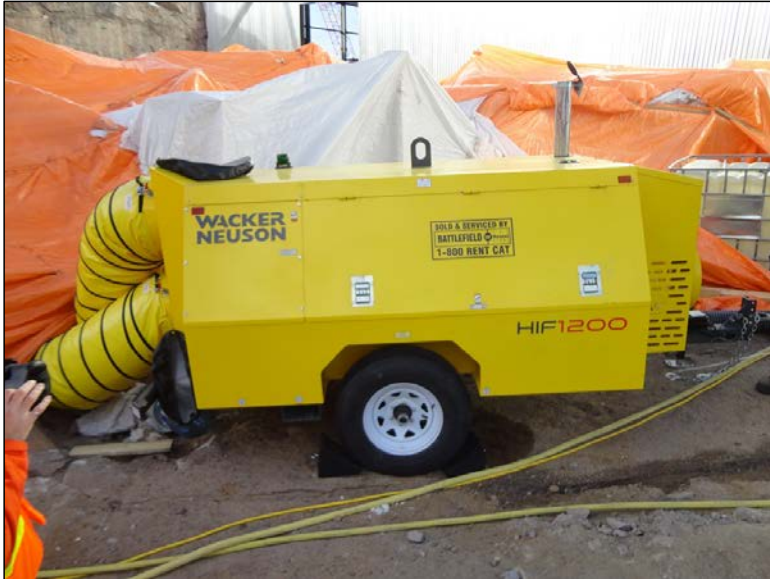
Photo 9.5: Wacker Neuson heating unit used for heating the works in the north service bay. (November 26, 2014)

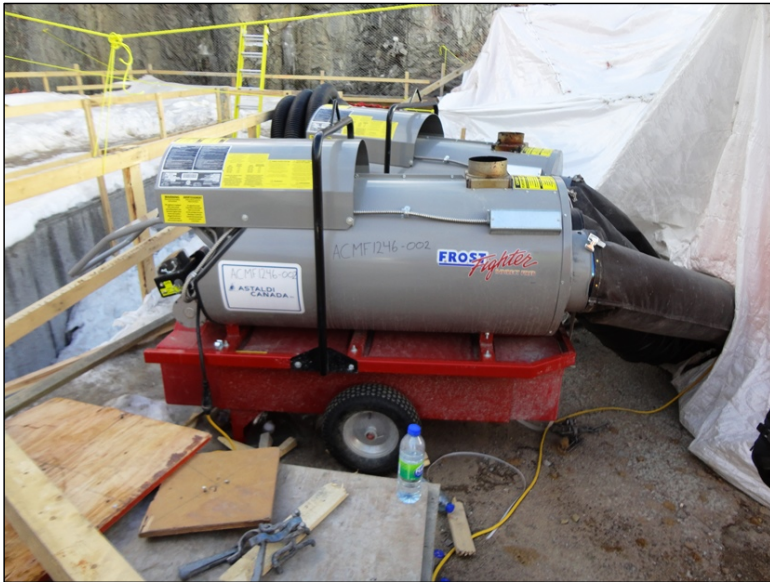
Photo 9.6: Backup heating plants for the north service bay foundation works. (November 26, 2014)
