MEETINGS IN ST. JOHN'S AND VISITS TO LOWER CHURCHILL PROJECT SITES, NOVEMBER 24 TO 27, 2014

Prepared for: Nalcor Energy

Photos
Muskrat Falls Site Visit - November 25 and 26, 2014

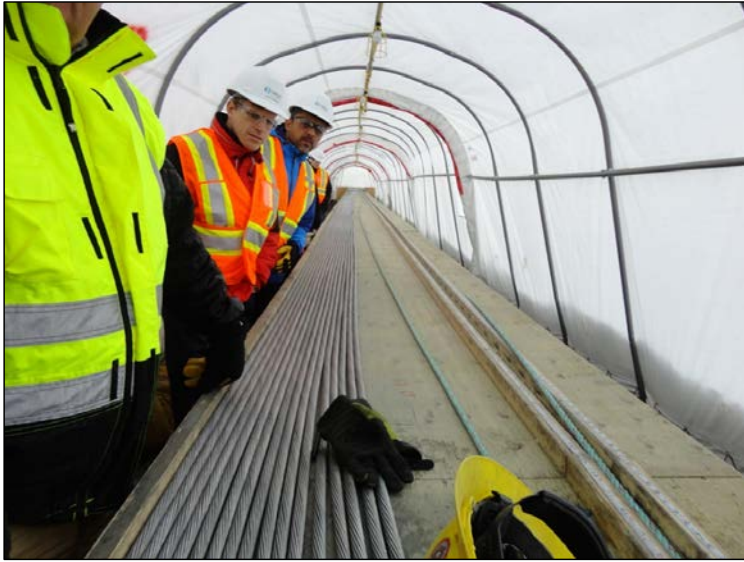
- A site visit was made to the guy wire assembly facility (Photos 2.1 and 2.2) and typical guy wire attachment installations were viewed (Photo 4.3).
- Tower assembly work (Photo 3.2) at each tower site was continuing at the time of the site visit. A significant number of units (approximately 300) have been completed and are ready for erection.

Photo 2.1: Laydown and preparation of guy cables for HV_{ac}AC transmission towers. (November 25, 2014)

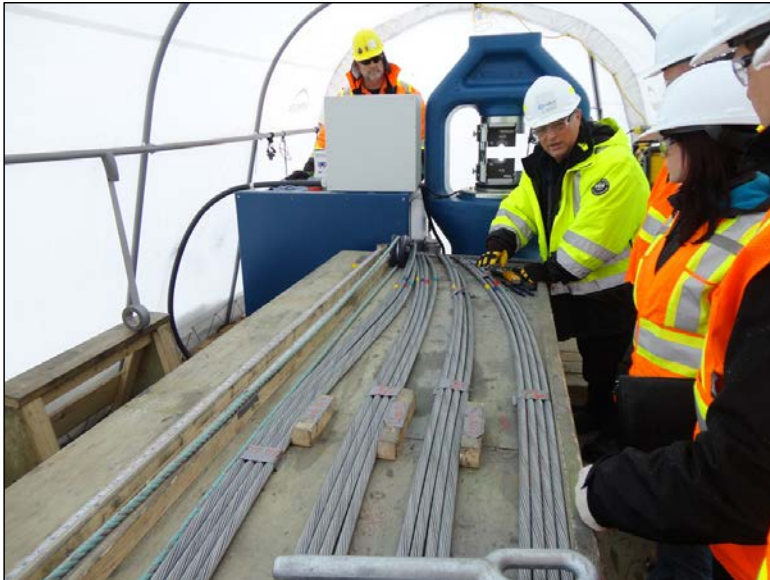
Photo 2.2: Laydown and preparation of guy cables for HV_{ac}AC transmission towers. (November 25, 2014)

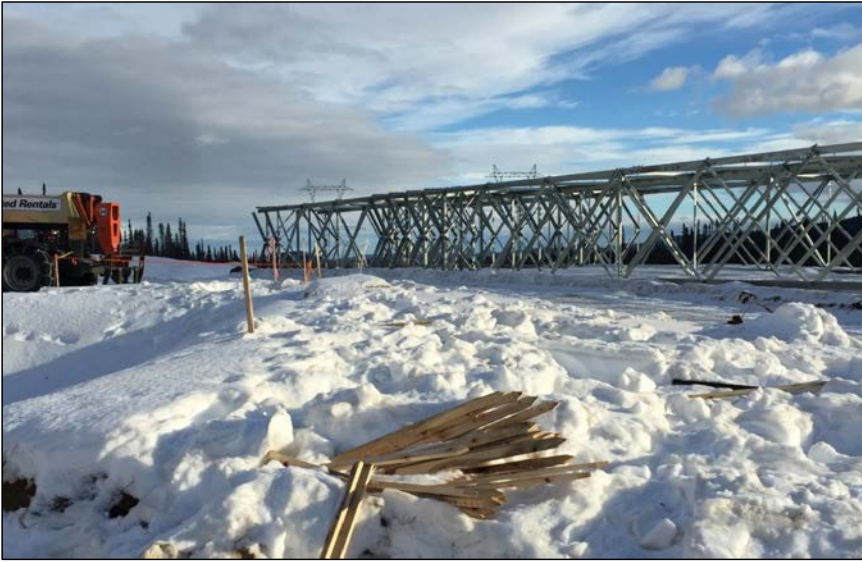
Photo 3.1: HVac transmission line structure assembly, November 25, 2014

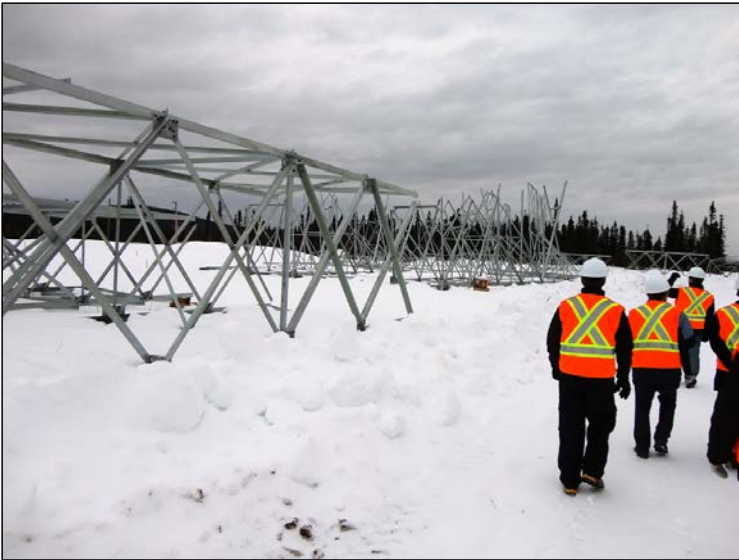
Photo 3.2: Assembling a HVacAC transmission tower near the North Spur. (November 25, 2014)

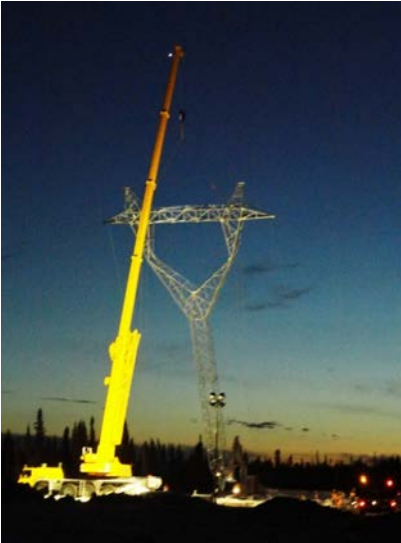
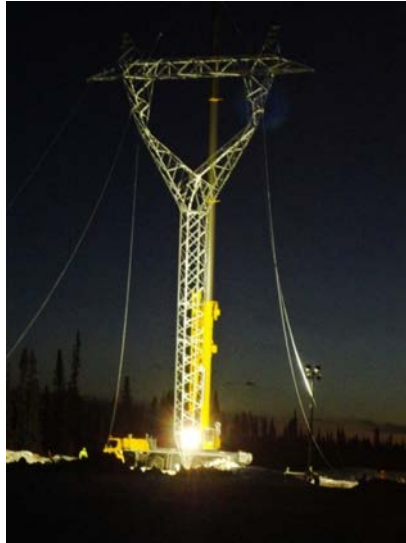
- No stringing or insulator/hardware has been installed yet.
- The IE witnessed the night time erection of a single foundation tower (Photos 4. 1, 4. 2a and b). The total time for the crew to move onto the site and erect the tower with a crane was just over one hour. When the IE team departed the site, crews were starting to secure to guy wires to the previously installed ground anchors.

Photo 4.2 a (left) and b (right) : Erection of HVac Transmission Tower 58 at sundown. (a) tower being hoisted into place with crane and excavator and (b) in final position, still suspended from the crane; note untethered guy wires at this stage of erection. (November 26, 2014)

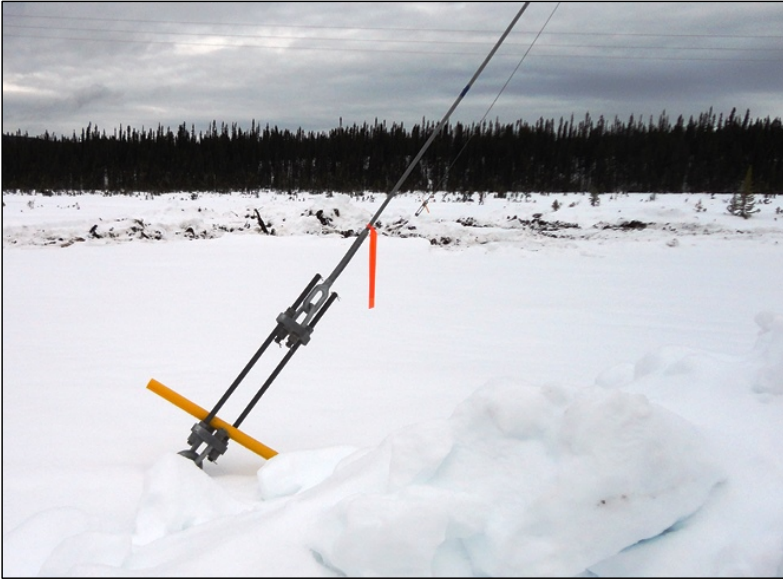
Photo 4.3: Lower connection of guy cable on single footing transmission tower

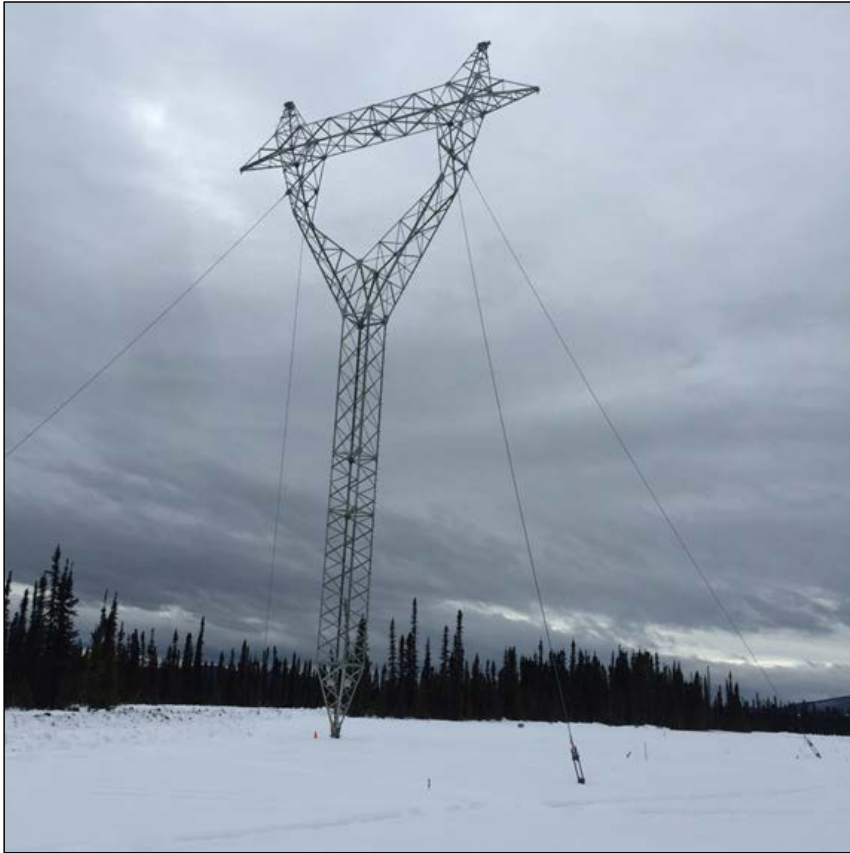
- A large number of foundations (approximately 300) have been completed.
- 56 HVac towers (Photos 5.1a, b, c and 5.1d) had been erected at the northern end of the line by the time of the site visits.

Photo 5.1a: HVac transmission line – erected guyed structure. (November 26, 2014)

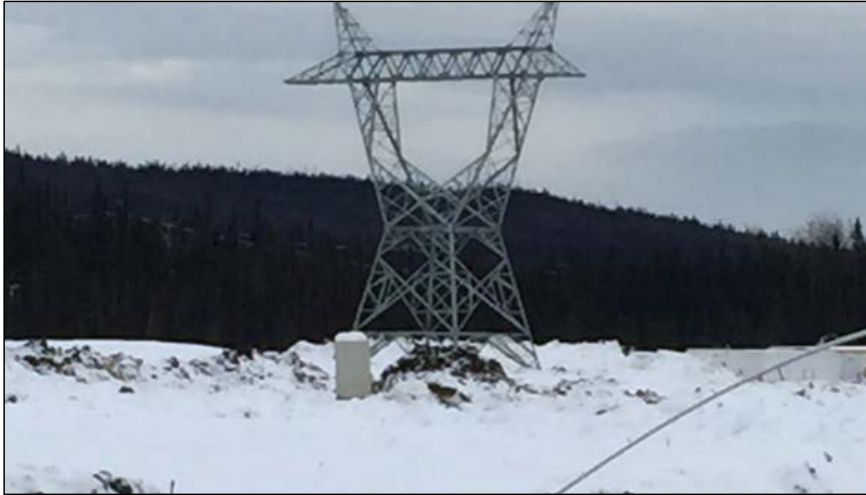
Photo 5.1b: HVac transmission line – erected Self Supporting Structure. (November 26, 2014)

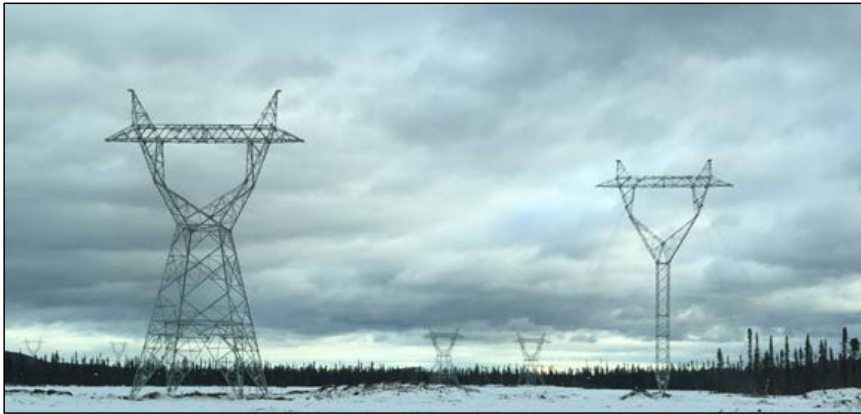
Photo 5.1c: HVac transmission line – erected Structures – Looking South toward both Lines. (November 26, 2014)

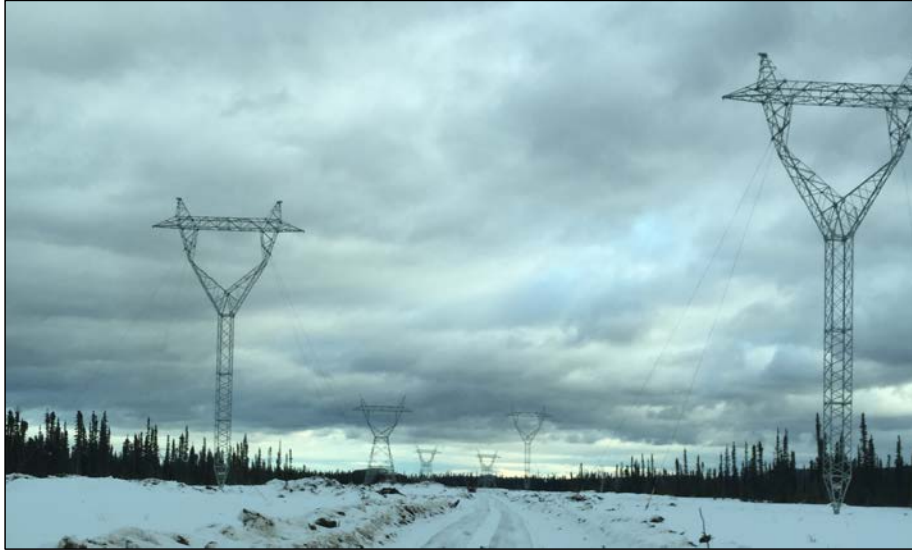
Photo 5.1d: HVac transmission line – erected structures – Looking South toward both Lines, November 26, 2014

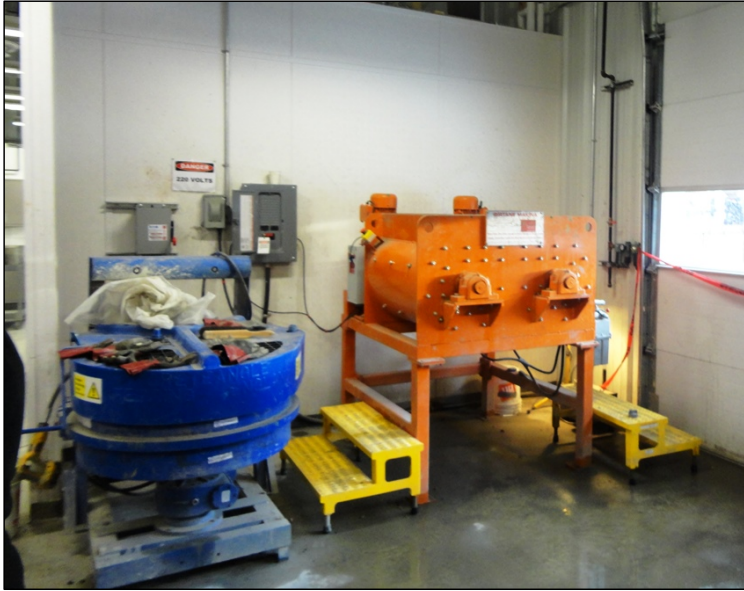
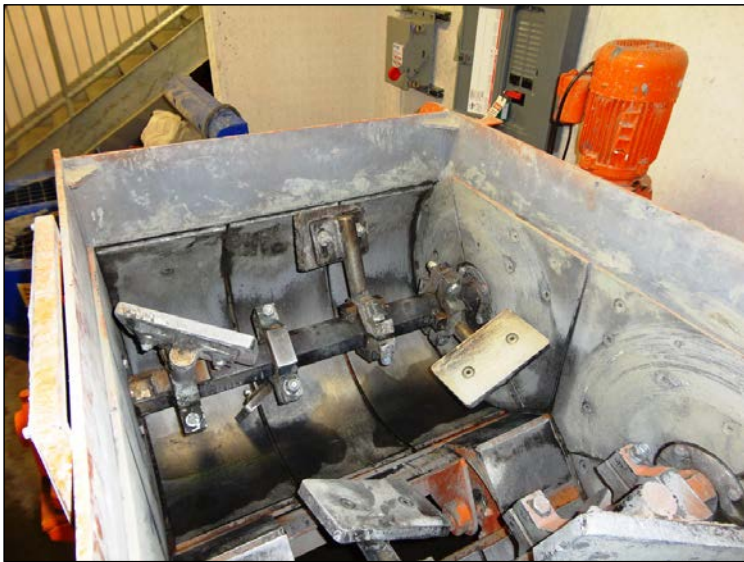
The IE inspected the soils and concrete testing laboratory on November 25, 2014. This facility is operational to carry out soil mechanics testing on fill samples and concrete testing. A program of concrete and RCC mix design is currently underway (Photos 6.1 – 6.5). A full range of soils mechanics and various concrete aggregate quality testing is carried out on aggregate and fill samples. It is understood that this facility is utilized by all contractors when confirming compliance with various technical specifications. The facility is well equipped, albeit a bit on the small size for a project of this magnitude.

Photo 6.1 Site laboratory; mixer for concrete mix design. (November 25, 2014)

Photo 6.2: Site laboratory; mixer for concrete mix design. (November 25, 2014)

Photo 6.3: Site laboratory; graded aggregates for concrete mix design. (November 25, 2016)

Photo 6.4: Site laboratory , unconfined compressive strength testing of concrete cylinders.

Photo 6.5: Drilled concrete cores from the field

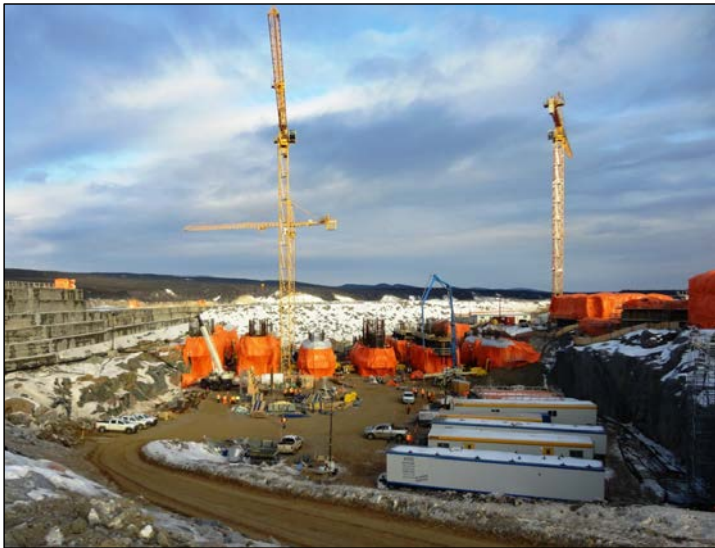
- Formwork erection and concrete placement work were underway in both abutments and all piers of the spillway structure (Photos 7.1 to 7.9). All works were enclosed in temporary shelters and heated with forced air heaters (Photos 7.6 to 7.9). This work is being carried out to a good standard and the shelter/heating arrangements are satisfactory for continuation of the work throughout the upcoming winter months.
- Steel rebar erections (Photos 7.5, 7.8 and 7.9) were observed in the various works and were of a good standard.
- A recently green cut horizontal construction joint was in Pier 3 as shown in Photo 7.9. This work was seen to be satisfactory.
- While it is understood that there has been schedule slippage, the activities and construction works observed during the site visit were all in accordance to good construction practice standards.

- Concrete placement for the transition dam between the Powerhouse excavation and the spillway was at an advanced stage (Photo 8.14). The left end structure was enclosed in weather protection shelter (Photos 7.1 and 7.2) and formwork erection/concrete placement work was underway at the time of the IE site visit.

Photo 7.1: Spillway; view looking downstream towards the piers. RCC cofferdam is visible on the left side and the orange tarp covered transition dam is on the right. (November 26, 2014)

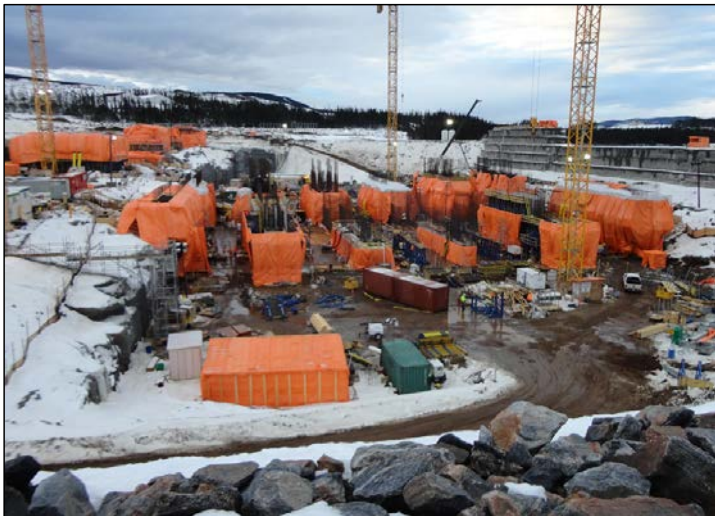
Photo 7.2: Spillway; view looking upstream towards the piers. RCC cofferdam is visible on the right side and the orange tarp covered transition dam is on the left. (November 25, 2014)

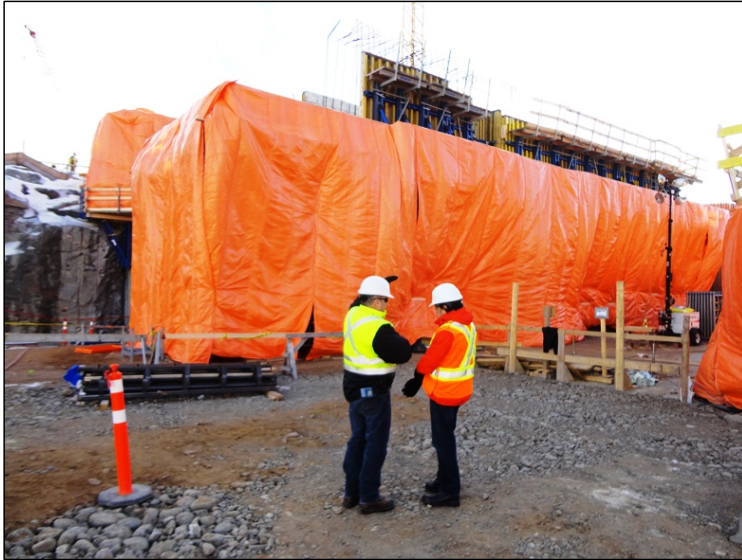
Photo 7.3: Right side of the spillway. Transition dam is visible at the top of the photograph. (November 26, 2014)

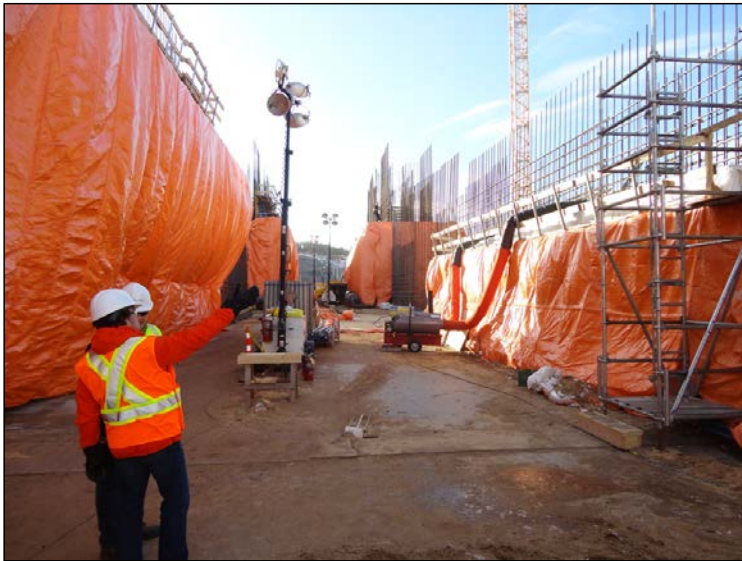
Photo 7.4: Spillway; view looking upstream between North Piers and Pier 1. (November 26, 2014)

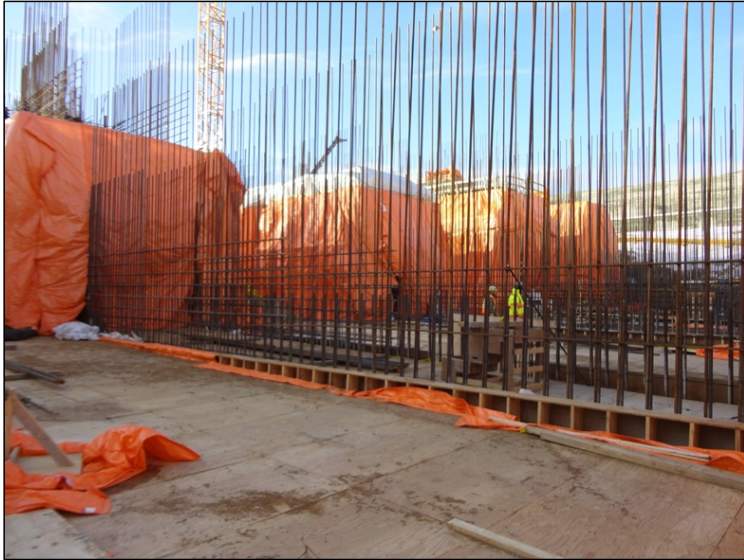
Photo 7.5: Spillway, rebar installation for Pier 3. (November 26, 2014)

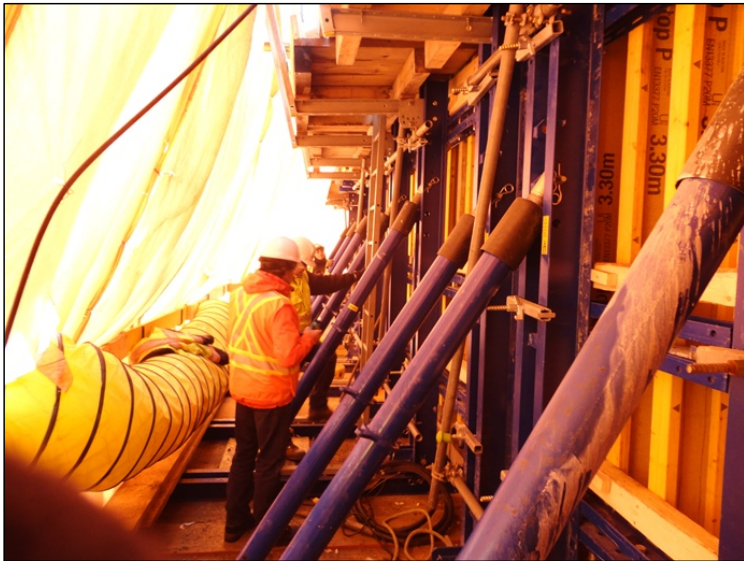
Photo 7.6: Spillway; shrouded and heated formwork. (November 26, 2014)

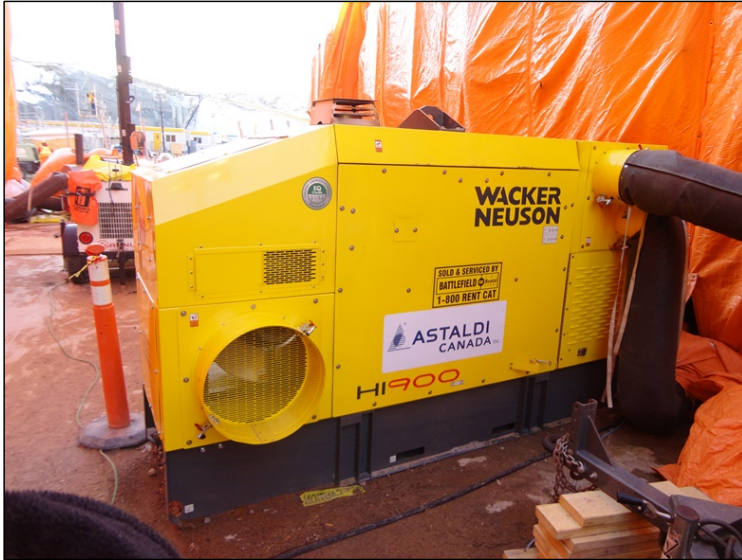
Photo 7.7: Spillway; Wacker Neuson heater, one of many used for heating the formwork and concrete pours of the piers. (November 26, 2014)

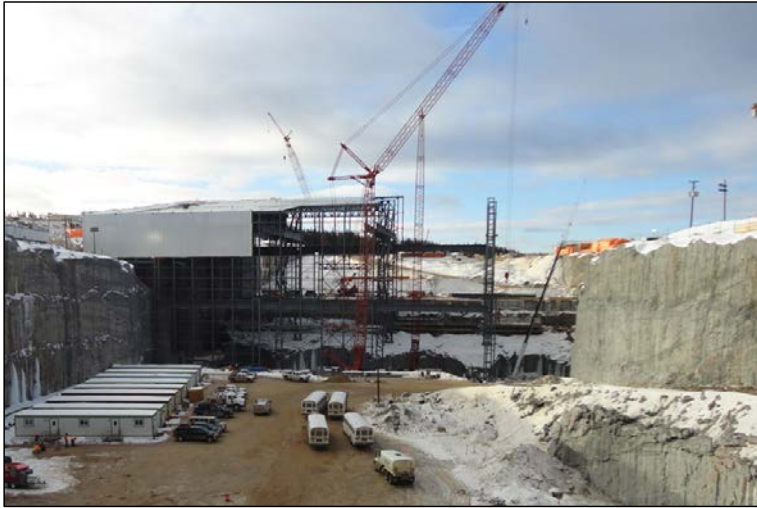
- Astaldi ~~Canada's~~ progress on the Integrated Cover System (ICS) (shelter structure) for the powerhouse construction is considerably behind schedule. At the time of the IE site visit the ICS structure was partially completed over two of the four bays (minus much of the wall cladding - Photos 8.1 to 8.5). It was understood that closed-in shelter will be provided for Bays 1 and 2 by January and additional shelter will be provided over Bay 3 shortly after. As seen during the site visit, it was assumed no shelter will be available for the Unit 4 area during early winter.

- There has been significant schedule slippage at the Powerhouse, Spillway and Intake area. Astaldi Canada's progress on the ICS (shelter structure) for the Powerhouse construction is considerably behind schedule. At the time of the IE site visit the ICS portion over Bays 1 and 2 was substantially completed (minus much of the wall cladding (Photos 8.1 to 8.3)

Photo 8.1: Powerhouse ICS looking upstream. Units 1 and 2 framework erection and first roof covering are substantially complete and almost half of the wall cladding has been erected. At Unit 3 the framework and first roof covering are substantially complete but no progress has been made on the wall cladding. No progress with the ICS in the area of Unit 4. . (November 26, 2014.)

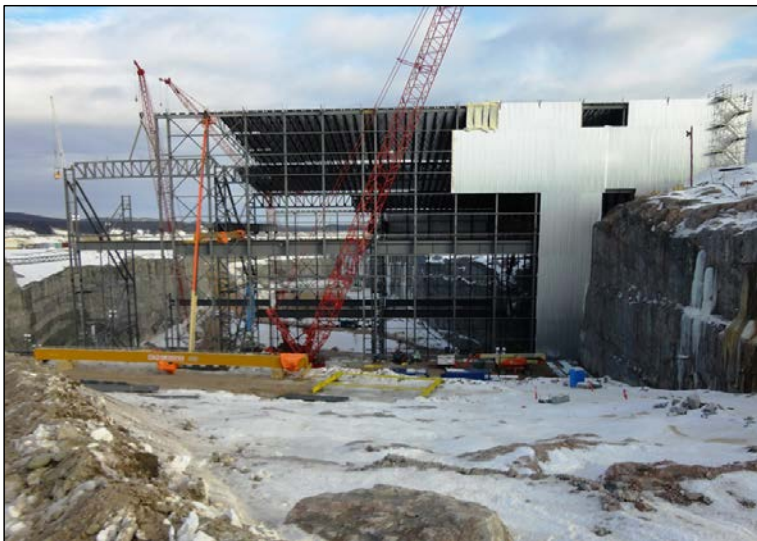
Photo 8.2: Powerhouse ICS looking downstream. Framework and cladding in Units 1, 2 and 3 can be seen. (November 26, 2014.)

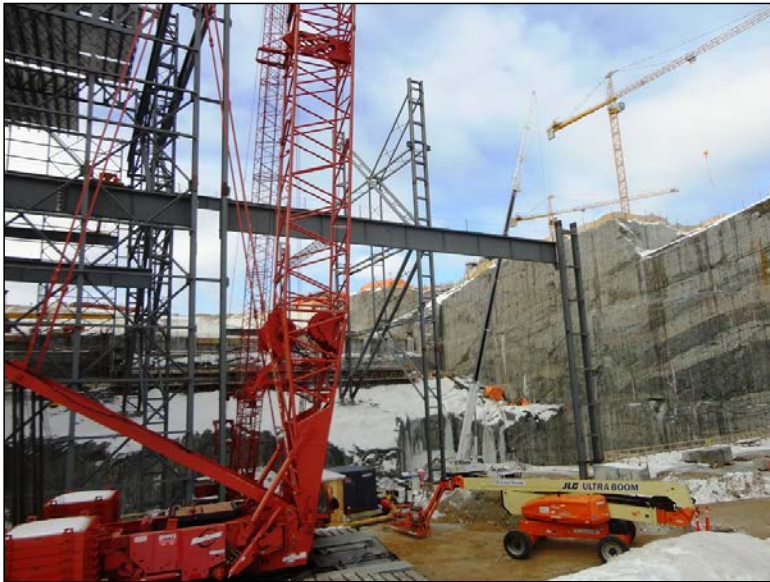
Photo 8.4: View looking upstream at the initial ICS framework erection over Unit 3 (November 26, 2014)

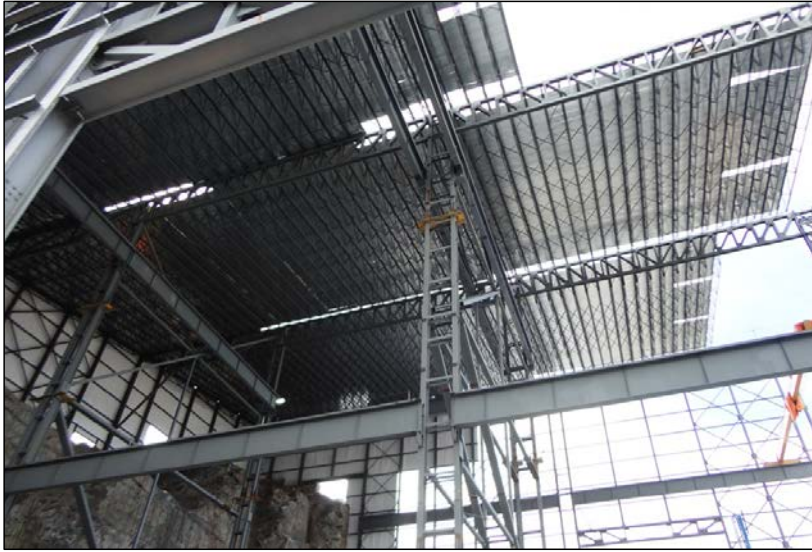
Photo 8.5: Powerhouse ICS Roof over Units 1 and 2. (November 26, 2014)

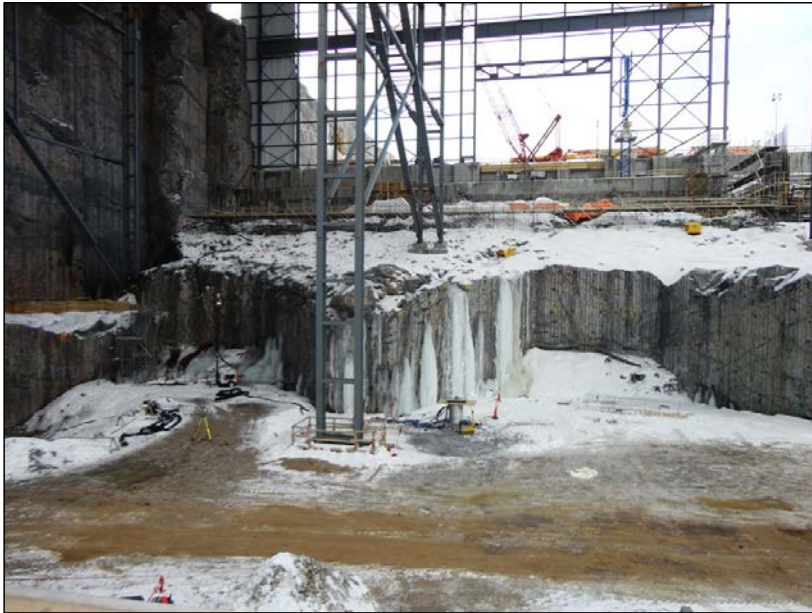
- The final rock excavation faces of each generator unit bays were inspected (Photos 8.6, 8.7 and 8.8). As shown on the photographs, the blasting at each location is excellent and the resulting rock conditions are suitable for the planned installations.

Photo 8.6: Final rock faces in Powerhouse bays 1 and 2. (November 26, 2014)

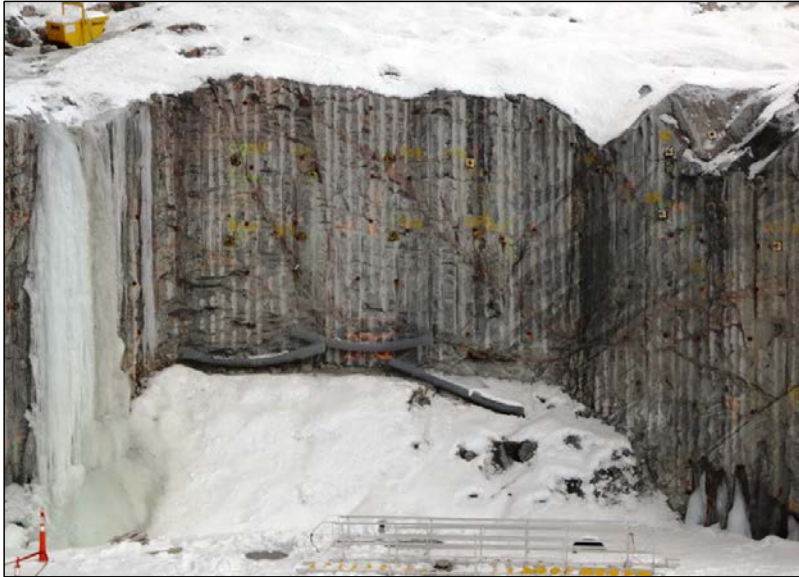
Photo 8.7: Powerhouse Bay 2. Photo shows the excellent quality of the blasting. (November 26, 2014)

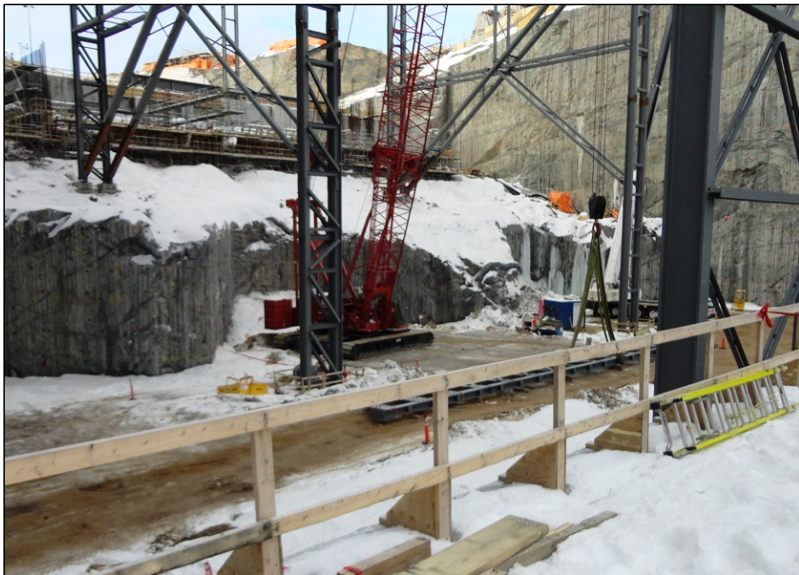
Photo 8.8: Final rock faces in Powerhouse at Bays 3 and 4. (November 26, 2014)

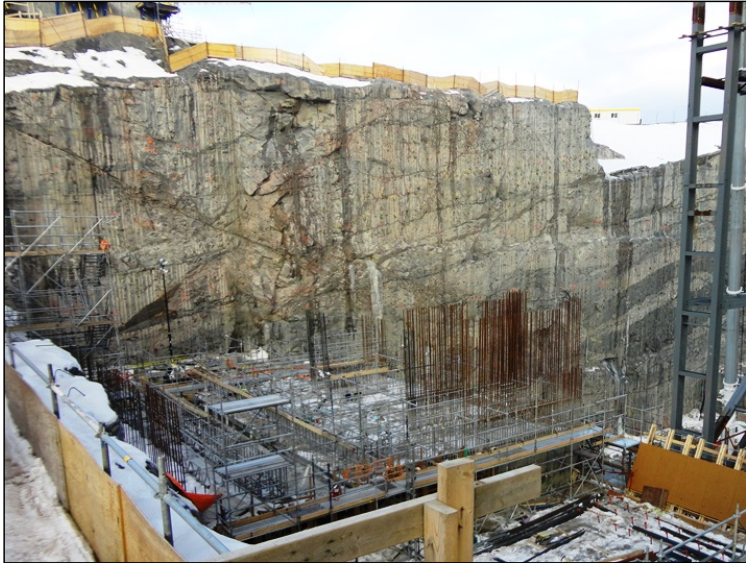
- A relatively small block of permanent concrete has been placed in Unit 4 of the intake (Photo 8.11). No further work is planned on the intake concrete works in the immediate future. Work on this structure will proceed in earnest when there has been more progress in the Powerhouse construction.

Photo 8.11 Powerhouse, Bay 4. Permanent concrete at base of intake structure at Bay 4. This is the only permanent concrete in the powerhouse/intake structures. (November 26, 2014)

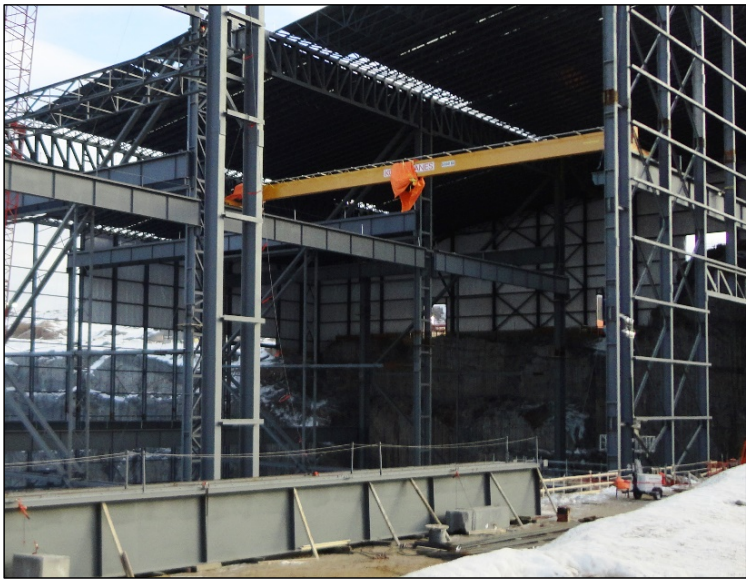
- Erection and concrete placement facilities are being installed. As seen in (Photos 8.10 and 8.12), an overhead crane and beam have been laced over the Unit bay. A Putzmeister concrete pump has been erected on a fixed swivel mounting between Bays 2 and 3 in the Powerhouse (Photo 8.13). Additional pumps and rail cranes will be installed throughout the Powerhouse to make sure that all areas can be reached.

Photo 8.12: Powerhouse ICS. Beam crane above Unit 2. (November 26, 2014)

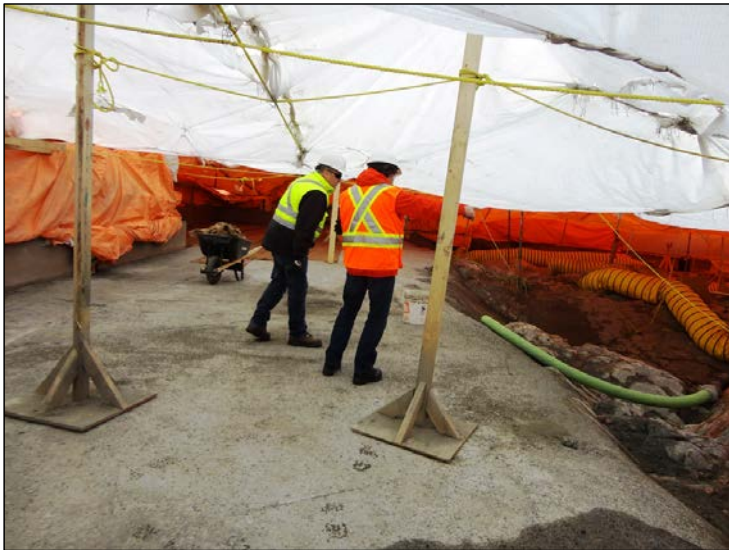
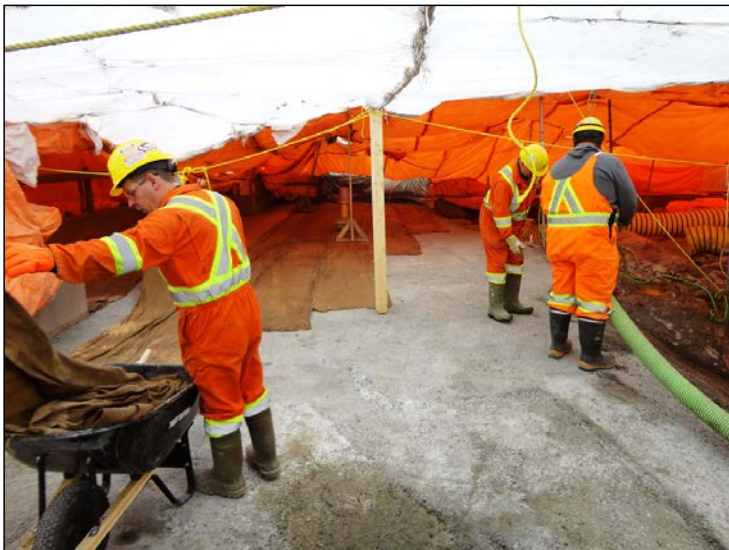
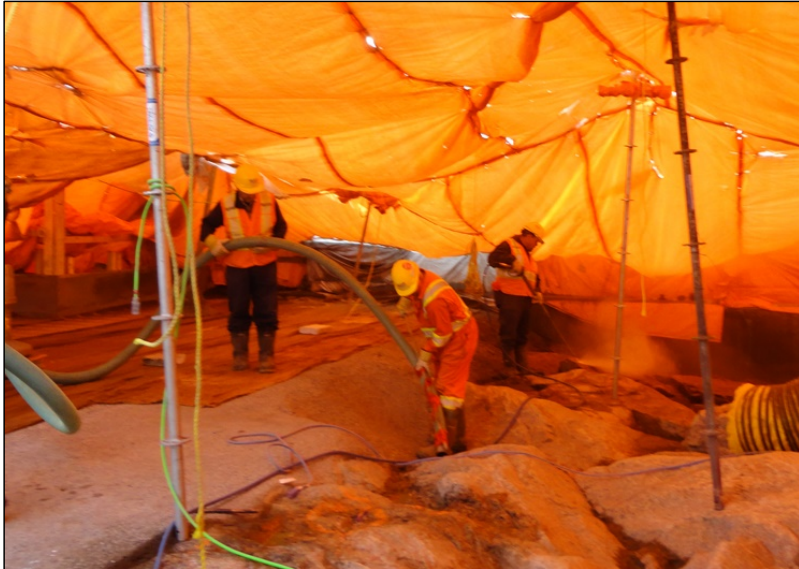
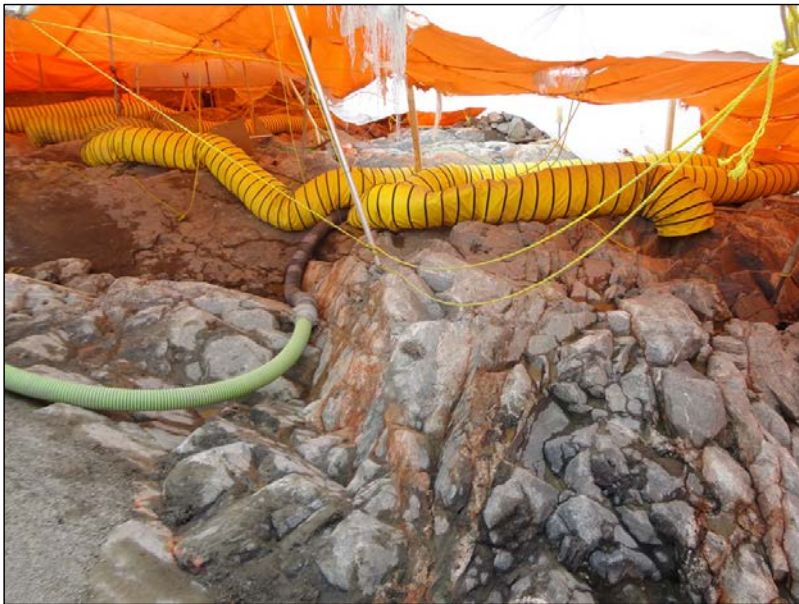
- Foundation preparation works in the Powerhouse North Service Bay were inspected (Photos 9.1 to 9.6). A concrete base slab has been placed in the upstream side (Photos 9.1 and 9.2) and foundation preparation work was underway at the time of the IE site visit. The rock mass in this area consists of competent, blocky granitic gneiss that is fresh to slightly weathered (Photo 9.4). The rock surface is being cleaned with water and with a large vacuum system in preparation for concrete placement (Photo 9.3). The work area is fully protected from the weather by a tarpaulin covering and heated with industrial heaters (Photos 9.5 and 9.6). The foundation preparation work is being carried out to an acceptable standard.

Photo 9.1: Powerhouse north service bay foundation. Recently poured base concrete. (November 26, 2014)

Photo 9.2: Powerhouse north service bay foundation. Note wetted burlap mats being placed on the surface of the base slab. (November 26, 2014)

Photo 9.3: Powerhouse north service bay foundation. Cleaning the rock surface with an air vacuum and water jet. (November 26, 2014)

Photo 9.4: Powerhouse north service bay foundation. Cleaned surface in blocky granitic gneiss. (November 26, 2014)

Photo 9.5: Wacker Neuson heating unit used for heating the works in the north service bay. (November 26, 2014)

Photo 9.6: Backup heating plants for the north service bay foundation works. (November 26, 2014)
