## MEETING IN ST JOHN'S AND VISIT TO MUSKRAT FALLS - SEPTEMBER 21-23, 2015

Prepared for: Nalcor [Energy](#)  
 Project Manager: James Low  
 Date: November 03, 2015

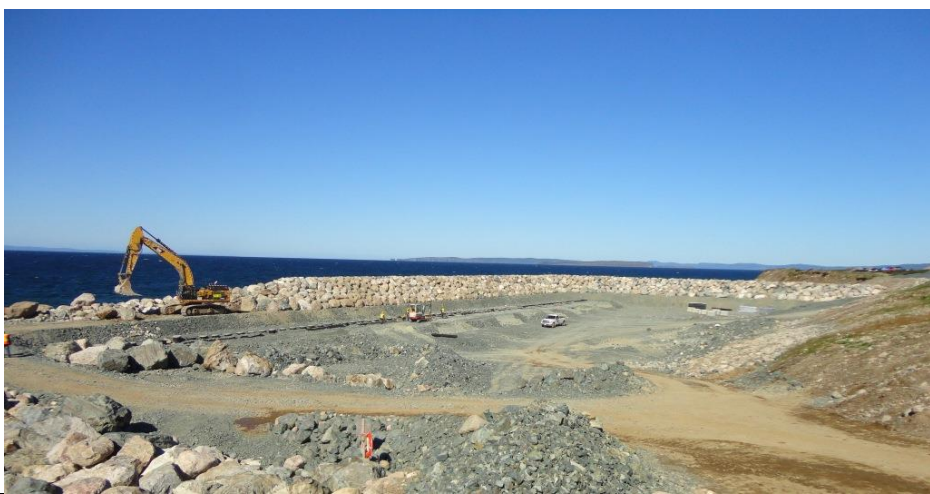
- o The shoreline dyke is at an advanced stage of construction (Photo 1.1). The eastern end (Photo 1.2) and central areas are completed. Work was progressing on the western end (Photo 1.3) of the dyke at the time of the site visit.

Photo 1.1: Dowden's Point dyke. Note the line of electrode wells at the base of the dyke.

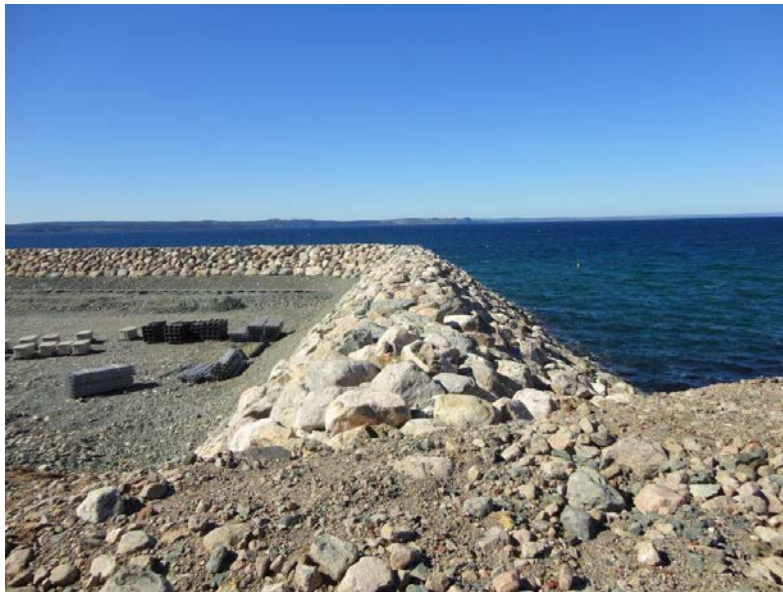
Photo 1.2: East end of the dyke

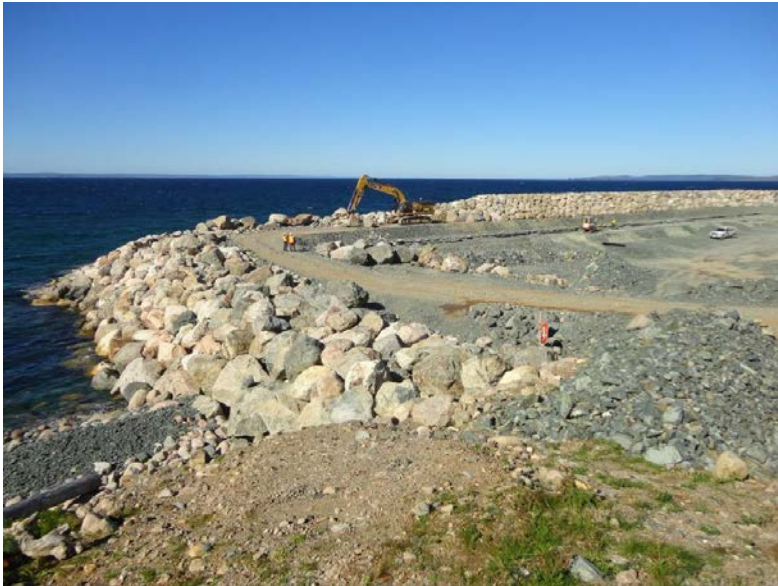
Photo 1.3: West end of the Dowden's Point dyke. Note the ongoing armour stone placement work.

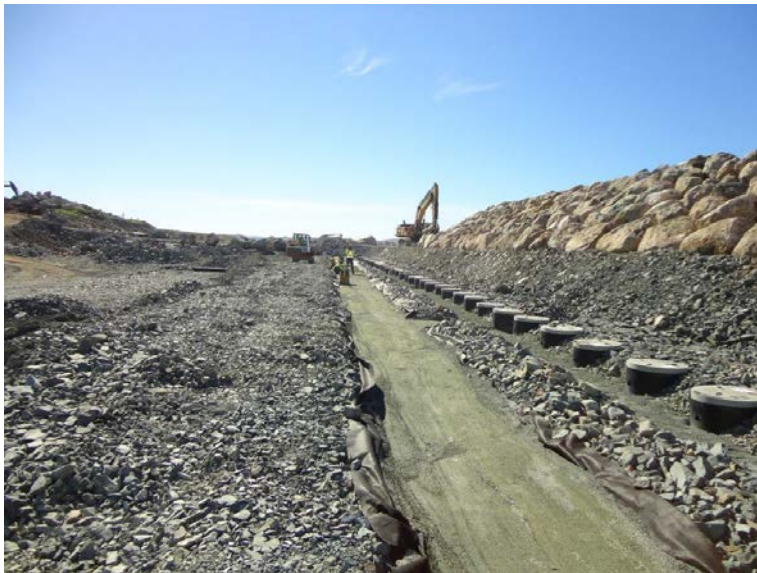
- o The electrode wells have been installed adjacent to the inner toe of the dyke (Photo 1.4 and 1.5) and work on the conductor bedding trench was progressing (Photos 1.4 and 1.6).

Photo 1.4: Looking west along the line of electrode wells and the conductor bedding trench.

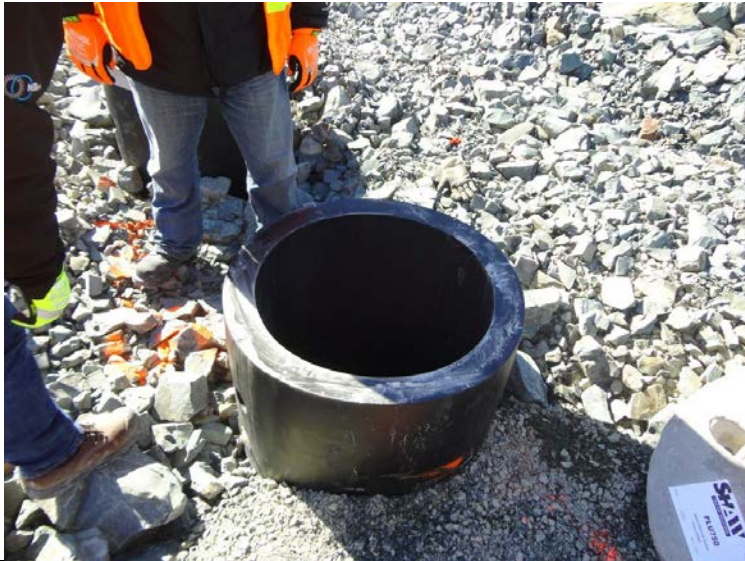
Photo 1.5: Electrode well casing installation

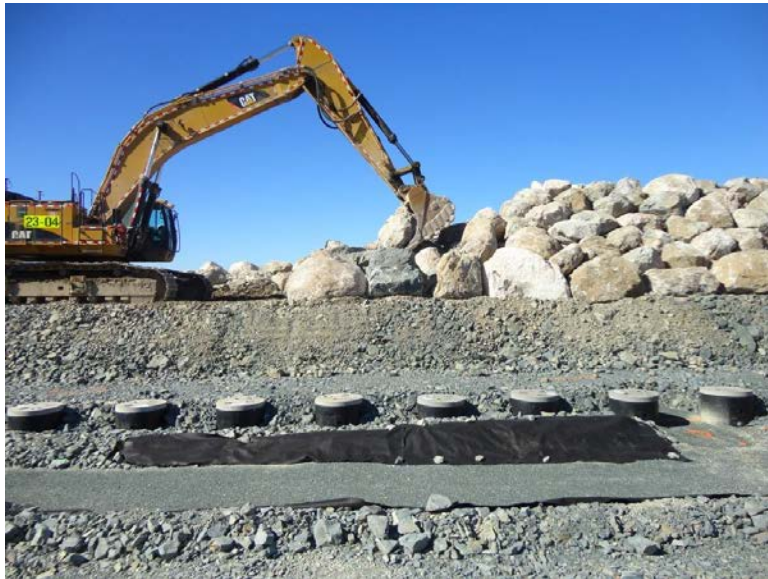
- o The upper inner slope, crest and full height outer slope of the dyke are covered by armour stone erosion protection (Photos 1.6 and 1.7). The armour stone consists of equidimensional blocks of very strong granitic rock and Precambrian siltstone. This material was obtained from various off-site sources and is stockpiled at Dowden's Point. Approximately 80% of the armour stone has been placed and 100% has been delivered to the site. In general the rock is of very good quality although a few of the metamorphosed siltstone blocks had numerous tight incipient cracks that could cause some spalling and breakdown over time.

Photo 1.6: Placing and dressing the armour stone at the west end of the dyke. Electrode wells visible in foreground.

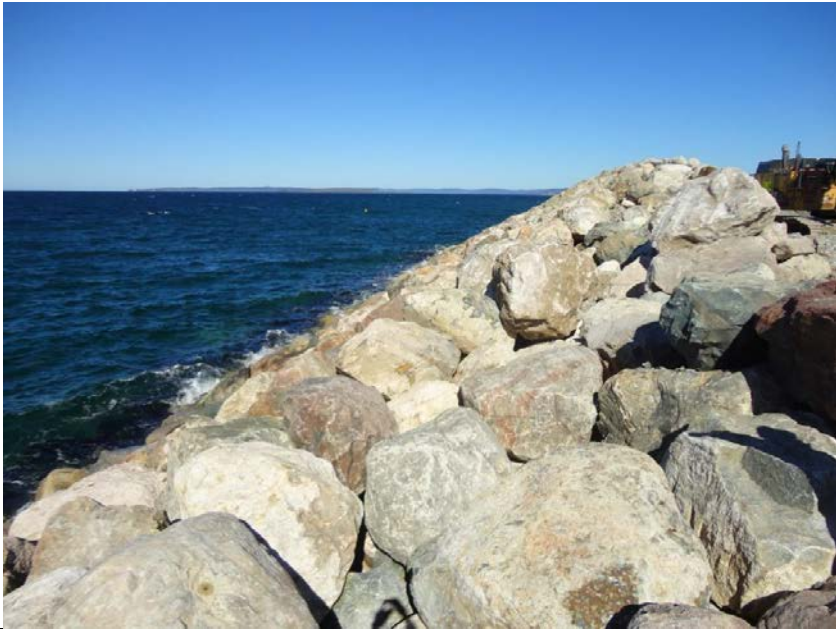
- o All of the work on excavations, well installations and fill placement is high quality and in keeping with accepted standards. In particular the armour stone placement works (Photo 1.6 and 1.7) are of exceptionally high quality, generally better than the norm for breakwater installations.

Photo 1.7: Armour stone blanket on the outer slope.

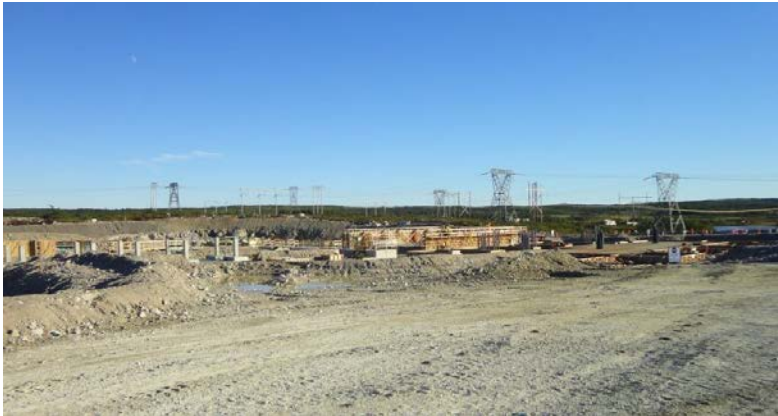
- o In general, most of the ongoing work is focused on foundation construction for many major facilities. Foundation footings and/or base slabs are being constructed for [the converter building \(Photos 2.1 and 2.9\)](#), [gantries for the AC sub-station \(Photo 2.8\)](#), and the converter transformer (Photos 2.9 and 2.10). The footings of the [converter facility](#) are at an advanced stage of completion at the south side of this facility (Photo 2.9) and in the very initial stages of construction at the north side (Photo 2.10).

**Photo 2.1:** AC/DC converter site

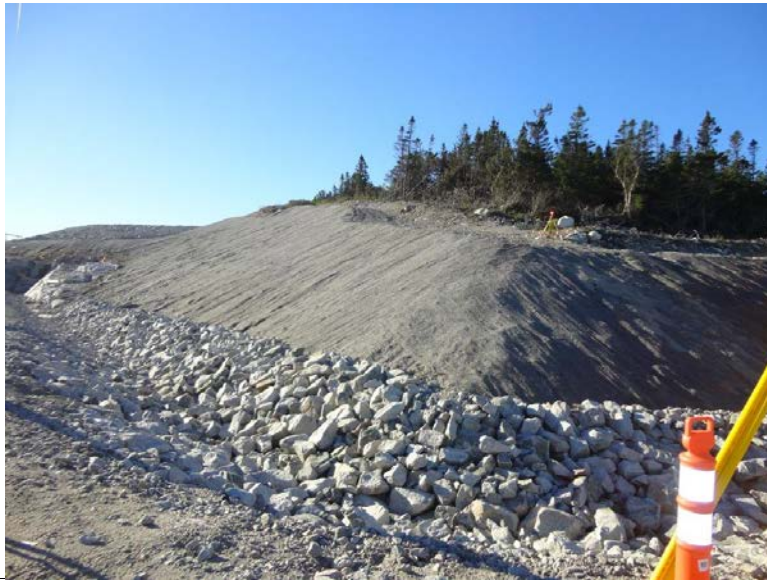
- o Virtually all site preparation, including site grading excavations and fill placements has been completed.
- o The cut slopes at various locations around the perimeter of the complex have been excavated and are generally of good quality. Photo 2.2 shows the slope at the western side. At this location upper slope is covered by porous coconut/wire mesh slope protection. No seeding has been done and this mat has deteriorated in many places. Rip rap layer is placed on the lower slope.

**Photo 2.2:** Cut slope in glacial moraine at west end of the facility. The upper slope is covered by porous coconut/wire mesh slope protection. No seeding has been done and this mat has deteriorated in many places. Rip rap layer in place on the lower slope.

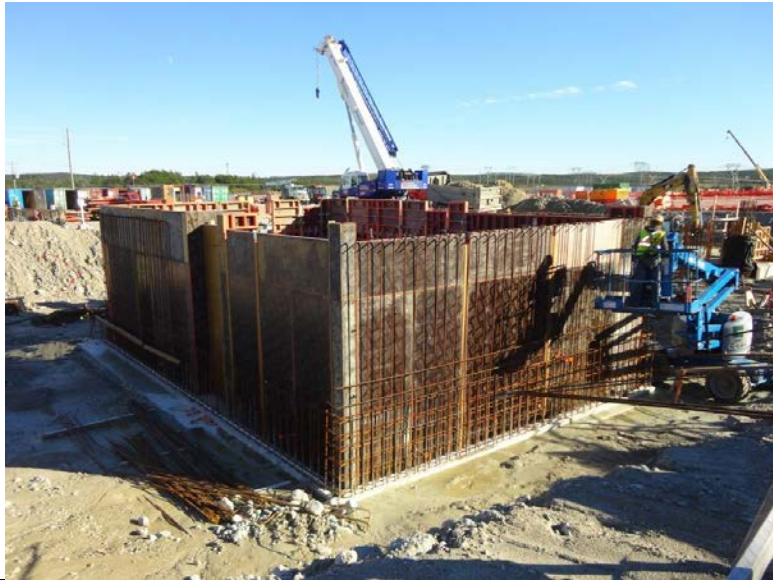
- o Formwork has been erected for the sides of the water tank at the converter transformers location (Photo 2.3).
- o Erection of the steel framework of the synchronous condenser building is at an advanced stage (Photo 2.5).

Photo 2.3: Formwork and rebar installation for water tank for synchronous condenser facility

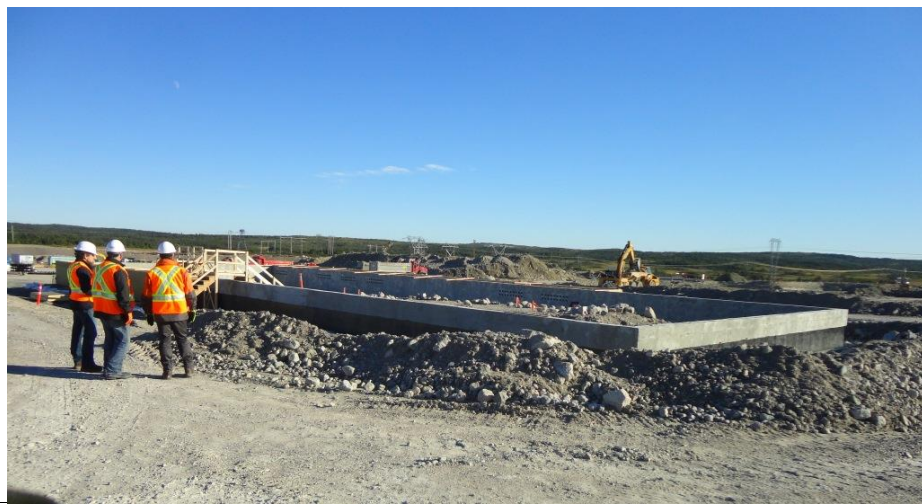
- o The footings of the [converter AC substation control building \(Photo 2.4\)](#) and the base slab of the oil/water separator [for the converter facility \(Photo 2.6\)](#) at the western end of the site have been completed.

Photo 2.4: AC Substation Control Building foundation

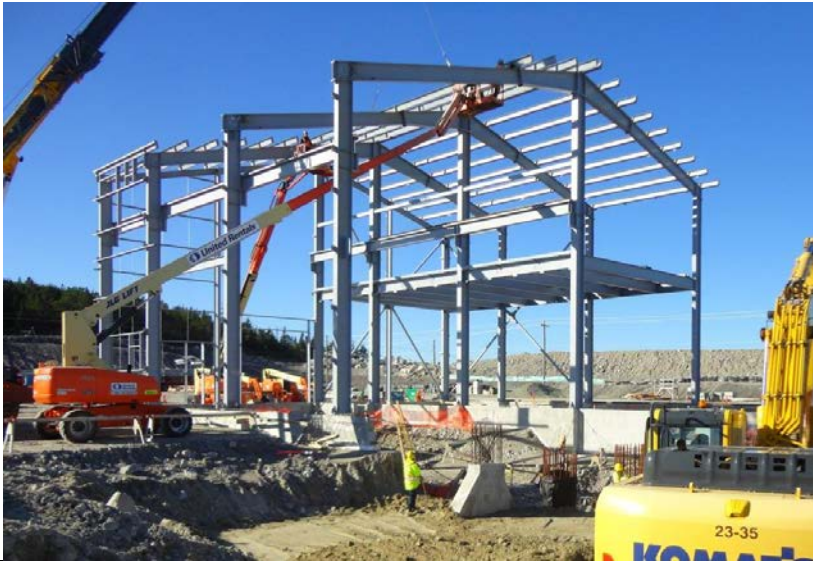
Photo 2.5: Synchronous condenser building

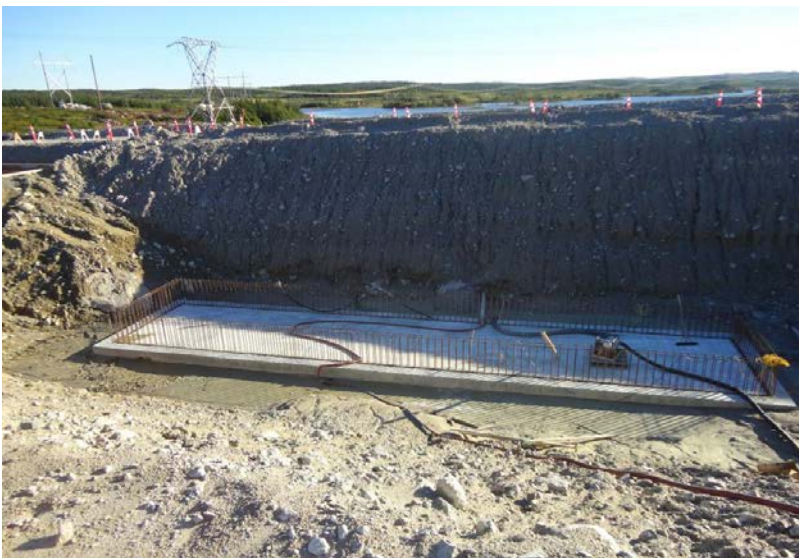
Photo 2.6: Base slab for oil/water separator

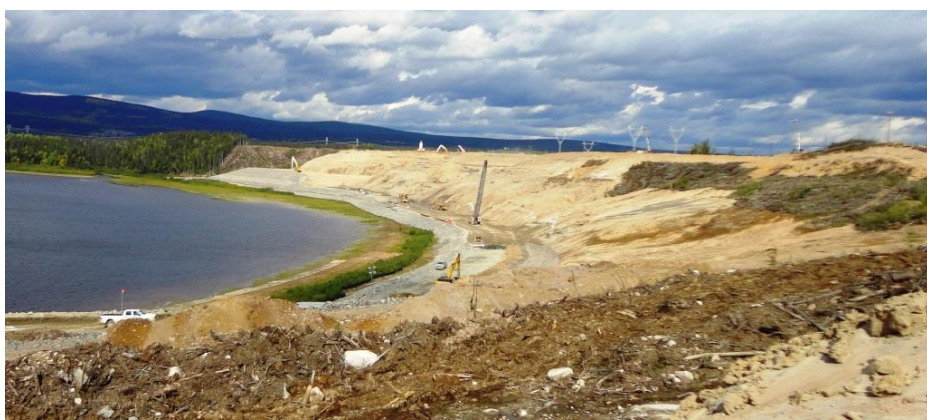
Photo 3.1: Upstream slope - Overall view of the upstream slope of the North Spur, showing the excavated slope and the cut-off wall line along el 20m the toe berm. View is looking towards the north. The el 10m berm is visible along the toe of the excavated and trimmed slope. In the back ground, the el 24m and el28 m fill intermediate placement berms can be seen.

Commented [GS9]: The is no 10 m berm on the upstream site (WL = 17+ m). I'm not sure what is being referred to, probably the working platform at 20m?

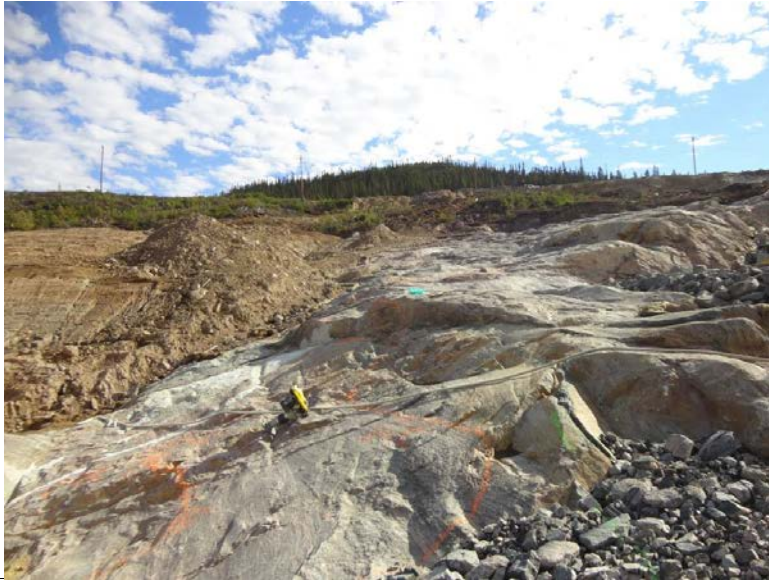
**Commented [SP5]:** This is commonly referred to as the "rock knoll". The term "knob" is also used in Photo 3.11 – we should be consistent.

Photo 3.11: Upstream slope. Granitic bedrock exposed at the periphery of the rock knob at the south end of the upstream slope.

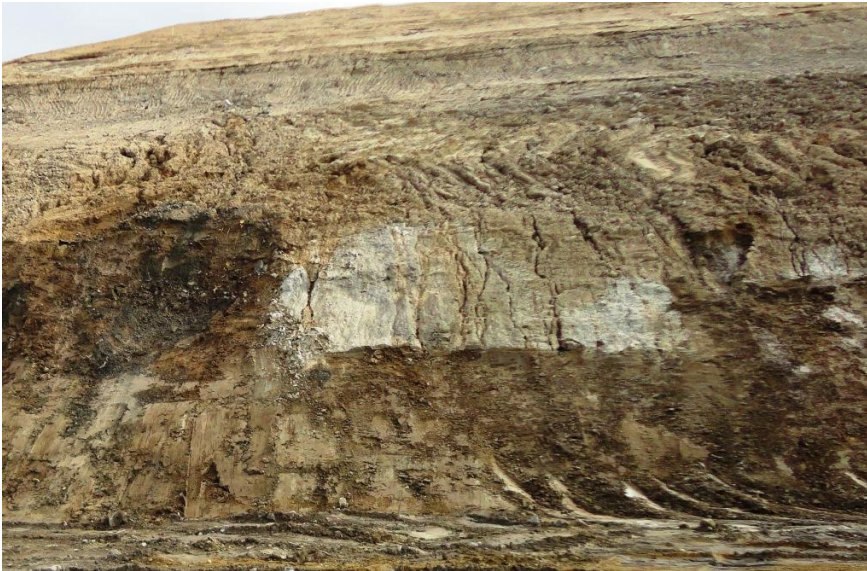
**Photo 3.13:** Upstream slope- Excavated slope in the upper clay and sand. Note the erosion runnels in the sand/silt at mid height.

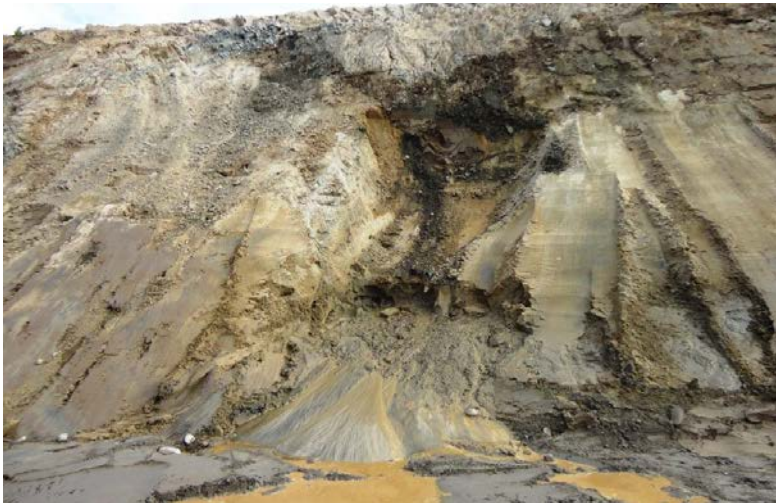
- There are numerous water seepages from sand layers in the excavated faces (Photo 3.14). This causes minor localized washouts but has not caused any significant geotechnical issues. It was noted that temporary slopes in the sands and silts are very susceptible to erosion but once again this is not a problem since the slopes are temporary and will later be covered and protected.

**Photo 3.14:** Upstream slope, layered Upper Clay/Sand zone. Note the water seepage from sand layers at lower and upper slope levels. This has caused localized washout of materials.

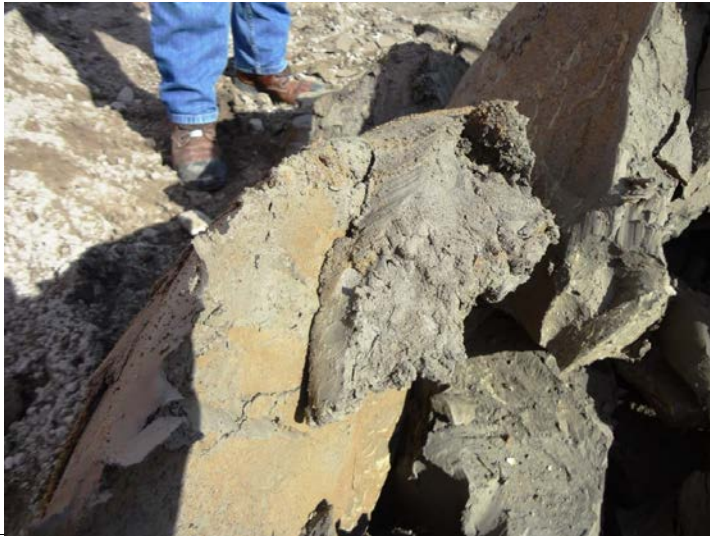
- The lower clay rises to high levels at the south end of the North Spur. Recently excavated material was examined during the September 23 site visit (Photo 3.15). This material which was examined could be seen to be very different from the upper sand and silt/cay. It is dark greenish grey, firm and plastic with no tendency for liquefaction behaviour when disturbed.
- Bedrock is exposed adjacent to the cutoff near the rock ~~knob~~ **knoll** at the south end of the North Spur (Photos 3.11 and 3.12). This is a competent granitic rock. The surface of the rock has been cleaned to an acceptable standard and locally forms the base of the impervious till blanket above el 20m.

Photo 3.15: Upstream slope- Excavated greenish grey "lower clay" from the south end of the cut-off. The lower clay is a firm, plastic clay with low sensitivity. This material is at approximate el [-5.14 to 5m](#) along most of the upstream face and is the impervious material that the base of the cut-off wall is seated in.

**Commented [GS10]:** This is about a 4 m wide band above elevation 20 m, approx.

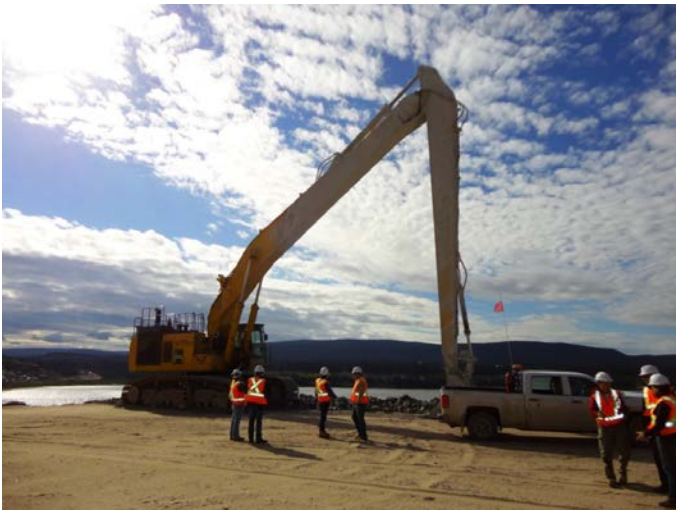
- o To date, the wall was excavated with a long-stick backhoe (Photo 3.16). This excavator can dig to depth of just below 17m. Bentonite/cement slurry was mixed on site (Photo 3.18) and ~~delivered to trench in trucks~~ by pipe. The slurry is a plastic bentonite/cement mixture with a 28 day strength of 300 to 400 KPa. Batching quantities are as follows

Photo 3.16: Upstream slope- Long stick backhoe excavator used to excavate most of the upstream slope cut-off wall to depths of about 15m

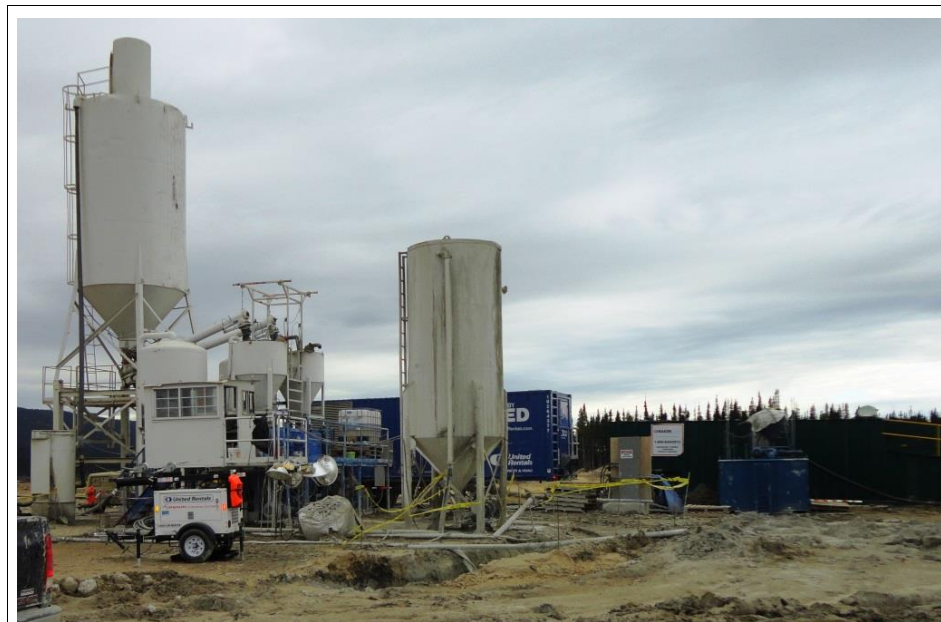
Photo 3.18: Plant for mixing the cement bentonite slurry concrete of the cut-off wall.

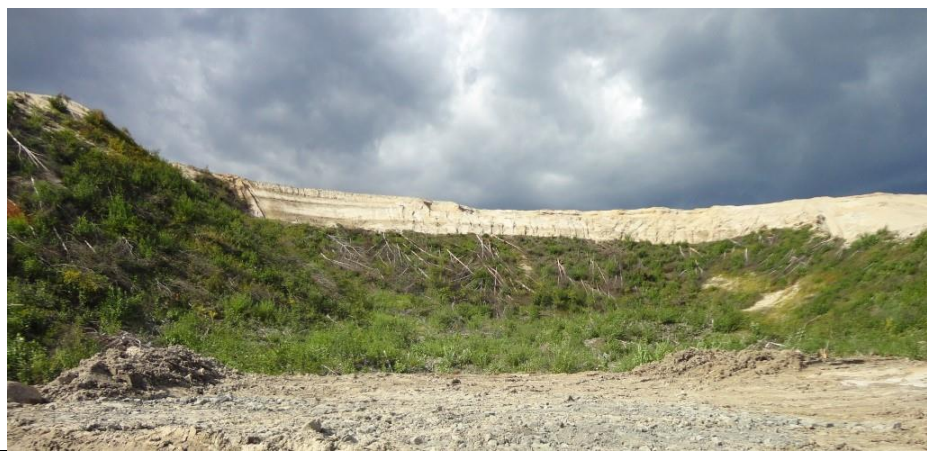
- Brush clearing is complete in the area and various features are now more visible than was the case in earlier site visits. Photo 3.19 shows the back scarp of the 1978 landslide. Slide debris from that event can still be seen in some areas.

Photo 3.19: Downstream slope. View of the scarp of the 1978 landslide.

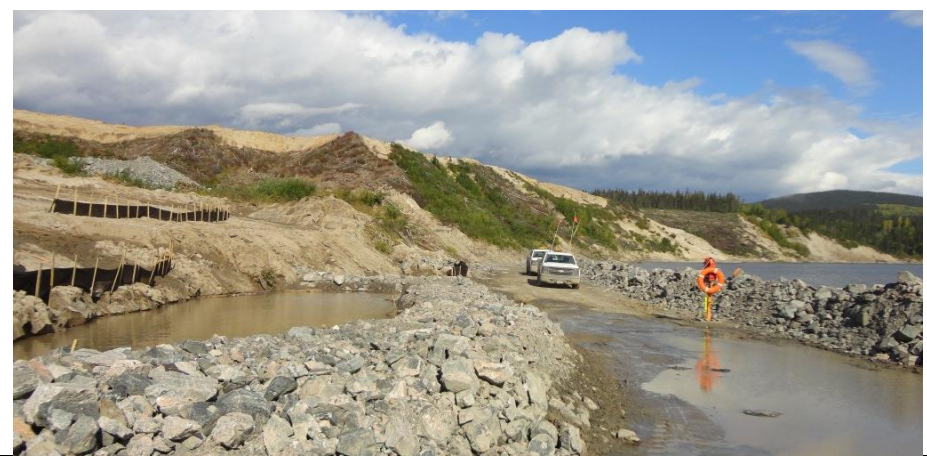
- A toe berm has been excavated and some slope trimming has been done in the lower slope (Photo 3.20).
- Water collection ditches and berms have been constructed at the toe of the slope (Photos 3.20 and 3.21).

Photo 3.20: Downstream slope; water collection and silt fences at toe of slope. Some slope trimming has been done in the lower slope. Some debris from the 1978 slide are visible in the background (upslope from the white pick-up trucks).

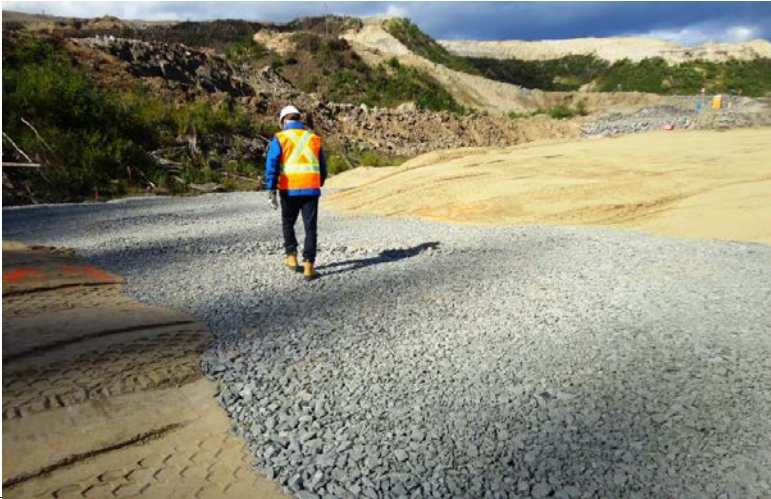
- Work on the southernmost finger drain is at an advanced stage (Photo 3.22). The finger drain will be embedded within the fill that will form the lower slope in this area. These drains are part of the water control measures designed to depress the water table in the slope.

Photo 3.22: Downstream slope; finger drain near the toe of the slope. The finger drain filters extend ~~is oriented~~ across the slope.

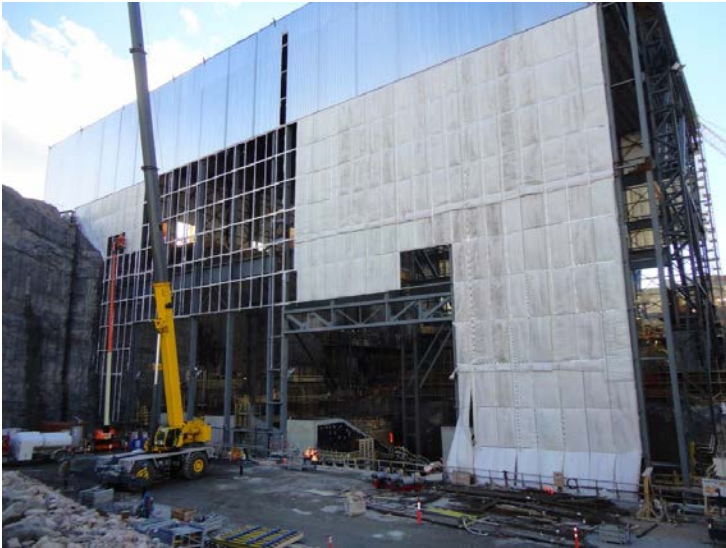
- o The ICS (Integrated Cover System) shelter structure, which was never completed as planned, is currently being dismantled (Photos 4.7 and 4.8). Winter shelter for various works will be provided by local heated shelters, similar to those used for the spillway works.

Photo 4.7: Powerhouse – ICS shelter structure over units 1 and 2 is currently being dismantled.
