Subject: IE Site Visit Report Nov 2014 - Final

# MEETINGS IN ST. JOHN’S AND VISITS TO LOWER CHURCHILL PROJECT SITES, NOVEMBER 24 TO 27, 2014

Prepared for: Nalcor Energy

Date: February 05, 2015

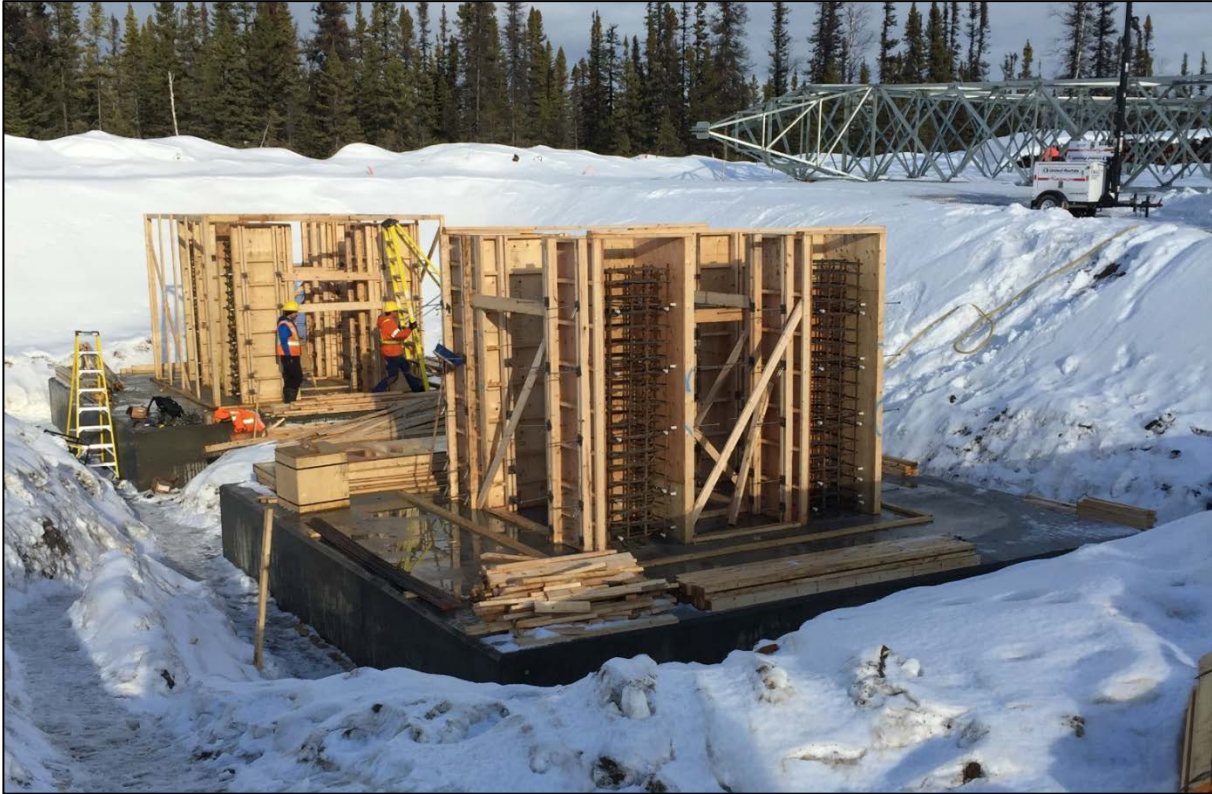
Photo 1.1 HVAC transmission line foundation installation. (November 25, 2014)

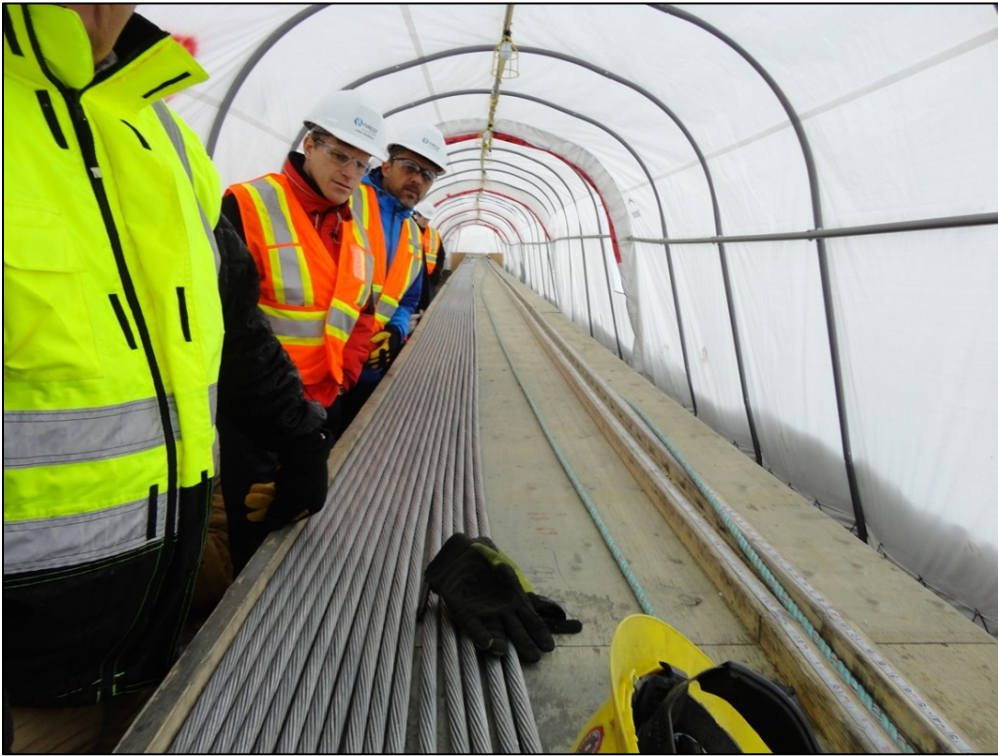
- A site visit was made to the guy wire assembly facility (Photos 2.1 and 2.2) and typical guy wire attachment installations were viewed (Photo 4.3).
- Tower assembly work (Photo 3.2) at each tower site was continuing at the time of the site visit. A significant number of units (approximately 300) have been completed and are ready for erection.

Photo 2.1: Laydown and preparation of guy cables for HVac transmission towers. (November 25, 2014)

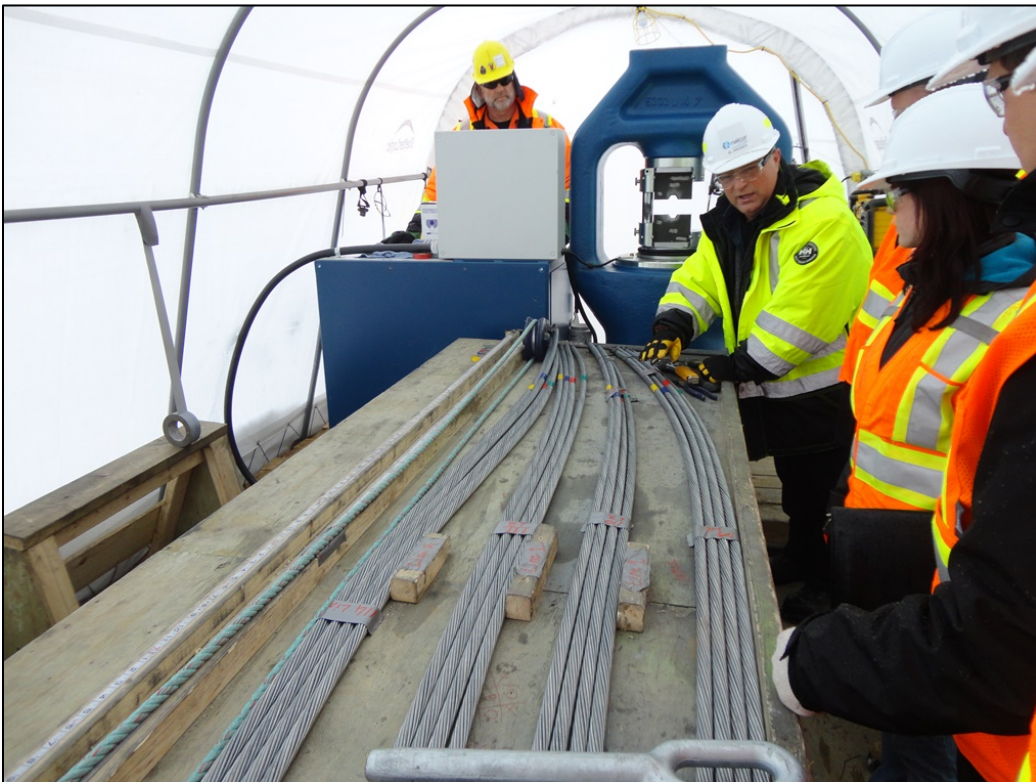
Photo 2.2: Laydown and preparation of guy cables for HVac transmission towers. (November 25, 2014)

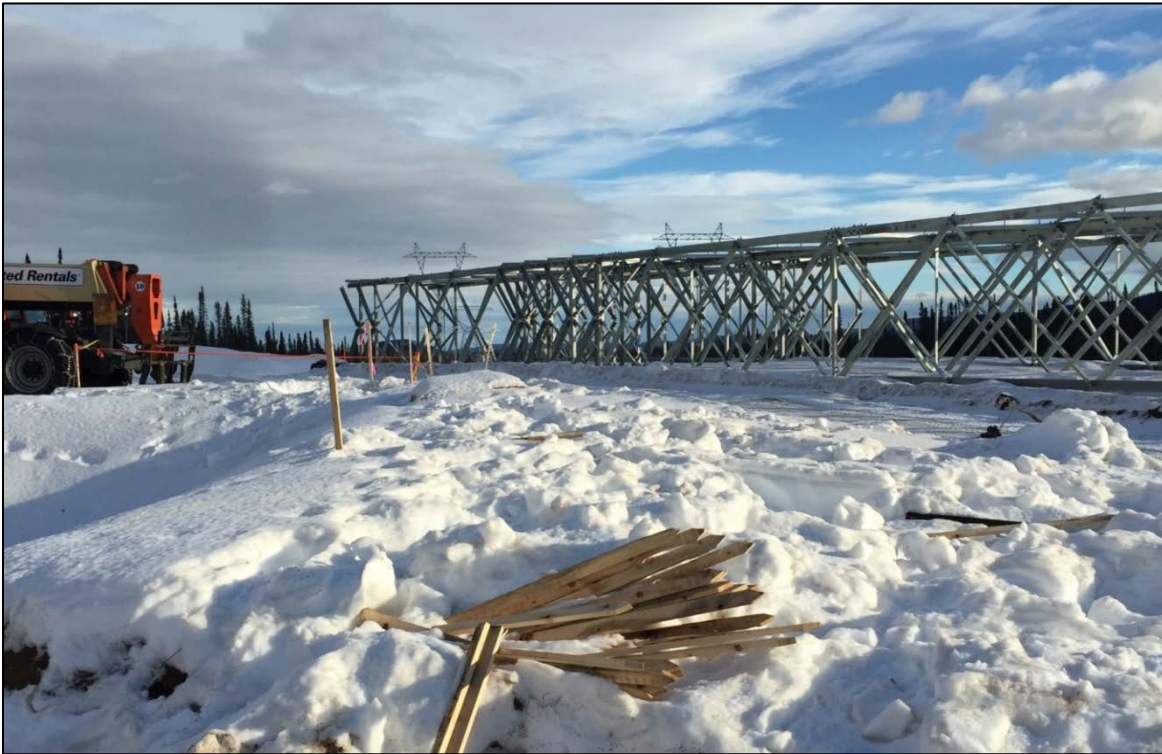
Photo 3.1: HVAC transmission line structure assembly. (November 25, 2014)

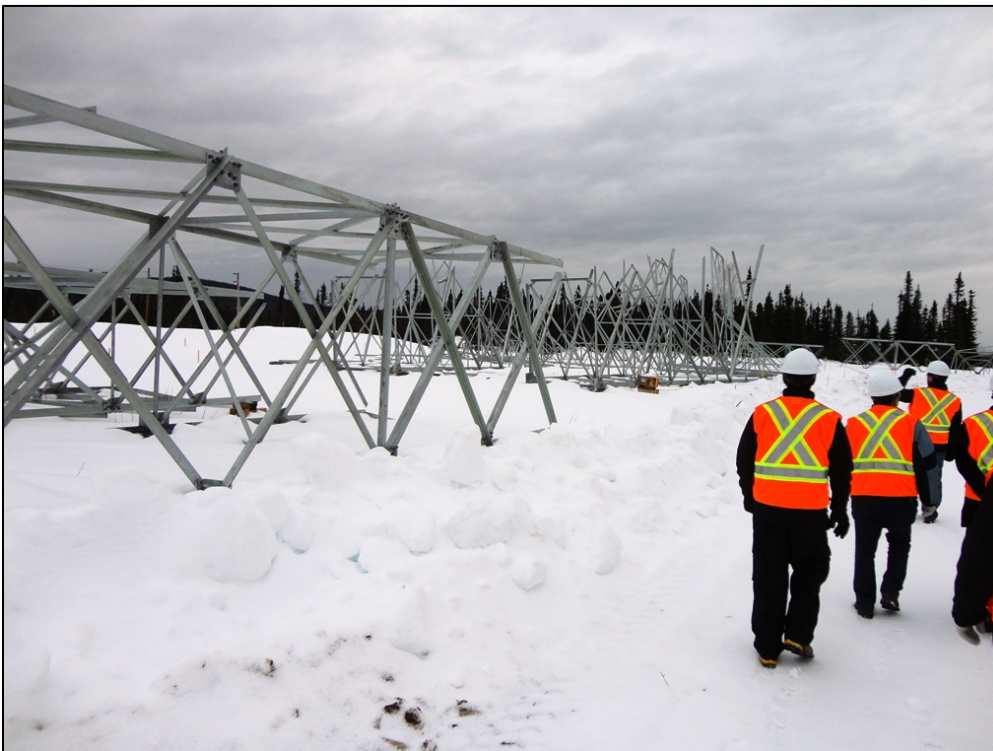
Photo 3.2: Assembling a HVAC transmission tower near the North Spur. (November 25, 2014)

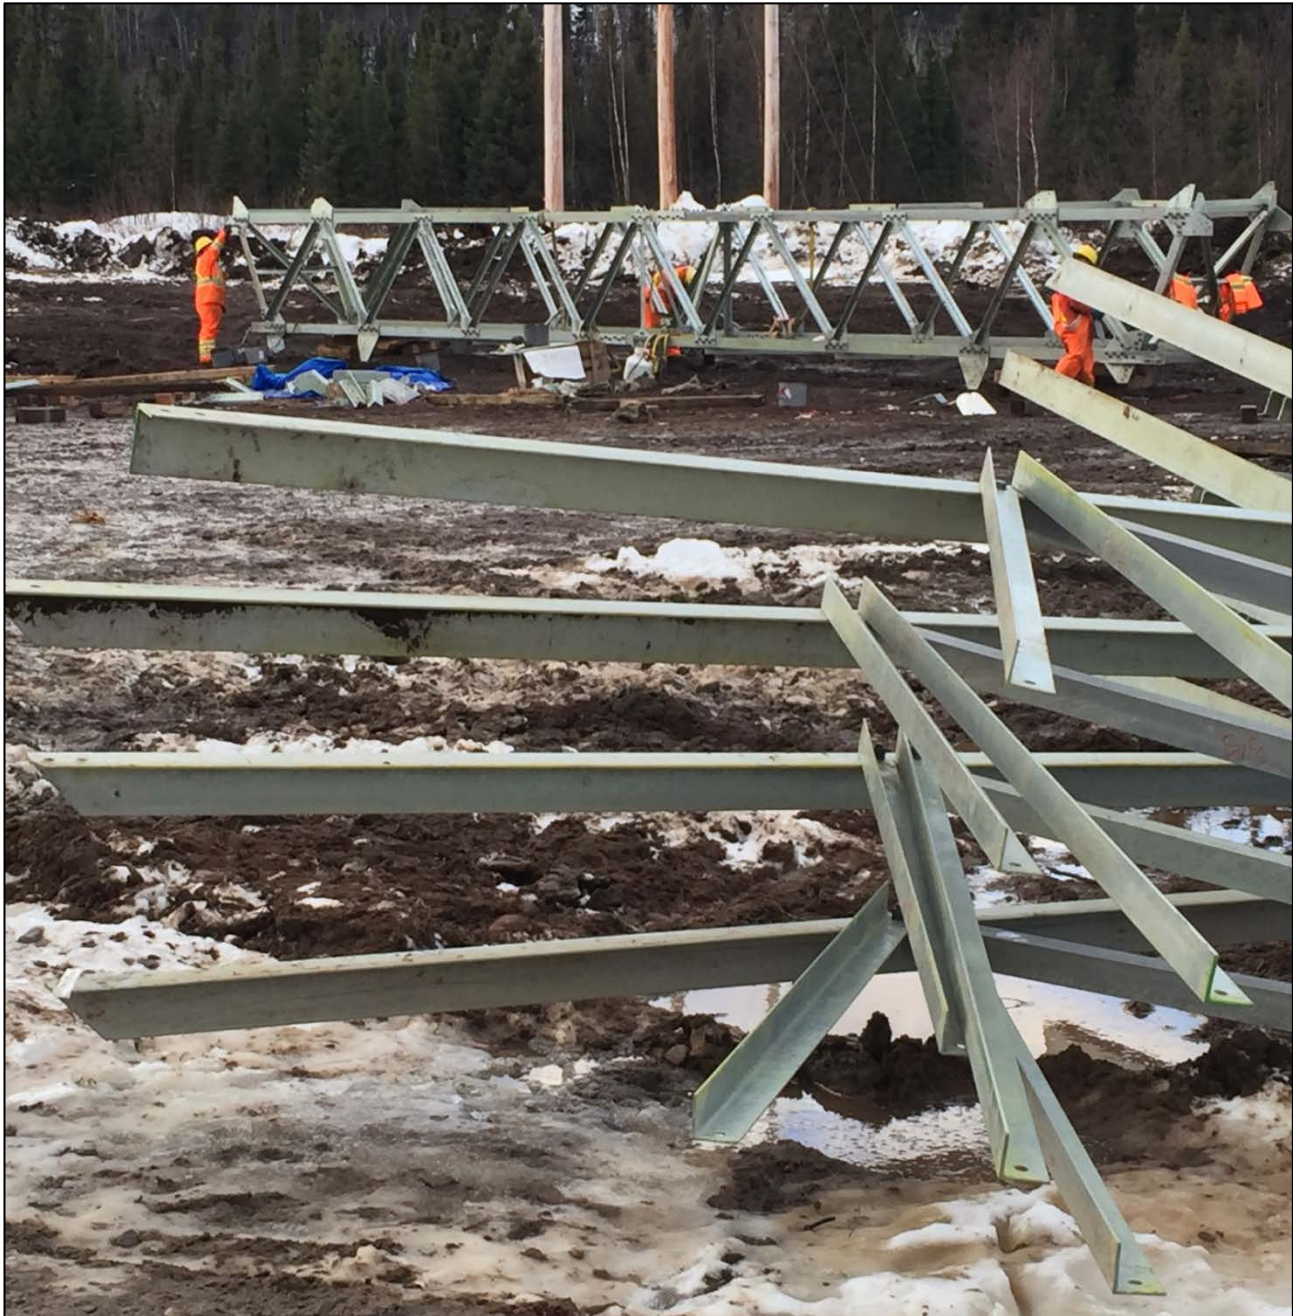
Photo 3.3: HVAC transmission line structure assembly. (November 25, 2014)

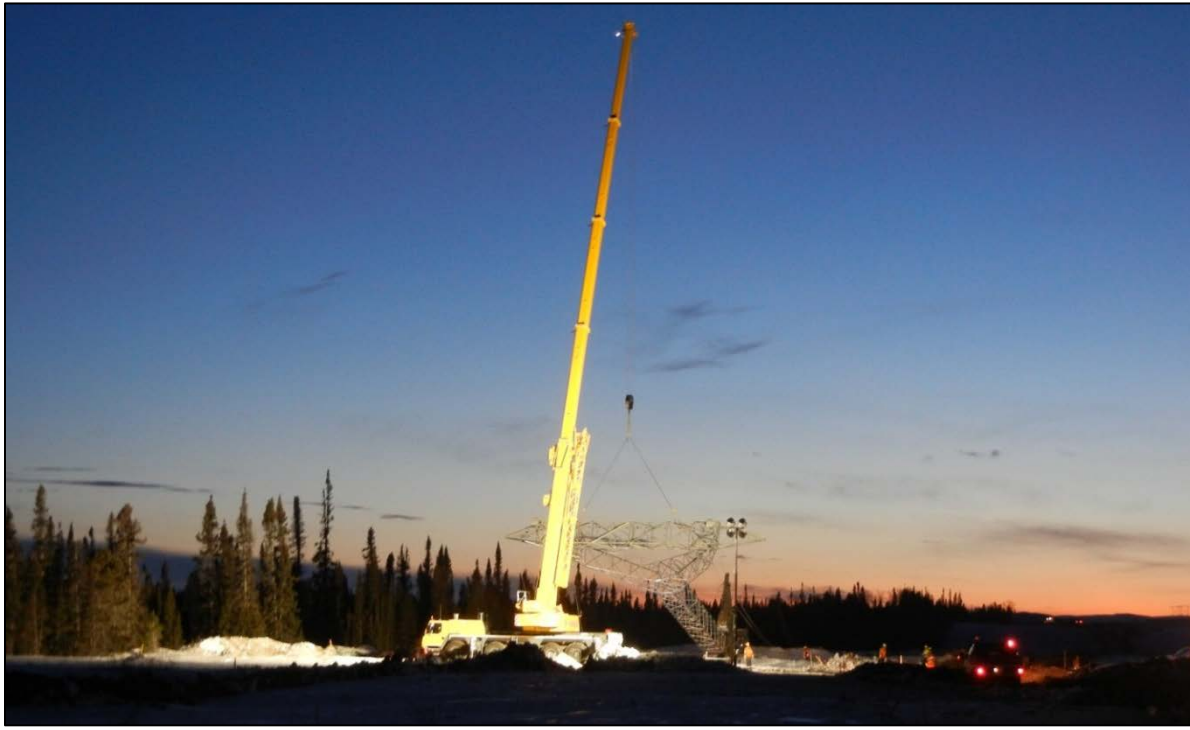
- No stringing or insulator/hardware has been installed yet.
- The IE witnessed the night time erection of a single foundation tower (Photos 4. 1, 4. 2a and b). The total time for the crew to move onto the site and erect the tower with a crane was just over one hour. When the IE team departed the site, crews were starting to secure to guy wires to the previously installed ground anchors.

Photo 4.1: HVac transmission line – structure erection. (November 26, 2014)

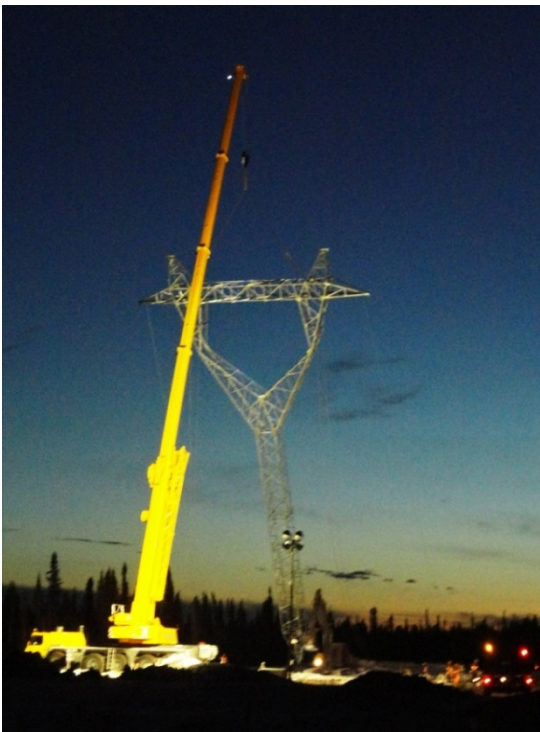
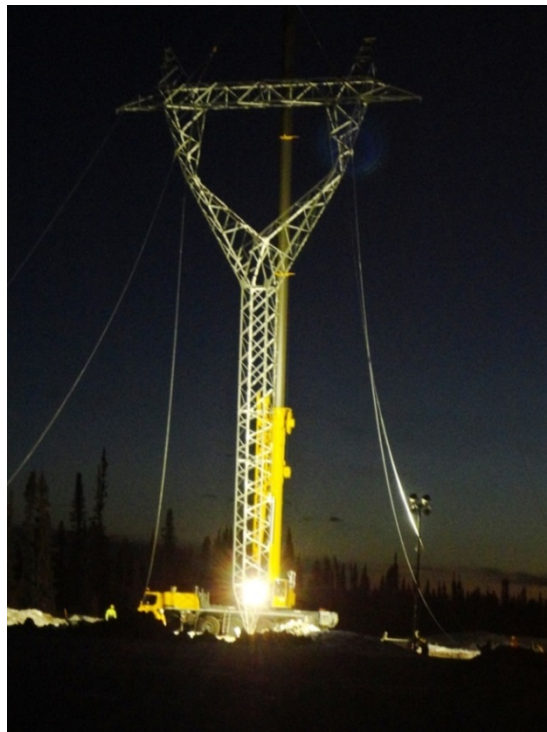
Photo 4.2 a (left) and b (right) : Erection of HVac Transmission Tower 58 at sundown. (a) tower being hoisted into place with crane and excavator and (b) in final position, still suspended from the crane; note untethered guy wires at this stage of erection. (November 26, 2014)

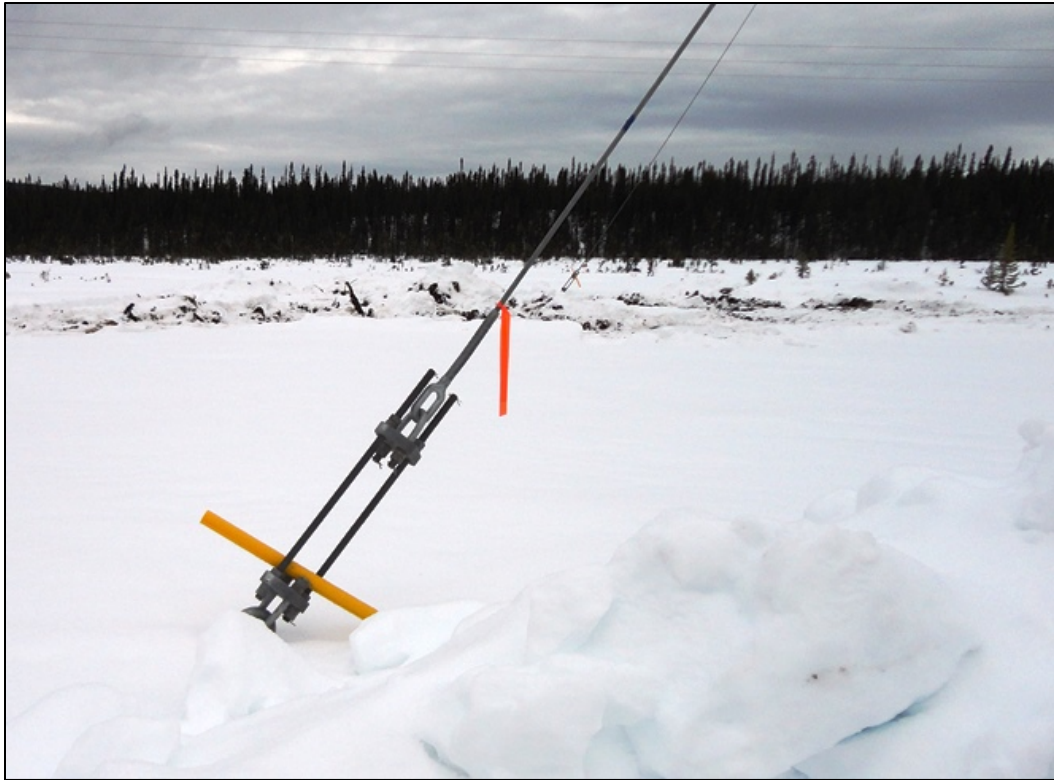
Towers in photos 4.3 and 5.1a are missing their yellow guy guards. While I followed up with Al Hacker to have them installed on the day of the tour, they are not present in the photos.

**Photo 4.3:** Lower connection of guy cable on single footing transmission tower. (November 26, 2014)

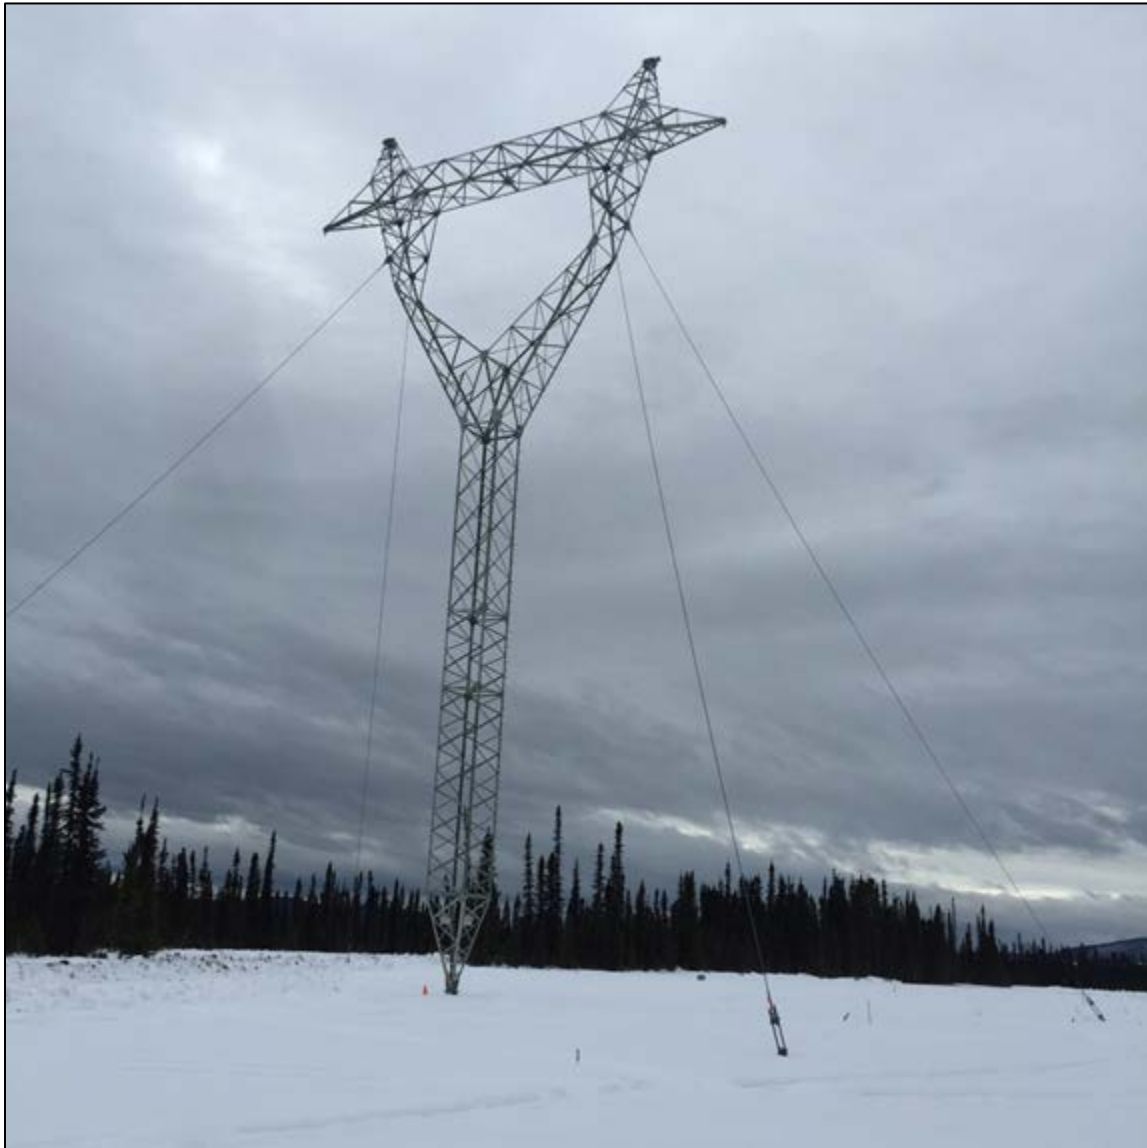
Photo 5.1a: HVac transmission line – erected guyed structure. (November 26, 2014)

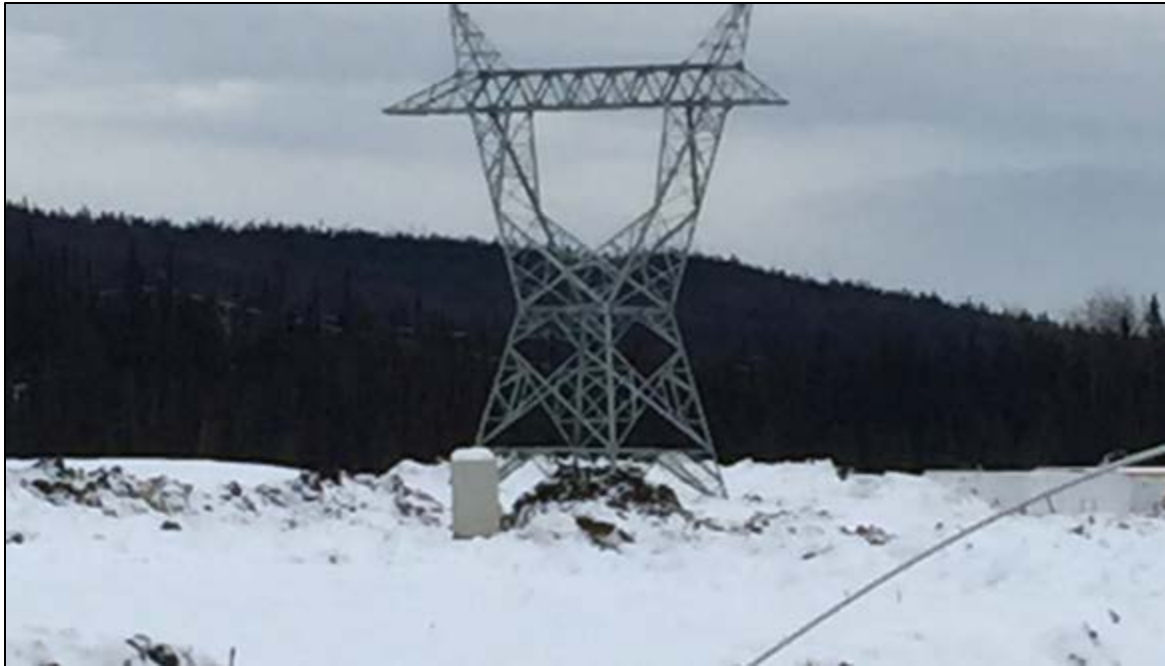
Photo 5.1b: HVac transmission line – erected Self Supporting Structure. (November 26, 2014)

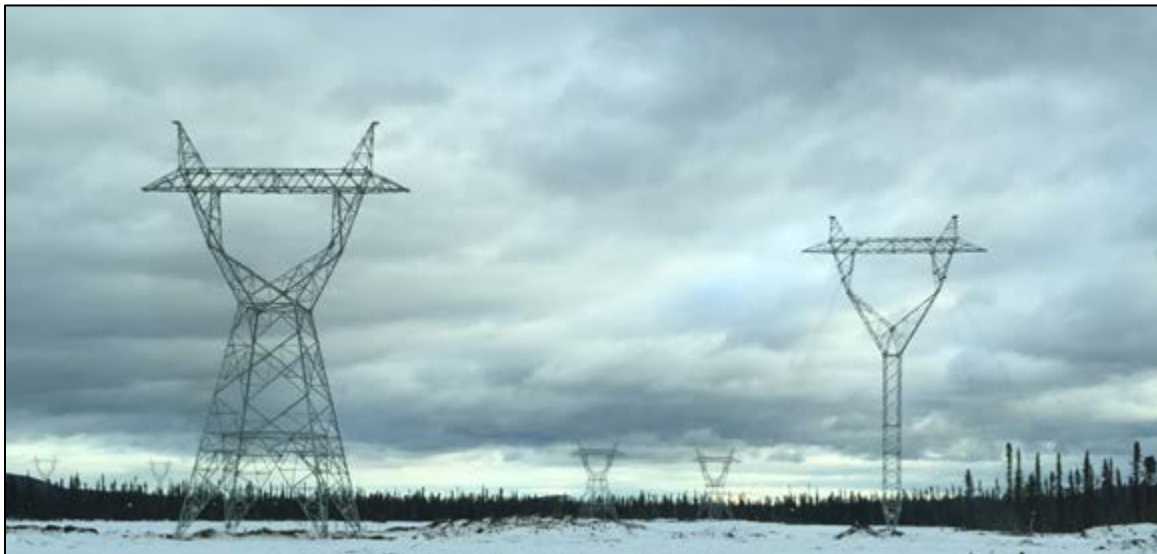
Photo 5.1c: HVac transmission line – erected Structures – Looking South toward both Lines. (November 26, 2014)

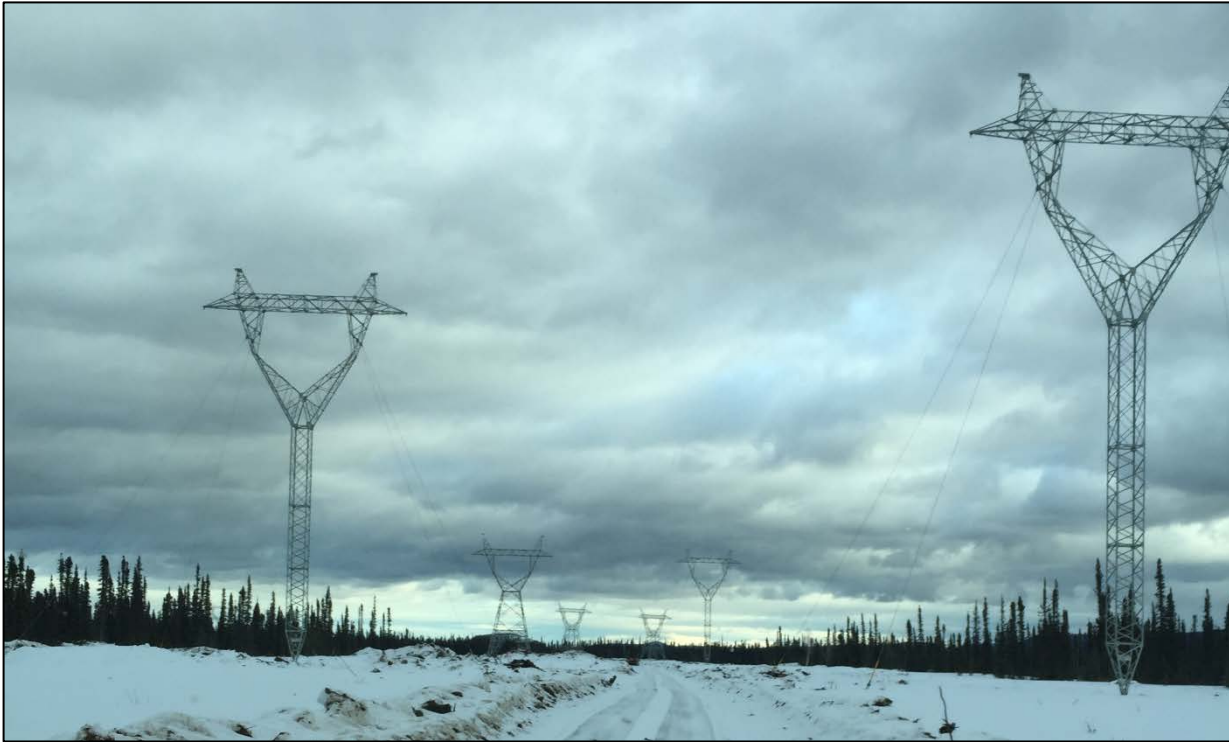
Photo 5.1d: Hvac transmission line – erected structures – Looking South toward both Lines, (November 26, 2014)

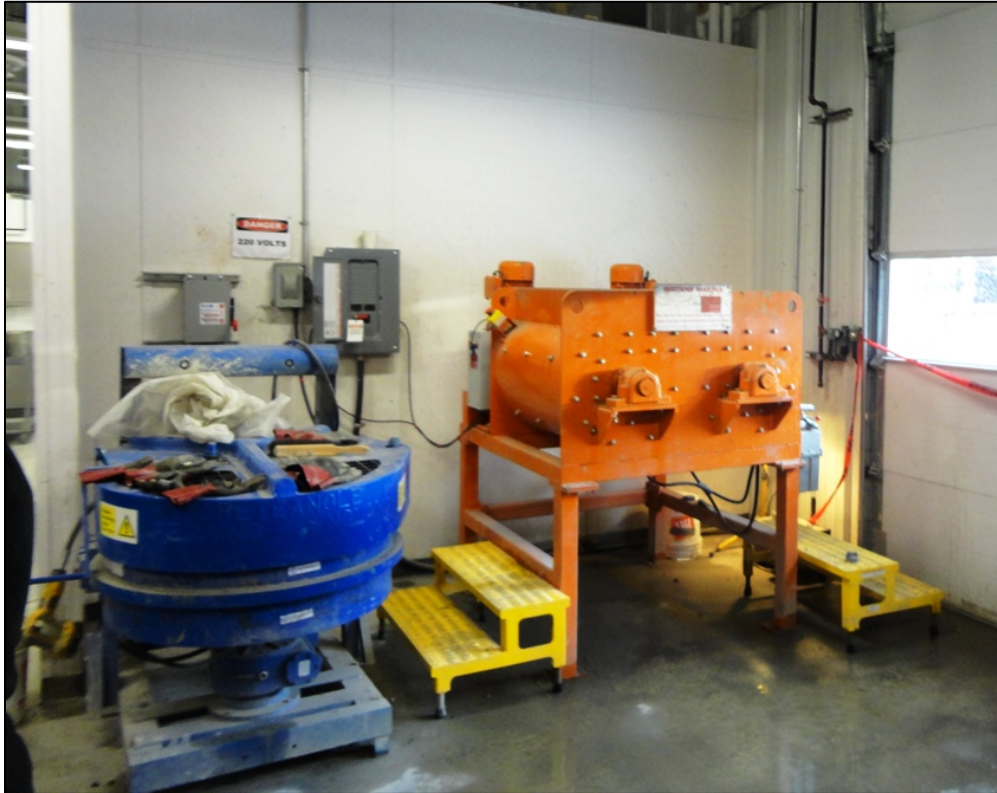
Photo 6.1 Site laboratory; mixer for concrete mix design. (November 25, 2014)

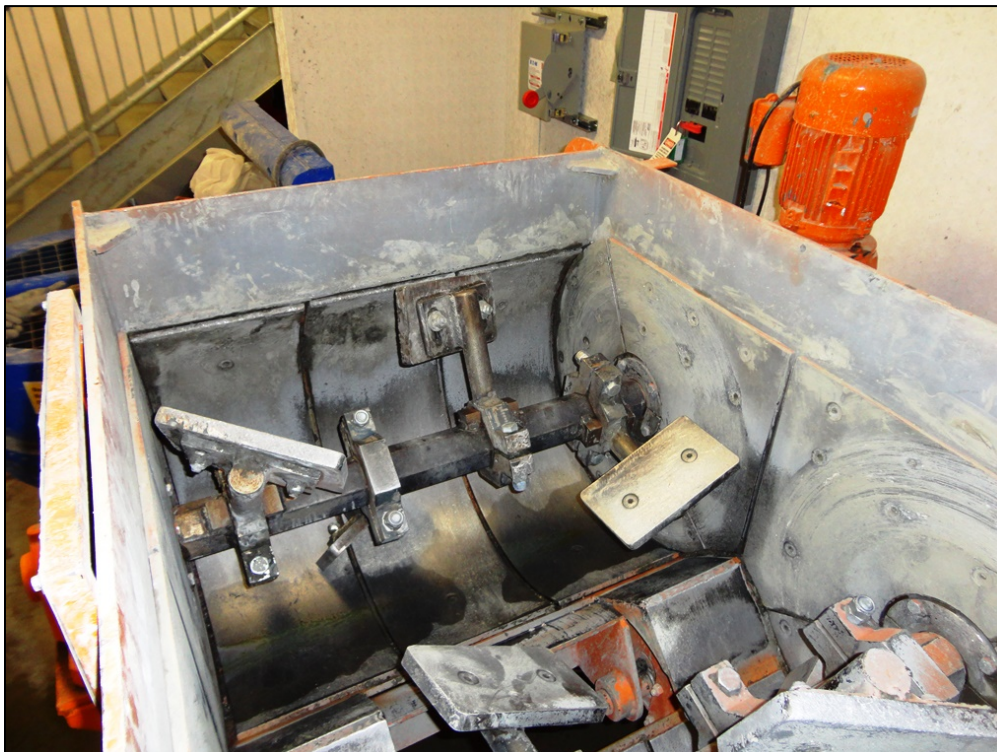
Photo 6.2: Site laboratory; mixer for concrete mix design. (November 25, 2014)

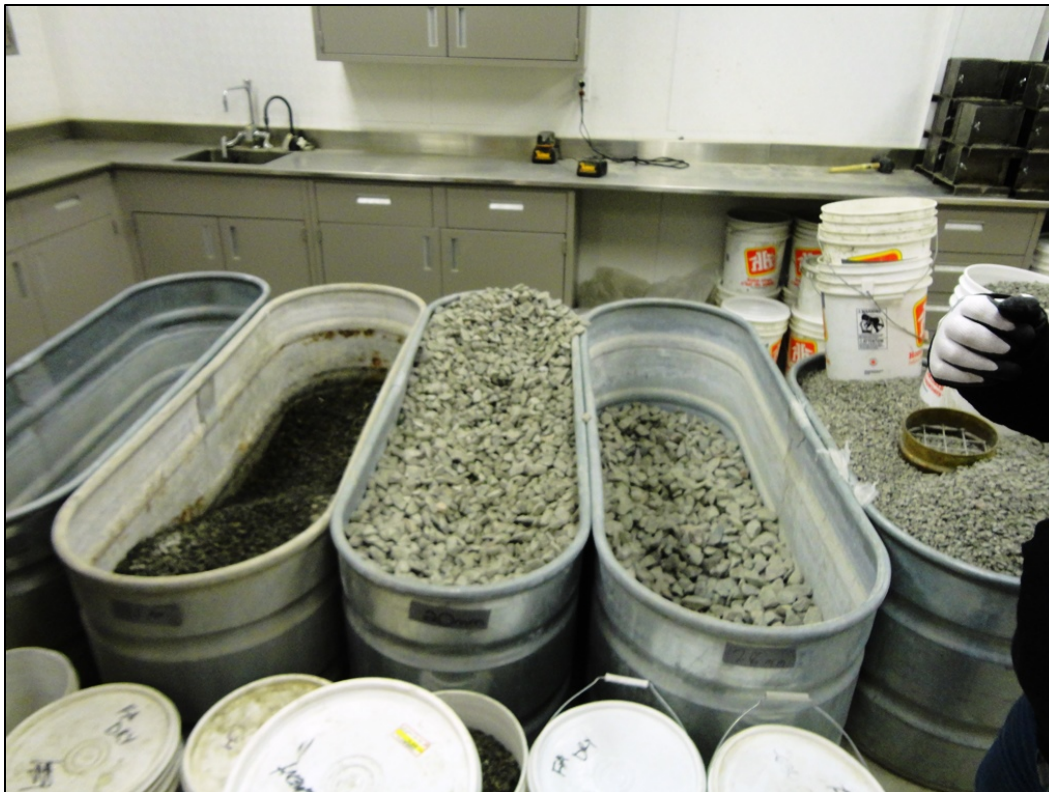
Photo 6.3: Site laboratory; graded aggregates for concrete mix design. (November 25, 2016)

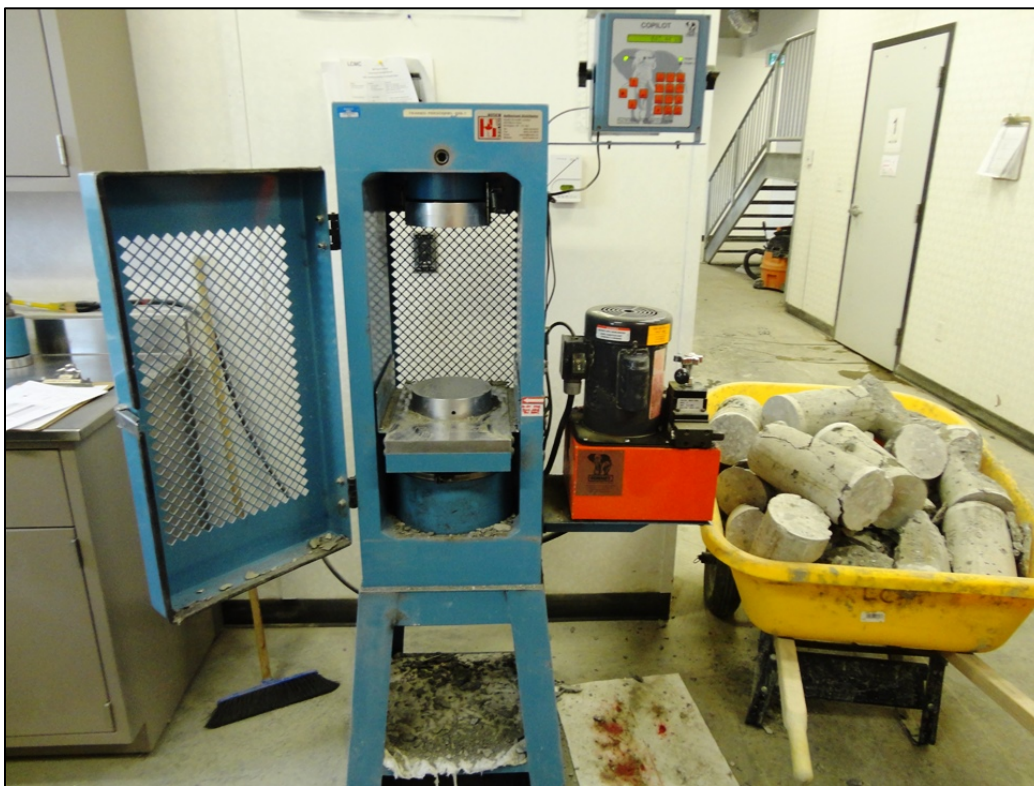
Photo 6.4: Site laboratory , unconfined compressive strength testing of concrete cylinders. (November 25, 2016)

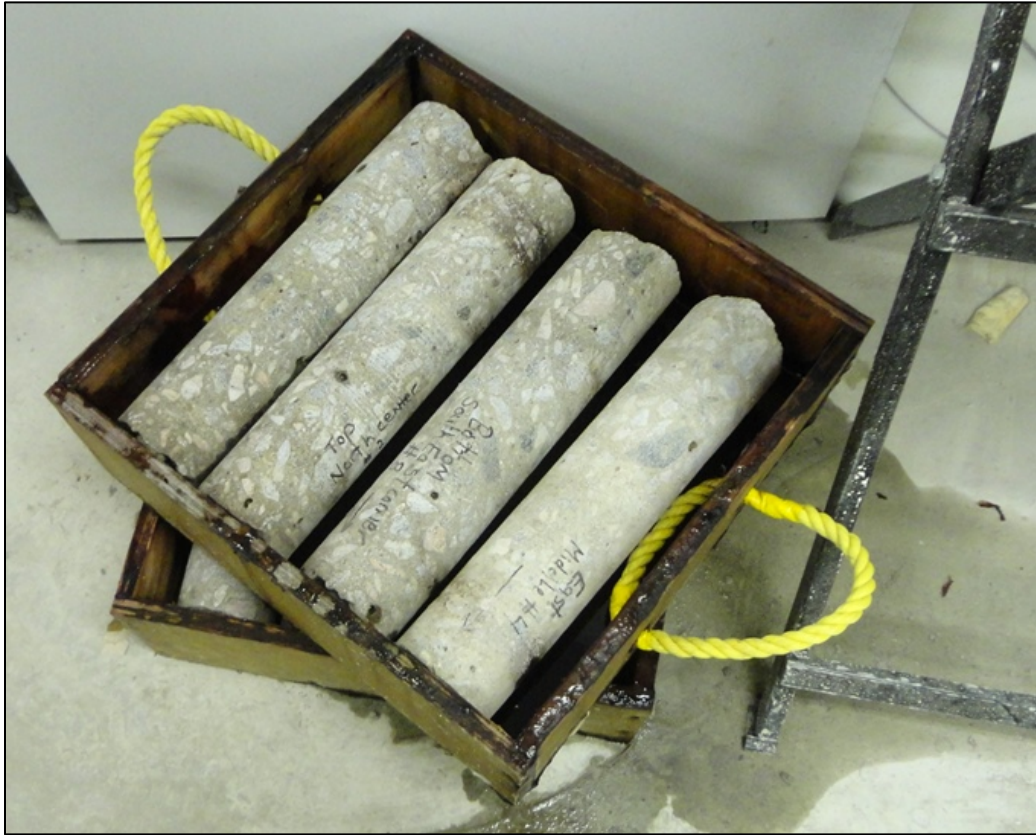
Photo 6.5: Drilled concrete cores from the field. (November 25, 2016)

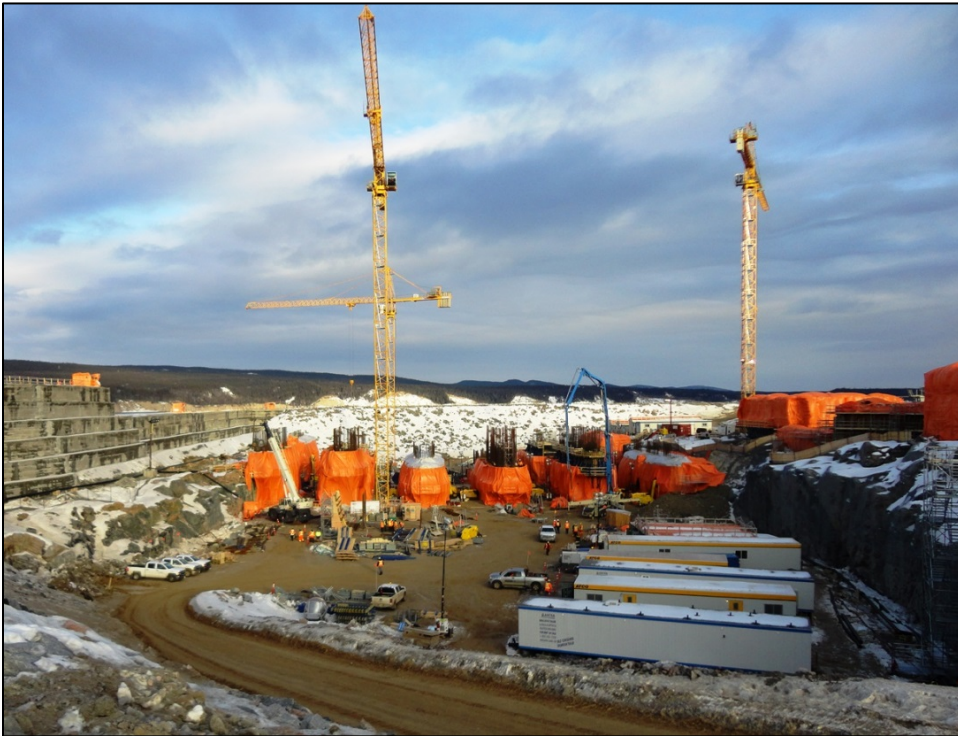
Photo 7.1: Spillway; view looking downstream towards the piers. RCC cofferdam is visible on the left side and the orange tarp covered transition dam is on the right. (November 26, 2014)

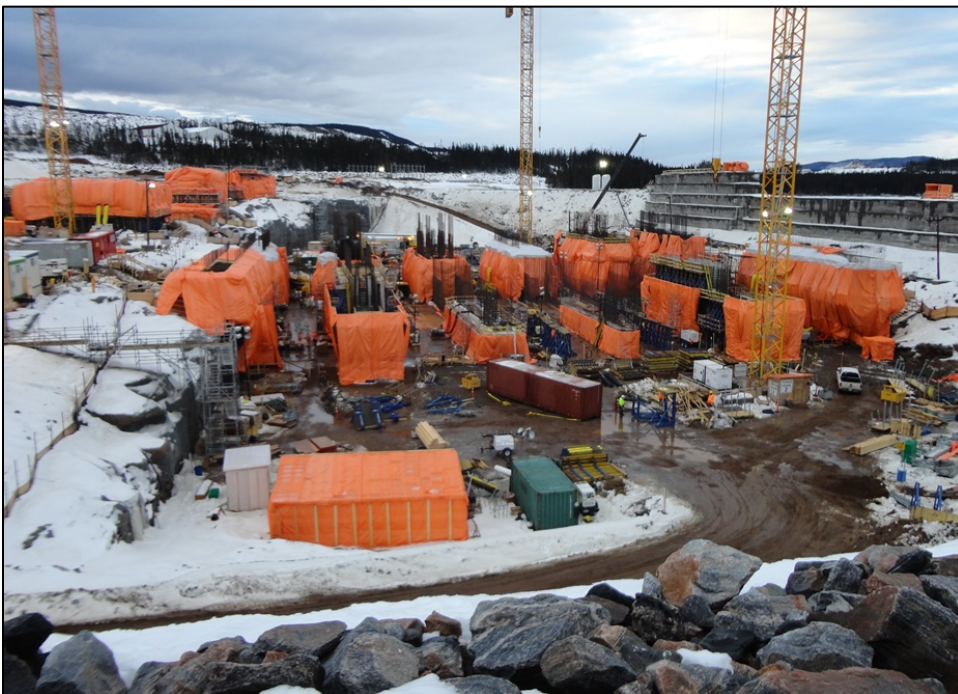
Photo 7.2: Spillway; view looking upstream towards the piers. RCC cofferdam is visible on the right side and the orange tarp covered transition dam is on the left. (November 25, 2014)

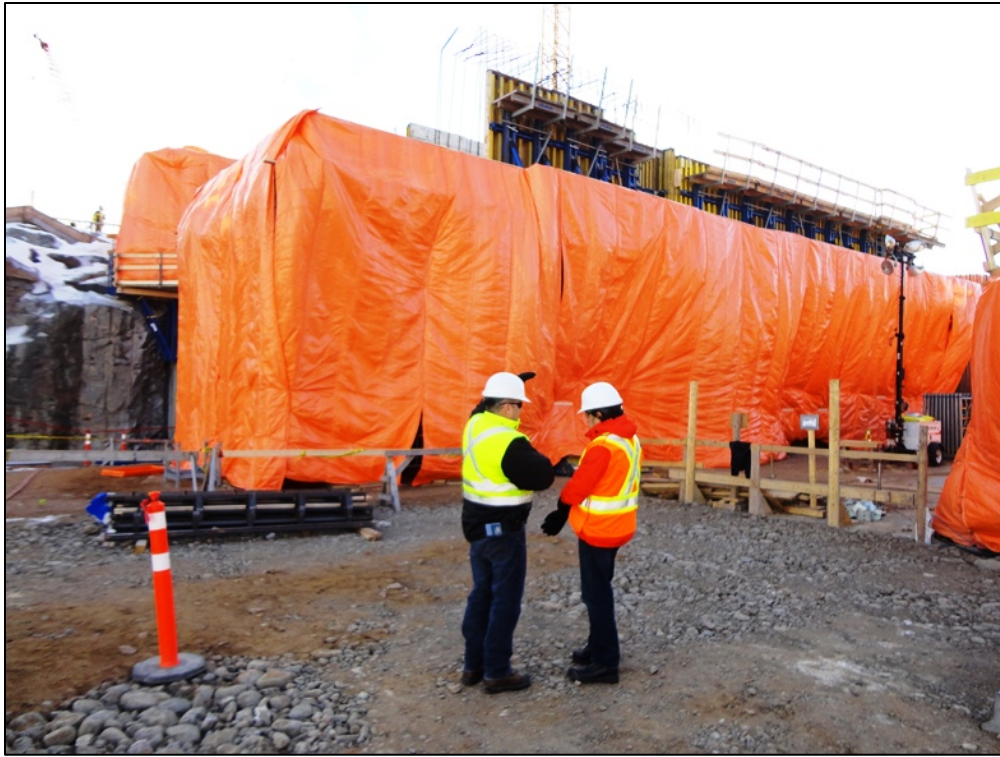
Photo 7.3: Right side of the spillway. Transition dam is visible at the top of the photograph. (November 26, 2014)

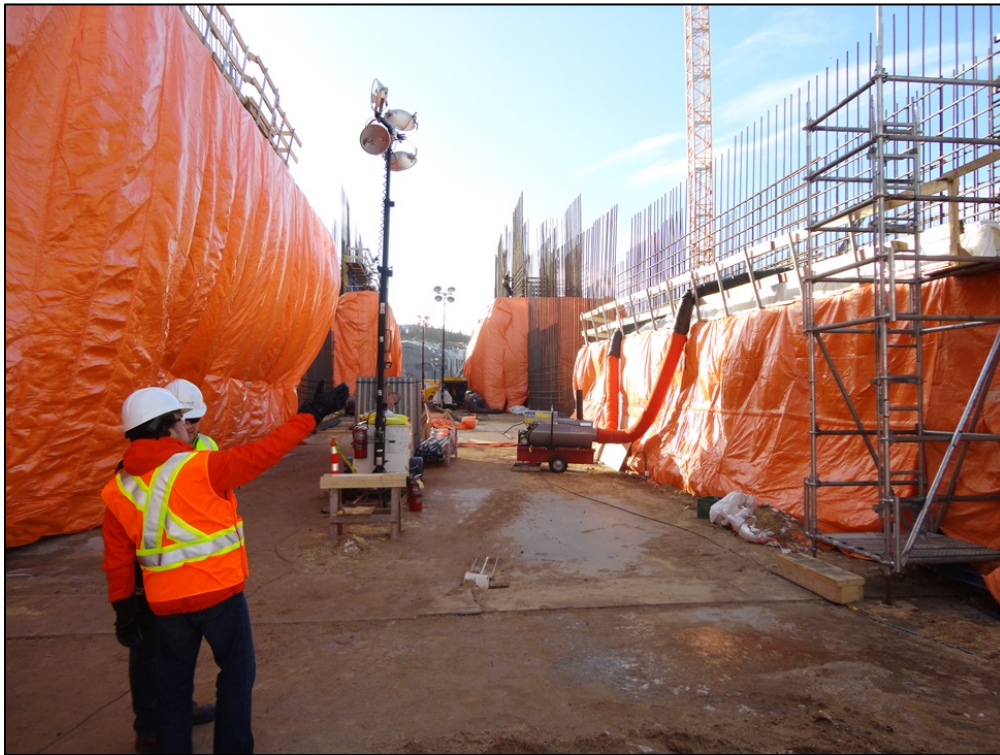
Photo 7.4: Spillway; view looking upstream between North Piers and Pier 1. (November 26, 2014)

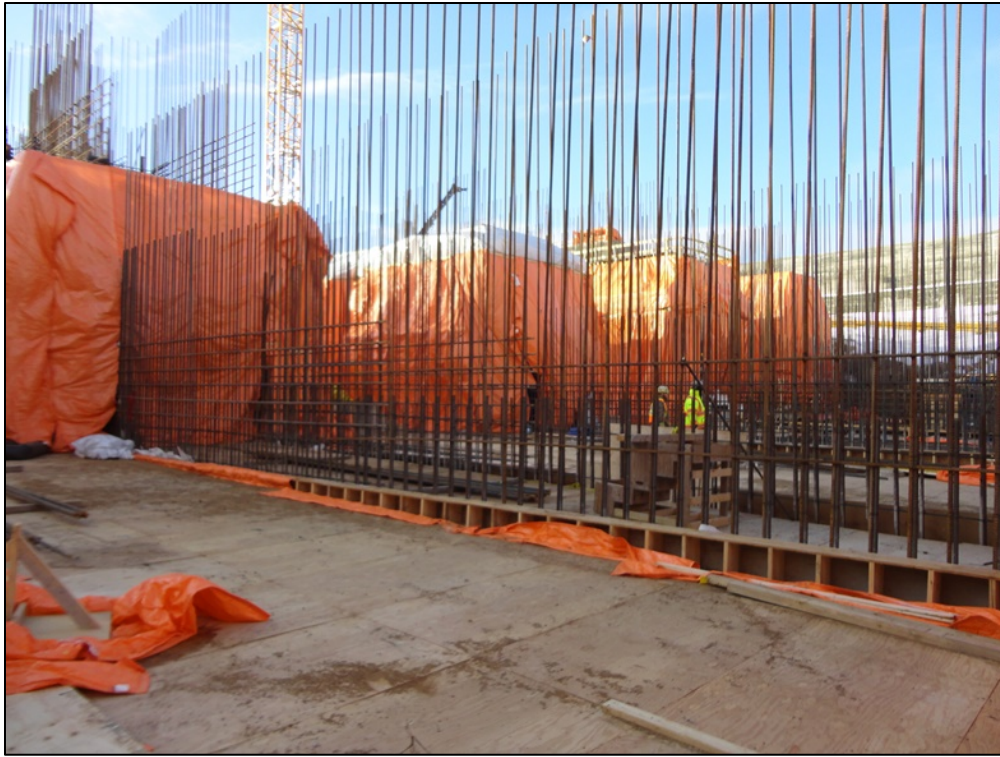
Photo 7.5: Spillway, rebar installation for Pier 3. (November 26, 2014)

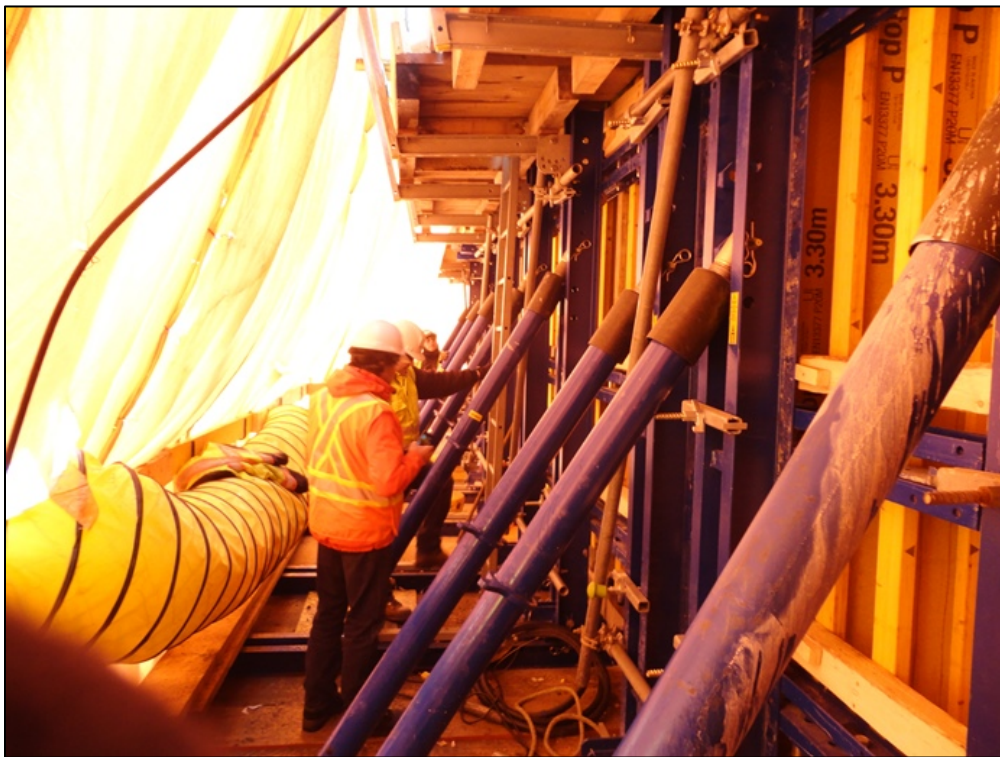
Pier .7.6: Spillway; shrouded and heated formwork. (November 26, 2014)

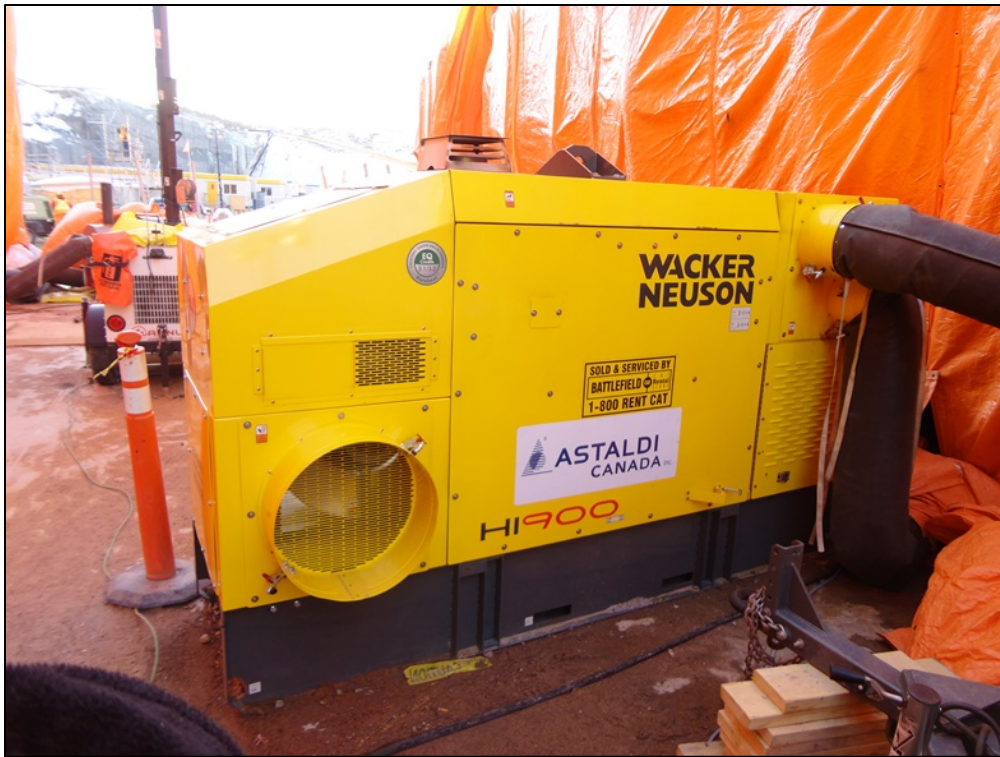
Photo 7.7: Spillway; Wacker Neuson heater, one of many used for heating the formwork and concrete pours of the piers. (November 26, 2014)

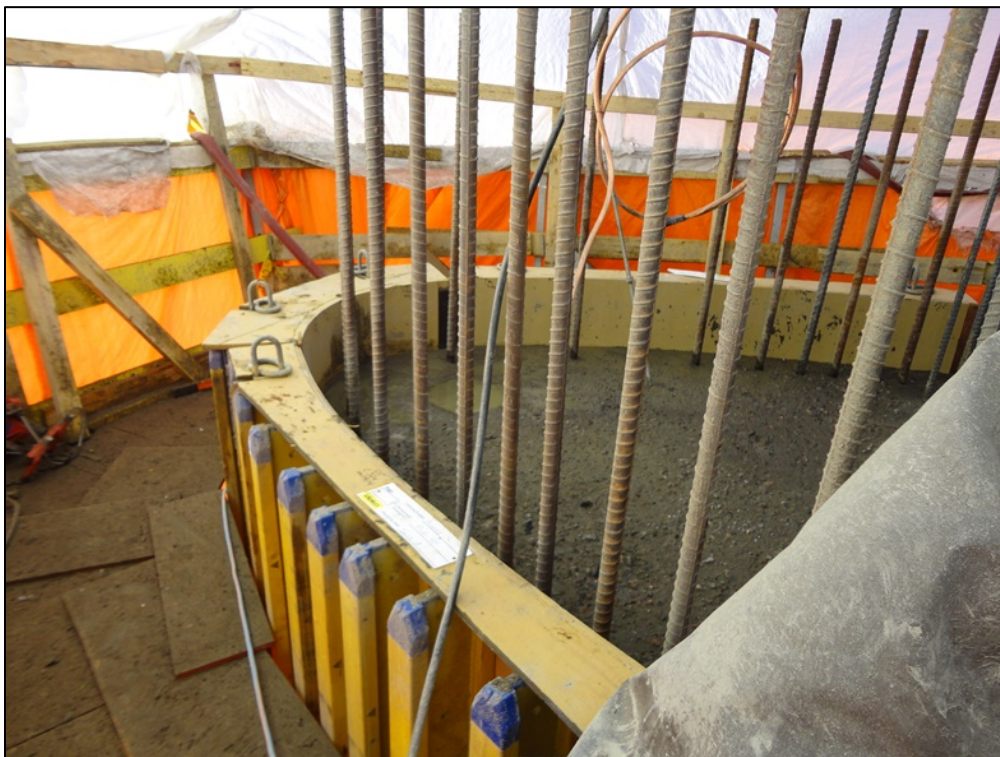
Photo 7.8: Spillway; Upstream nose of Pier 3. (November 26, 2014)
