Subject: IE Site Visit Report Nov 2014 - Final

# MEETINGS IN ST. JOHN’S AND VISITS TO LOWER CHURCHILL PROJECT SITES, NOVEMBER 24 TO 27, 2014

Prepared for: Nalcor Energy

Date: February 05, 2015

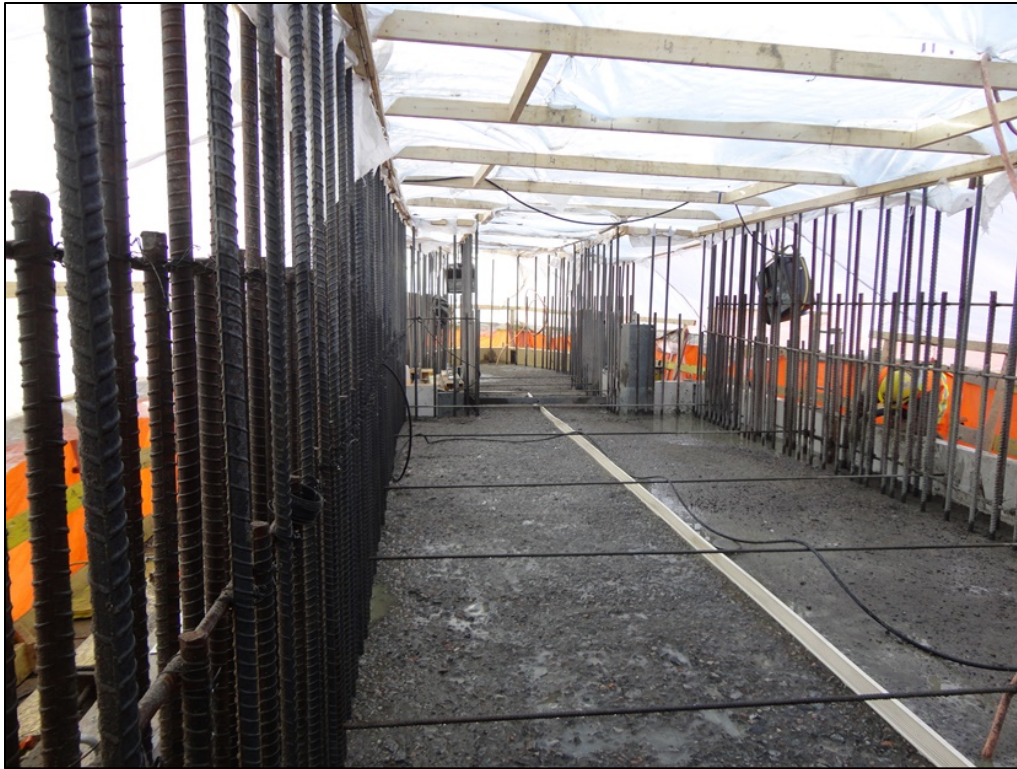
**Photo 7.9:** Current top of Pier 3 looking upstream. The concrete was green cut on the previous day and was currently being washed at the time of the photograph. Note the cut-out for the upstream stop logs in the background and the white water stop running down the centerline of the pier. (November 26, 2014)

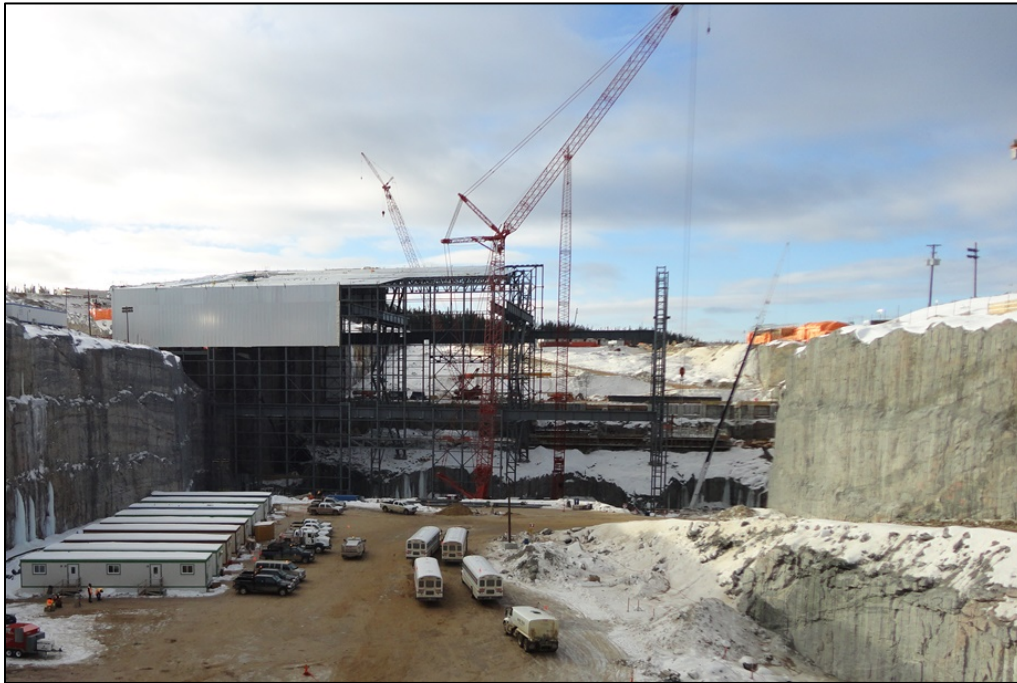
- Astaldi Canada's progress on the ICS (shelter structure) for the Powerhouse construction is behind schedule. At the time of the IE site visit the ICS portion over Bays 1 and 2 was substantially completed (minus much of the wall cladding (Photos 8.1 to 8.3)

**Photo 8.1:** Powerhouse ICS looking upstream. Units 1 and 2 framework erection and first roof covering are substantially complete and almost half of the wall cladding has been erected. At Unit 3 the framework and first roof covering are substantially complete but no progress has been made on the wall cladding. No progress with the ICS in the area of Unit 4. . (November 26, 2014.)

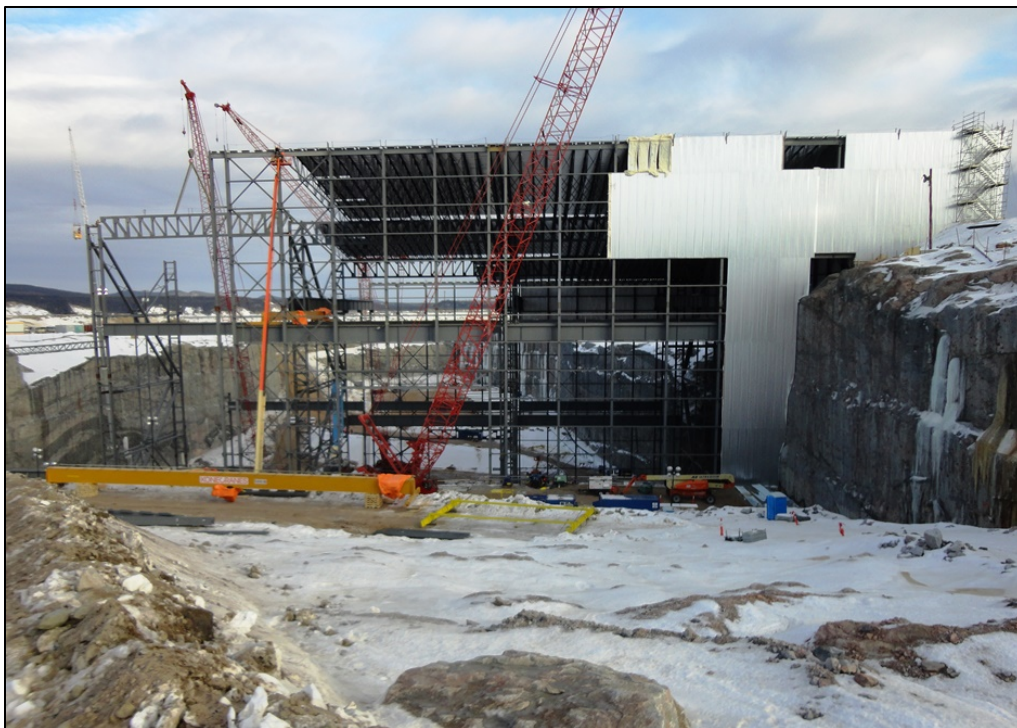
**Photo 8.2:** Powerhouse ICS looking downstream. Framework and cladding in Units 1, 2 and 3 can be seen. (November 26, 2014.)

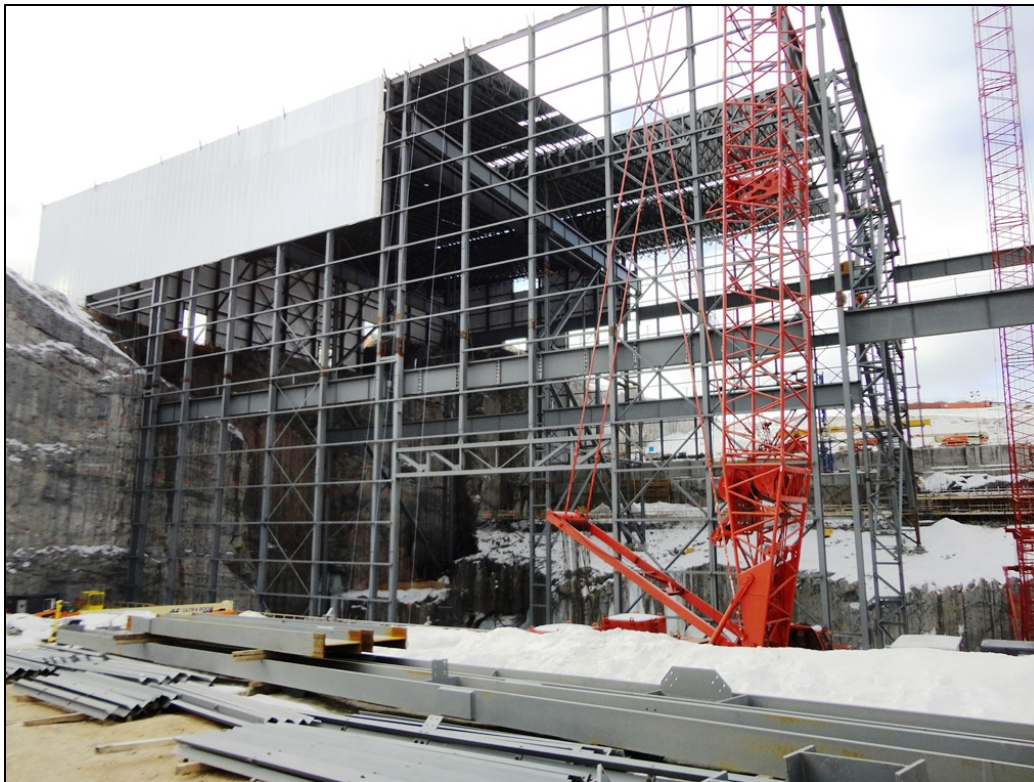
Photo 8.3: View looking upstream at the ICS construction over Units 1 and 2. (November 26, 2014)

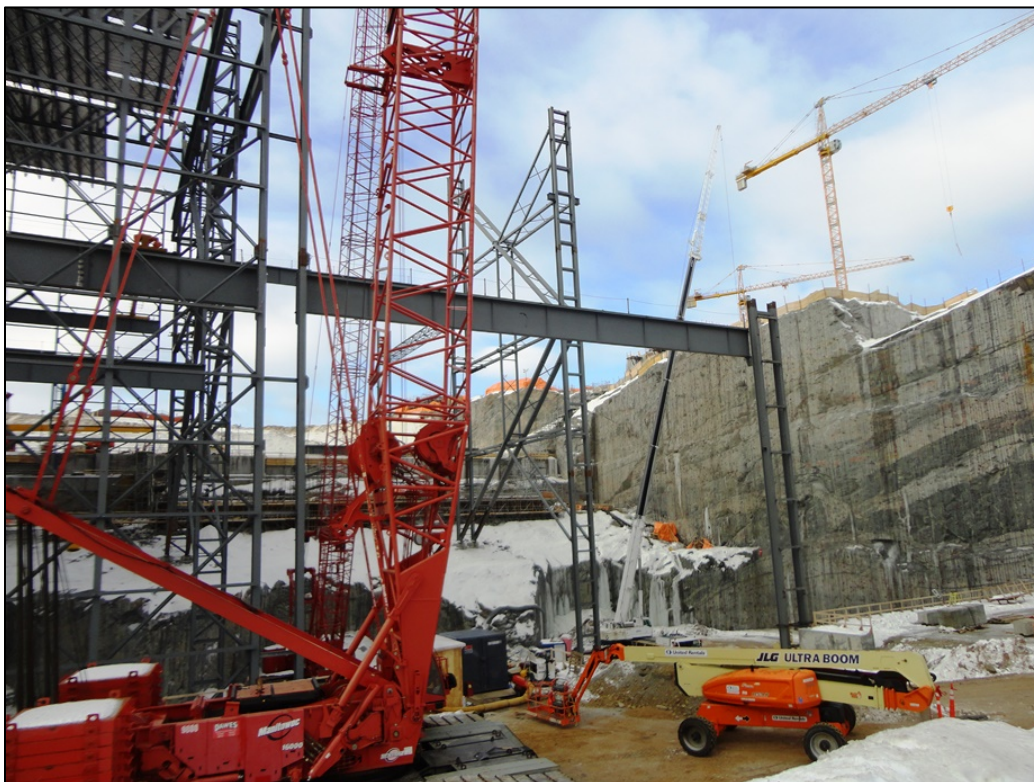
Photo 8.4: View looking upstream at the initial ICS framework erection over Unit 3 (November 26, 2014)

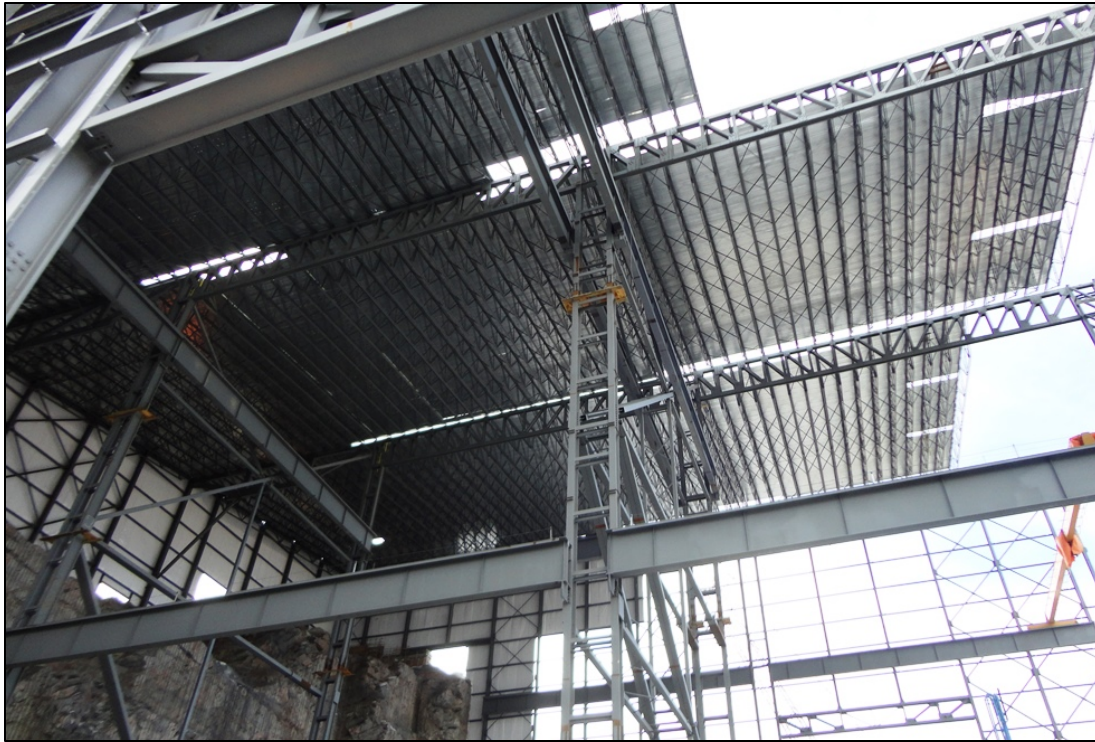
Photo 8.5: Powerhouse ICS Roof over Units 1 and 2. (November 26, 2014)

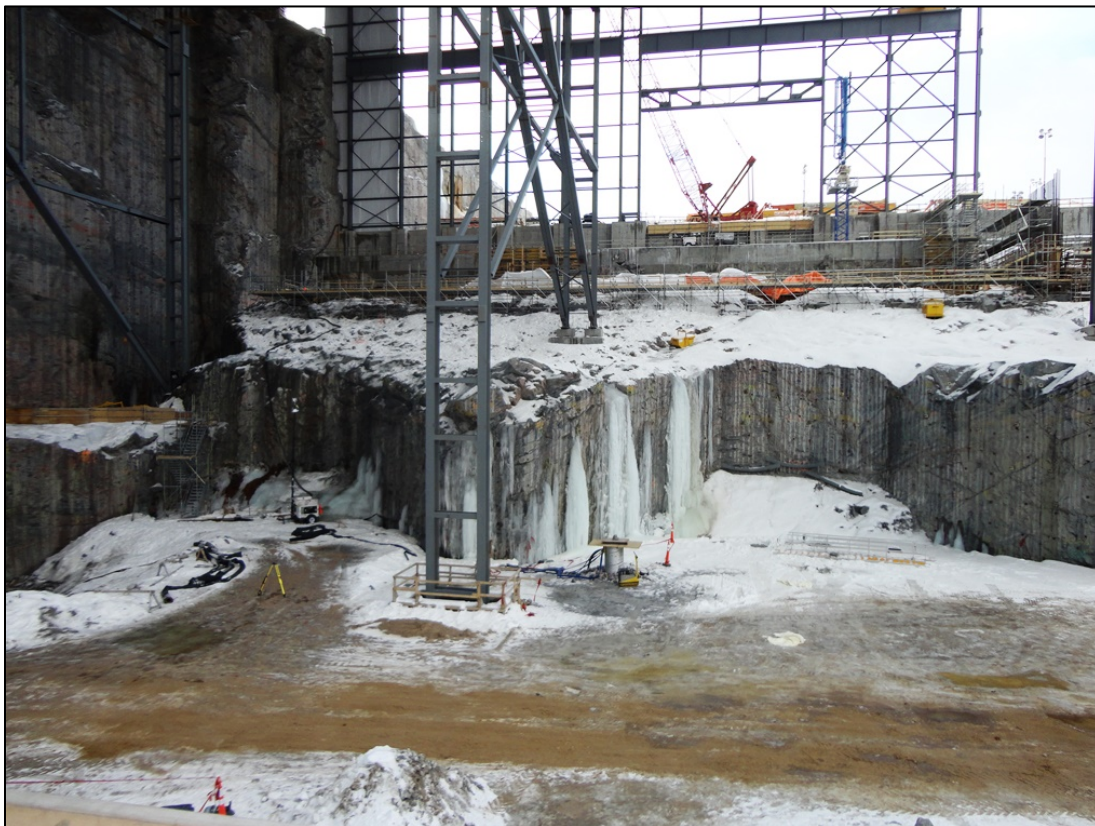
Photo 8.6: Final rock faces in Powerhouse bays 1 and 2. (November 26, 2014)

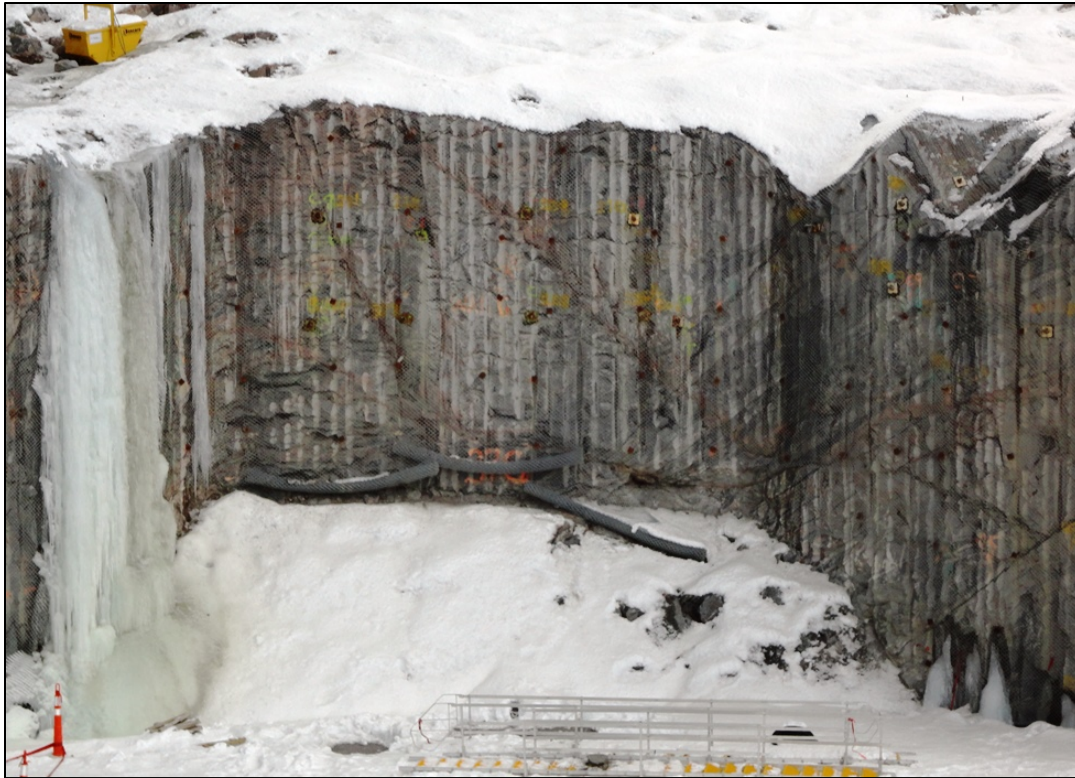
Photo 8.7: Powerhouse Bay 2. Photo shows the excellent quality of the blasting. (November 26, 2014)

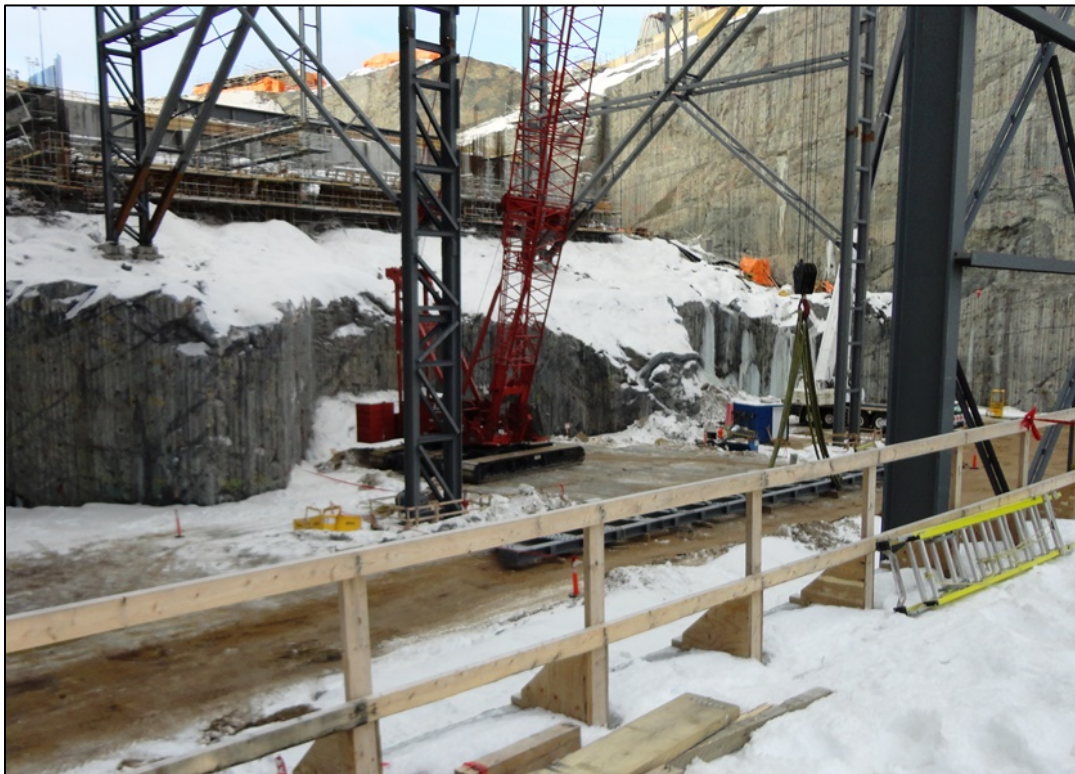
Photo 8.8: Final rock faces in Powerhouse at Bays 3 and 4. (November 26, 2014)

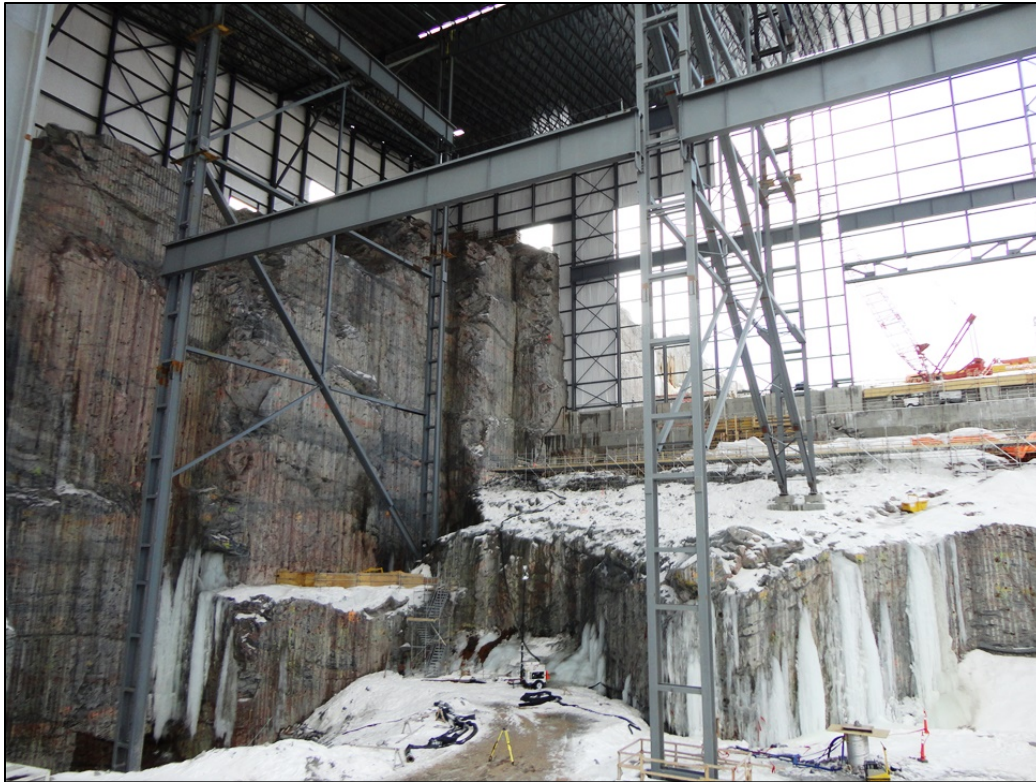
Photo 8.9: View looking upstream at the interior of the ICS over Bays 1 and 2. (November 26, 2014)

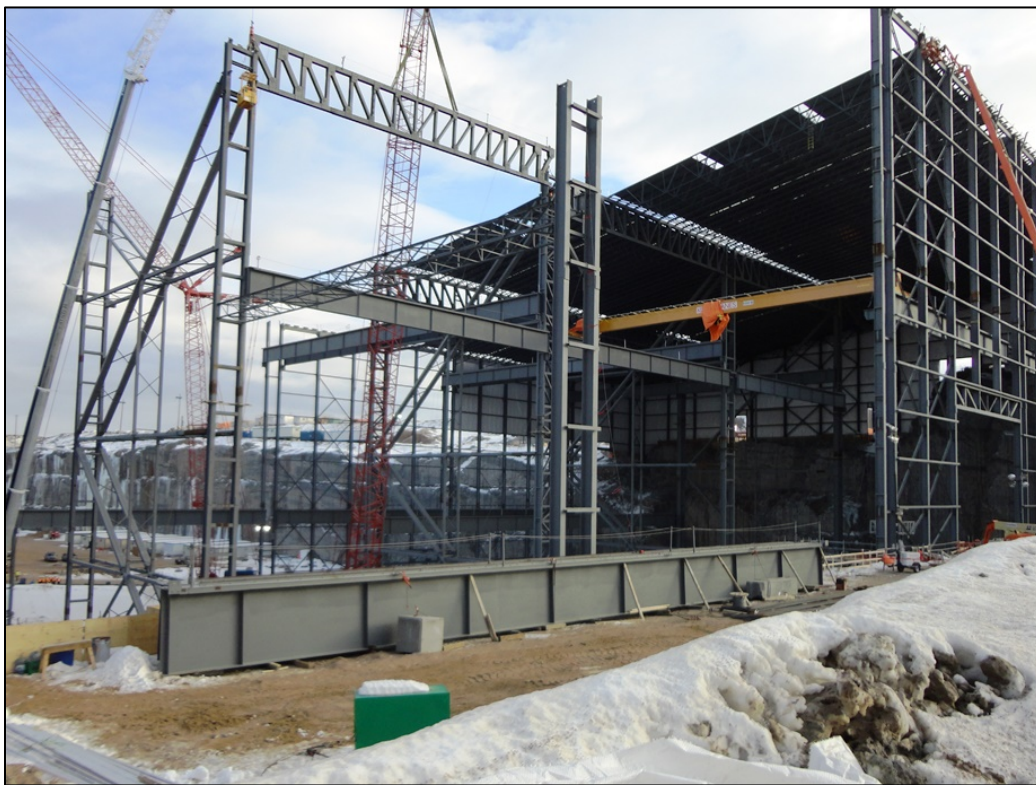
Photo 8.10: View looking downstream at the ICS framework over Bay 3. (November 26, 2014)

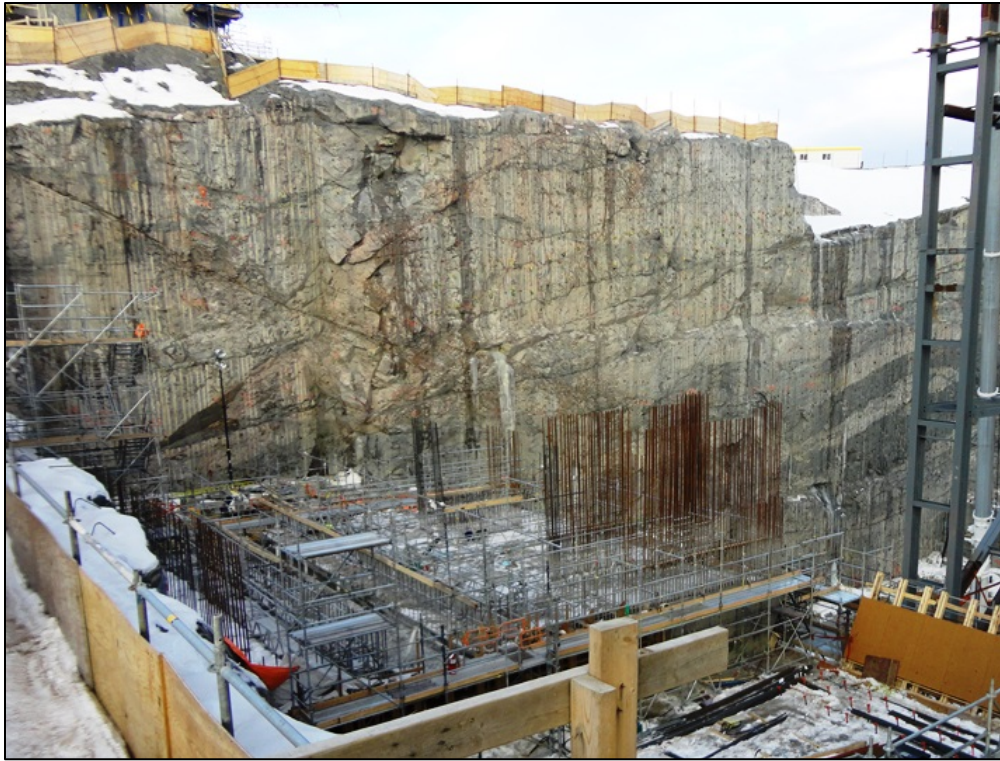
- A relatively small block of permanent concrete has been placed in Unit 4 of the intake (Photo 8.11). No further work is planned on the intake concrete works in the immediate future. Work on this structure will proceed in earnest when there has been more progress in the Powerhouse construction.

**Photo 8.11** Powerhouse, Bay 4. Permanent concrete at base of intake structure at Bay 4. This is the only permanent concrete in the powerhouse/intake structures. (November 26, 2014)

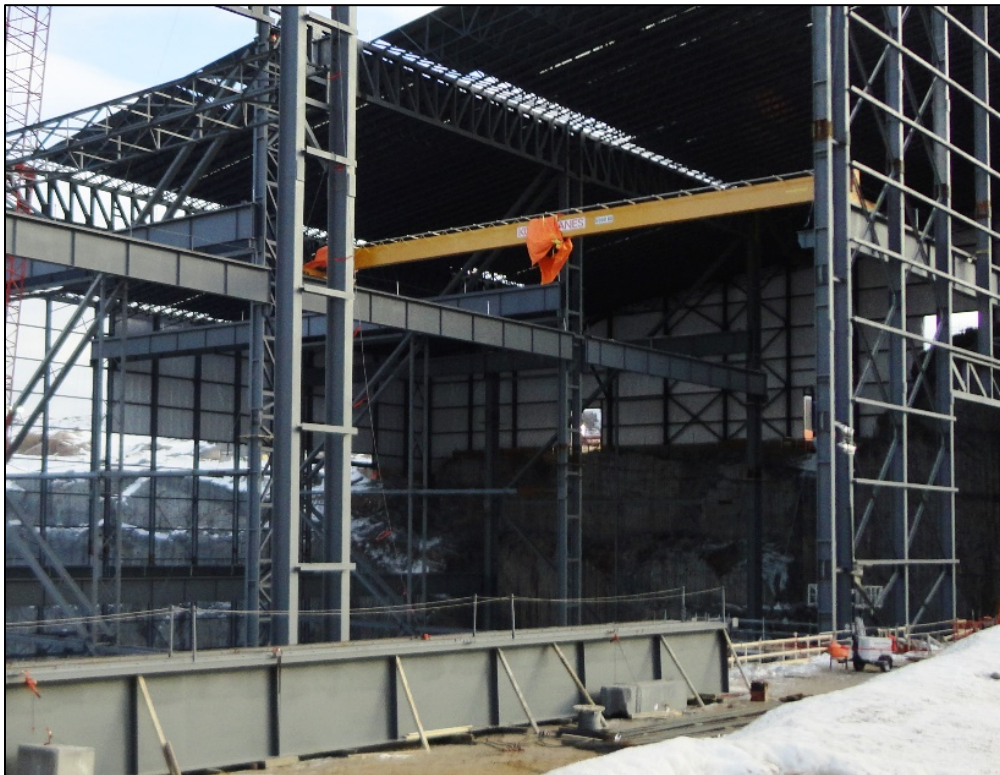
**Photo 8.12:** Powerhouse ICS. Beam crane above Unit 2. (November 26, 2014)

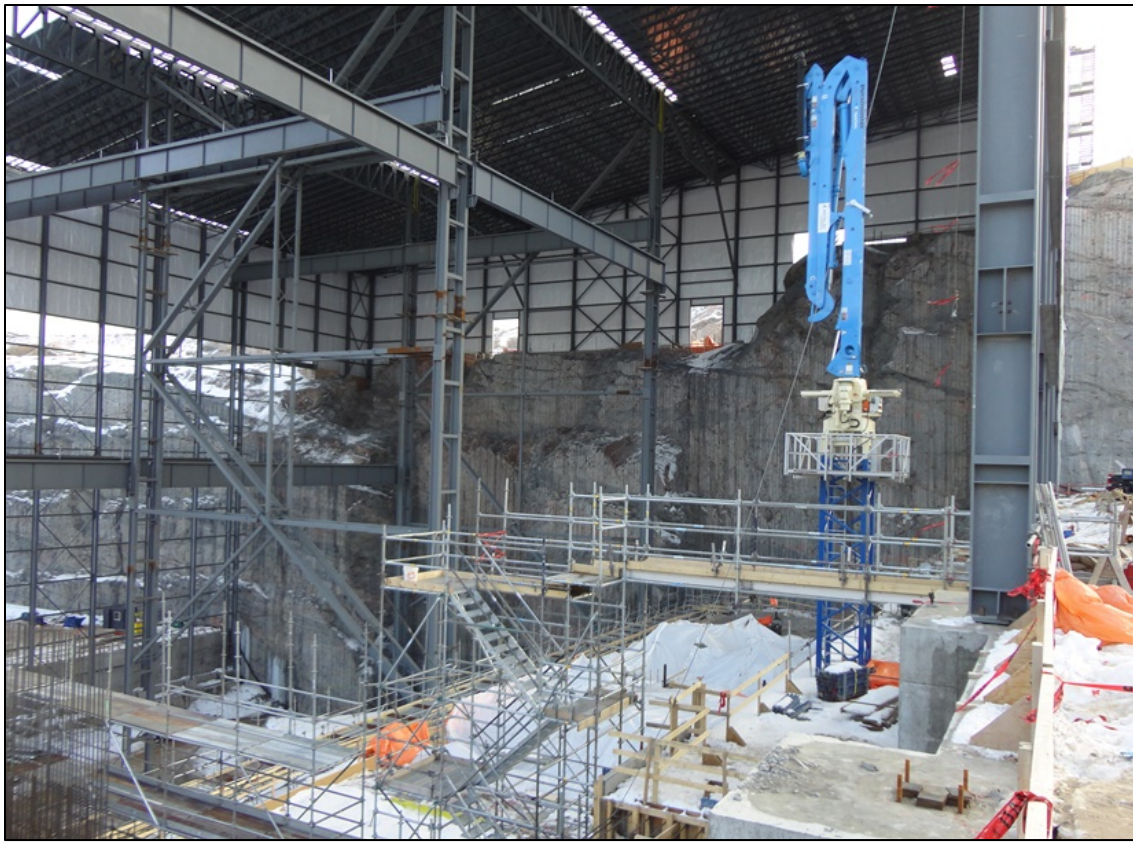
- Erection and concrete placement facilities are being installed. As seen in (Photos 8.10 and 8.12), an overhead crane and beam have been laced over the Unit bay. A Putzmeister concrete pump has been erected on a fixed swivel mounting between Bays 2 and 3 in the Powerhouse (Photo 8.13). Additional pumps and rail cranes will be installed throughout the Powerhouse to make sure that all areas can be reached.

**Photo 8.13:** Putzmeister concrete pump on a fixed swivel mounting between Bays 2 and 3 in the Powerhouse. Additional pumps will be installed throughout the powerhouse to make sure that all areas can be reached. (November 26, 2014)

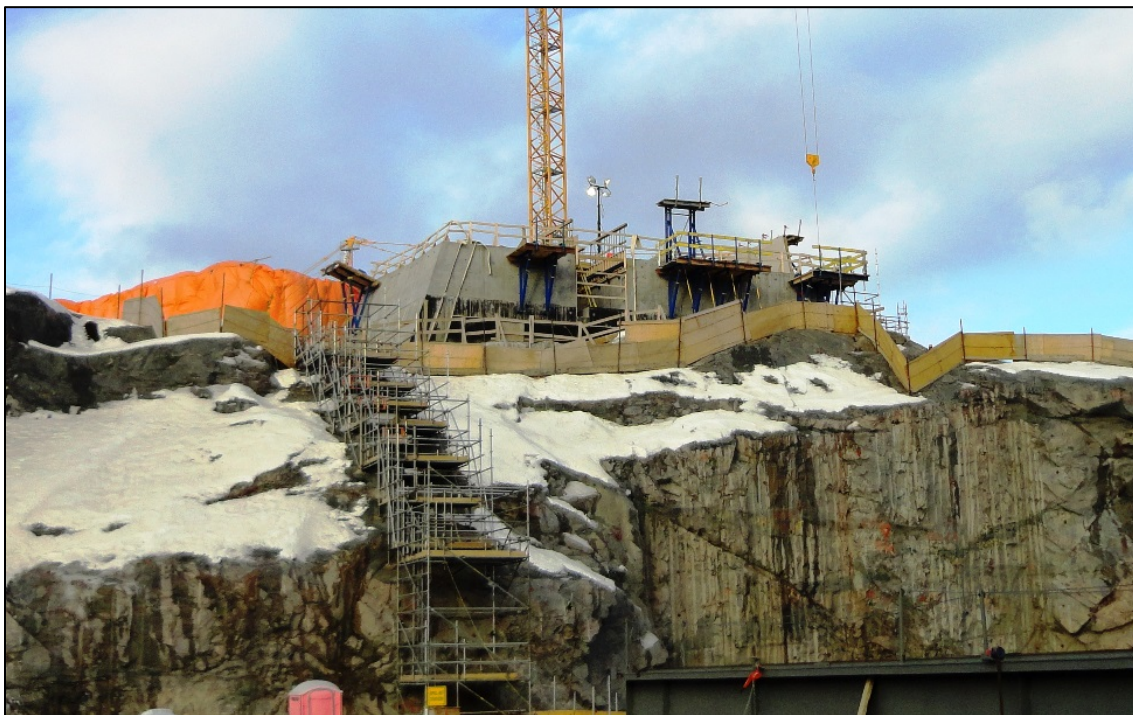
- Concrete placement for the transition dam between the Powerhouse excavation and the spillway was at an advanced stage (Photo 8.14). The left end structure was enclosed in weather protection shelter (Photos 7.1 and 7.2) and formwork erection/concrete placement work was underway at the time of the IE site visit.

**Photo 8.14:** Right end of transition dam adjoining the powerhouse intake. (November 26, 2014)

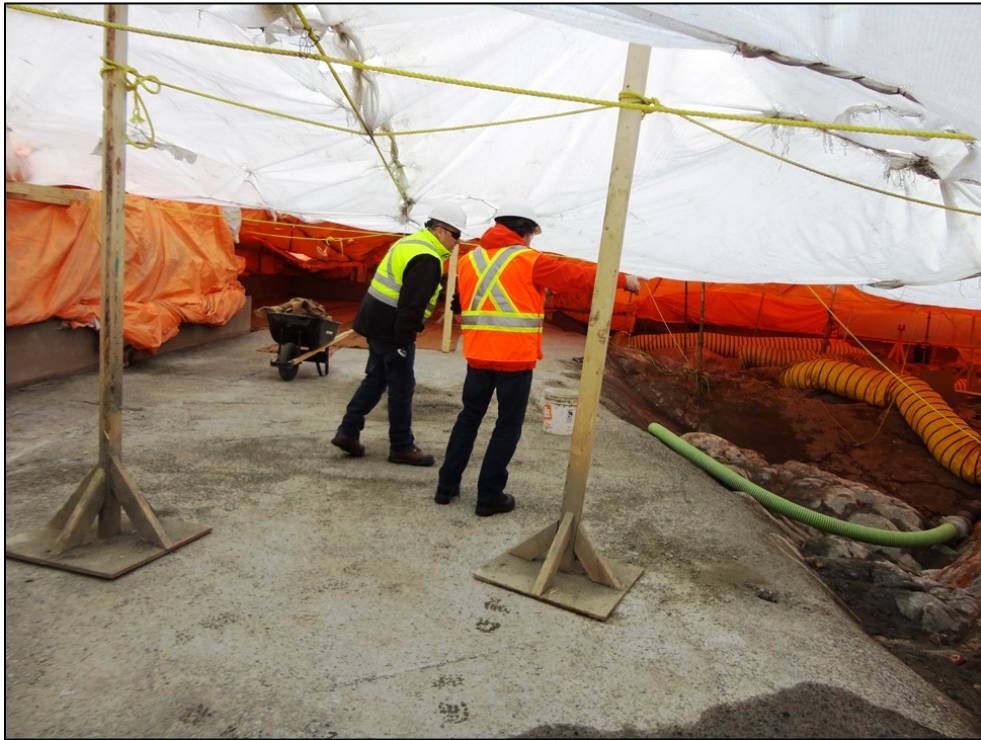
**Photo 9.1:** Powerhouse north service bay foundation. Recently poured base concrete. (November 26, 2014)

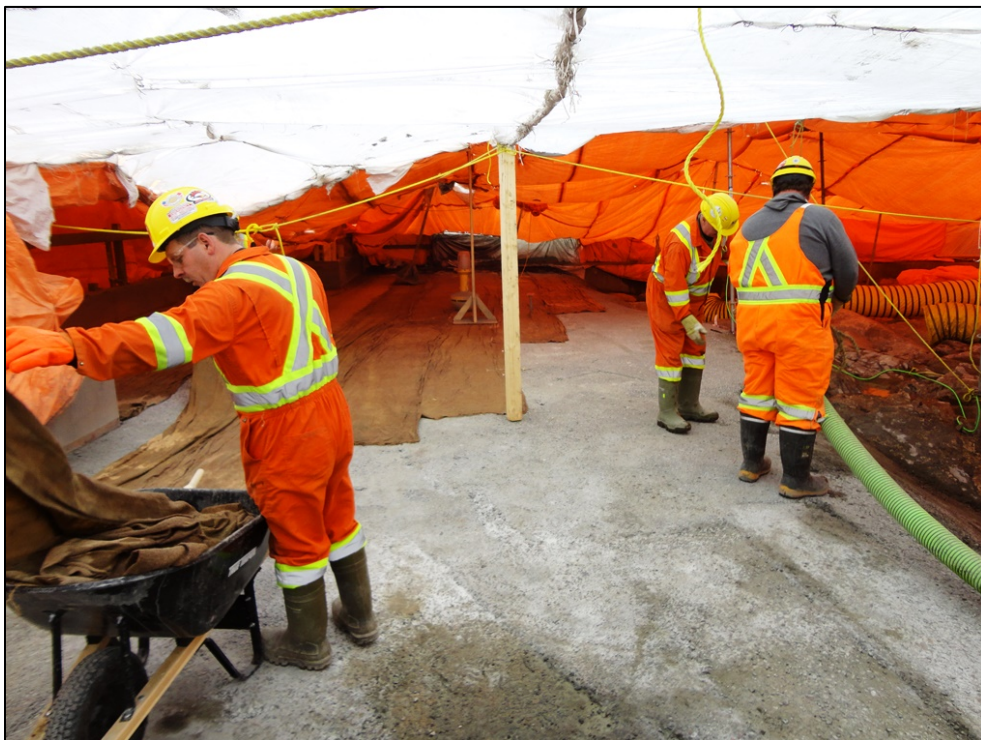
**Photo 9.2:** Powerhouse north service bay foundation. Note wetted burlap mats being placed on the surface of the base slab. (November 26, 2014)

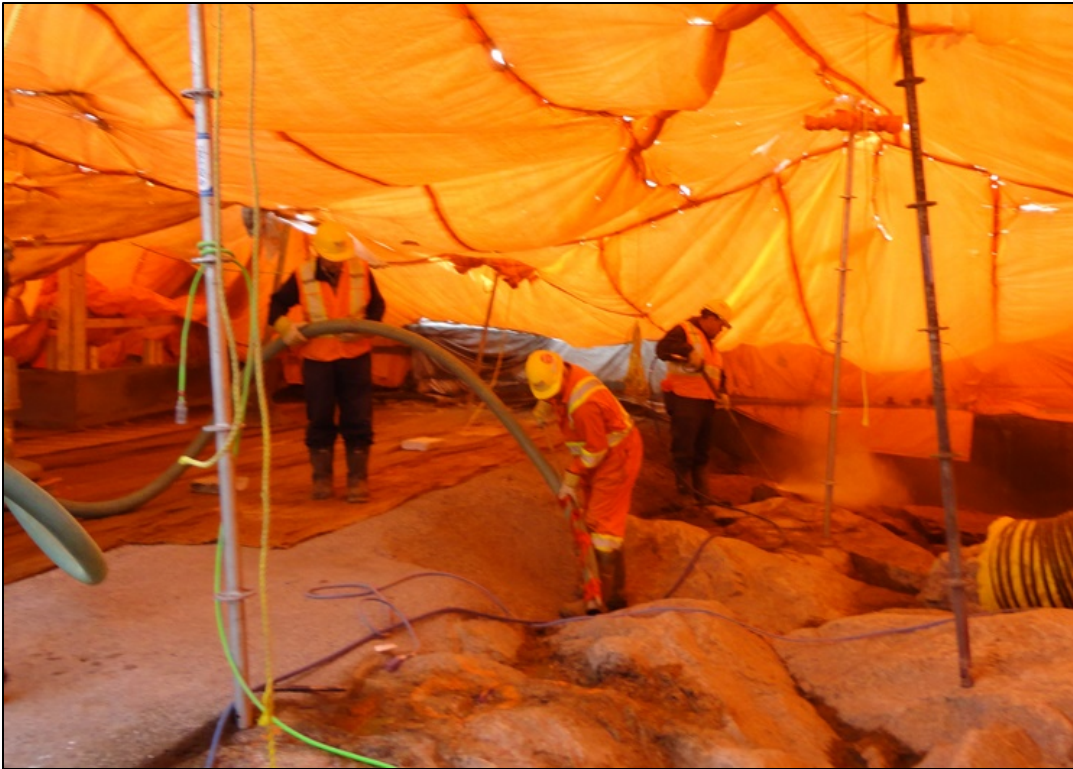
Photo 9.3: Powerhouse north service bay foundation. Cleaning the rock surface with an air vacuum and water jet. (November 26, 2014)

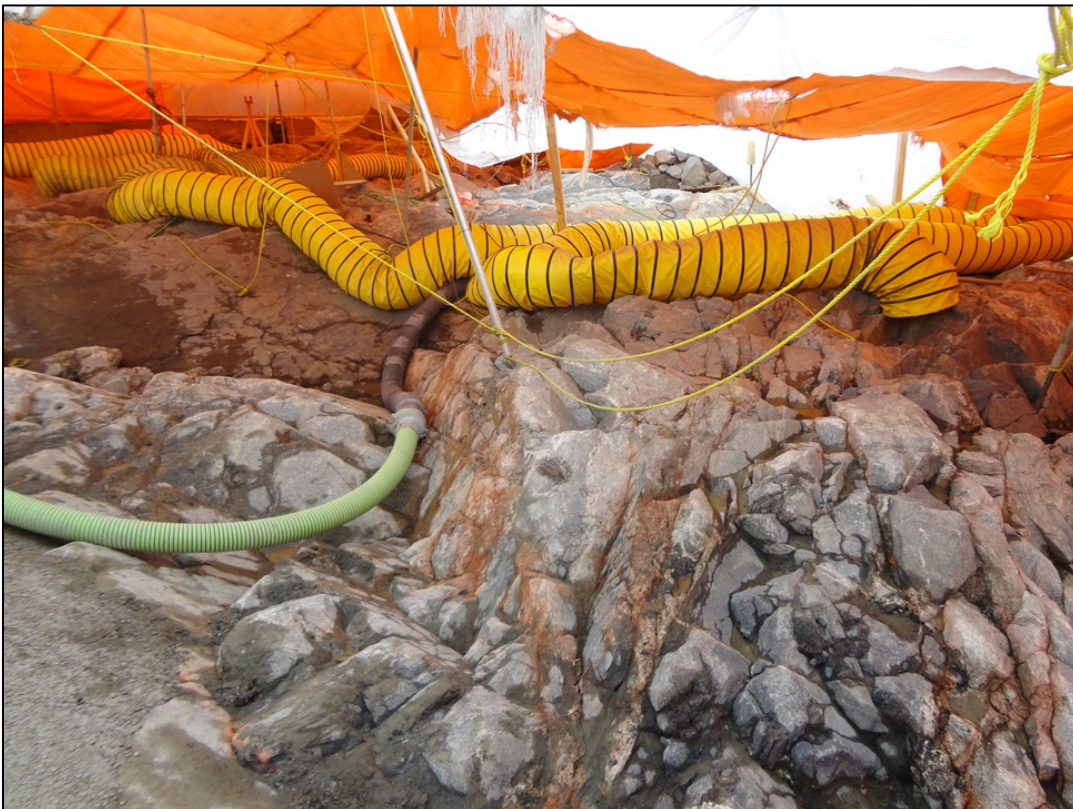
work was underway at the time of the IE site visit. The rock mass in this area consists of competent, blocky granitic gneiss that is fresh to slightly weathered (Photo 9.4). The rock surface is being cleaned with water and with a large vacuum system in preparation for concrete placement (Photo 9.3). The work area is fully protected from the weather by a tarpaulin covering and heated with industrial heaters (Photos 9.5 and 9.6). The foundation preparation work is being carried out to an acceptable standard.

Photo 9.4: Powerhouse north service bay foundation. Cleaned surface in blocky granitic gneiss. (November 26, 2014)

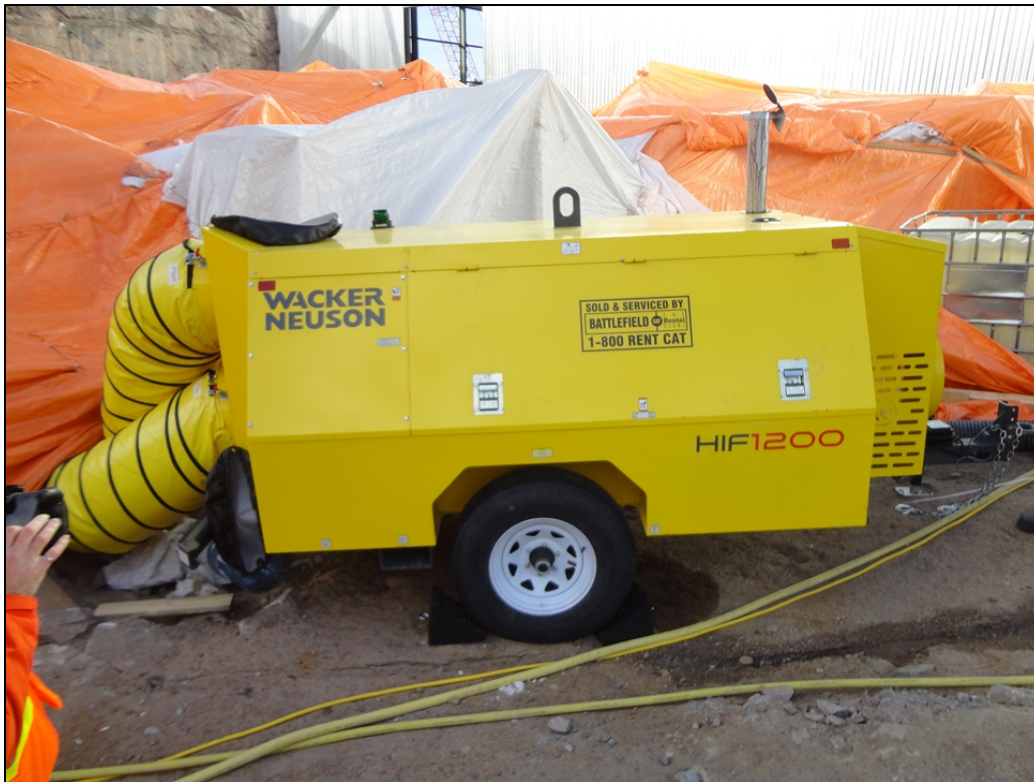
Photo 9.5: Wacker Neuson heating unit used for heating the works in the north service bay. (November 26, 2014)

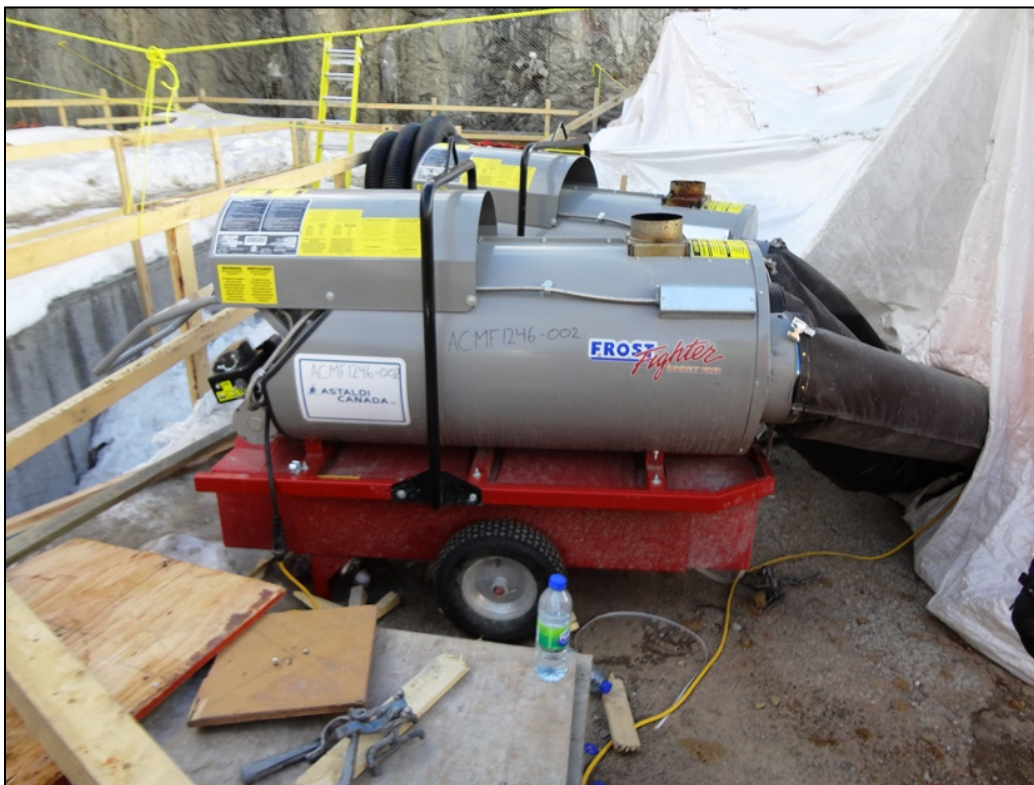
Photo 9.6: Backup heating plants for the north service bay foundation works. (November 26, 2014)
