MEETINGS IN ST. JOHN'S AND VISITS TO LOWER CHURCHILL PROJECT SITES, JULY 11 TO 15, 2016

Prepared for: Natural Resources Canada and Nalcor Energy
 IE Point of Contact: Nik Argirov
 Date: September 20, 2016

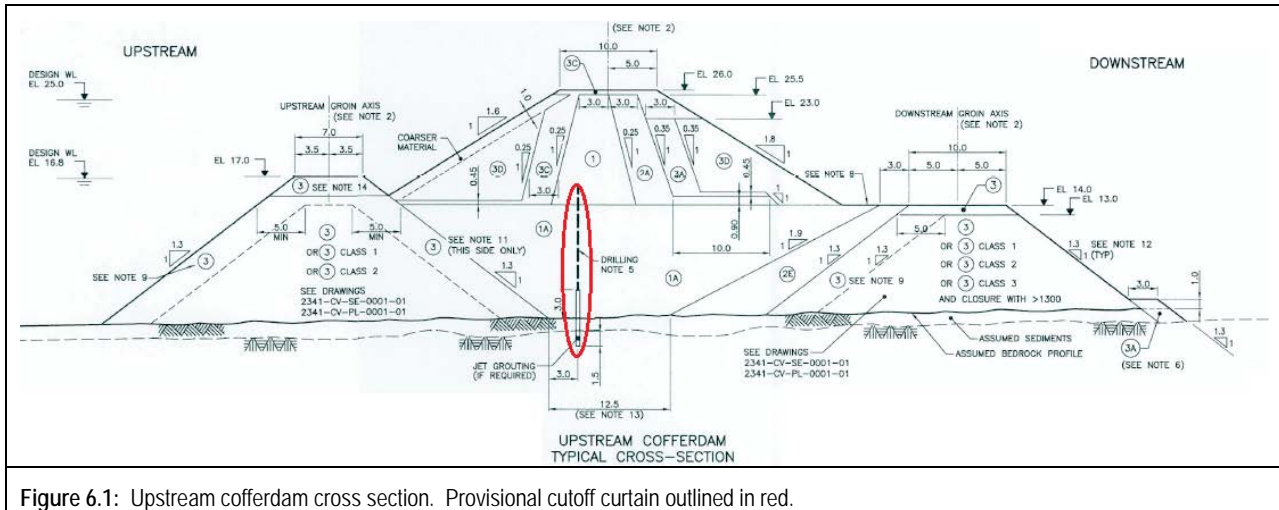
Figure 6.1: Upstream cofferdam cross section. Provisional cutoff curtain outlined in red.

The rockfill groins of starter dam will be placed on the natural riverbed. The impervious fill zone will be about 12.5 m wide at the base and will be placed on the cleaned riverbed between the groins. Much of the impervious foundation will not likely be fully dewatered because of copious water flow. Due to likely water inflows hand/air pressure cleaning will not be possible for much of the foundation and these areas will be machine cleaned with backhoes. Most of the riverbed bedrock foundation will have been scoured clean by river flows and will provide a good seal at the base of the impervious fill. In submerged areas that have not been scoured by the river, machine cleaning will remove most of the debris and overburden from the bedrock surface. It is possible, however, that the machine cleaning will miss some debris materials or zones of disturbed, broken rock.

The IE submits that there is a risk of serious leakage in submerged foundation areas where debris, boulders, broke/disturbed rock have not been completely removed by machine cleaning. Significant water flows can generate extra costs in terms of schedule delays, beneath the impervious zone. It appears that the designers have considered this risk by including the contingency jet grouting in the design. Details of the contingency jet grouting program are shown on Drawing MFA-SN-CD-2340-CV-SE-0002-01 Rev C2. The grout holes would be drilled through the core into the permeable material at its base. The IE notes that jet grouting will be very effective in sandy or granular overburden, but will have limited success in open-work boulders or broken rock.

The IE recommends the following actions:

- Barnard Pennecon should supplement its work plan with a contingency plan for dealing with unexpectedly high water flows through the cofferdam foundation. This must include plans for pumping leakage water downstream of the cofferdam and construction of a cut-off through the base of the core if needed.
- The cut-off can be the jet grouting scheme proposed by the designers on Drawing MFA-SN-CD-2340-CV-SE-0002-01 Rev C2 (see Figure 6.1 above). Alternatively, a local slurry cut-off wall could be constructed using equipment already present at the site. It is noted that a slurry cut-off is better suited for dealing with open-work boulders than jet grouting.
- The contractor should demonstrate that equipment can be available on a timely basis to deal with unexpected foundation water inflows so that the potential impact on schedules is minimized.
