Nalcor Energy - Lower Churchill Project

Assessment of North Spur Construction Processes

**Draft Report**

MFA-HE-CD-2800-GT-RP-0002-01 Rev. A1 September 18, 2015

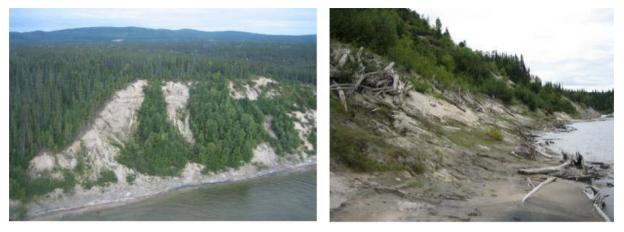
Figure 1-2: Instabilities along the North Spur

In the spring of each year, a hanging ice dam is created downstream of the lower falls which causes a raised tail water level. When the dam collapses, a rapid drawdown condition is created at the toe of the downstream slope. The effect of the rapid drawdown plus the high groundwater plus the erosion has produced very large slides

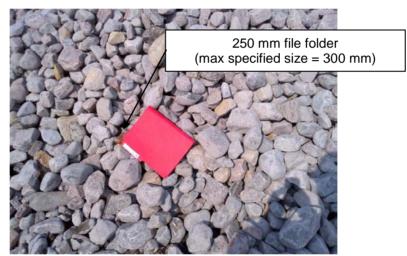
Figure 3-2: View of one of the Oversized Waste Stockpiles

In the case of the Zone 1 fill, the specification allows for a 300 mm maximum size and, given the width of the zone, an occasional rock fragment in excess of this size embedded in the fill would not result in a quality issue. Based on observation of the oversized materials stockpiled from the Zone 1C processing operation, a very small percentage appeared to be in excess of 300 mm (Figure 3-2). Therefore, the CA believes that the planned processing using a grizzly is not necessary. Normal QC procedures involving selective exploitation in the pit and raking as required at the fill site will be effective in producing a good quality fill meeting the specified requirements. It is understood that this would result in savings in the order of \$5 to \$7 per m3.
