<b>NE-LCP Contractor/Supplier</b>	Contract or Purchase Number and Description: CH0007-001 – Intake & Powerhouse, Spillway & Transition Dams		Contractor/Supplier Name: ASTALDI CANADA INC.	
	Document Title: MUSKRAT FALLS - DRAFT TUBE UNIT 2 OUTLET - CIVIL GENERAL REPORT - MAN BASKET INSPECTION		Total Number of Pages Incl. Front Sheet 22	
	Contractor Document Number: A-DT000-NA-CV-D31-200-01		Revision Number: 0	
	Supplier Document Number:		Revision Number:	
	NE-LCP Document Number: MFA-AT-SD-331A-EN-A99-0002-01		NE-LCP Issue Number: B1	
	Approver's Signature: Giuseppe Mazzucco

**GENERAL REPORT – MAN BASKET INSPECTION OF UNIT 2 FORMWORK FAILURE**

This document provides summary observations from visual inspection by man basket on June 4<sup>th</sup> and June 11<sup>th</sup>, 2016 in the Draft Tube 2 formwork/falsework incident area. The purpose of the inspection was to document the extent of the collapse, identify damage to main structural members and note any deficiencies or deviations in the fabrication and construction process.

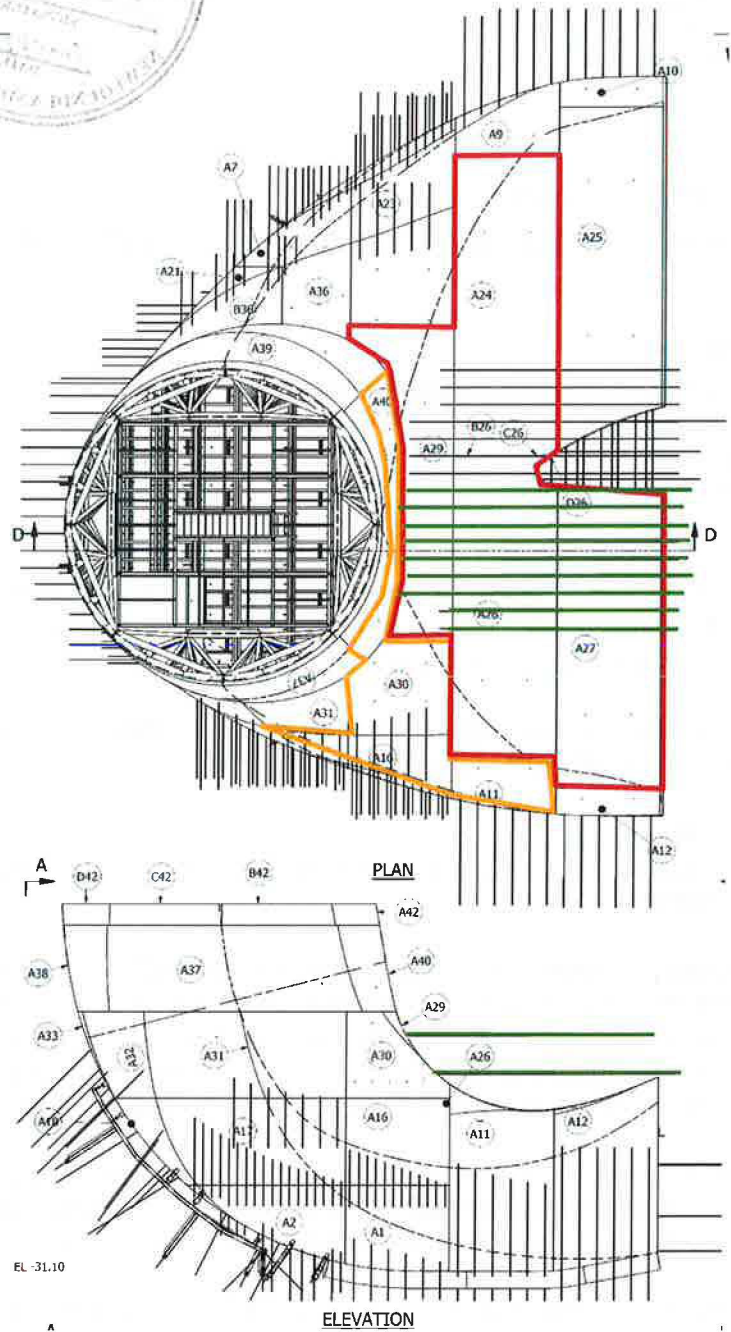
The formwork and shoring underneath the panels outlined in Figures 1 and 2 were identified as damaged. Items outlined in red were destroyed in the collapse and must be replaced, items outlined in orange were damaged and may be repairable in the field. Failed tie rods are indicated in green. Formwork and shoring elements that are repaired and/or reused should be inspected by a qualified person to ensure they are fit for use prior to supporting fresh concrete.

Figure 1: Major CEI formwork elements damaged in the collapse.

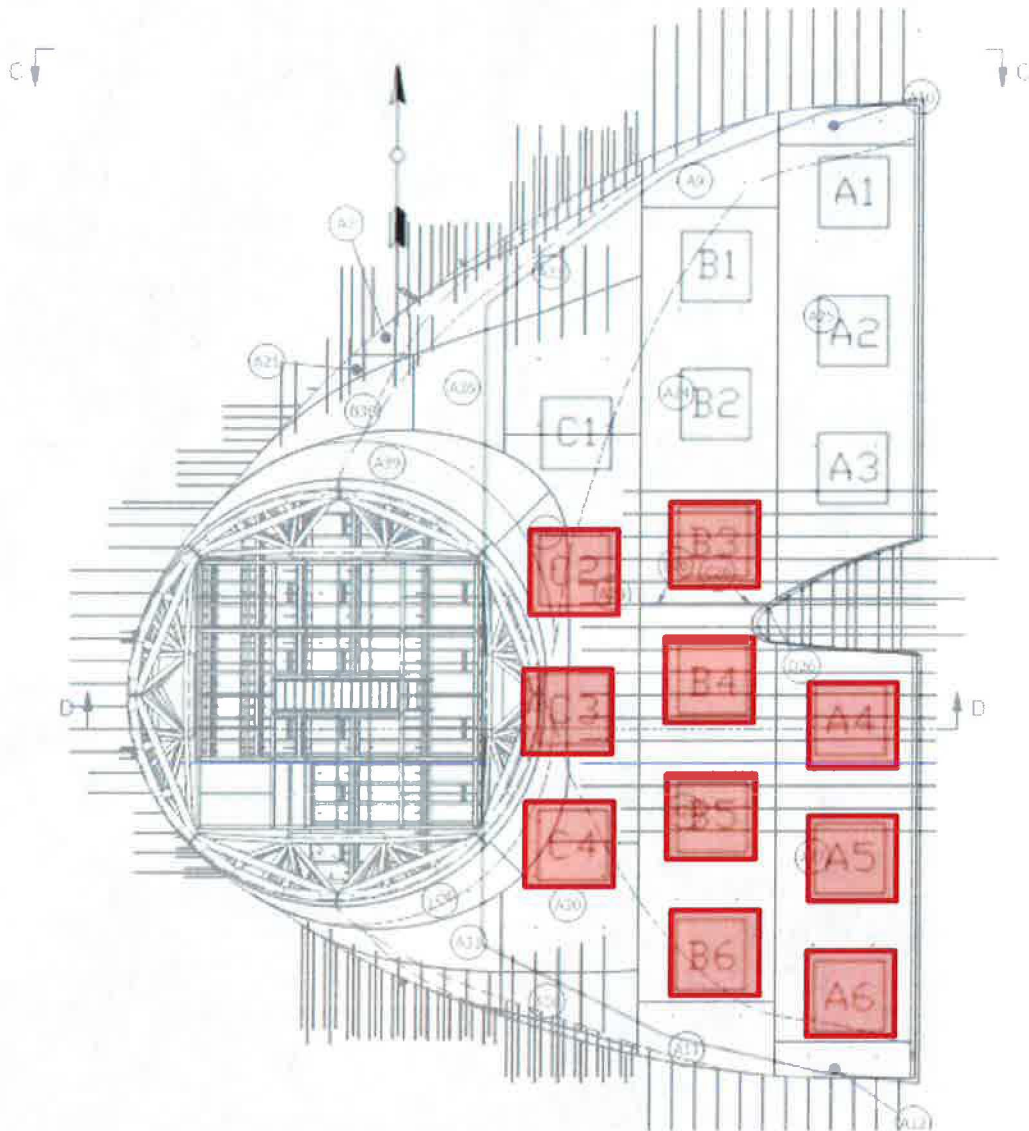
Figure 2: CEI Wooden shoring towers damaged in the collapse

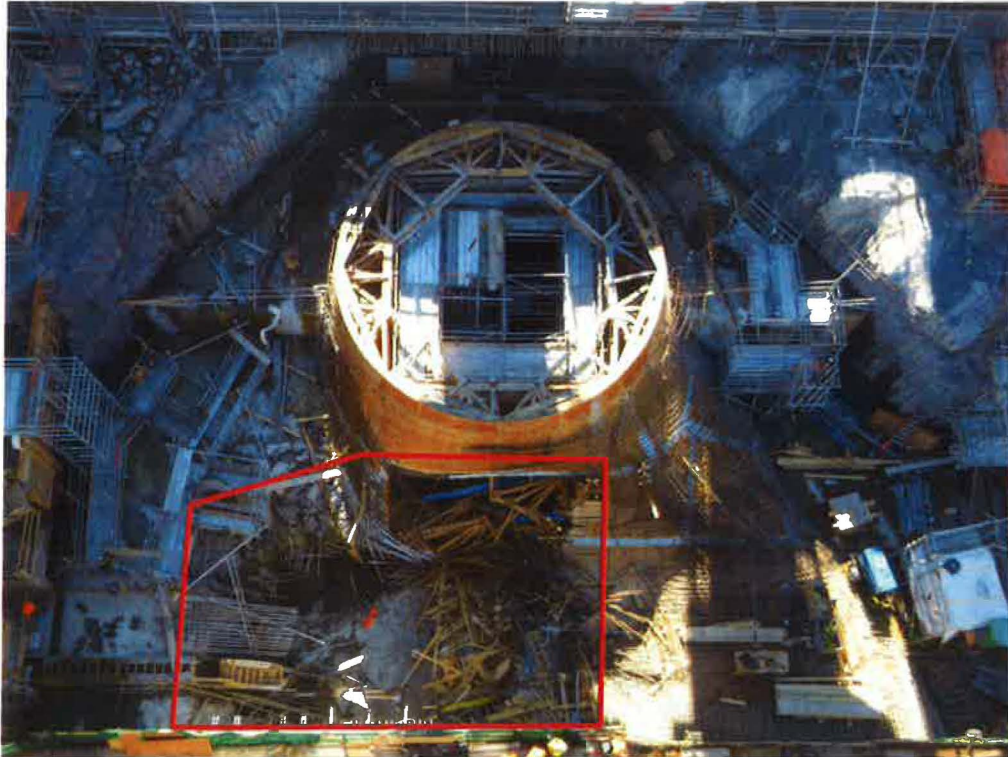
**Figure 3: General view of the collapsed area taken from above**

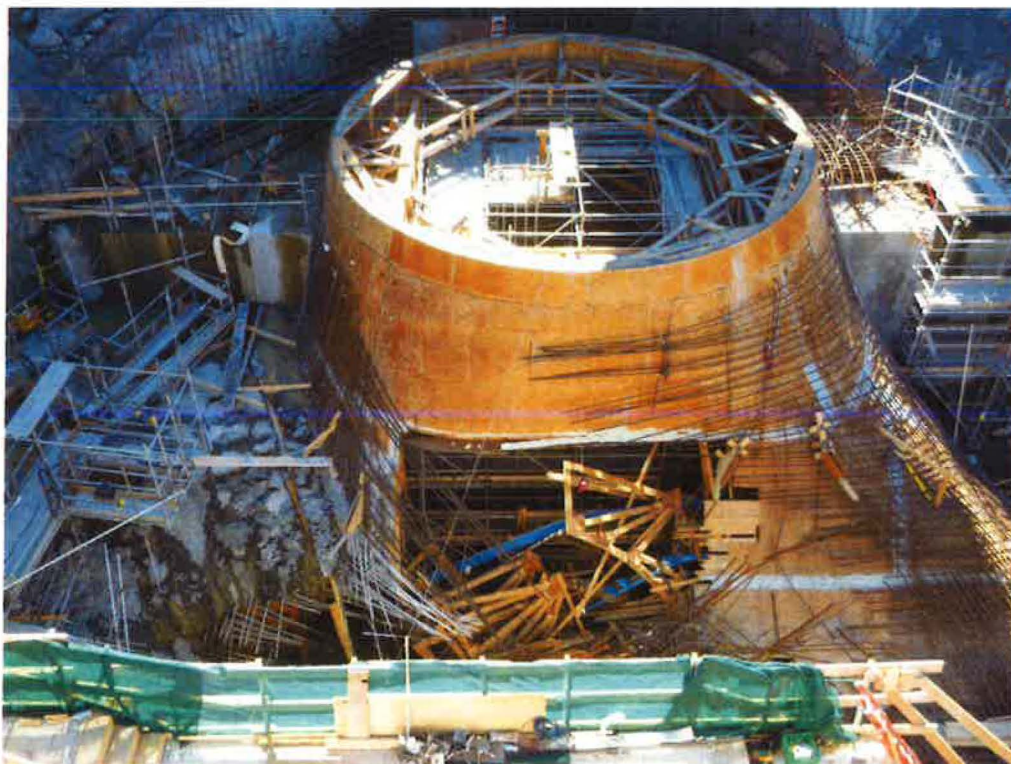
**Figure 4: General view of the collapsed area taken from downstream.**

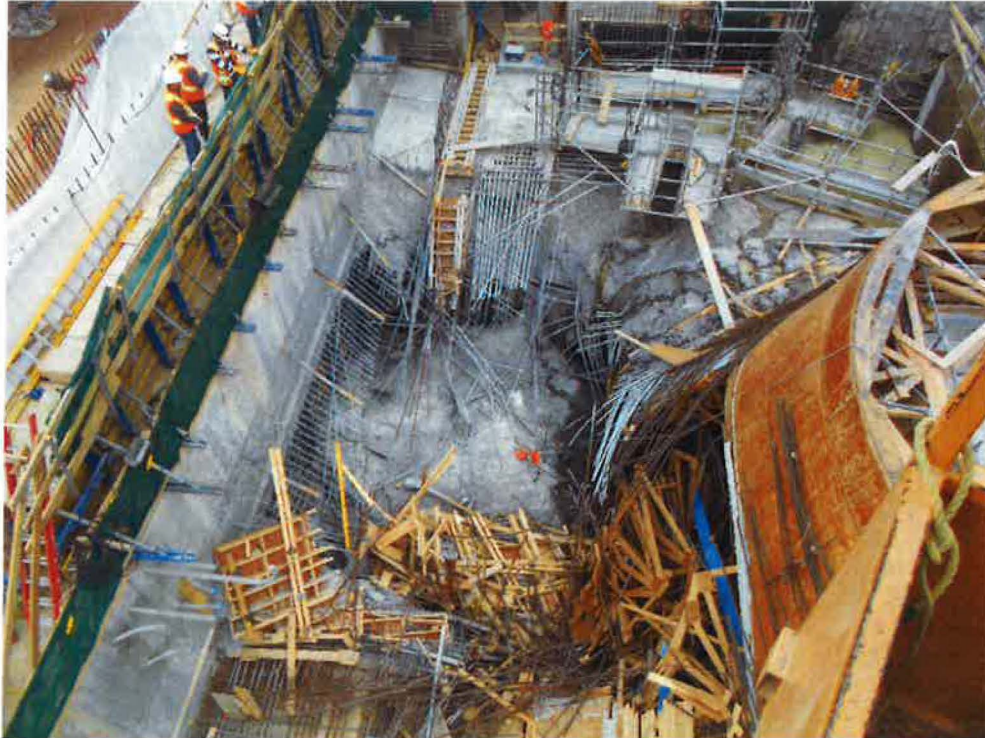
**Figure 5: General view of the collapsed area taken from North**

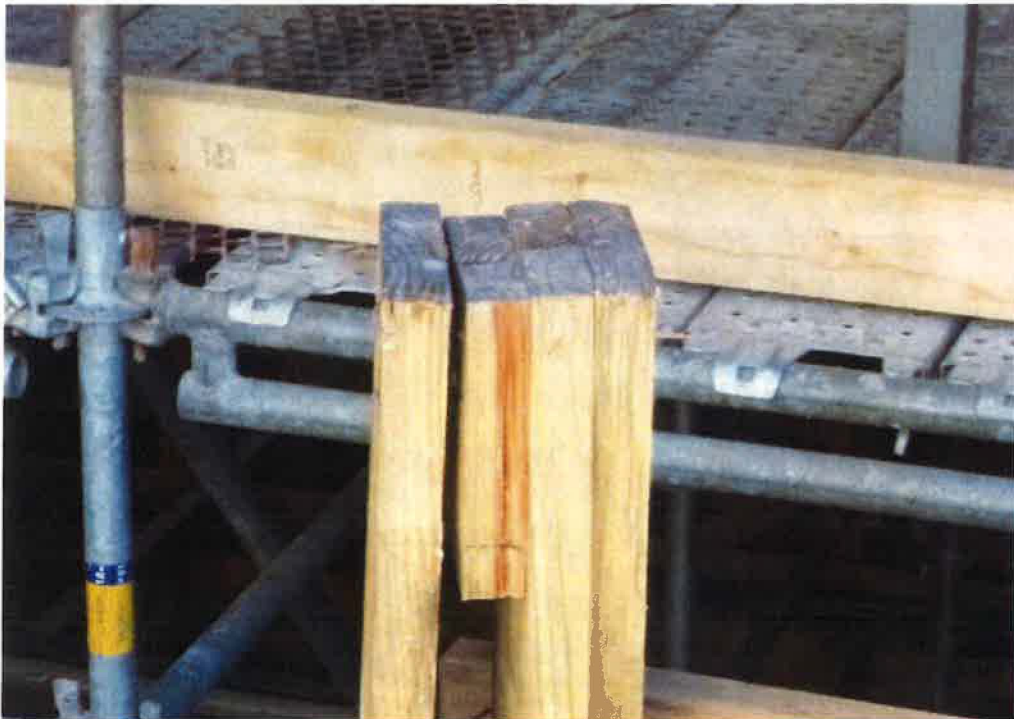
There was some indication that the bearing surface on top of the shoring towers was not uniform. This is evident in Figure 6 where some of the column members end grain is compressed, and others is not.

Figure 6: Shoring Tower C3, SW leg. Note compressed end grain in portions of leg.

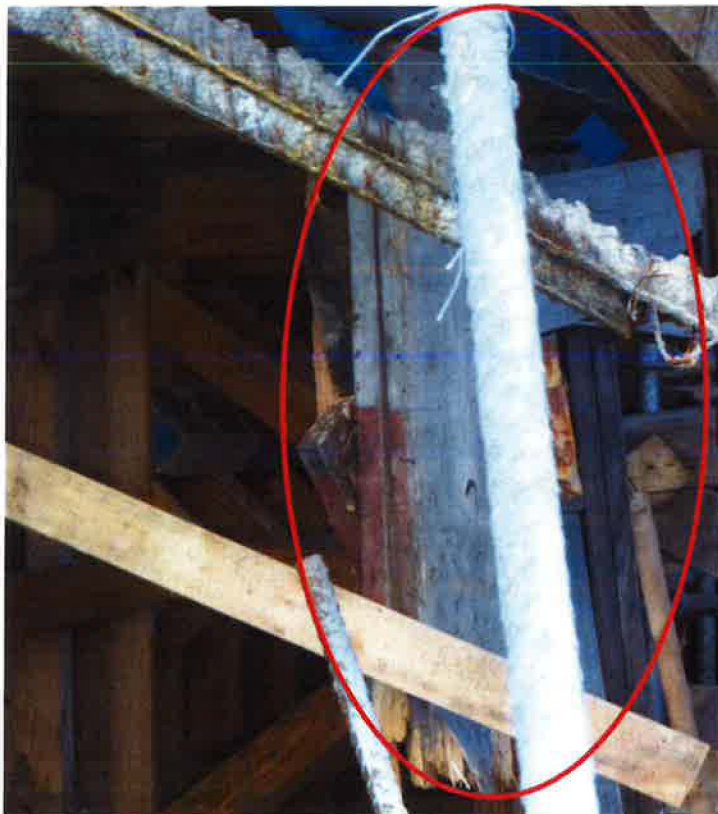
Visible tower leg members have indication of weathering, in form of grey appearance. This is easily seen in Figure 7, with a suspended portion of tower leg clearly grey in color, compared to adjacent formwork lumber.

Figure 7: Shoring Tower C4, southern legs (behind rebar). Note weathered wood.

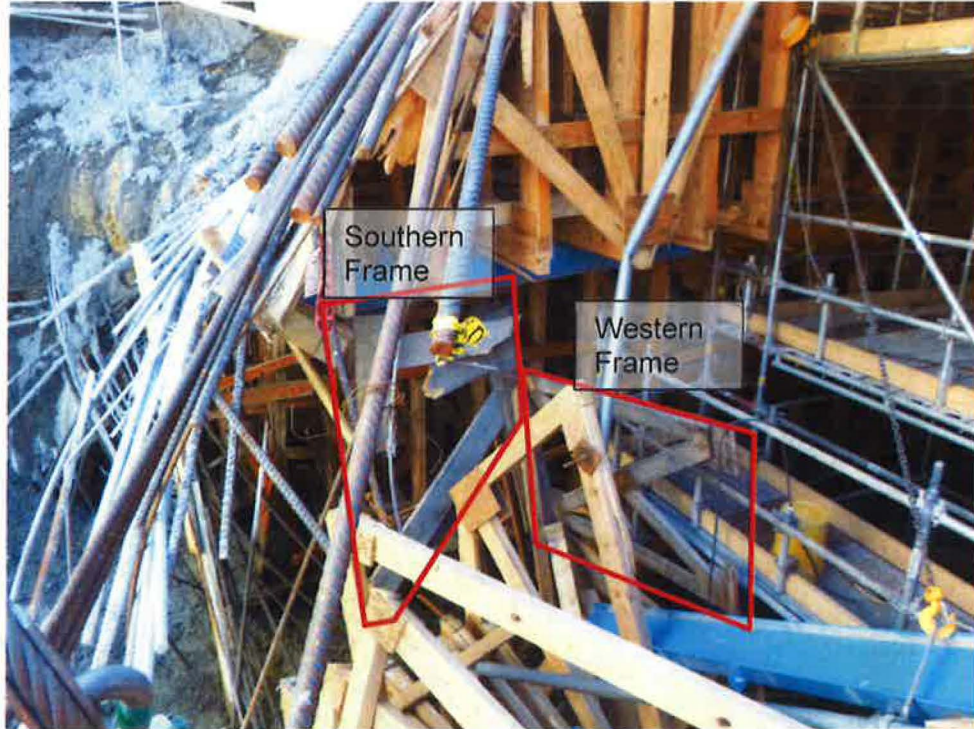
Several of the upstream (west) legs of towers C3 and C4 have potential indication of inadequate nailing of the 2x10's forming the legs. In some instances, the plys are separated, in others, pieces of leg members are missing. Tower C4 gusset plates pulled free of the tower legs in the NW corner, as shown in Figure 8.

Tower frames have indication of a north-progressing failure due to frames being "racked" to the north. See Figures 8 and 9 for examples.

Figure 8: Shoring Tower C4, southern frame and western frame. Tower members outlined in red.

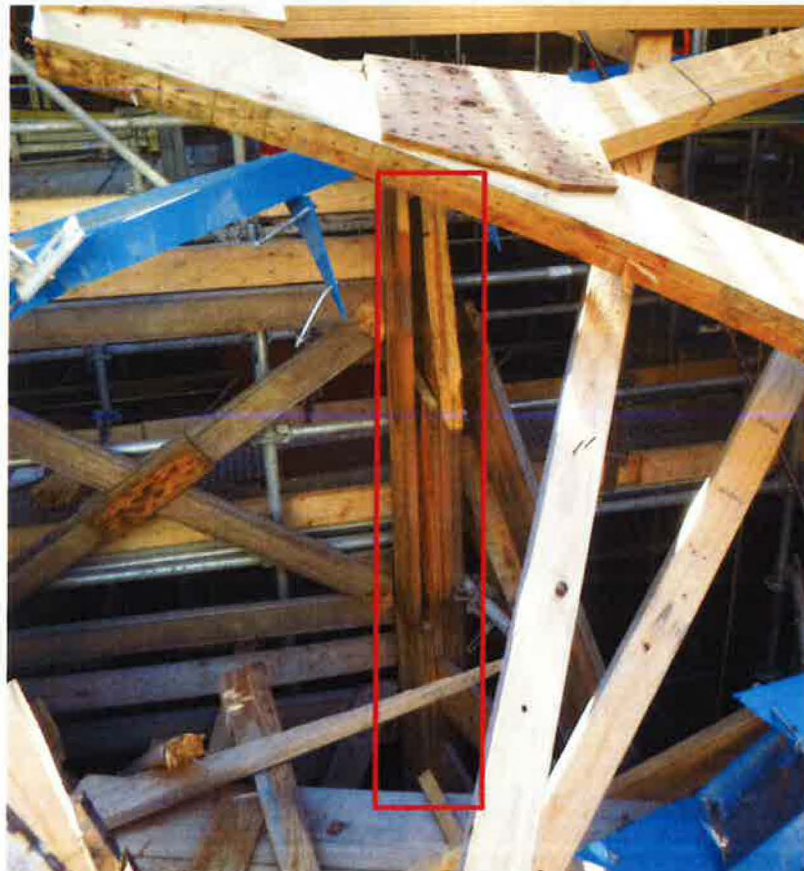
Figure 9: Tower C3 NW leg. Note separation of plies and missing elements

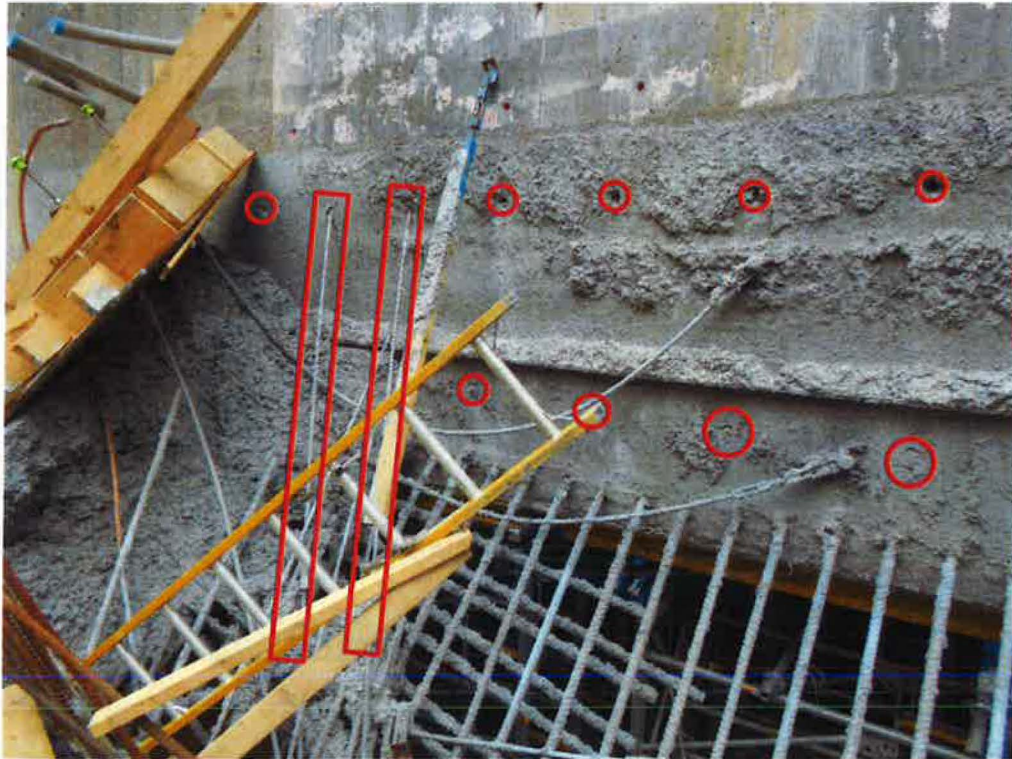
The original formwork configuration includes coil rod connecting element A29 to the Draft Tube Outlet 2 to carry the horizontal loads generated by the pouring of concrete. The coil rod connecting trusses inside formwork panel A39 to the concrete pours D2USB-02 were pulled out or sheared out under the weight of falling concrete and debris. This is shown in Figure 10.

**Figure 10: Upstream face of pour D2USB-02 with the two rows of holes from failed ties**

The coil rods tying panel A29 to pour D2USB-02 appear to have been in place at the time of the failure. Due to poor lighting conditions, we were not able to visually inspect the failed material in order to identify mode of failure. Additional man basket photos are proposed using artificial lighting to illuminate the failed coil rod and/or coil rod tie. Inspection of recovered coil rod in the debris should also be made.

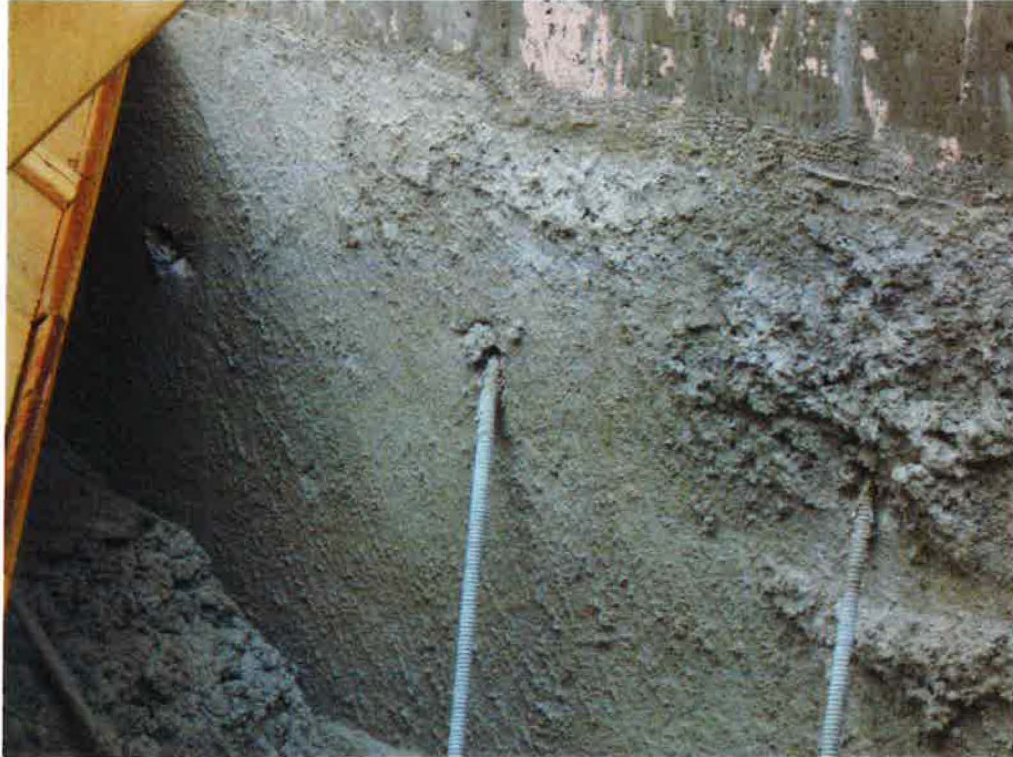
Figure 11: Ties remaining in the upstream face of pour D2USB-02

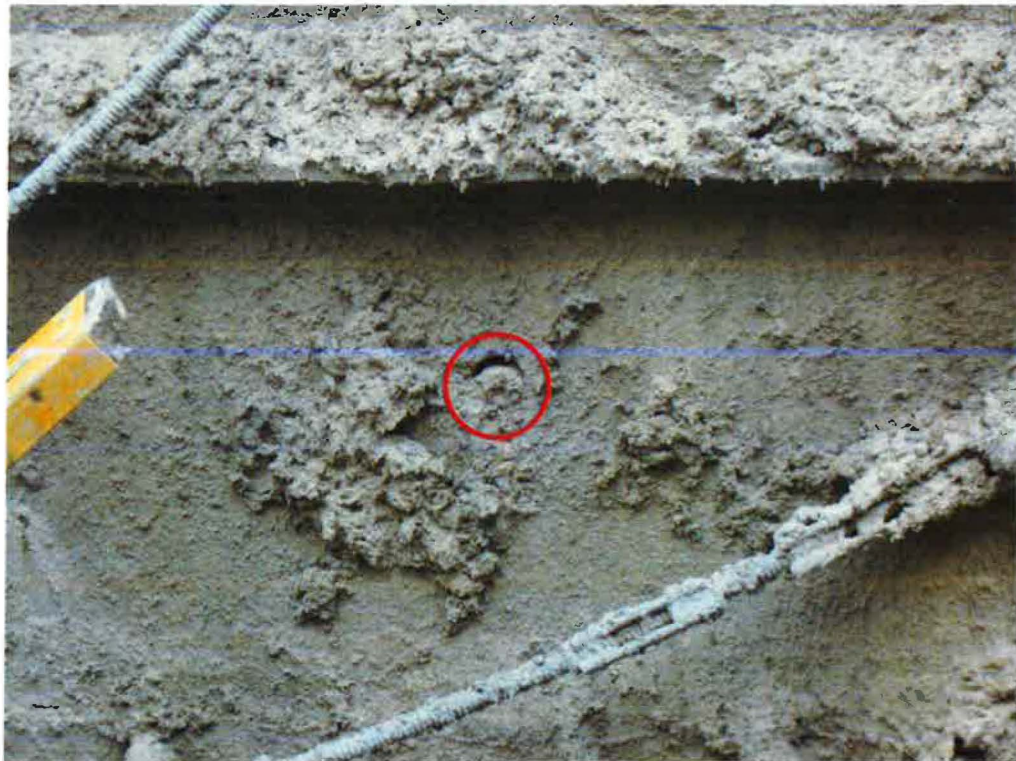
Figure 12: Holes from failure lower row of ties filled with concrete

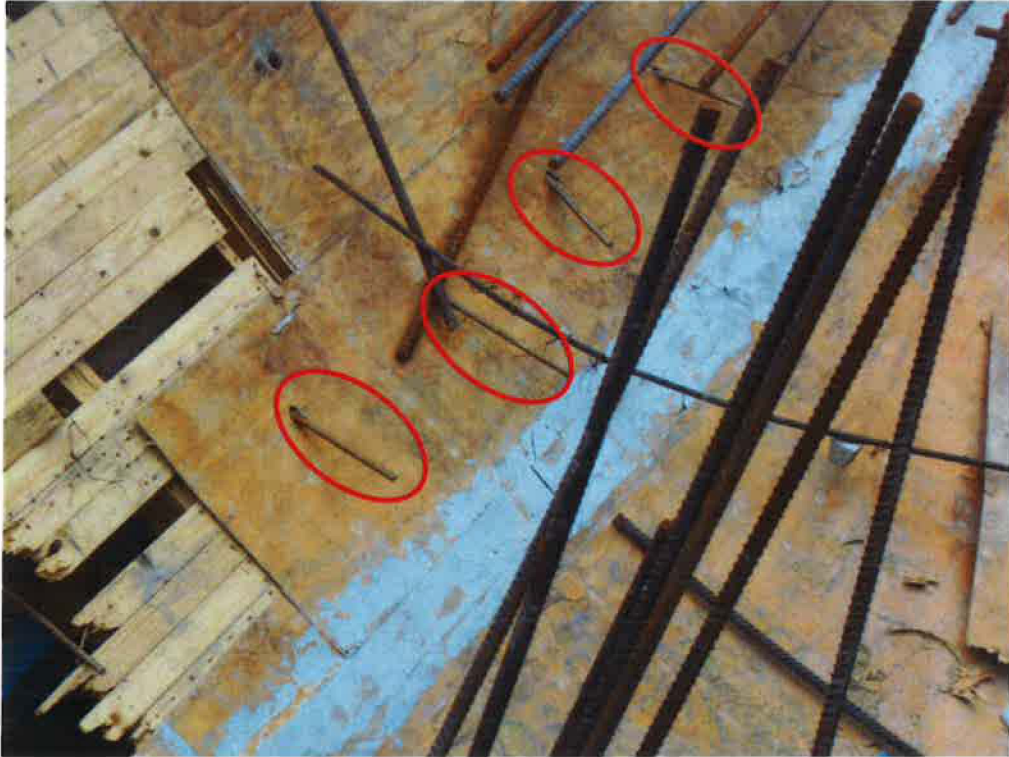
**Figure 13: Ties penetrating the formwork (for upcoming pour D2ENB-03)**

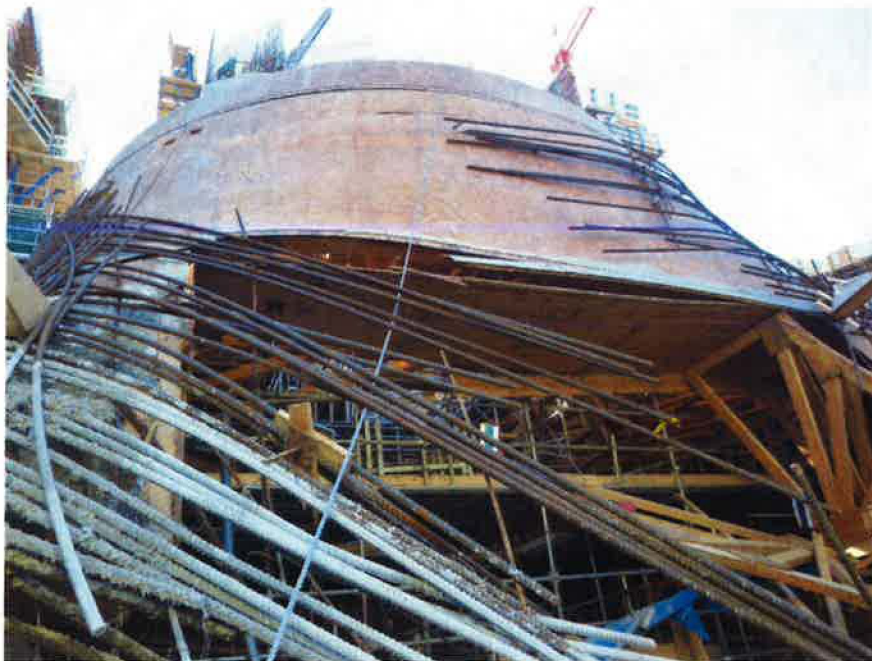
**Figure 14: View from downstream of the hole left by the collapse of shoring towers supporting A29**

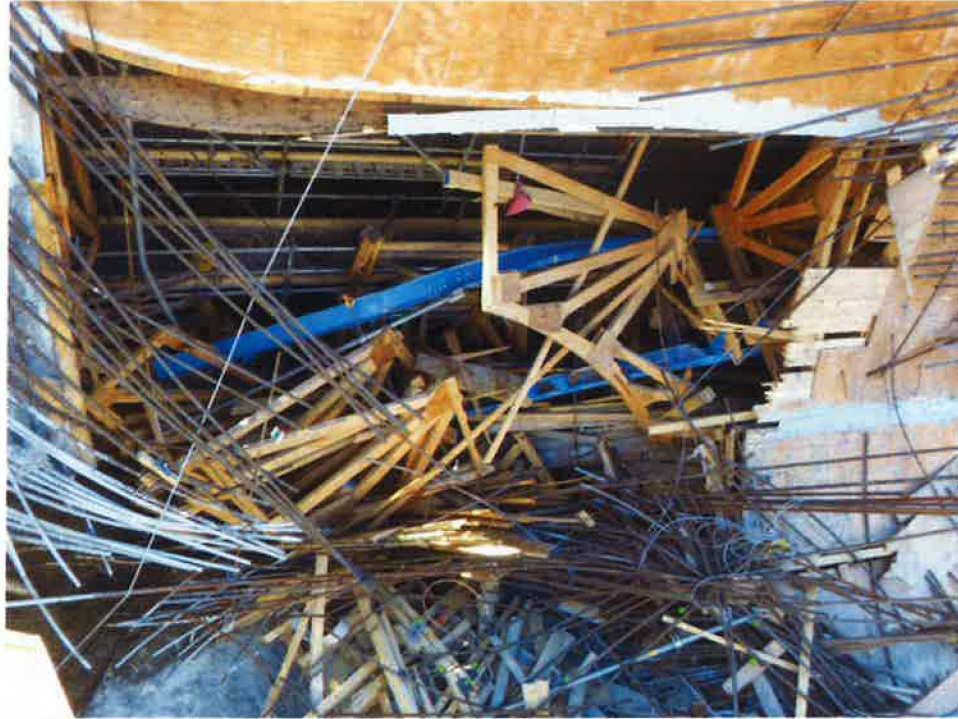
Figure 15: View from above of the hole left by the collapse of shoring towers supporting A29

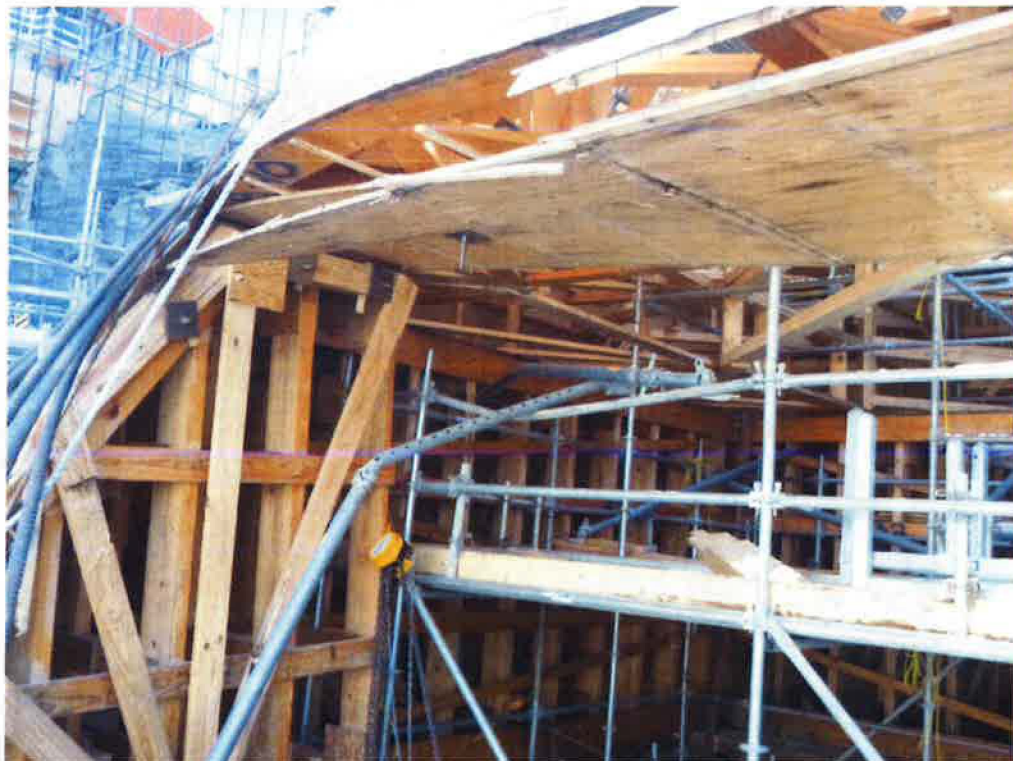
Figure 16: View of element A30 on the South side of collapsed A29

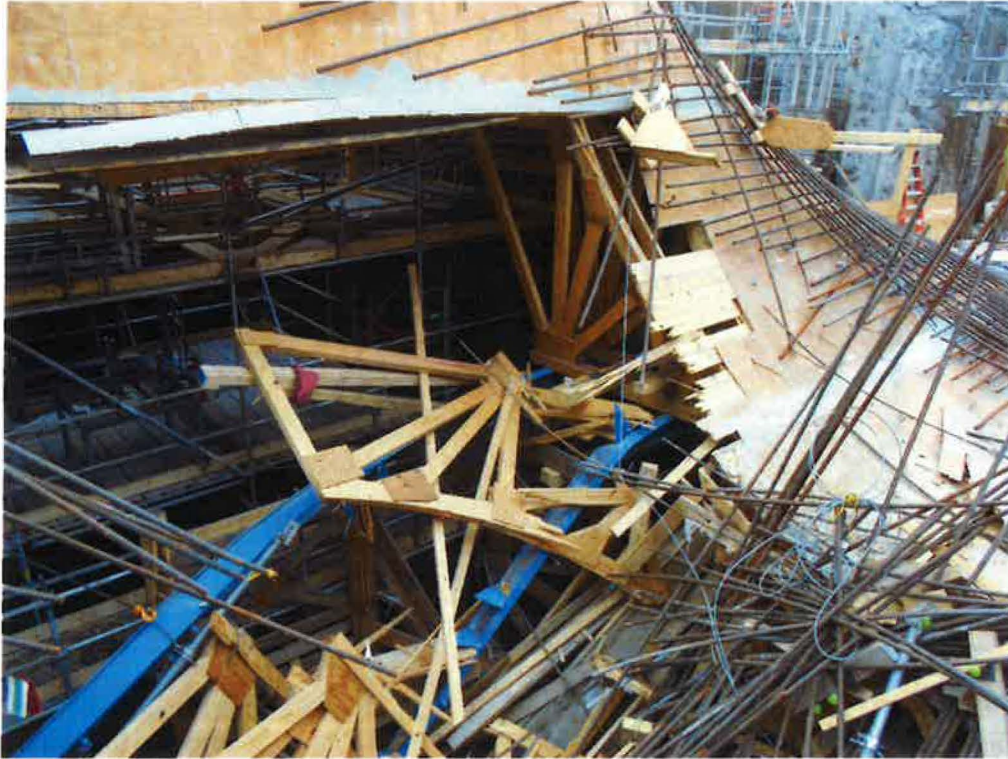
**Figure 17: View of the North portion of Panel A29**

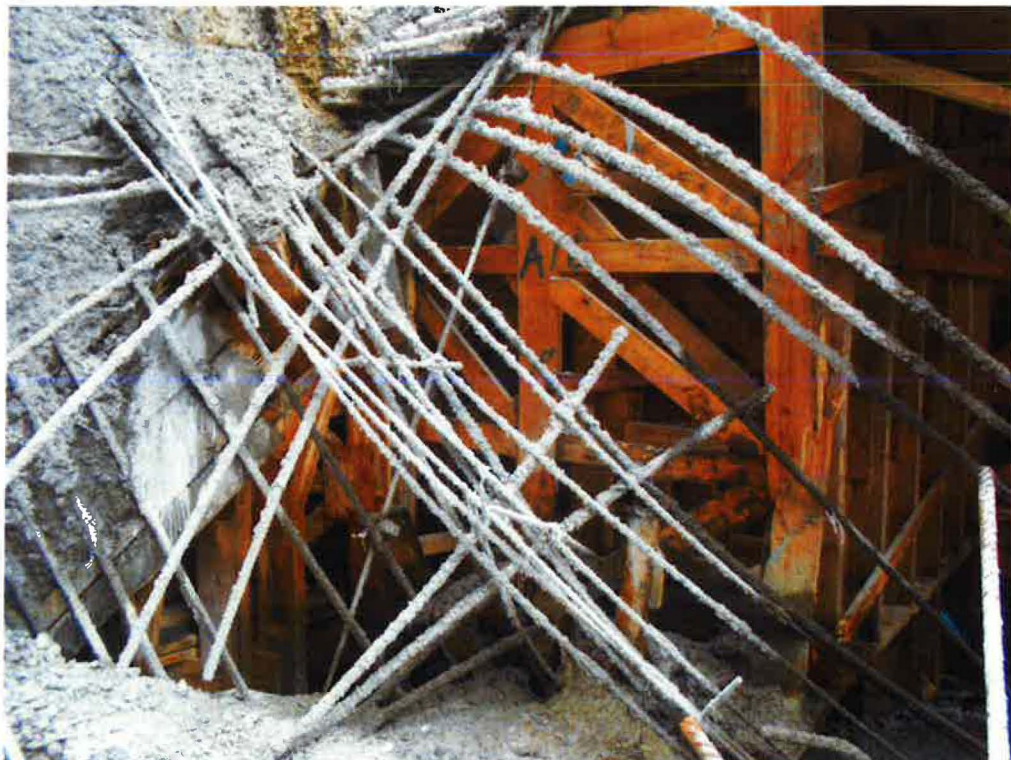
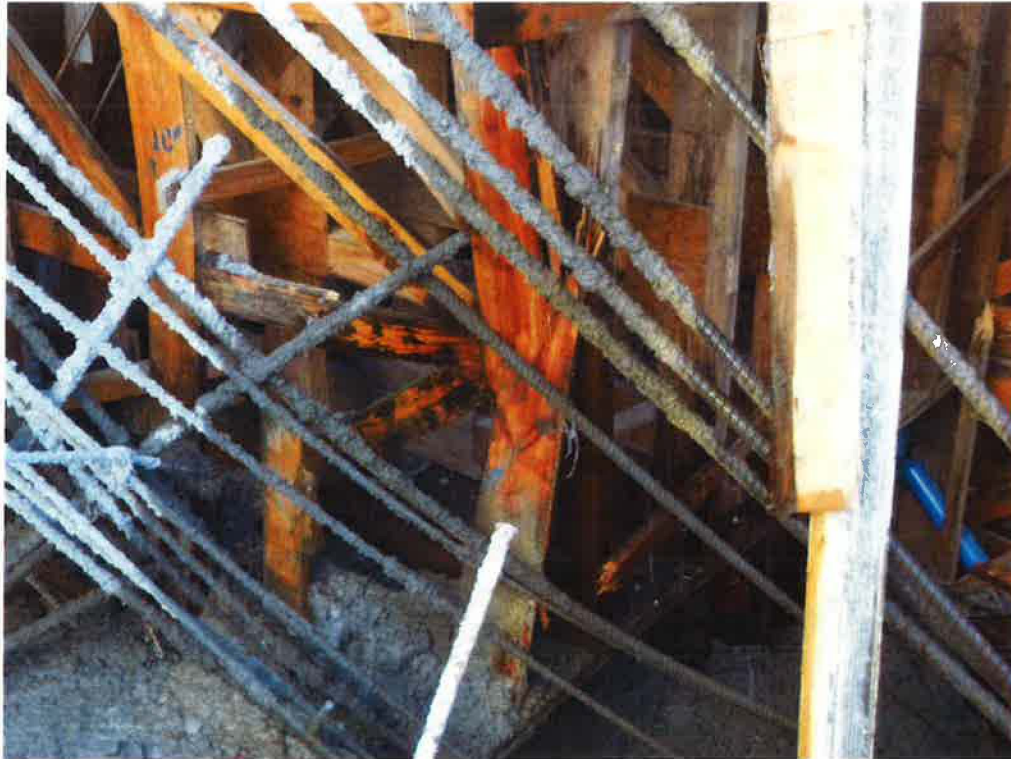
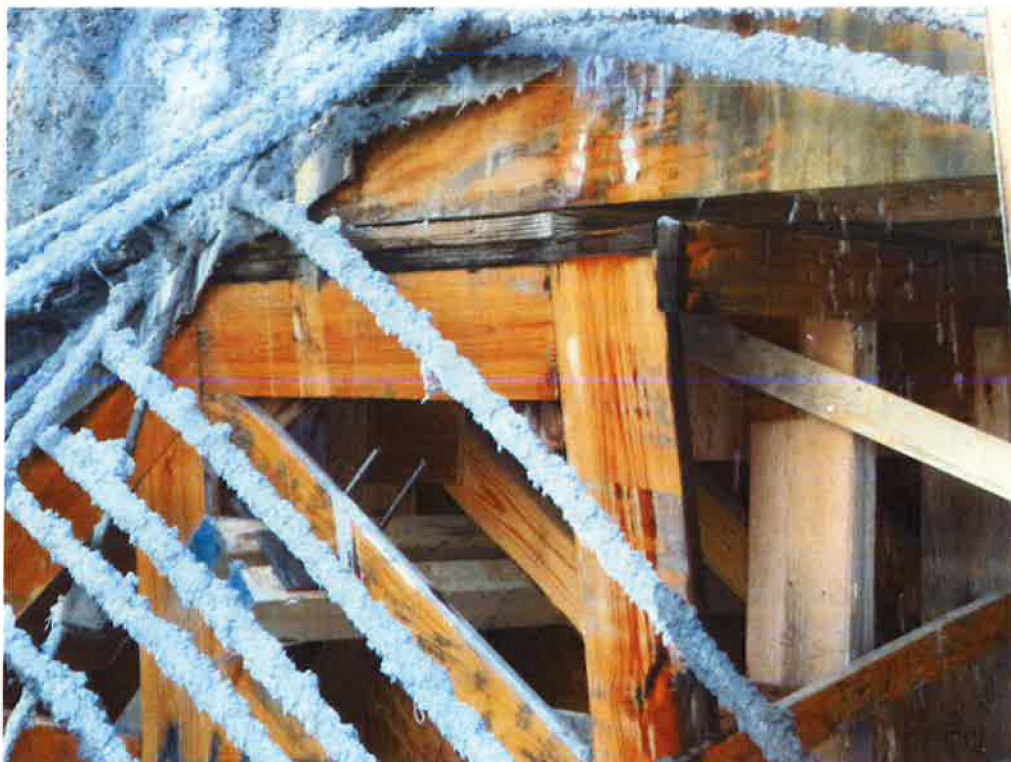
**Figure 18: Timber structure of element A16**

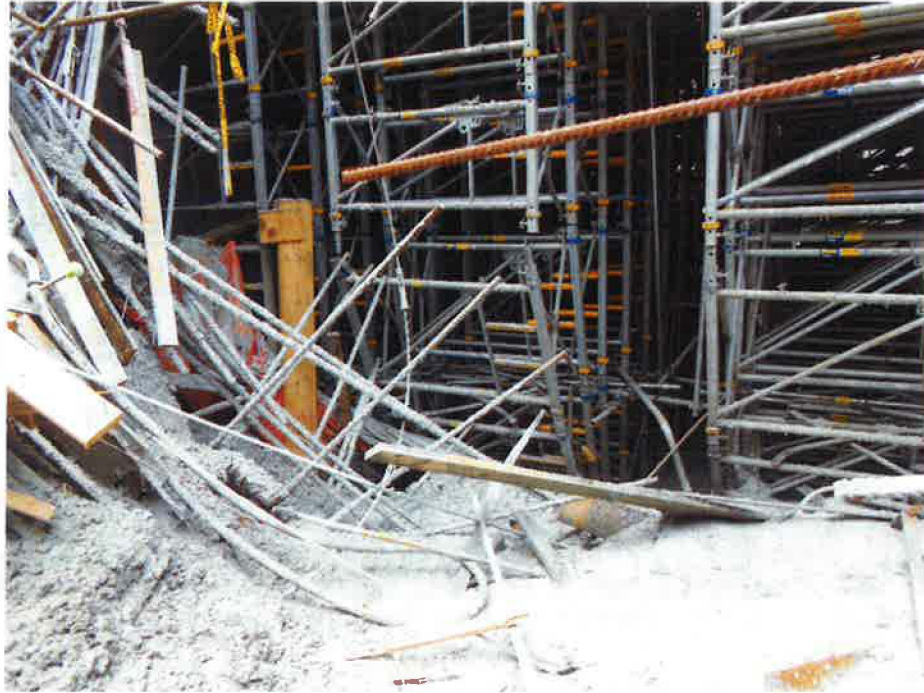
Concrete and limited debris bent and displaced the bottom row of Doka tower legs (see Figure 21 and Figure 22). It was observed that the first 2 towers had significant damage and the first 7 towers legs are covered in concrete.

**Figure 21: View of the Doka shoring towers from the Elbow**

The observations made of the damaged Doka towers in Draft Tube 2 South outlet were used to develop a remediation plan for the removal of the towers and formwork panels in this area. Details are outlined in the Phase 3B Report.

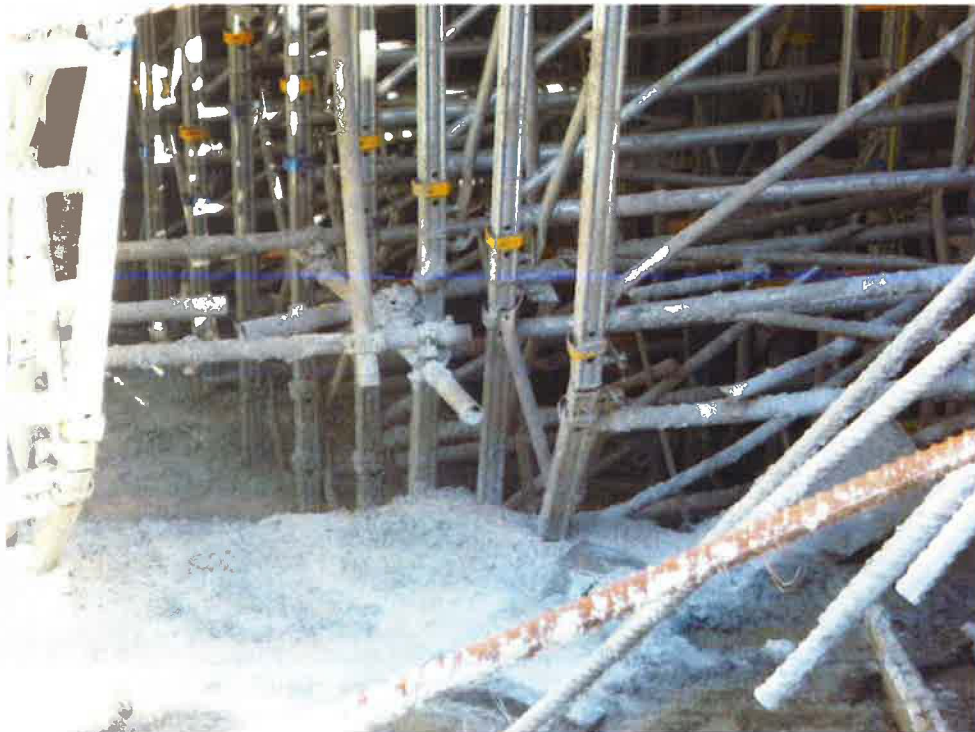
**Figure 22: Detail of damaged Doka tower legs; bent and encased in concrete**

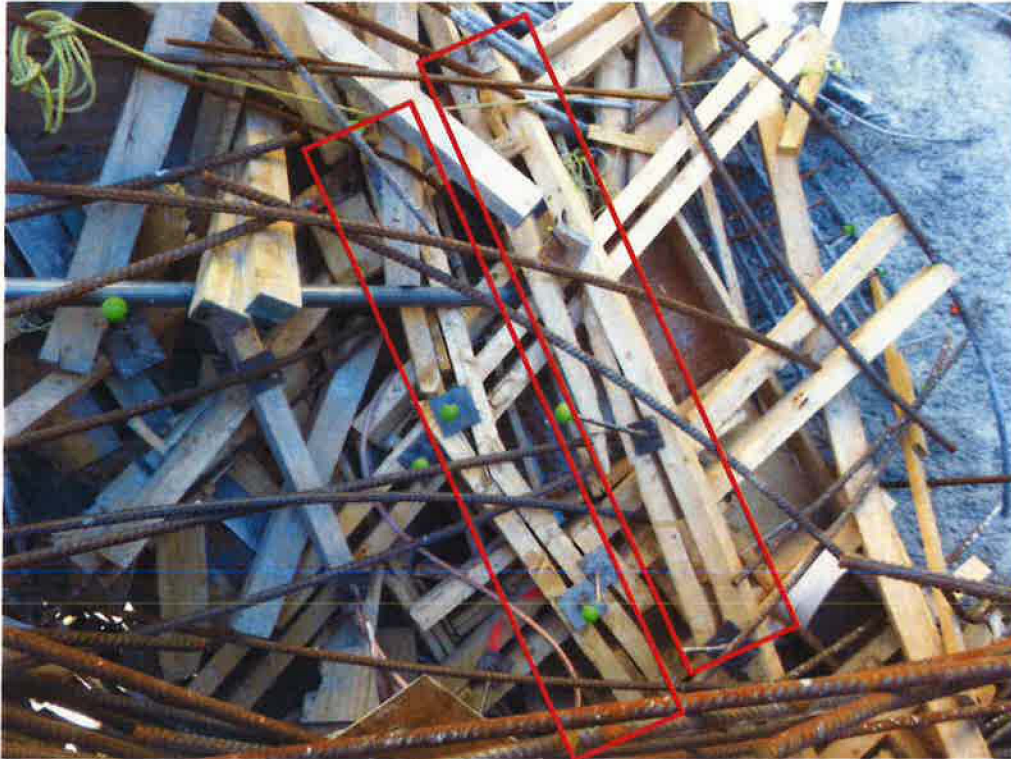
Built in place formwork for the bulkhead separating the failed D2ESB-03 from the D2ENB-03 pour collapsed on top of the formwork debris in Draft Tube 2. Portions of the formwork are still connected to tie rods.

**Figure 23: Whalers and ties from Built-in-place bulkhead separating D2ENB-02 and D2ENB-03**

Suspended materials should be lowered prior to allowing access in the area.

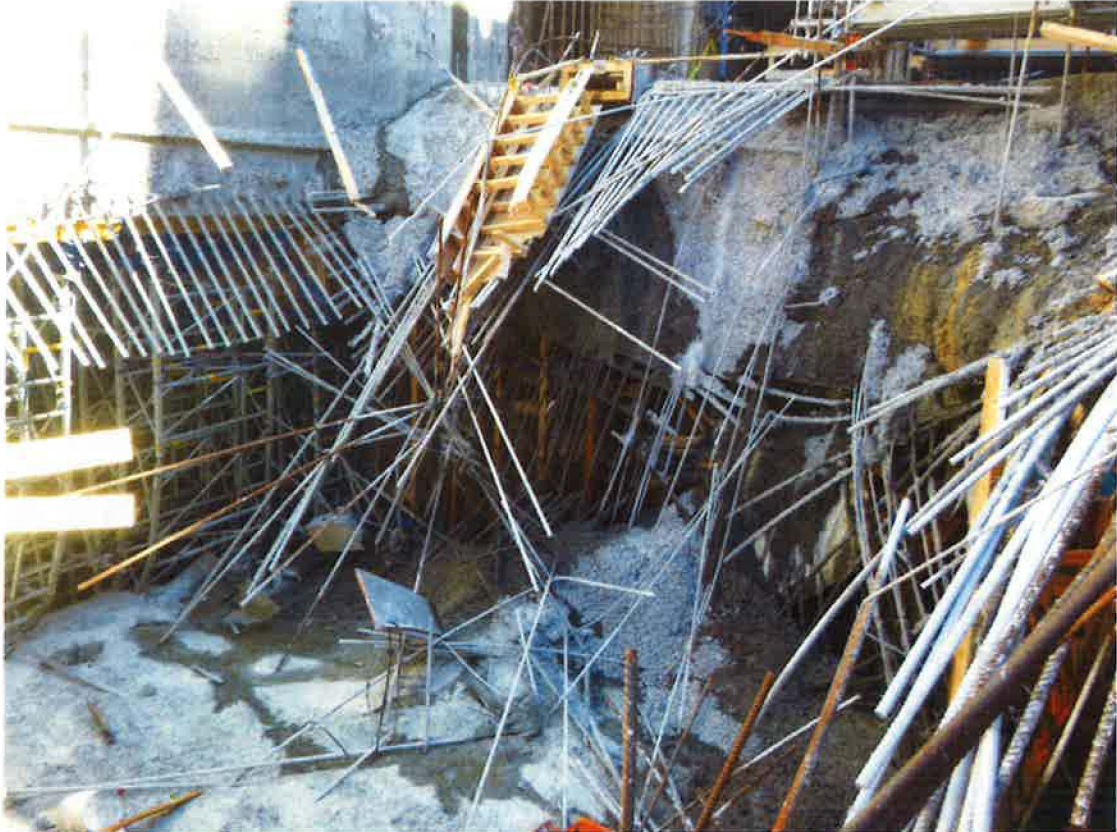
The block-out for drainage trench is also on top of debris in Draft Tube 2 and portions are suspended above the opening in the failed formwork/shoring.

Figure 24: Suspended formwork, rebar, and concrete, looking SE

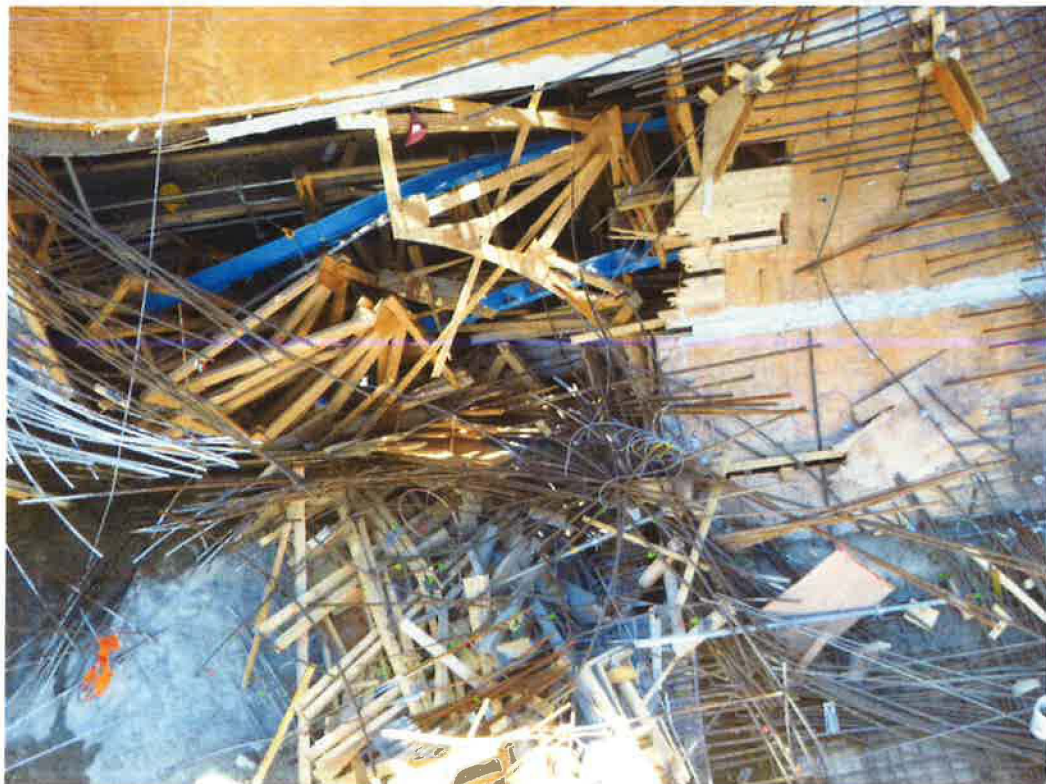
Figure 25: Debris, looking west.

A remediation plan to remove debris from the affected area should be developed based on the photos and observations made during the man basket investigation.

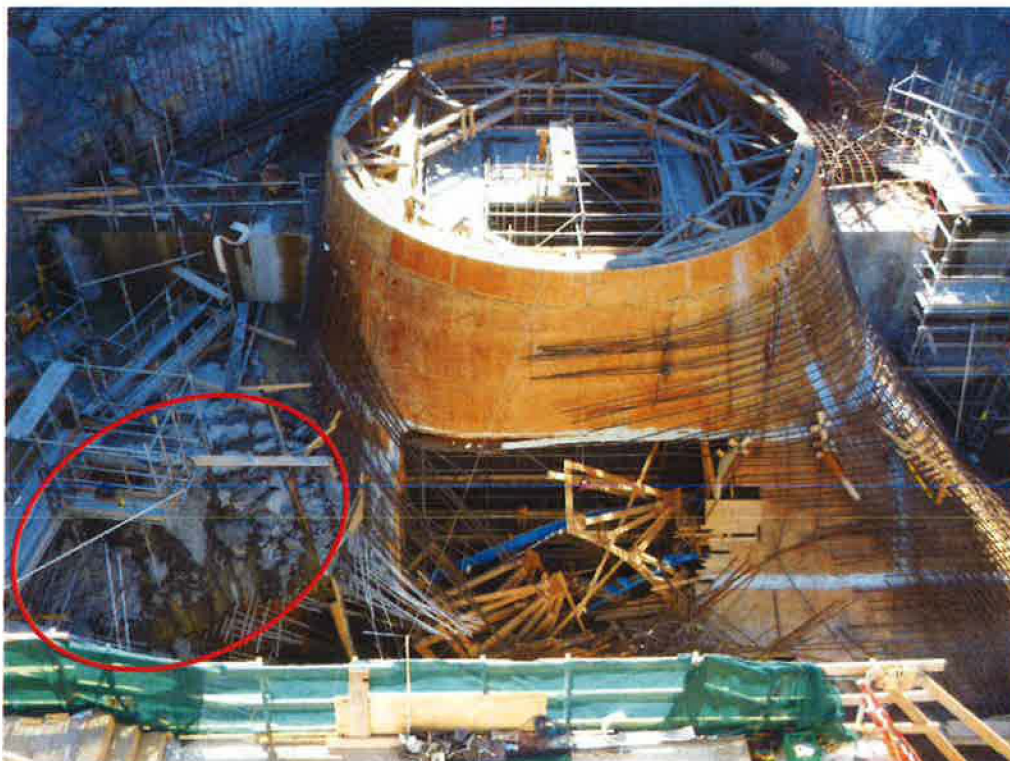
Fresh concrete supported by the cured D2ESA-02 concrete flowed into the draft tube after the D2ESB-03 formwork failed, resulting in non-conforming concrete above D2ESA-02.

**Figure 26: Non-conforming concrete circled in red.**

Remediation of non-conforming concrete and yielded rebar will be required.

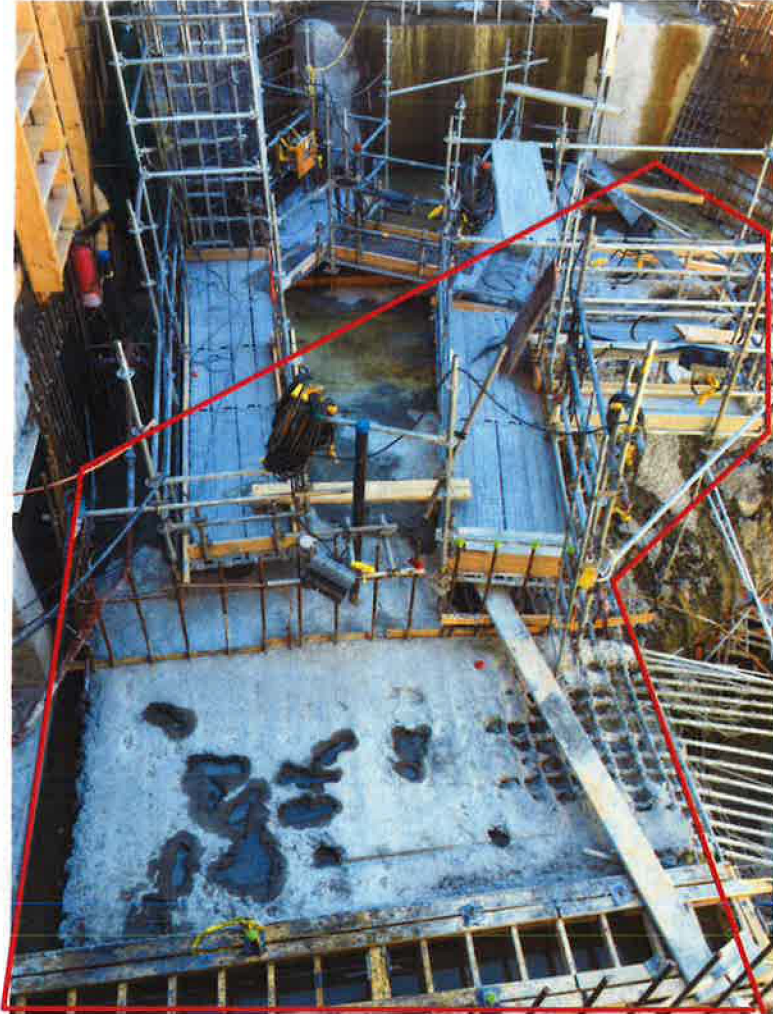
Figure 27: Approximate extents of non-conforming concrete, in red.

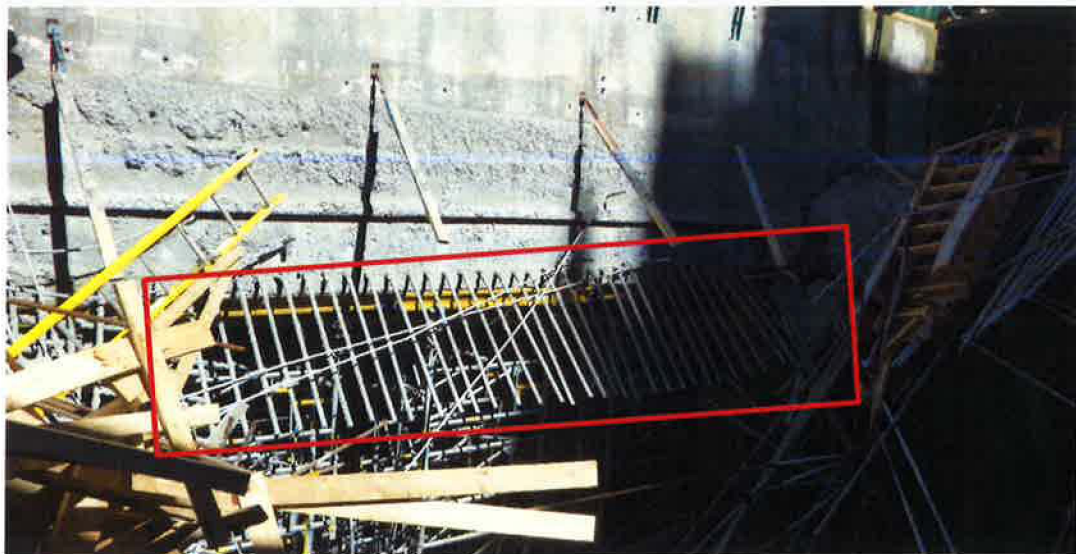
35M rebar penetrating from the outlet roof into Draft Tube 2 were bent down during the May 30 failure. See Figure 28. These bar do not pose an immediate safety hazard but will have to be addressed with the powerhouse engineer of record.

Figure 28: DT02 South Outlet Rebar yielded by failure.
