ILF CONSULTANTS, INC.
 400 112th Ave NE #205
 Bellevue WA 98004
 U.S.A.

Date: September 9, 2016

LOWER CHURCHILL PROJECT
GENERAL REPORT – SITE INSPECTION OF DRAFT TUBE UNIT 1 FORMWORK AND FALSEWORK

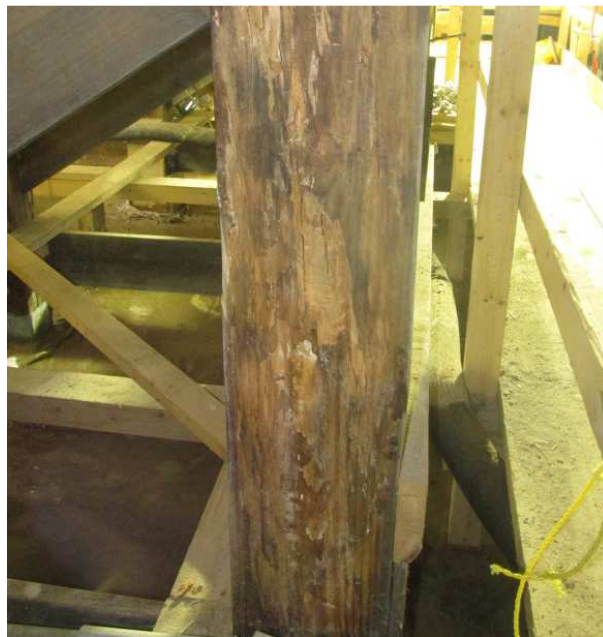
The material used for the shoring tower legs showed signs of extensive weathering and rot as seen in Figures 2 to 5. All shoring towers throughout Draft Tube 1 have some degree of weathering, with varying degrees of intensity. Instances of biological attack (mold, fungi, insect) were also observed.

Figure 2: Highly weathered column member with extensive rot and damage due to overstress

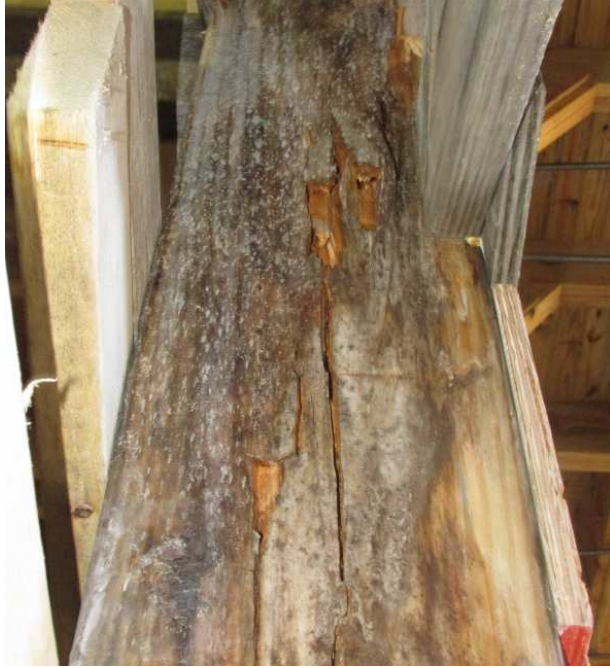
Figure 3: Highly weathered column member with extensive rot and damage due to overstress

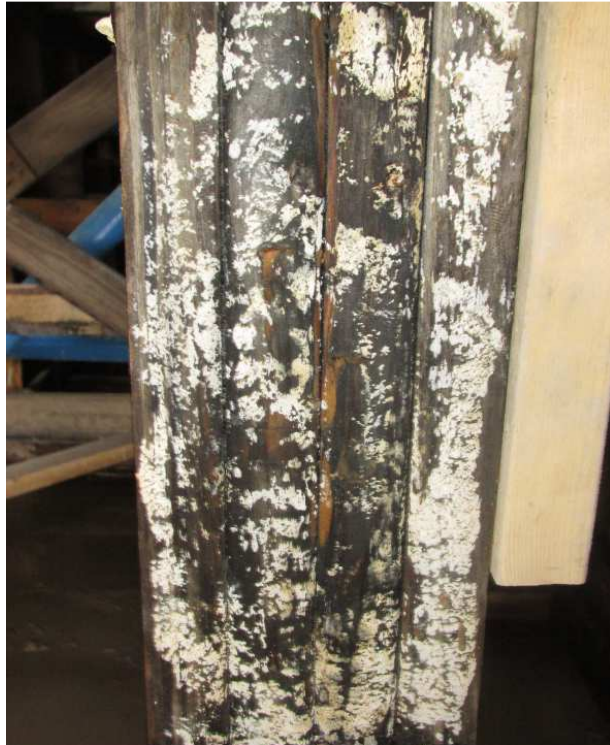
Figure 4: Highly weathered column member with mold growth

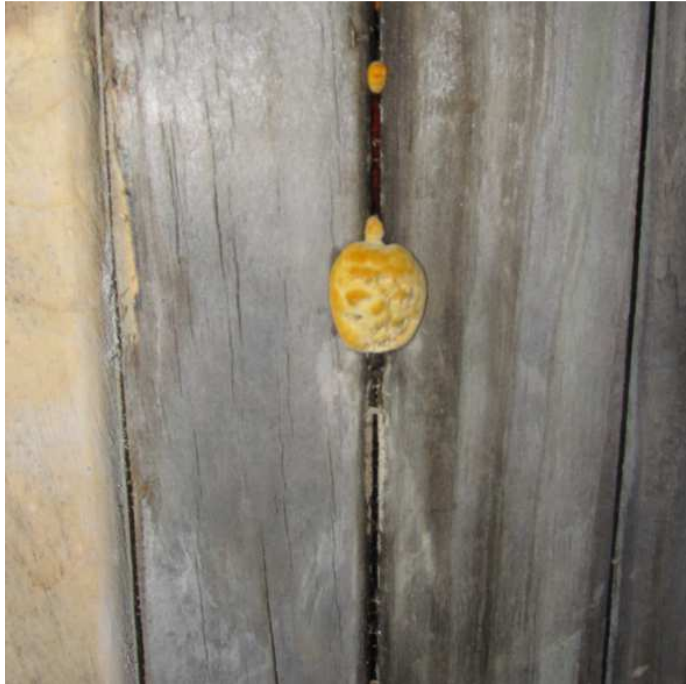
Figure 5: Weathered column member with fungal growth

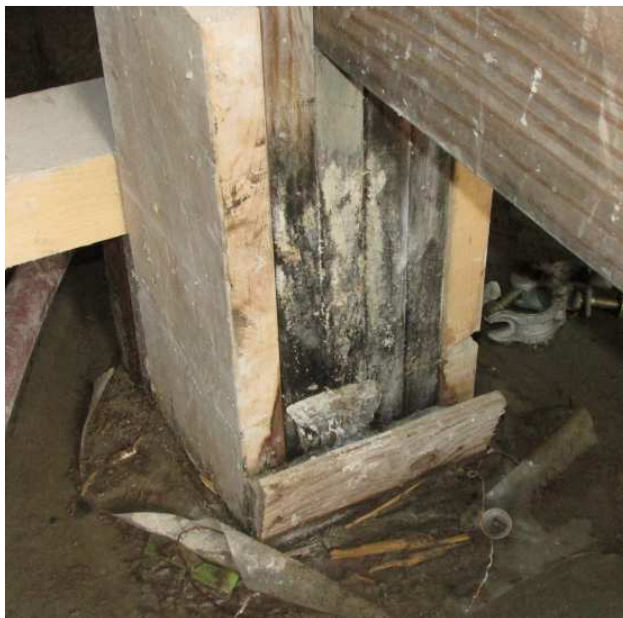
The bases of the tower legs on all towers were generally in very poor condition, with obvious indications of moisture damage and weathering as see in Figure 6.

Figure 6: Highly weathered column base with moisture damage

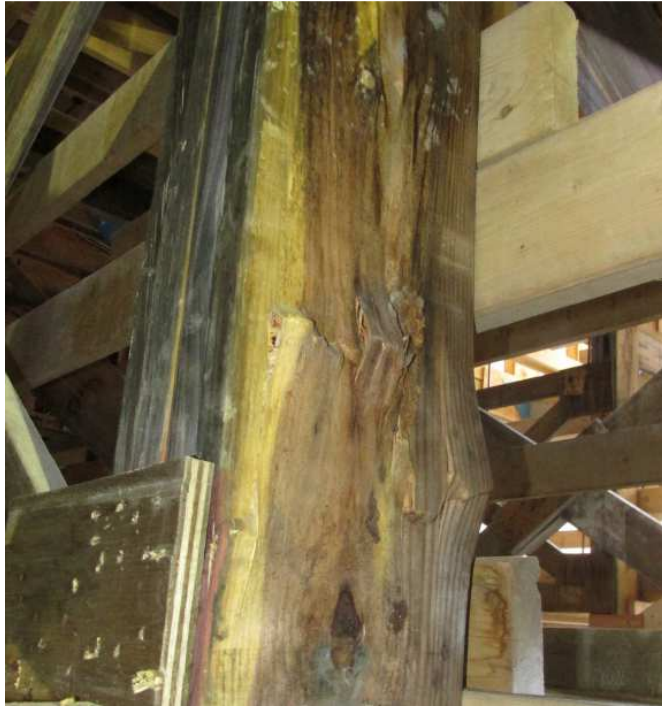
All towers in Row B were overstressed and showed some indication of compression failure as shown Figures 7, 8 and 9.

Figure 7: Compression failure of column member in tower B2

Buckling of column legs was observed in Row B as seen in Figures 7, 8 and 9.

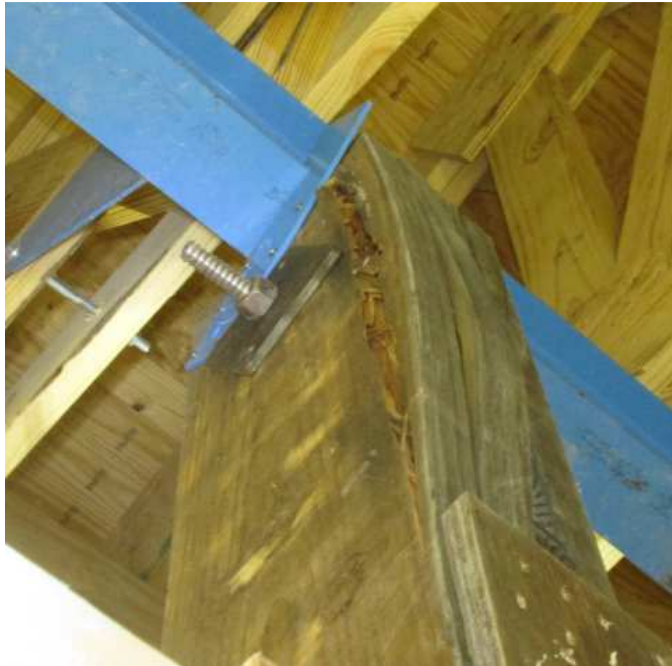
Figure 8: Compression failure of column member in tower B6

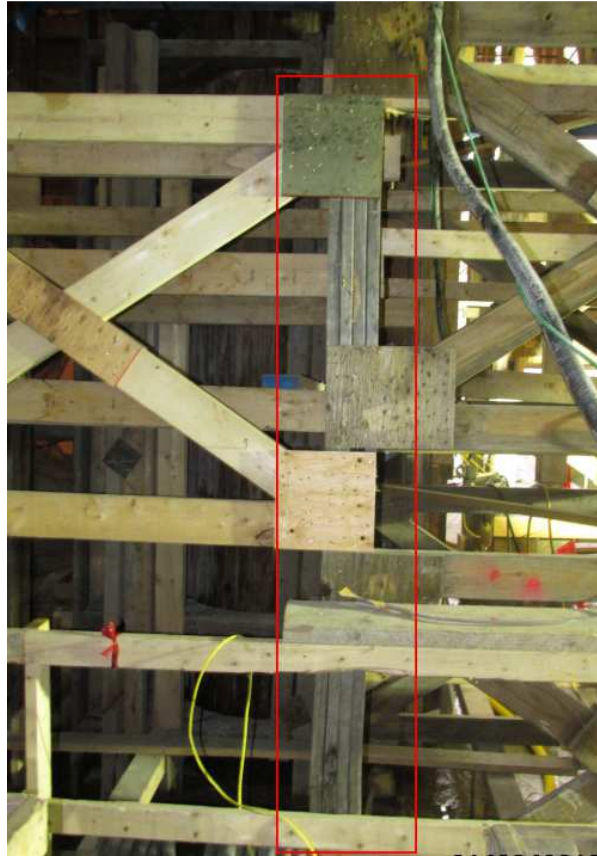
Figure 9: Buckling of column in tower B4

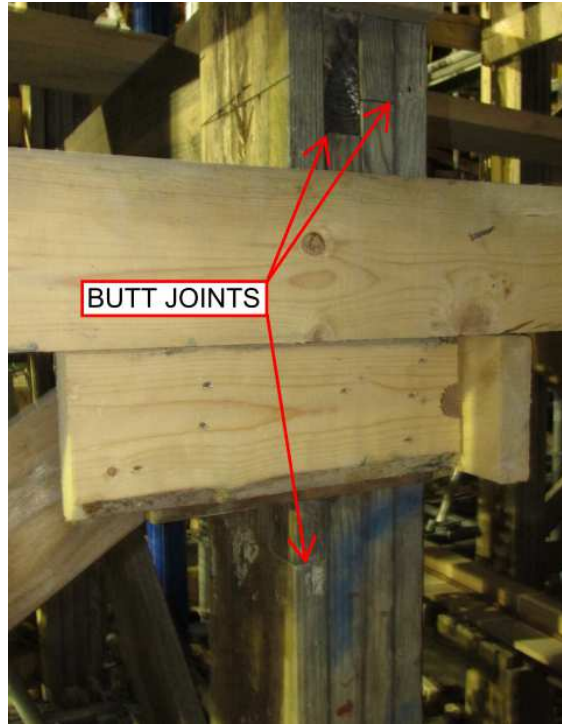
Butt joints in column members were not staggered as seen in Figure 10.

Figure 10: Butt joints not staggered (tower C1)

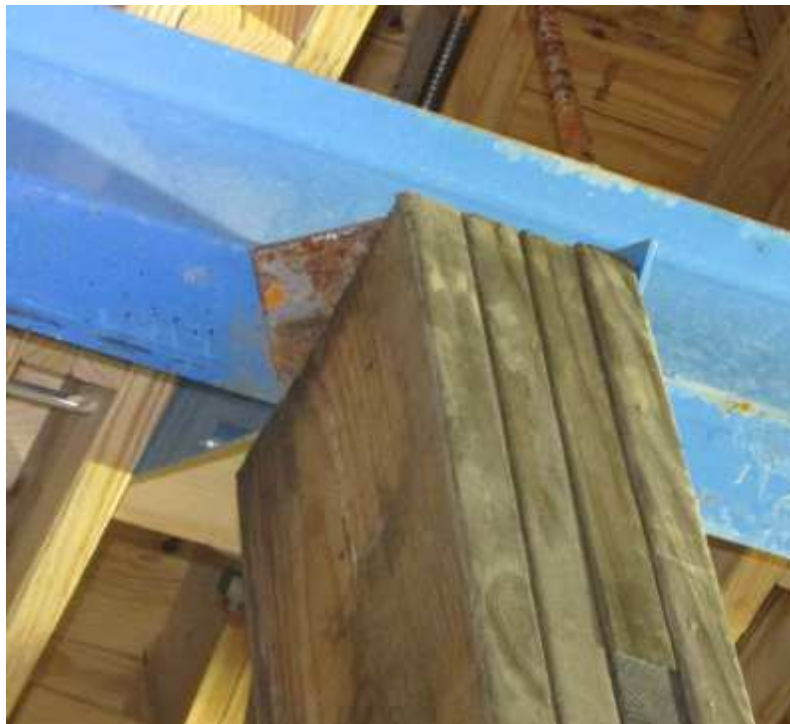
Approximately 90% of the shims between the shoring tower columns and the steel beams were not installed. Shim plates that were installed do not cover the bearing surface of the columns resulting in unevenly distributed loads to the column (Figure 11 and 12). It was noted that a combination of softwood and steel shims were used.

Figure 11: Inadequate shim plate (shifted plate)

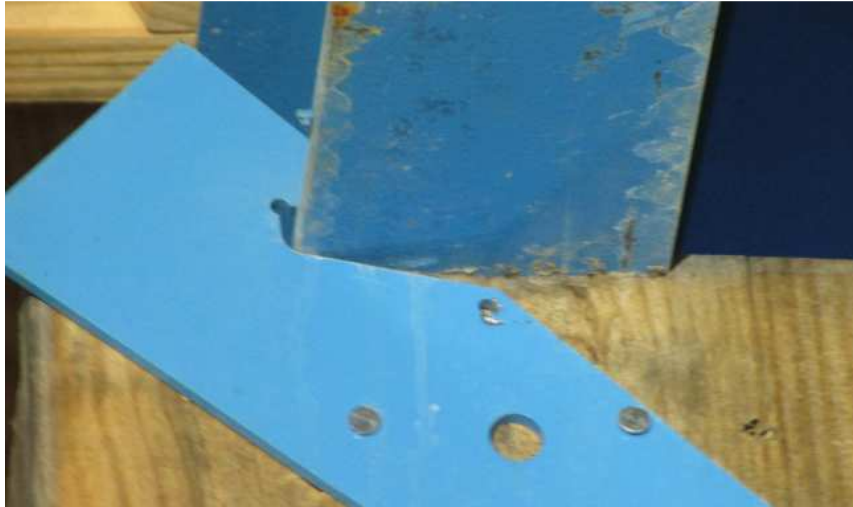
Figure 12: Localized end-grain compression due to lack of shim plate

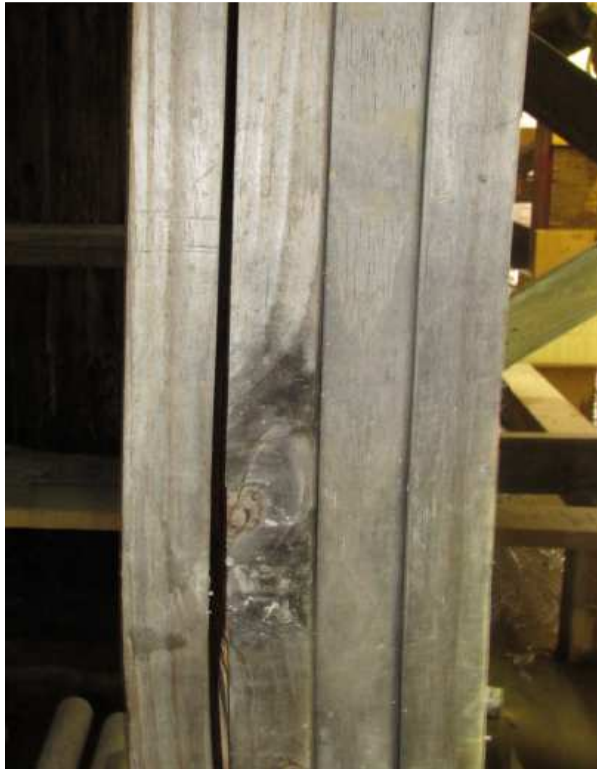
Column members were observed to be inadequately nailed together, as large gaps between column laminations were visible in Figure 13. Figure 14 shows an extreme example of inadequate nailing of tower legs (nails should penetrate all column laminations).

Figure 13: Inadequate nailing of column panels

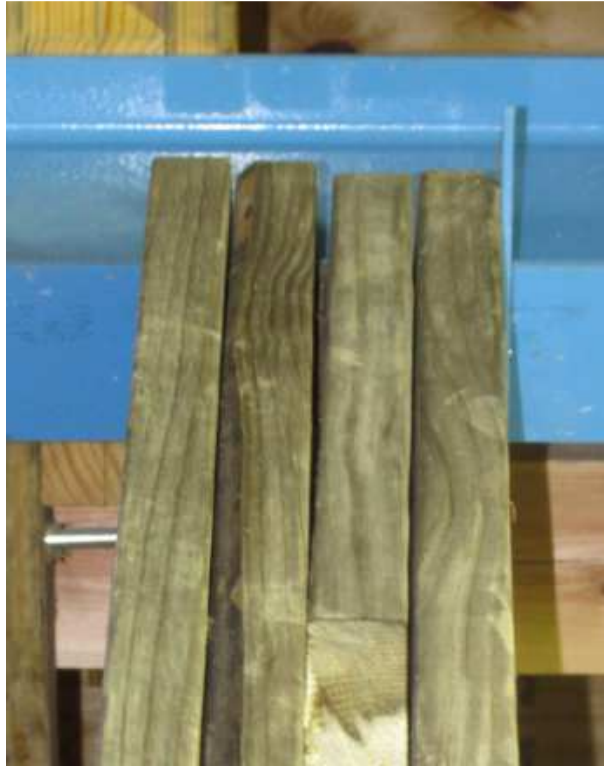
Figure 14: Inadequate nailing of column leg (tower B1)

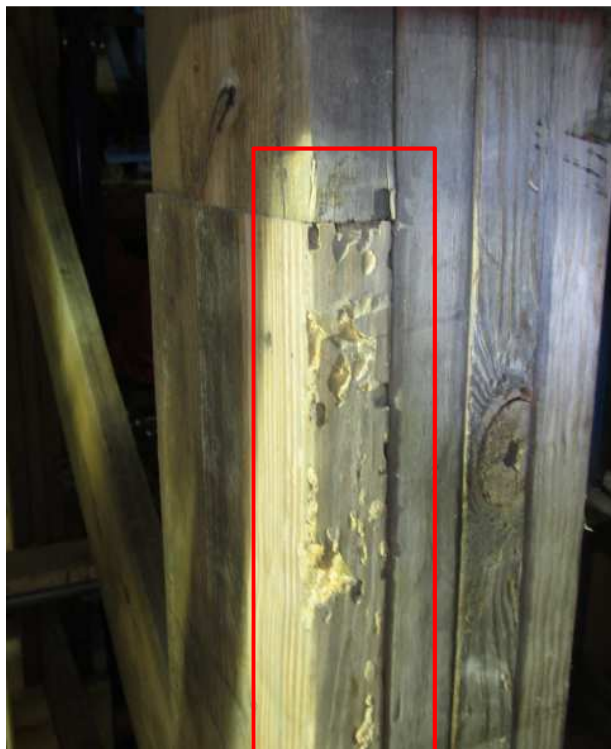
Evidence of termite damage was found on one of the shoring tower legs (see Figure 15).

Figure 15: Termite damage on shoring tower leg with wood filler added

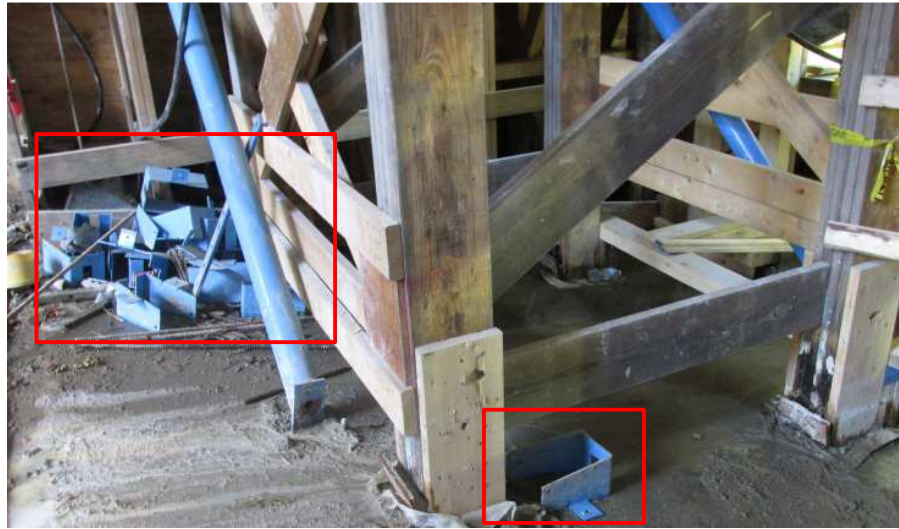
14 of the 16 shoring towers were not anchored to the concrete base slab as indicated on drawing MFA-AT-SD-3310-CS-D04-0066-01 to MFA-AT-SD-3310-CS-D04-0066-06. Figure 16 shows Tower A6 with no anchors installed and uninstalled anchors off to the side.

Figure 16: Uninstalled tower base anchors

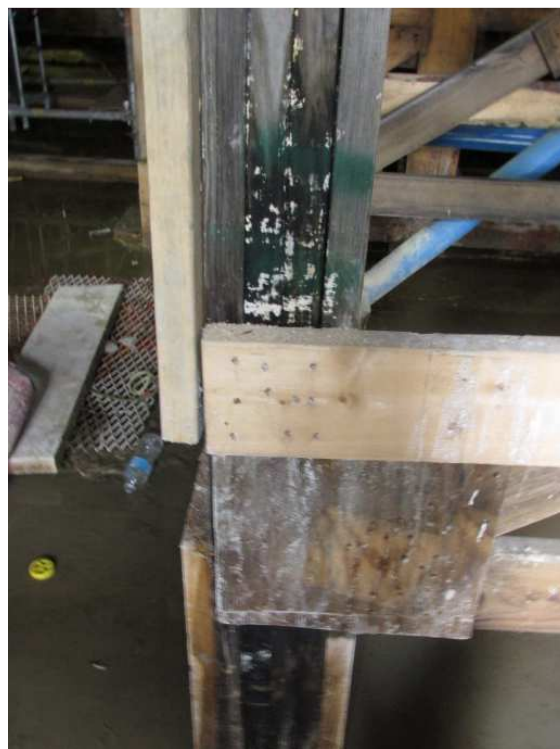
Some shoring towers color coded green (meant for Draft Tube 3) were installed in Draft Tube 1 as seen in Figure 17.

Figure 17: Shoring towers for Draft Tube 3 (green paint) found in Draft Tube 1

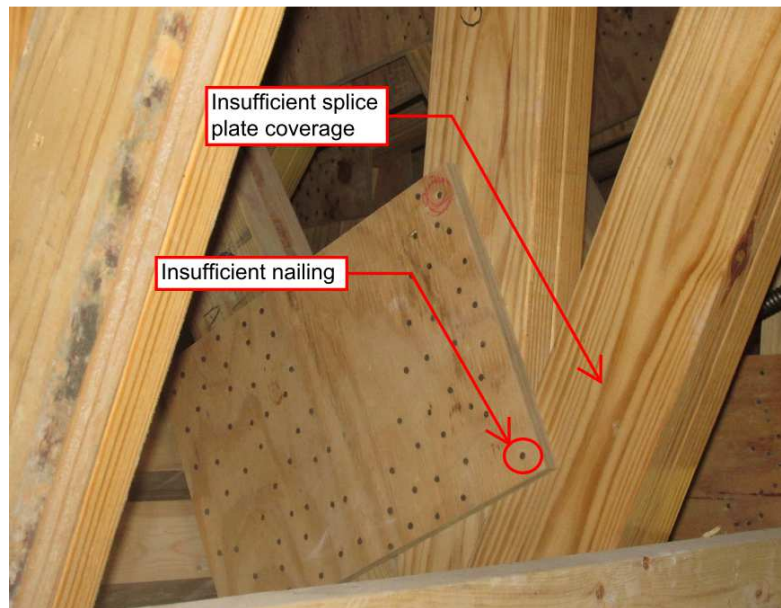
The observed deficiencies in Draft Tube 1 were primarily insufficient nailing and inadequate splice plates, as shown in Figure 18 and 19. OSB splice plates were not observed in Draft Tube 1. Signs of weathered wood and mold were also seen in the formwork panels (Figure 20). A summary of observed deficiencies in the formwork is found in Table 1.

Figure 18: Inadequate splice plate coverage of structural member and insufficient nailing

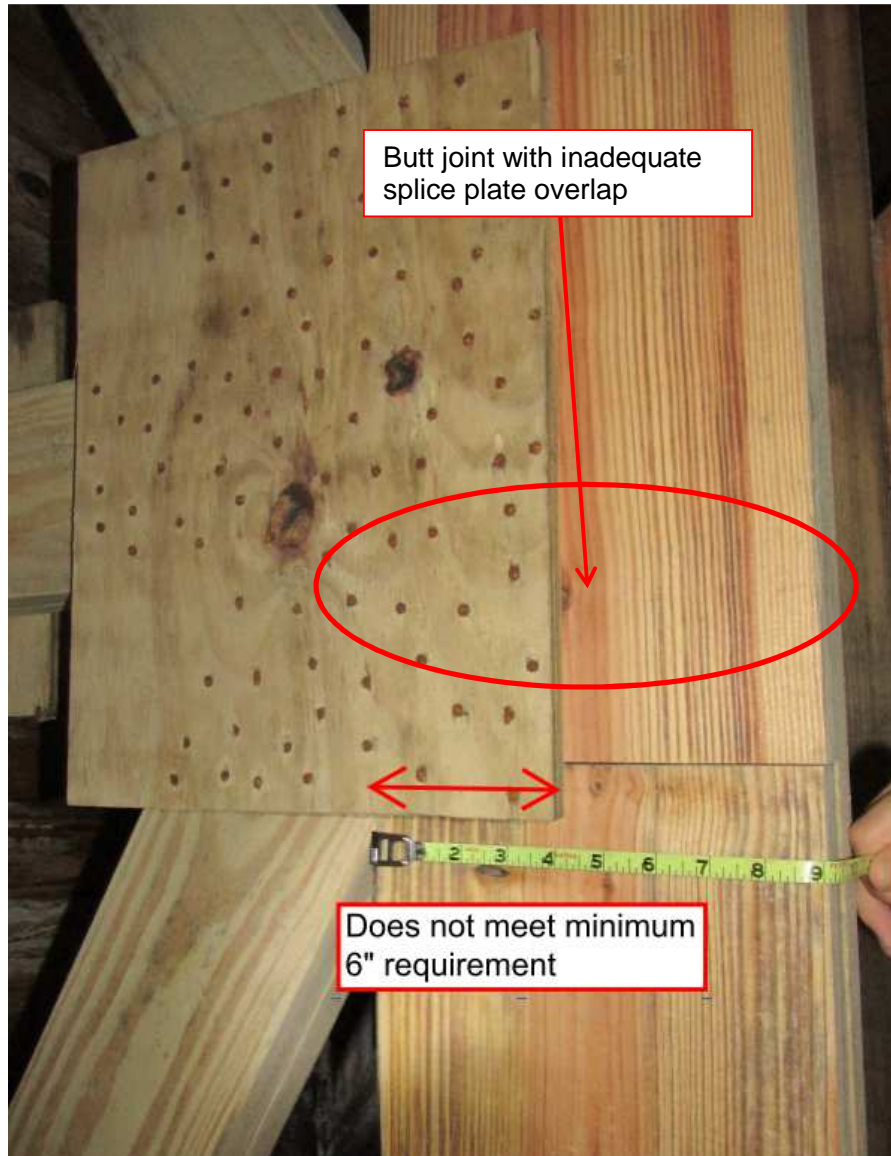
Figure 19: Incorrect size and installation of splice plate

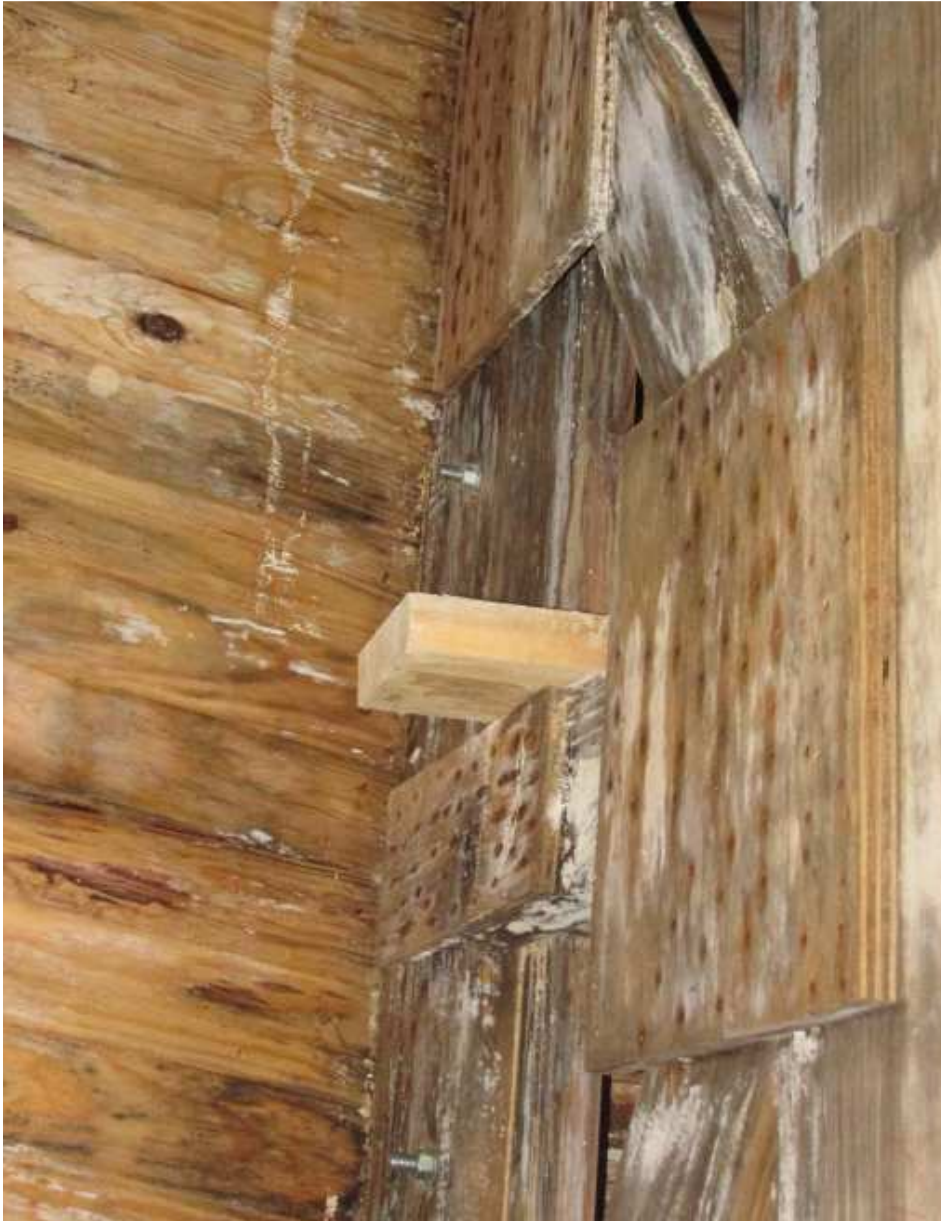
Figure 20: Weathered formwork
