Lower Churchill Project

Final Engineering Assessment Report of Draft Tube 2 Formwork/Falsework Failure

February 24, 2017

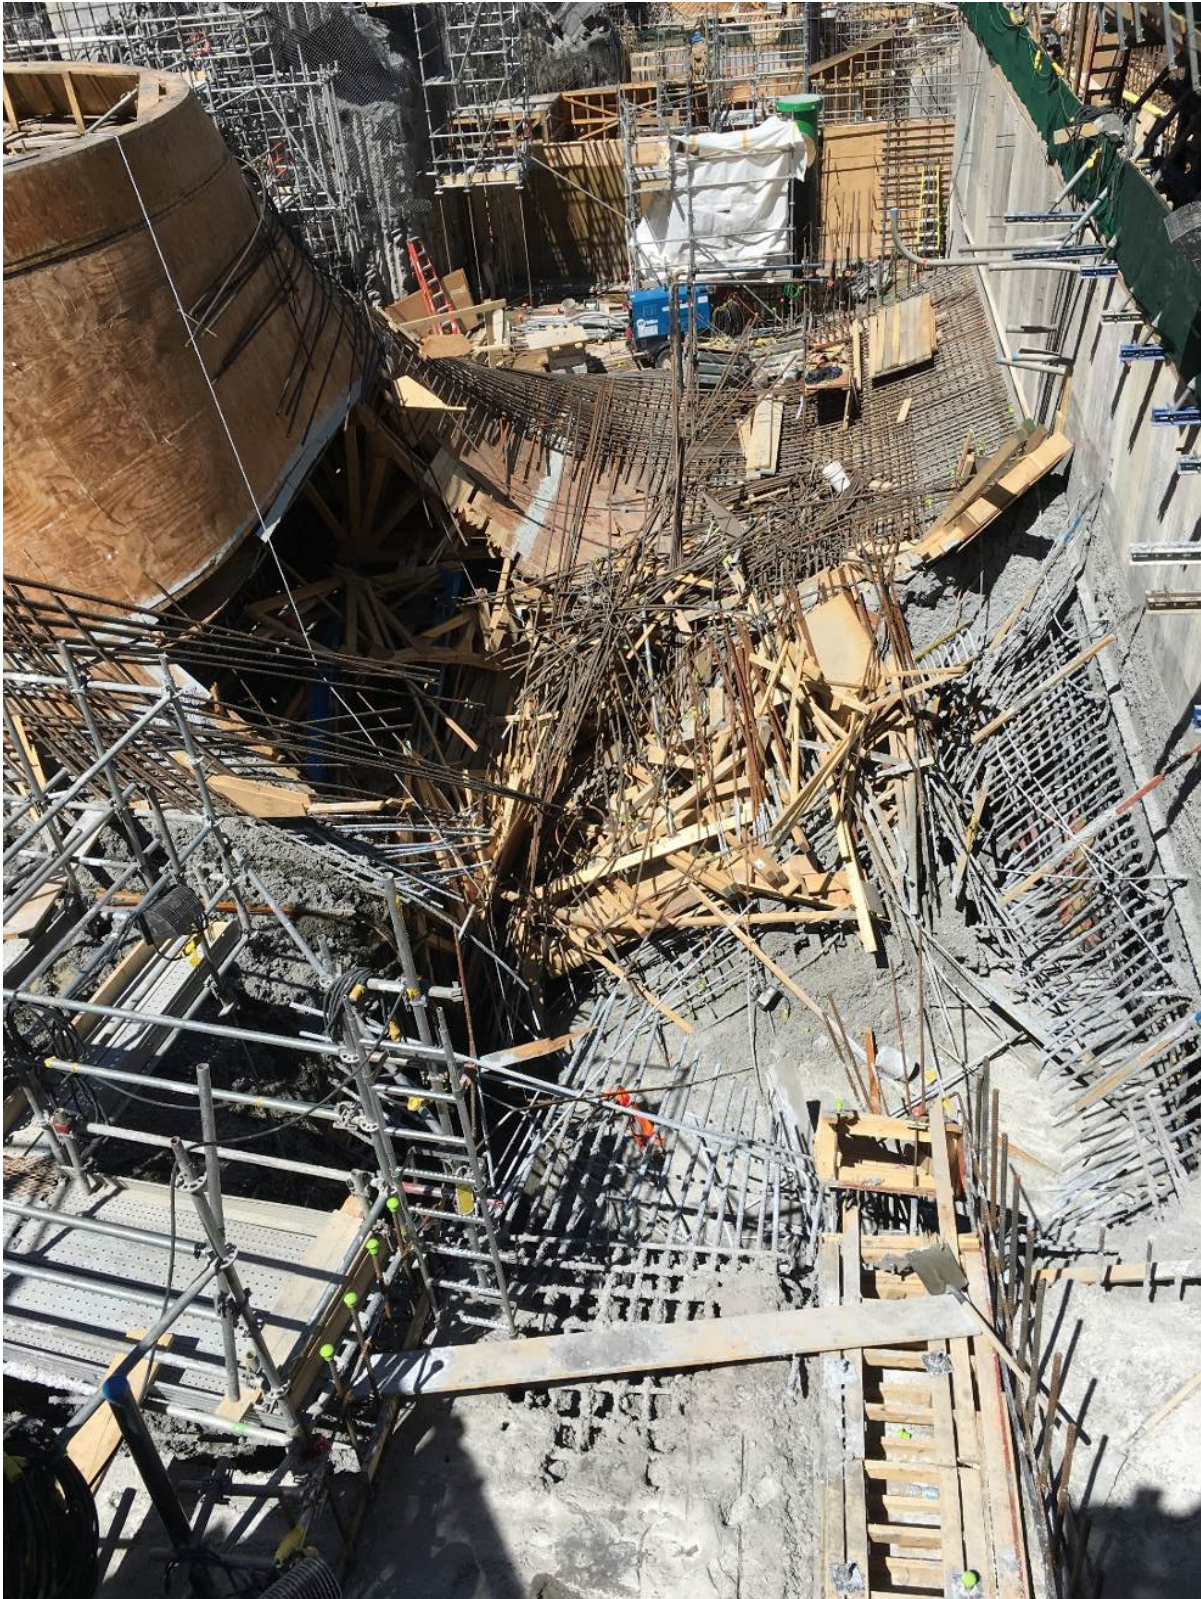
Figure 8: DT2 failure area, looking north

General observations from the preliminary field investigation revealed a large mass of concrete approximately 3.5m in thickness in the area underlying the failed pour. The majority of the visible formwork debris was concentrated to the north and upstream (western) edges of the failure area. Formwork and rebar to the north were partially supported by pier nose. Formwork to the west was partially supported by the remaining Row C tower legs, which had shifted to bear against access scaffold behind. The southern and eastern edges of the failure area had a distinct lack of CEI formwork from the failed area visible, suggesting the failure likely propagated from the SE to the NW. The DT2 south outlet had spilled concrete from the failure, which damaged up to 4 rows of Doka Staxo 100 falsework towers downstream from the draft tube.

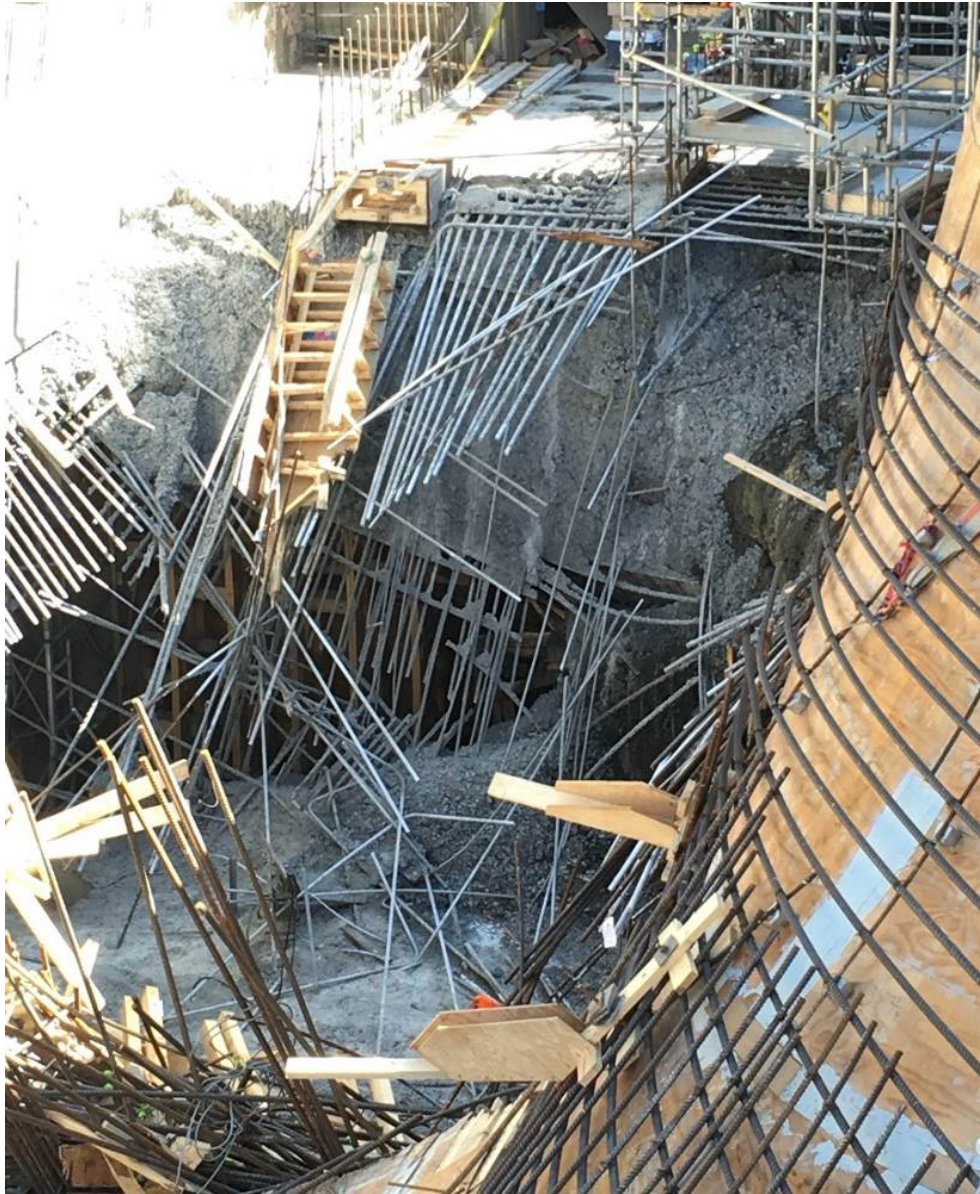
Figure 9: DT2 failure area looking southeast

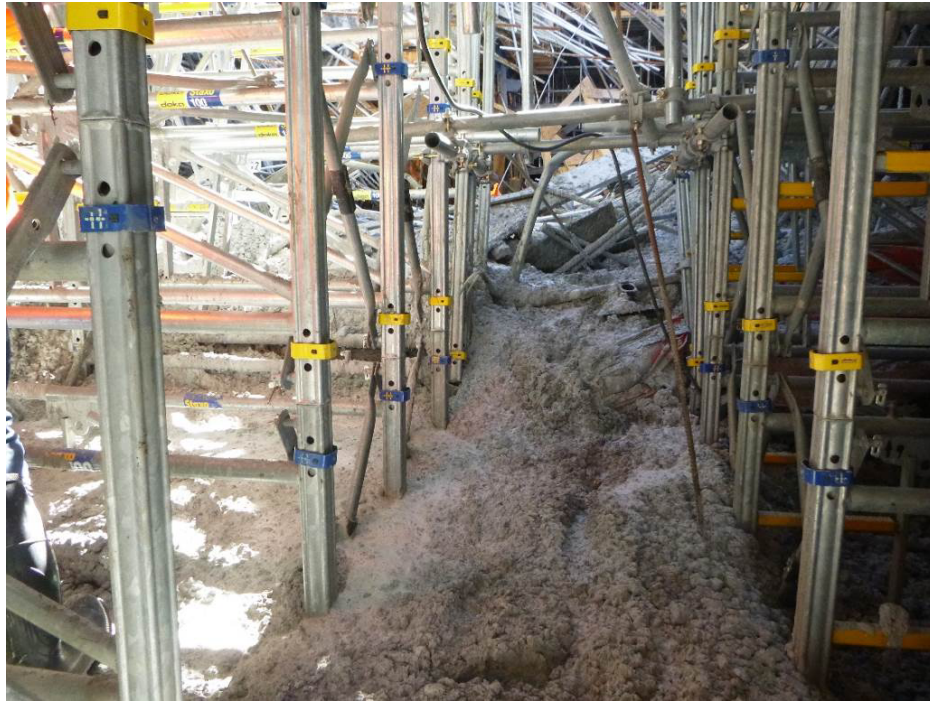
Figure 10: DT 2 south outlet looking upstream (west) into failure area

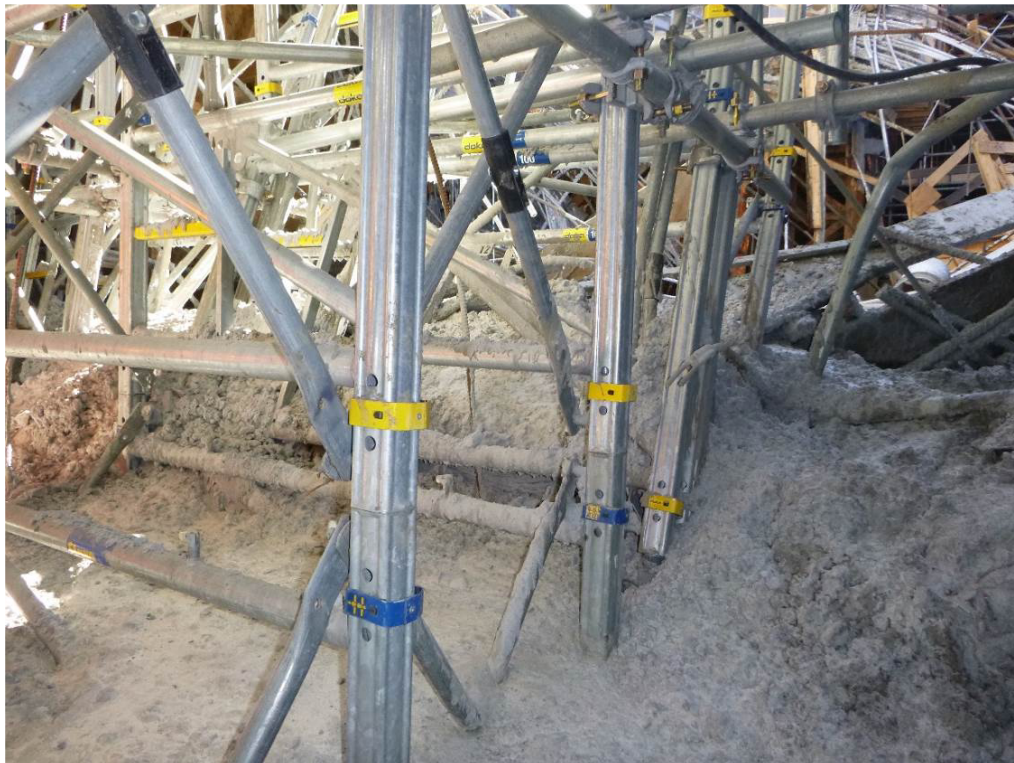
Figure 11: DT2 south outlet looking west-southwest into failure area

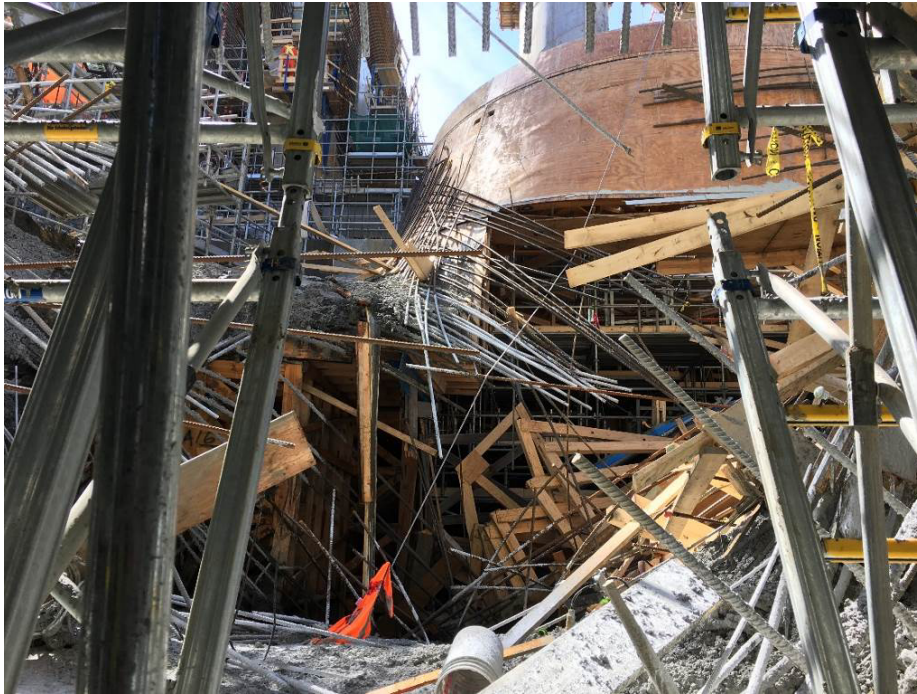
Figure 12: DT2 failure area looking west from northern portion of DT2 south outlet

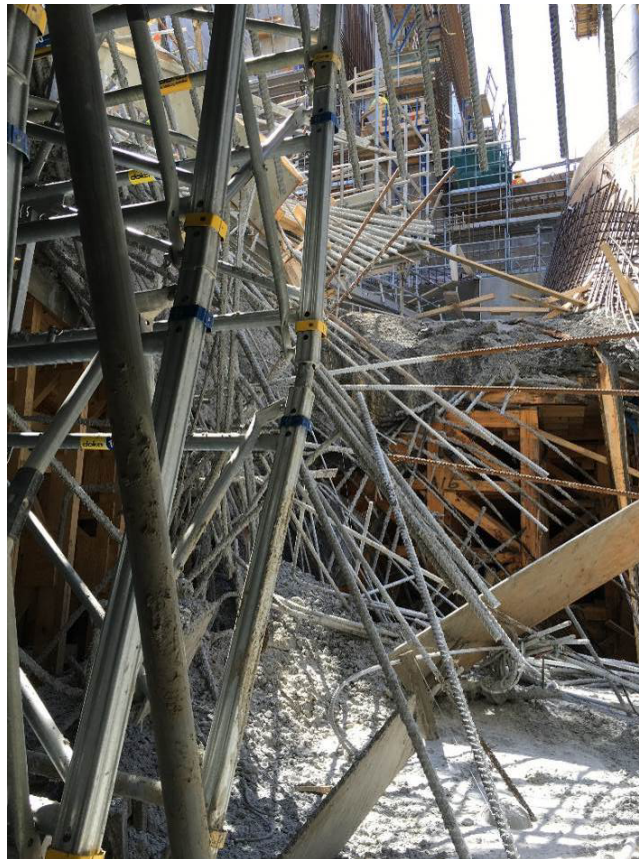
Figure 13: DT2 failure area looking west from southern portion of DT2 south outlet

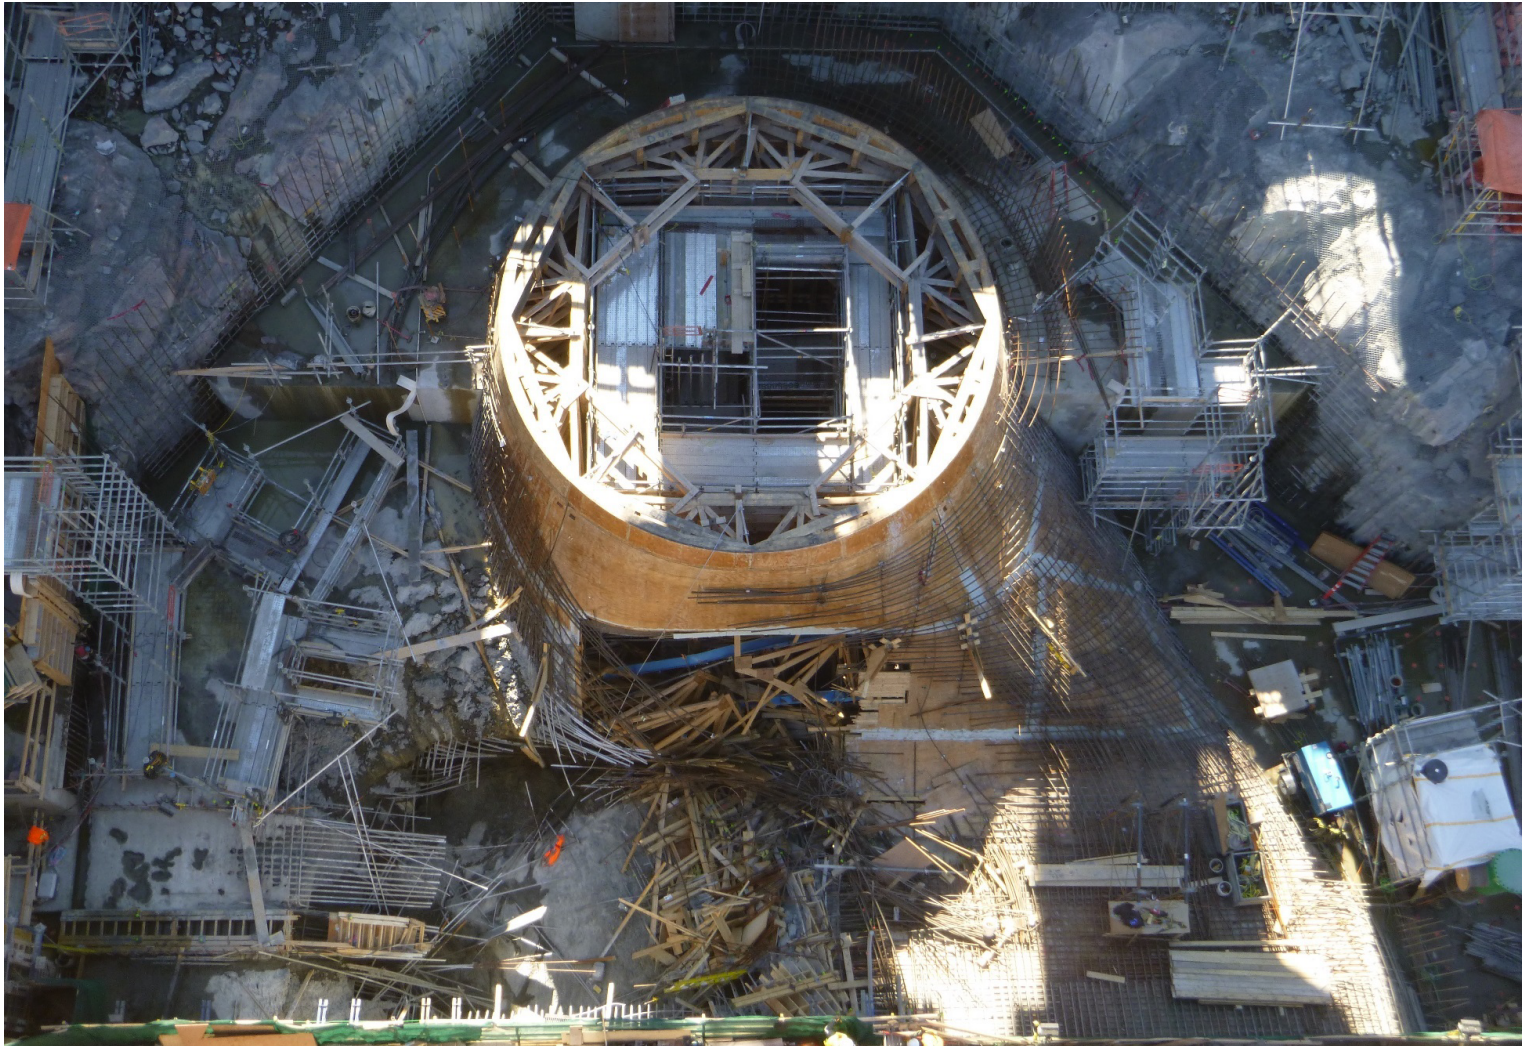
Additional visual inspections in the DT 2 formwork/false work incident area were conducted by man basket on June 4 and June 11, 2016. Visible tower leg members had signs of weathering and were clearly darkened and grey in color compared to adjacent formwork lumber. It was observed and recorded that several of the upstream legs of towers C3 and C4 had potential indication of inadequate nailing of the 2x10's forming the legs. In some instances, plies were separated. See Figure 7 for Falsework tower naming convention. There were visible indications that the bearing surface on top of the Falsework towers was not uniform, as shown by the column members' end grain being compressed on some 2x10 members but not on others, attributable to the lack of bearing plate and uneven tower leg bearing surface. There was no evidence of a bearing plate being installed at the top of tower legs in the rubble or on remaining erect towers. It was deemed that a ground level inspection would be required to further assess the extent of the deficiencies and damage to the Falsework towers and formwork.

Figure 14: DT2 photo from man basket

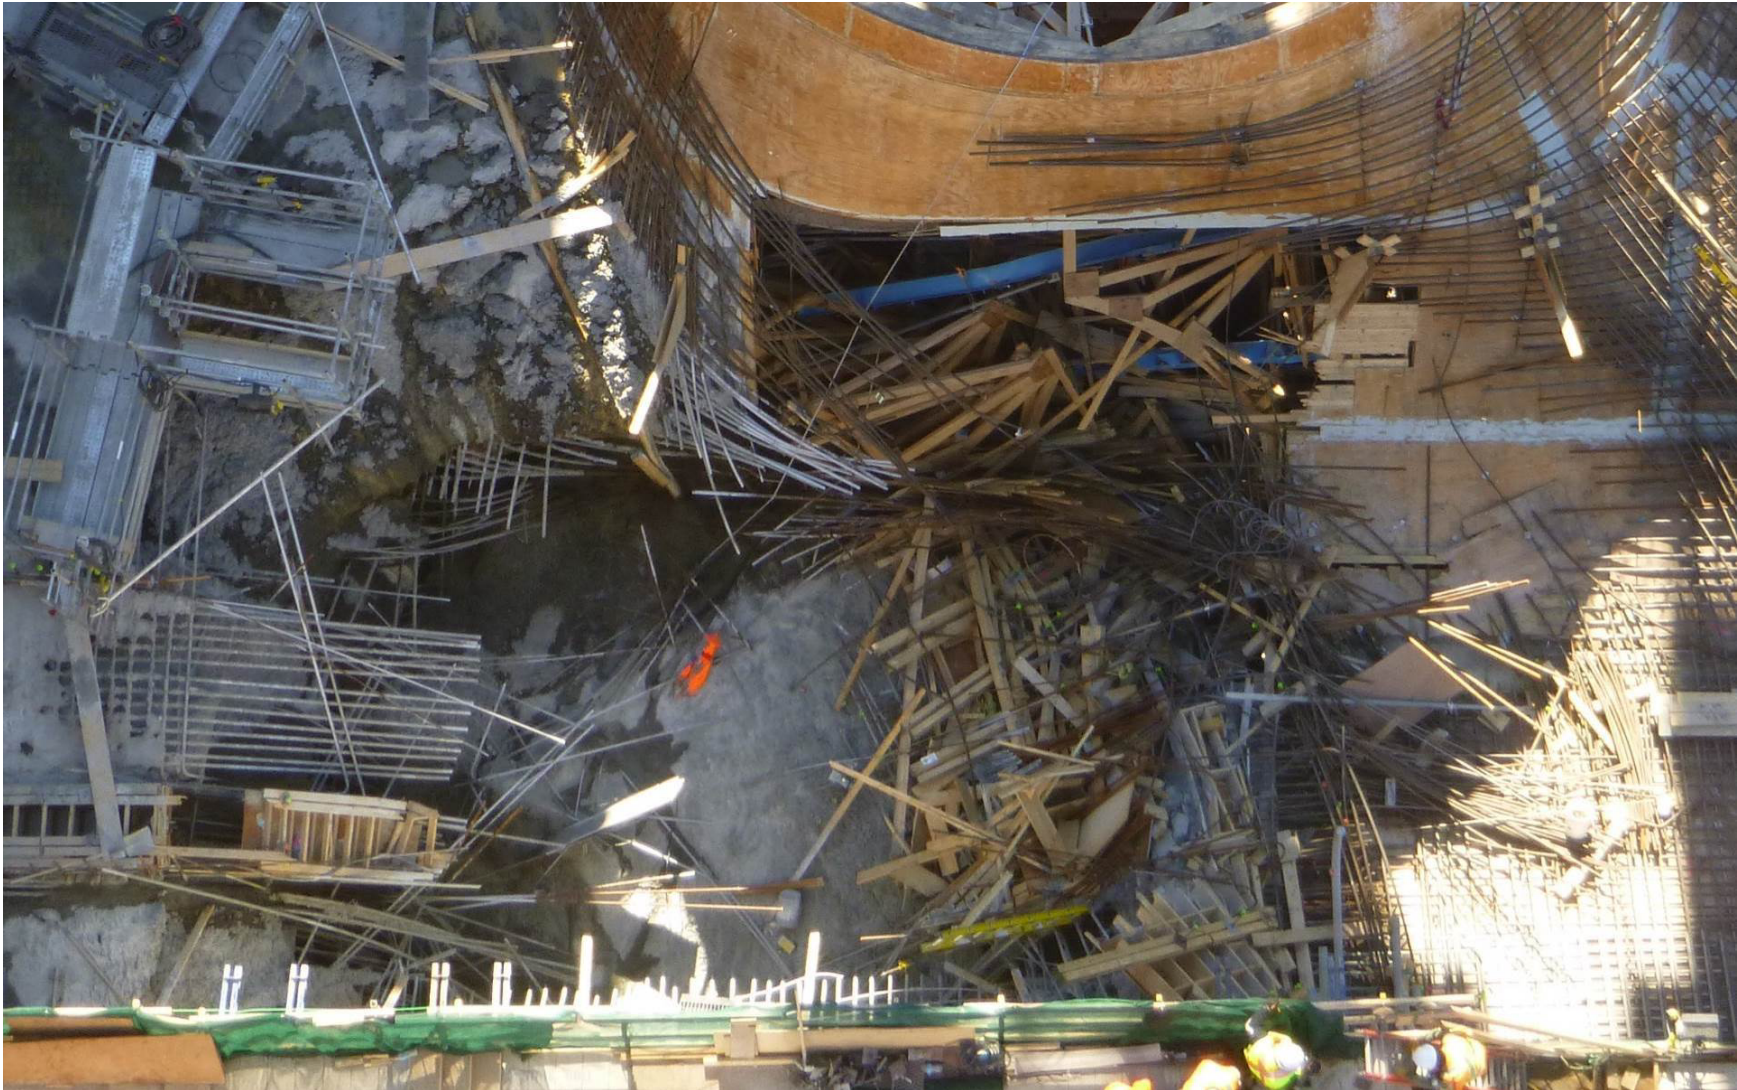
Figure 15: DT2 failure area from man basket

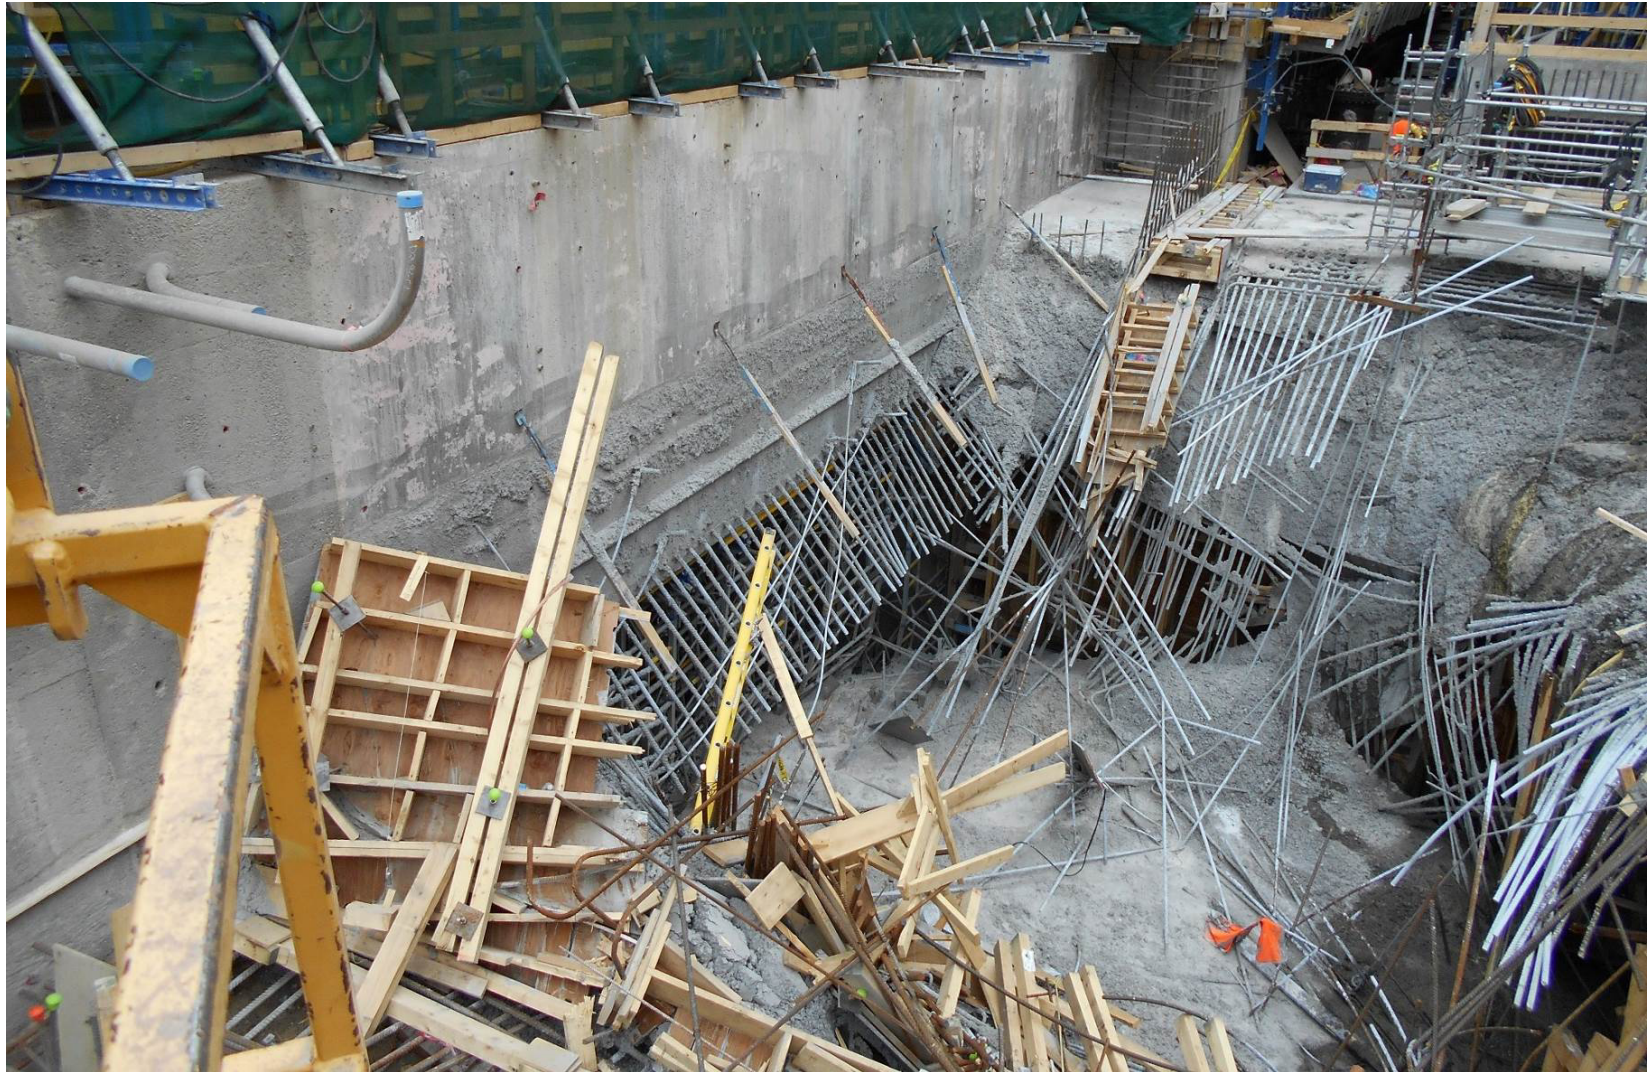
Figure 16: DT2 failure area from man basket looking southeast

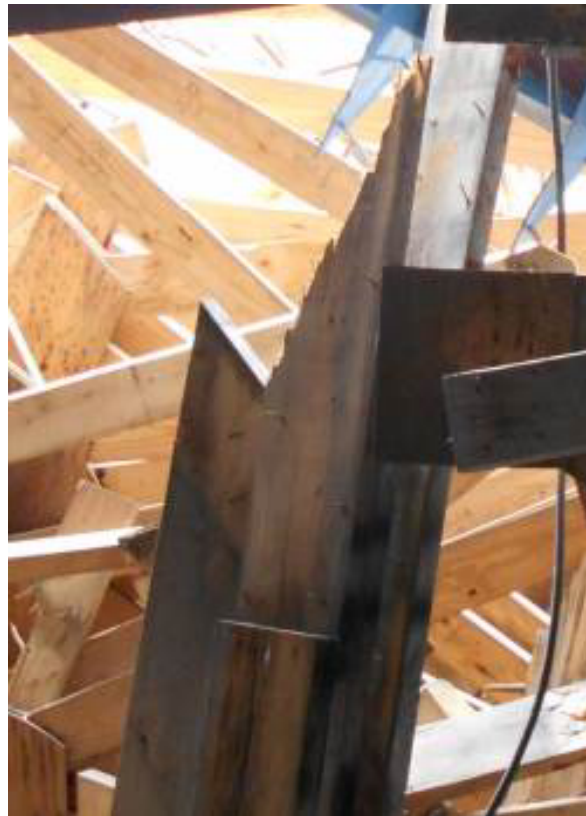
- Column members were inadequately joined (i.e. nails did not have proper penetration through the column laminations). Column members were observed beginning to separate due to inadequate joining. See Figure 18 and Figure 19. CSA O86 and NDS 2012 provide explicit direction for joining of built up members including fastener length, spacing, and edge distance. Requirements for nailing and bolting are provided. ILF was not able to identify any instances of conforming built-up members in visual inspections or in subsequent disassembly of tower legs.

Figure 18: Inadequate nail length (did not penetrate all column laminations)

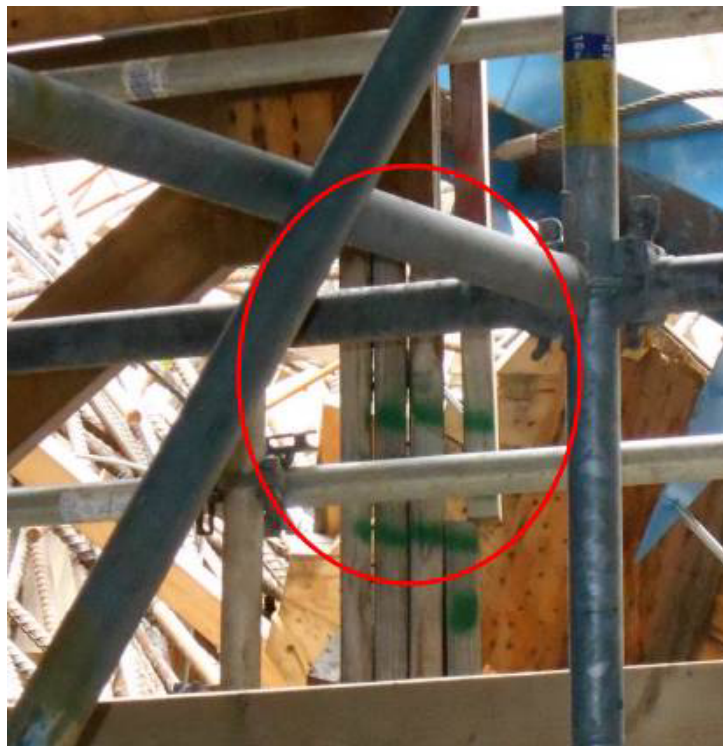
Figure 19: Built-up column members separating due inadequate joining

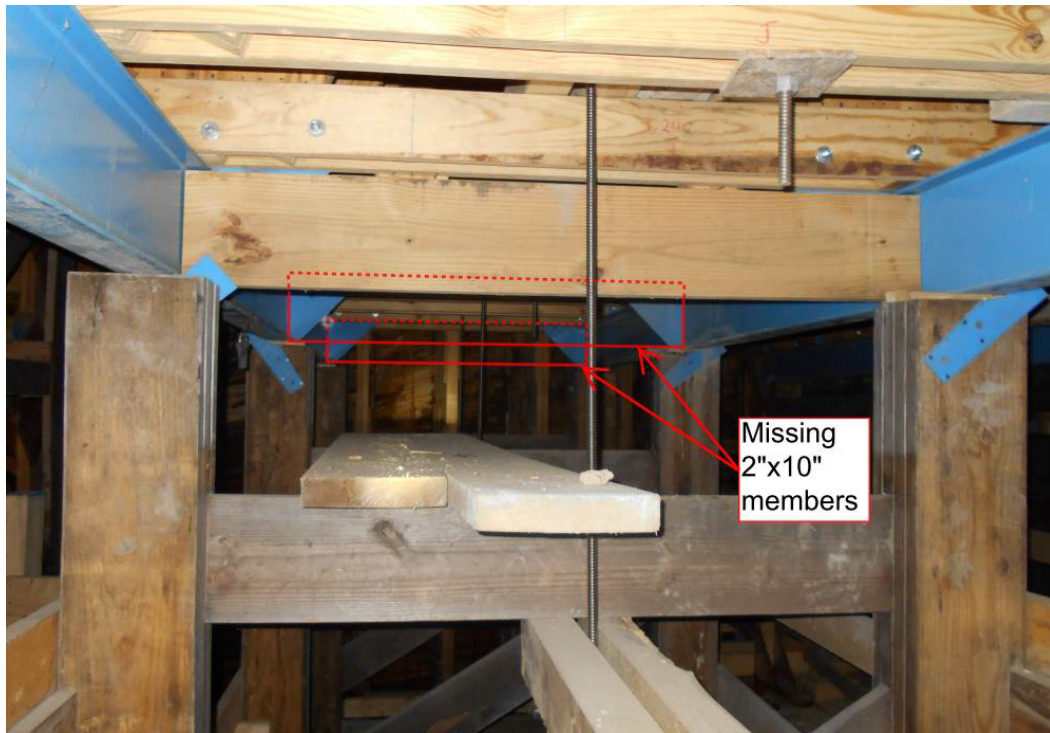
- There were two (2) 2"x10" members missing that were to be located in the web of the two steel beams above the falsework towers B1 and B3. See Figure 20.

Figure 20: Missing members between steel beams above Tower B1

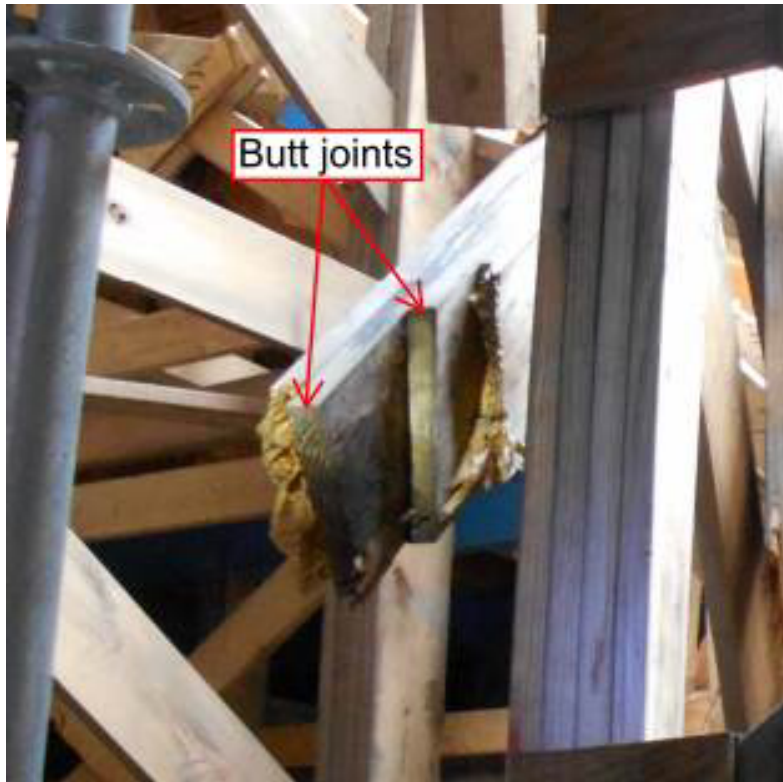
- Butt joints in some column members were observed to be in close proximity, in contradiction to sound engineering practice. See Figure 21.
- There was no evidence of bearing plates being installed in any DT2 falsework towers. Despite both CSA and NDS guidelines requiring the use of bearing plates to ensure even distribution of concentrated loads under the W10x22 beams resting on towers, none were specified by CEI.

Figure 21: Close proximity of butt joints in broken tower leg

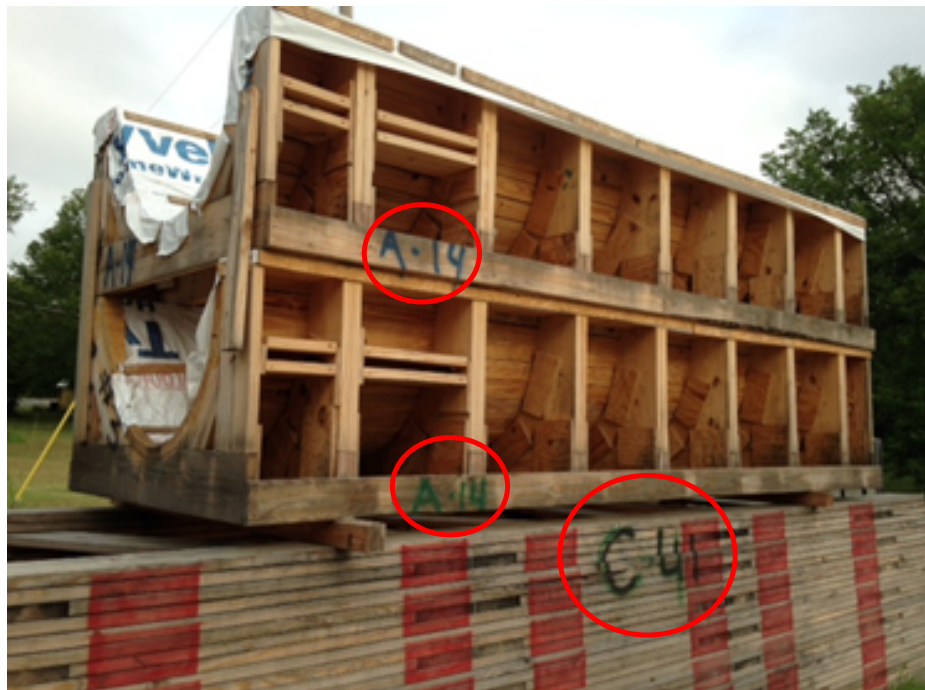
Figure 22: Formwork and falsework with multiple color markings "C41" and "A14" at CEI's facility

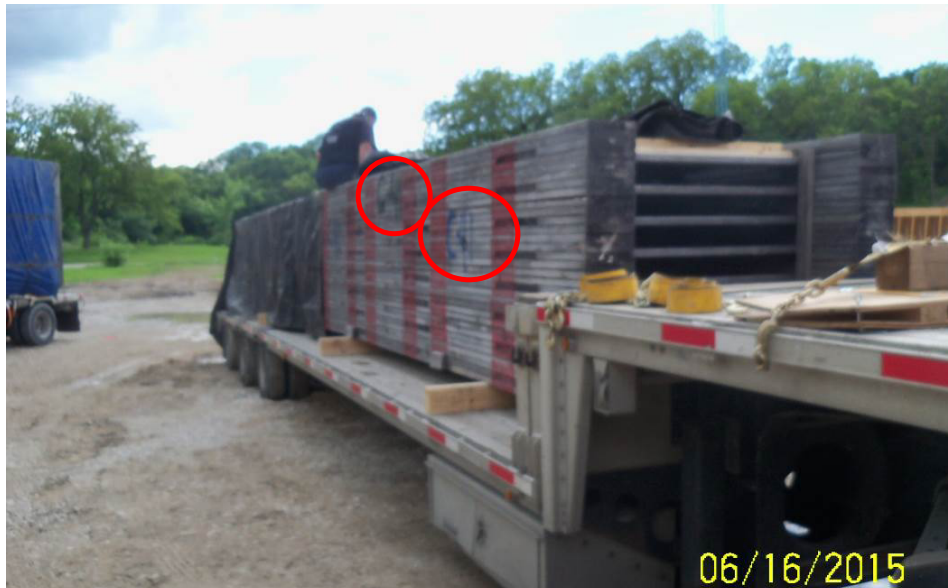
Figure 23: Falsework with multiple color markings "C41" at CEI's facility

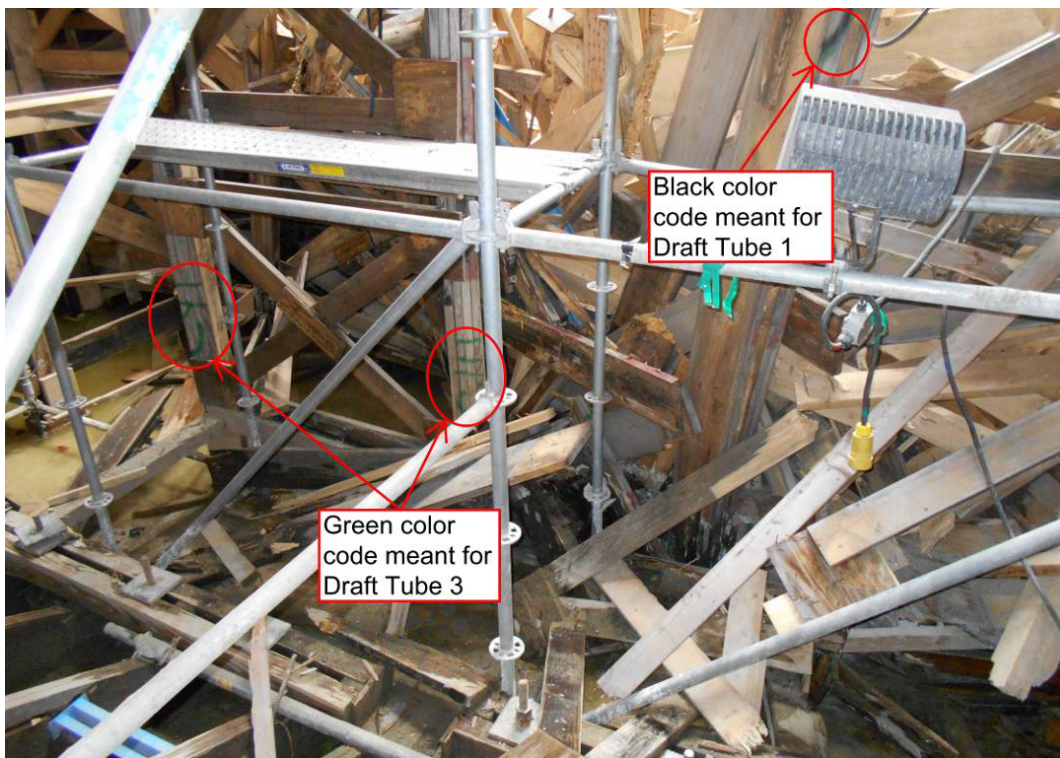
Falsework towers colored coded green and black (meant for Draft Tubes 3 and 1 respectively) were installed in DT 2. The correct color code should be blue, matching identifying markings for formwork installed in DT2. See Figure 24. The use of multiple color codes poses no practical impact to structural capacity of the formwork and falsework but is poor practice leading to potential for confusion in the field.

Figure 24: Incorrect color coding used in DT 2, multiple colors present

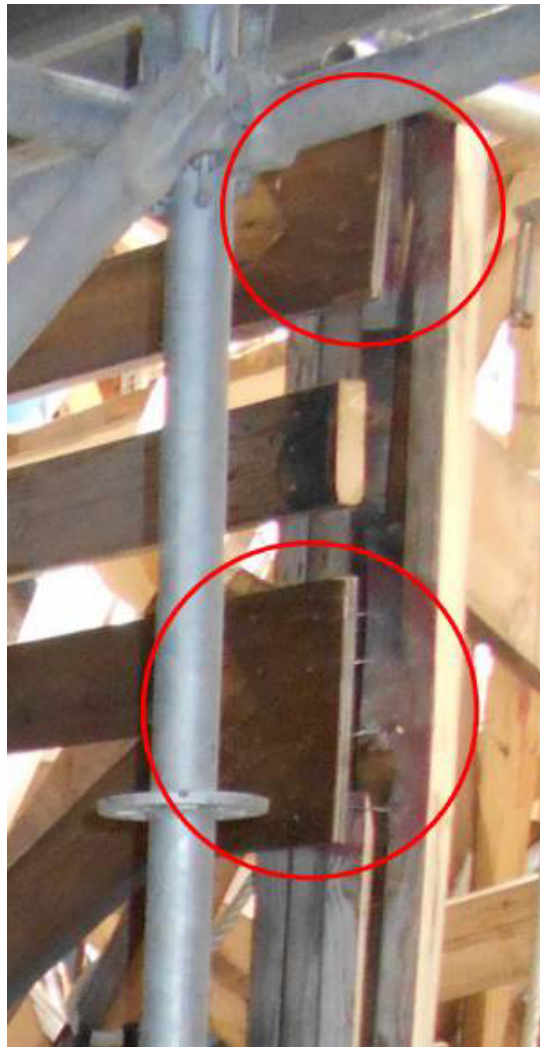
- Inadequate nailing of splice plates to falsework tower legs was observed. Nailing patterns were random and did not adhere to the typical splice plate detail shown on drawing CEI fabrication drawing MFA-AT-SD-3310-CS-D04-0001-01_C1. See Figure 25 and Figure 26.

- Splice plates used to join falsework towers were inadequately nailed to tower legs. See Figure 25 and Figure 26. Reference MFA-AT-SD-3310-CS-D04-0001-01 within Appendix J for splice plate dimensions and nailing requirements.

Figure 25: Splice plates pulling away from column legs

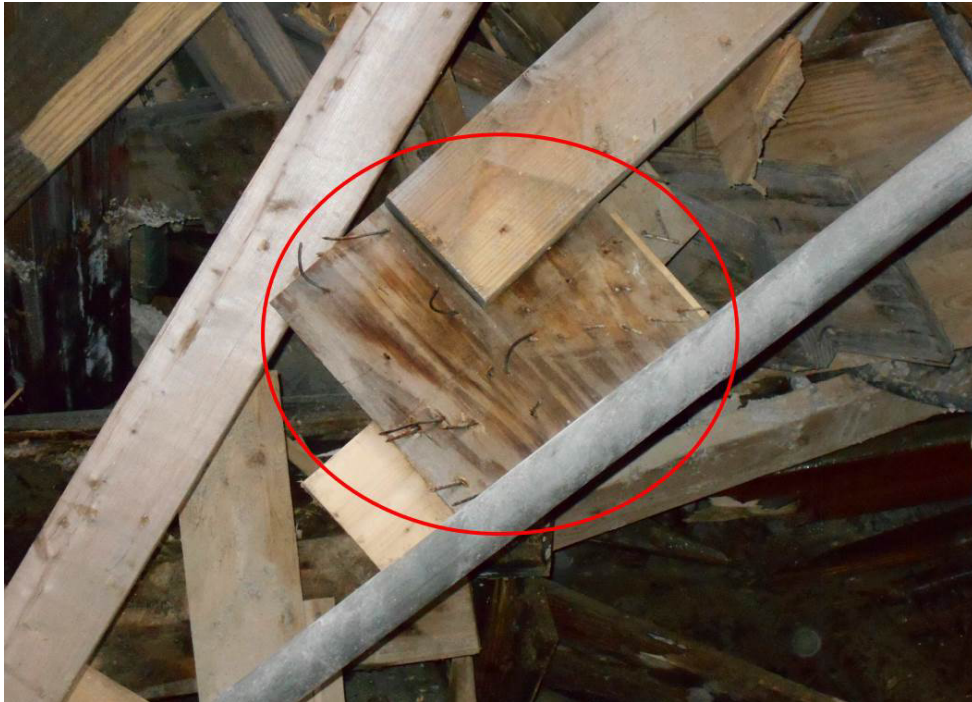
Figure 26: Splice plate pulled away from tower leg

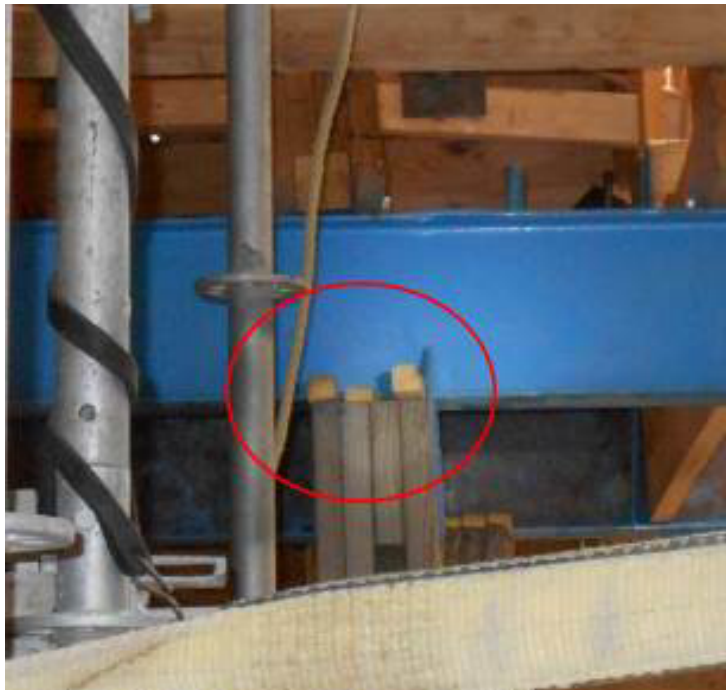
- Shims between the falsework tower columns and the steel beams were poorly installed. In some cases the shims did not cover the entire bearing surface of the column, potentially overstressing isolated column members. It should be noted that a combination of softwood

Figure 27: Inadequate shimming on top of falsework towers. No bearing plate installed

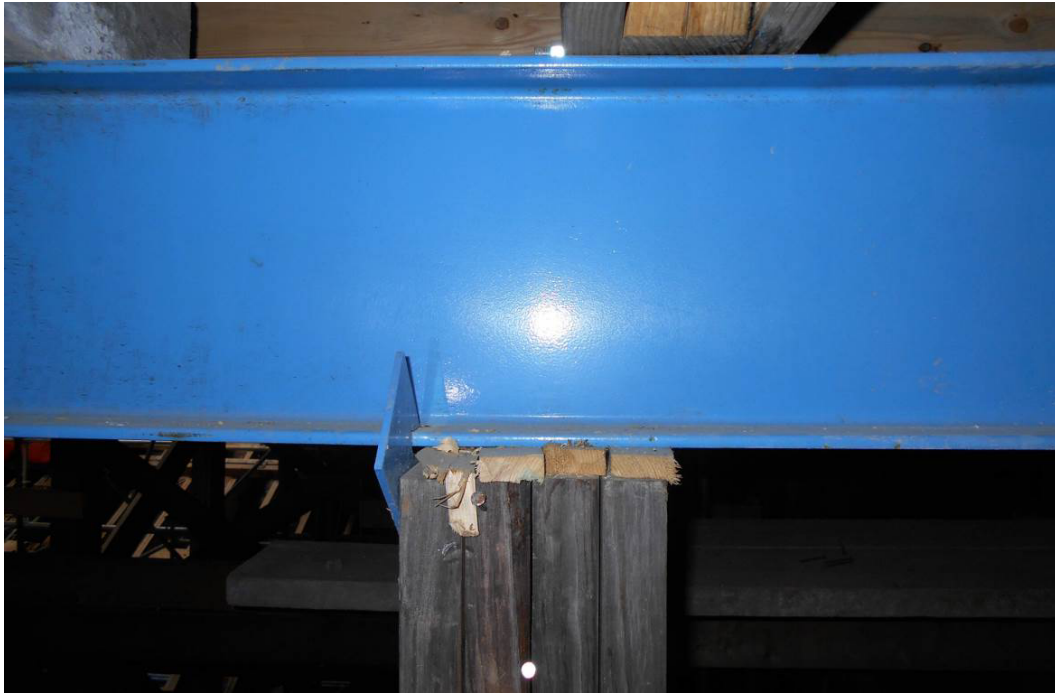
Figure 28: Inadequate shimming on top of falsework towers. No bearing plate installed.

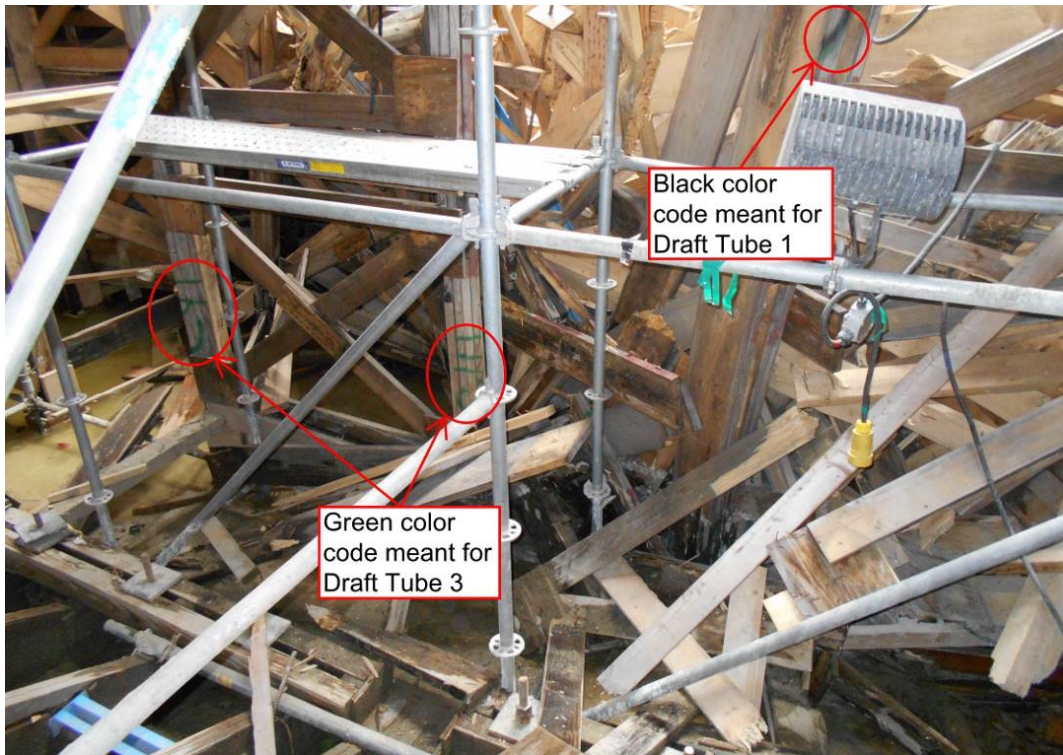
Figure 29: Incorrect color coding used in DT2

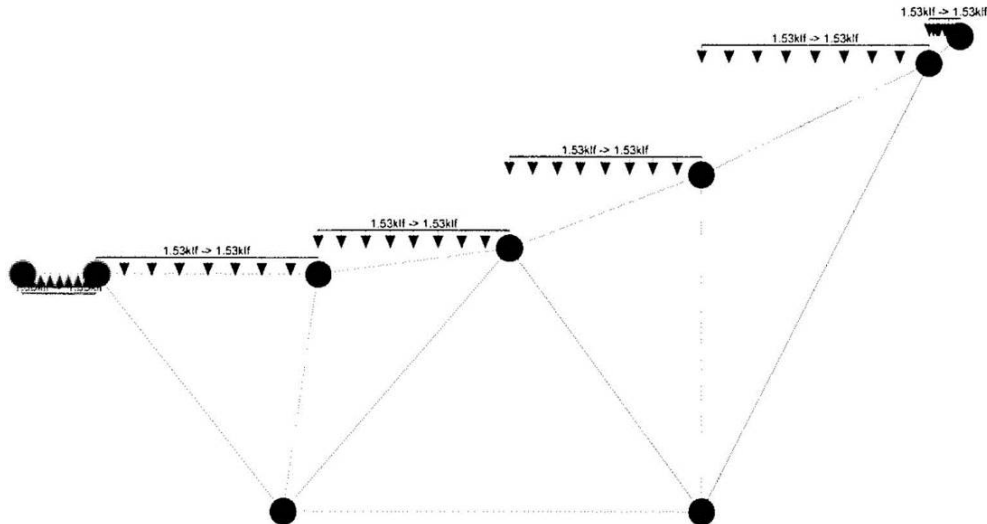
The loading CEI applied to the rib models was inconsistent and incorrect in some of the analysis, specifically for modules A24, A25, A26, A27, and A29. Uniform vertical and horizontal loading was applied where variable loading along members would have been appropriate. The analysis of rib G24 is an example of this. A uniform load of 1.53 kips per linear foot (22.3 kN/m) was applied to the members in the Global Y (down) direction. However lower elevation members experience a higher concrete head load than members at a higher elevation. This method neglects lateral load induced into the rib. As identified in the independent formwork analysis completed by ILF, pressure applied perpendicular to the member creates a bending moment in the vertical elements of the rib truss. Moment coupled with vertical loading overstresses the element to a utilization ratio greater than 1.20. Utilization ratio is defined as the ratio of applied stress divided by the maximum allowable stress, as determined by code requirements.

Figure 33: Rib G24 loading in CEI calculations

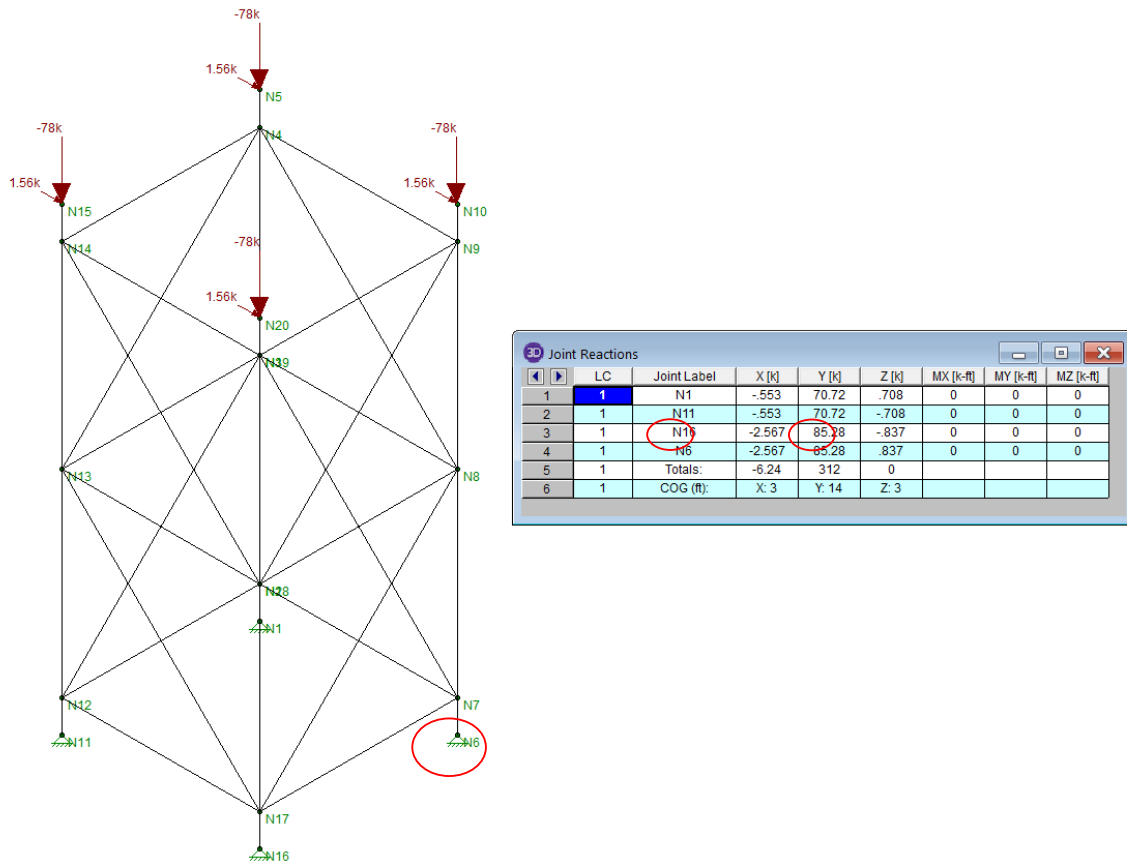
CEI falsework calculations did not account for the required 2 percent lateral load for towers, per CSA 269.1-1975. This requirement is not explicit in NDS codes but sound engineering judgement would expect a portion of vertical load to be accounted for as lateral load and applied at top of the towers. The impact of this error results in approximately 9 percent increase in axial load in the most heavily loaded tower row, Row B. A similar increase would be expected in tower Row A and approximately 13% increase in Row C due to the increased height in those towers. The increase in axial load is due to the moment couple of lateral load and height of tower. Rows A and B have approximately the same heights and Row C is in the order of 6 feet (2m) higher. A lateral load applied at top of tower applies a moment that is resolved through axial loading at the bottom of tower. The increase in axial tower load due to lateral load was not considered by CEI. Reference Figure 36 showing the anticipated axial load increasing from 78 kips to 85 kips (y direction) due to consideration of 2 percent lateral load.

Figure 36: ILF model showing impact of neglecting 2% lateral load in Row B towers
