Lower Churchill Project

Final Engineering Assessment Report of Draft Tube 2 Formwork/Falsework Failure

February 24, 2017

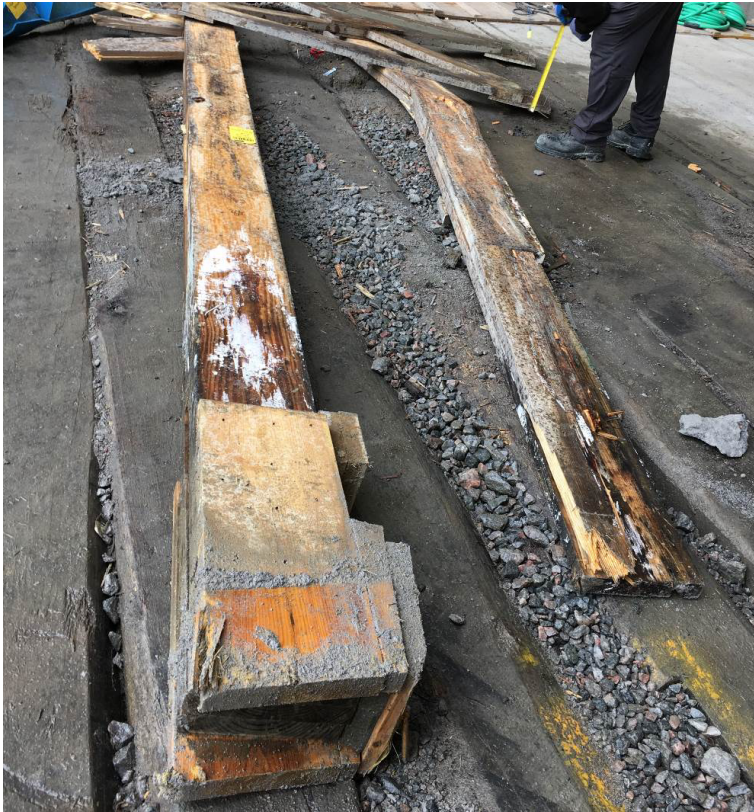
During visual inspection in the field, ILF identified that the wood used to fabricate the towers had undergone significant weathering and had reason to believe the degree of weathering affected the towers' strength. Some portions of tower legs, especially the lower 4 feet (1.2m) had undergone decay, changing appearance to a dark color and weakening such that portions of tower members could be easily penetrated with a probe, e.g. a mechanical pencil, including samples from towers C3 and C4 removed from the rubble in DT2 on August 25, 2016. Astaldi submitted samples of wood from towers A1, B1, and C2 to the University of Toronto to determine the material properties for back-analysis. Testing was to report NDS 2005 base design values for Southern Pine, including modulus of rupture, modulus of elasticity, and compressive strength parallel to the grain.

Figure 37: Tower Legs obtained from DT2 Tower C3

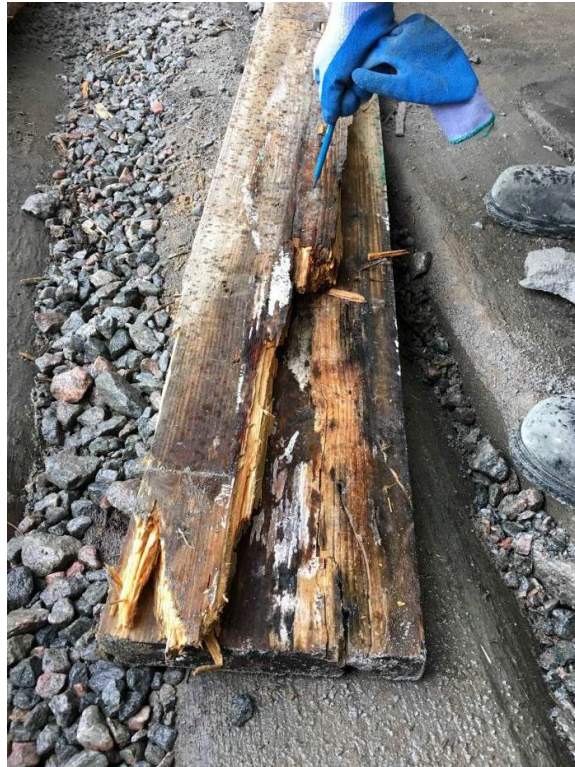
Figure 38: Bottom of Tower Leg obtained from DT2, Tower C3

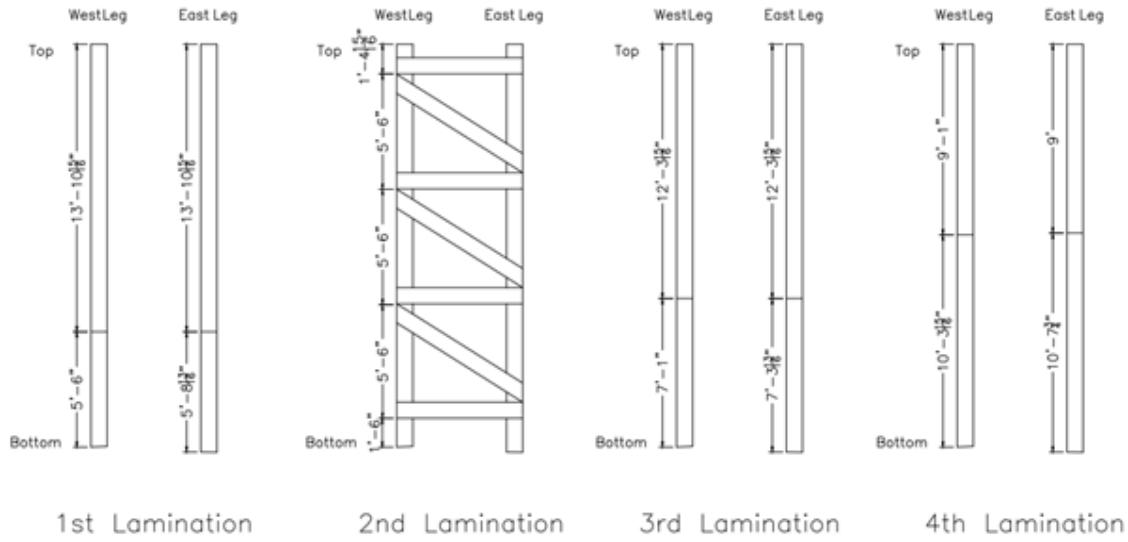
Leg layers 1, 3, and 4 were constructed using multiple pieces of 2x10, whereas shop drawing #W-41b specified one continuous member. This resulted in multiple butt joints within a given tower leg. If butt joints were adequately spaced, the impact on structural capacity is negligible. However, as shown in Figure 40 and Figure 41, butt joints were close spaced among layers 1, 2, and 3. Members in the second lamination closely matched the dimensions specified on CEI shop drawing # W-41b. Reference MFA-AT-SD-331A-EN-A99-0010-01 "Muskrat Falls Draft Tube Quality Report, Manufacturing quality –shoring Tower Disassembly" report.

Figure 40: South face of tower C3 lamination components

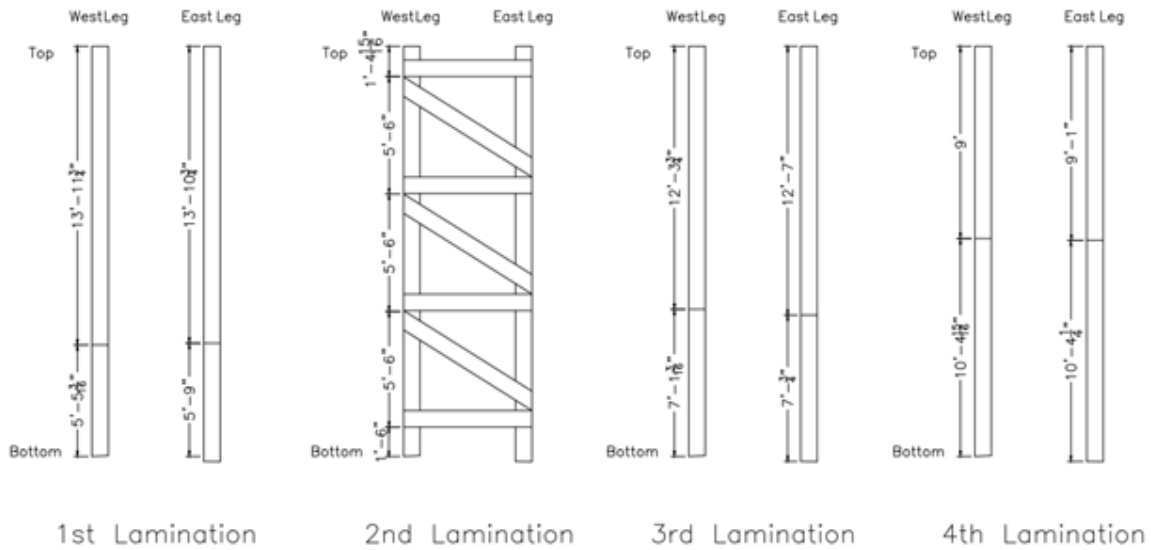
Figure 41: North face of tower C3 lamination components

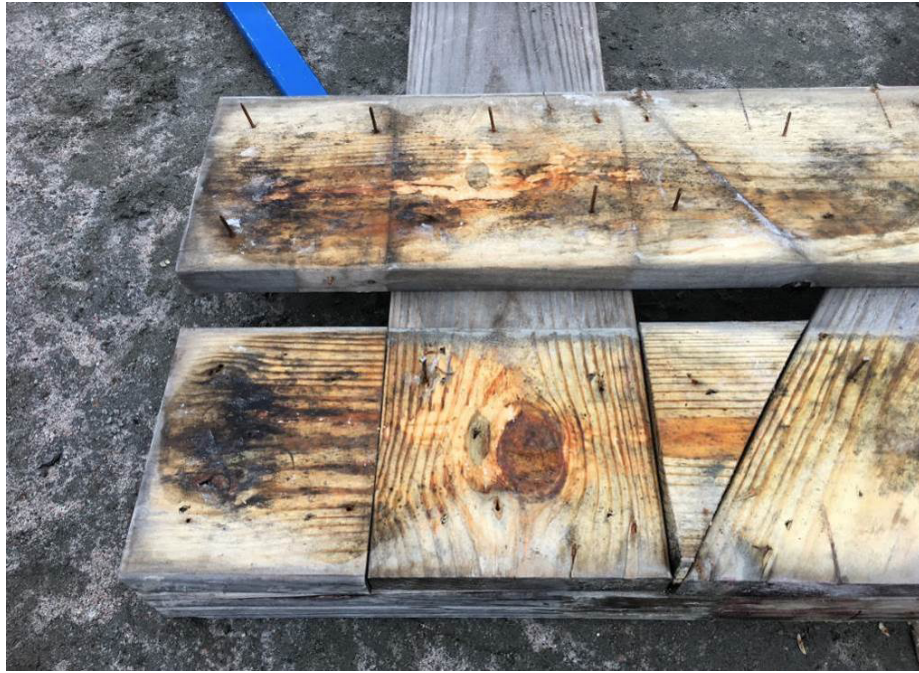
Figure 42: Disassembled Leg at Bracing from DT3

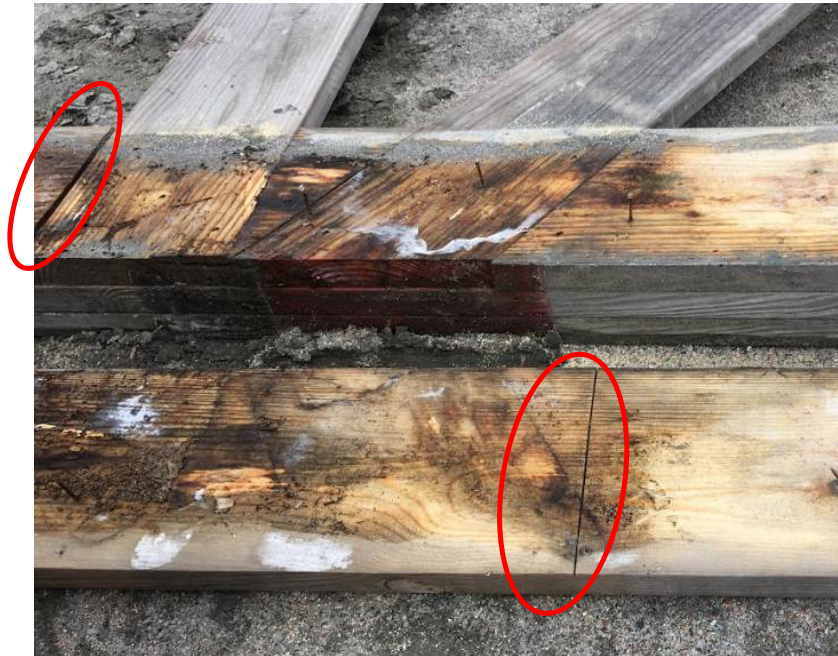
Figure 43: Gaps in Tower Leg Butt Joints (left) and saw kerfs (right) from DT3

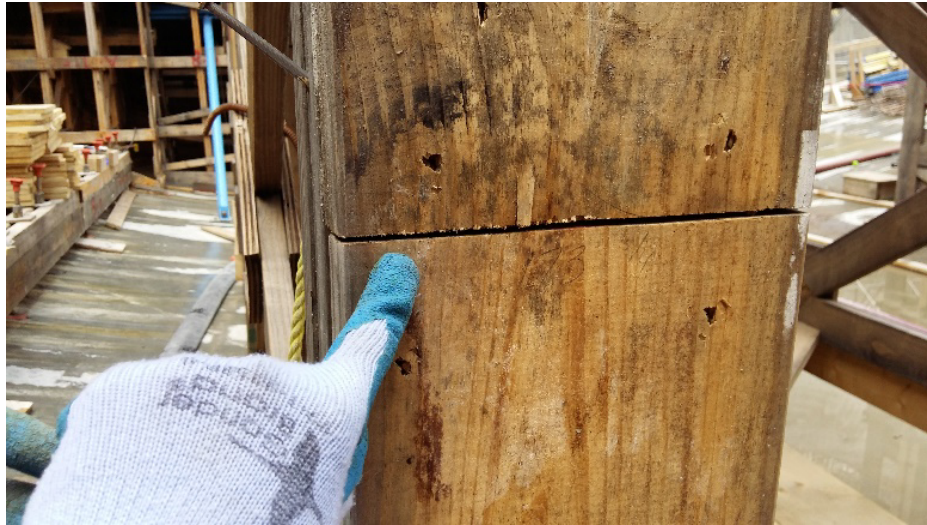
Figure 44: Gap in Tower Leg Butt Joint in DT3

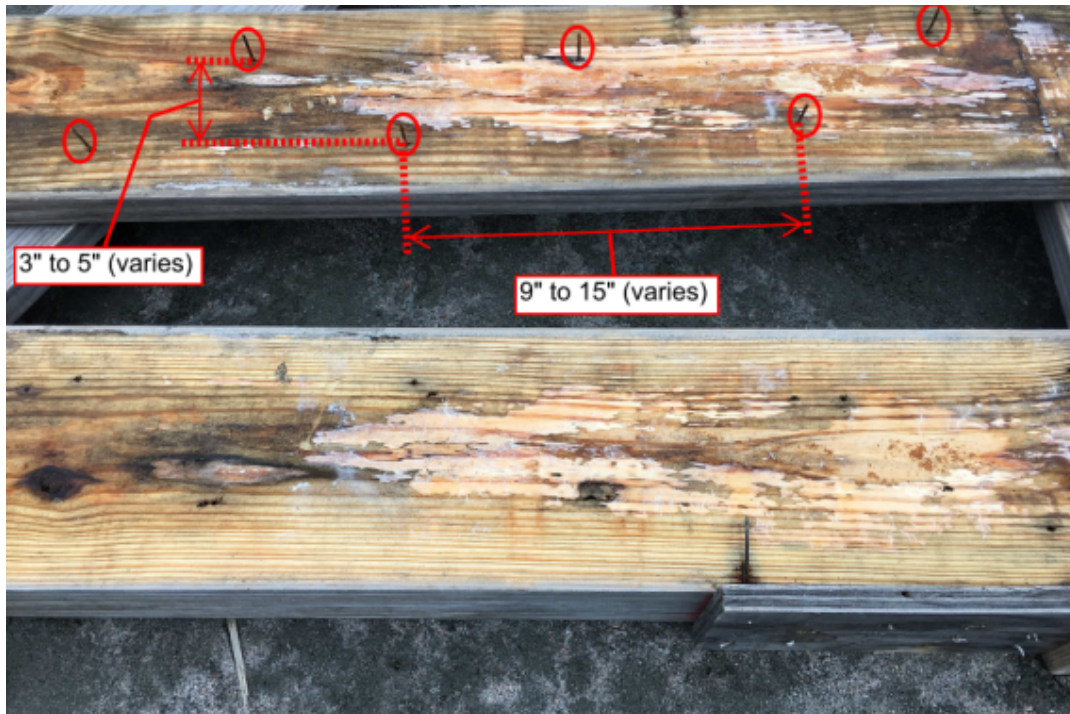
During disassembly of tower legs, ILF documented the size of nails and approximate spacing. It was observed that two rows of 2 3/4 inch ring shank nails were used, with nail spacing varying between 9 and 15 inches (230 and 380 mm). This does not meet NDS or CSA requirements for joining a built up member as nails must be in two rows at 9 inch (230mm) centers (max) with nails penetrating all members, at least 3/4 through the farther outer lamination. A nail with length over 5.5 inches (140mm) would be needed to meet this requirement.

Figure 45: Typical nailing pattern used to build up falsework tower leg member

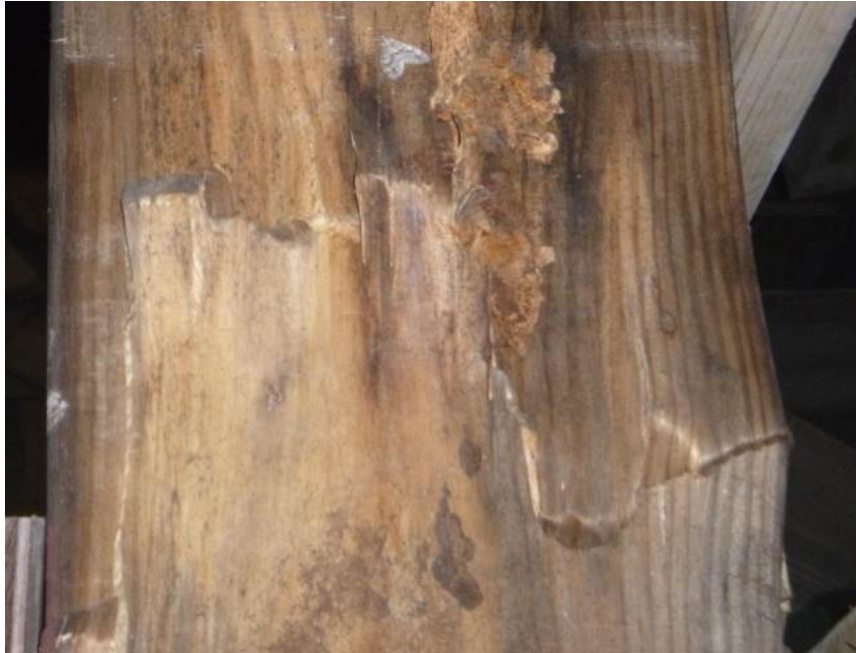
Figure 50 through Figure 52 indicate the overstress due to lack of bearing plate and penetrating bracing members results in failure of tower legs. The performance of falsework in DT1 is indicative of the types of failure anticipated to have occurred in DT2 prior to collapse. These photographs were taken by ILF in Draft Tube 1 on June 10, 2016.

Figure 50: Local failure of outer ply of tower leg in DT1

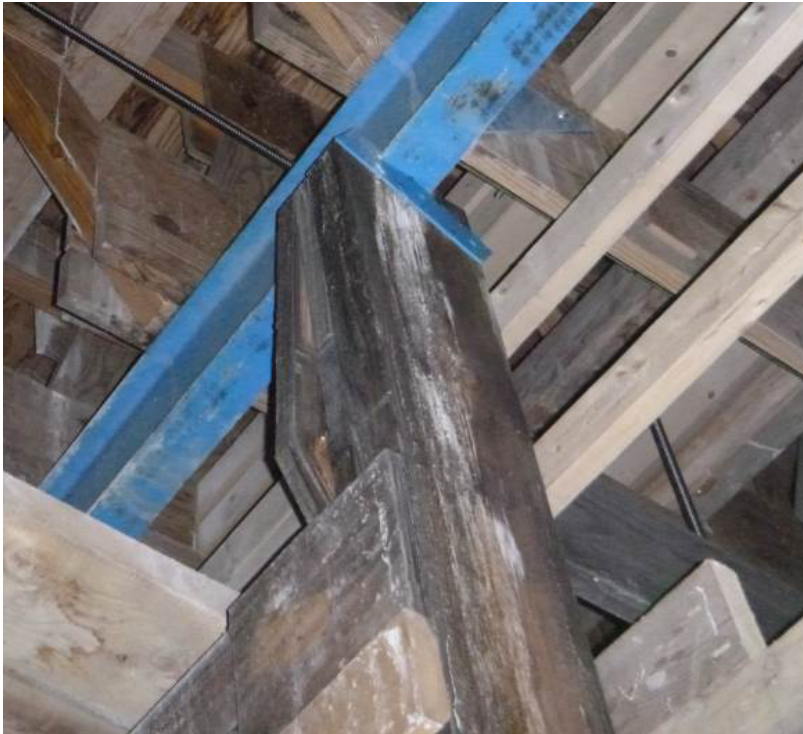
Figure 51: Local failure of tower leg at bracing penetration in DT1

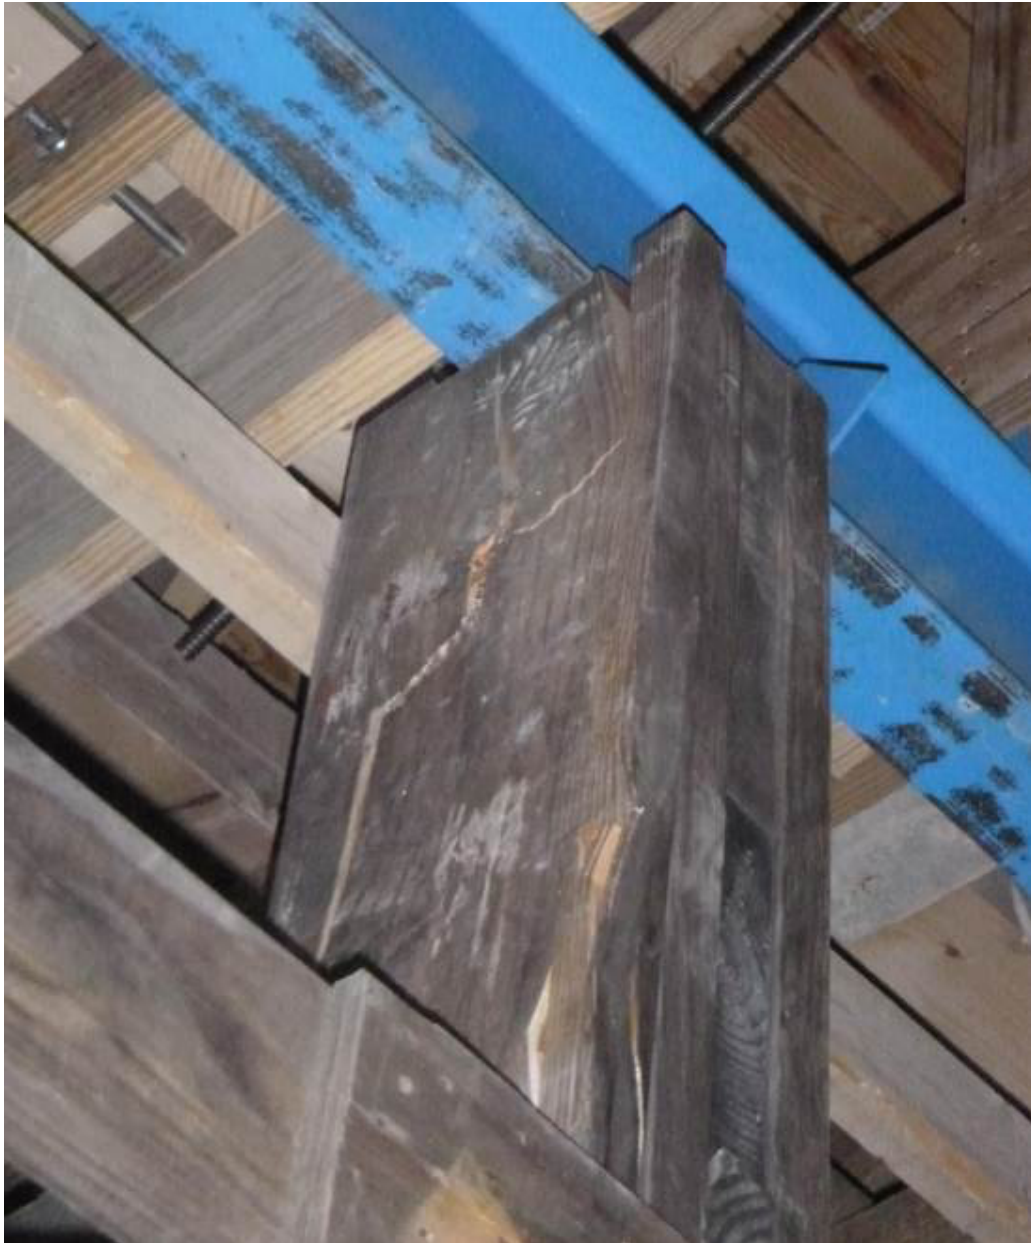
Figure 52: Local failure of tower leg at beam interface and bracing penetration in DT1

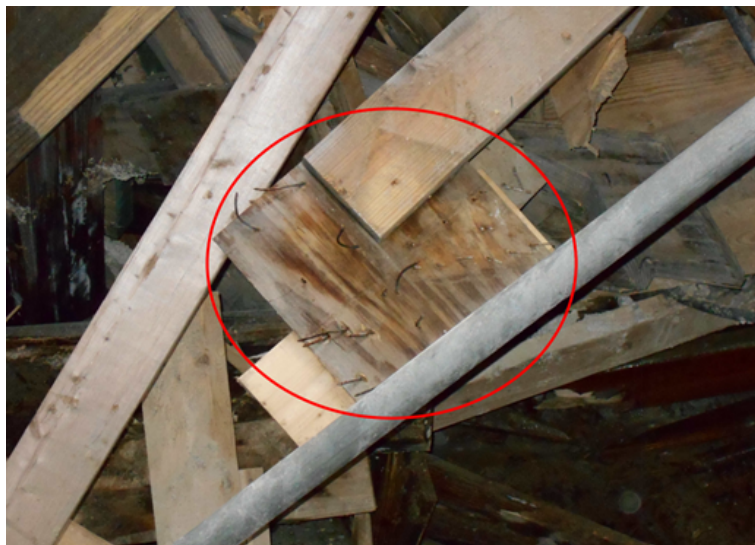
Inadequate nailing of splice plates to falsework tower legs was observed. Nailing patterns were random and did not adhere to the typical splice plate detail shown on drawing #MFA-AT-SD-3310-CS-D04-0001-01_C1. See figures below for examples observed in DT2.

Figure 54: Inadequate nailing of splice plate in DT2

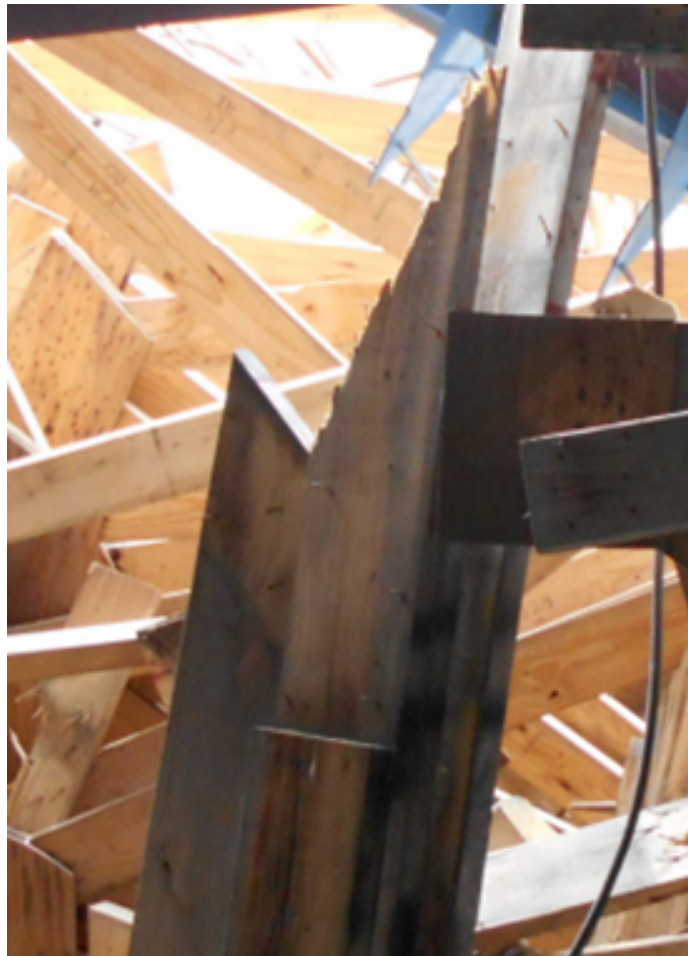
It was also observed in a global nature that the nails used to join column laminations into a built-up member did not adequately penetrate the four members that formed a tower leg. CSA O86 and 2012 NDS both identify the requirement for through penetrating nails or bolts, exacerbating the impact of the built up member capacity that CEI did not address in their calculation package. Column members were observed beginning to separate due to inadequate nailing. ILF was not able to identify any instances where built-up falsework tower legs met code requirements for nailing. See Figure 55 and Figure 56 below for examples observed in DT2.

Figure 55: Inadequate joining of built-up member

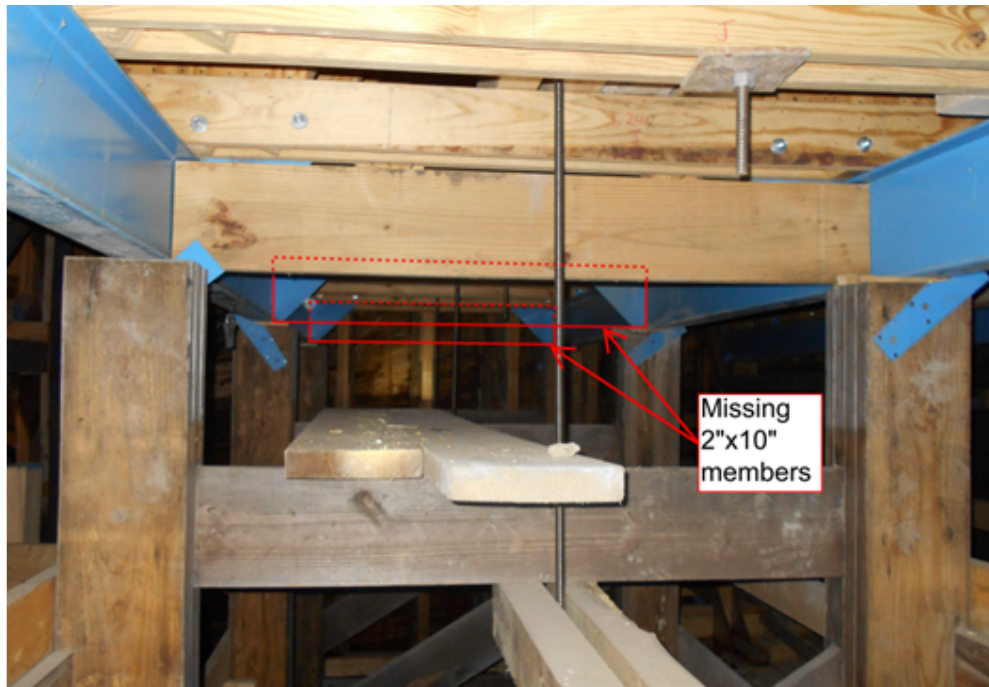
There were two (2) 2"x10" lateral supporting members missing that were to be installed in the web of the two steel beams above the falsework towers B1 and B3. The members reduced the unbraced length of the steel beams and provided lateral stability. Their omission reduced the capacity of the steel beams. See Figure 57.

Figure 57: Missing members between beams. DT3 tower B1

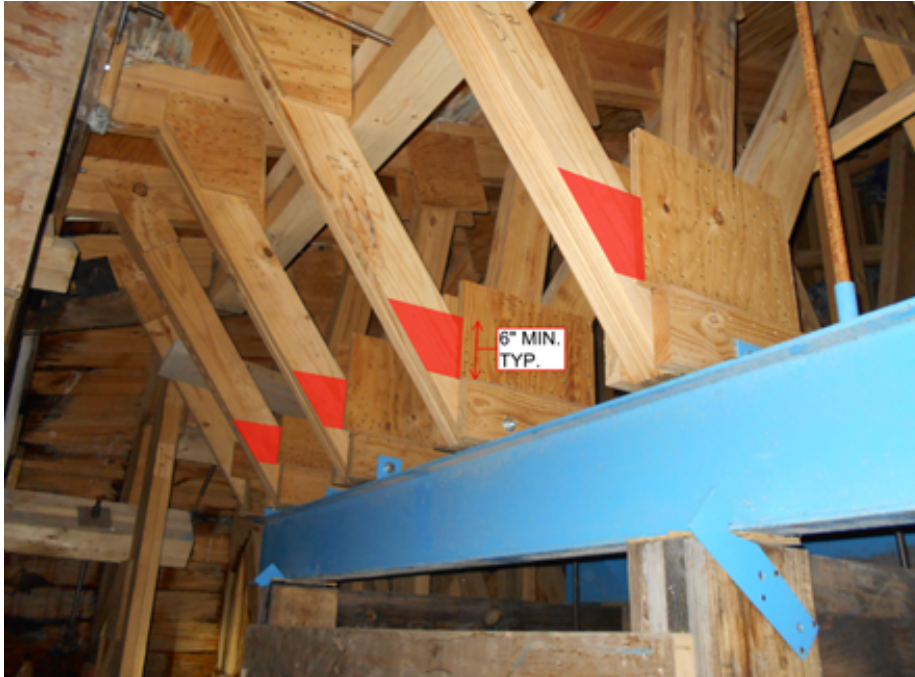
The splice plates used in the ribs overlying the falsework towers were generally too small and did not adhere to the typical splice plate detail shown on drawing MFA-AT-SD-3310-CS-D04-0001-01_C1.

Figure 58: Inadequate splice plate size DT2

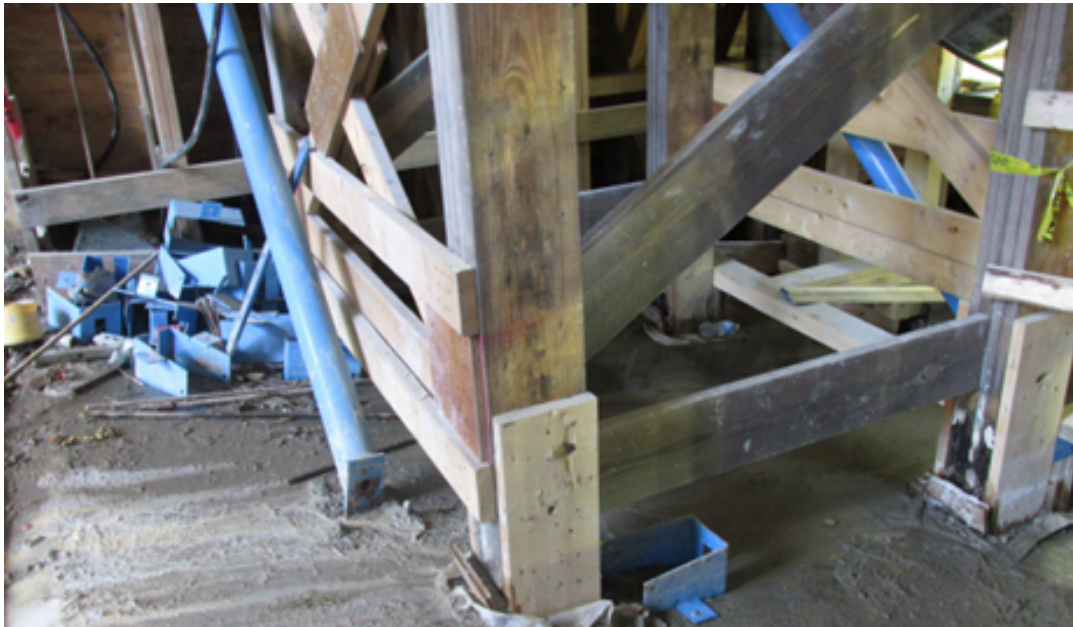
In Draft Tube 1, 14 of the 16 falsework towers did not use the anchorage detail indicated on drawings MFA-AT-SD-3310-CS-D04-0066-01 through MFA-AT-SD-3310-CS-D04-0066-06. An alternative detail consisting of a polyethylene sheet under a grout pad without anchorage to the concrete invert was utilized. The figure below shows Tower A6 in DT1 with the alternate tower grout pad and CEI designed column anchors uninstalled in the background. The alternate detail reduced sliding resistance of the columns, but was compensated for by additional bracing at the bottom of tower legs. Lateral movement at tower base was not observed in DT1. Based on observations in field, it is anticipated that the alternate anchorage was used in some of DT1 and all of DT's 2, 3, and 4. ILF was not able to identify use of the CEI designed "shoe" in the DT2 rubble and found examples of the alternate on all observed towers. Similarly, the alternate was exclusively observed in DT3 and DT4.

Figure 60: DT1: Uninstalled tower base anchors (blue steel clips) in foreground and piled in background. Alternate grout pad with form installed in foreground left and right.

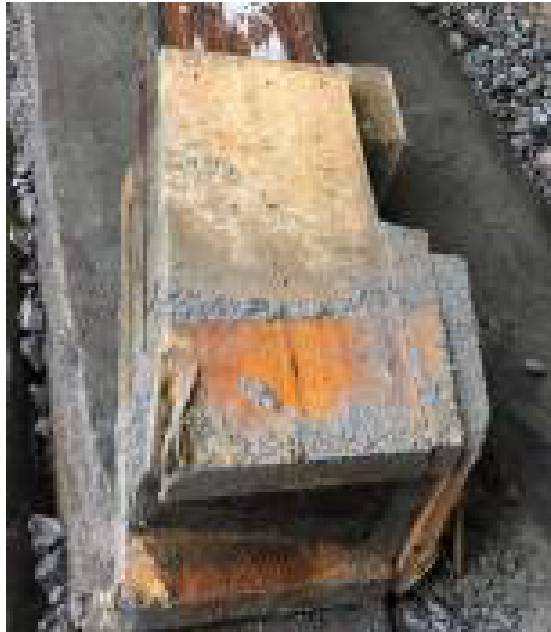
Figure 61: Alternate grout form at base of falsework tower leg. Recovered from Row C towers DT2

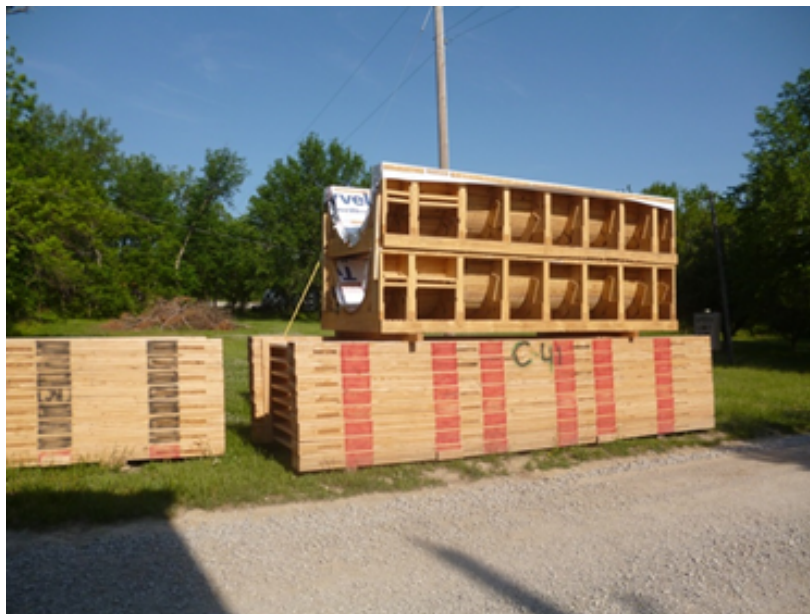
Standard practice of placing lath between layers of face-to-face lumber was not practiced by CEI, as shown in Figure 62 through Figure 66. The lumber marked "C41" are tower legs stored face-to-face, which does not promote air circulation between layers of tower legs. This practice can encourage damp conditions that are conducive to biological attack.

Figure 62: May 15, 2014. Formwork and falsework at CEI facility. Note fresh, unweathered wood.

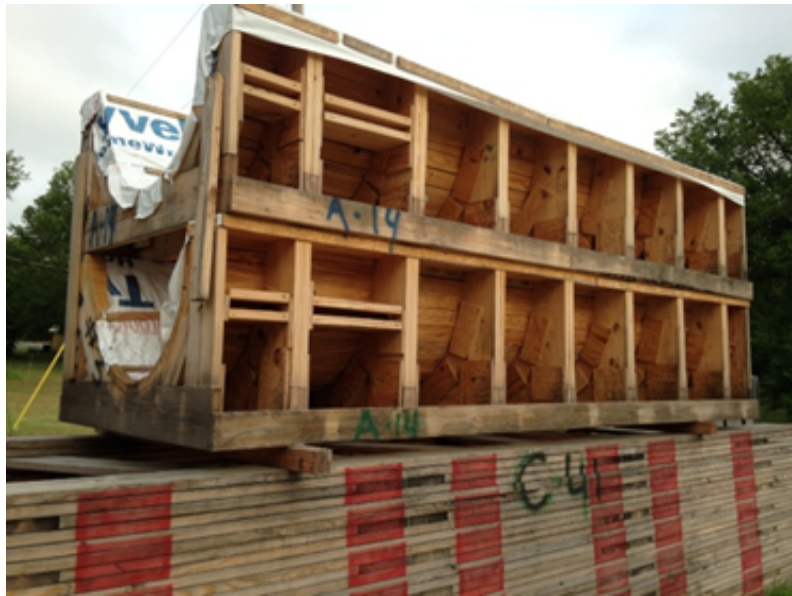
Figure 63: July 23, 2014. Formwork and falsework at CEI facility. Note weathering of wood compared to same material in Figure 62.

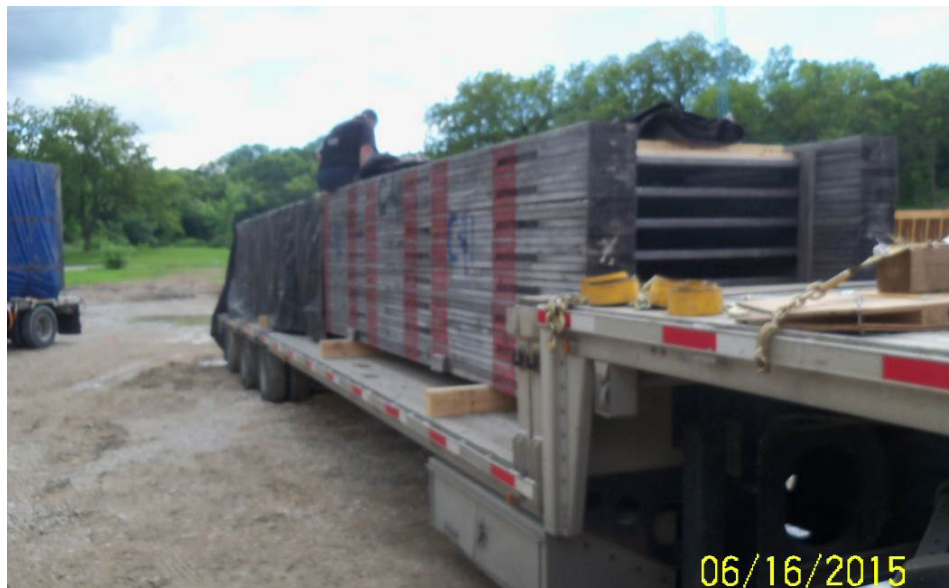
When viewing Figure 64 and Figure 65, reference Figure 62 and Figure 63, noting the progression of weathering over a 15 month period. Also reference Figure 29 in Section 3.3.3, which depicts the same black and green paint markings “C41”. ILF believes the towers depicted in Figure 62 through Figure 66 were installed in DT2 at time of the collapse.

Figure 64: June 16, 2015 at CEI yard. Right hand view of falsework towers believed to have been installed in DT2.

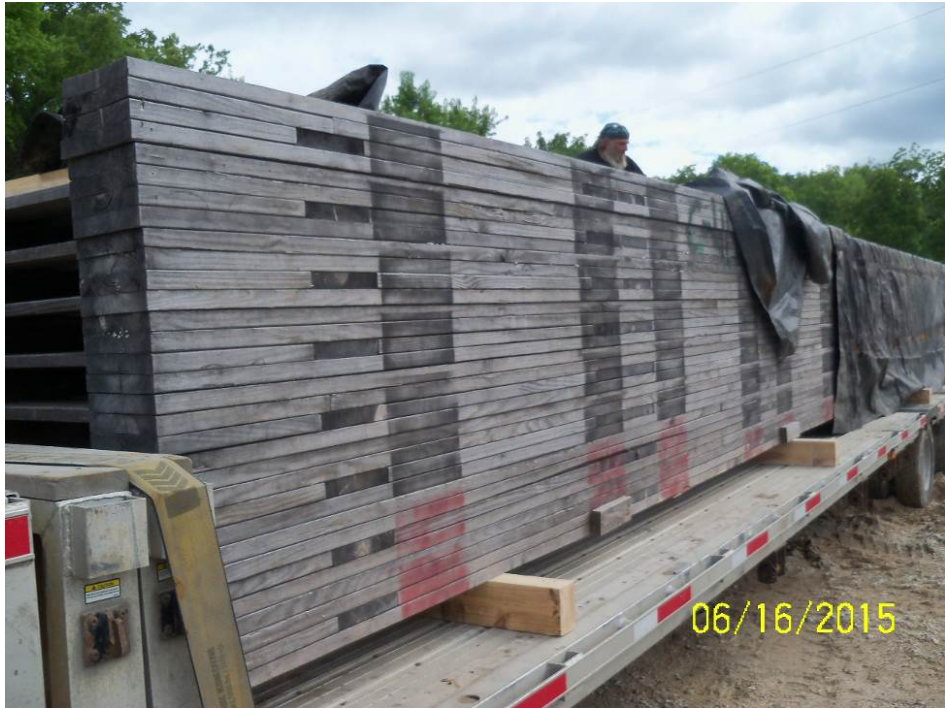
Figure 65: June 16, 2015 at CEI yard. Left hand view of falsework towers believed to be installed in DT2

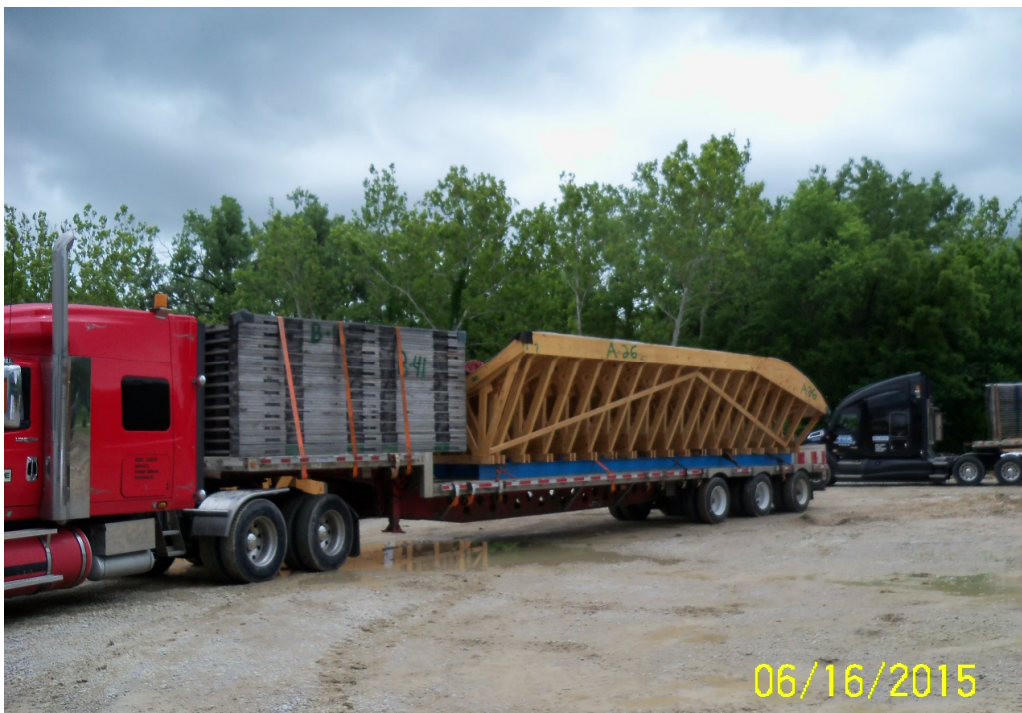
Figure 66: June 16, 2015 DT1 formwork and falsework at CEI yard in Kansas. Note weathering of tower legs relative to formwork module A26.

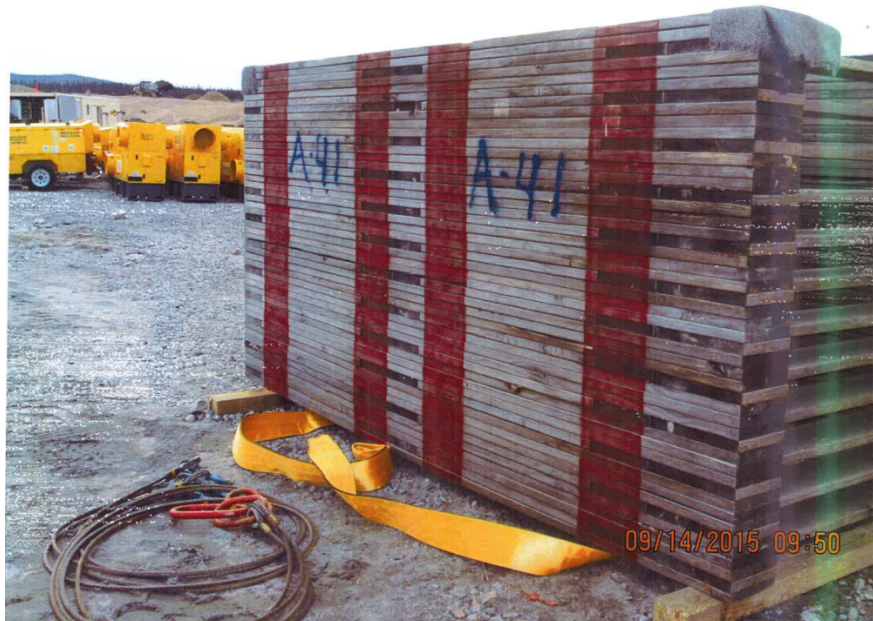
Photos of the shipments were taken once the formwork arrived and was offloaded on site. Reference Figure 67 taken at C1 laydown. Although the photos reviewed by ILF show the formwork stored without protection from the weather (i.e. not tarped), it cannot be verified whether the formwork remained stored in these conditions as records of periodic inspections were not provided to ILF for review. Figure 67 depicts the state of weathering of the falsework tower legs when received at site.

Figure 67: September 14, 2015. DT2 Falsework offloaded on site and stored at C1 laydown
