Muskrat Falls Generation Project
 Unit #2, Pour D2ESB-03, Draft Tube Formwork
 Collapse Investigation Report

Prepared for:
 Nalcor Energy Lower Churchill Project

Project No.160450

Date: April 20, 2017

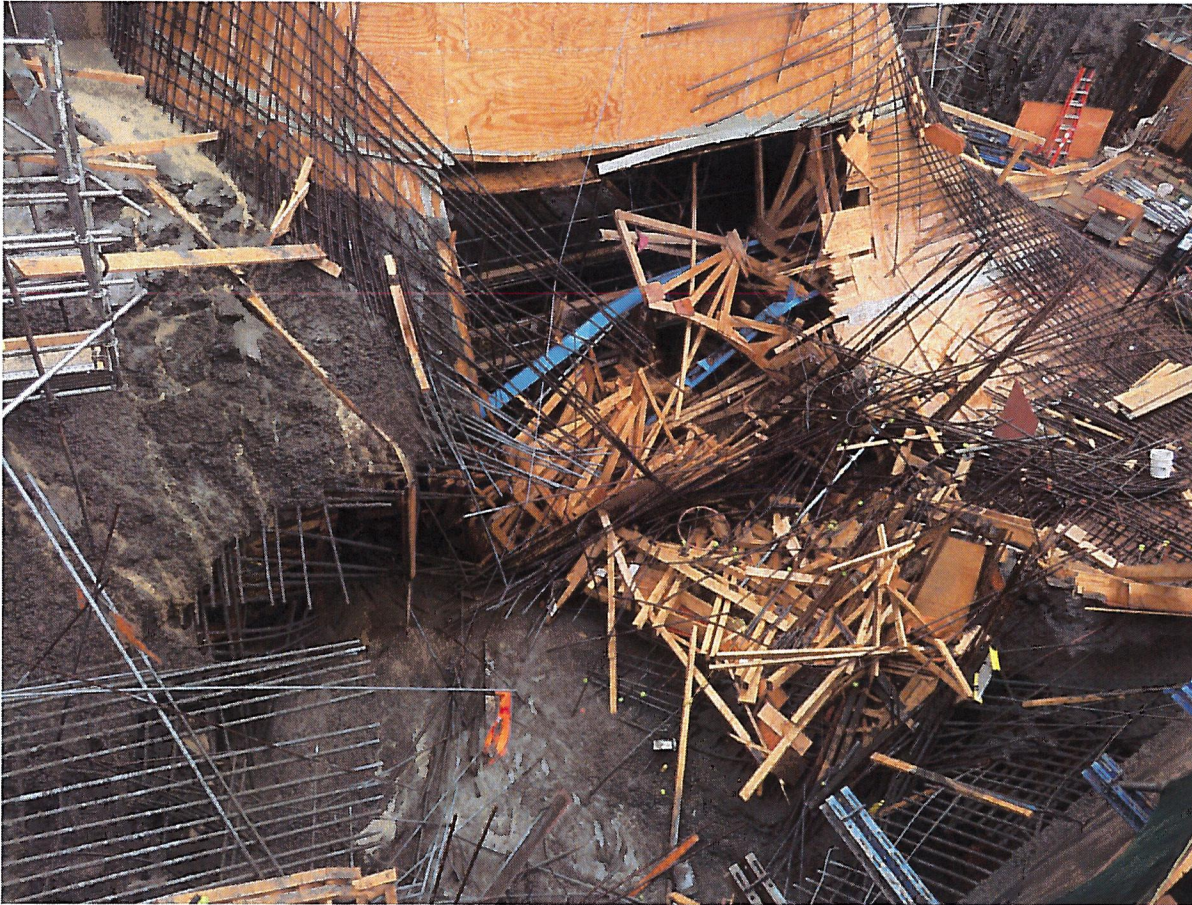
Figure 2: Unit 2 draft tube formwork collapse - view of SE corner of unit

The collapse was significant in that it damaged all lumber shoring towers directly underneath this section of concrete. The workers in the area were finishing the concrete on the gallery's floor when the falsework collapse. The collapse resulted in the workers falling directly into the freshly poured concrete where one worker was fully submerged.

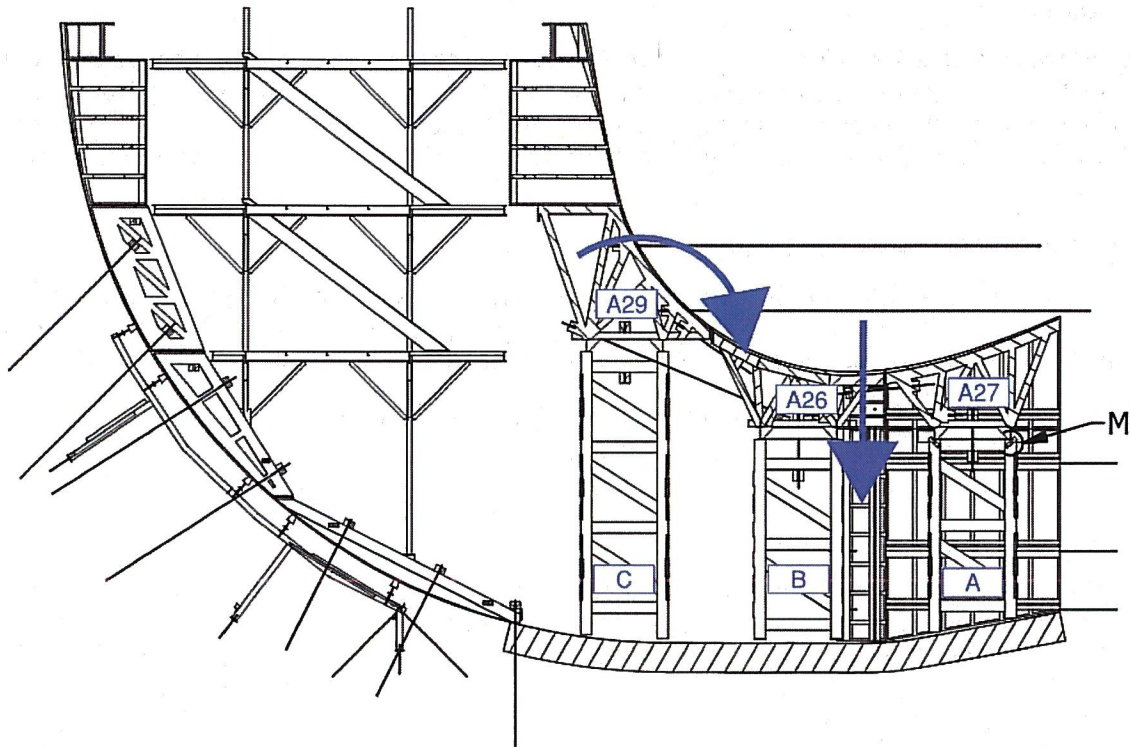
Figure 7: Section view of the draft tube formwork with assumed collapse sequence

Concrete poured downwards and in between shoring tower rows A and B (Figure 7), which suggests issues with the shoring towers. The side panels (draft tube panel A29 and the north built-in-place panel) were pulled over the fallen concrete by the tie-rods that held lateral concrete pressure.

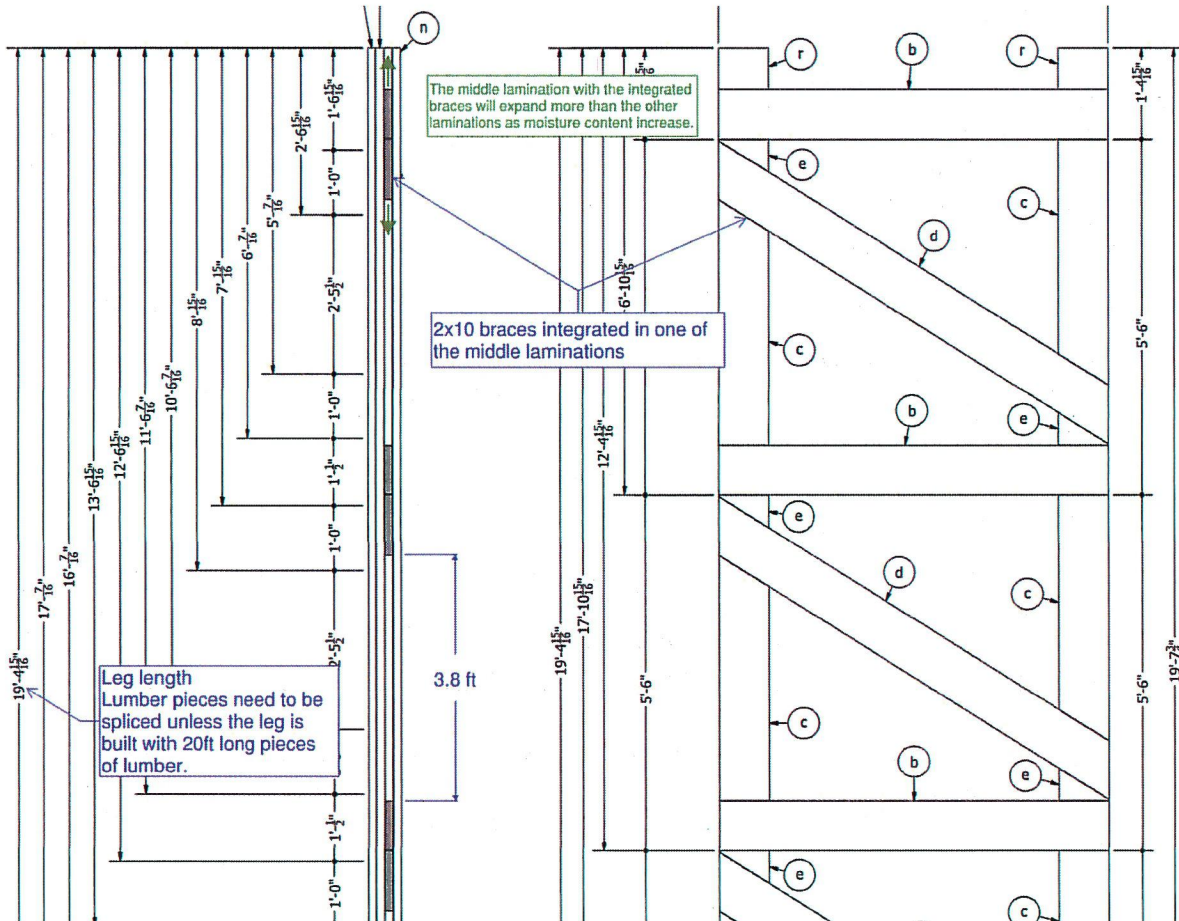
Figure 10: Shoring tower braces assembly detail

The brace configuration illustrated on the tower fabrication drawing integrates the braces within the built-up column laminations. This is made possible by cutting a plank of one of the middle laminations to introduce the brace into the column.

This configuration is in contradiction with the built-up column splicing specifications identified above.

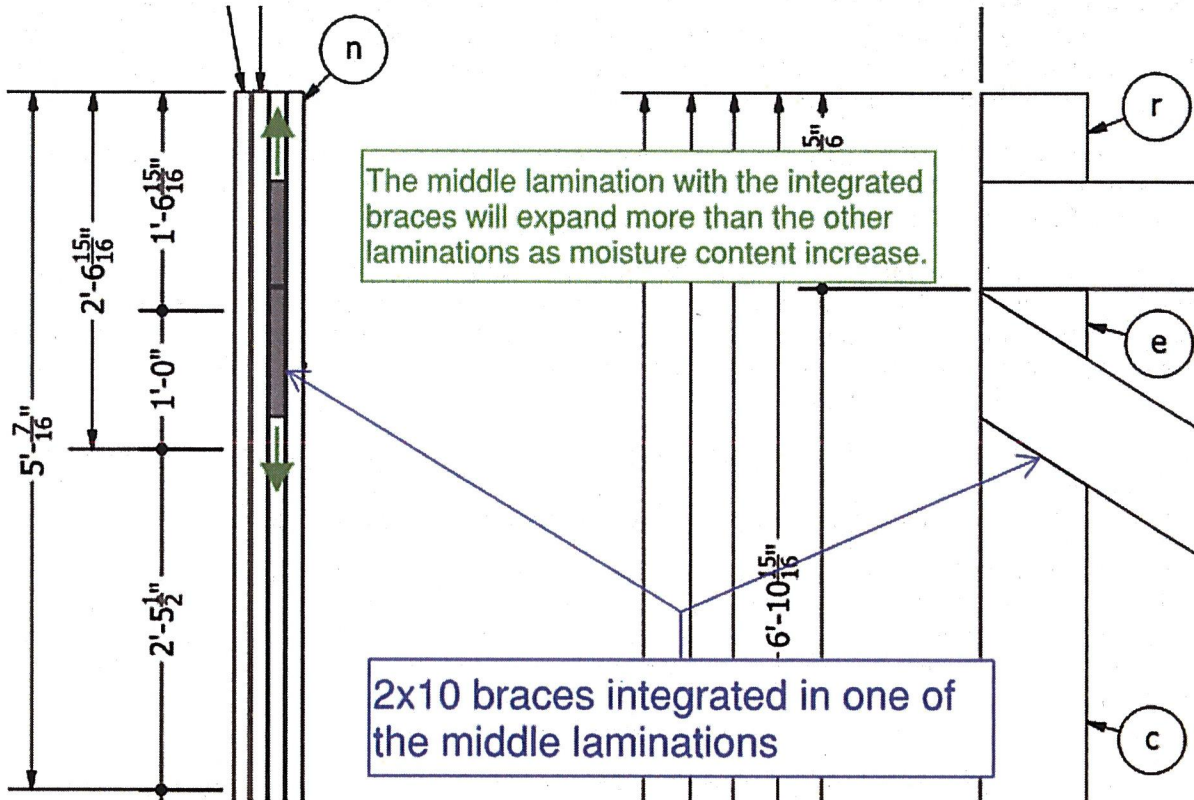
Figure 11: Shoring tower braces assembly detail, drawing "W-41b, Rev A – Shoring Tower C41"

On the other hand, the lamination with the diagonal braces would experience significant elongation upon wood moisture content increases (Figure 11). This change in lumber dimension given changing wood moisture content has the potential to significantly compromise structural integrity if it is not accounted for in the design. Distortion in the tower legs was observed on-site, and has the potential to compromise the structural integrity of the tower legs.

In our opinion, the tower legs cannot be expected to retain their design dimensions over the course of more than six months while exposed to the elements. Wood moisture content fluctuations would result in distortion of the tower legs.

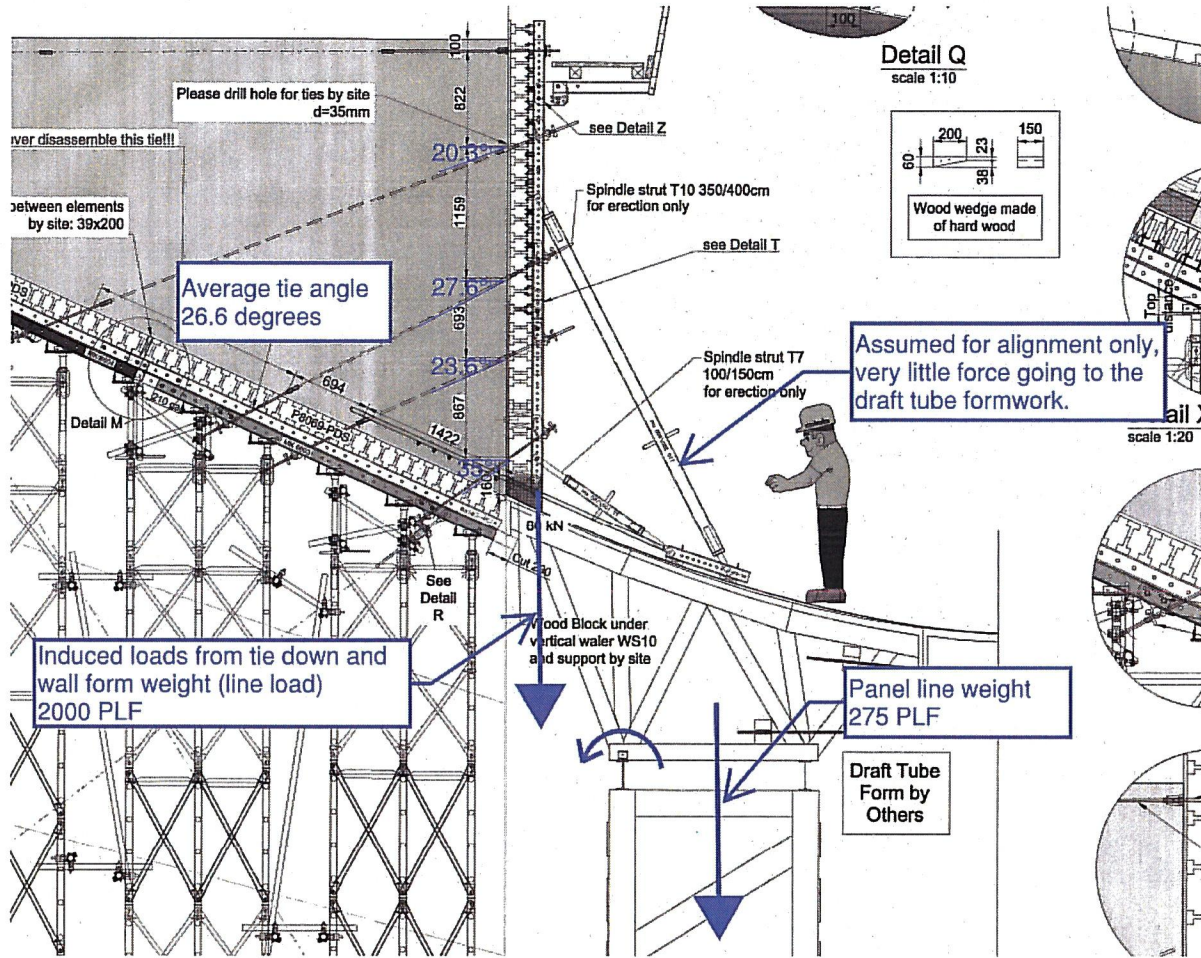
Figure 12: Tailrace wall-form sitting on the draft tube formwork

Although nothing has been reported regarding the possible overturning of the draft tube panels during the tailrace concrete pours, it is possible that this disrupted the integrity of the formwork prior to the pouring concrete on the draft tube level 3 form.

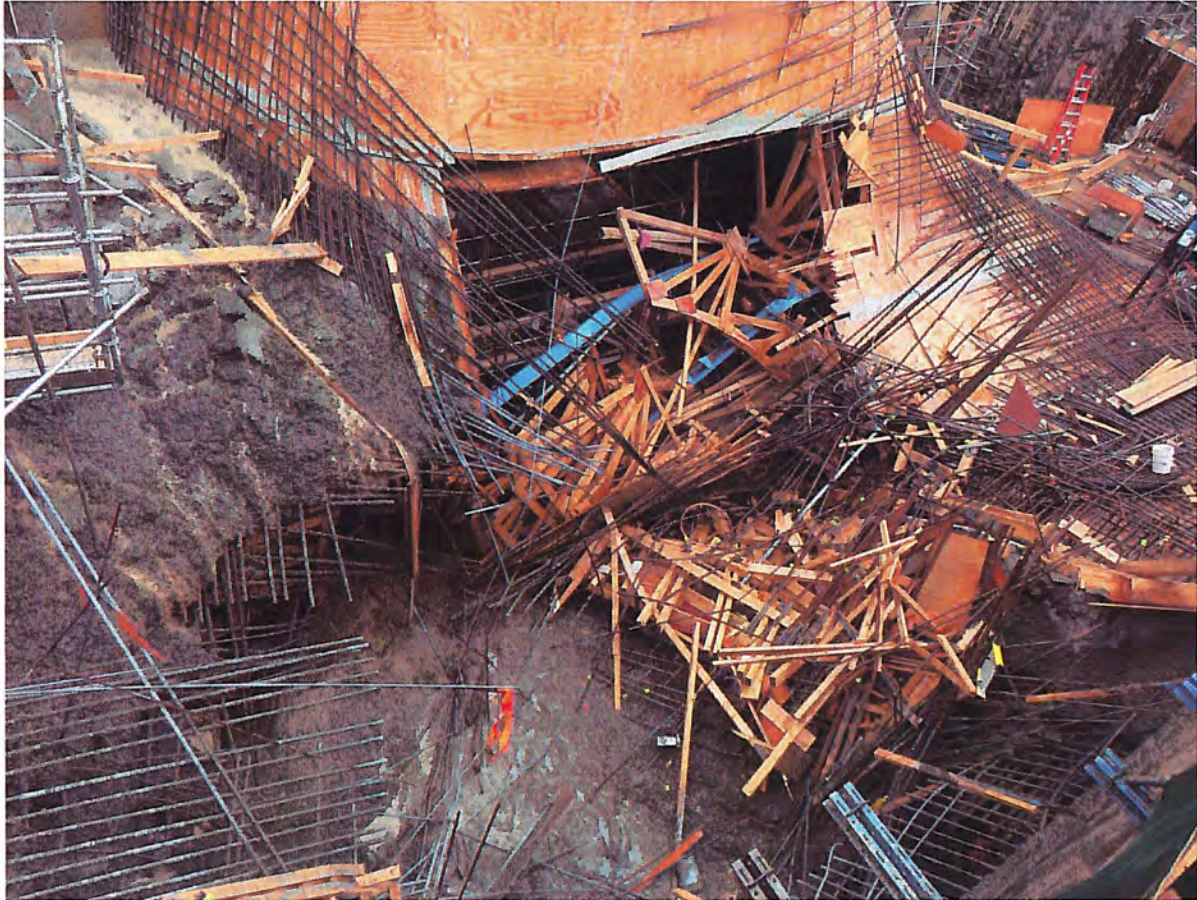
Approximately 500 m³ of freshly poured concrete covered the collapsed formwork. As such, direct observations to determine the condition of the formwork at the Unit 2 draft tube could not be made.

The catastrophic formwork failure covered a large area. Six shoring towers at Row B and Row C that supported the load of concrete were completely destroyed.

Unit 2 draft tube - View of South East corner of unit, looking below

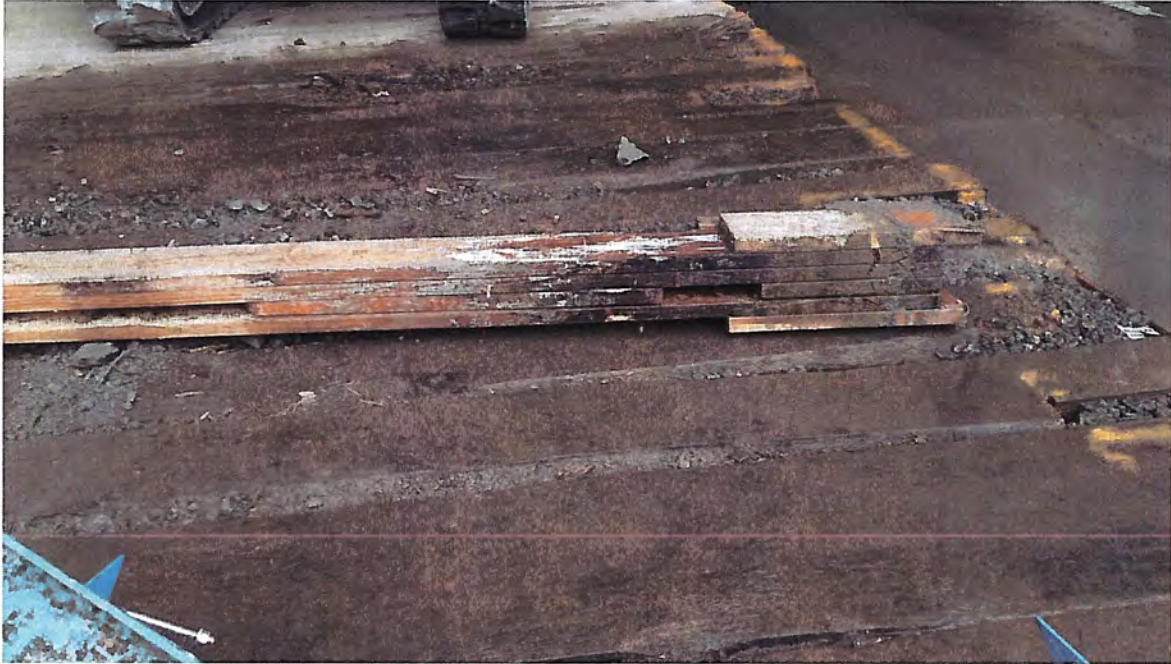
During the site visit, a clearly defined line marking a flooding elevation was observed on the towers and the formwork approximately three feet from the ground. Fungi and decayed wood was also evident on the tower. Observations made at Unit 2 correlated to observations made at Unit 1's draft tube formwork (Section 6.3).

Unit 2 - Shoring Tower weathering

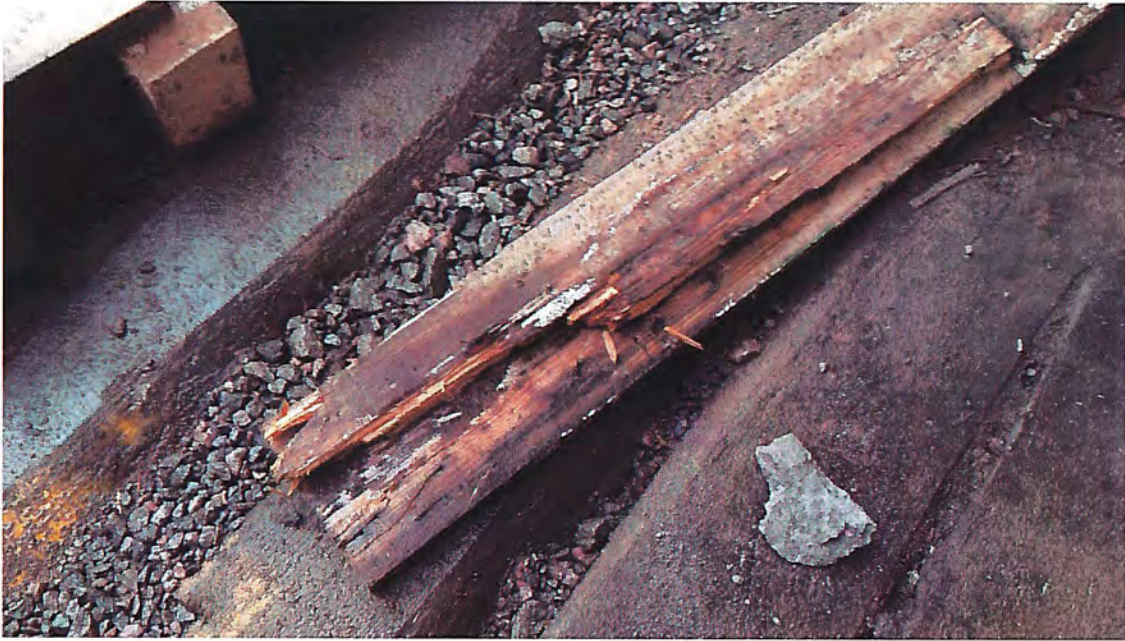
Unit 2 - Shoring tower rotten lumber

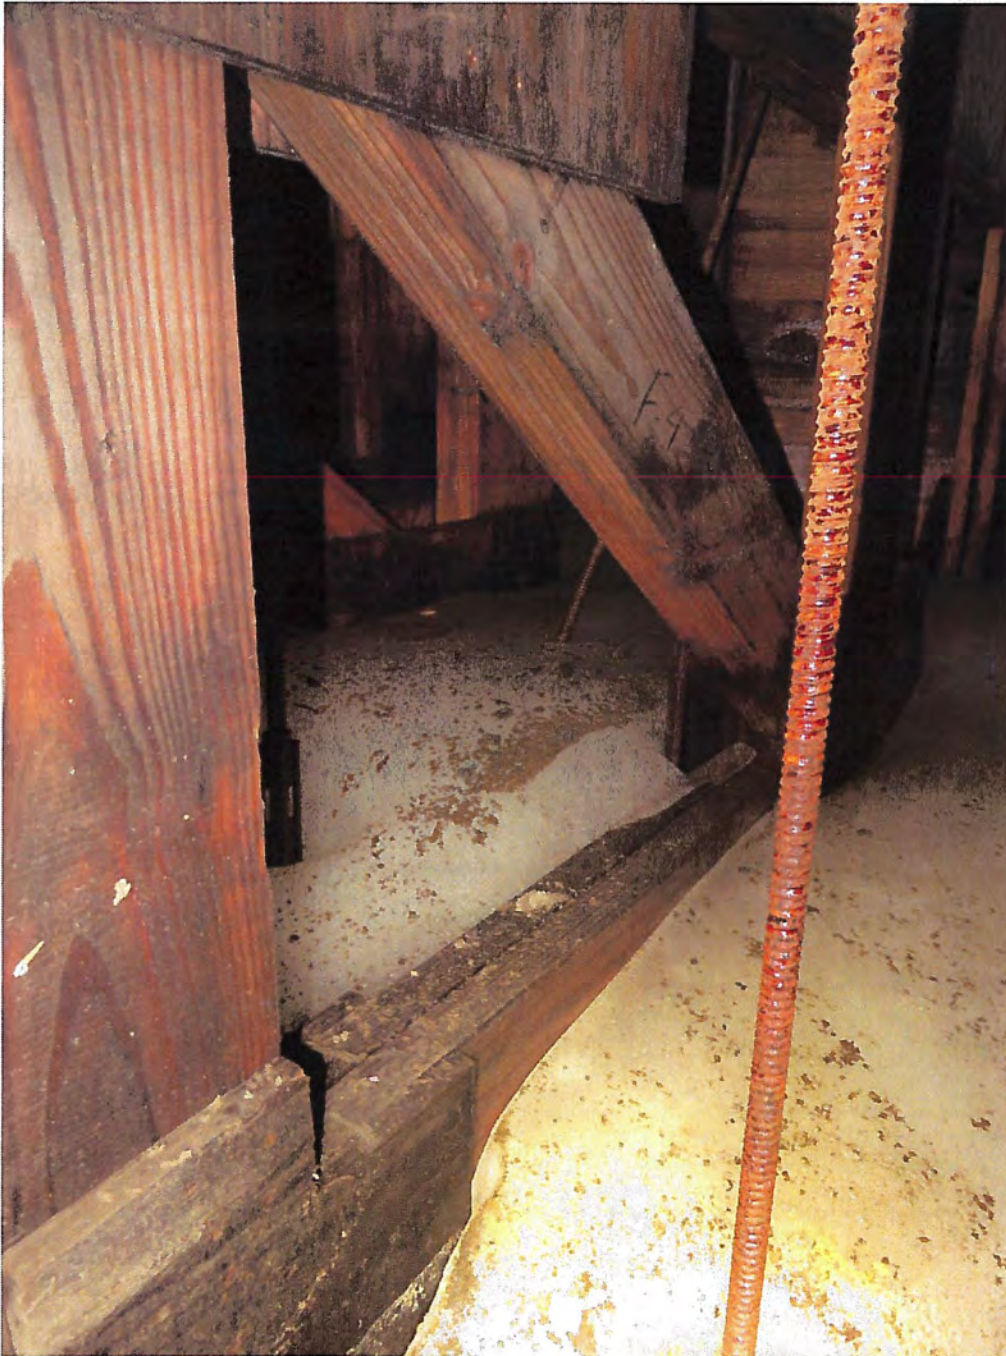
The formwork in the Unit 1 draft tube displayed evidence of exposure to high relative humidity, rain, and snow. The bottom of the formwork also displays evidence of having been submerged in water for a prolonged period of time. The evidence observed includes:

Unit 1 - Ice built up within ribs of panels A9

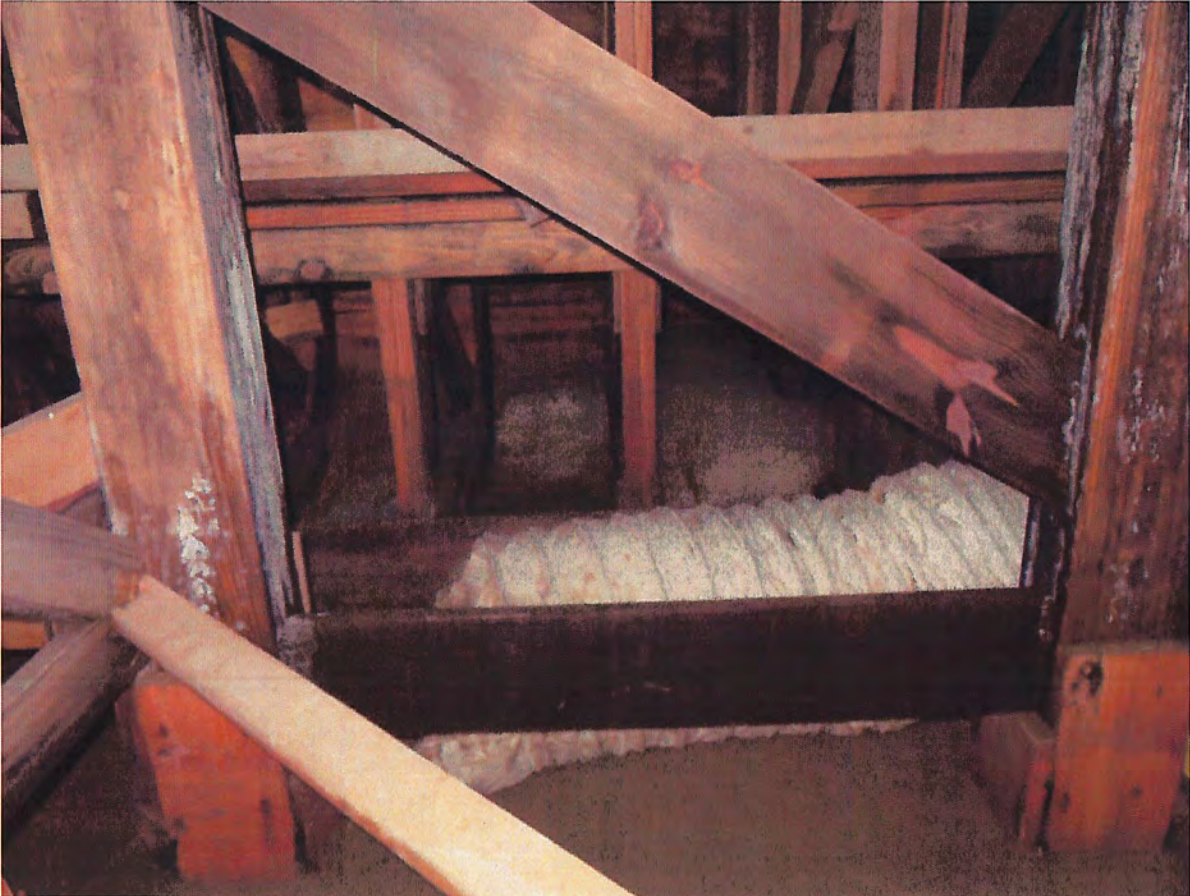
Unit 1 - Fungi growth on lumber of tower B6

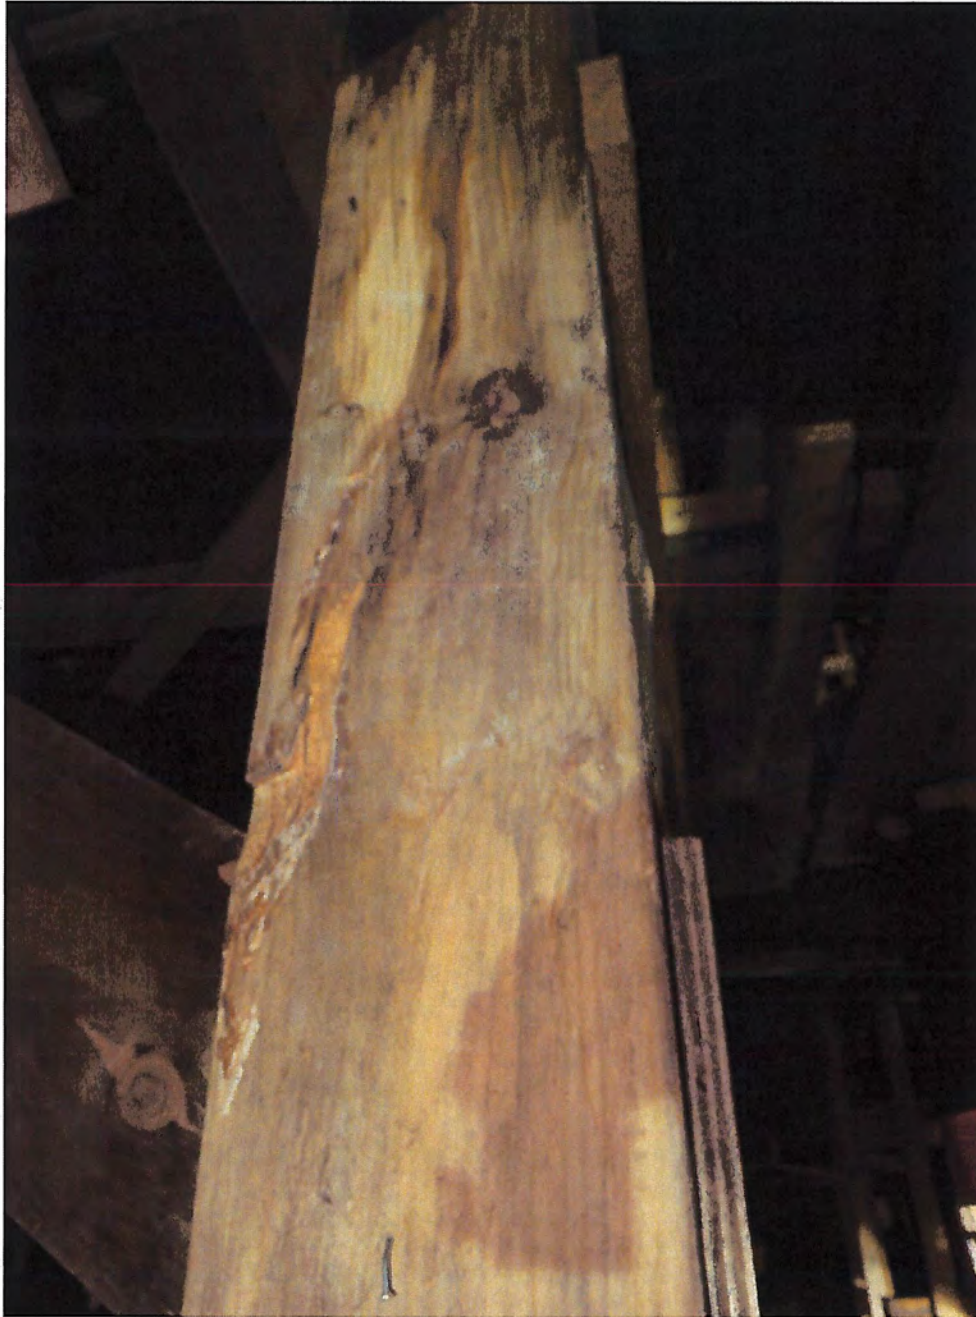
Unit 1 - Fungi growth on lumber of tower B4

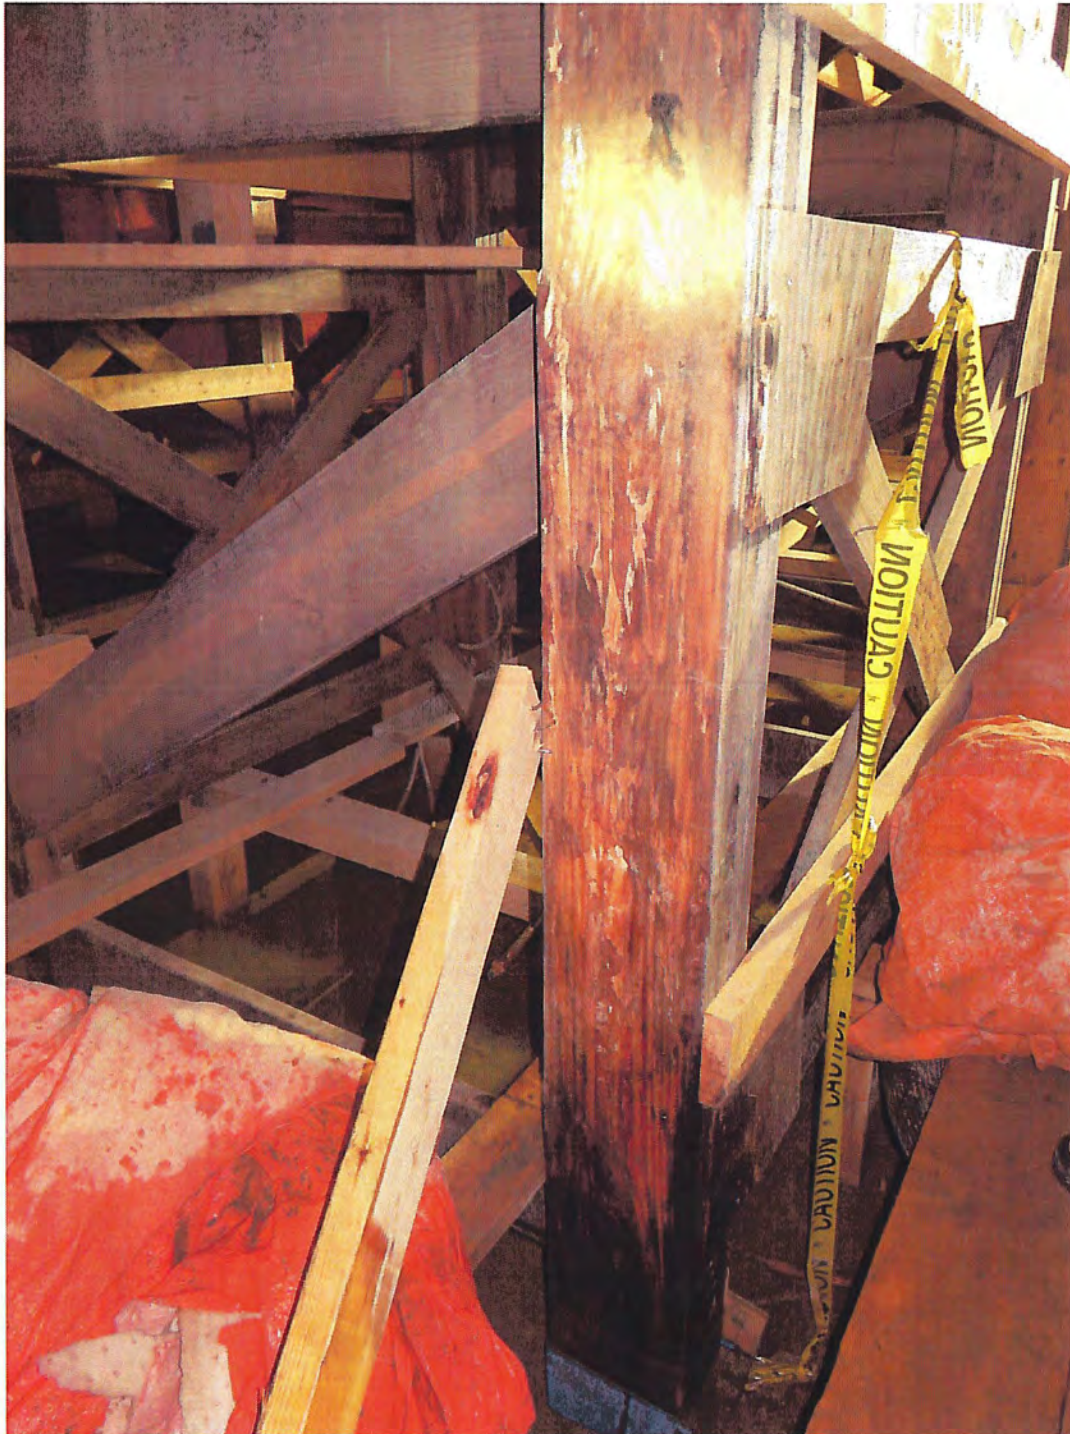
Unit 1 - Decayed wood on tower B3

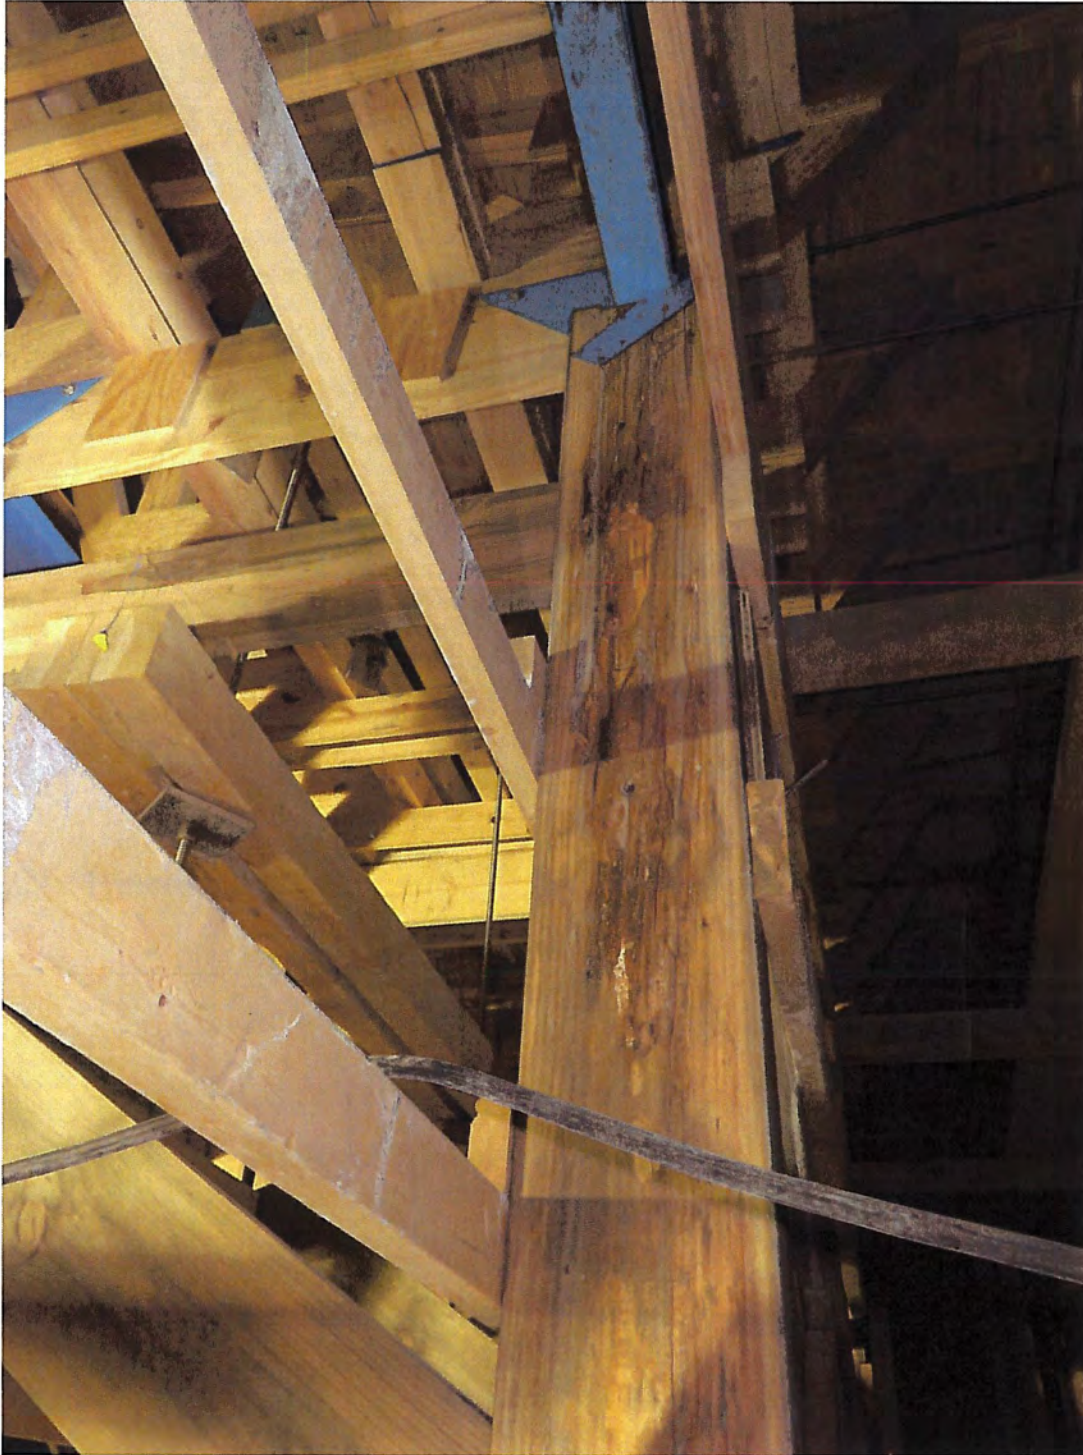
Unit 1 - Decayed wood on tower B2

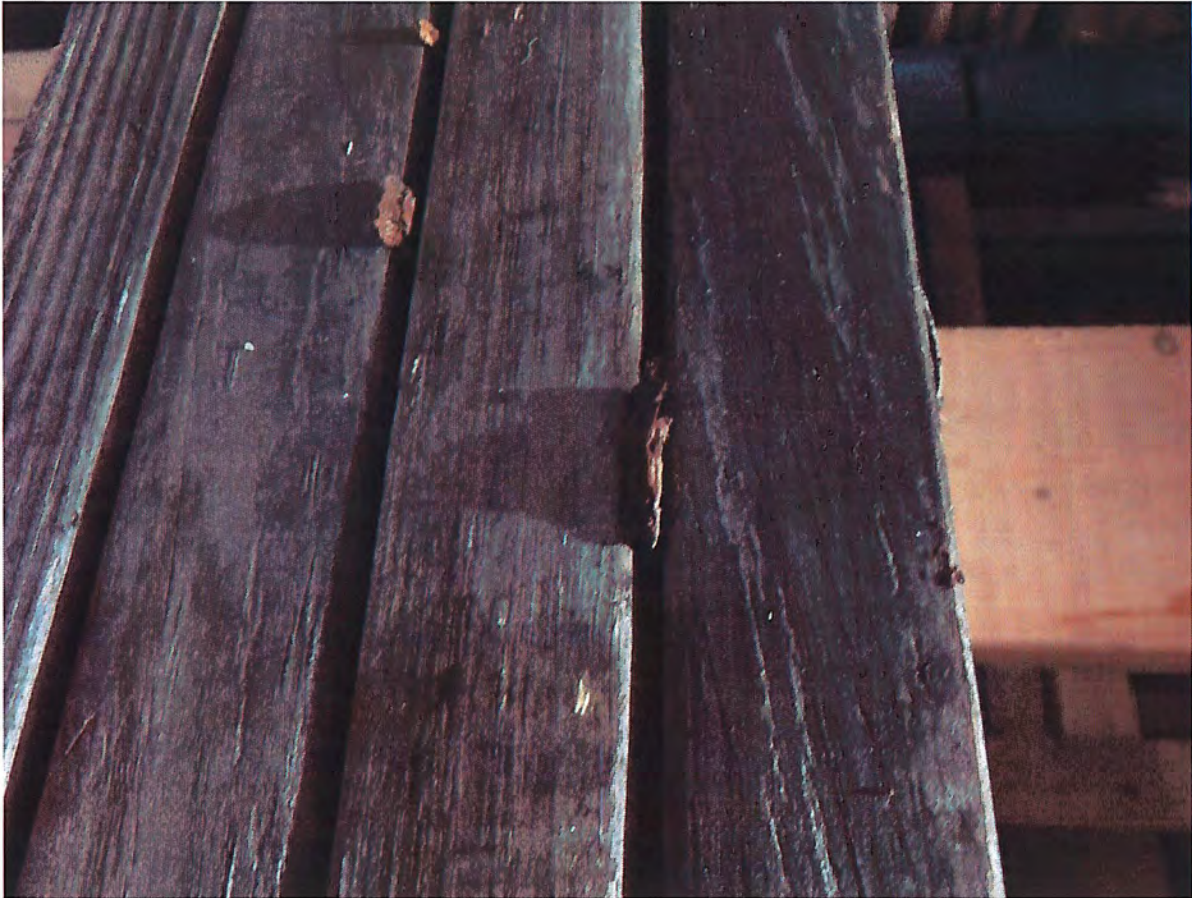
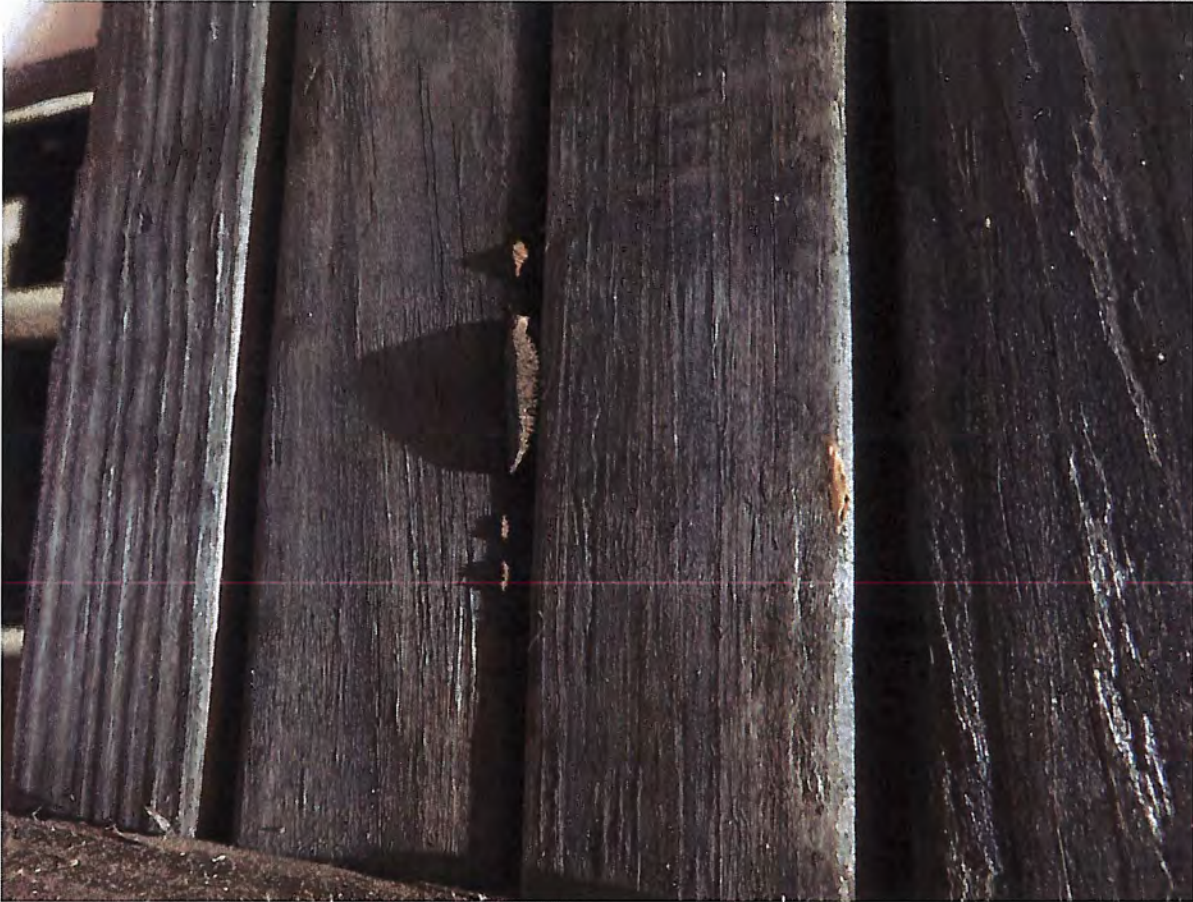
Unit 1 – Mushroom growth on tower B3

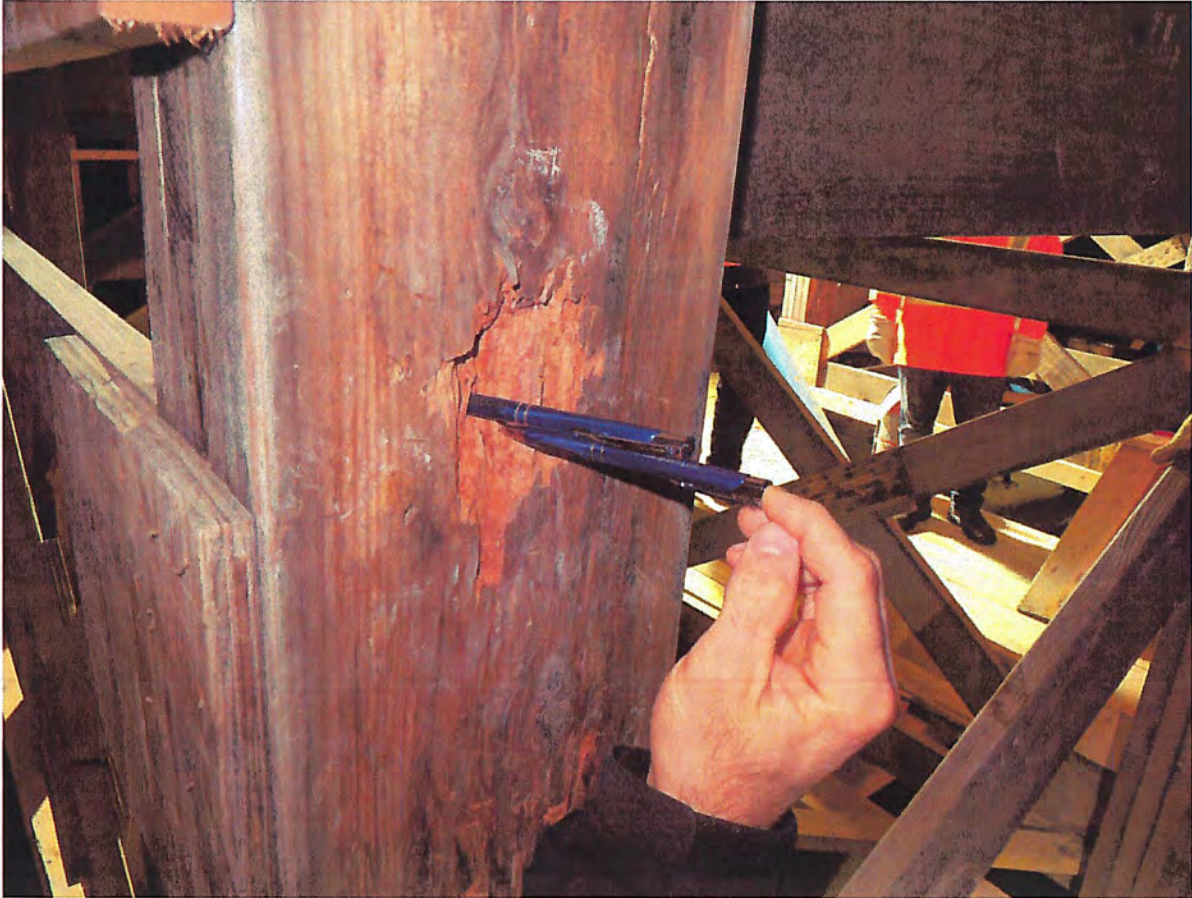
Unit 1 - Dry rot on shoring tower

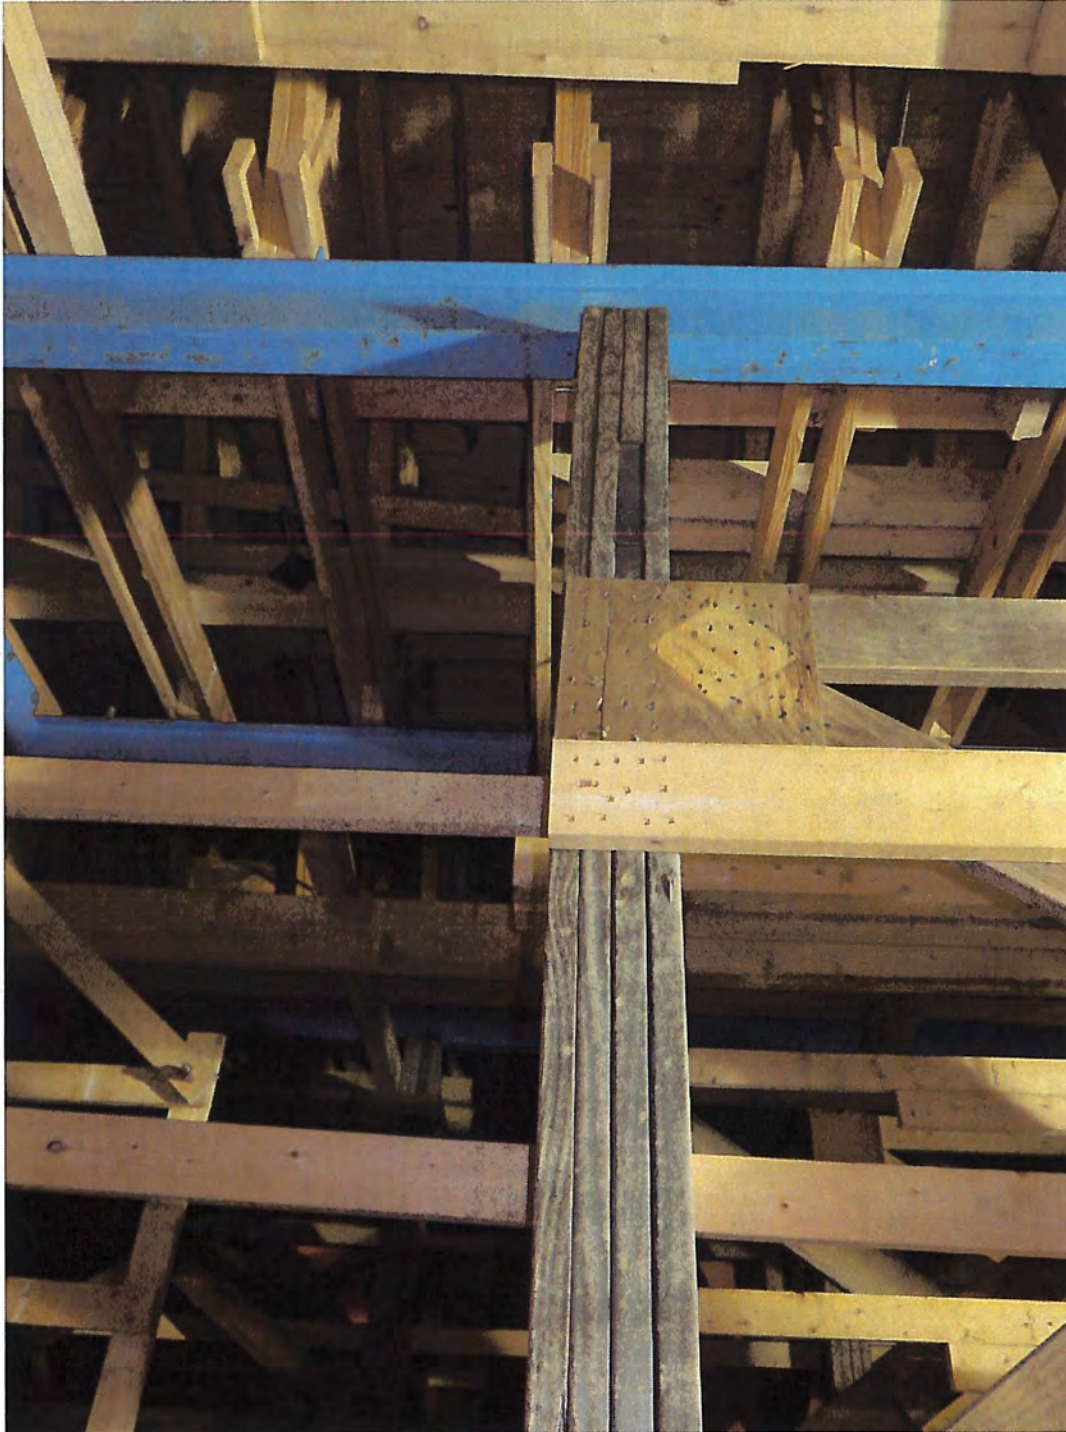
Noticeable S-shaped buckling was evident in the built-up posts of the shoring frames. The steel beam cantilevered fulcrum posts displayed the most noticeable buckling. These posts will take slightly more load than the other posts of the falsework system (about 5% more load). The buckling observed was consistently in the North-South plan (the plan parallel to the smallest dimension of the shoring leg). During a subsequent site visit on October 18, 2016, the buckling of the post was even more noticeable, indicating that the load had increased since the first visit, or that material properties of the wood had diminished over time.

Unit 1 - Tower B2, buckling at top of post

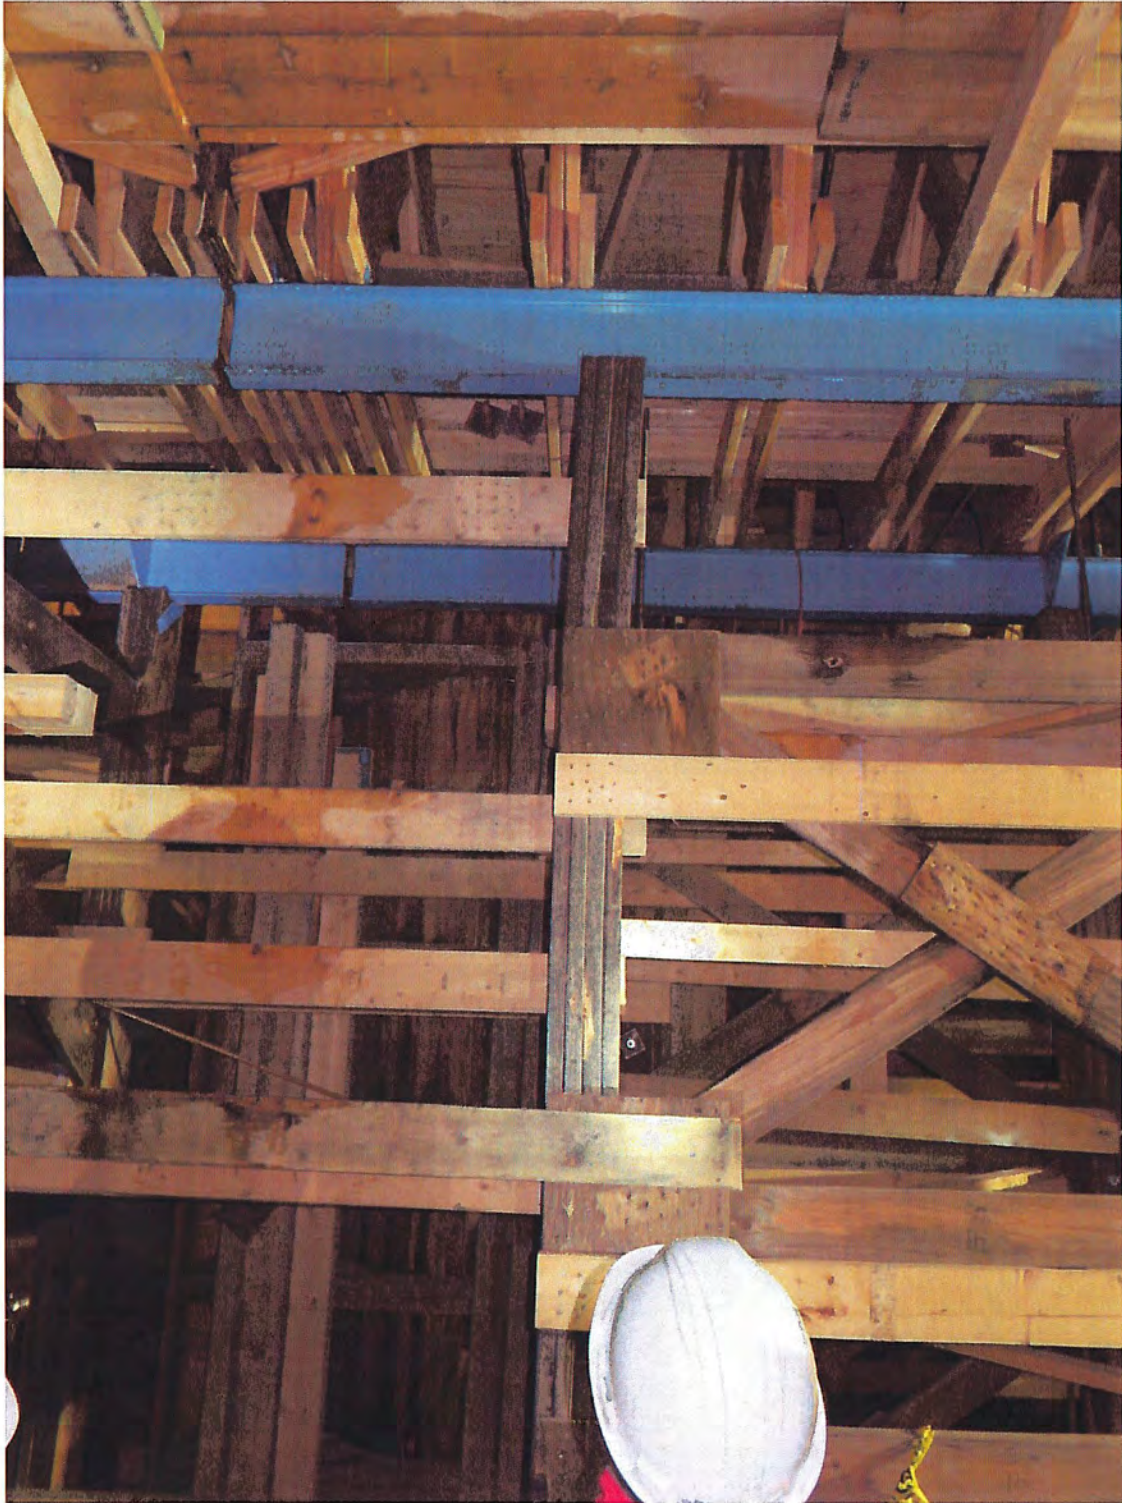
Unit 1 - Tower B3, buckling at top of post
