Muskrat Falls Generation Project
 Unit #2, Pour D2ESB-03, Draft Tube Formwork
 Collapse Investigation Report

Prepared for:
 Nalcor Energy Lower Churchill Project

Project No.160450

Date: April 20, 2017

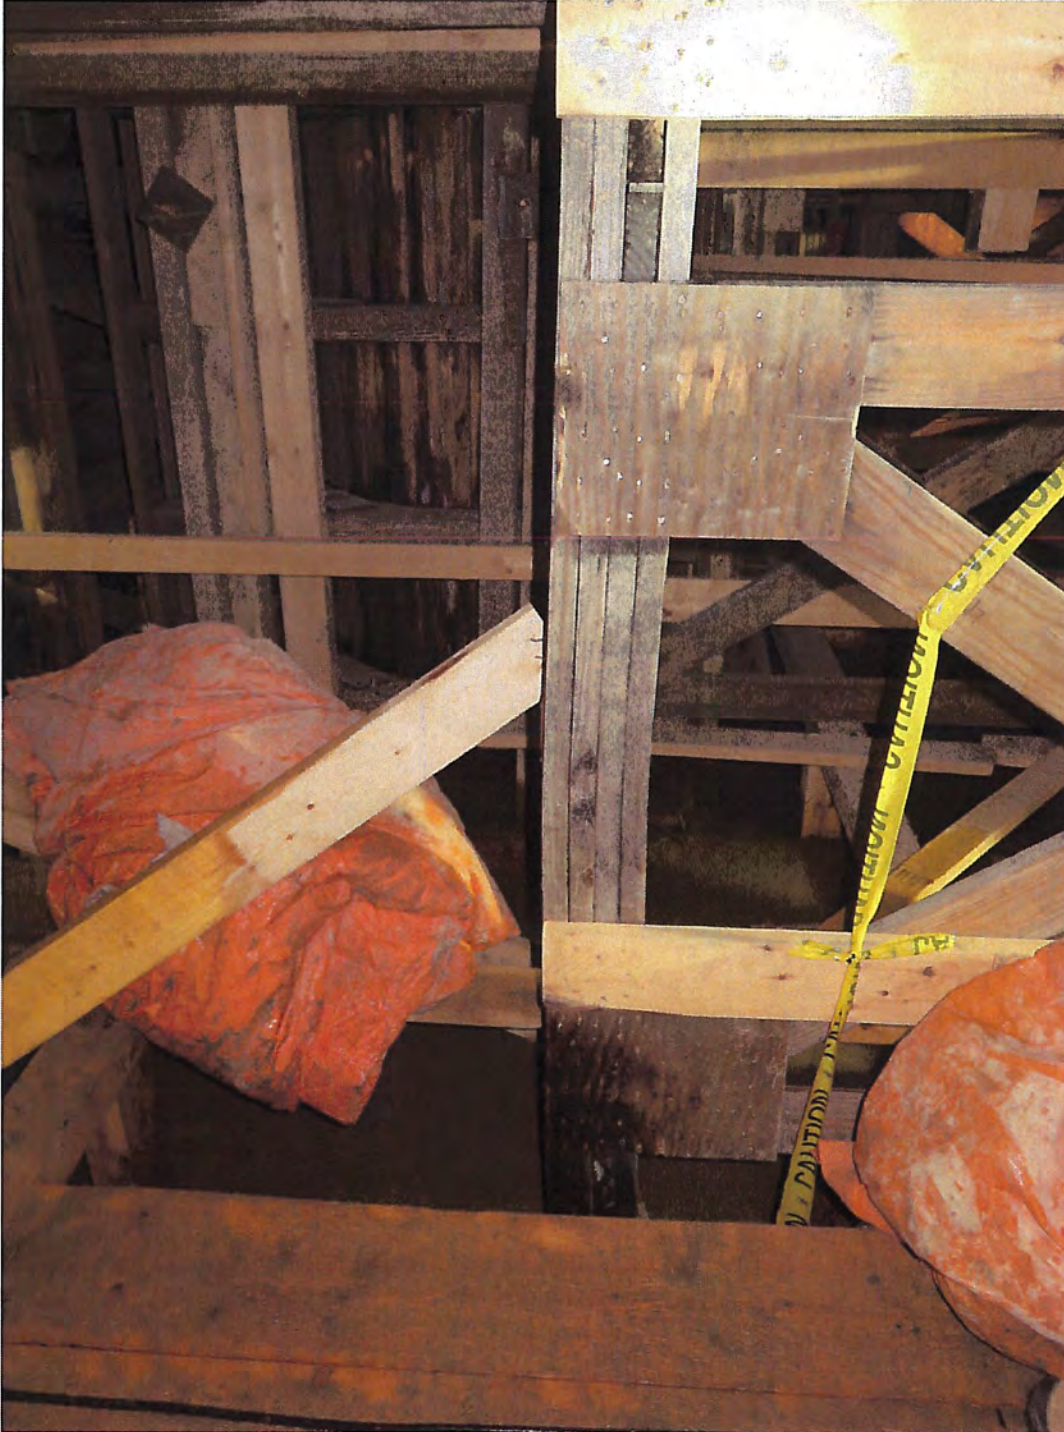
Noticeable S-shaped buckling was evident in the built-up posts of the shoring frames. The steel beam cantilevered fulcrum posts displayed the most noticeable buckling. These posts will take slightly more load than the other posts of the falsework system (about 5% more load). The buckling observed was consistently in the North-South plan (the plan parallel to the smallest dimension of the shoring leg). During a subsequent site visit on October 18, 2016, the buckling of the post was even more noticeable, indicating that the load had increased since the first visit, or that material properties of the wood had diminished over time.

Unit 1 - Tower B3, buckling at bottom of post

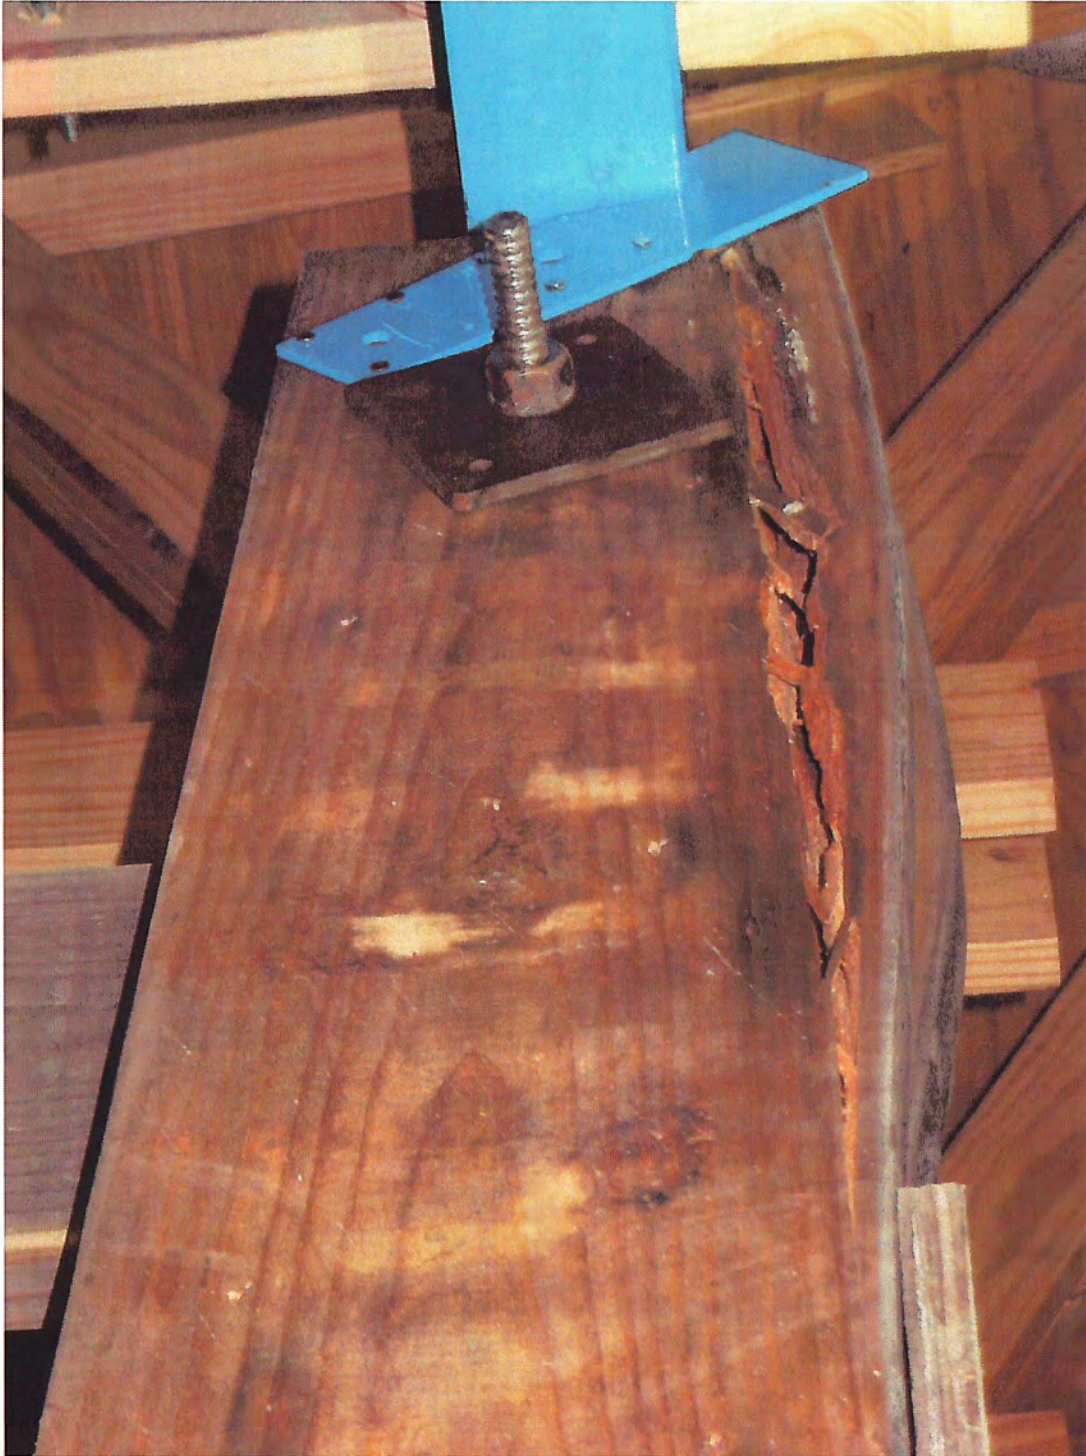
Compression failure is evident on some built-up columns at the interface of the shoring leg and the steel beam. The lumber used for the construction of the built-up columns have a depth of 235mm. The W250x25 steel beams sitting on top of the shoring columns have a flange width of 102mm. Per the Design Review section (Section 8), there are no steel plates between the two elements to spread the load equally through all the vertical wood fibers. The loaded wood fibers below the beam were sheared off from the unloaded wood fibers due to the concrete load.

Unit 1 - Tower B1, compression failure below steel beam

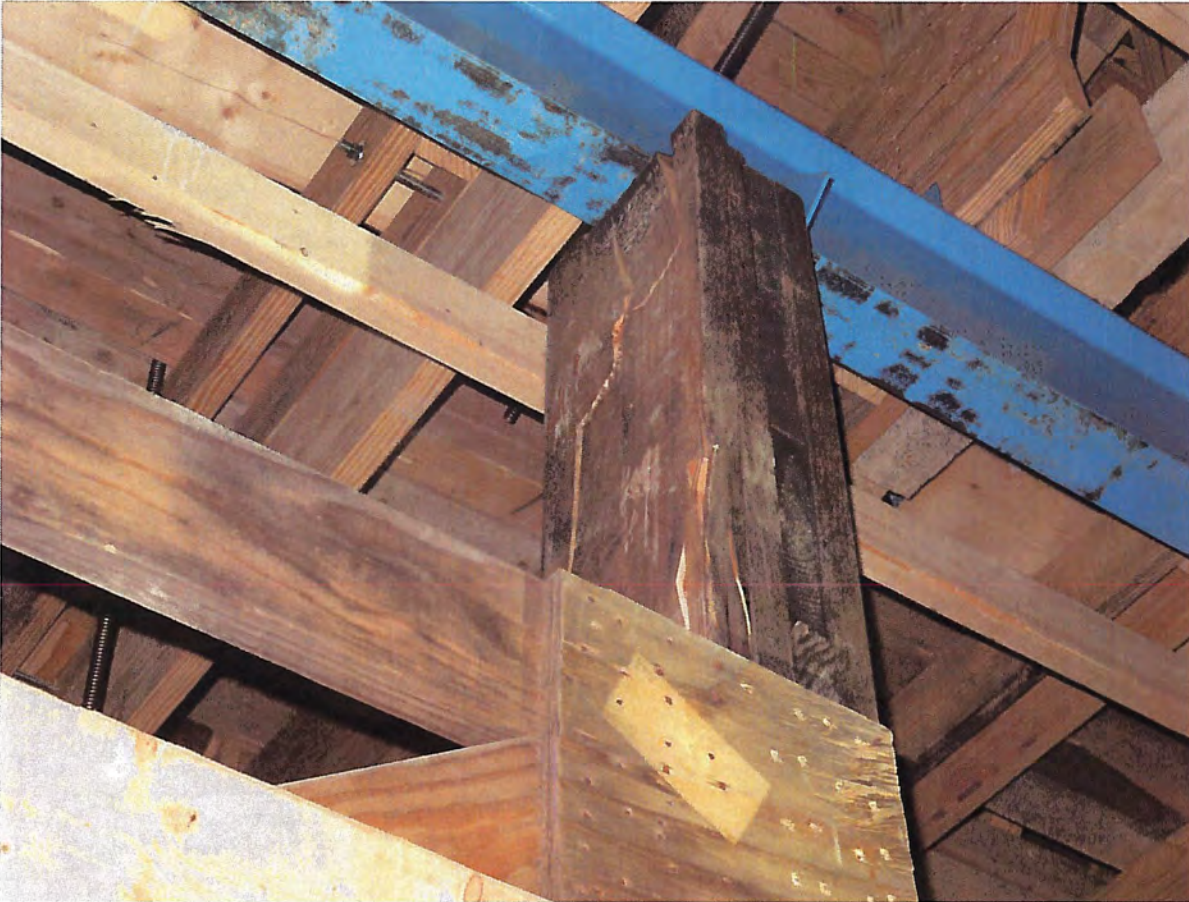
Unit 1 - Tower B5, compression failure below steel beam

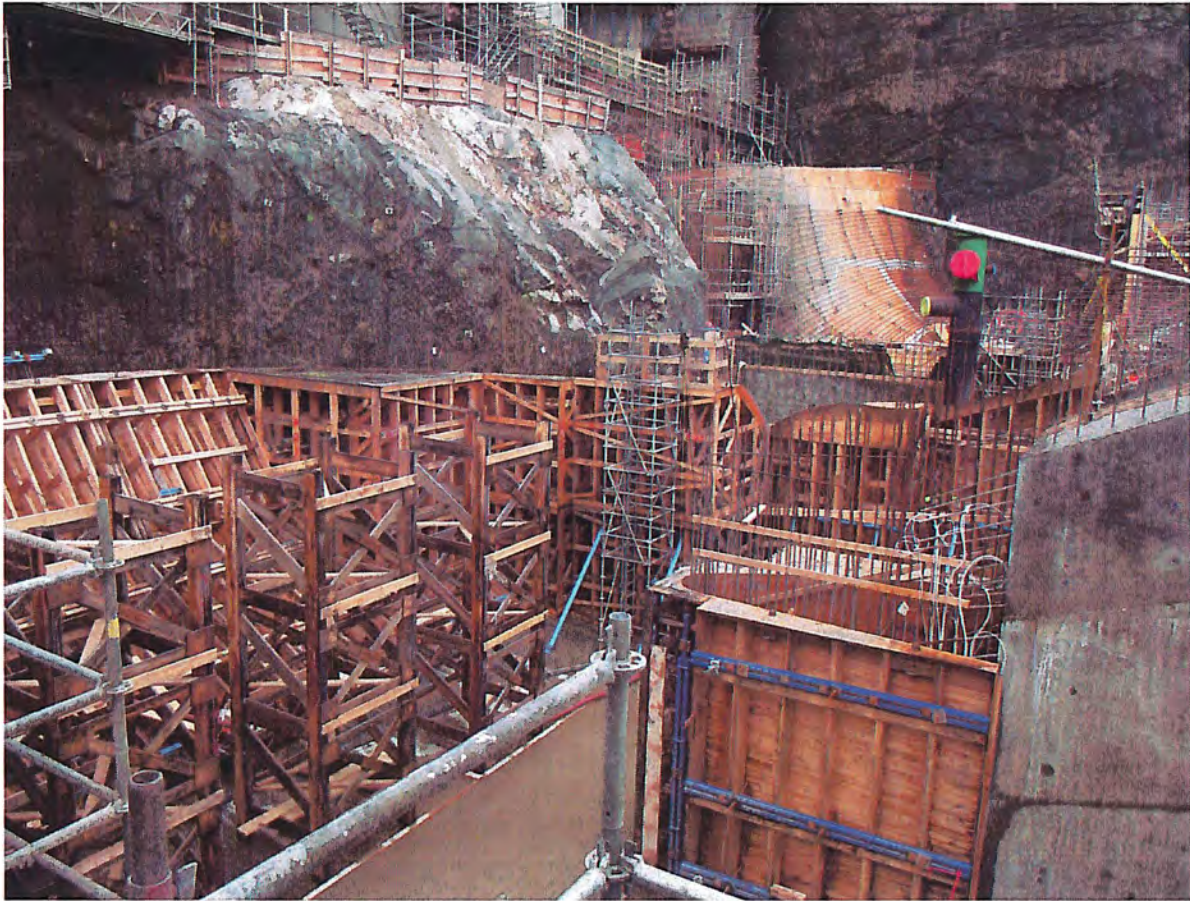
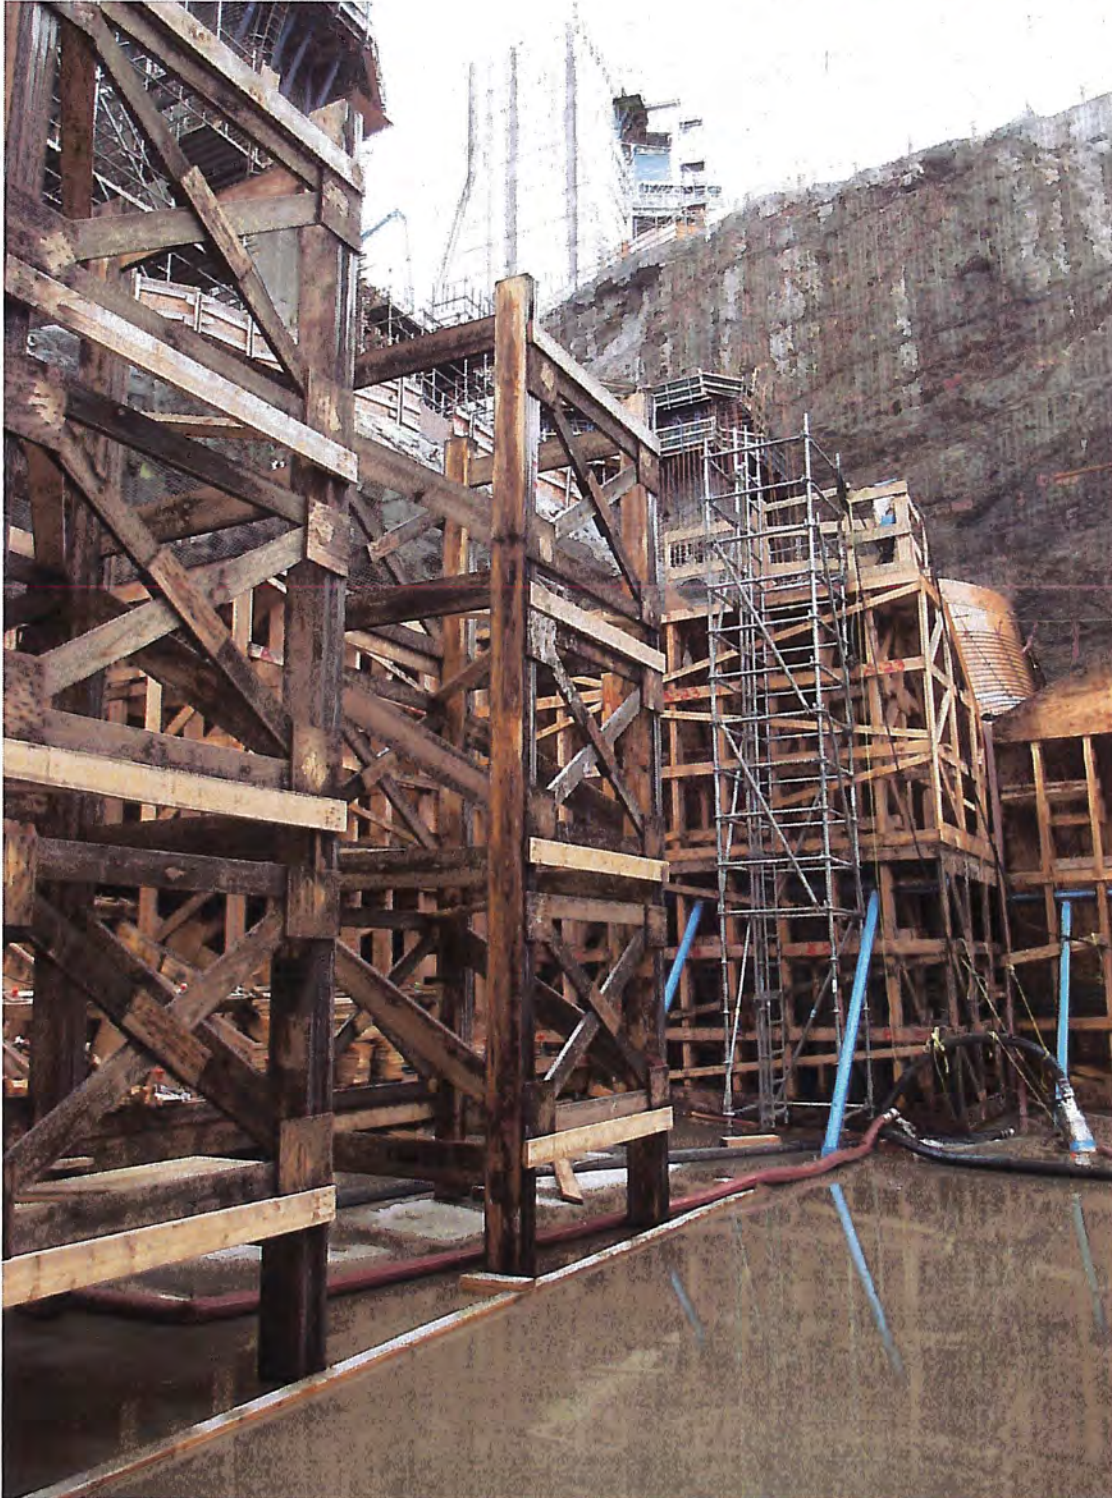
The towers displayed evidence of severe weathering. The lumber planks were dark grey / black in colour due to the weathering. This is indicative of the towers having been damaged before installation. It is also an indication that the wood structures were not well protected in storage between fabrication and installation.

Unit 3 - Installed shoring tower weathering

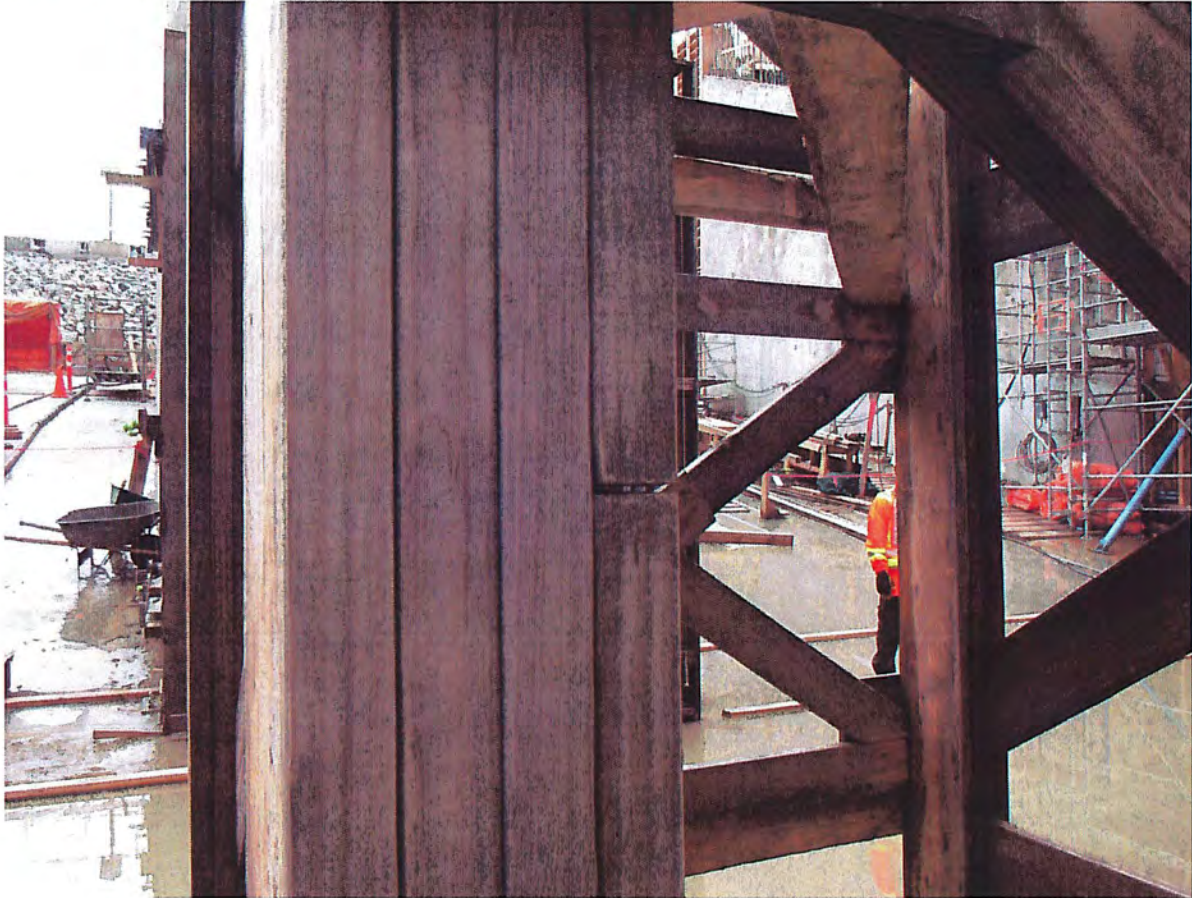
Noticeable gaps in the built-up shoring tower columns at the lumber butt joints were observed. The gaps in the built-up legs were identified as a fabrication quality issue post-collapse. The brace configuration built into the legs do not facilitate for lumber expansion or shrinking as the wood moisture content changes, which does not mitigate built-up column deformation. Assuming wood moisture content of the tower lumber has increased since fabrication, the internal lamination with the braces will have expanded and pulled the lumber of the other lamination apart. Refer to Section 8.5.3 for details.

Unit 3 - Built-up tower with a gap between two planks

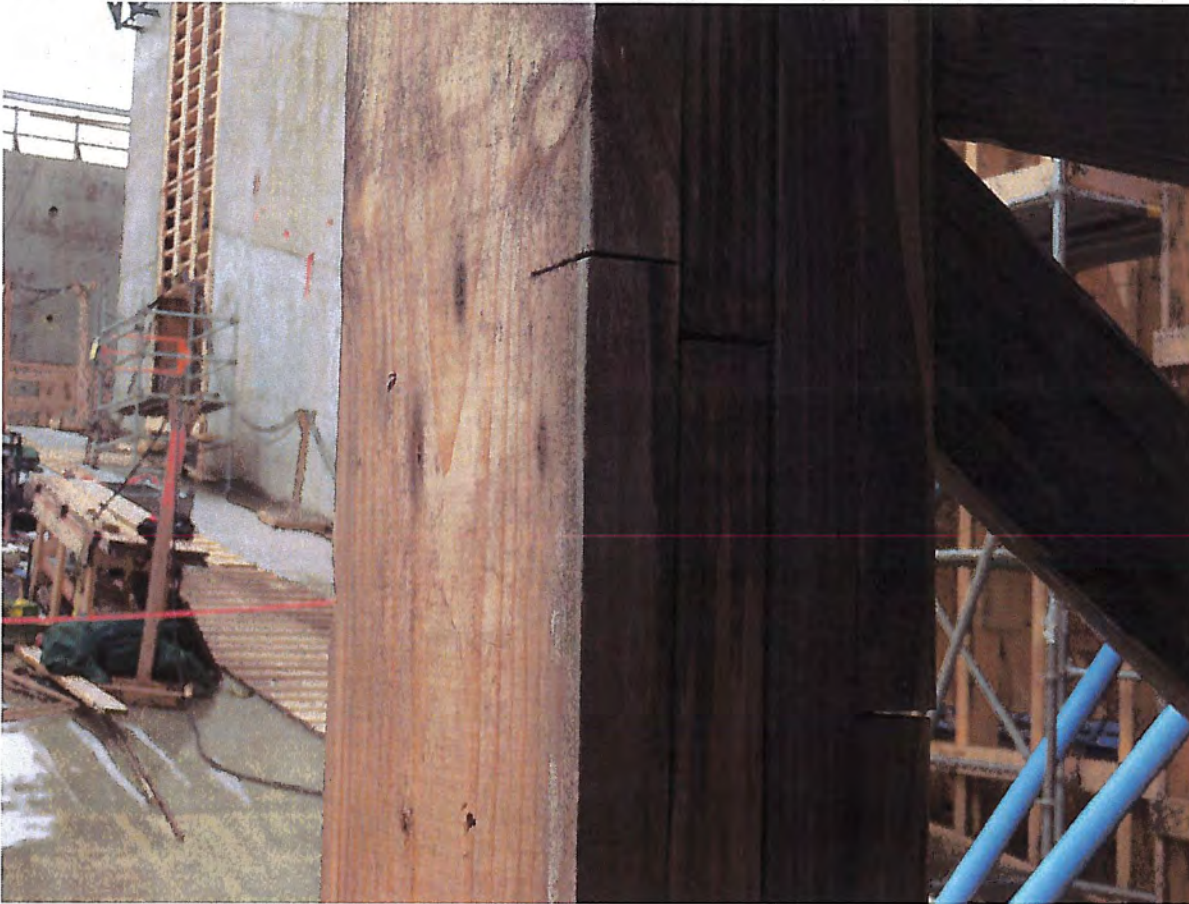
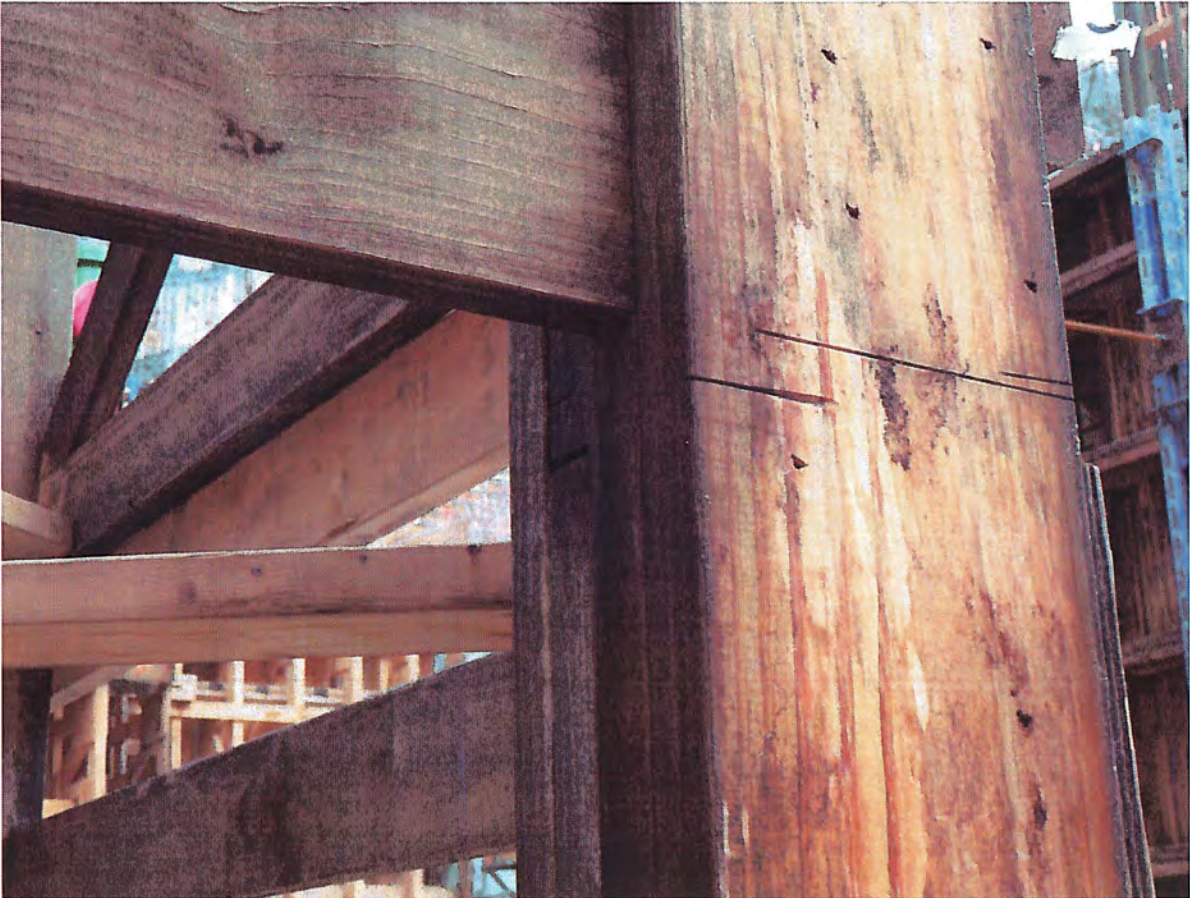
There is evidence that the lumber was damaged during fabrication by improperly handling the wood saw. There is evidence of damaged planks being used in fabrication of the built-up towers. The damaged planks were then assembled to make the built-up tower legs. No quality control programs, at either the fabrication shop or on-site, identified the defects before erection of the towers in the Unit 3 draft tube.

Unit 3 - Saw cut mark in lumber

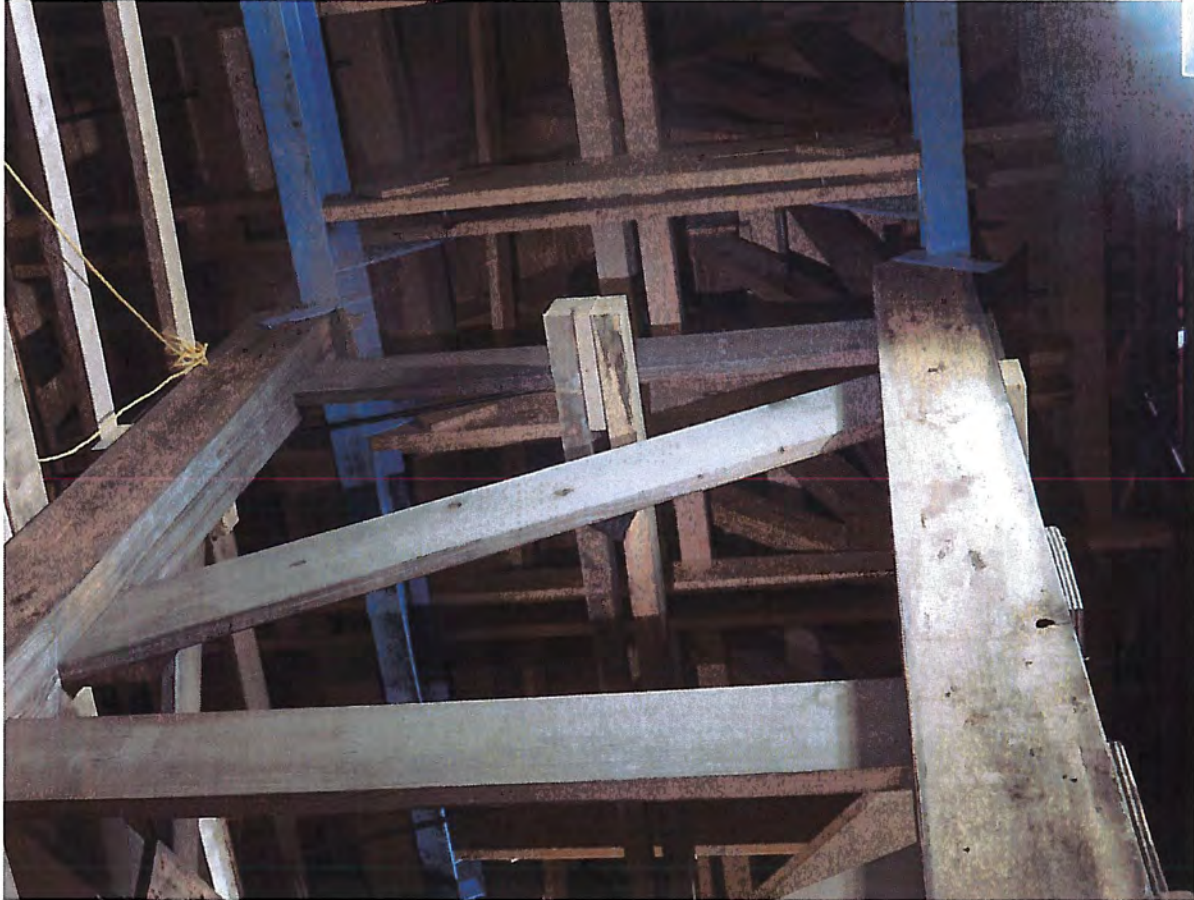
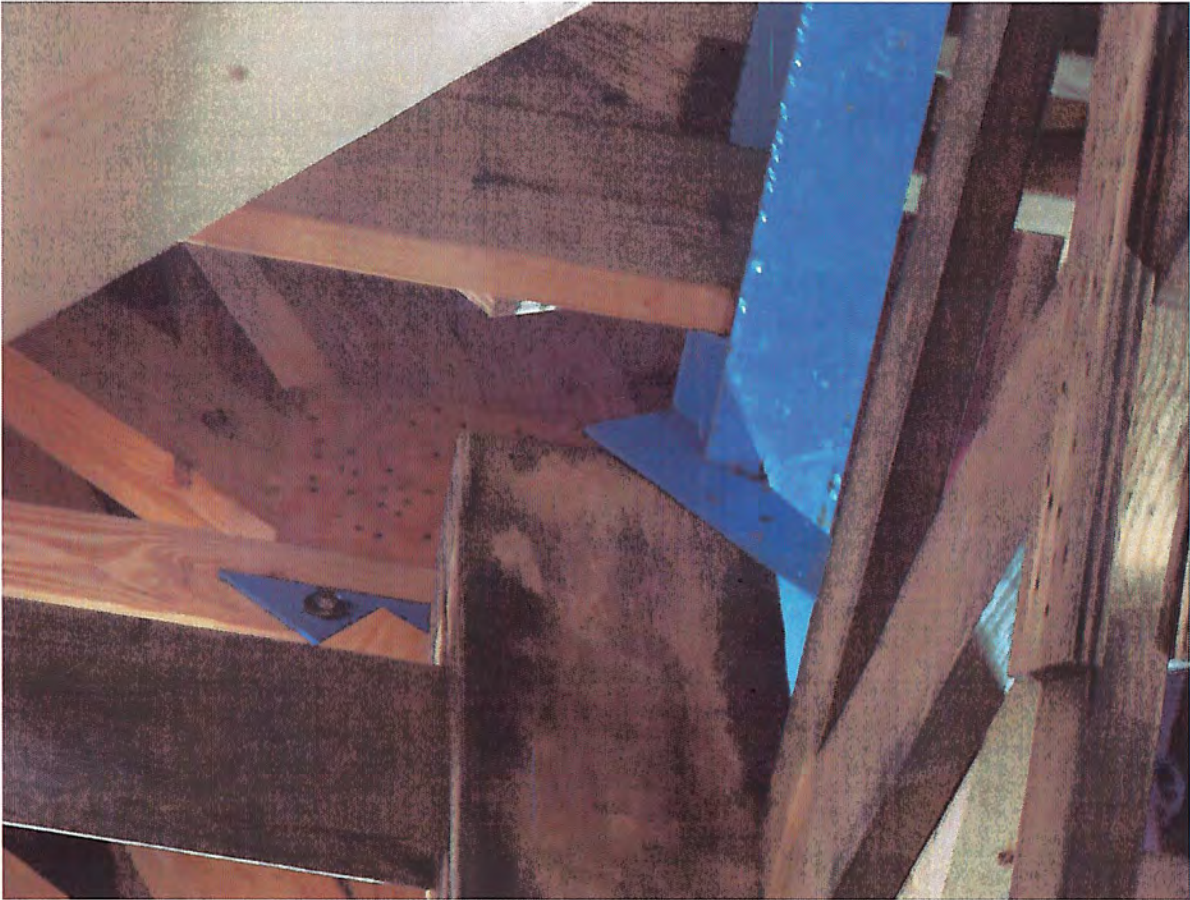
Unit 4 - Tower misaligned with steel beam

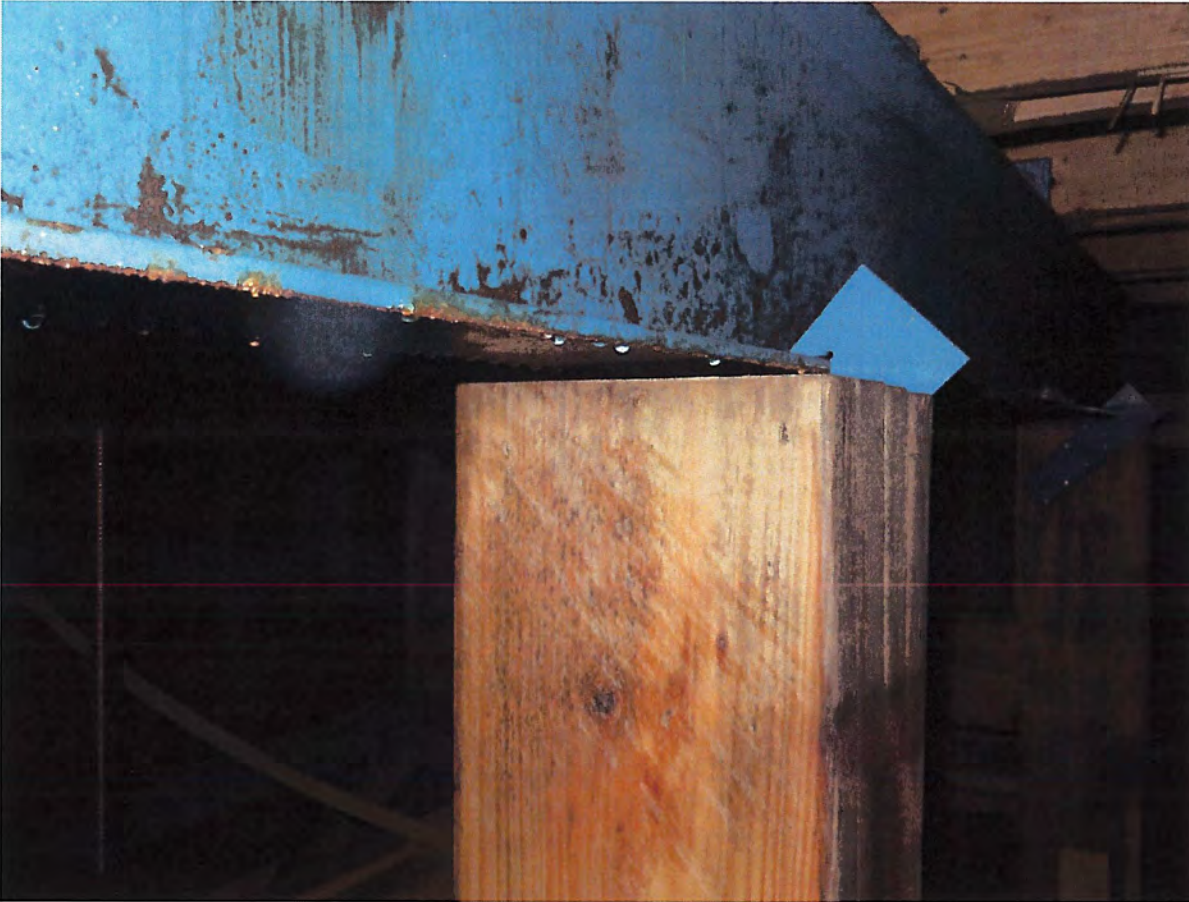
There is evidence that the leg height was not perfectly adjusted and that top leg shims were required. Some of the shims were missing, leaving a gap between the steel beam and the leg. In other cases, shims were installed but the material chosen and the installation itself were not sufficient to transfer the bearing load adequately to the legs.

Unit 4 - Missing shim between post and steel beam

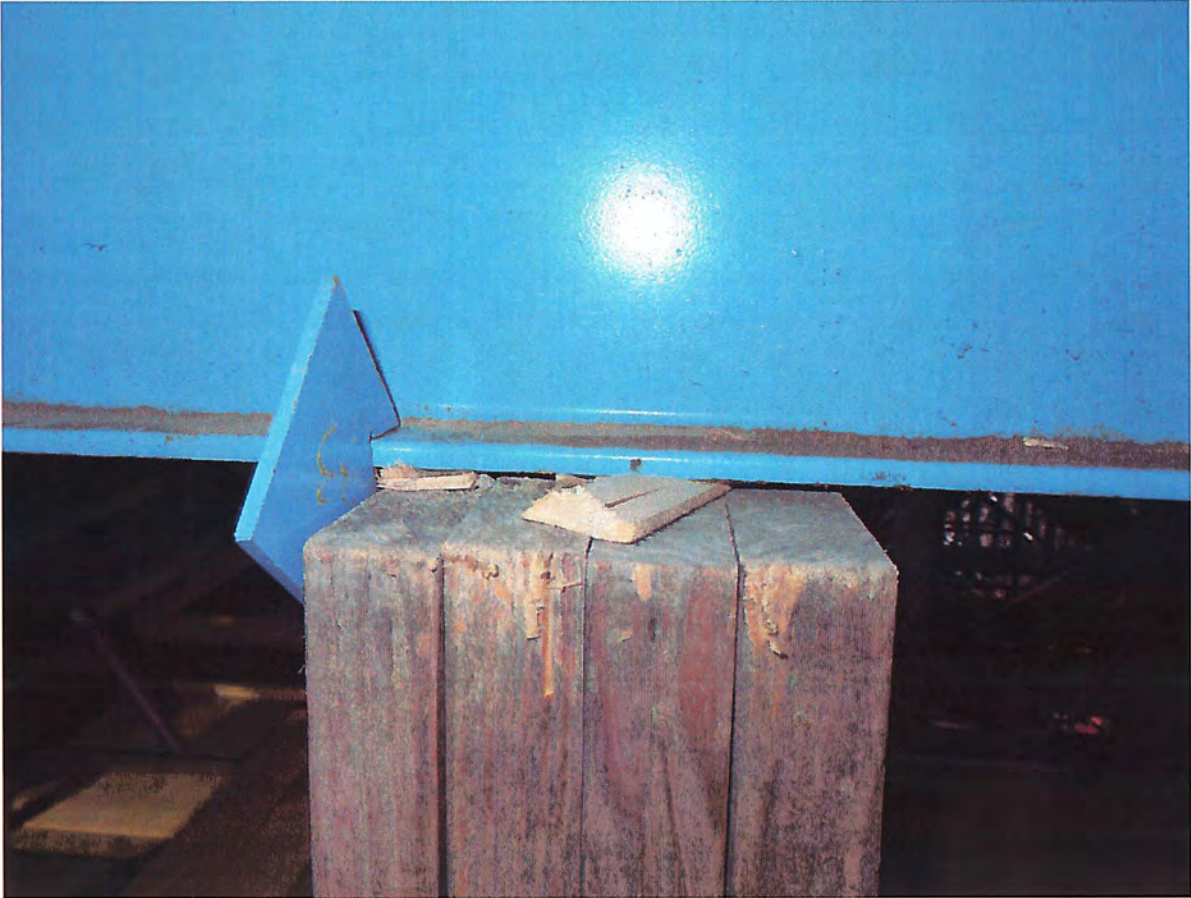
Unit 4 - Insufficient shim between post and steel beam

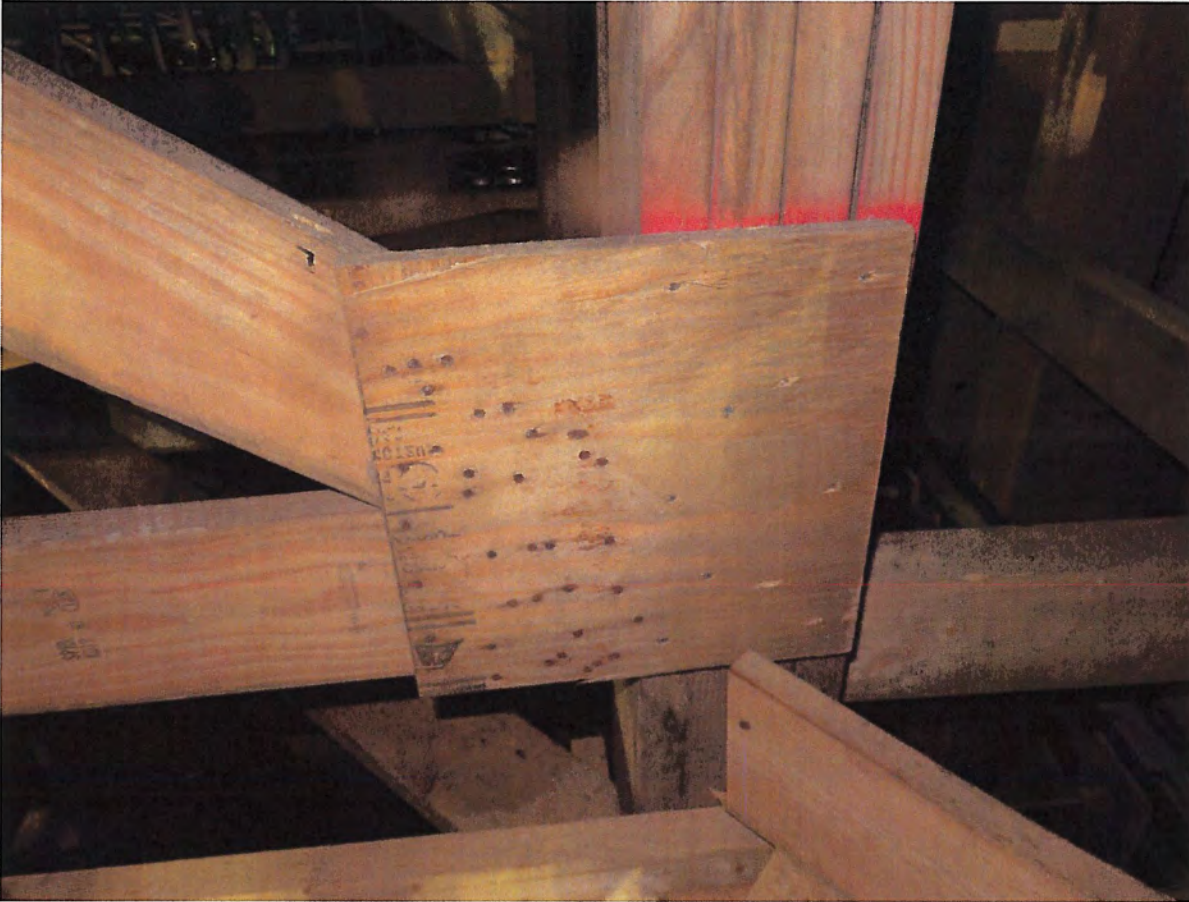
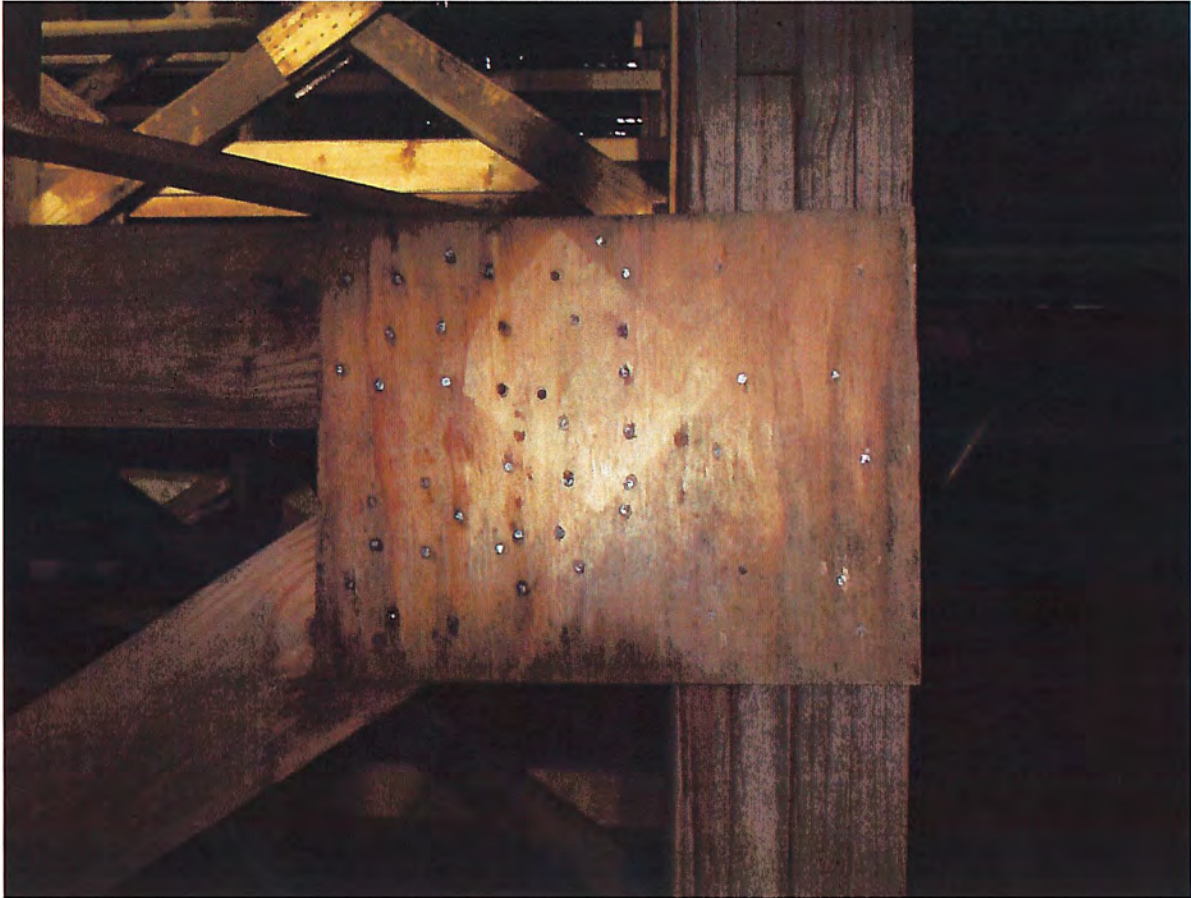
Unit 4 - Tower brace installed on site – Insufficiently nailed

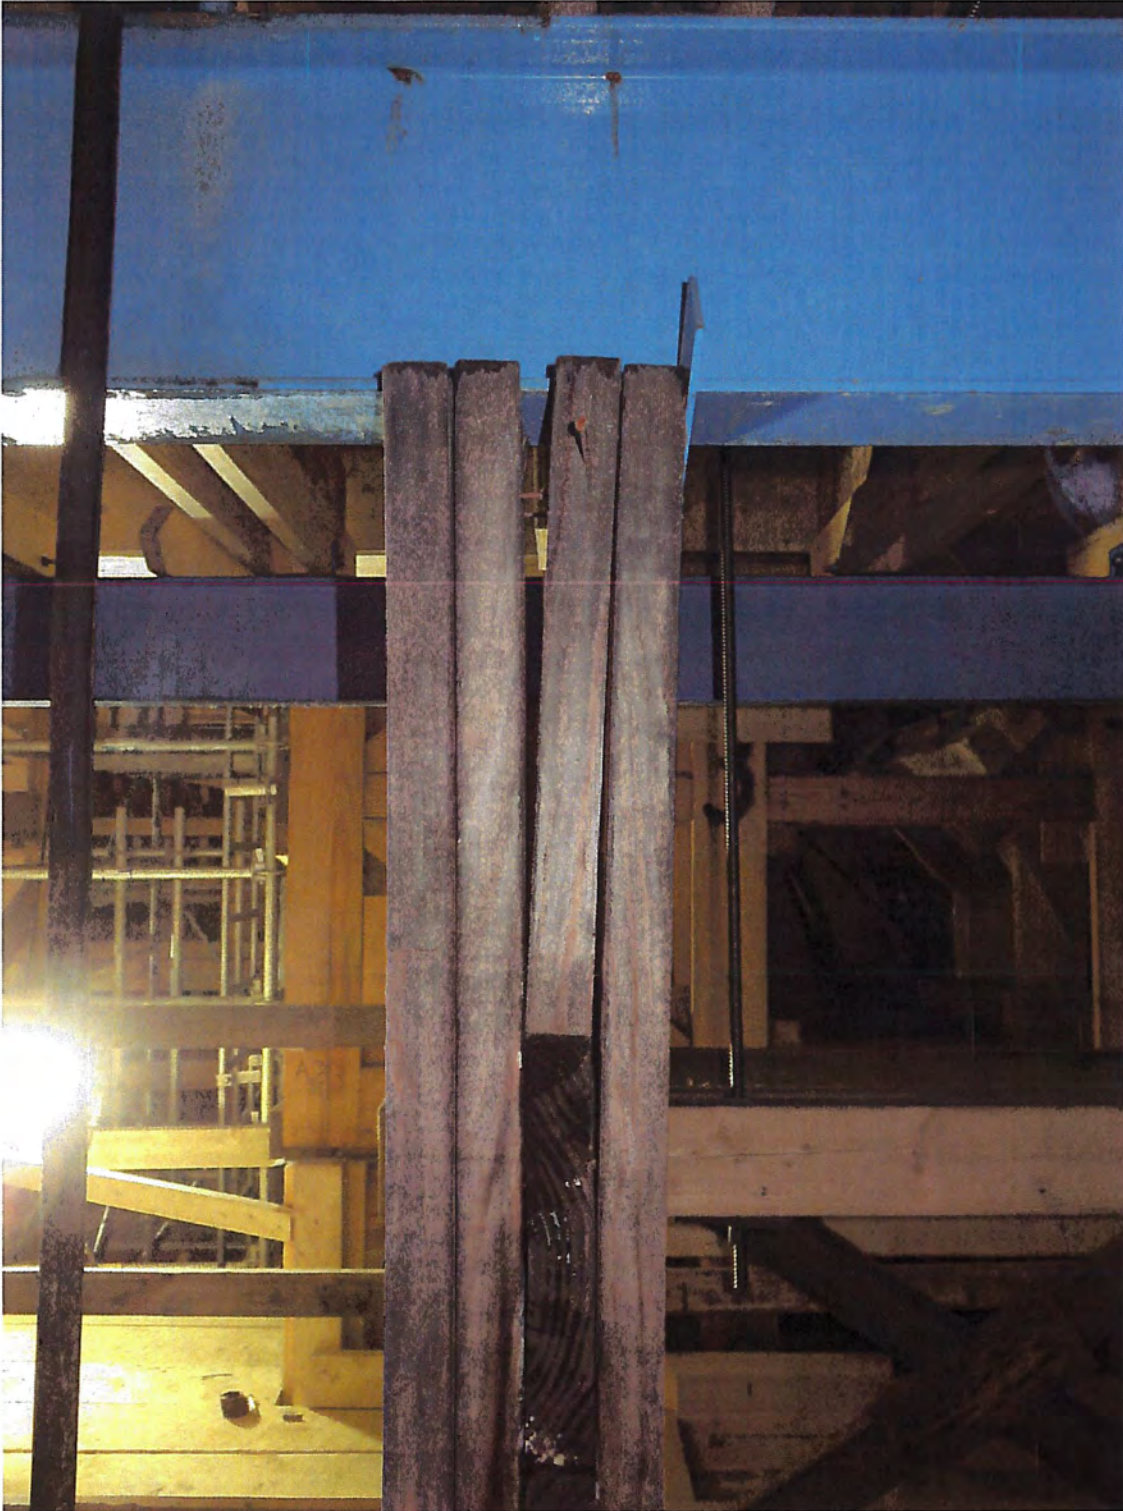
Observations on-site indicated noticeable damage to Row B's North tower indicating that readjustment was completed without the required precautions after the module was installed. The readjustment resulted in deformation to the wood structure. It would be expected that damage of this nature would be addressed, either right away, or before adding the rebar load to the shoring.

Unit 4 - Damage to tower during formwork or tower alignment

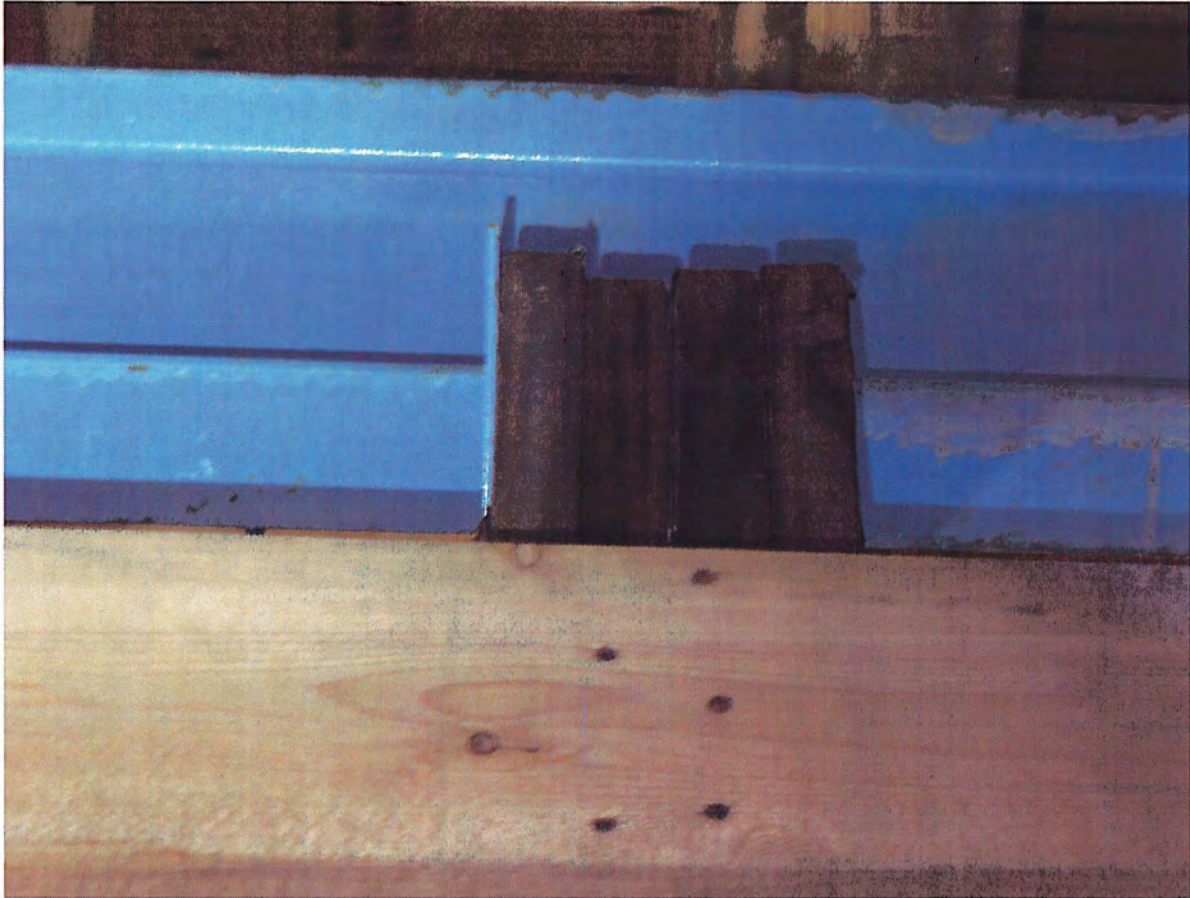
Observations on-site indicated tower legs with laminations that were not flush at the top of the tower. This observation was discussed during the visit as a fabrication issue. It is unlikely that the tower was shipped from the fabrication shop in this uneven condition. As discussed in previous sections, it is most likely the result of changes to wood moisture content (per Section 8.5.3).

Unit 4 - Uneven tower top

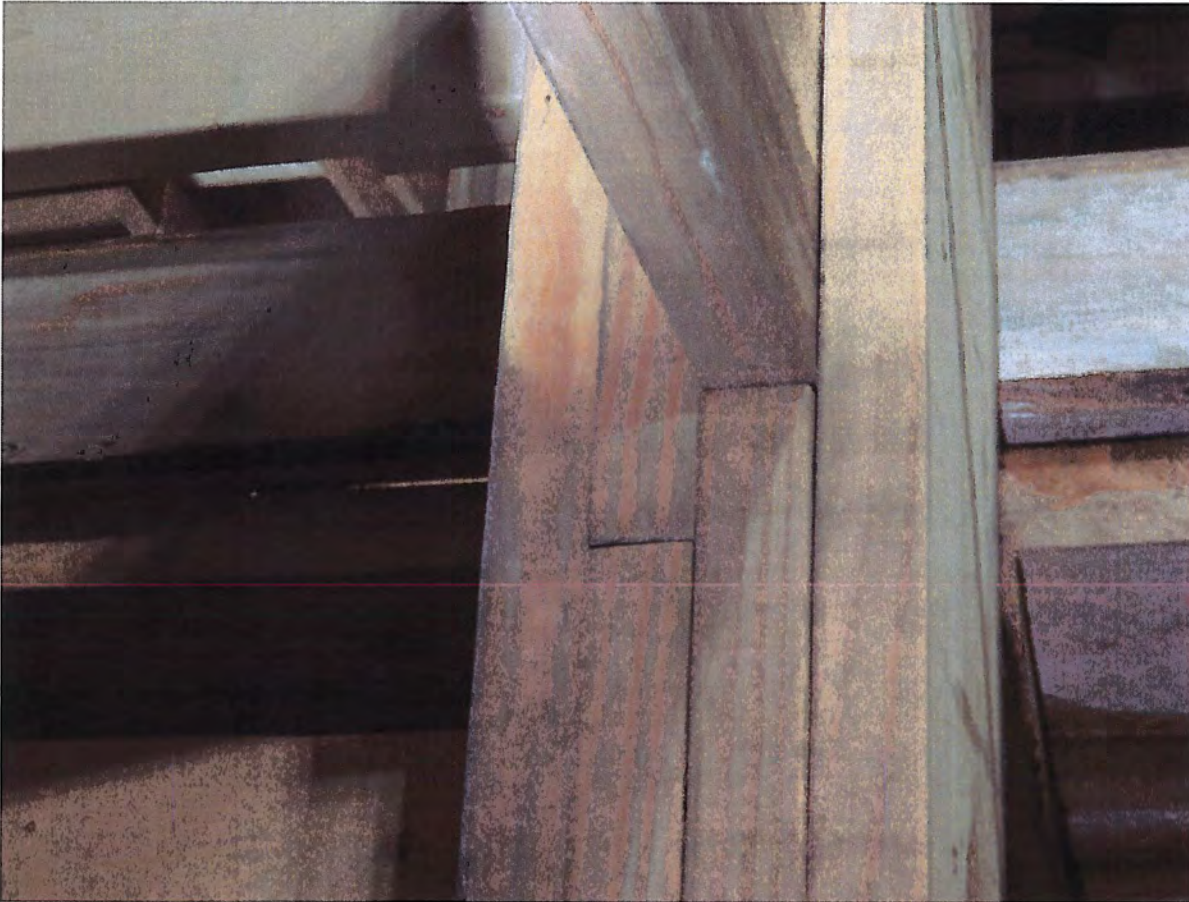
The longest tower legs were assembled using built-up planks that were spliced together. The splicing rules from CSA S269.1-16 Falsework and Formwork standard apply in this case (Section 8.5.1). Splices were found close to each other between the built-up laminations.

Per the CSA standard, the tower legs were built inadequately.

Unit 4 - Inappropriate location for built-up post joint

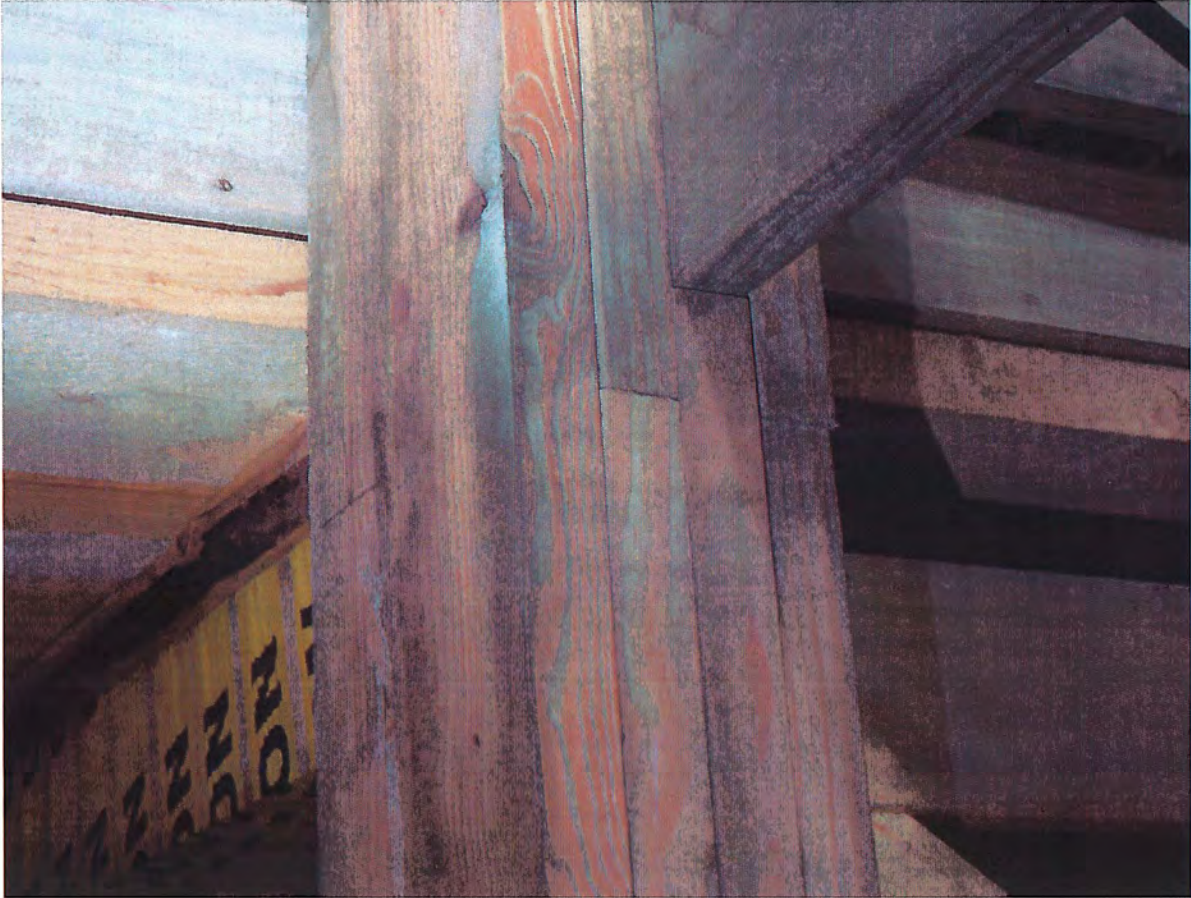
Unit 4 - Inappropriate location for built-up column joint
