Date: April 27, 2017

LOWER CHURCHILL PROJECT**TECHNICAL MEMORANDUM: Comments on the aDB Collapse Investigation Report****1 Purpose**

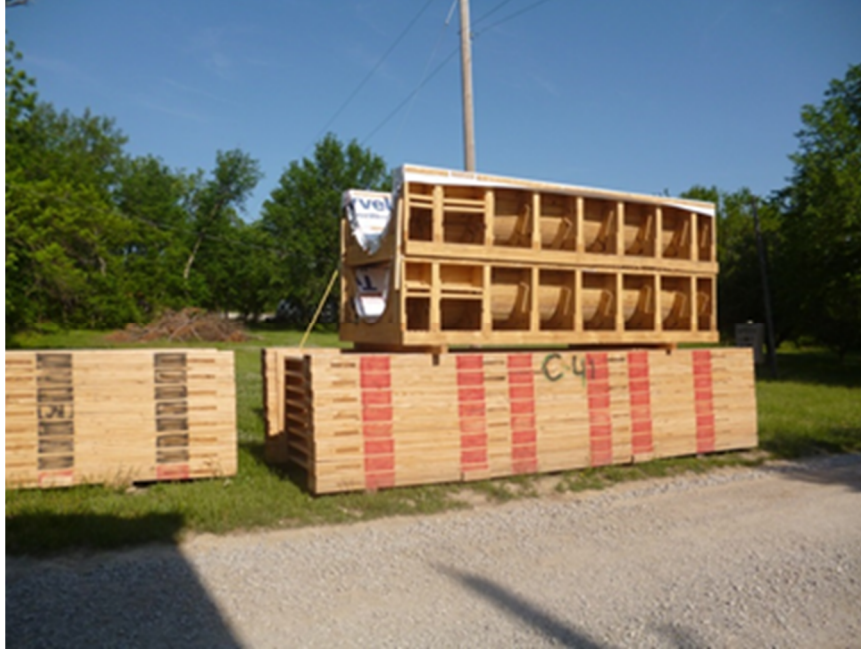
observer would likely not appreciate the impacts of southern pine being exposed to the elements over 15 months, Figure 1 through Figure 5 provide visual indication of the weathering that occurred in this period of time. The weathering is observed as darkened and grey wood surfaces. In short, weathering of formwork and falsework started prior to Astaldi receiving the materials.

Figure 1: May 15, 2014. Formwork and falsework at CEI facility. Note fresh, unweathered wood.

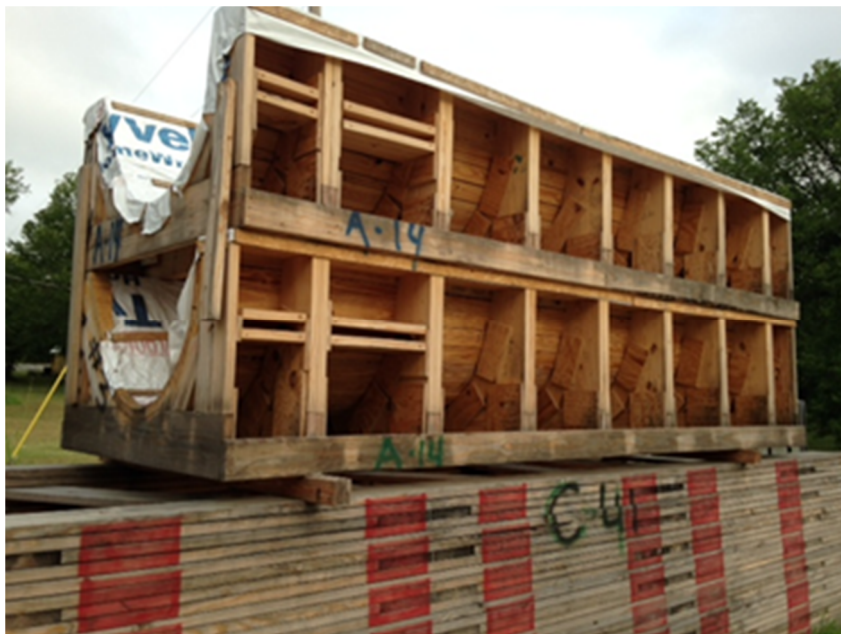
Figure 2: July 23, 2014. Formwork and falsework at CEI facility. Note onset of weathering of wood compared to same material in Figure 1.

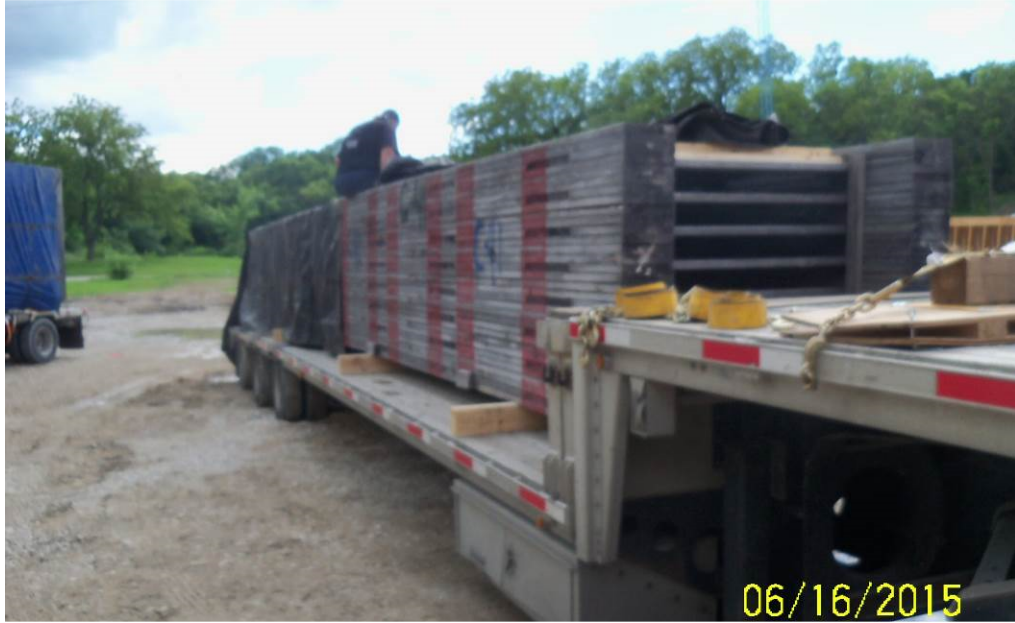
Figure 3: June 16, 2015 at CEI yard (more than one year after fabrication). Right hand view of falsework towers believed to have been installed in DT2.

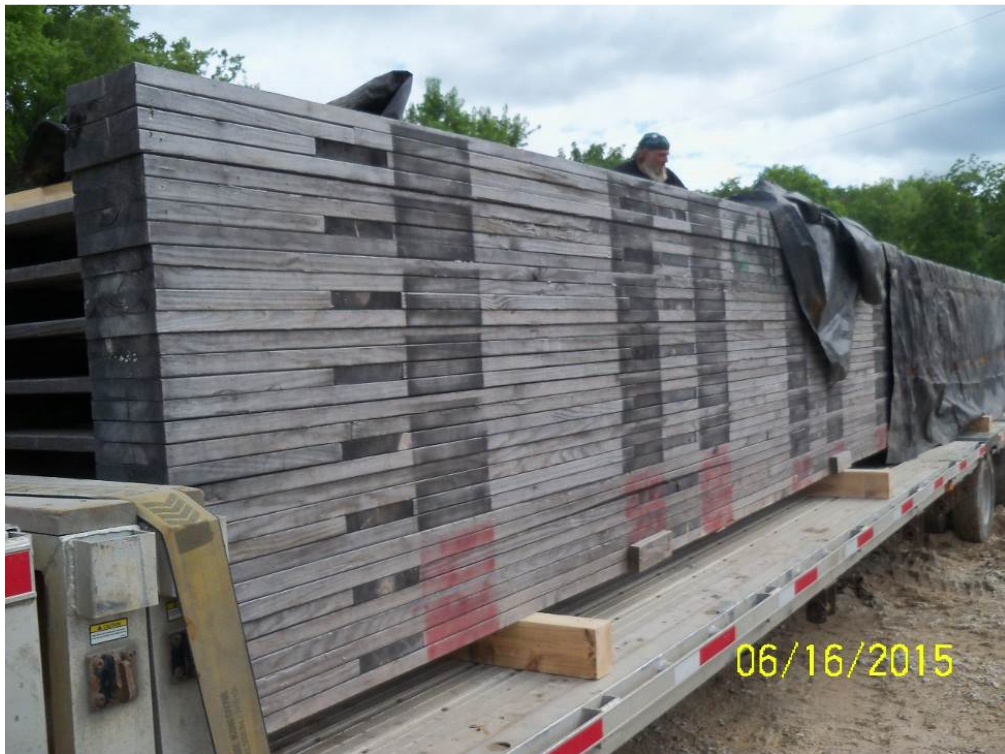
Figure 4: June 16, 2015 at CEI yard (more than one year after fabrication). Left hand view of falsework towers believed to be installed in DT2

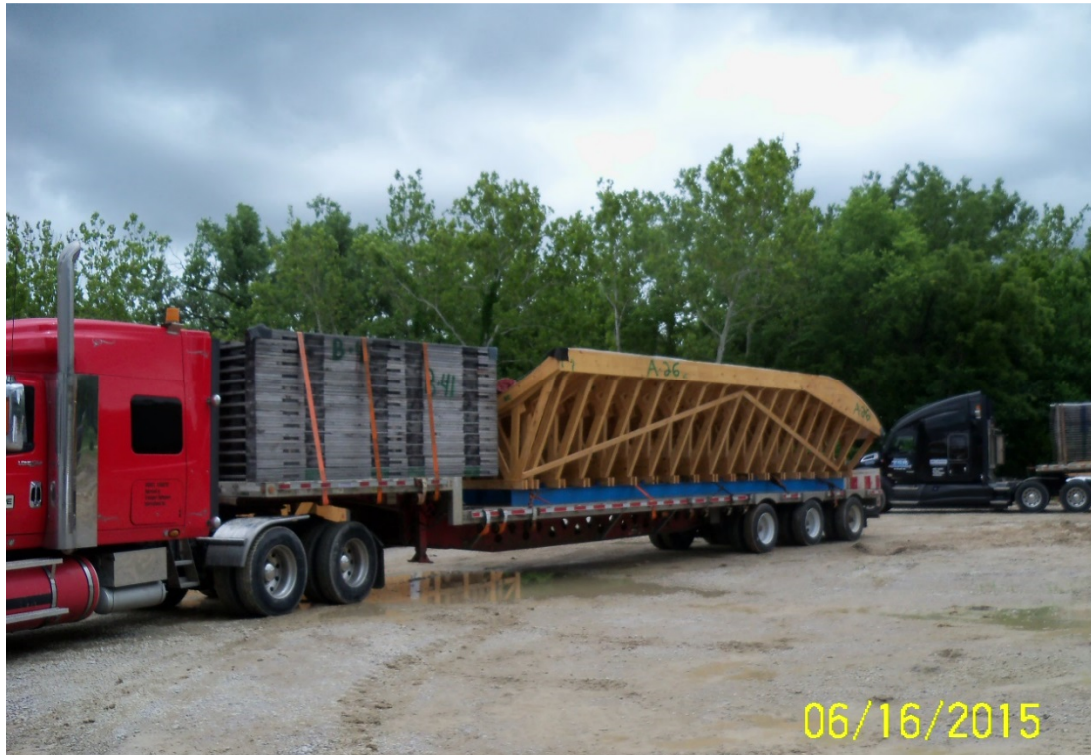
Figure 5: June 16, 2015 DT1 formwork and falsework at CEI yard in Kansas. Note weathering of tower legs relative to formwork module A26.
