### Final Engineering Assessment Report of Draft Tube 2 Formwork/Falsework Failure

This document examines the Draft Tube 2 formwork/falsework failure that occurred May 29, 2016 on the Lower Churchill Project. ILF Consultants Inc. (ILF) has performed field inspections, reviewed design and fabrication documents, care and preservation practices, and erection and inspection documentation in an effort to identify the cause of failure.

On May 29, 2016, the timber formwork and falsework supporting concrete pour D2ESB-03 in Draft Tube 2 (DT2) failed nearing completion of the 530 cubic meter pour. On May 30, 2016, Newfoundland and Labrador Occupational Health and Safety (OHS) issued Stop Work Order #0671924-01. This effectively stopped all concrete work in the powerhouse until the falsework and formwork systems were evaluated by a Structural Professional Engineer (P.Eng.) licensed to practice in the Province.

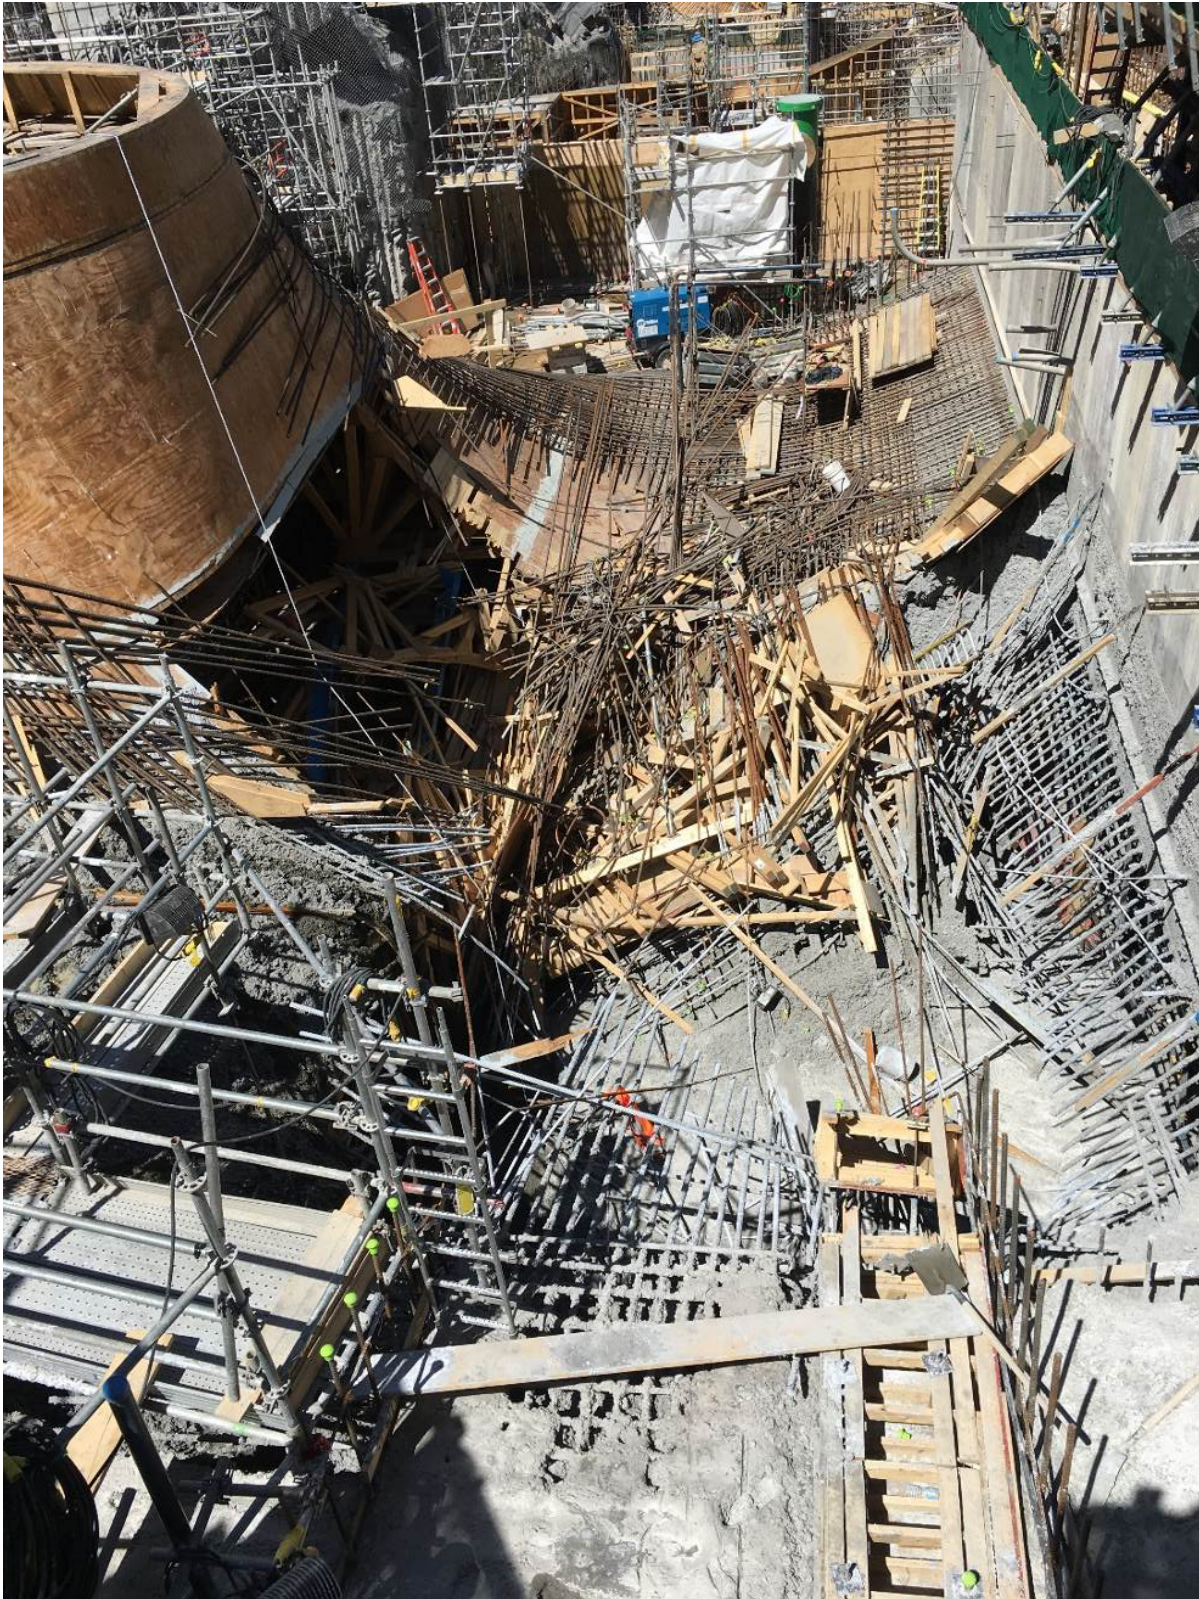
Figure 8: DT2 failure area, looking north

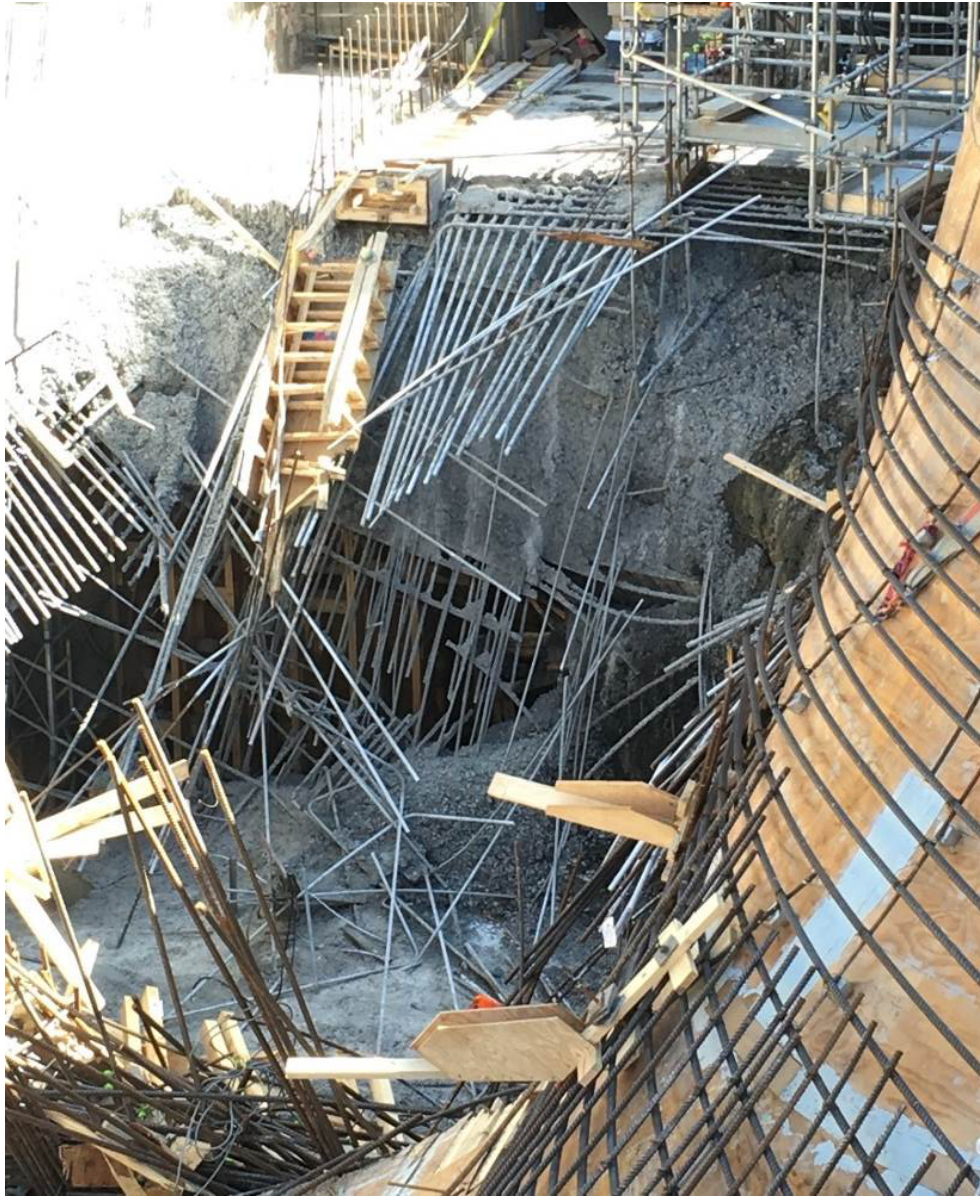
Figure 9: DT2 failure area looking southeast

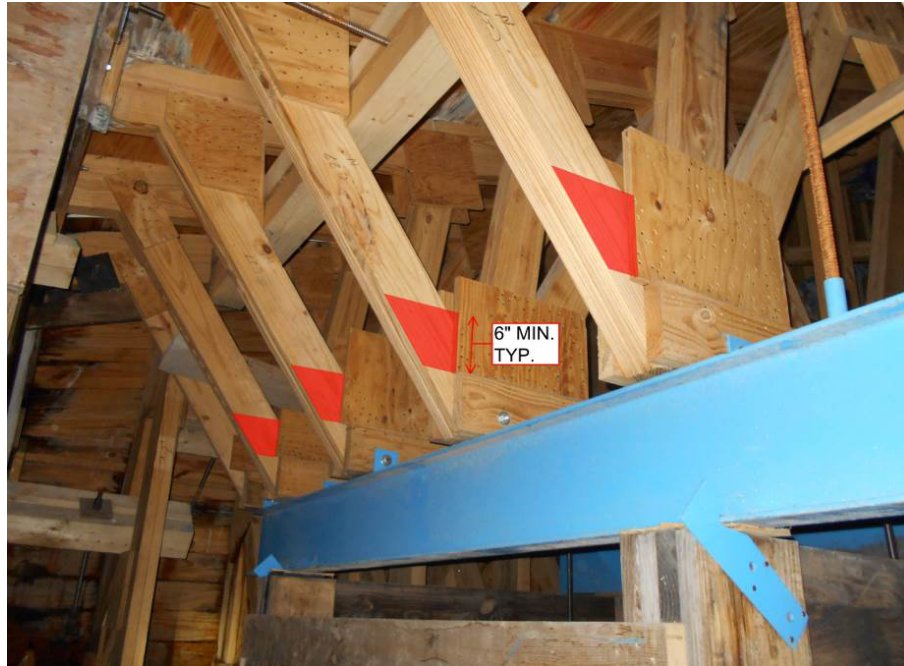
Figure 17: Inadequate splice plates should extend to area in red

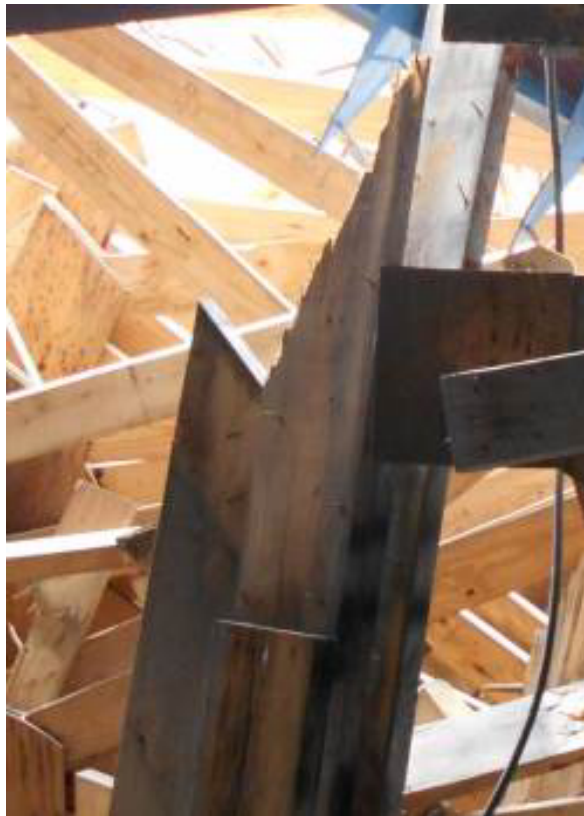
Figure 18: Inadequate nail length (did not penetrate all column laminations)

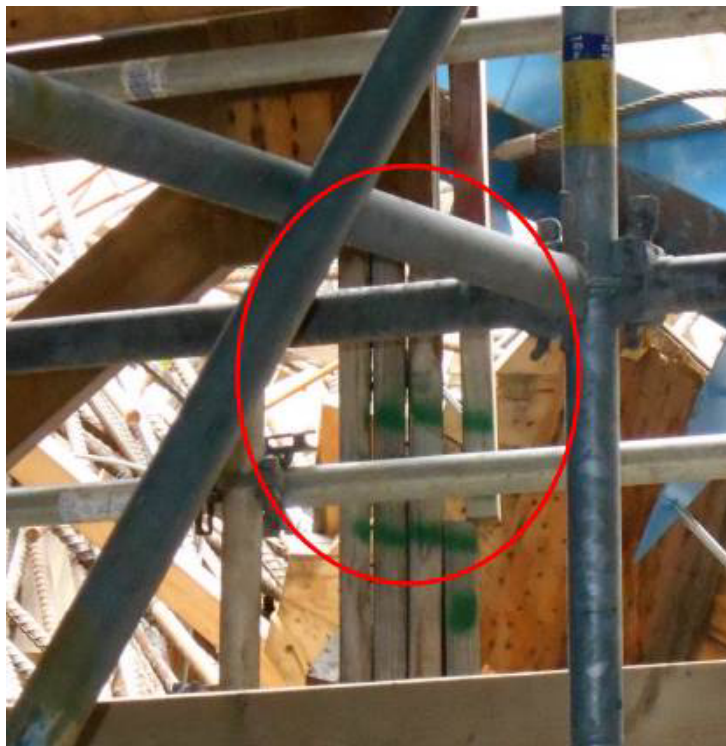
Figure 19: Built-up column members separating due inadequate joining

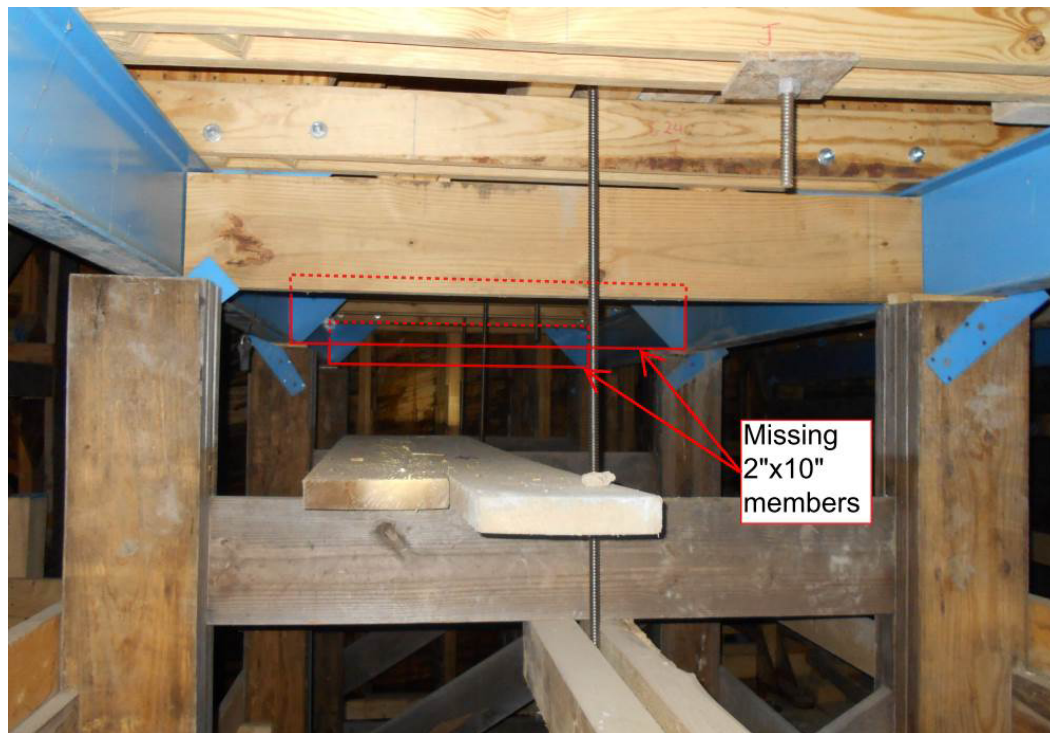
Figure 20: Missing members between steel beams above Tower B1

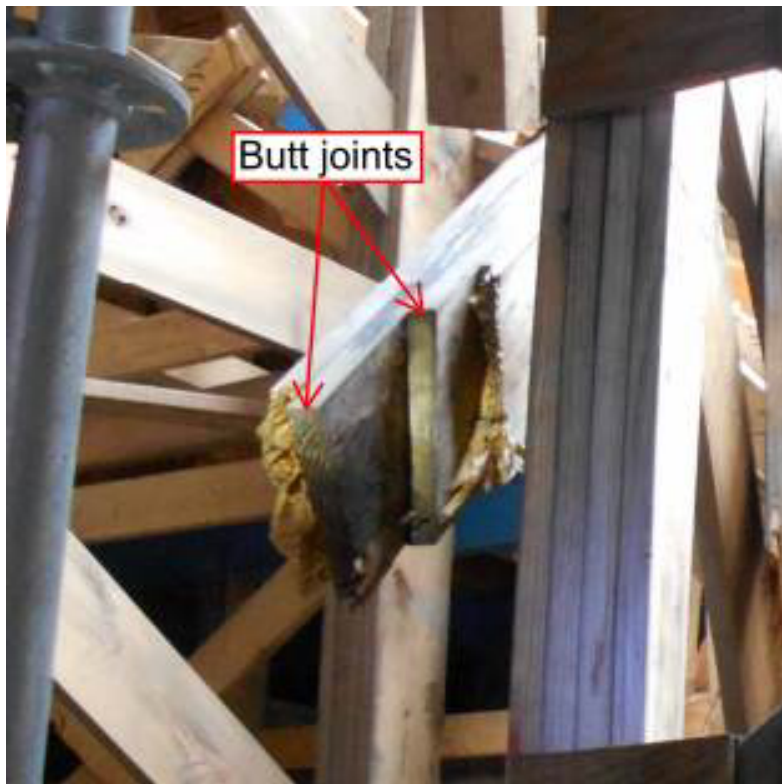
Figure 21: Close proximity of butt joints in broken tower leg

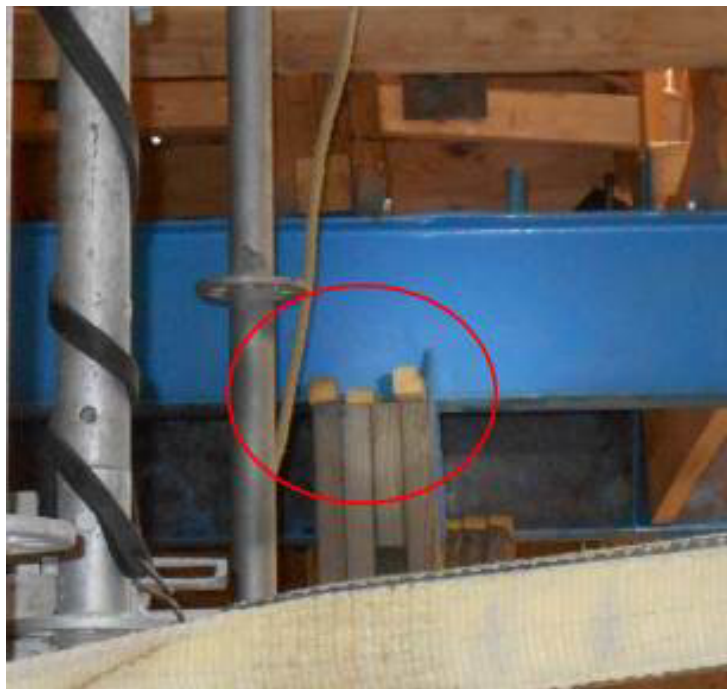
Figure 27: Inadequate shimming on top of falsework towers. No bearing plate installed

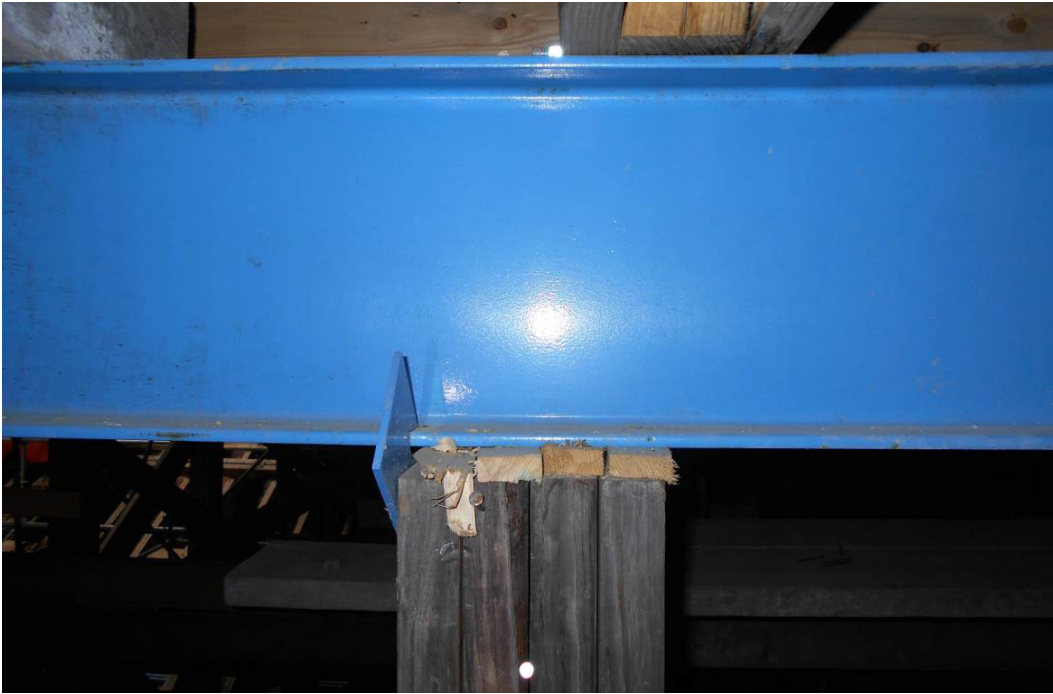
Figure 28: Inadequate shimming on top of falsework towers. No bearing plate installed.

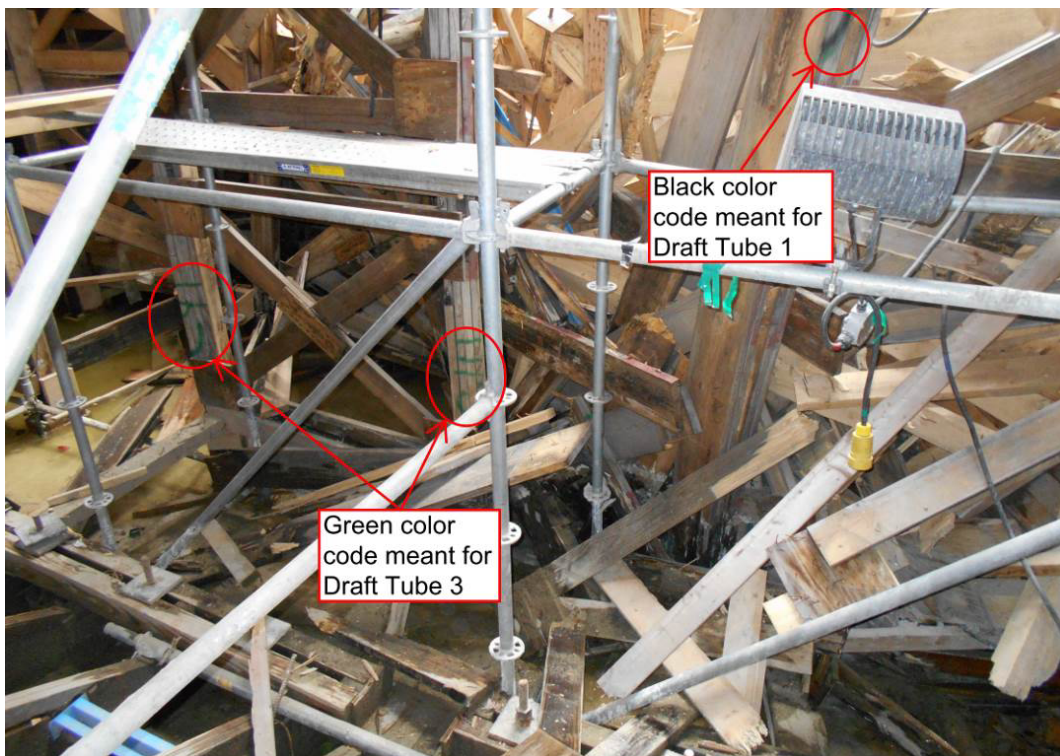
Falsework towers colored coded green and black (meant for Draft Tubes 3 and 1 respectively) were installed in DT 2. The correct color code should be blue, matching identifying markings for formwork installed in DT2. See Figure 24. The use of multiple color codes poses no practical impact to structural capacity of the formwork and falsework but is poor practice leading to potential for confusion in the field.

Figure 29: Incorrect color coding used in DT2

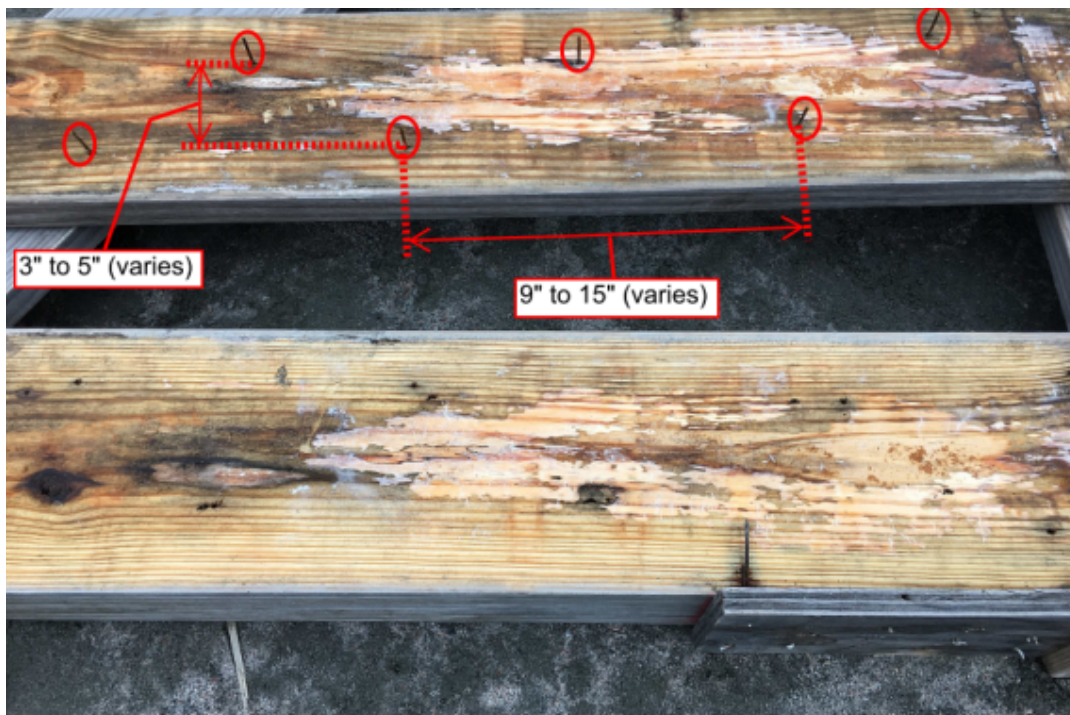
During disassembly of tower legs, ILF documented the size of nails and approximate spacing. It was observed that two rows of 2  $\frac{3}{4}$  inch ring shank nails were used, with nail spacing varying between 9 and 15 inches (230 and 380 mm). This does not meet NDS or CSA requirements for joining a built up member as nails must be in two rows at 9 inch (230mm) centers (max) with nails penetrating all members, at least  $\frac{3}{4}$  through the farther outer lamination. A nail with length over 5.5 inches (140mm) would be needed to meet this requirement.

Figure 45: Typical nailing pattern used to build up falsework tower leg member

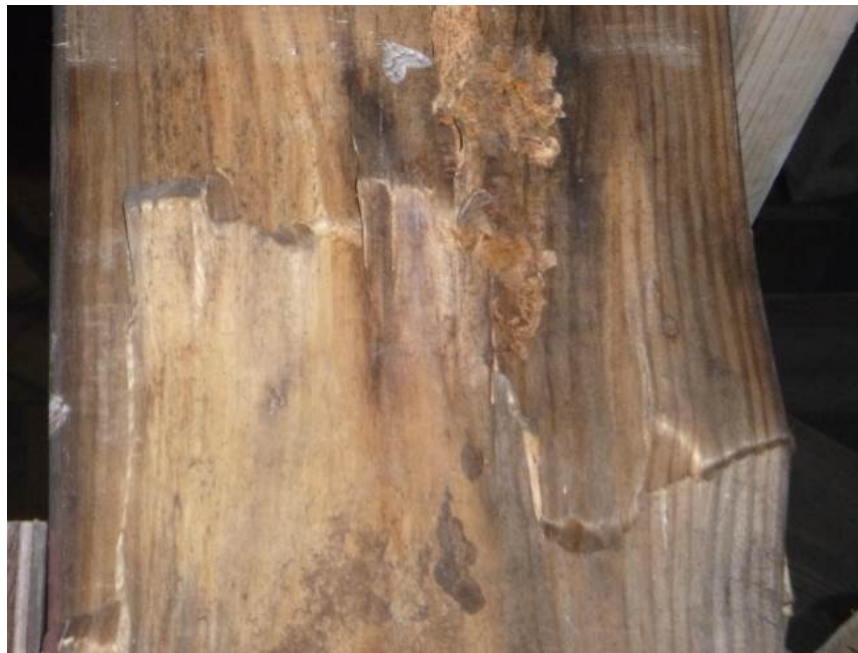
Figure 50 through Figure 52 indicate the overstress due to lack of bearing plate and penetrating bracing members results in failure of tower legs. The performance of falsework in DT1 is indicative of the types of failure anticipated to have occurred in DT2 prior to collapse. These photographs were taken by ILF in Draft Tube 1 on June 10, 2016.

Figure 50: Local failure of outer ply of tower leg in DT1

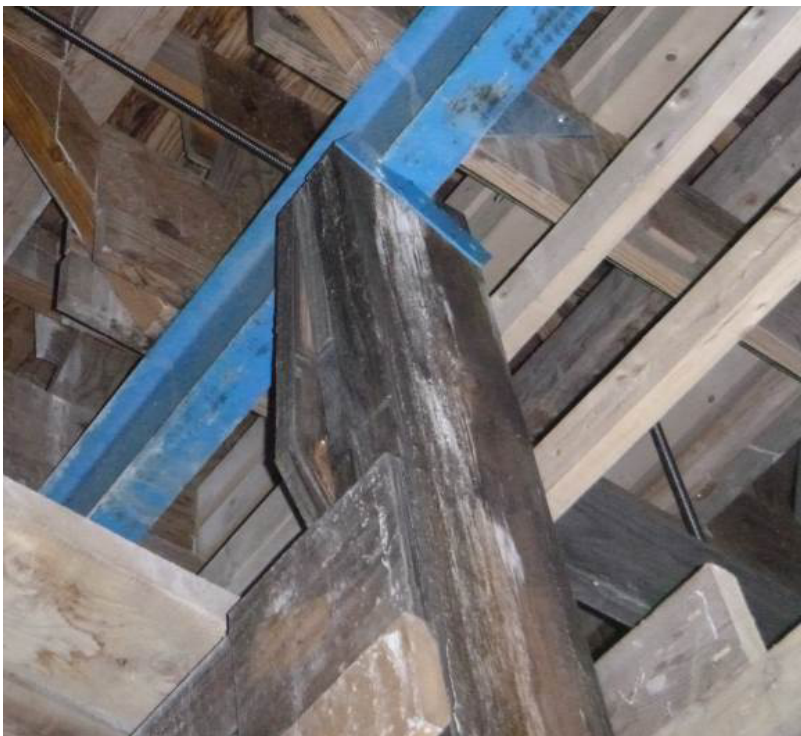
Figure 51: Local failure of tower leg at bracing penetration in DT1

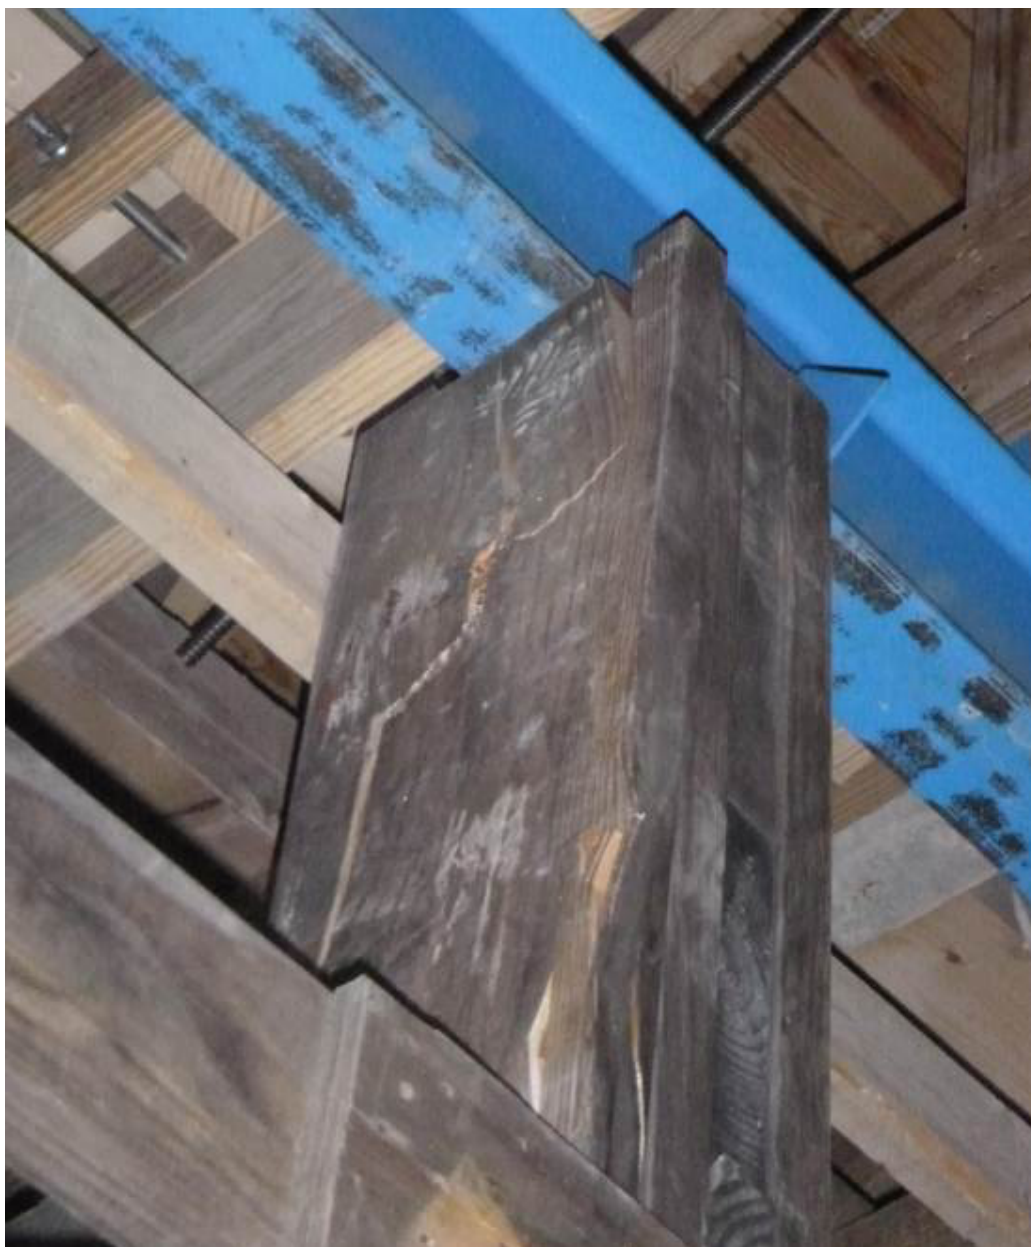
Figure 52: Local failure of tower leg at beam interface and bracing penetration in DT1

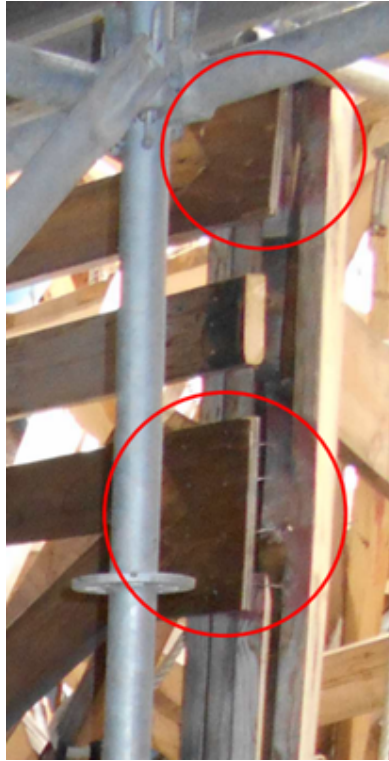
Inadequate nailing of splice plates to falsework tower legs was observed. Nailing patterns were random and did not adhere to the typical splice plate detail shown on drawing #MFA-AT-SD-3310-CS-D04-0001-01\_C1. See figures below for examples observed in DT2.

Figure 53: Splice plates pulling away from column legs in DT2

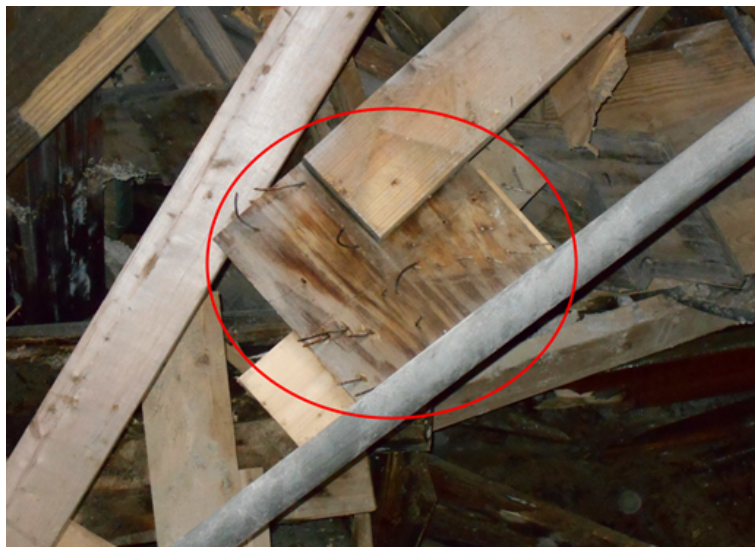
Figure 54: Inadequate nailing of splice plate in DT2

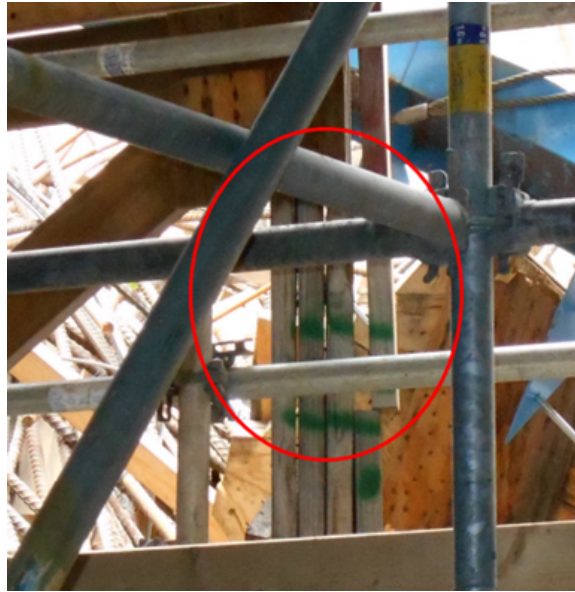
Figure 56: Inadequate joining of built-up member, members separating

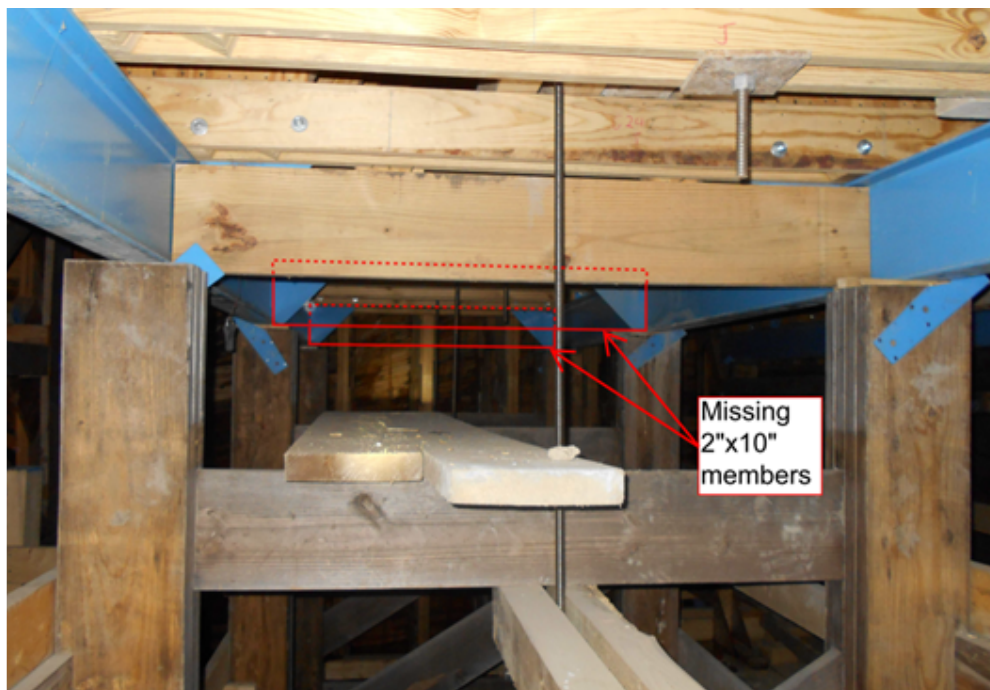
There were two (2) 2"x10" lateral supporting members missing that were to be installed in the web of the two steel beams above the falsework towers B1 and B3. The members reduced the unbraced length of the steel beams and provided lateral stability. Their omission reduced the capacity of the steel beams. See Figure 57.

Figure 57: Missing members between beams. DT3 tower B1

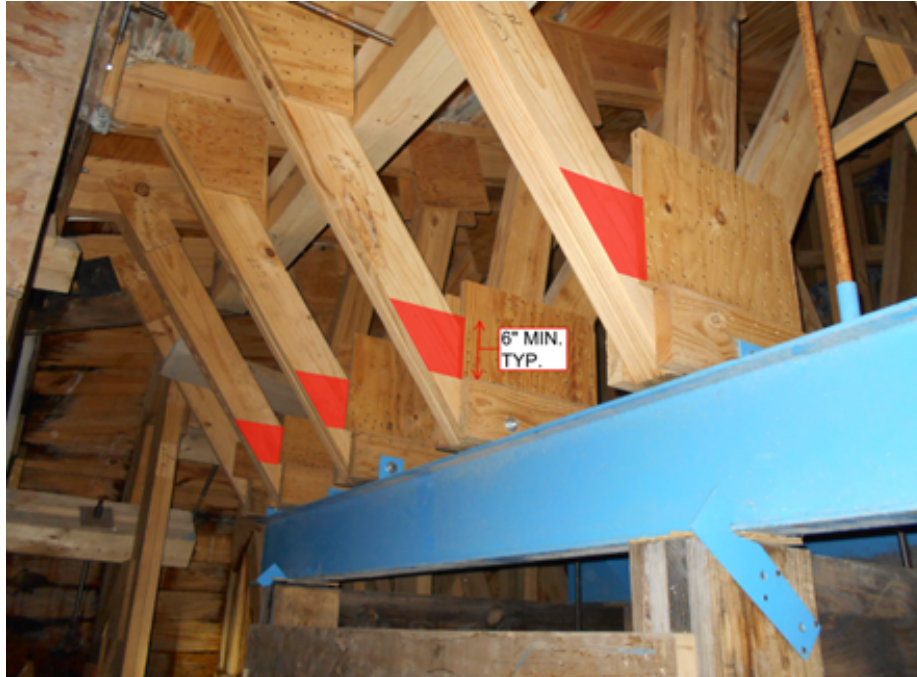
The splice plates used in the ribs overlying the falsework towers were generally too small and did not adhere to the typical splice plate detail shown on drawing MFA-AT-SD-3310-CS-D04-0001-01\_C1.

Figure 58: Inadequate splice plate size DT2

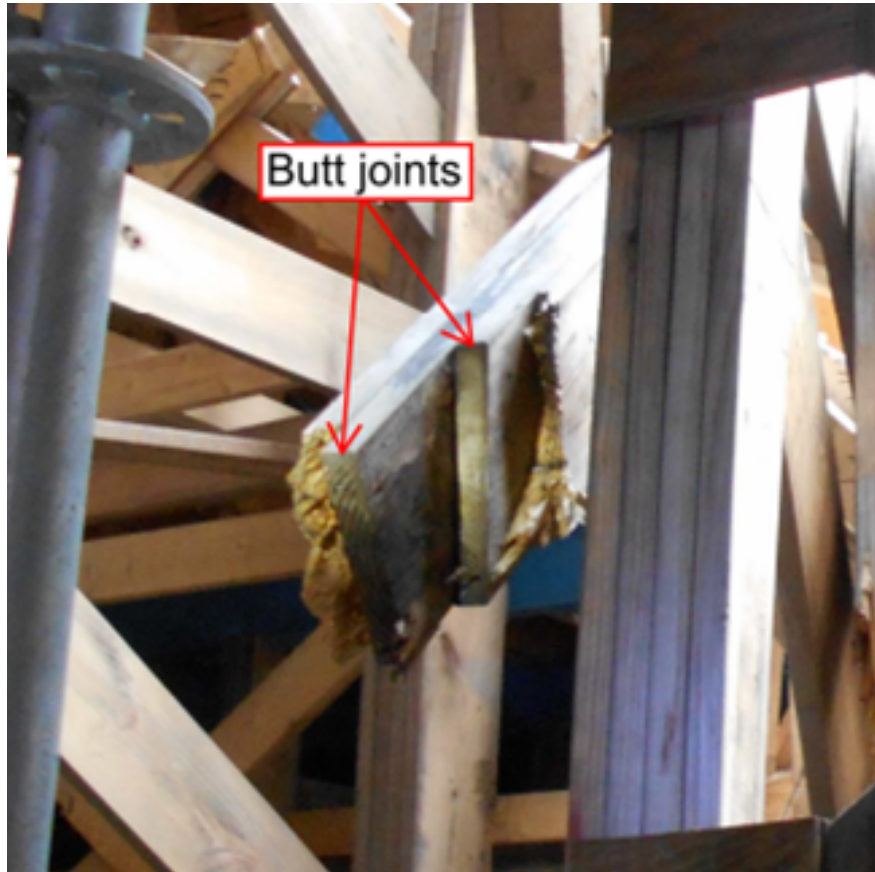
Butt joints in some column members were not appropriately staggered and were observed to be too close together. See figure below.

Figure 59: Close proximity of butt joints in broken tower leg

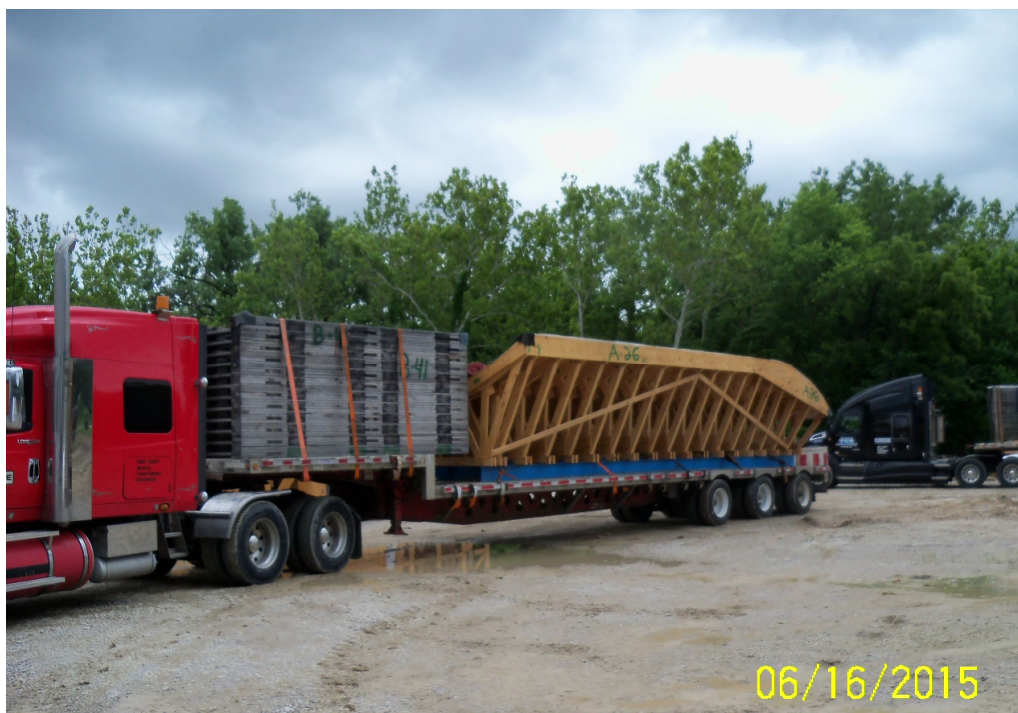
Figure 66: June 16, 2015 DT1 formwork and falsework at CEI yard in Kansas. Note weathering of tower legs relative to formwork module A26.

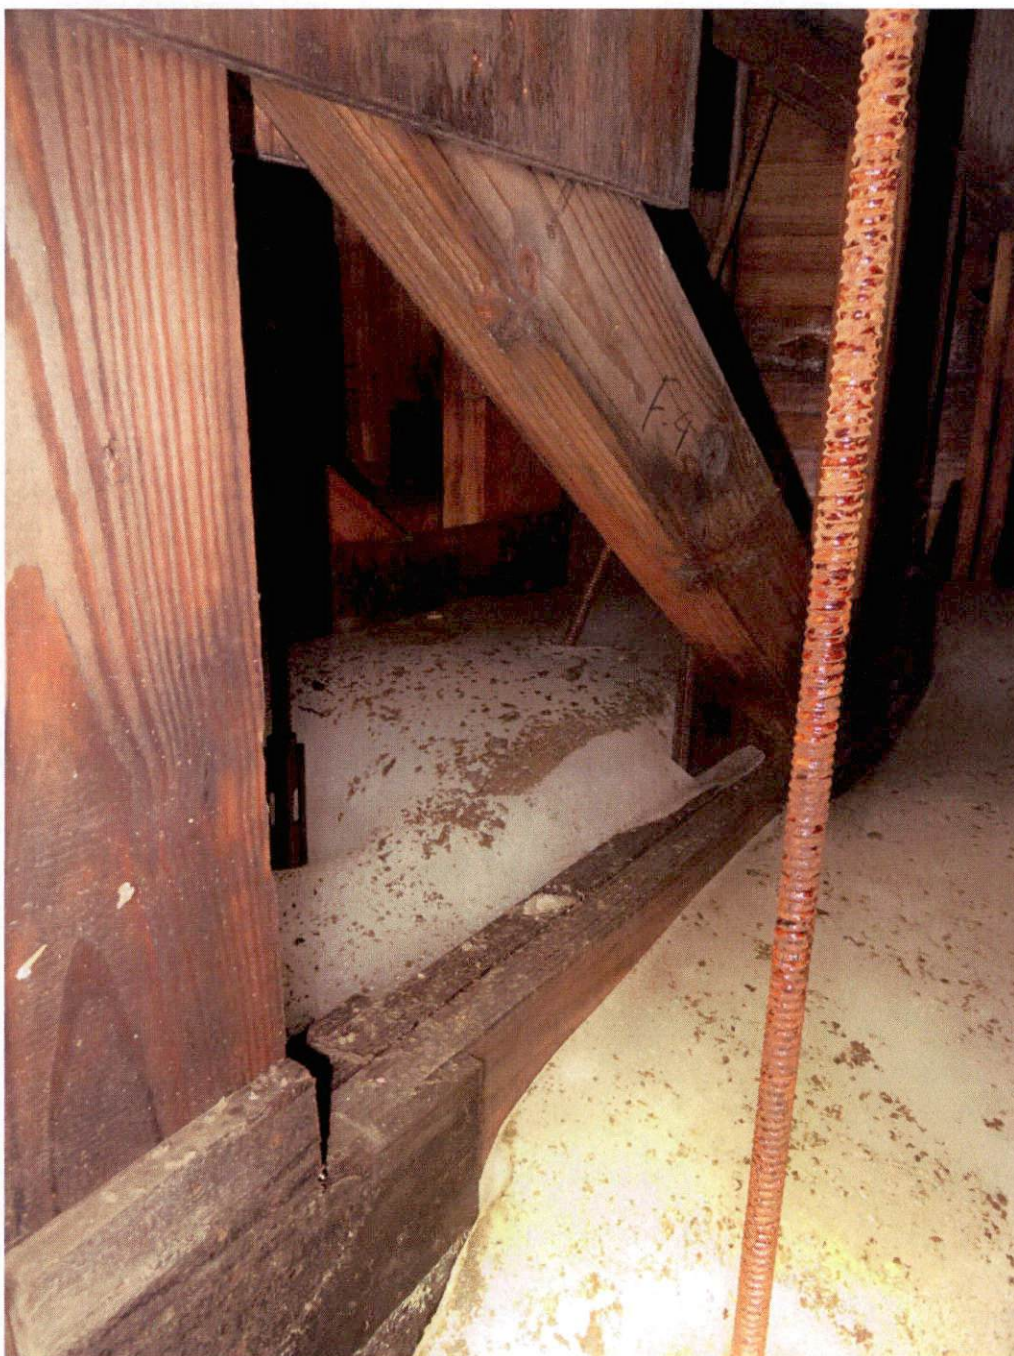
Unit 1 - Ice built up within ribs of panels A9

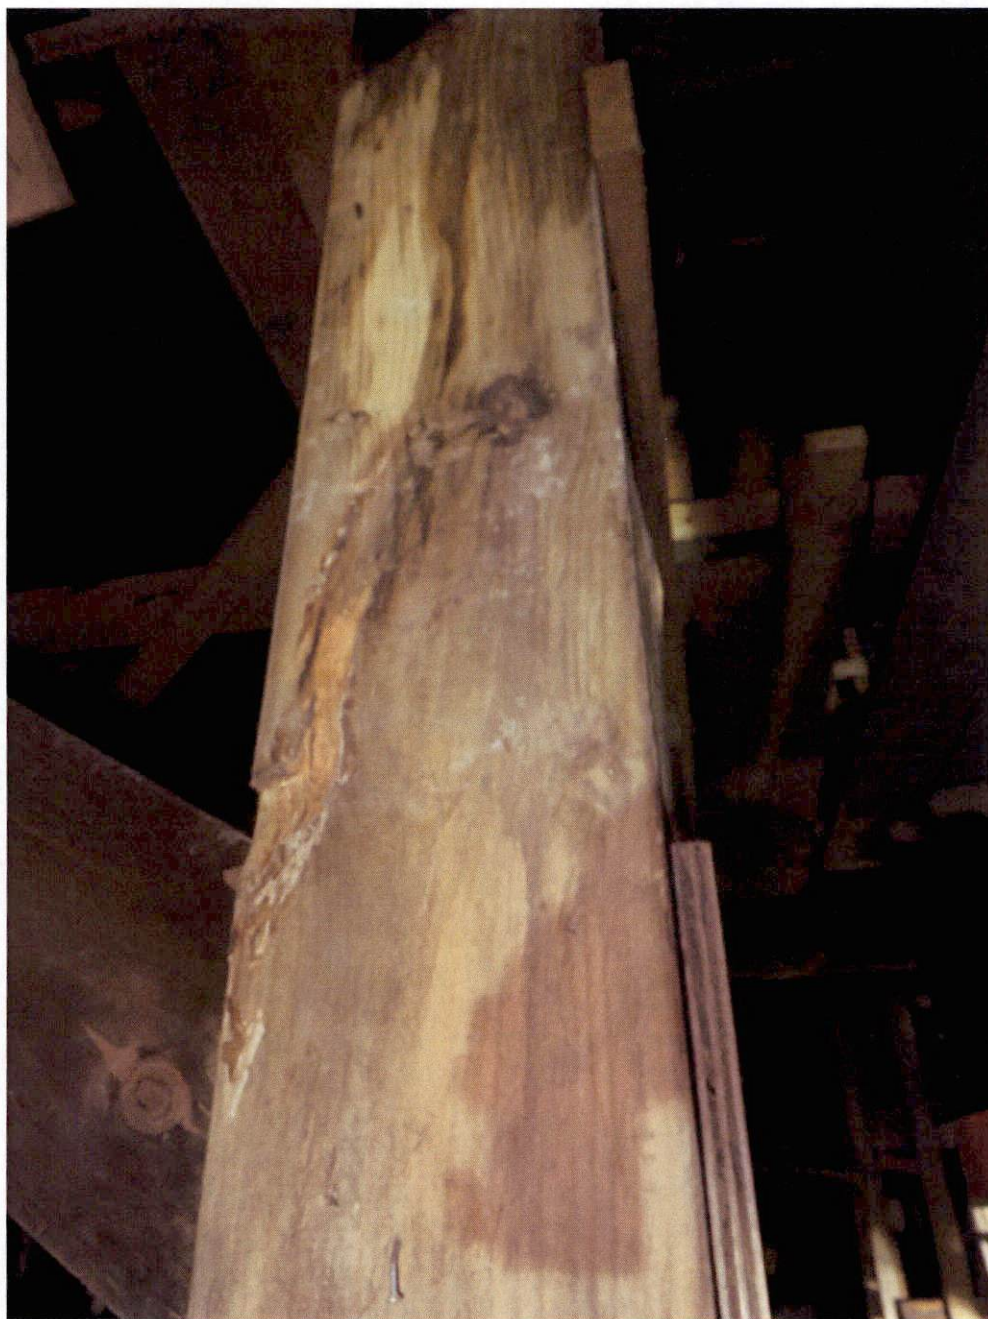
Unit 1 - Fungi growth on lumber of tower B4

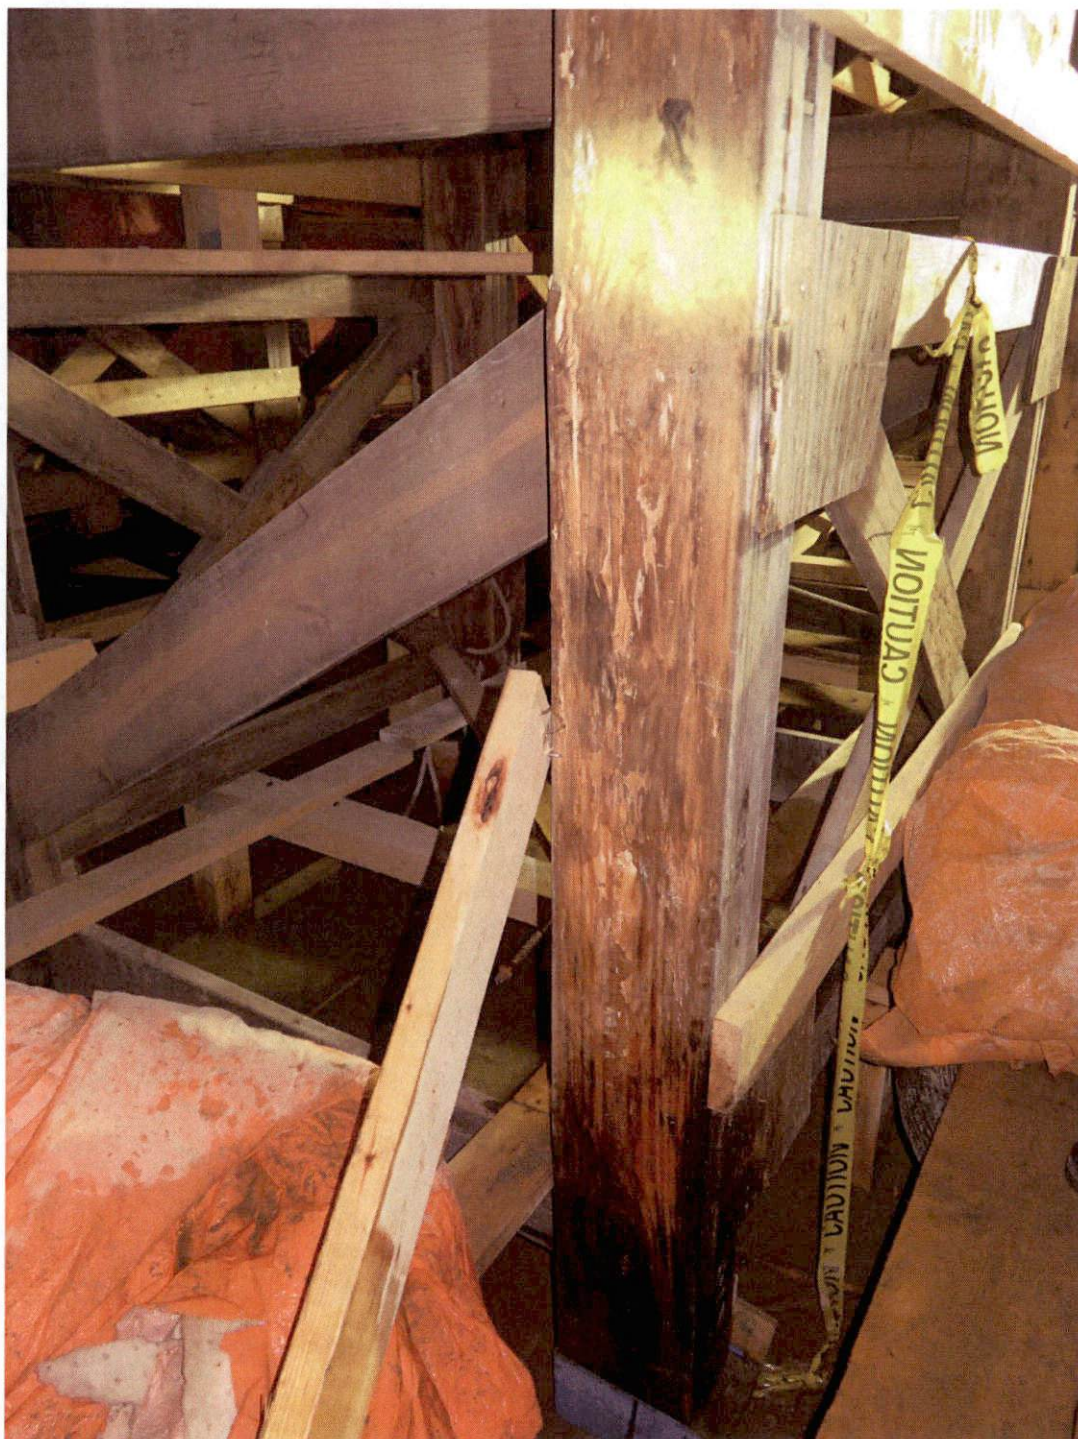
Unit 1 - Decayed wood on tower B3

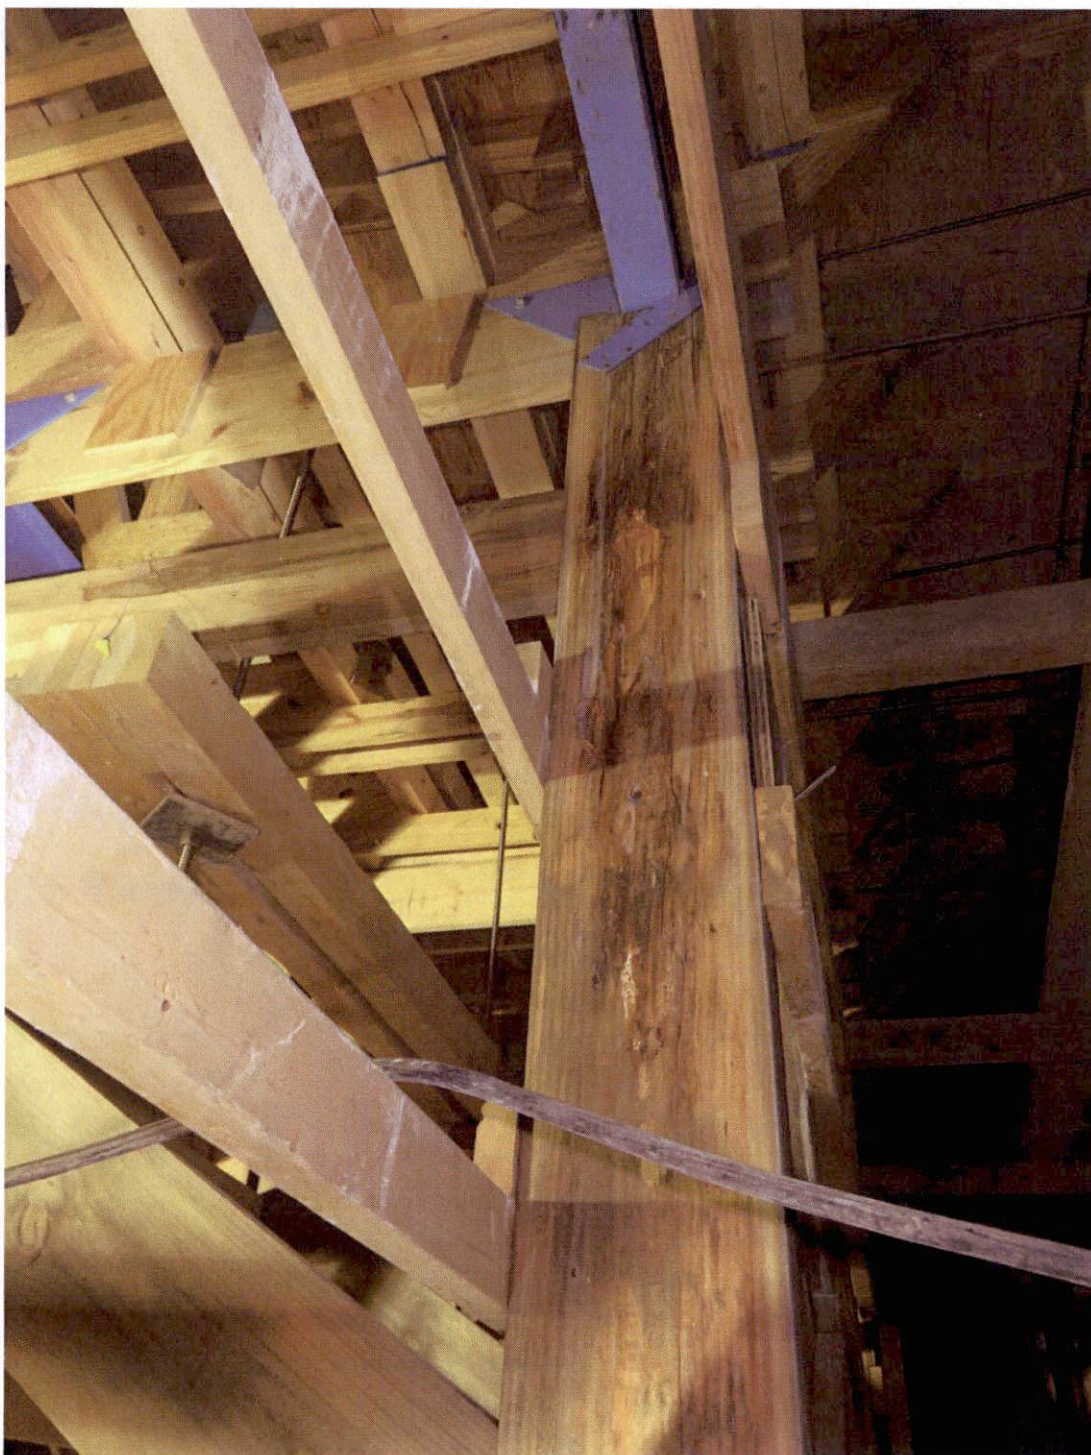
Unit 1 - Decayed wood on tower B2
