### Final Engineering Assessment Report of Draft Tube 2 Formwork/Falsework Failure

This document examines the Draft Tube 2 formwork/falsework failure that occurred May 29, 2016 on the Lower Churchill Project. ILF Consultants Inc. (ILF) has performed field inspections, reviewed design and fabrication documents, care and preservation practices, and erection and inspection documentation in an effort to identify the cause of failure.

On May 29, 2016, the timber formwork and falsework supporting concrete pour D2ESB-03 in Draft Tube 2 (DT2) failed nearing completion of the 530 cubic meter pour. On May 30, 2016, Newfoundland and Labrador Occupational Health and Safety (OHS) issued Stop Work Order #0671924-01. This effectively stopped all concrete work in the powerhouse until the falsework and formwork systems were evaluated by a Structural Professional Engineer (P.Eng.) licensed to practice in the Province.

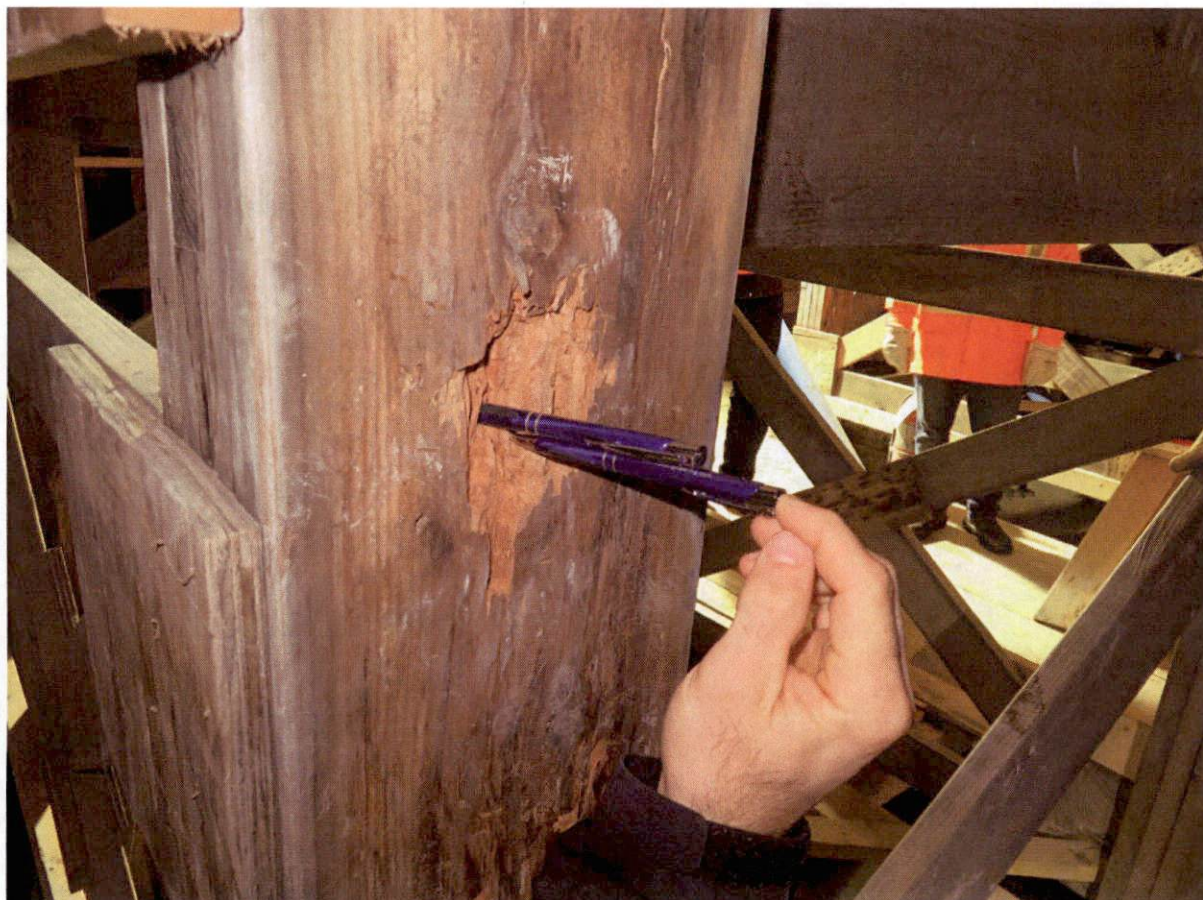
Unit 1 - Dry rot on shoring tower

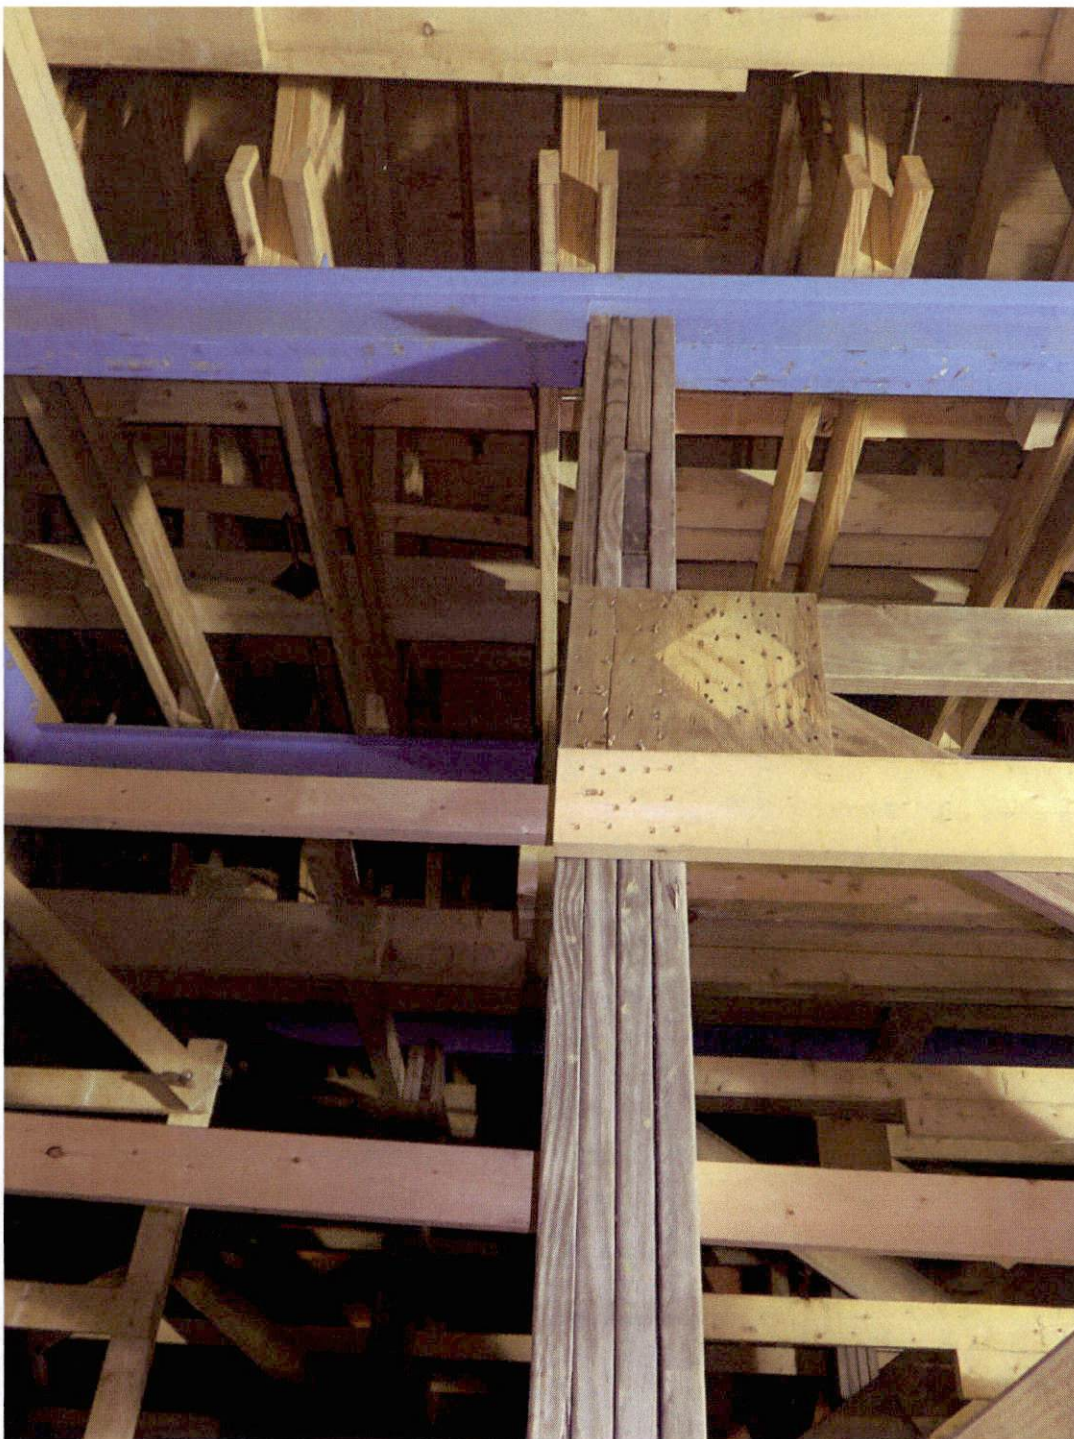
Unit 1 - Tower B2, buckling at top of post

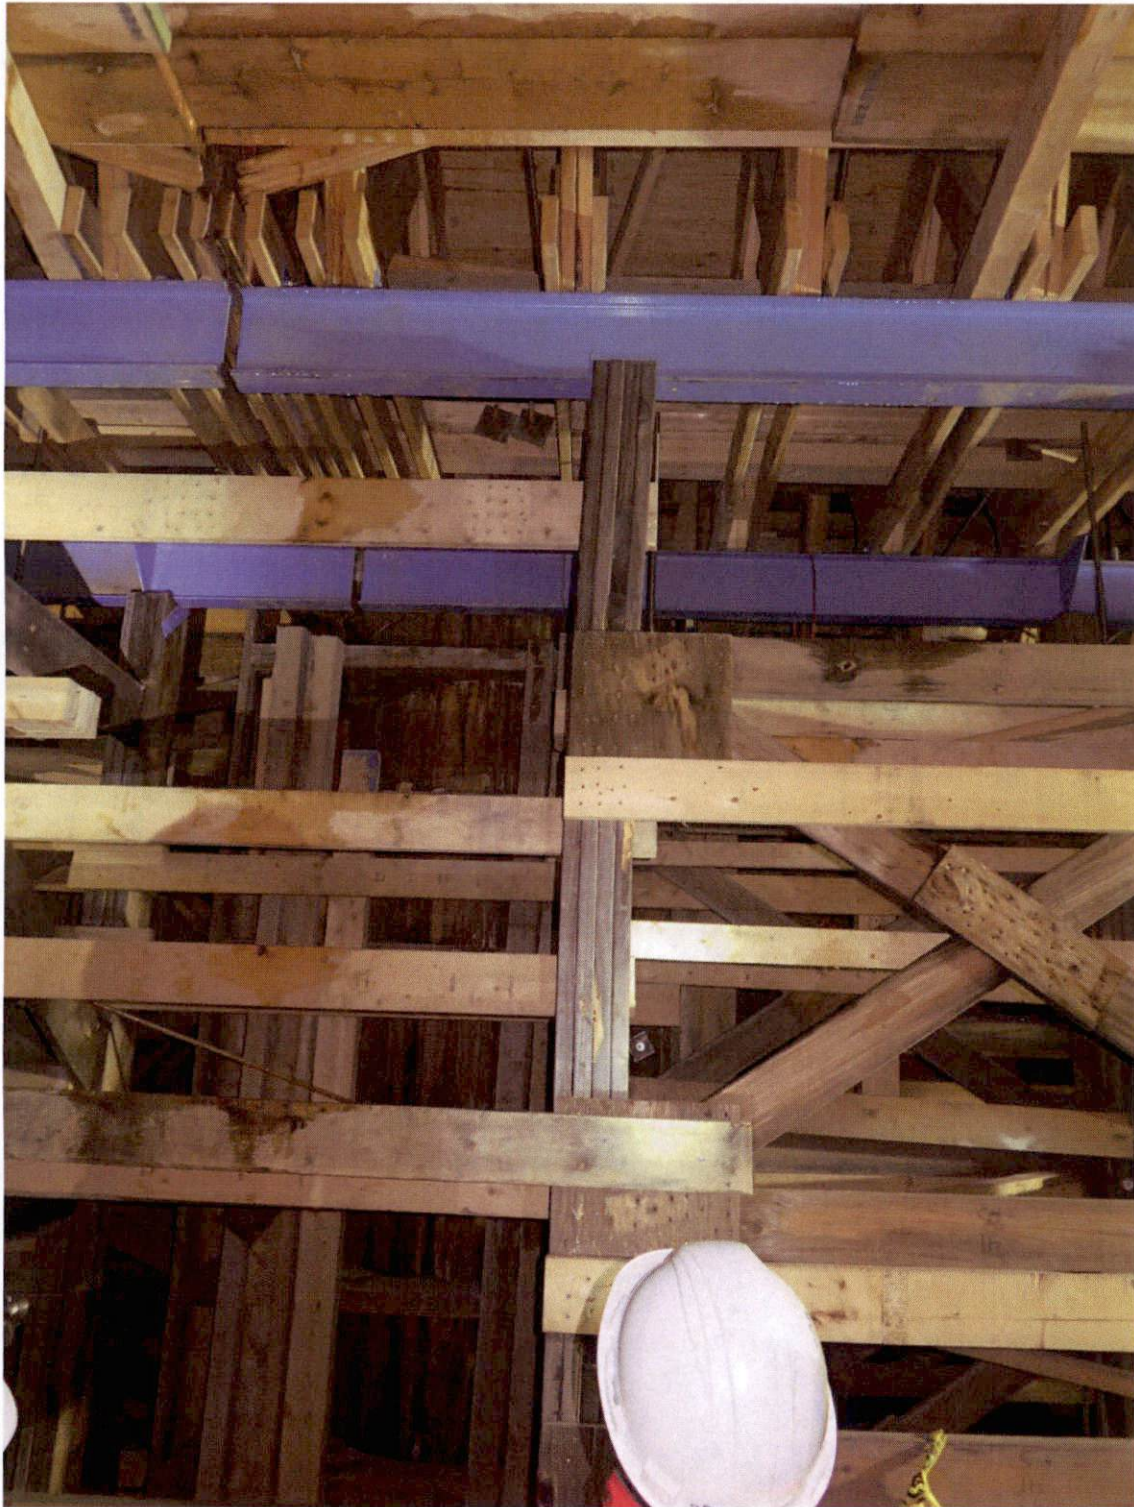
Unit 1 - Tower B3, buckling at top of post

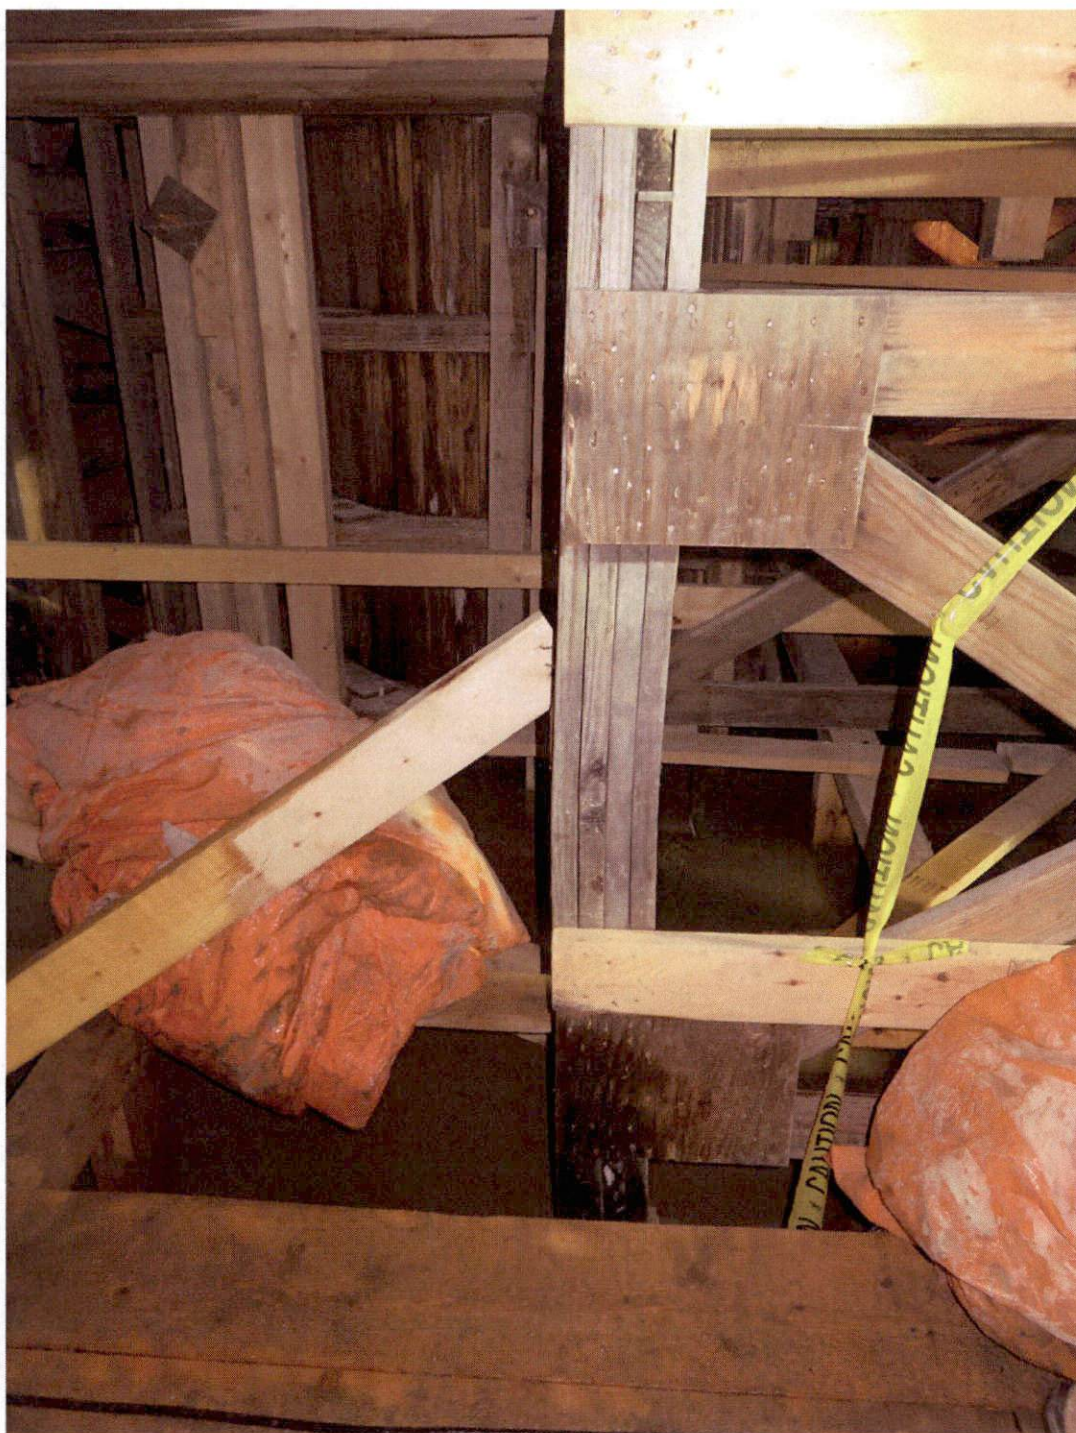
Unit 1 - Tower B3, buckling at bottom of post

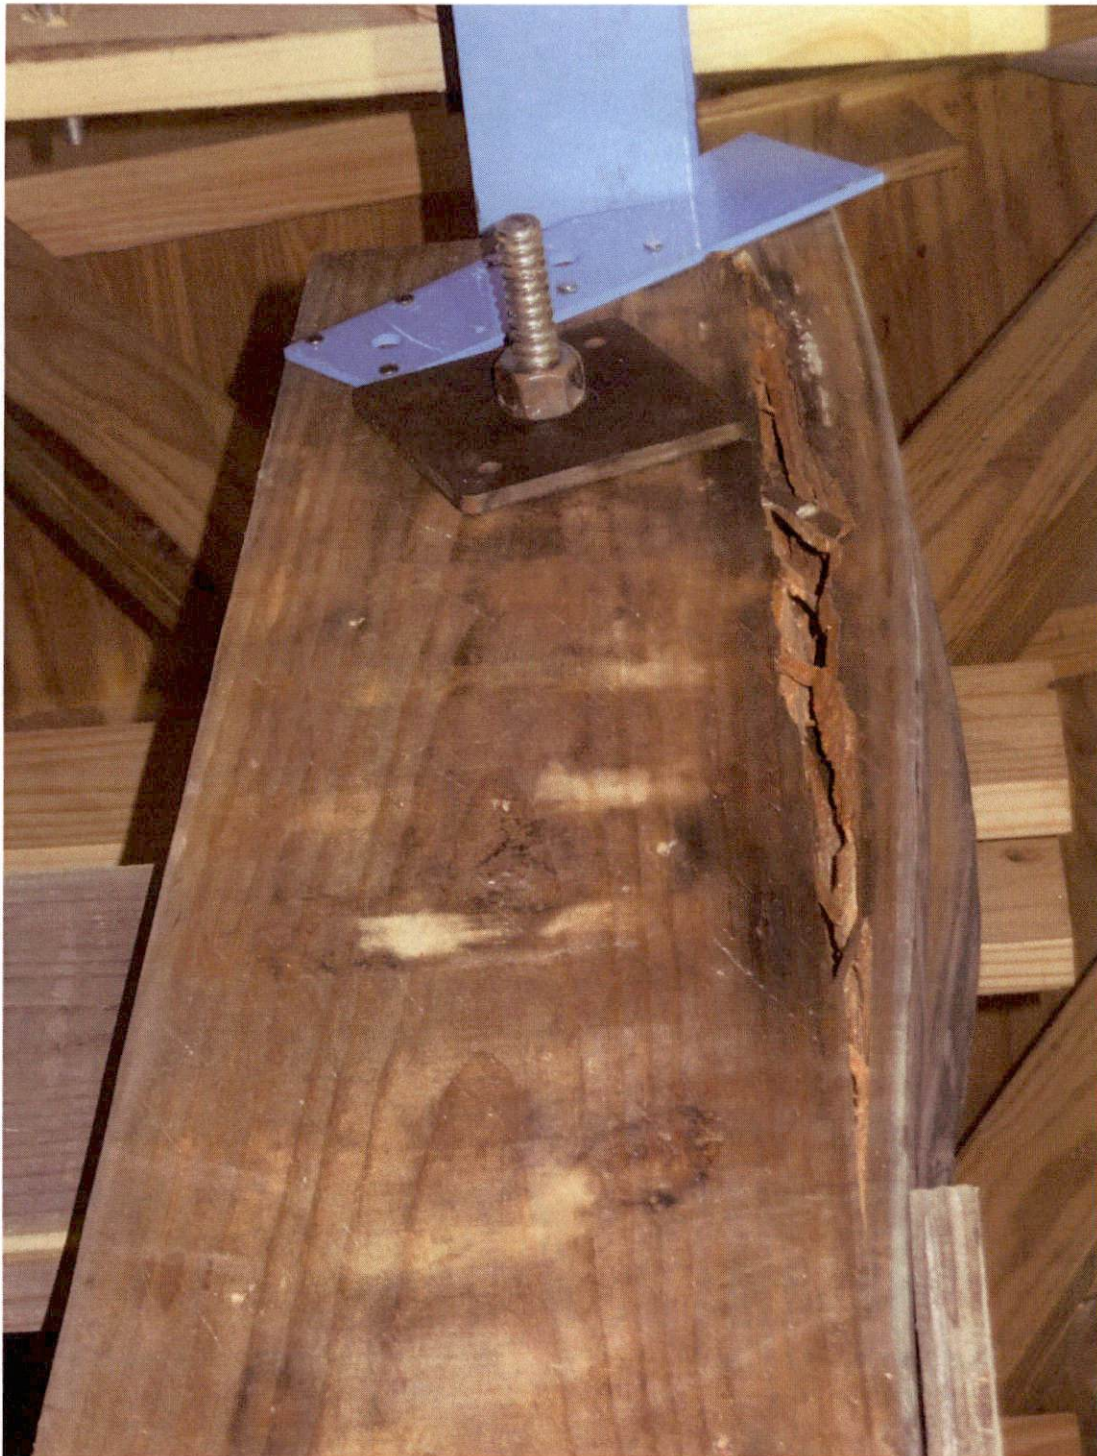
Unit 1 - Tower B1, compression failure below steel beam

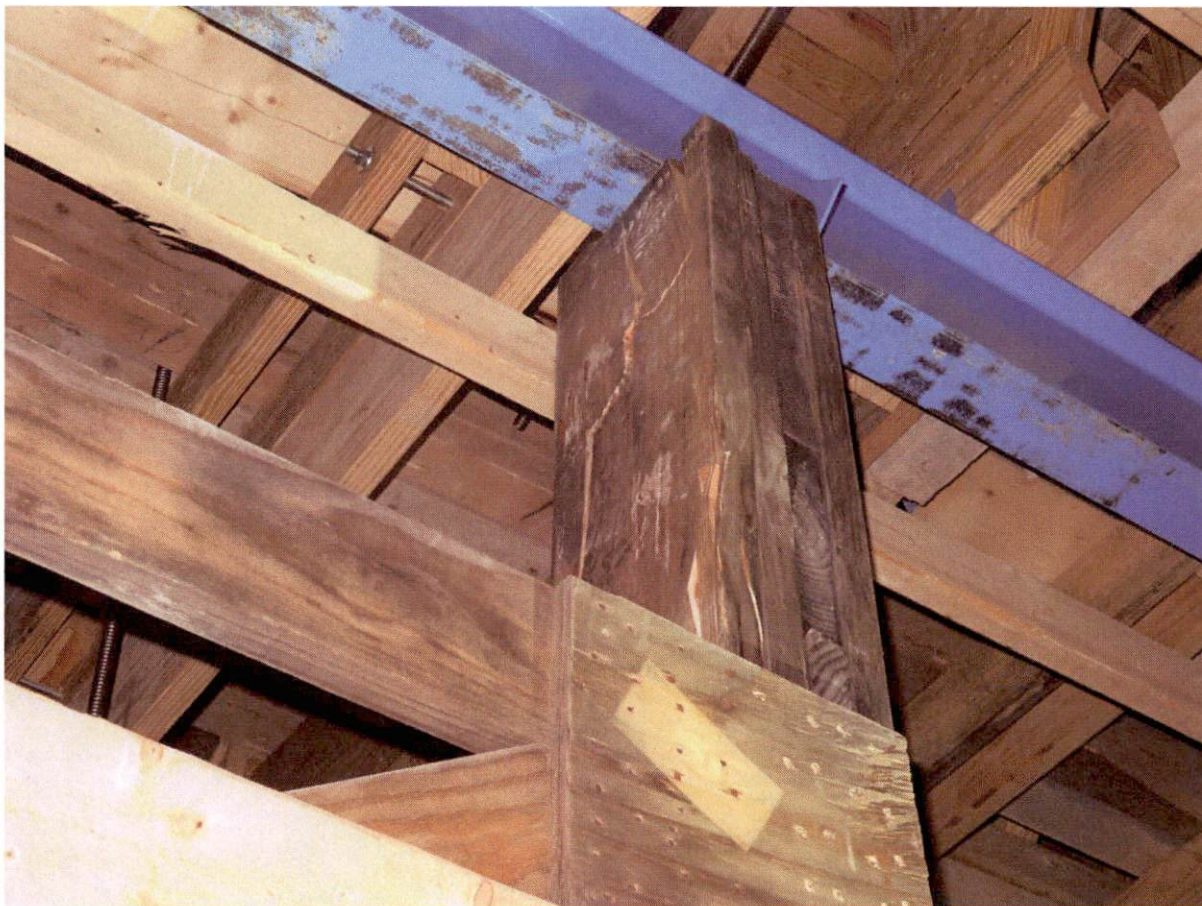
Unit 1 - Tower B5, compression failure below steel beam

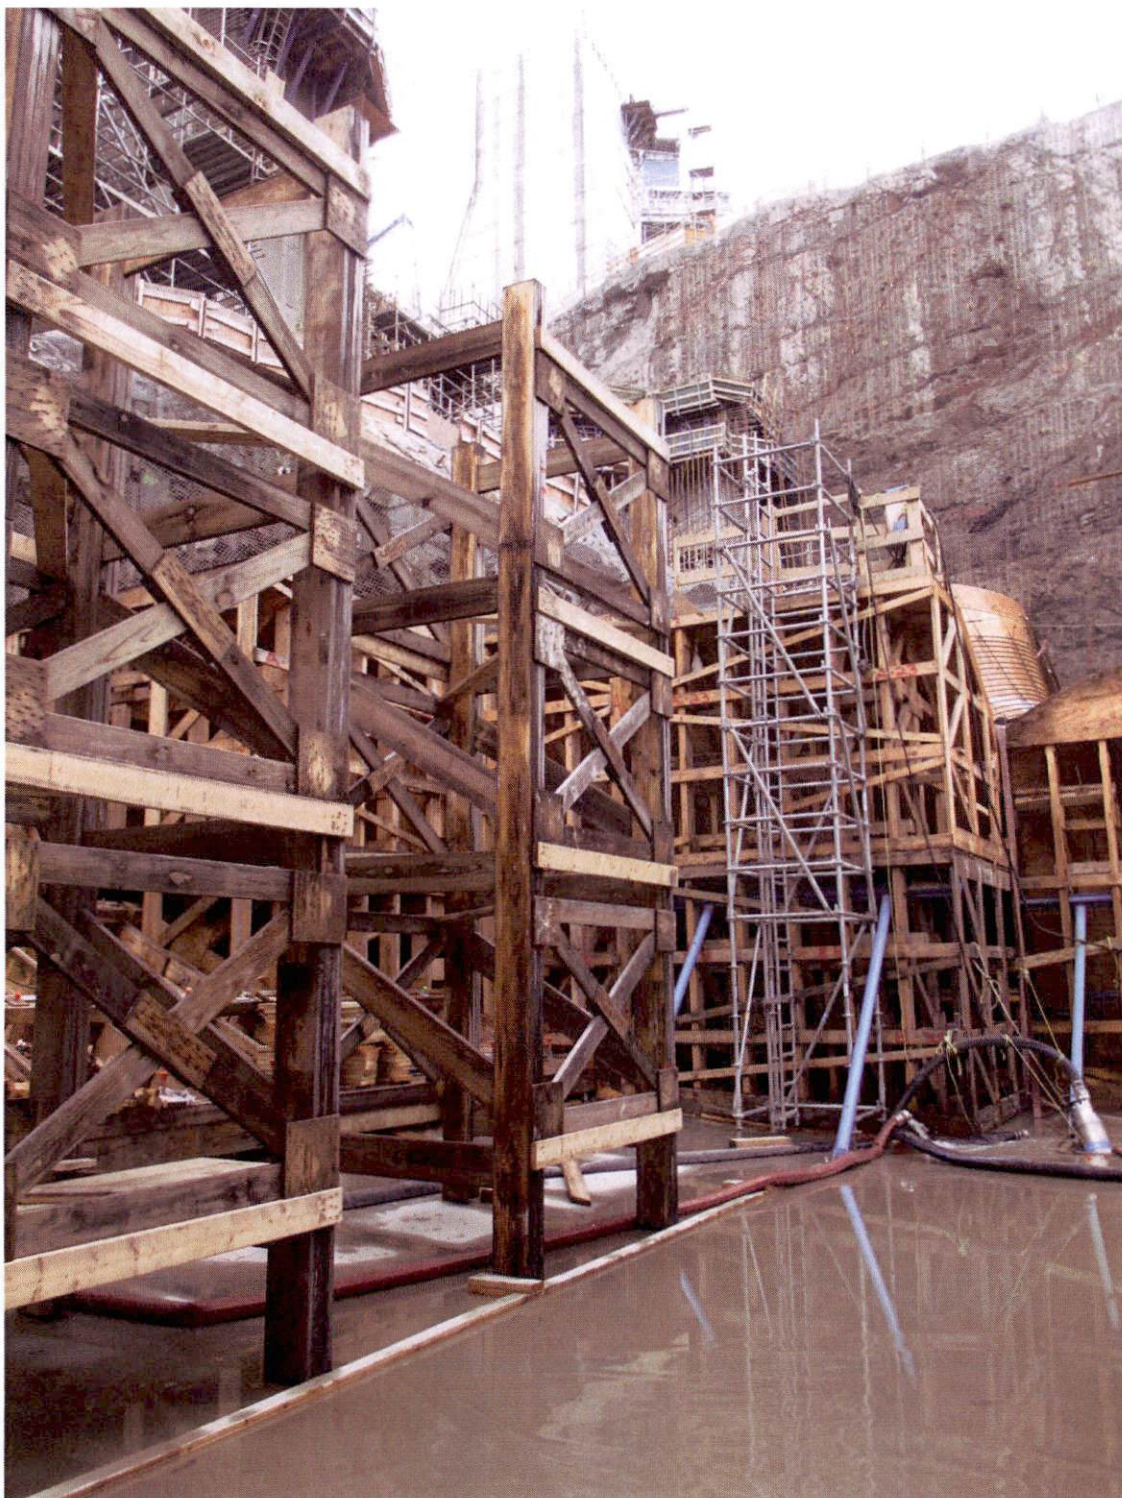
Unit 3 - Installed shoring tower weathering

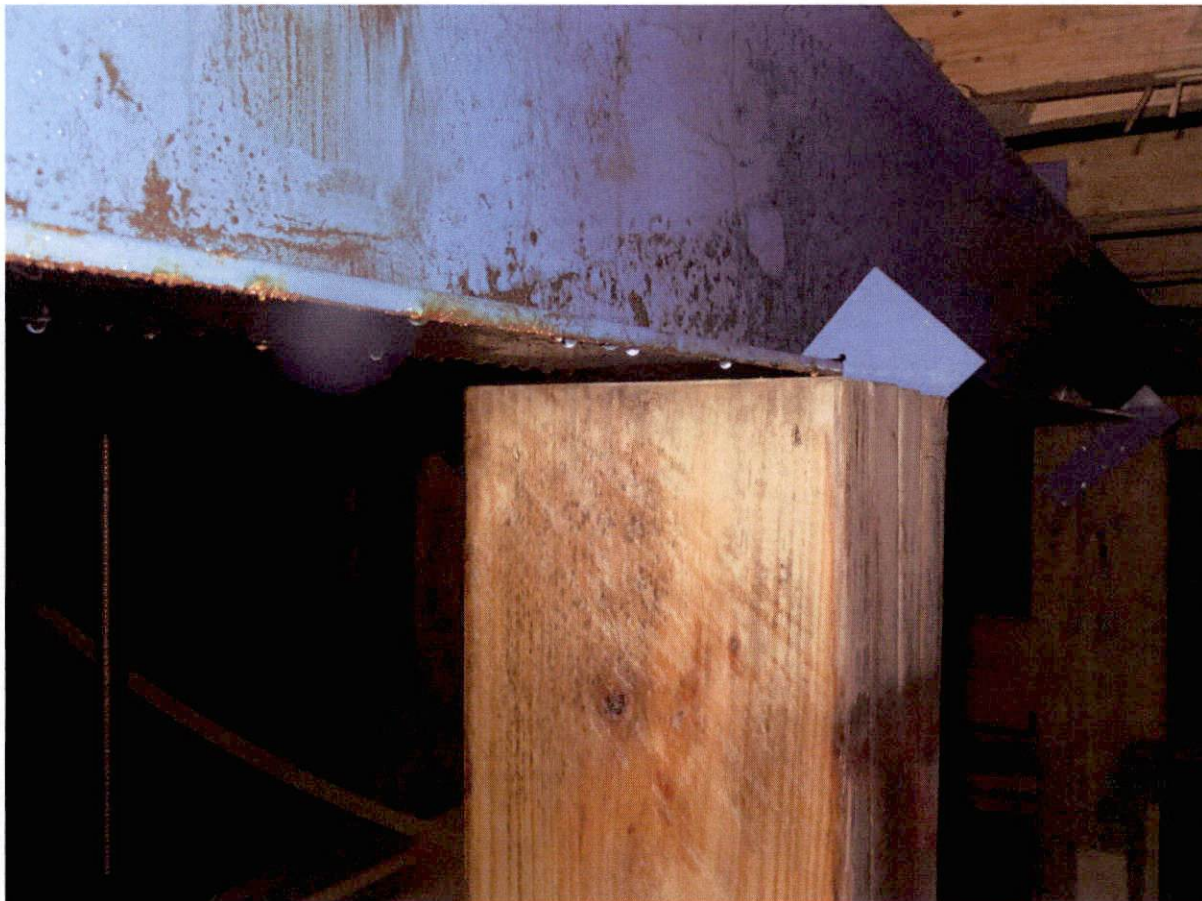
Unit 4 - Missing shim between post and steel beam

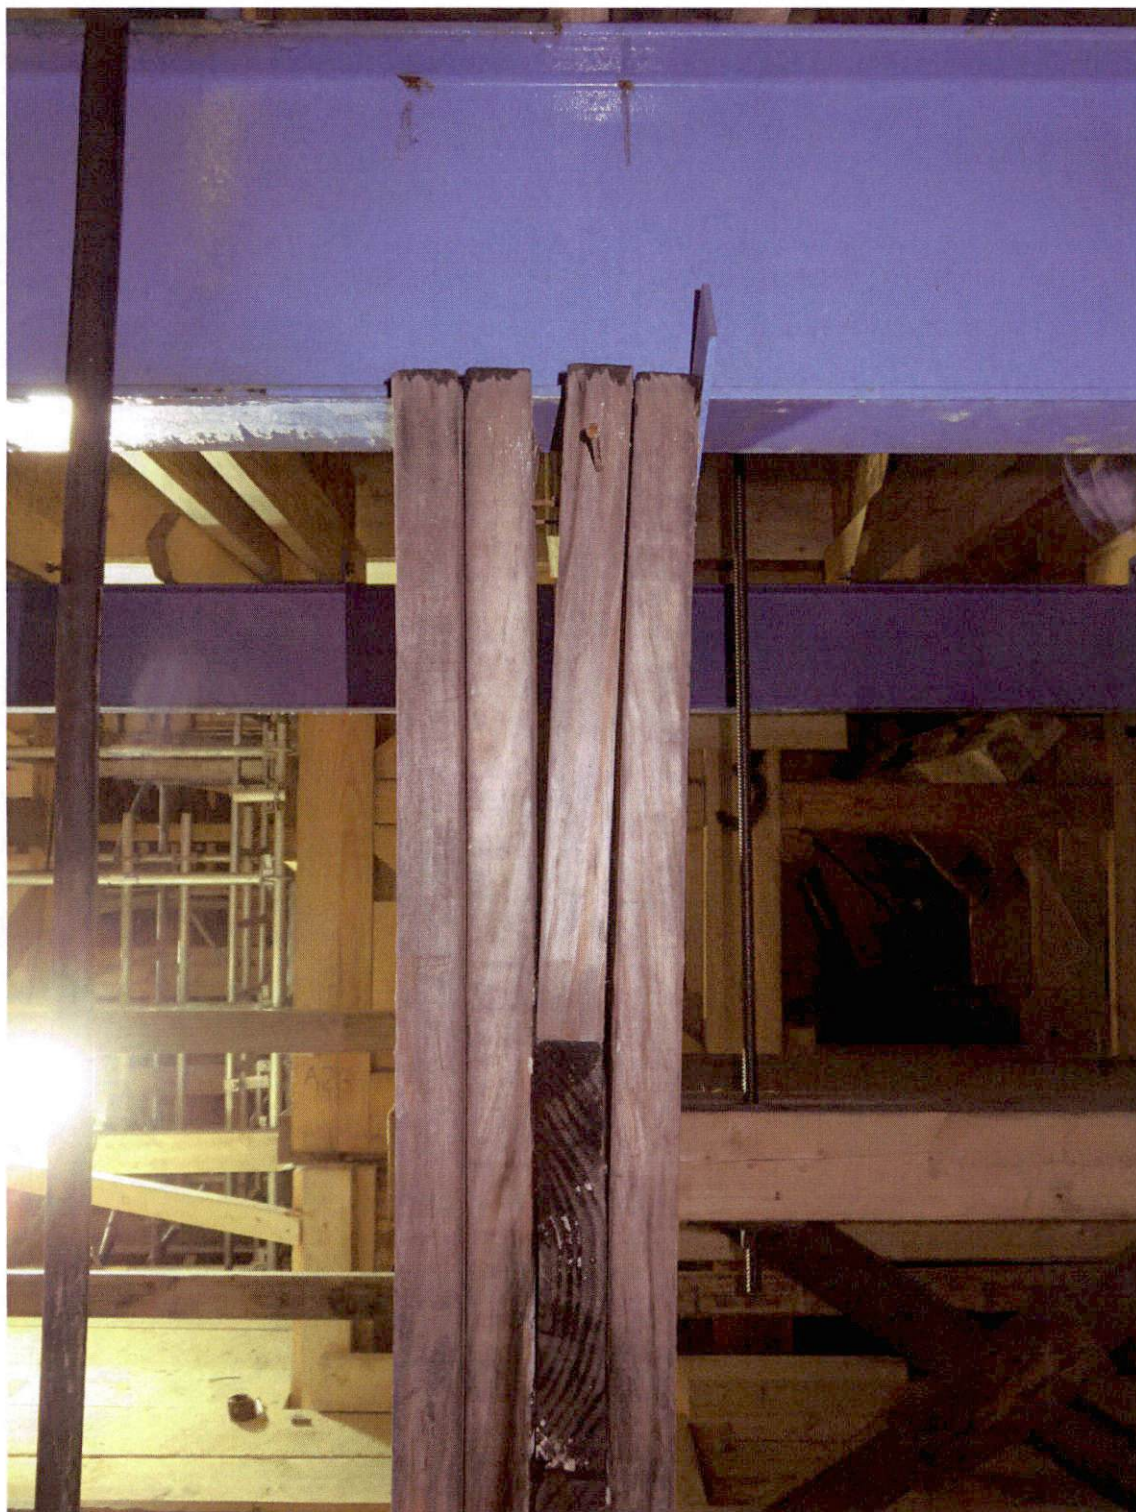
Unit 4 - Damage to tower during formwork or tower alignment
