Review of Foundation Works – Structure S1-70	
DATE: 26-Oct-2015	AREA/LOCATION: S1-70 Type E1 Tower	Page 1 of 6
CONTRACT : CT0327-001 – Construction of 350kV HVdc TL		CONTRACTOR: Valard Construction LP.

1. Initial Foundation Selection and Installation

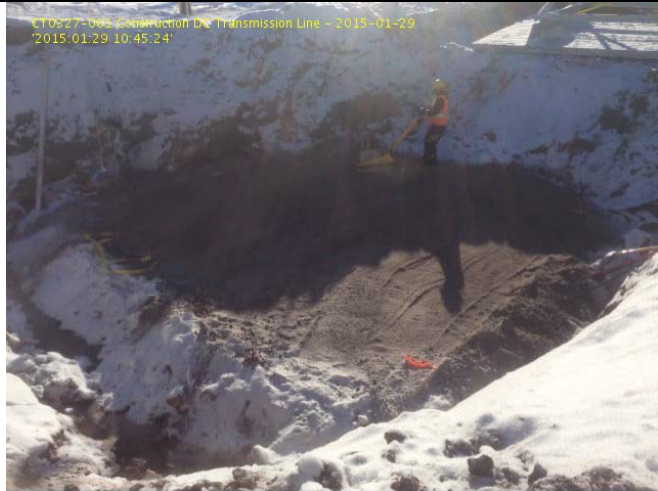
Photo 1: S1-70 Leg A Re-work on base preparation exposed to frost, compaction effort with no verification of test data.

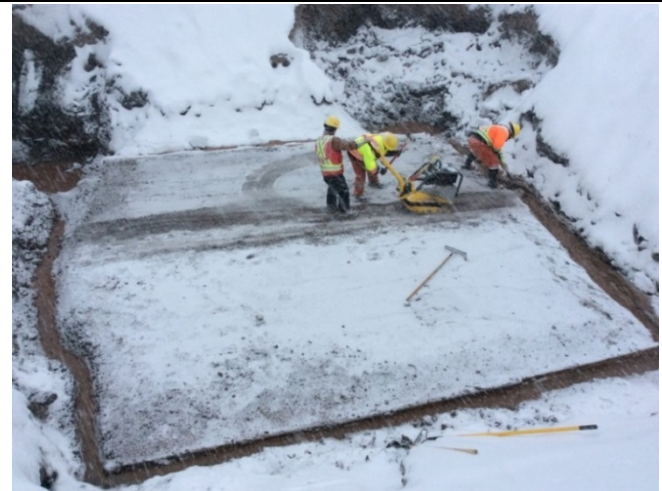
Photo 2: S1-70 Leg B Founding base preparation and compaction effort with no verification of test data.

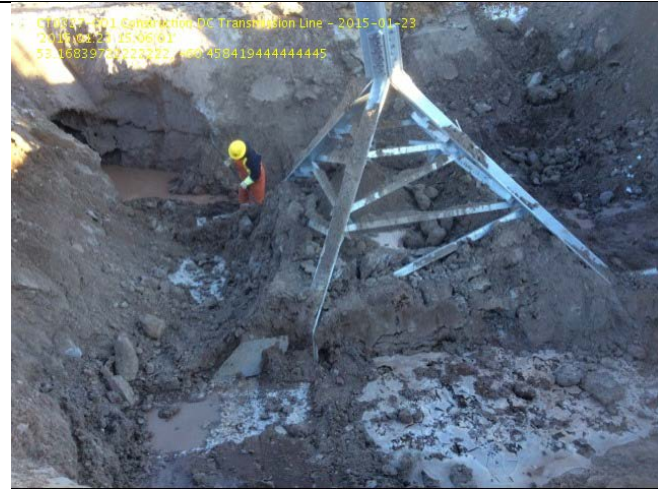
Photo 3: S1-70 Leg C– Reclaim of grillage during initial installation. Frozen founding base and frozen backfill with oversized boulders.

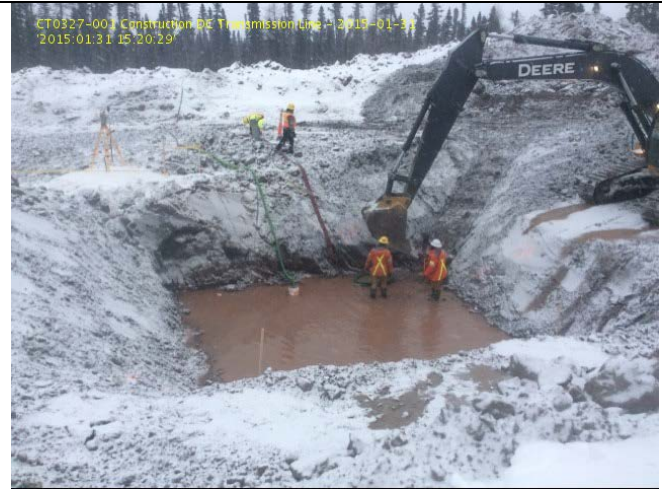
Photo 4: S1-70 Leg D excavation works with inefficient ground water control.

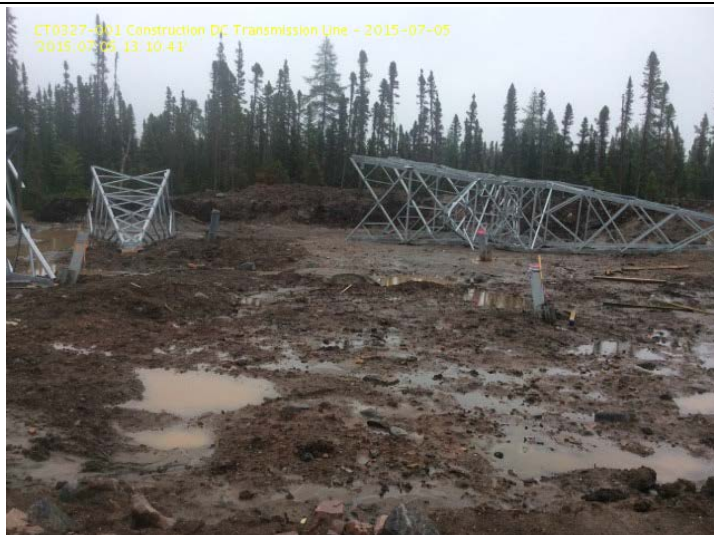
Photo 5: S1-70, General view looking East, July 5, 2015.

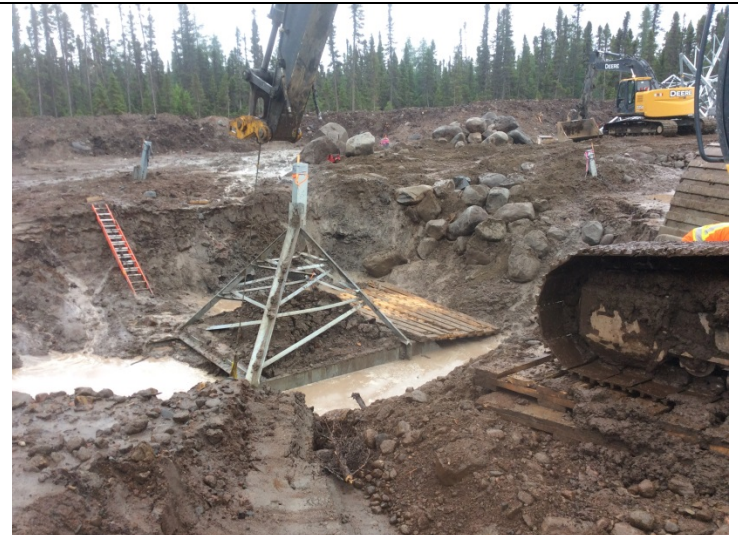
Photo 6: S1-70 Leg A, reclamation of grillage footing.

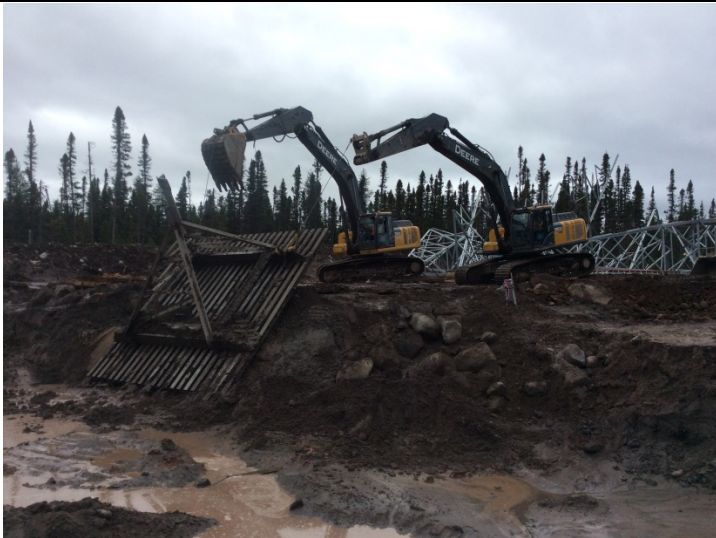
Photo 7: S1-70 Leg C, reclamation of grillage footing, saturated founding base and backfill.

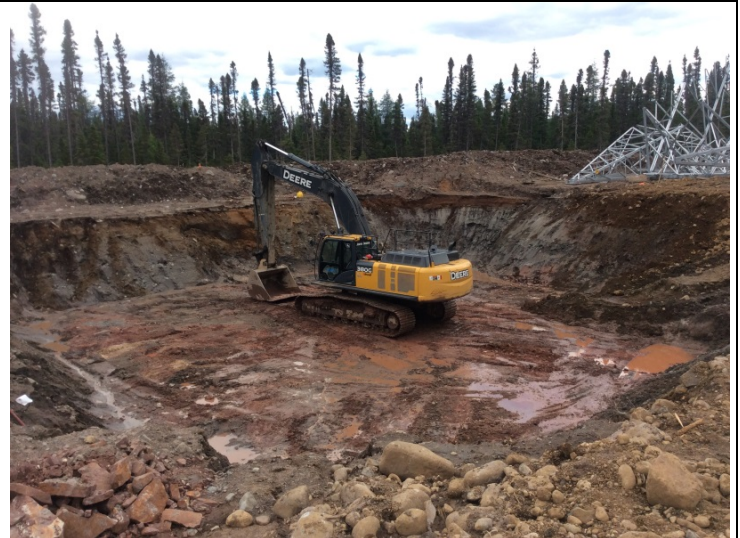
Photo 8: S1-70, common excavation, confirmed weathered bedrock below founding depth.

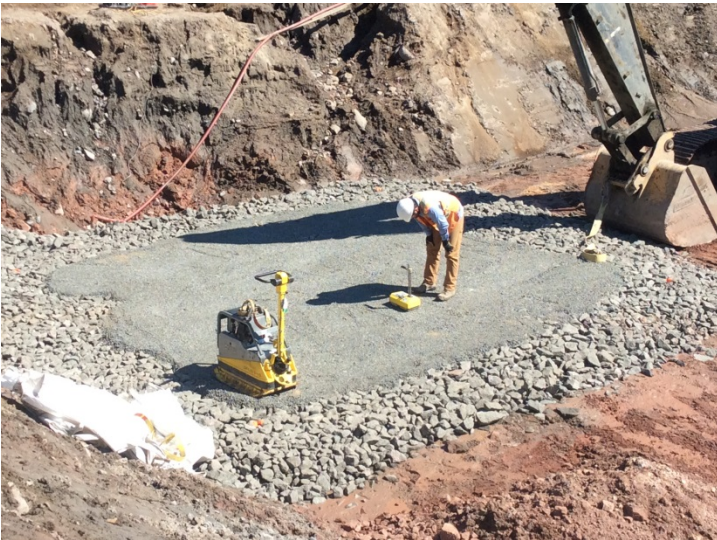
Photo 9: S1-70, Leg A, Groundwater control, found base preparation and compaction effort verification.

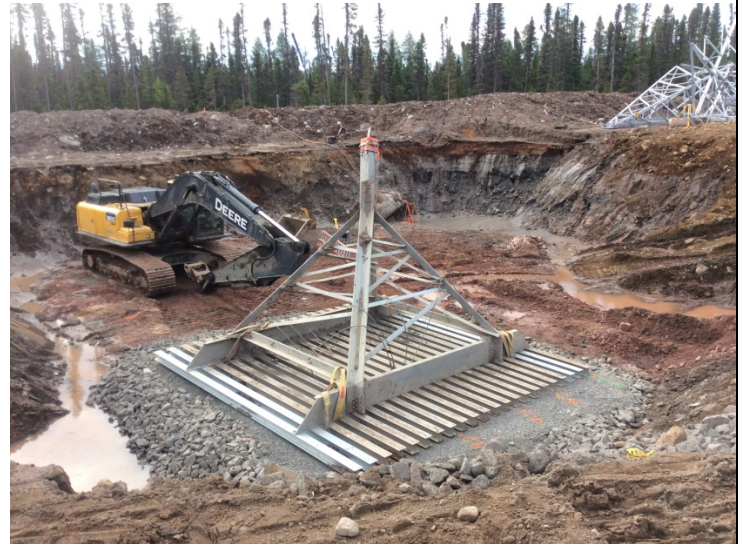
Photo 10: S1-70, Leg A, Grillage Placement on prepared founding base with groundwater control.

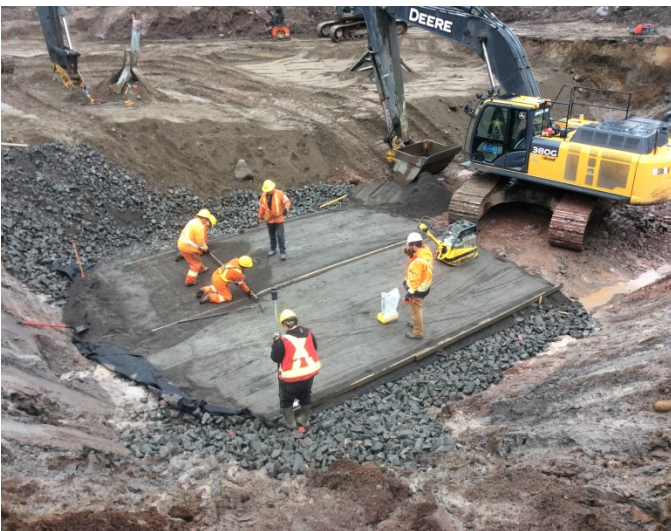
Photo 11: S1-70, Leg D, Grillage placement on prepared founding base with groundwater control.

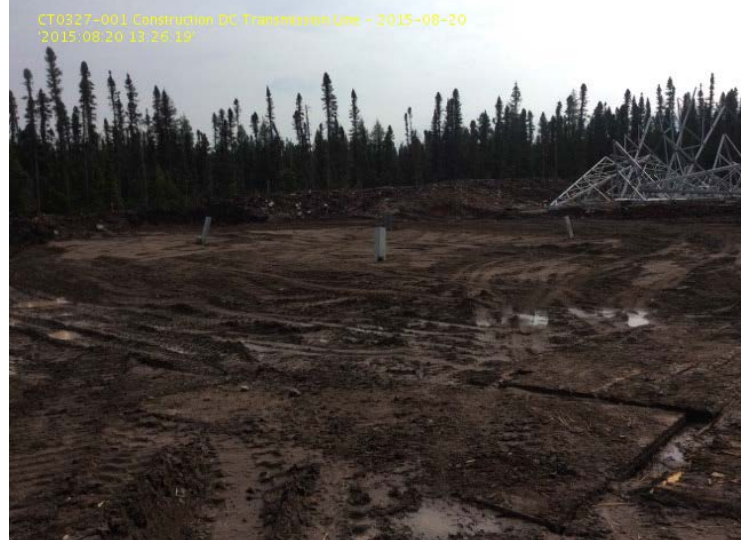
Photo 12: S1-70 completed reinstallation of foundations, general view looking Southeast. Proper grading however no additional mounding.
