# MEETINGS IN ST. JOHN'S AND VISITS TO LOWER CHURCHILL PROJECT SITES, JULY 11 TO 15, 2016

Prepared for: Natural Resources Canada and Nalcor Energy  
 IE Point of Contact: Nik Argirov  
 Date: November 2, 2016

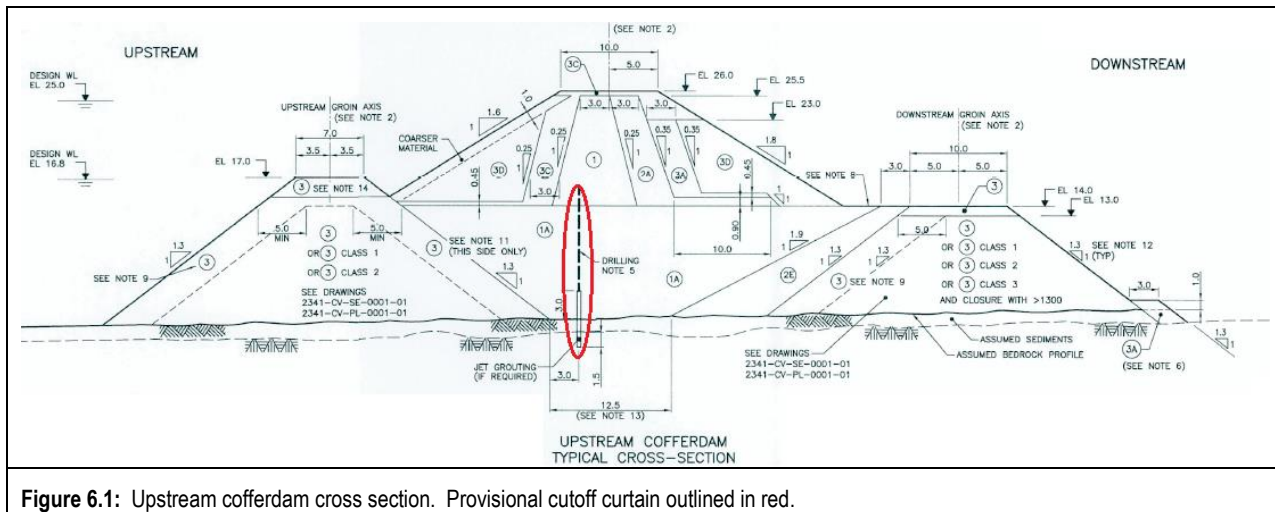
Figure 6.1: Upstream cofferdam cross section. Provisional cutoff curtain outlined in red.

The rockfill groins of starter dam will be placed on the natural riverbed. The impervious fill zone will be about 12.5 m wide at the base and will be placed on the cleaned riverbed between the groins. Much of the impervious foundation will not likely be fully dewatered because of copious water flow. Due to likely water inflows hand/air pressure cleaning will not be possible for much of the foundation and these areas will be machine cleaned with backhoes. Most of the riverbed bedrock foundation will have been scoured clean by river flows and will provide a good seal at the base of the impervious fill. In submerged areas that have not been scoured by the river, machine cleaning will remove most of the debris and overburden from the bedrock surface. It is possible, however, that the machine cleaning will miss some debris materials or zones of disturbed, broken rock.

The IE submits that there is a risk of serious leakage in submerged foundation areas where debris, boulders, broke/disturbed rock have not been completely removed by machine cleaning. Significant water flows can generate extra costs in terms of schedule delays, beneath the impervious zone. It appears that the designers have considered this risk by including the contingency jet grouting in the design. Details of the contingency jet grouting program are shown on Drawing MFA-SN-CD-2340-CV-SE-0002-01 Rev C2. The grout holes would be drilled through the core into the permeable material at its base. The IE notes that jet grouting will be very effective in sandy or granular overburden, but will have limited success in open-work boulders or broken rock.

The IE recommends the following actions:

- Barnard Pennecon should supplement its work plan with a contingency plan for dealing with unexpectedly high water flows through the cofferdam foundation. This must include plans for pumping leakage water downstream of the cofferdam and construction of a cut-off through the base of the core if needed.
- The cut-off can be the jet grouting scheme proposed by the designers on Drawing MFA-SN-CD-2340-CV-SE-0002-01 Rev C2 (see Figure 6.1 above). Alternatively, a local slurry cut-off wall could be constructed using equipment already present at the site. It is noted that a slurry cut-off is better suited for dealing with open-work boulders than jet grouting.
- The contractor should demonstrate that equipment can be available on a timely basis to deal with unexpected foundation water inflows so that the potential impact on schedules is minimized.

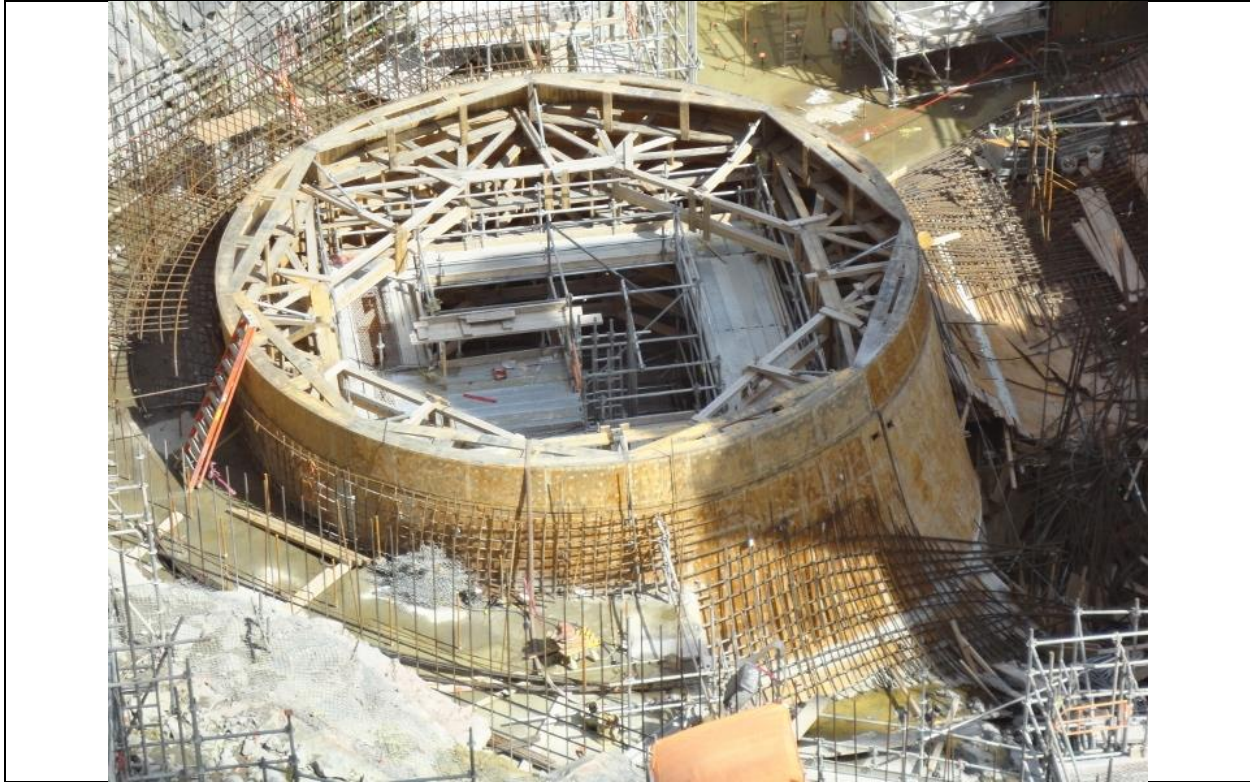
Photo C.11: Unit 2, note collapsed formwork in pyramidal shaped are on right side. (July 13, 2016)

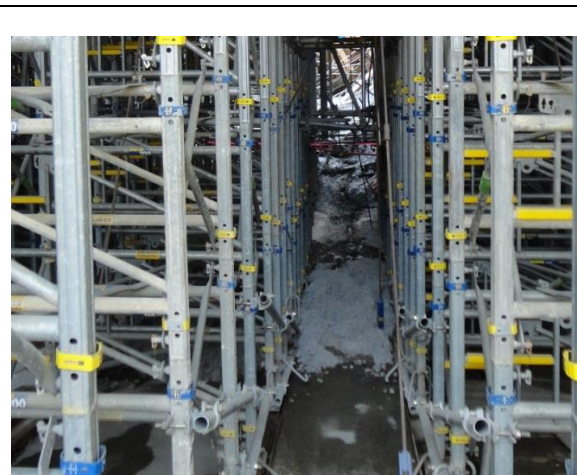
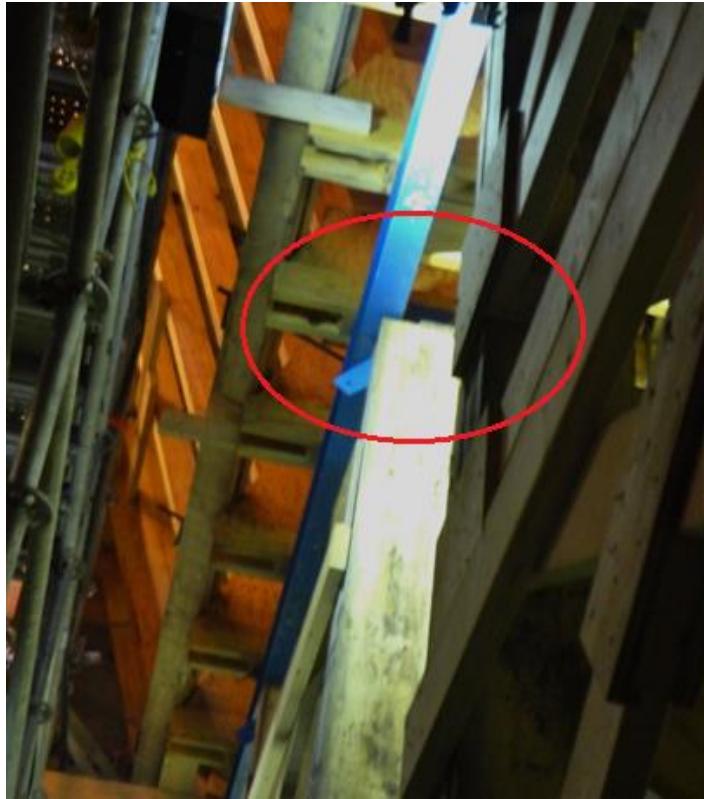
- A formwork failure at the draft tube of Unit 2 occurred on May 29, 2016 where 528 m<sup>3</sup> of concrete was released into the lower draft tube. No personal injuries occurred although a number of workers were inundated in wet concrete and had to be rescued. The OHS issued a “stop work” edict for all draft tube construction at that time. This has been mostly rescinded for Units 1, 3 and 4 where new work is currently progressing. The “stop work” edict was still in place for Unit 2 at the time of the July 13 IE visit and no formwork repairs or cleanup of the spilled concrete (Photos C.10 and C.11) had been done due to the OHS restriction. Design issues, faulty materials (some of the formwork timbers suffered from dry rot) and shoddy construction have been identified as potential contributing factors in the incident. Formwork in Draft Tubes #3 and #4, as well as plans to reconstruct formwork for #2 were under review at the time of the site visit and both wood and steel forms systems were under consideration. An example of poor construction work could be seen in old formwork in Unit 3 (Photo C.12) where the steel column is misaligned with the wooden beam that it is supporting.

Photo C.11: Unit 2 formwork failure above draft tube (Photo 'a') and spilled concrete in the bottom of the draft tube area (Photo 'b'). (July 13, 2016)

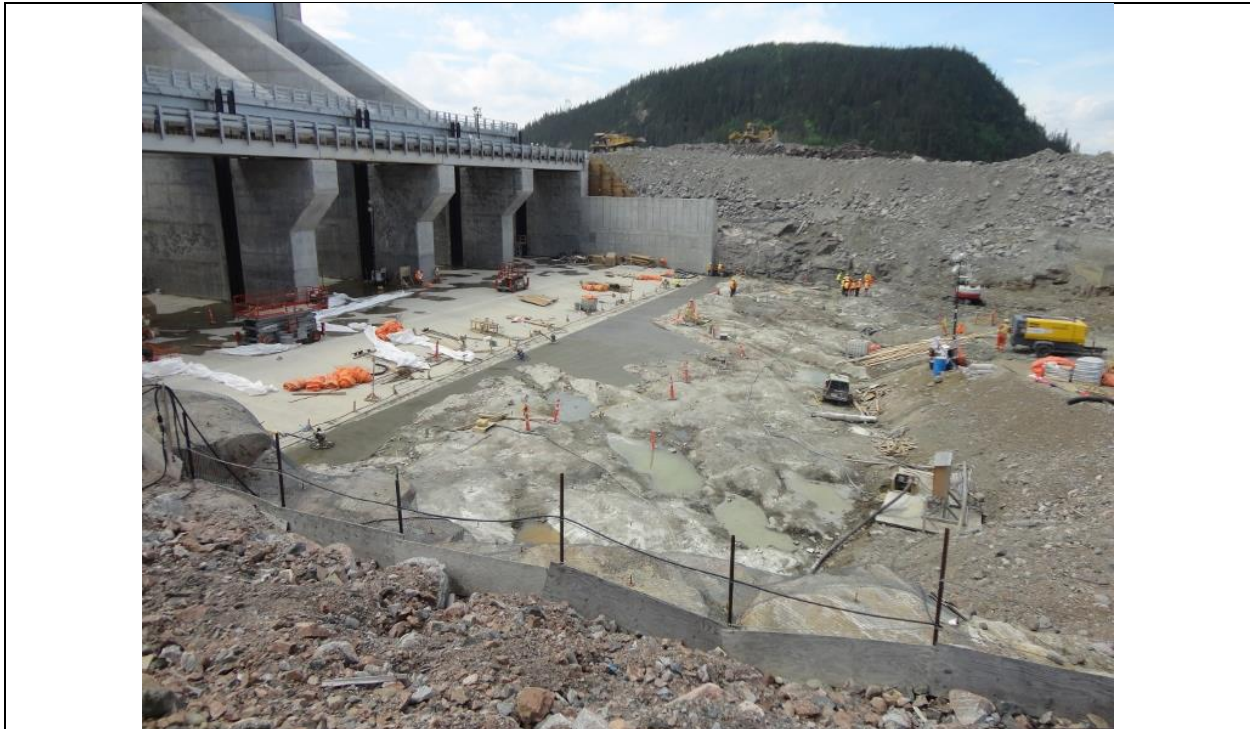
**Photo D.14:** Preparation of the Spillway apron surface. Dental concrete (dark colored) has been placed in the steel reinforced depressions adjacent to the concrete apron. (July 13, 2016)

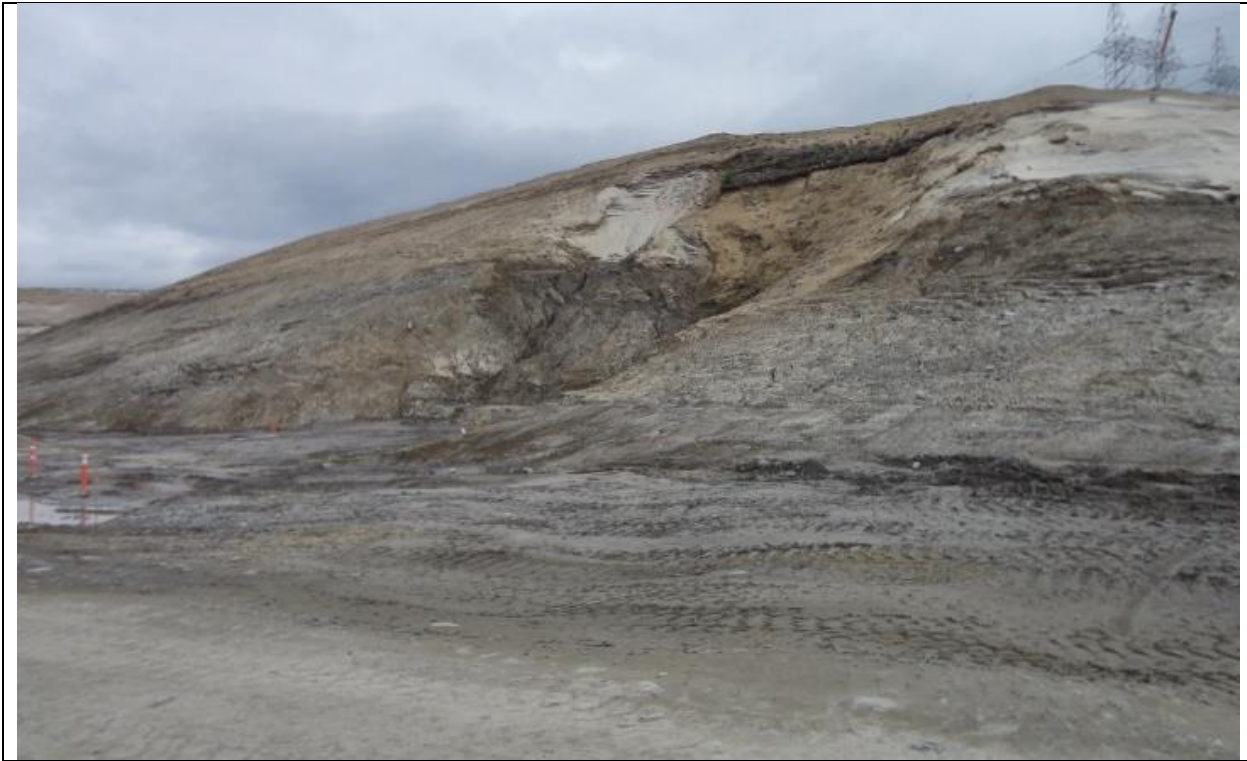
Photo E.4: North Spur, upstream slope. Old gully scar near the intersection of the north and upstream cut-off walls. (July 14, 2016)

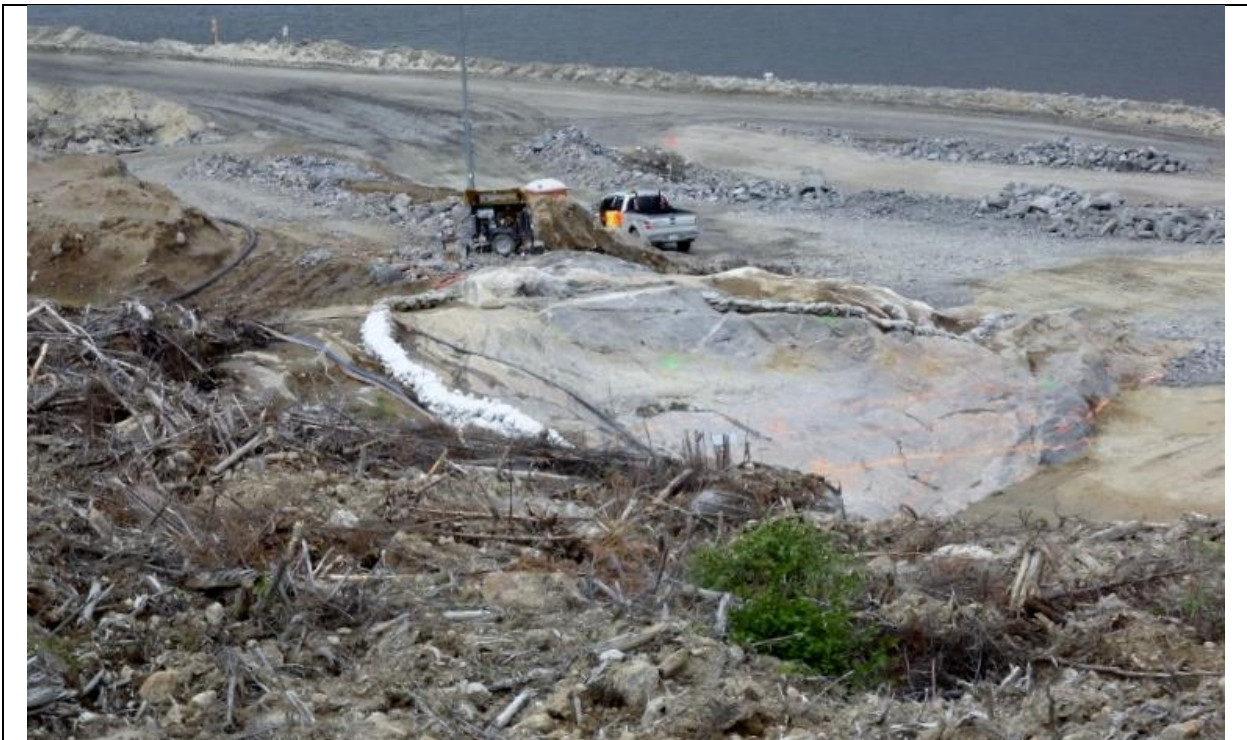
**Photo E.5:** North Spur, upstream slope. Old gully scar at the mid-point. (July 14, 2016)

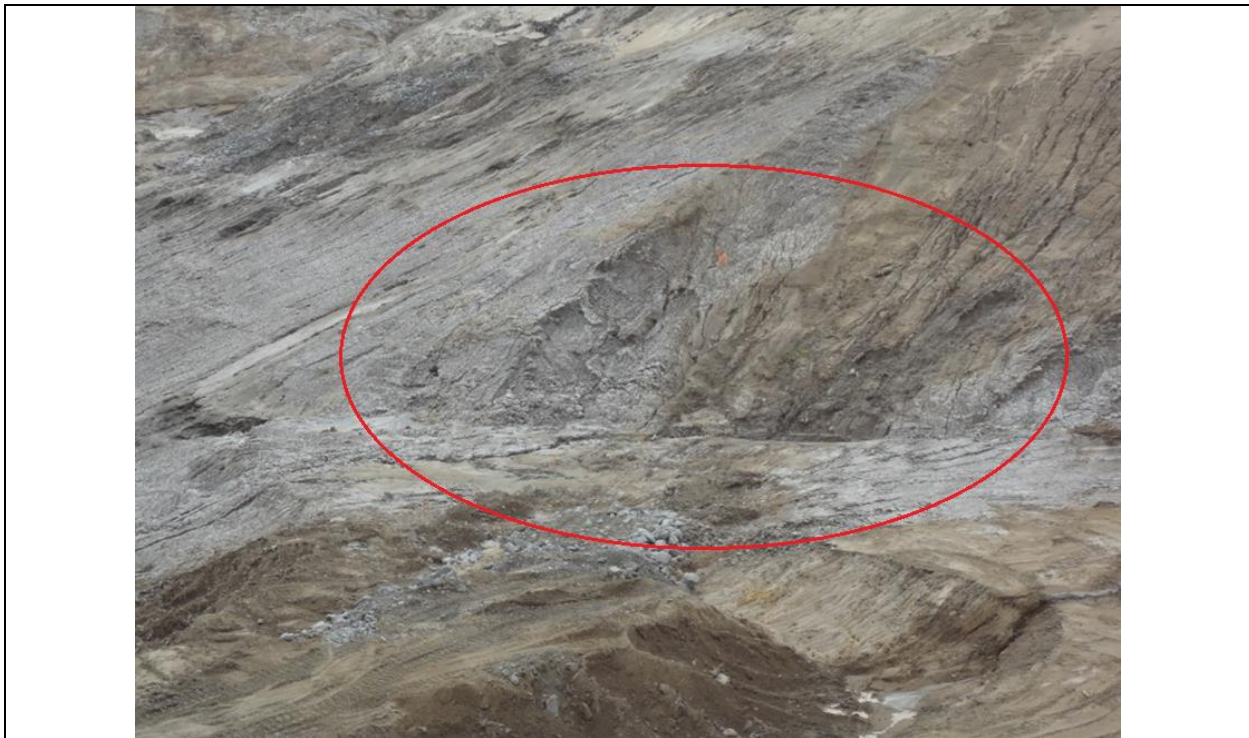
- As reported in our previous November 2015 visit report, NALCOR and site engineering staff have indicated that very few manifestations of high sensitive or “quick clay” behavior in clay/silt materials have been reported during excavations of the North Spur. In most cases, it was observed by geotechnical site staff that excavated material adhered together in clumps, even after dumped into the haul trucks. This is unlike typical “quick clay” materials which would normally lose cohesion and liquefy to slurry after such rough handling. Also, the north-west cut-off wall trench panels were stable during excavation in the upper sands and stratified drift and no liquefaction of materials was noted during excavation works.

**Photo E.9:** North Spur, upper level of the downstream slope. Area where liquefiable material was encountered in 2015 is outlined by the red ellipse. (July 14, 2016)

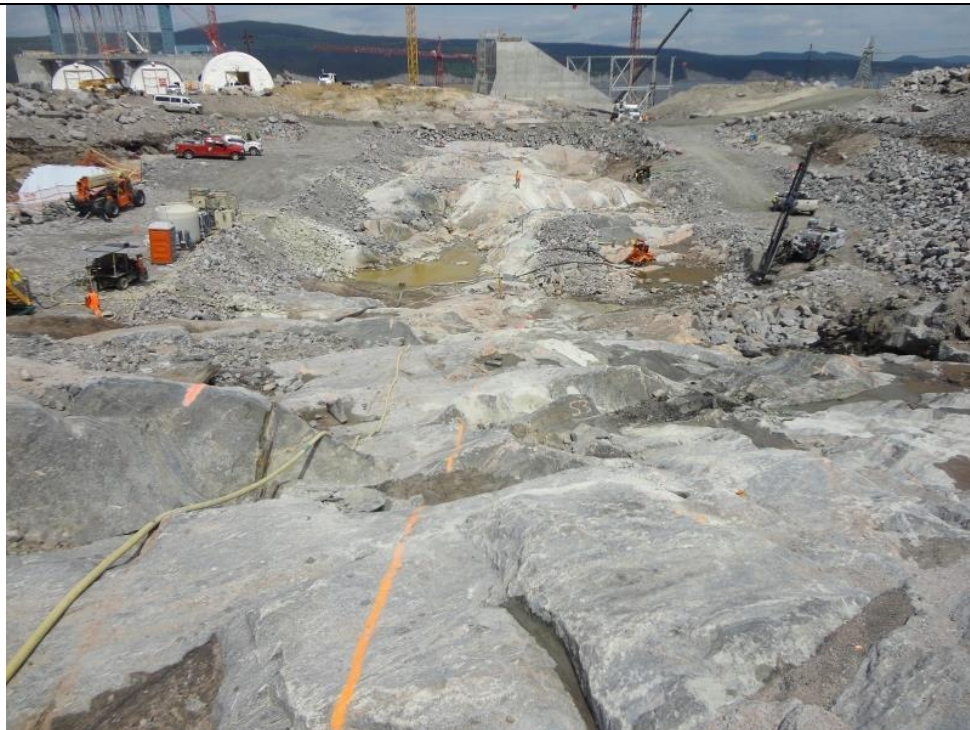
- Foundation preparation works for the Muskrat Falls South dam were inspected. This structure will be a center core embankment dam between the south side of the spillway intake transition dam and the right bank of the Churchill River. Photographs are presented in Appendix F. At the time of the site visit the bedrock under the core had been exposed (Photos F.1, F.2, F.3 and F.4). Foundation cleaning and grout curtain work were being carried out. The bedrock consists of widely jointed, slightly weathered to unweathered granitic gneiss. The foundation runs along the natural bedrock surface which is irregular with local relief in the order of about 1 to 2.5 m (Photos F.3 and F.4). There are zones of loosened rock and a few steeply inclined low scarps (Photo F.3). Remedial works consist of local dental excavations to remove loosened material and localized backfill concrete/mortar to smoothen out the topography and flatten steep scarps in some areas. Detailed topographical surveys and geological mapping is being carried out as part of the foundation documentation. All the geotechnical and foundation preparation works are being carried out to a very high standard.

**Photo F.1:** South Dam foundations, cleaned granitic gneiss rock along the impervious core footprint. View looking south up the abutment. Note the irregular surface. (July 14, 2016)

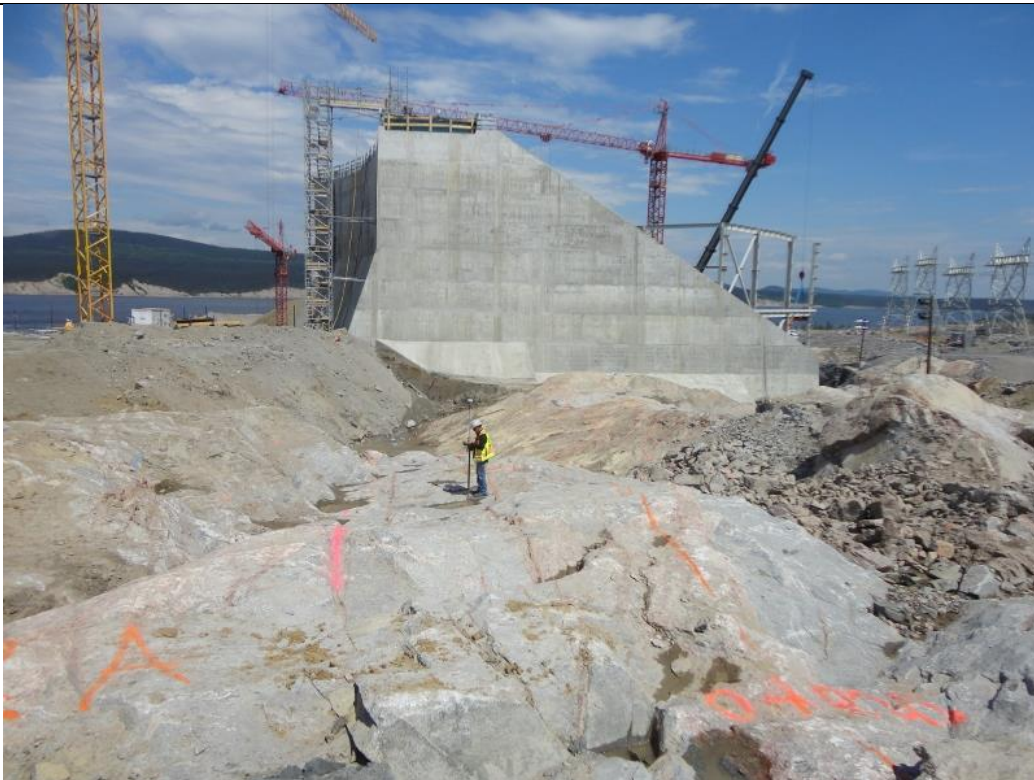
**Photo F.3:** Irregular granitic gneiss foundation surface. Dental excavation and concrete/mortar backfilling required in many areas. (July 14, 2016)

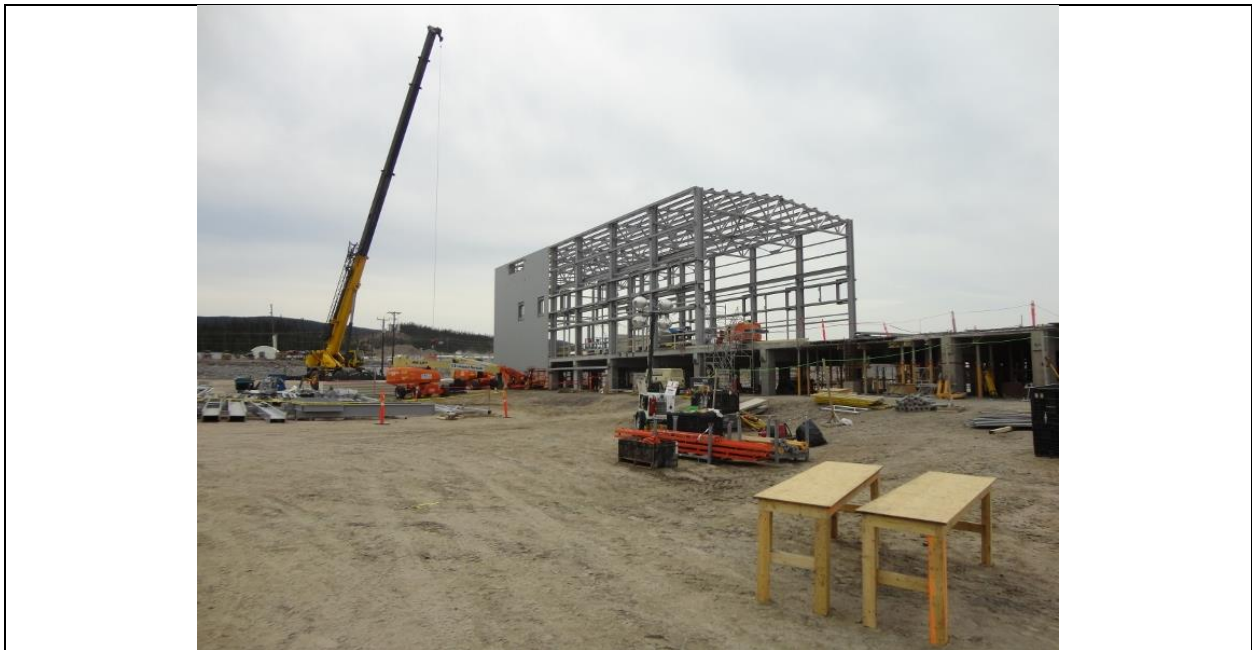
**Photo G.3:** GIS building- Partially installed structural steel frame. Steel erection will recommence upon completion of foundations (at right) repair work. (July 13, 2016)

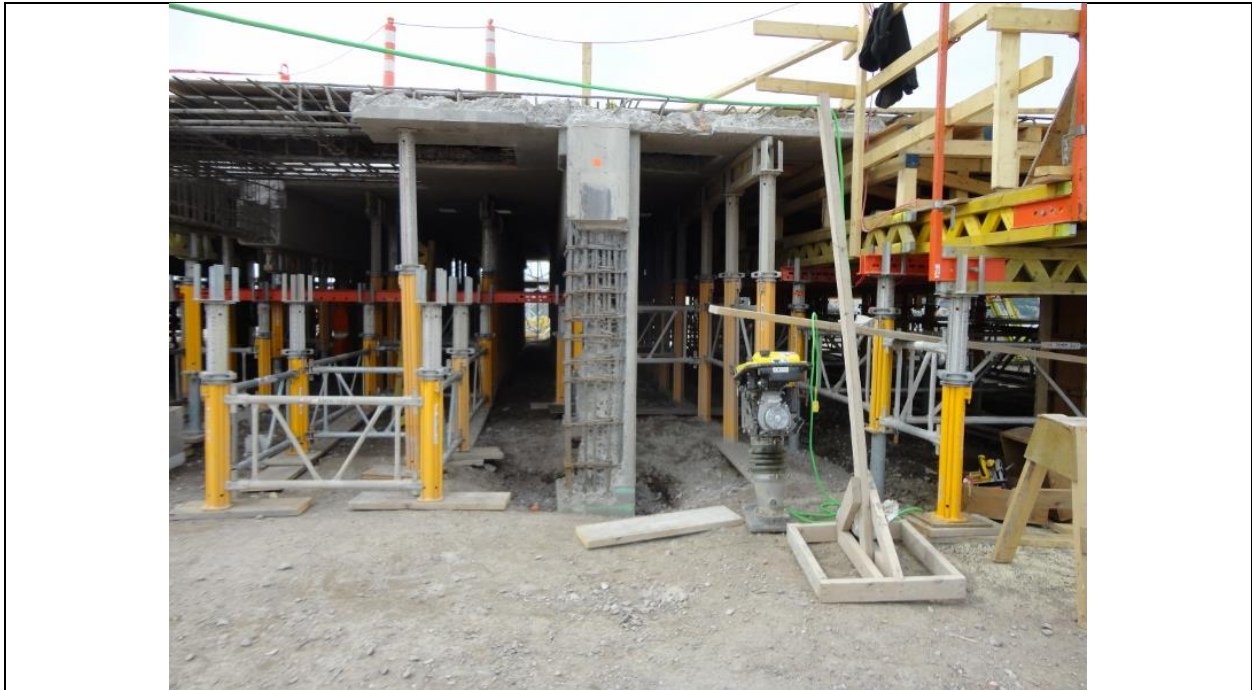
**Photo G.4:** GIS building with partially erected steel frame. Repair work on the building foundations (at right) was ongoing. (July 13, 2016)
