Cofferdam Repairs

IE also references the repair plans being localized to stations 280 to 400 rather than all of the of cofferdam, as we know it today.

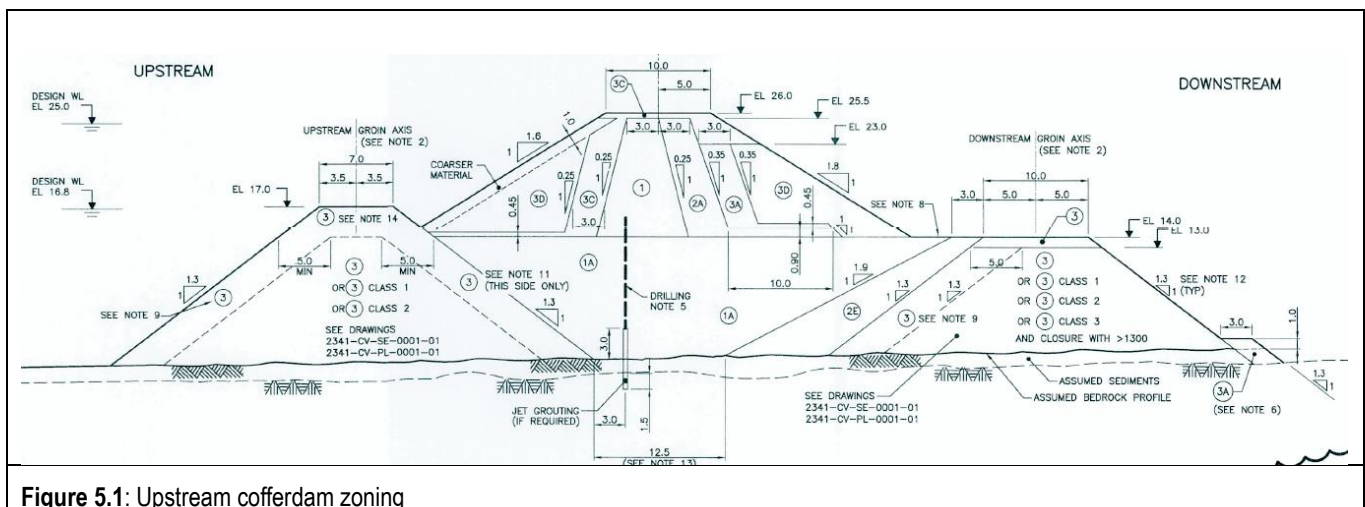
Figure 5.1: Upstream cofferdam zoning

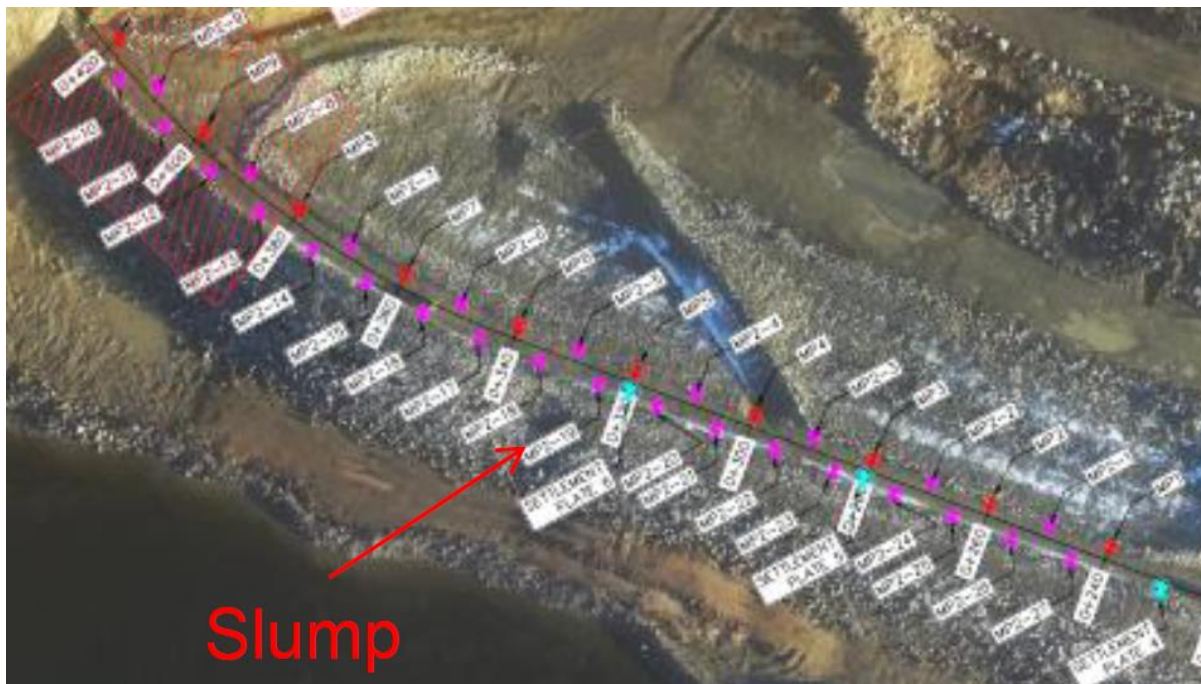
Figure 5.2: Aerial view of cofferdam showing location of the upstream slope slump at approximate Sta 0+330.

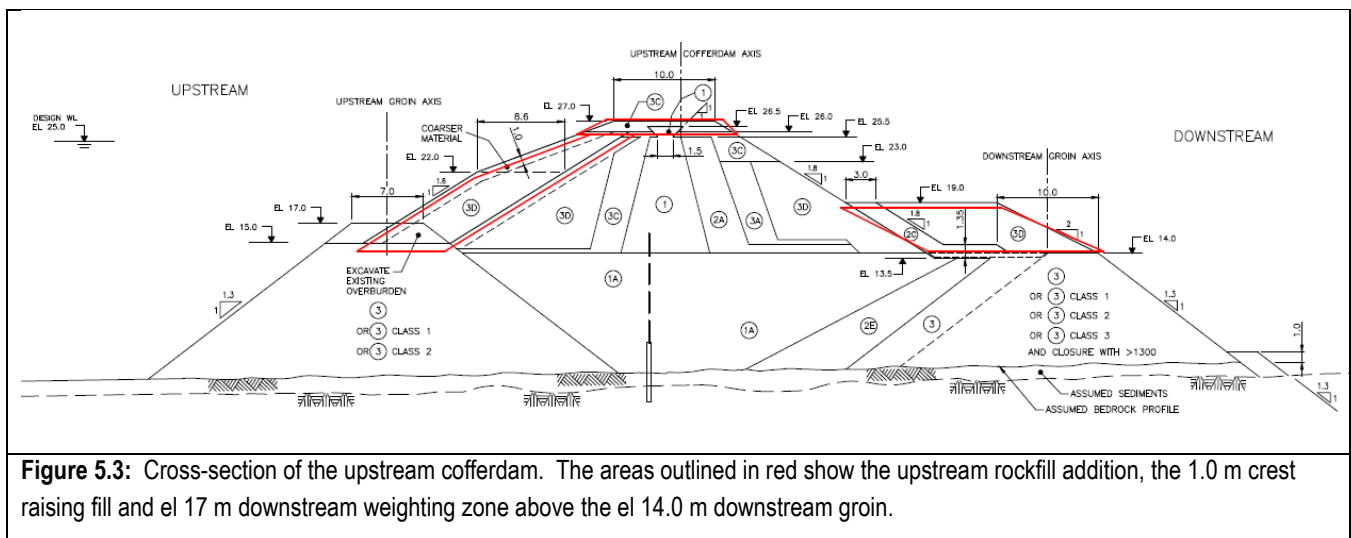
Figure 5.3: Cross-section of the upstream cofferdam. The areas outlined in red show the upstream rockfill addition, the 1.0 m crest raising fill and el 17 m downstream weighting zone above the el 14.0 m downstream groin.

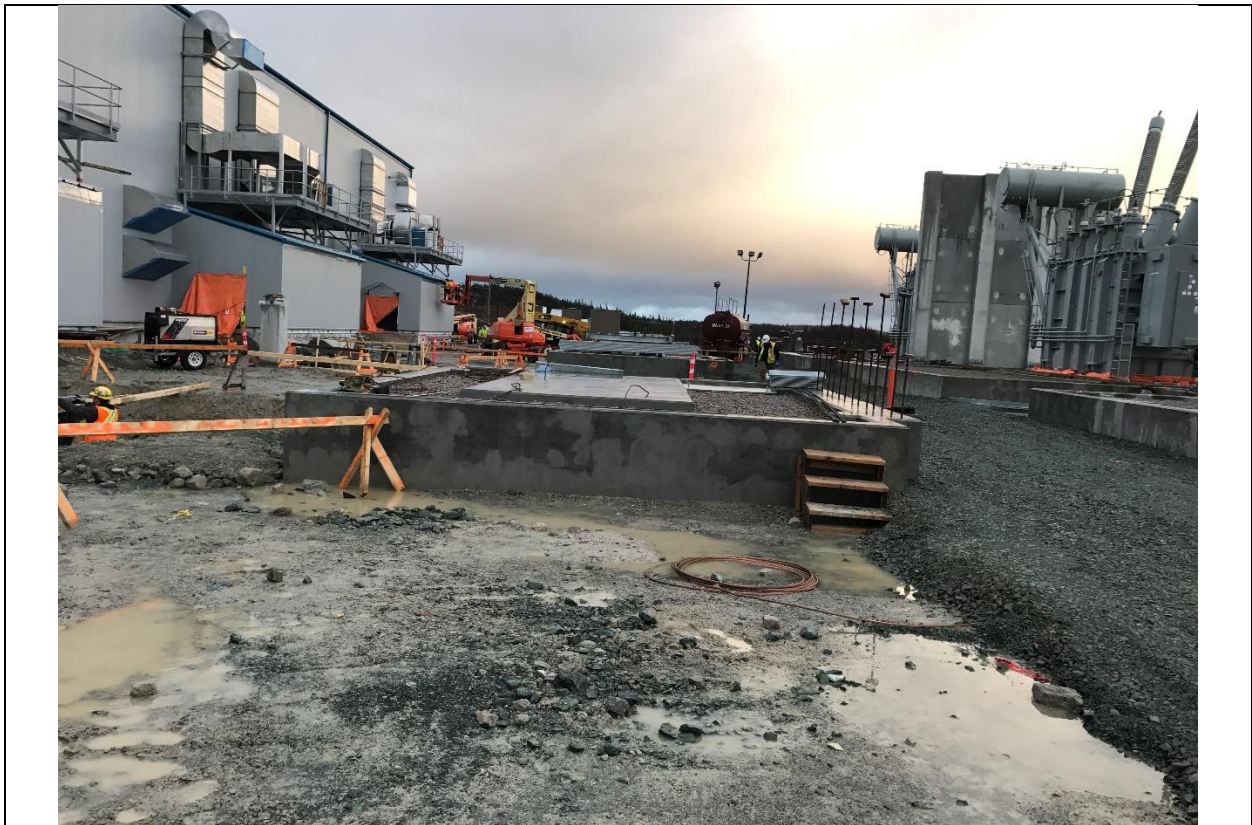
Photo A.10: Containment pits and foundation pads of excitation transformers. (November 29, 2016)

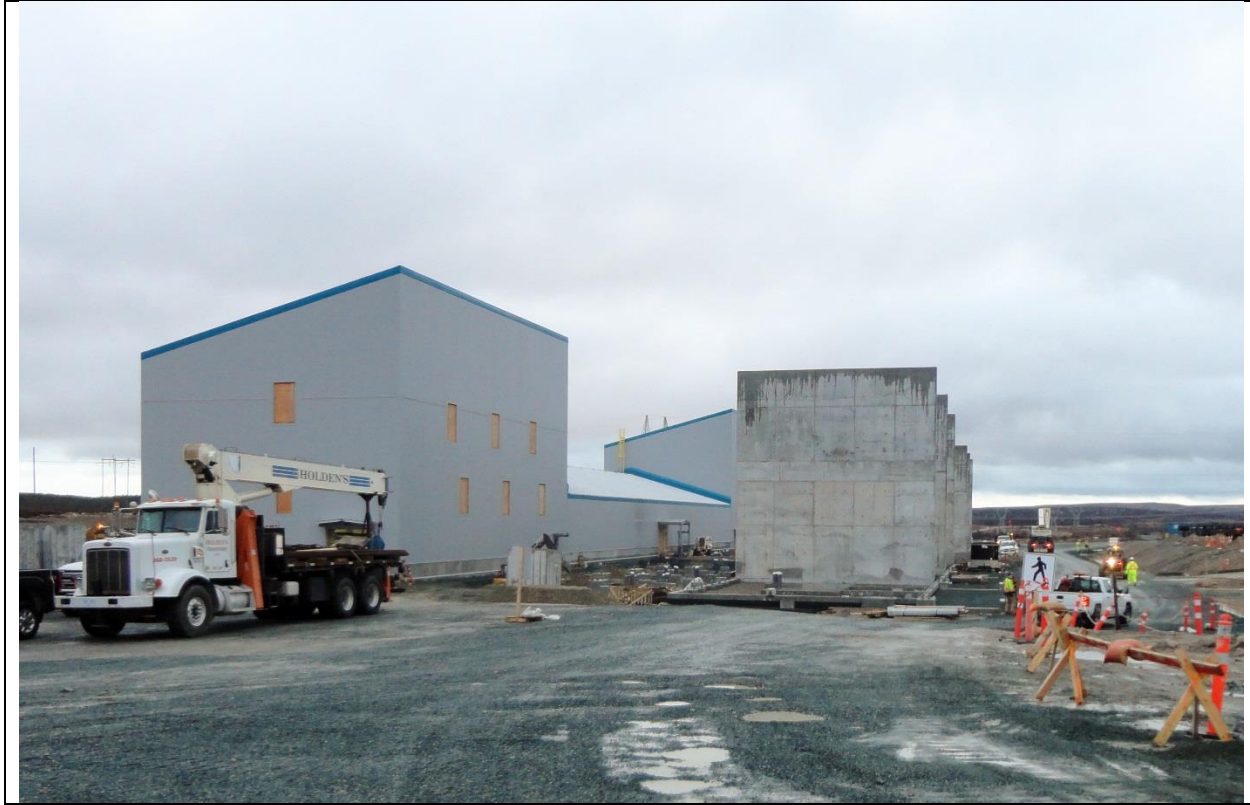
Photo A.11: Converter station building. (November 29, 2016)

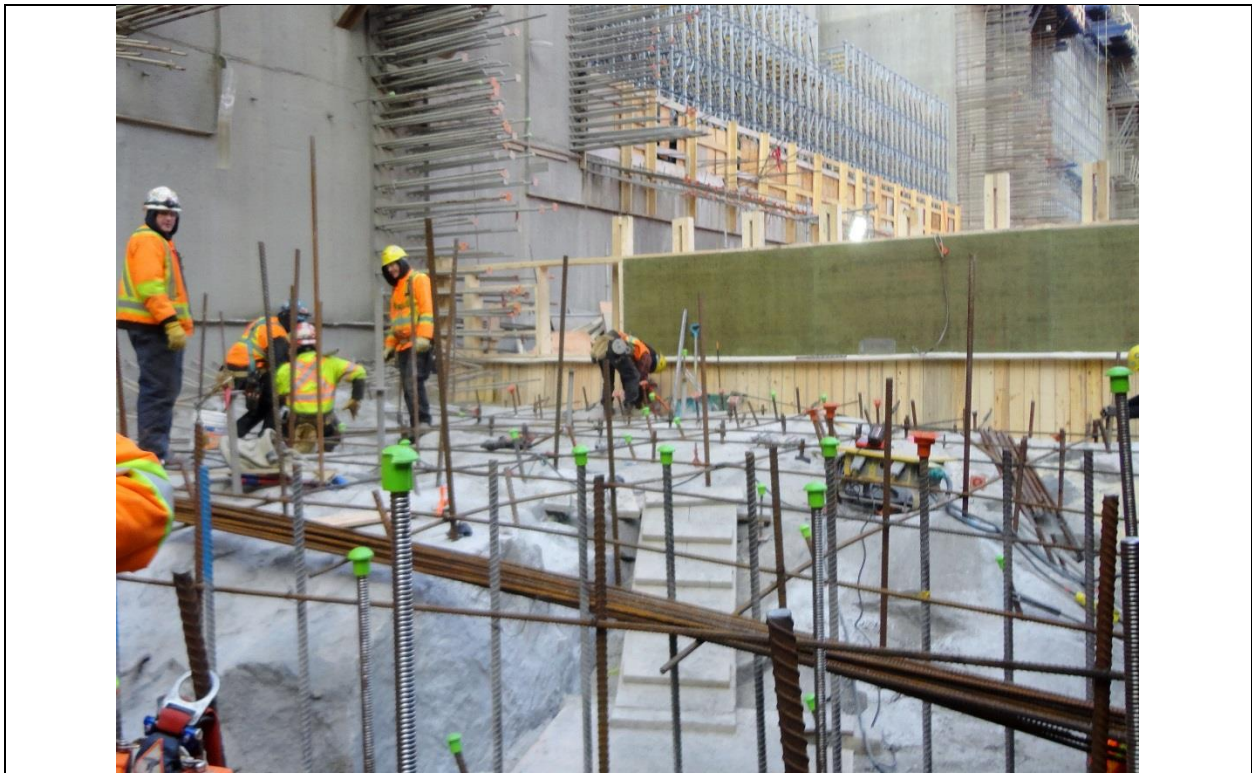
Photo B.6: Preparation of the bedrock foundation above Unit 2 draft tube area. (November 30, 2016)

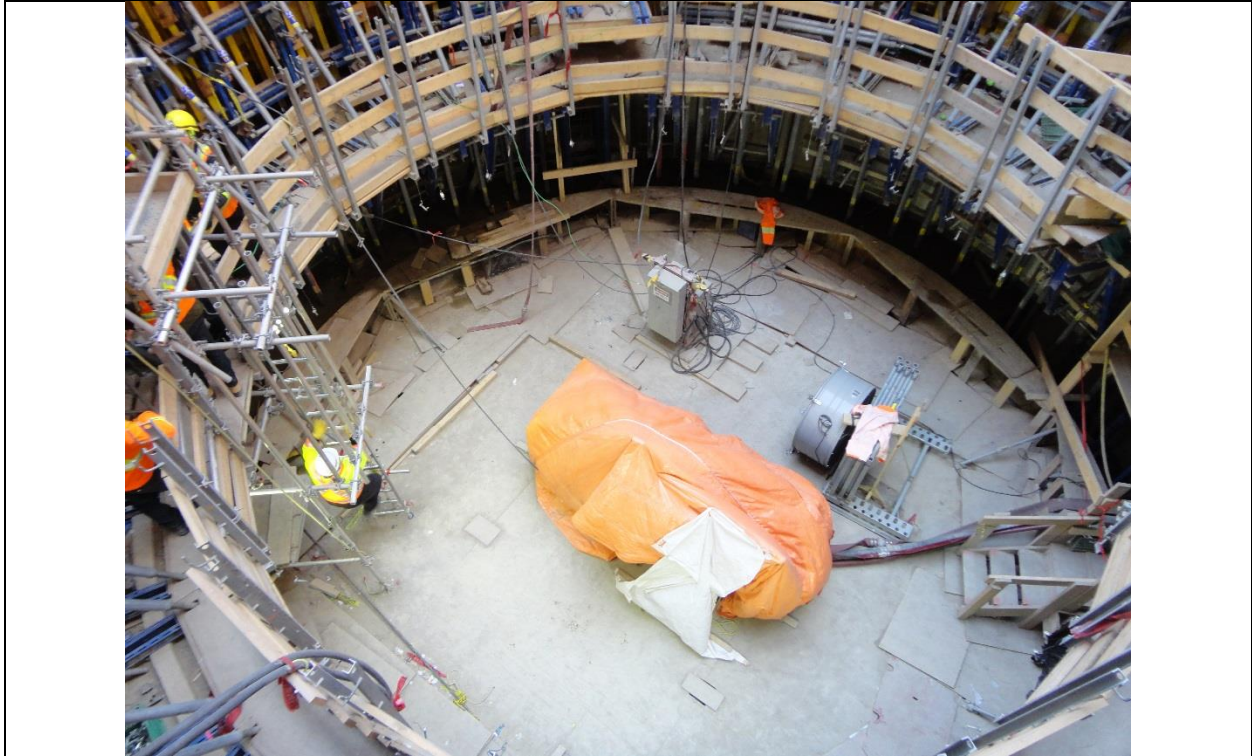
Photo B.7: Unit 2 formwork construction. (November 30, 2016)

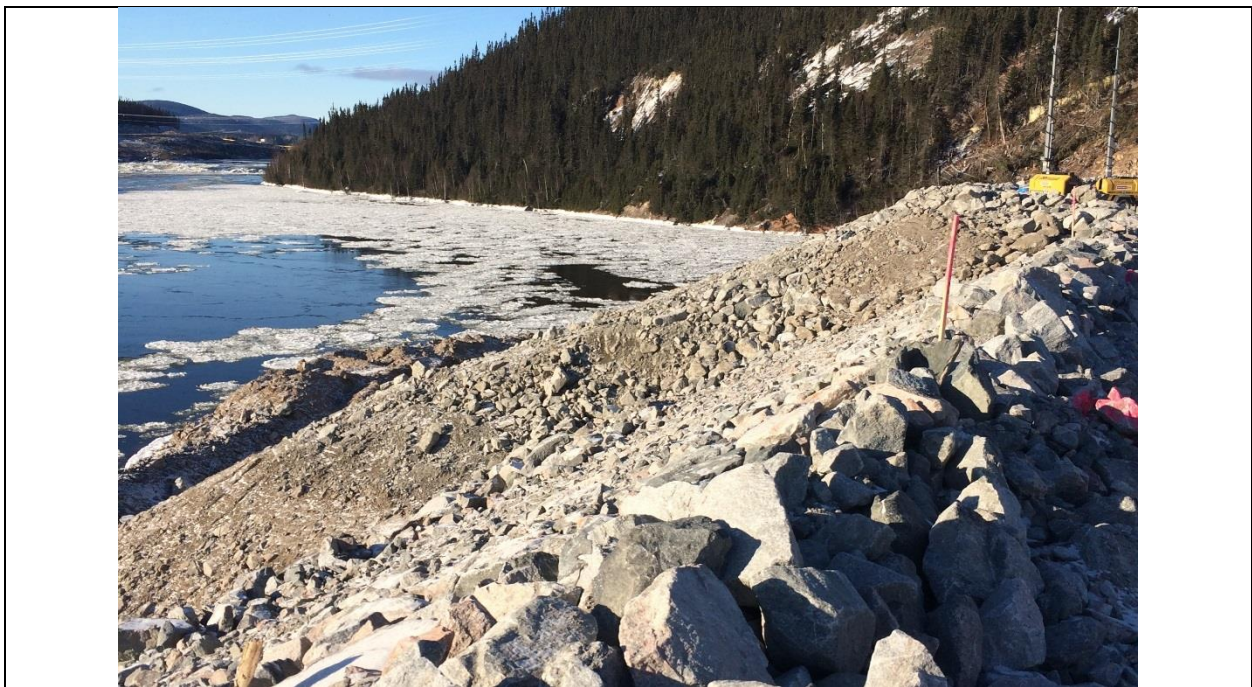
Photo D.10: Rock fill cover (brownish material) placed on the upstream face of the dam in the area of the leakage. (November 30, 2016)

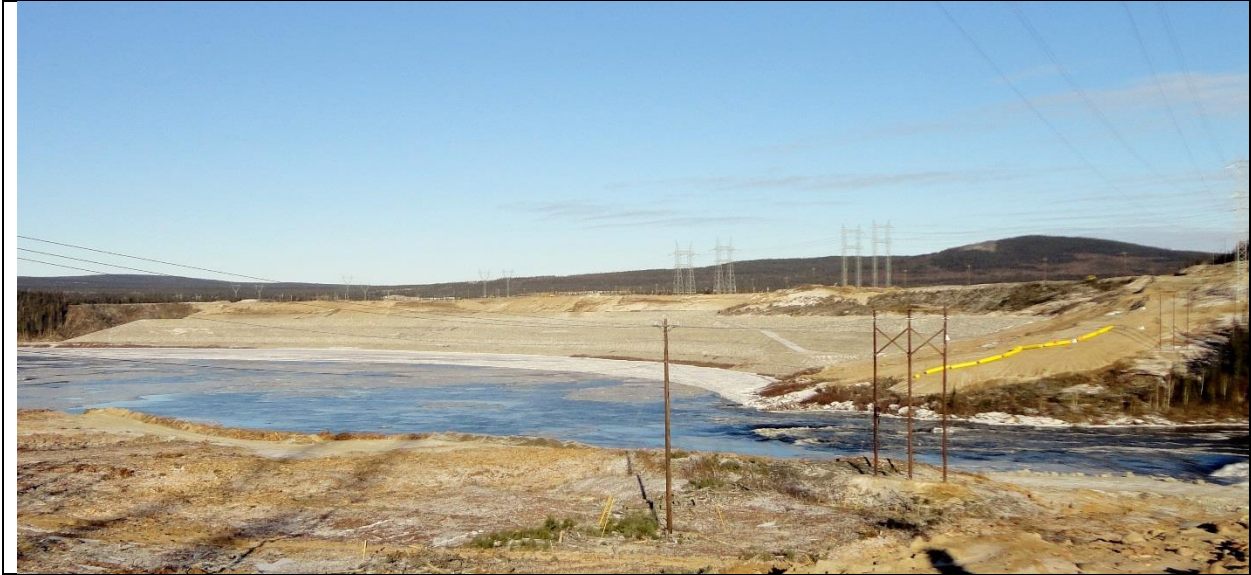
Photo E.1: Upstream face of the North Spur. (November 30, 2016)

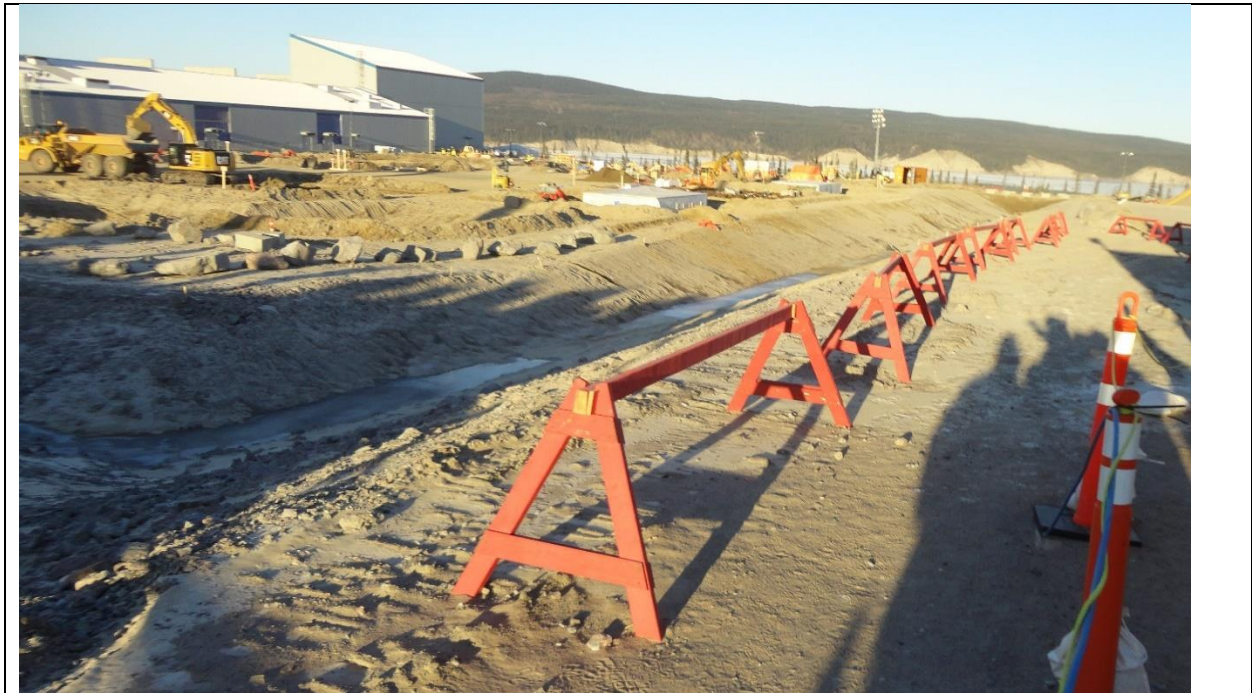
Photo F.4: Foundation preparation works for DC switchyard next to AC/DC converter building. (November 30, 2016)

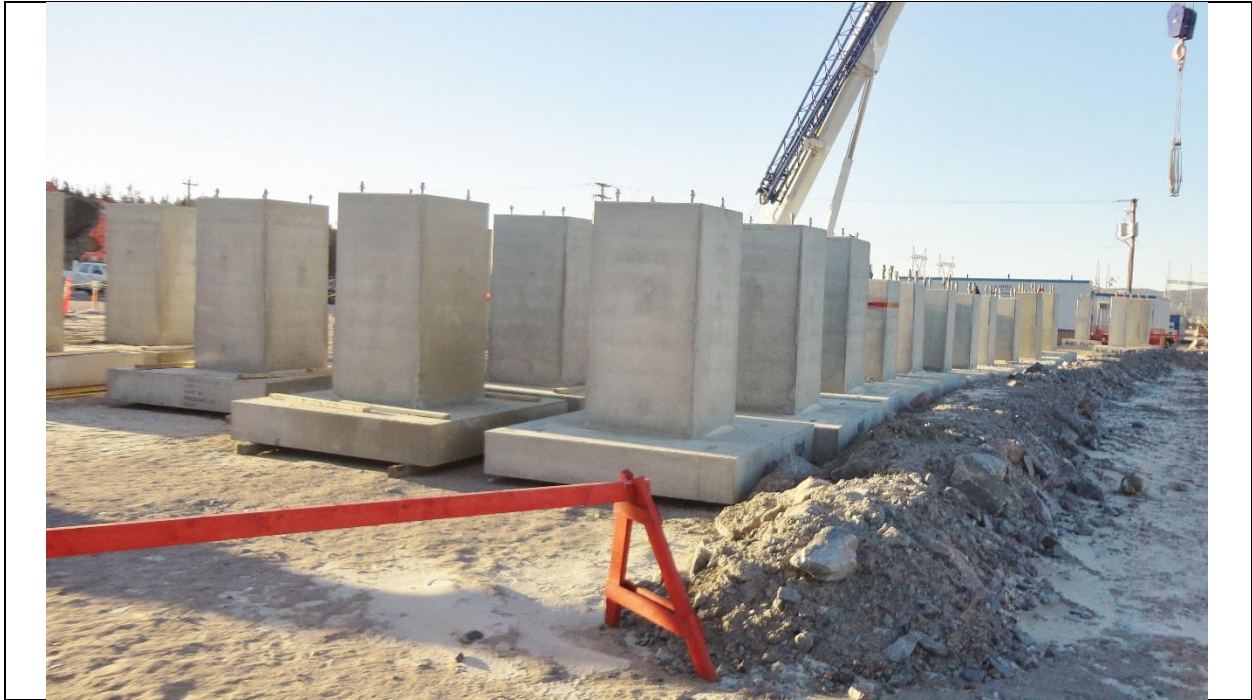
Photo F.5: Prefabricated concrete footings for switchyard equipment foundations. (November 30, 2016)

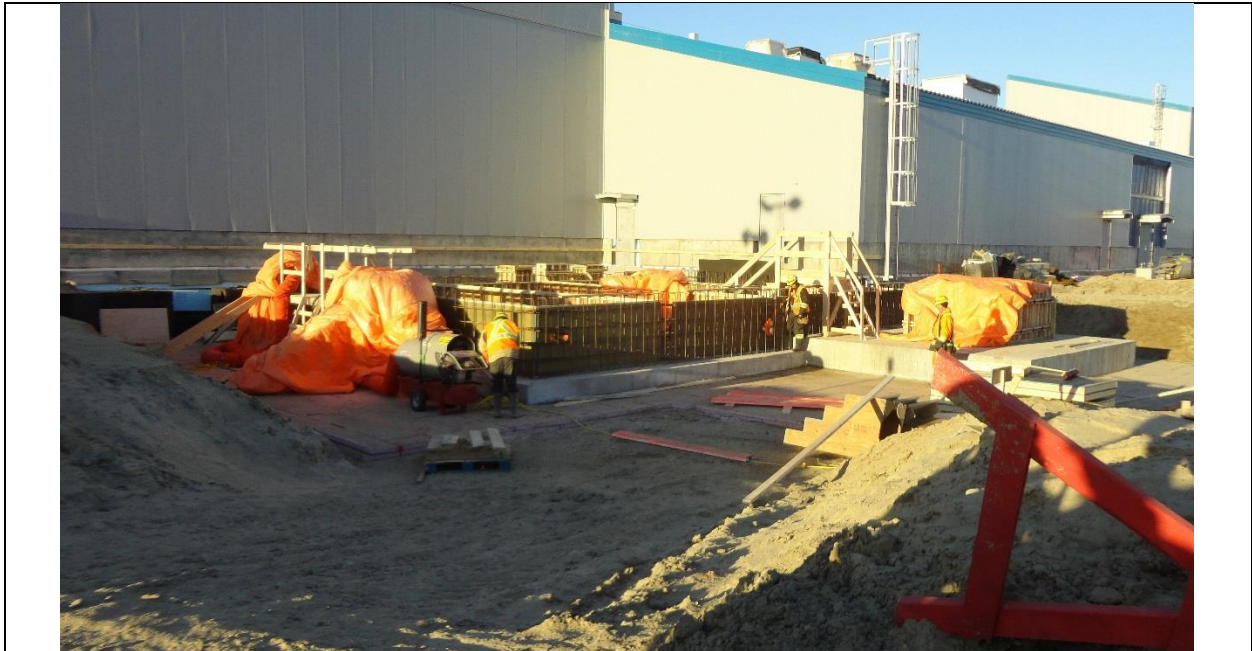
Photo F.6: Foundation preparation works for DC switchyard next to AC/DC converter building. (November 30, 2016)

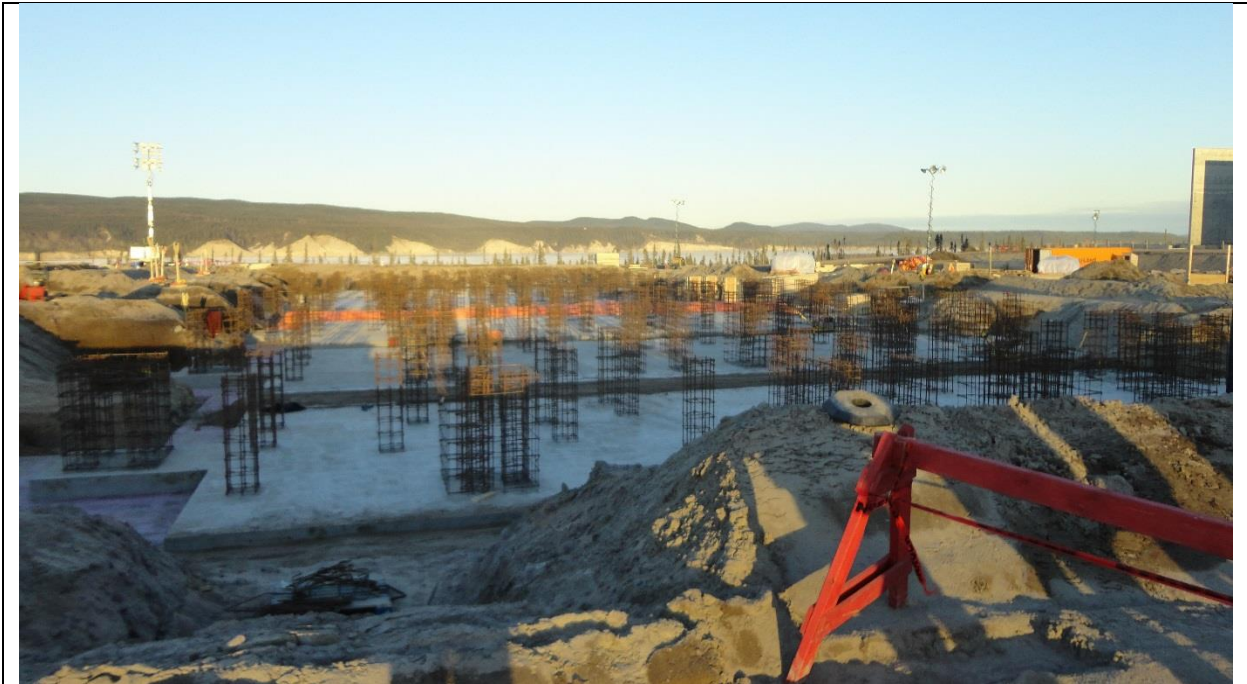
Photo F.7: Foundation works for AC filters equipment next to AC/DC converter building. (November 30, 2016)

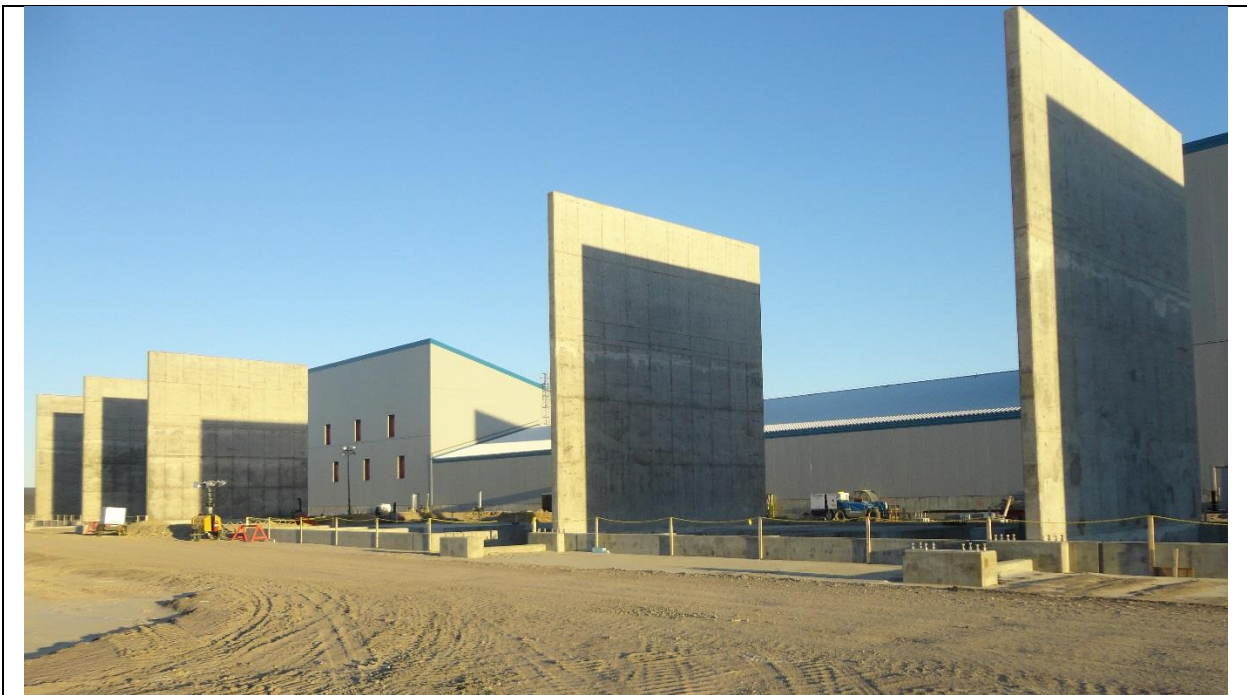
Photo F.8: Blast walls between the converter transformers containment pits at the AC/DC converter building. (November 30, 2016)
