**RELIABILITY STUDY
OF TRANSMISSION LINES
ON THE AVALON AND CONNAIGRE PENINSULAS**

Asim Haldar, Ph.D., P. Eng.
Sr. Engineer
Technical Support,
TRO Engineering

April, 1996

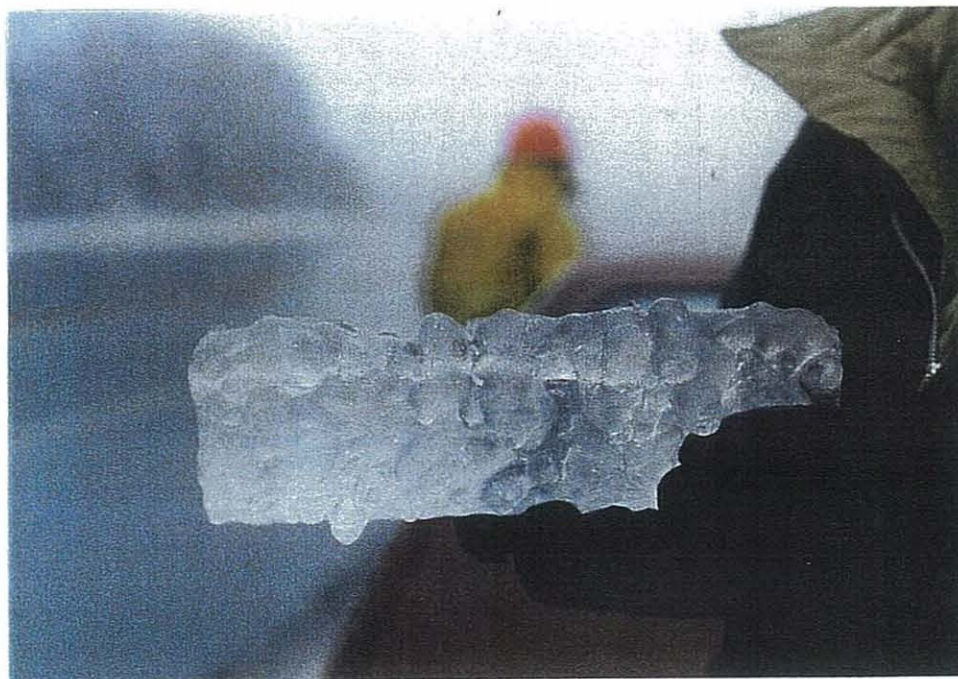
Photo No. 2-1
April 1984
Glaze Ice sample from Conductor-TL-237
(weight 7.8 kg/m)

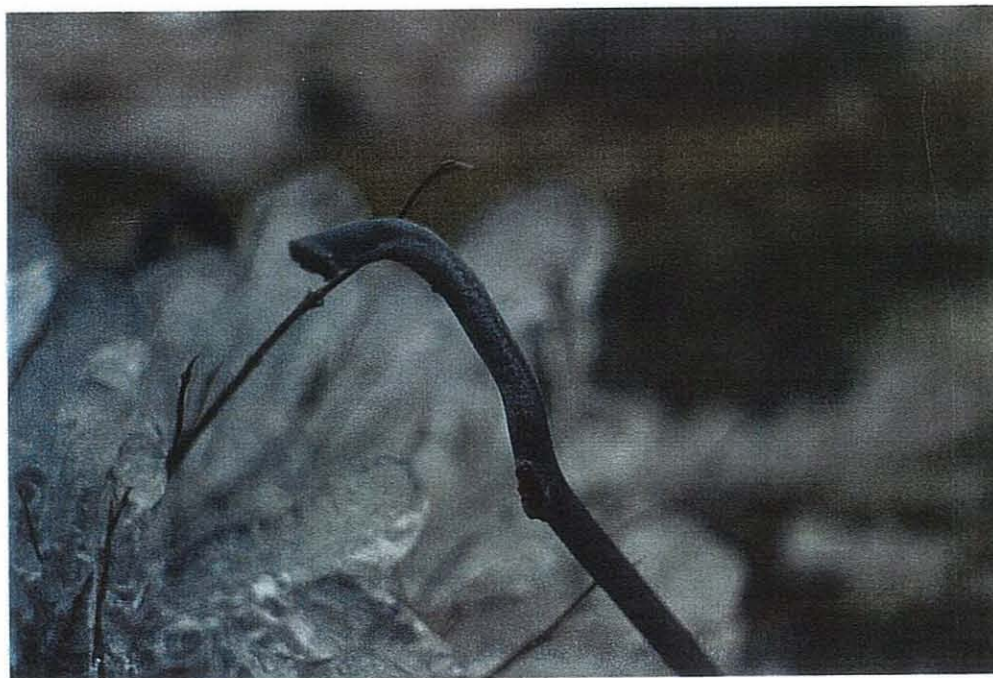
During this sleet storm, a number of lines that failed are detailed in Table 2.3. TL201 failed due to significant movement of a guying arrangement at a large angle structure location and this guying arrangement was subsequently modified (refer Fig. 2.7) under Work Order No. 5092 and implemented at various locations by Hydro forces in 1985. Failure of TL217 was also caused due to the collapse of a large angle (self-supported) structure (C-Type) thus causing a severe cascading failure. TL237 failure was primarily caused due to the conductor breakage in tension under 1.60 inches (41 mm) radial ice load. In all areas, ice load far exceeded the original design criteria and more than 2.0 inches (50 mm) of radial ice was observed at various places (refer Photos #2.1 and #2.2).

Photo No. 2-2
April 1984
Failed single eye Anchor Rod (TL-217)

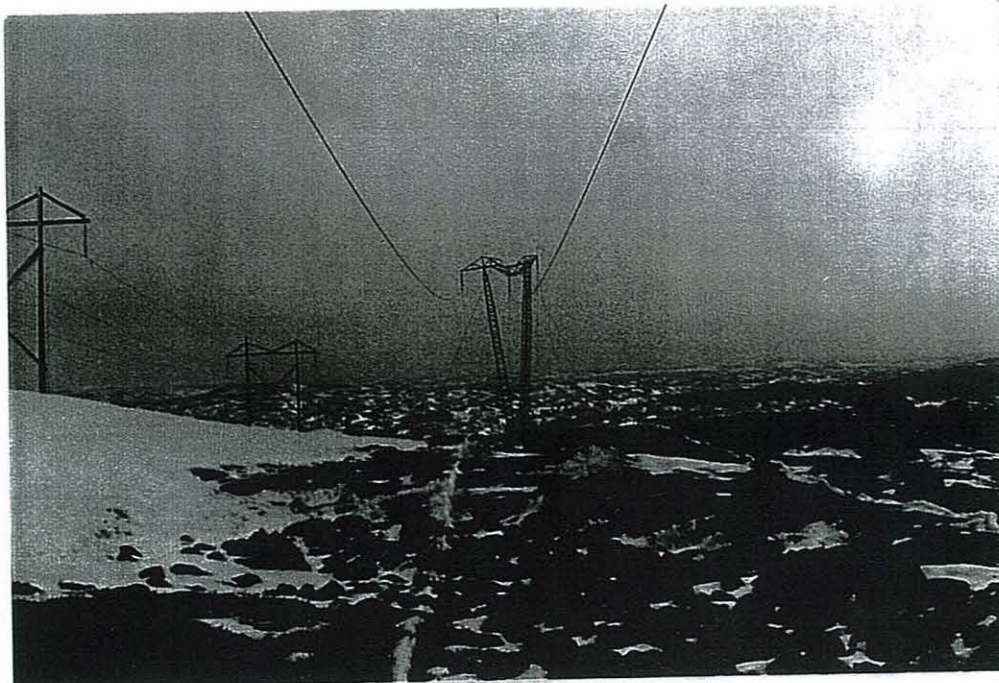
Photo No. 2-3
April 1988
Failure of bridge on Suspension Tower
(TL-217) at Hawke Hill

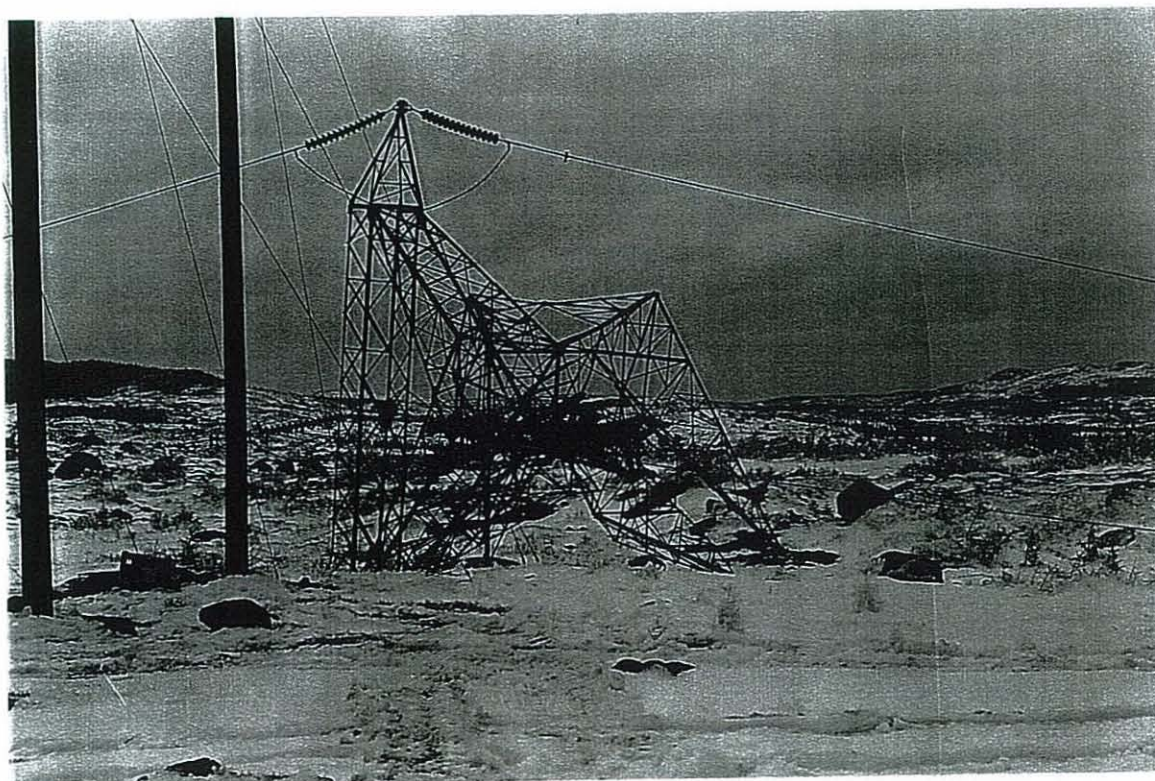
Photo No. 2-4
April 1988
"C" Tower (Heavy Angle) Failure on TL-217

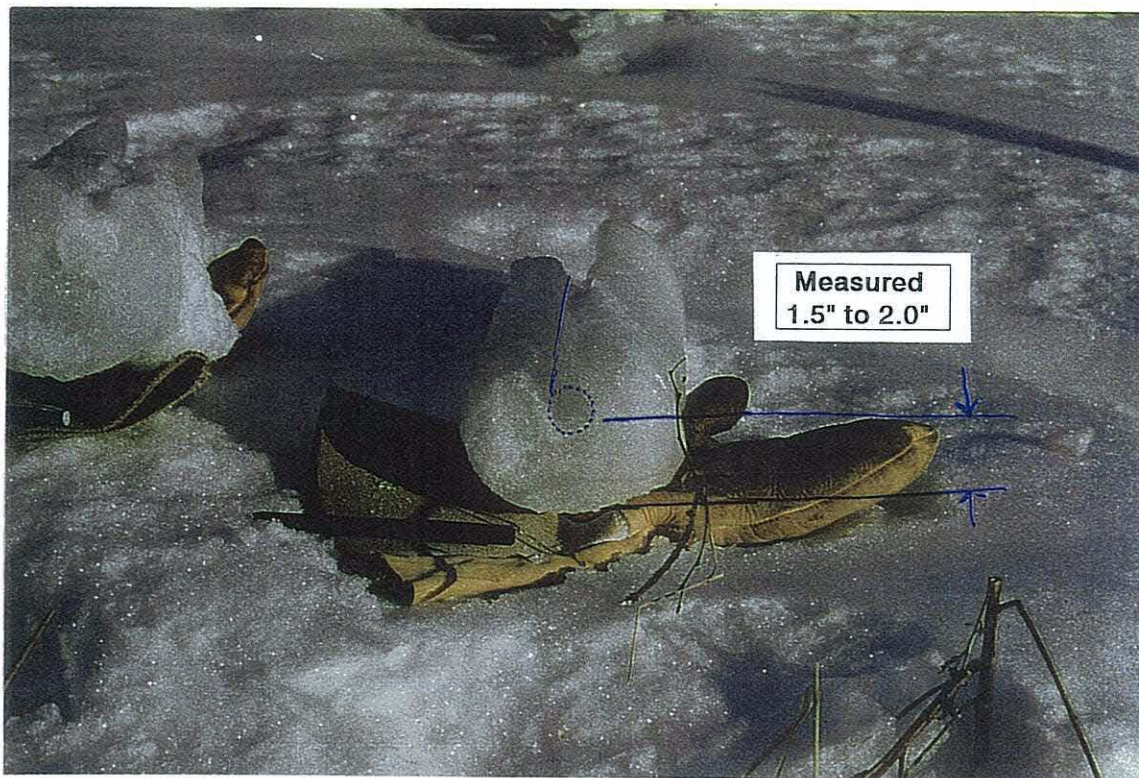
Photo No. 2-5
9 Dec. 1994

Icing observed on TL-201 1.5" to 2.0" (Radial)

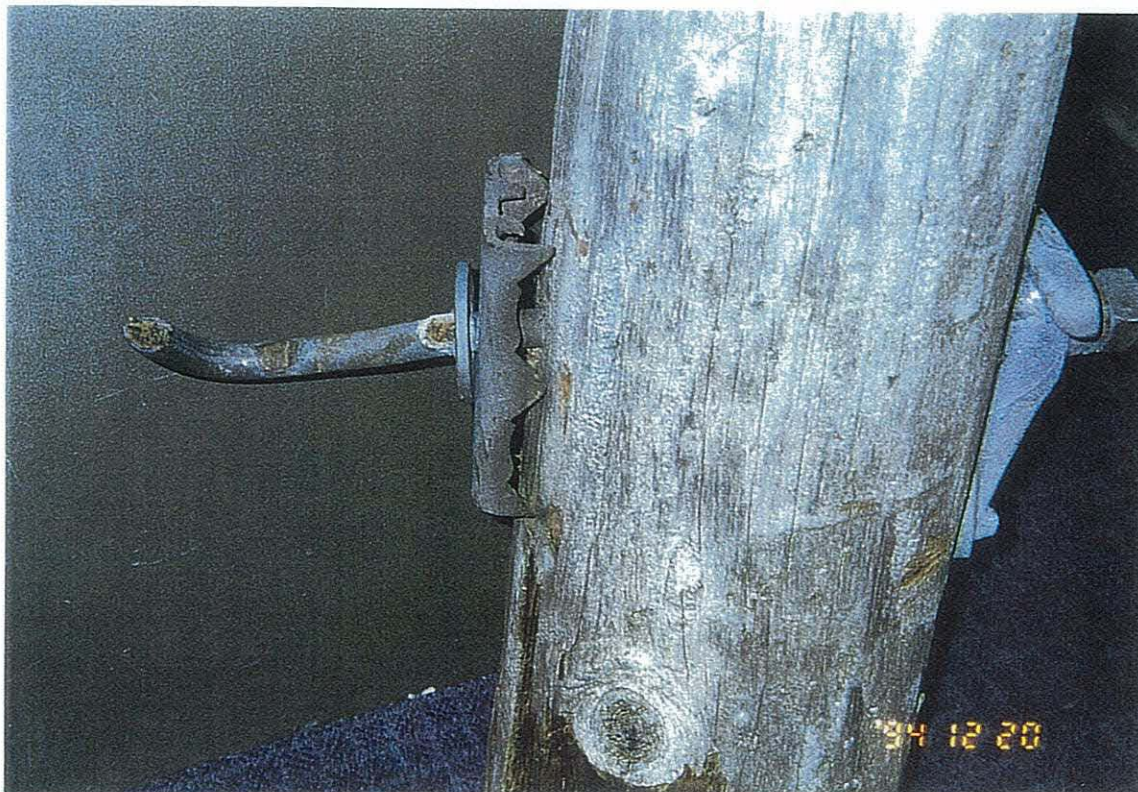
Photo No. 2-6
20 Dec. 1994

7/8" diameter welded Eye Bolt failure on TL-201

To improve the strength of the conductor hardware assembly, it is recommended that all welded eye bolts should at least be replaced by forged eye bolts where the strength of the bolt will only be governed by failure occurring at the threaded root. However, this still will not provide adequate strength when ice load on the conductor is being exceeded. TL201 and TL217, in general, have experienced 4 major failures (combined) in the past 30 years (Table 2.11), with an average failure rate of 1 failure in 7.5 years. TL201 alone has experienced 2 major failures in the past 30 years i.e.: 1 failure in 15 years (Table 2.9). Table 4.6 provides information on probability of encountering an ice storm as 49% (third storm) which is quite high when compared to a 50-year load which is only 5%. As these lines were designed with ice load as 1.0 inch (25 mm) radial which has been underestimated severely with regard to a real 50-year load, probability of a line failure, in future, is extremely high. Therefore, standard dead-end assembly shown in Fig. 5.3 is strongly being recommended in view of Item (d) in Section 5.4.1. To improve the strength of the conductor itself, several discussions were held with Aluminum Company of Canada (ALCAN) (Ref. 14) and it was suggested that a high strength special alloy conductor (equivalent to "Drake" 795 ACSR 26/7 in ampacity) be used for re-conductoring option. Strength of this 804 kcmil conductor is twice that of "Drake" and Table 5.6
