Independent Review of the 17 May 2017 Churchill River (Labrador) Flood Event

Karl-Erich Lindenschmidt, PhD, PEng

University of Saskatchewan

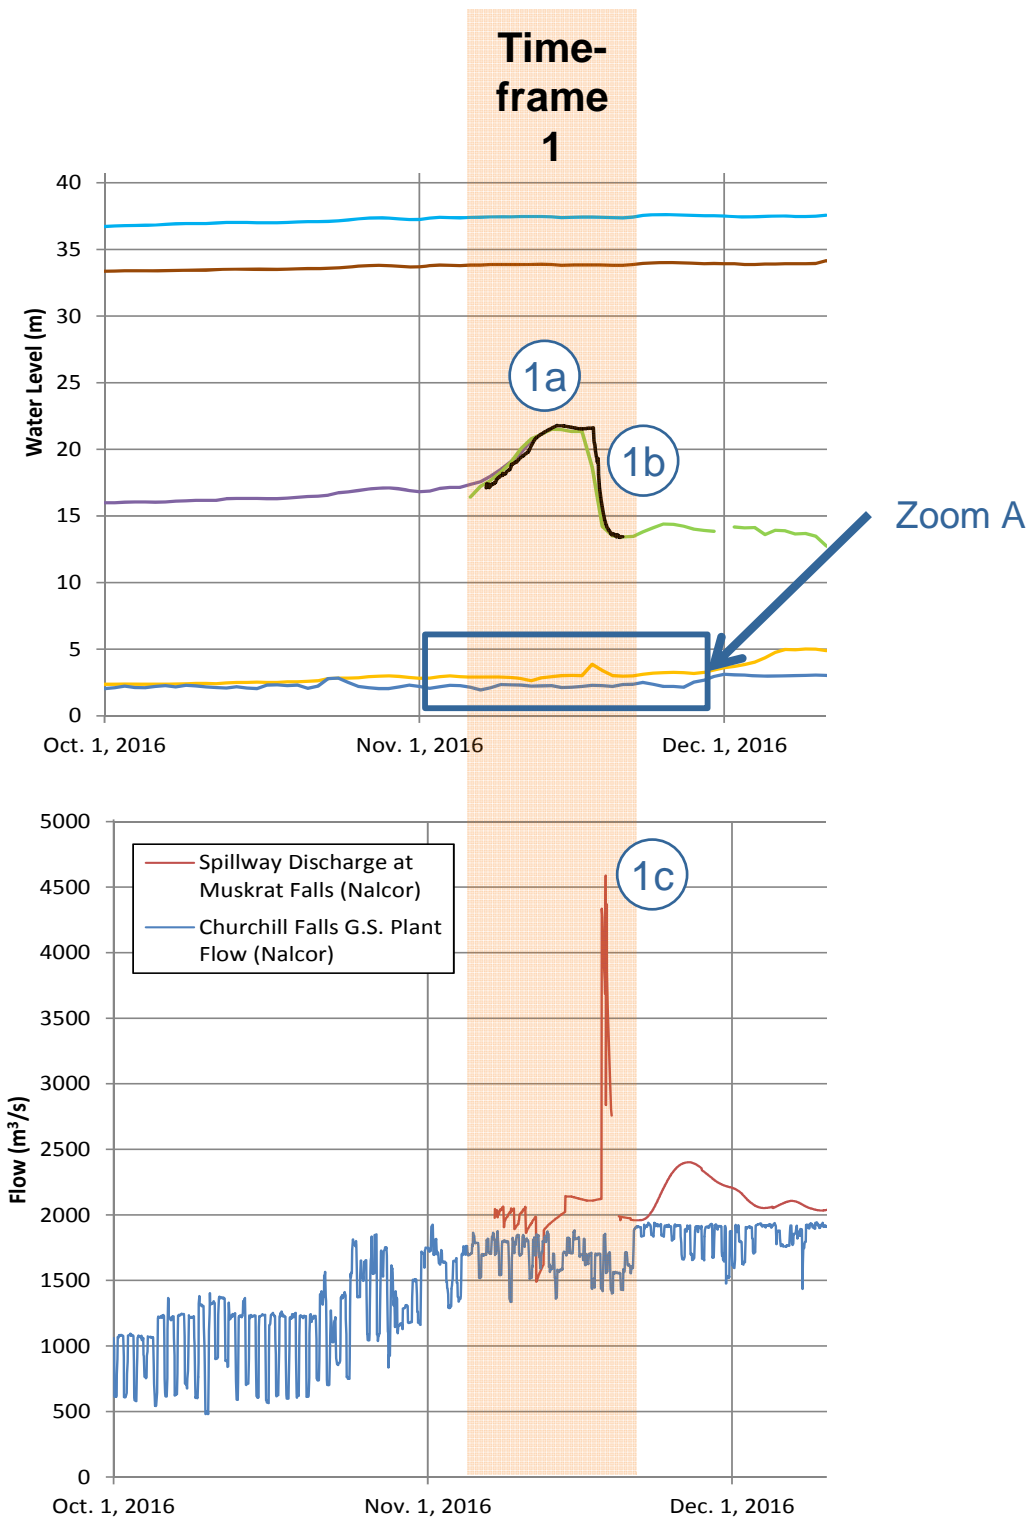
Figure 5: Timeframe 1 (7 – 22 November 2016). Zoom A is provided in Figure 6. The legend is shown in Figure 4.

Referring to Figure 5 for the first timeframe, open-water conditions prevailed during most of the month of November 2016. After the first week in November 2016, the water level in the Muskrat Falls forebay increased, coinciding with decreasing flows through the spillway to raise the water level to an elevation of 21.7 m, to the intended winter forebay level (1a in Figure 5). This would have provided a stabilized ice cover in the forebay to reduce frazil ice formation and hem the progression of a hanging ice dam downstream of Muskrat Falls. On 18 November 2016, the spillway gates were opened to rapidly release the water from the forebay and drop the water level to approximately that of the river's natural flow regime (1b in Figure 5). This quick operation over a period of approximately two days was in response to a leaking cofferdam. The water release caused a large increase in flow, from 2,120 to 4,590 m³/s (1c in Figure 5). The water levels recorded at the gauge 6.15 km downstream of Muskrat Falls responded with a water level rise immediately after the flow release from Muskrat Falls (1d in Figure 6). The response was rapid, with the water levels dropping back down to pre-peak conditions by 21 November 2016 (1e in Figure 6), well before river freeze-up. The same peak response was not observed at the water level gauge at English Point (1f in Figure 6). A small peak was recorded, later than expected on 24 November 2016 (1g in Figure 6), but the water level dropped to its pre-peak water levels by 25 November 2016 (1h in Figure 6), still a few days before the river began freezing over along the lowest reach of the Churchill River. Much of the peak may have been attenuated due to the off-channel flow into creeks and streams branching off from the Churchill River into storage. This artificial release and the dissipation of the flow downstream from Muskrat Falls occurred before backwater staging commenced along the lower Churchill River due to freeze-up.

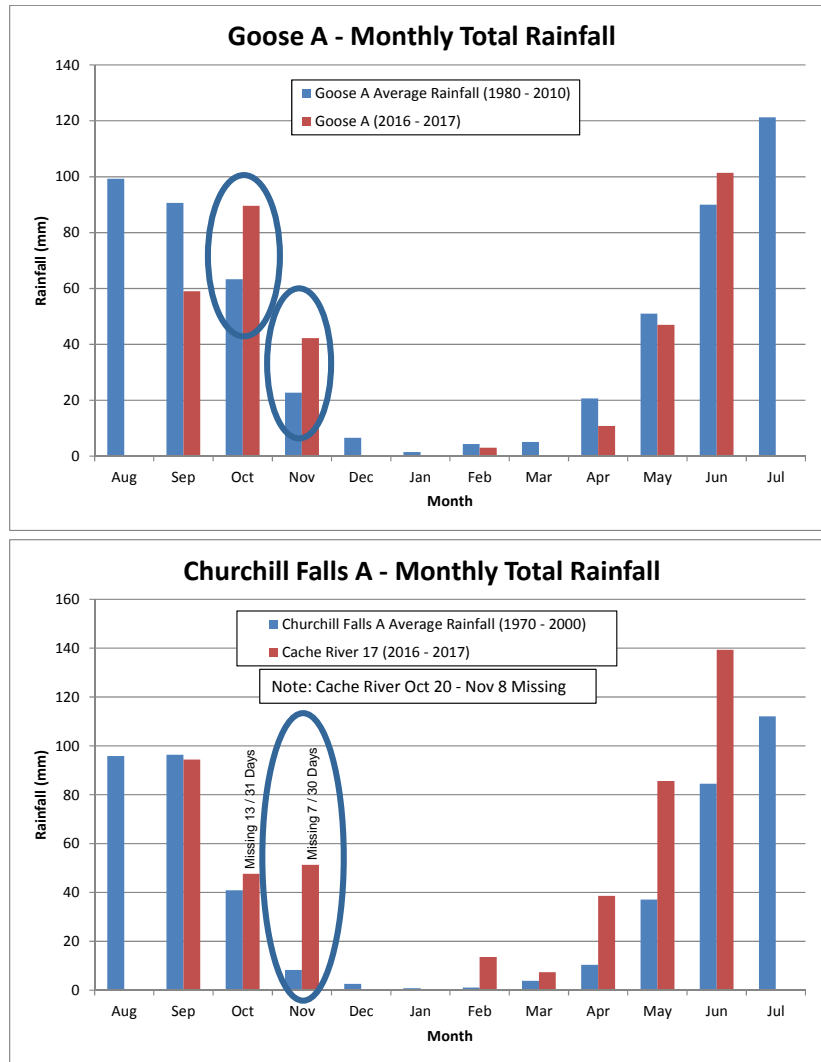
Figure 10: Total monthly rainfall recorded at Goose Bay (top panel) and Churchill Falls (bottom panel) from August 2016 to July 2017 (red bars), along with the 30-year averages (blue bars). Ellipses indicate total rainfall depths much higher than the 30-year average.

Rain depths measured at Churchill Falls and Goose Bay (see Figure 10) indicate that the total rainfall during the months of October and November 2016 was above the 30 year average for those months. Even with missing data from the November 2016 record, the total rainfall at Churchill Falls was more than five times the average for November. More details regarding the actual rain events are provided in Section 8.1 of Appendix 1.

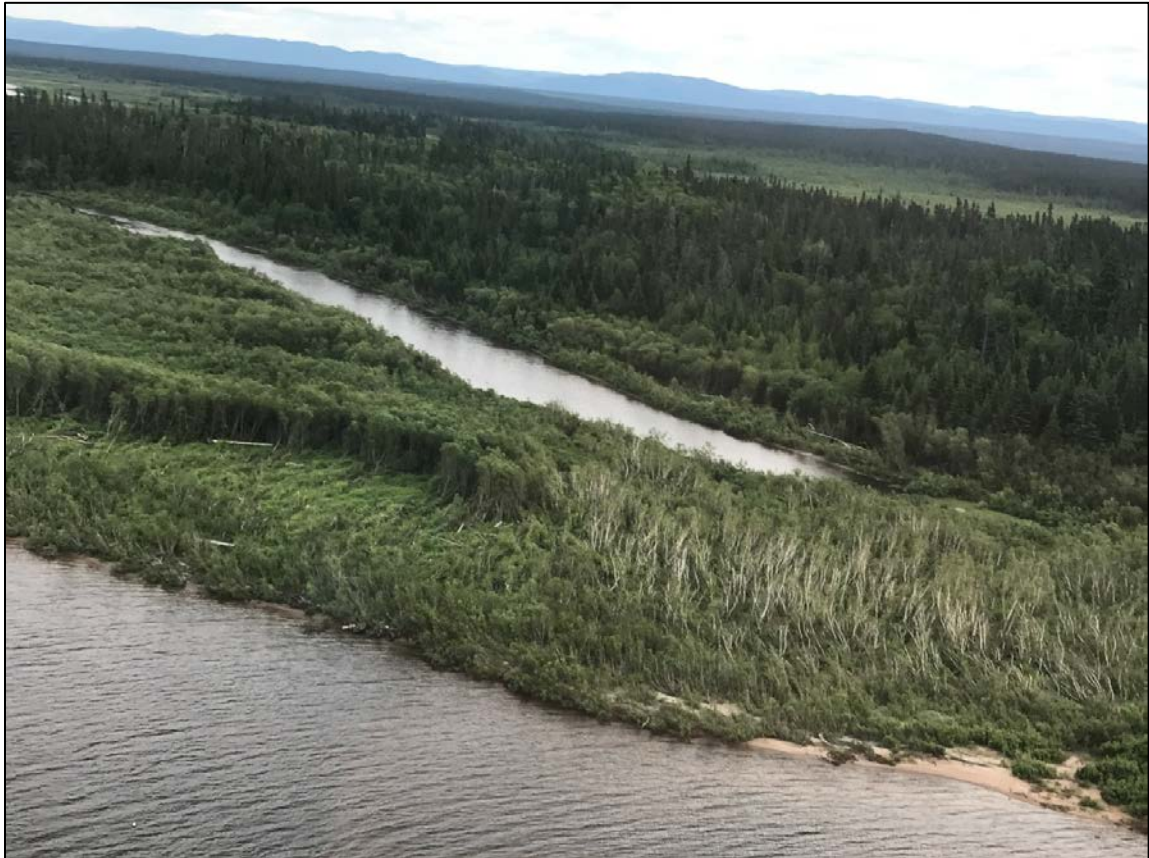
PHOTO 3.1
DAMAGE ALONG BANKS OF CHURCHILL RIVER FROM ICE JAM

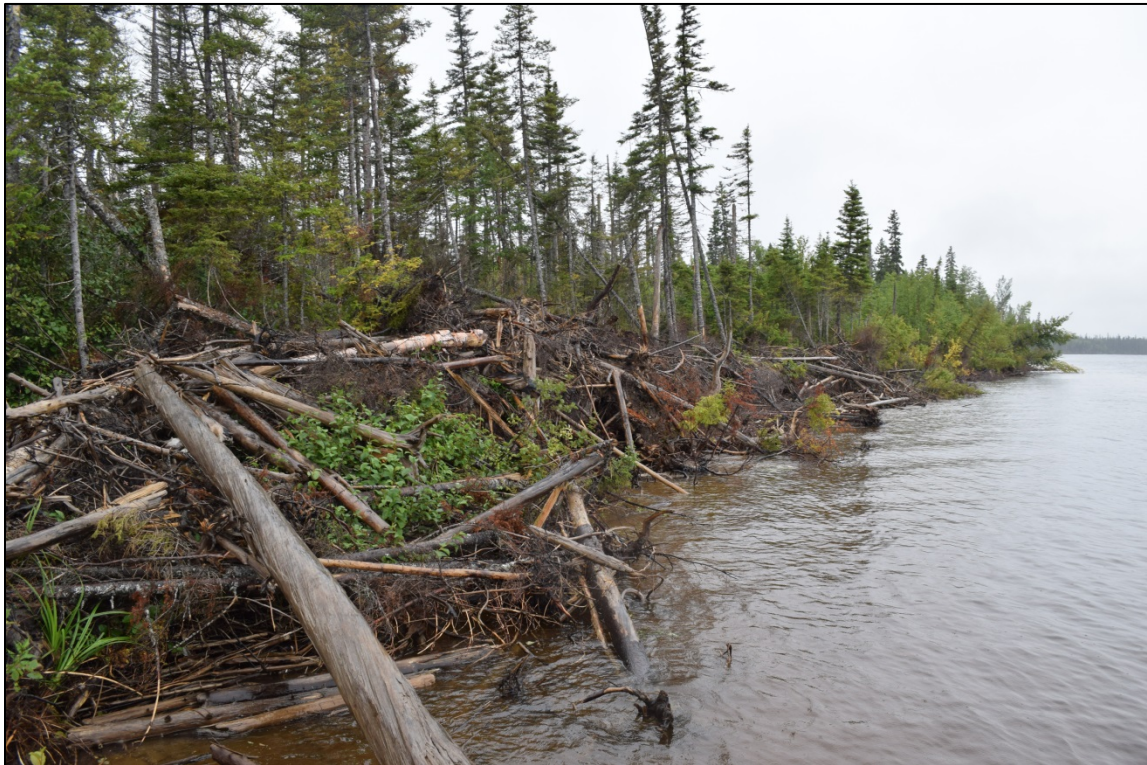
PHOTO 3.2
TREE DAMAGE ALONG BANKS OF LOWER CHURCHILL RIVER

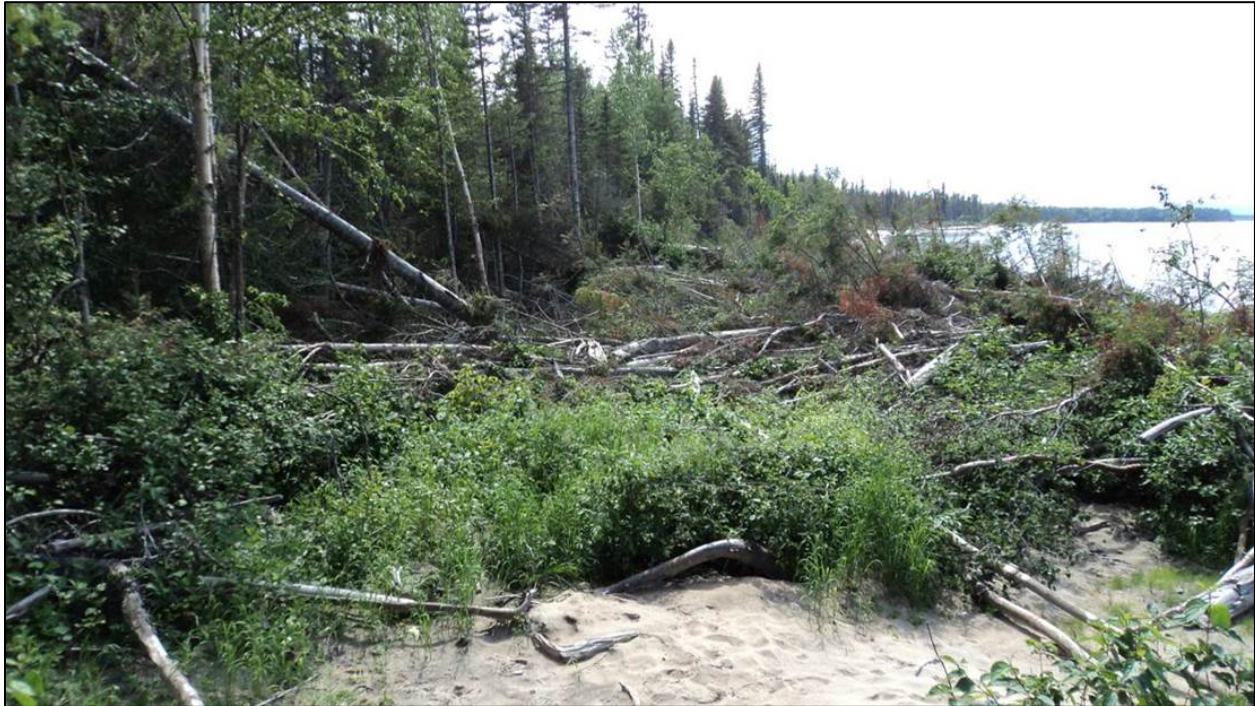
PHOTO 4.1
LARGE DIAMETER TREE PUSHED OVER BY ICE JAM

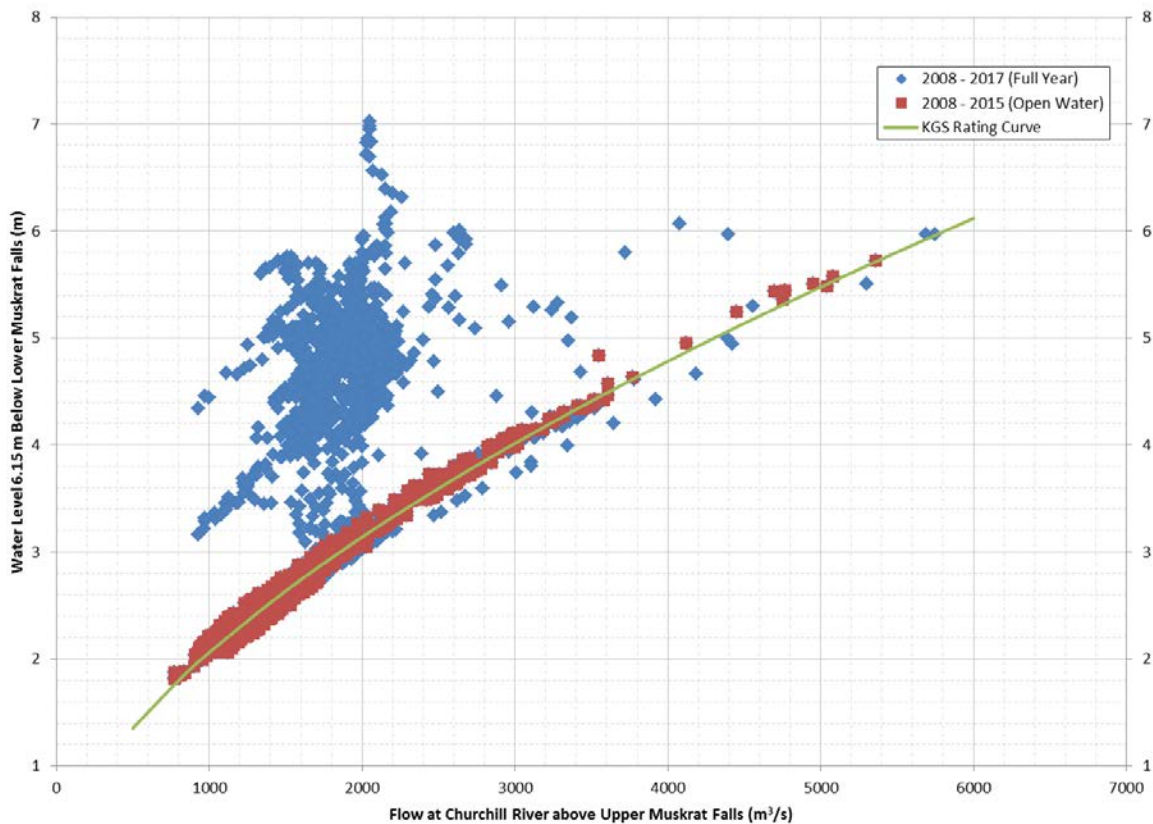
FIGURE 6.6
STAGE – DISCHARGE RELATIONSHIP 6.15 KM BELOW MUSKRAT FALLS

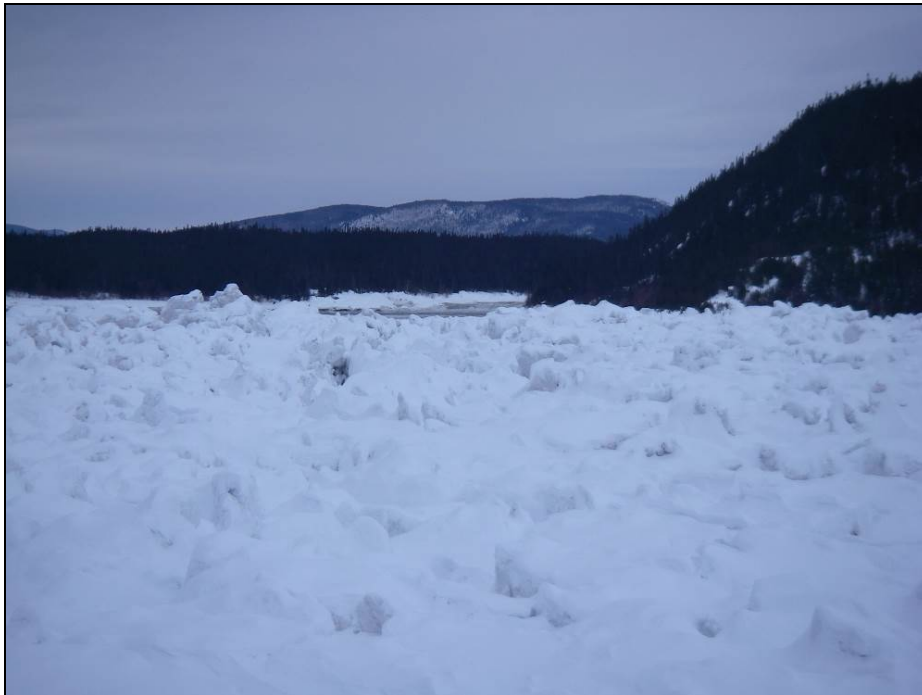
PHOTO 8-2
HANGING ICE DAM DOWNSTREAM OF MUSKRAT FALLS (MAR. 19, 2009)

Cheung and Guillaud (1981) describe surveys of the hanging ice dam that show that the water surface profile created by the fully developed ice dam extends downstream with a hydraulic gradient of 1 m per 1000 m of channel length, as shown in the Figure 8.27. This gradient along the hanging ice dam is consistent with ice dams observed on other rivers (Kivisild, 1958). This would mean that a thick deposition of ice would extend more than 10 km downstream of Muskrat Falls, if the water level rose by 10 m at the falls. In fact, staging well in excess of 10 metres has been recorded frequently in the past (SNC, 2013).
