MEETINGS IN ST. JOHN’S, NL AND VISITS TO LOWER CHURCHILL PROJECT SITES, JULY 6-9, 2015

Prepared for: Nalcor Energy

Date: October 02, 2015

Muskrat Falls Site Visit – July 6-9, 2015

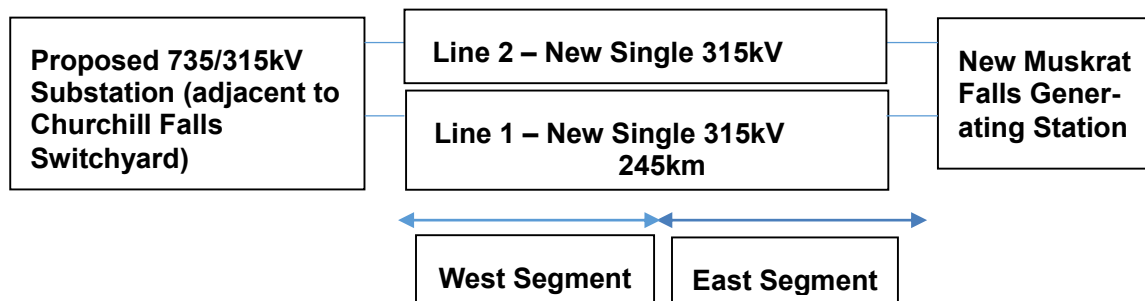
The HVac lines consist of two parallel 315kV lines connecting from the proposed 735/315kV Substation (adjacent to Churchill Falls Switchyard) to the new Muskrat Falls Generating Station as shown in the diagram below:

The two new HVac transmission lines have separate structures and share the same right of way (100m) in parallel to an existing 138kV line. The lines are split into East and West segment. The East segment starts from the new Muskrat Falls Generation Station and runs to STR # 323. The West segment is between STR # 323 and the new 735/315kV Substation at Churchill

Falls. Each line has bundled conductor (2-795kcmil – Drake/phase) and uses steel structures with horizontal configuration. There are approximately 1200 towers for the two lines. Line 1 is to the south, includes one OPGW (Optical Ground Wire) and one OHSW (Overhead Shield Wire) while Line 2 is to the north, and includes two OHSW.

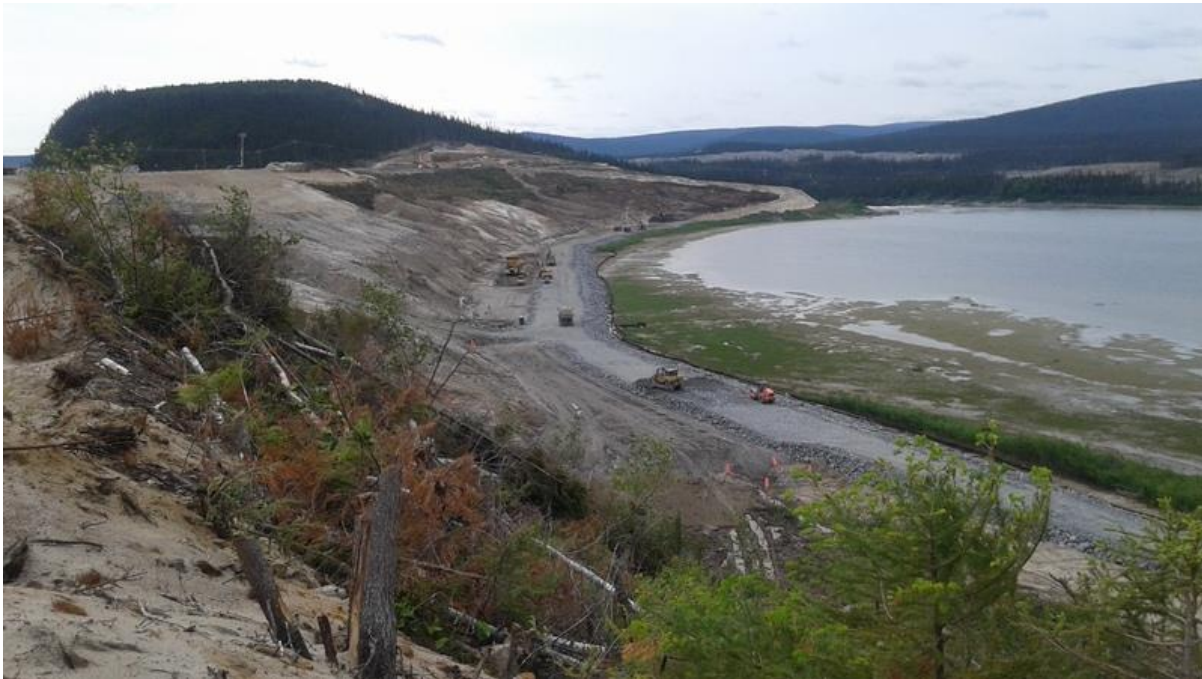
Photo 1.1 Looking at Upstream Slope of North Spur. Clearing and OM excavation completed. Contractor working on preparation of CB Work platform (July 7, 2015)

The Contractor appeared to be well organized and performing at an excellent pace. Mobilization of their earthmoving spread is fully complete and work is progressing ahead of their schedule. The upstream excavation of overburden material is completed and mobilization for the cut-off walls has just begun. The Contractor has started the upstream cut-of wall work platform (Photo 1.1). Clearing of the downstream slope is partially completed (Photo 1.2). This contract should be completed on time.

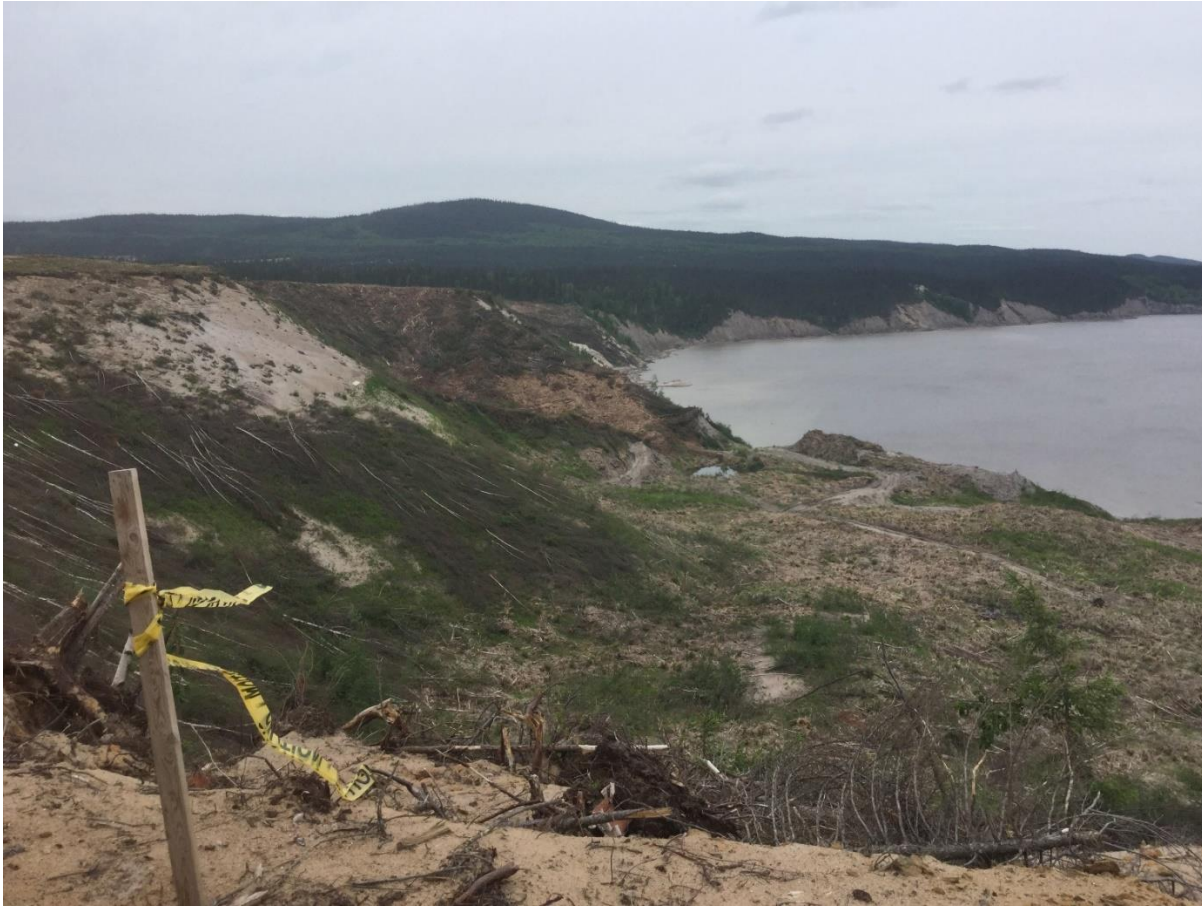
Photo 1.2 Looking at Downstream Slope of North Spur. (July 7, 2015)

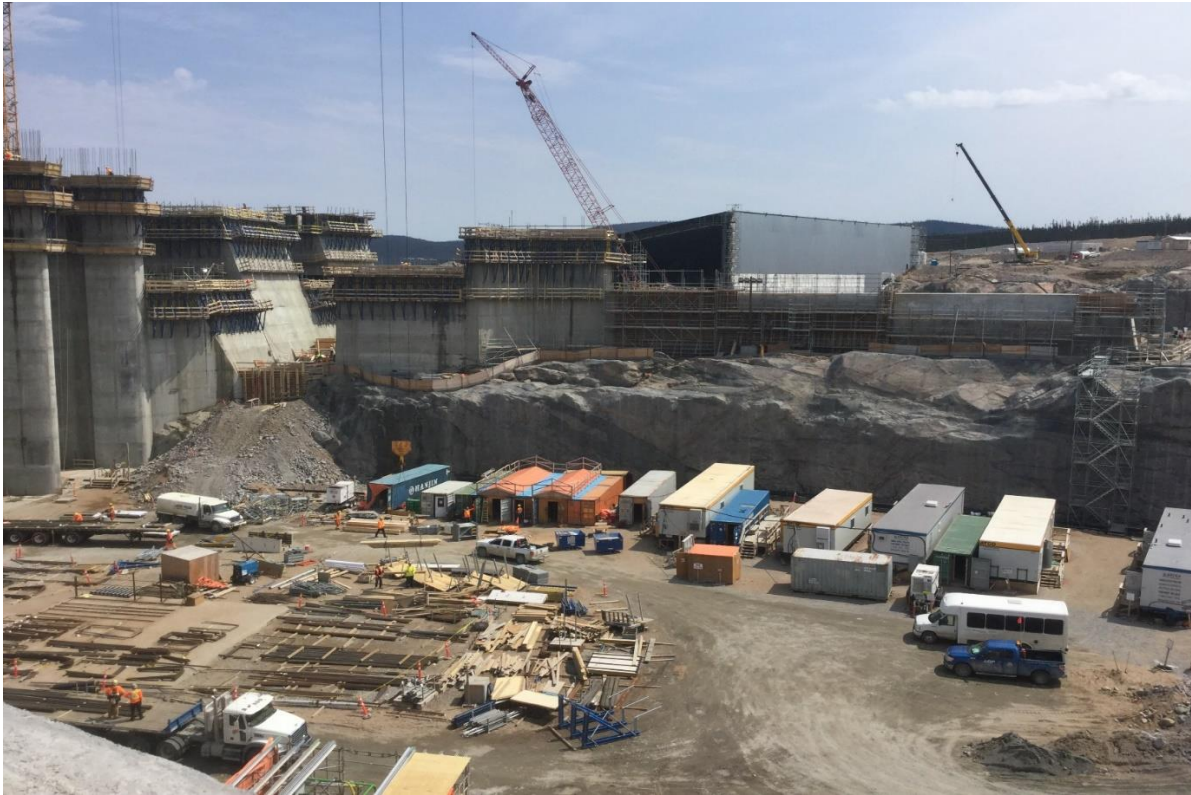
Photo 2: Looking (from top of RCC Cofferd Dam) along proposed centerline of Temporary Access Bridge to South Dam. (July 7, 2015)

Contract CH0009 for the north and south dams has been under negotiation for a significant length of time. The closure of the river is to be performed in July 2016 under this contract. Some concern should be expressed that the contract is not yet in place and is key to meeting the river closure date. Also critical to the access to the north dam is the design and construction of a temporary access bridge across the spillway approach channel. The location of this structure is illustrated in Photo 2. The bridge will span between the upstream leading edge of the Separation Wall (in view) and the RCC Cofferd Dam. The design and construction of this bridge is the responsibility of the CH0009 Contractor.

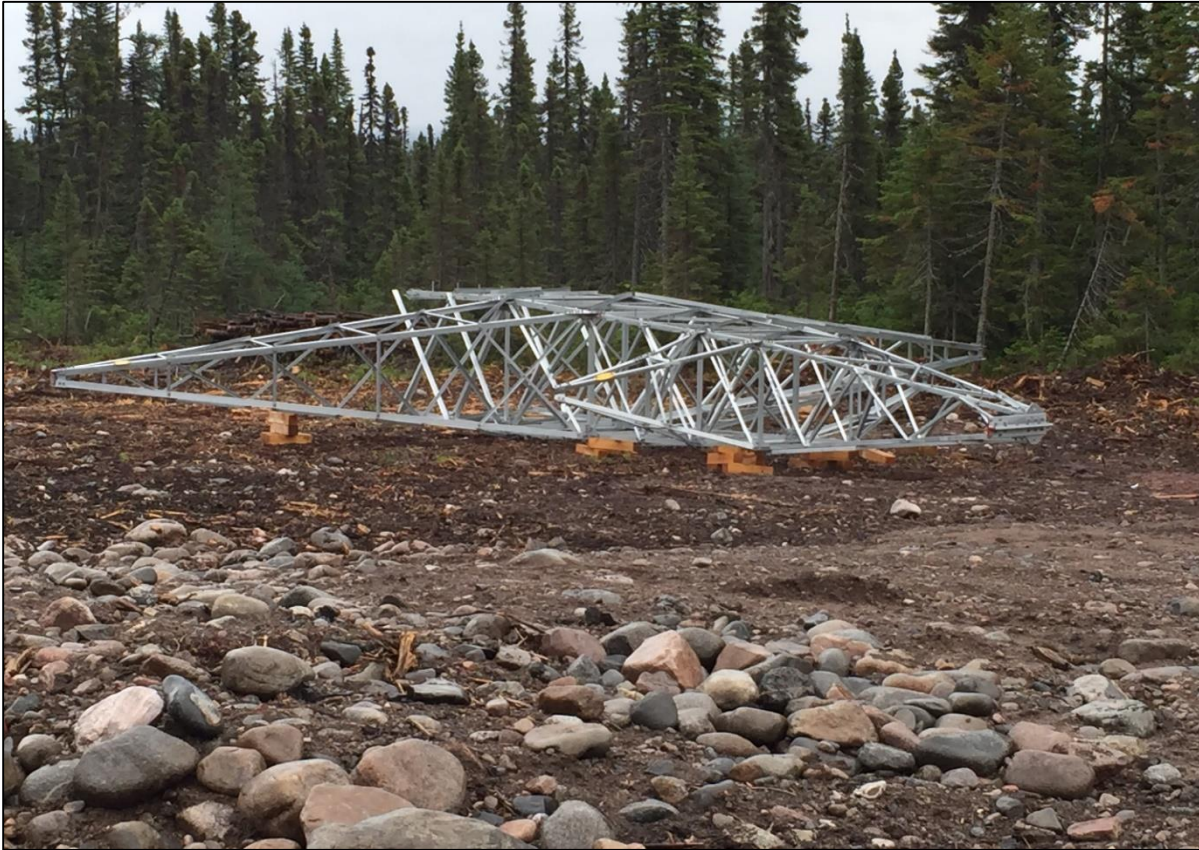
Photo 3.1 HVdc structure assembly (July 8, 2015).

- The quality of clearing along the transmission line was good.
- Foundation was approximately 20% complete.
- Tower assembly and installation was approximately 15% complete (Photos 3.1, 3.2 and 3.3).

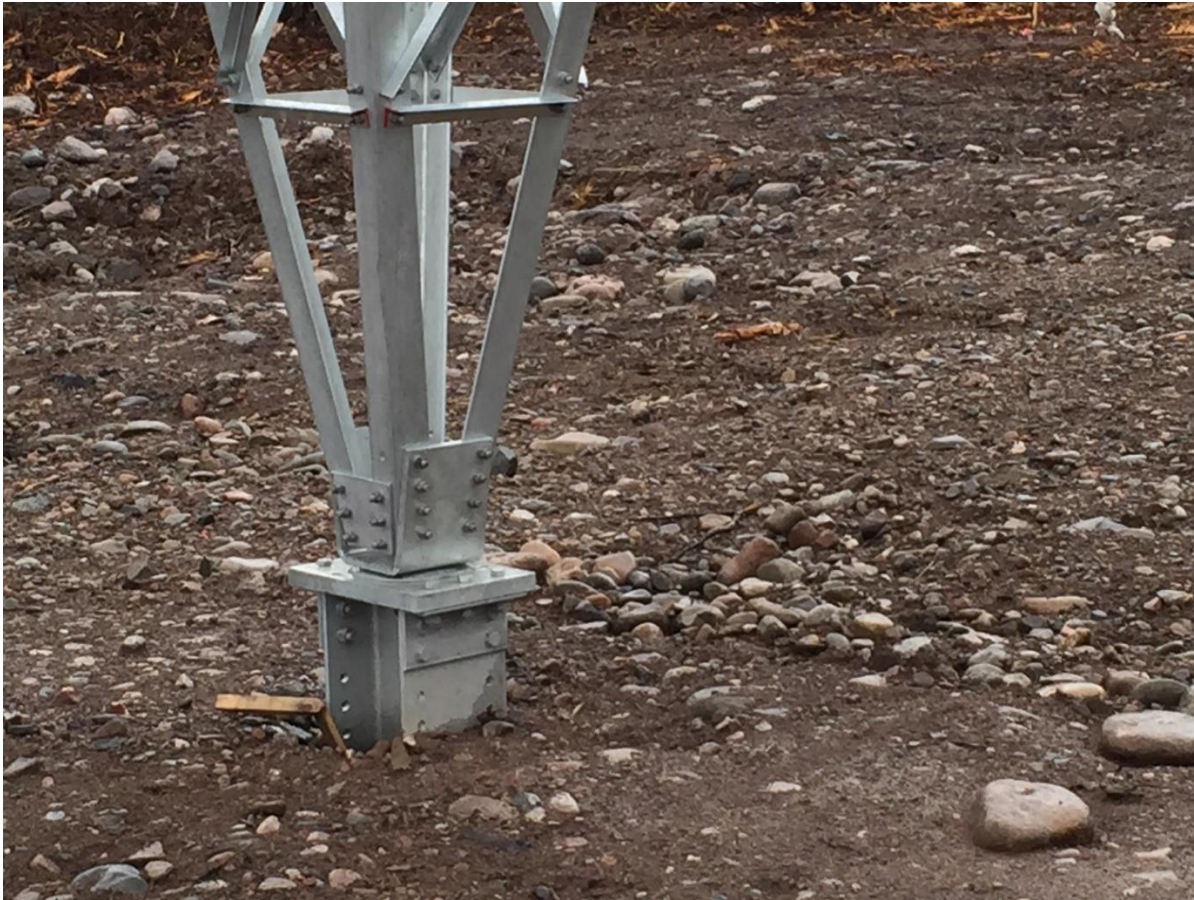
Photo 3.2 HVdc transmission line foundation installation (*July 8, 2015*).

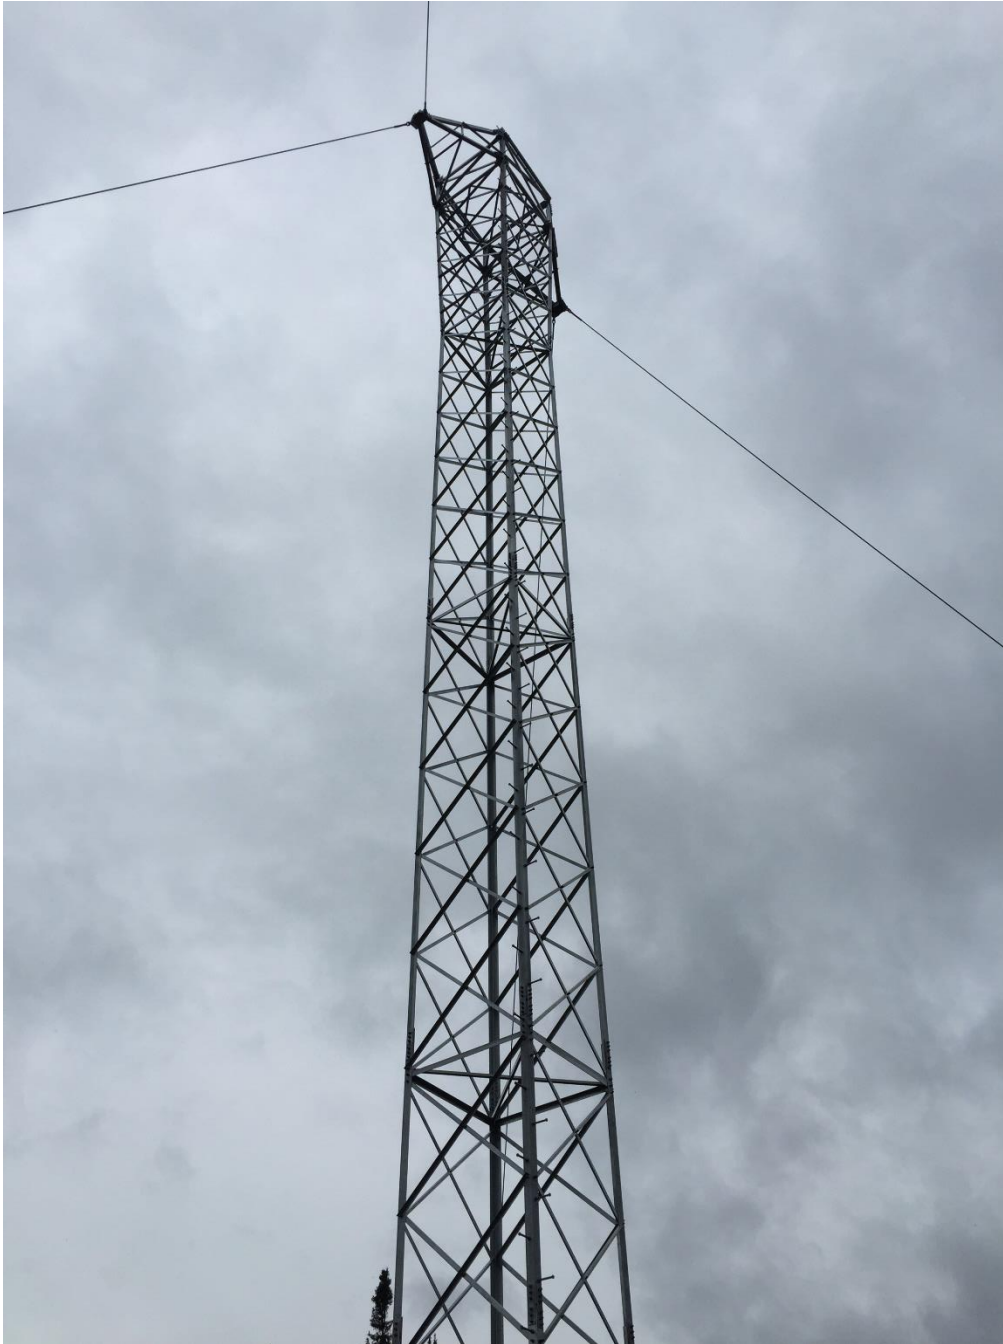
Photo 3.3 HVdc transmission line installation (*July 8, 2015*).

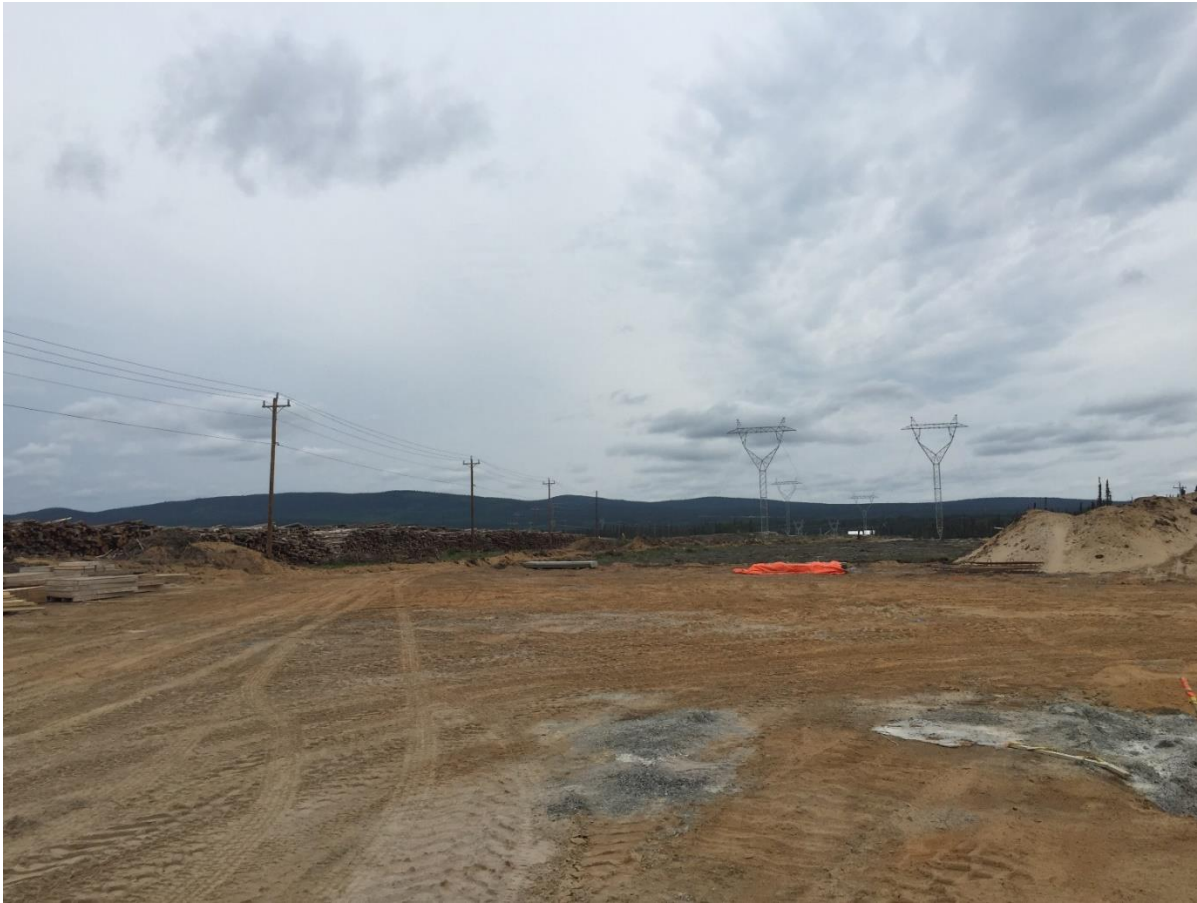
Photo 4.1 HVac transmission line clearing and clean up (*July 7, 2015*)

- The quality of clearing and cleanup along the transmission line is good (Photos 4.1 and 4.2).
- More than 90% of the foundations have been completed.
- More than 60% of the HVac towers (Photo 4.3) had been erected at the time of the site visits.

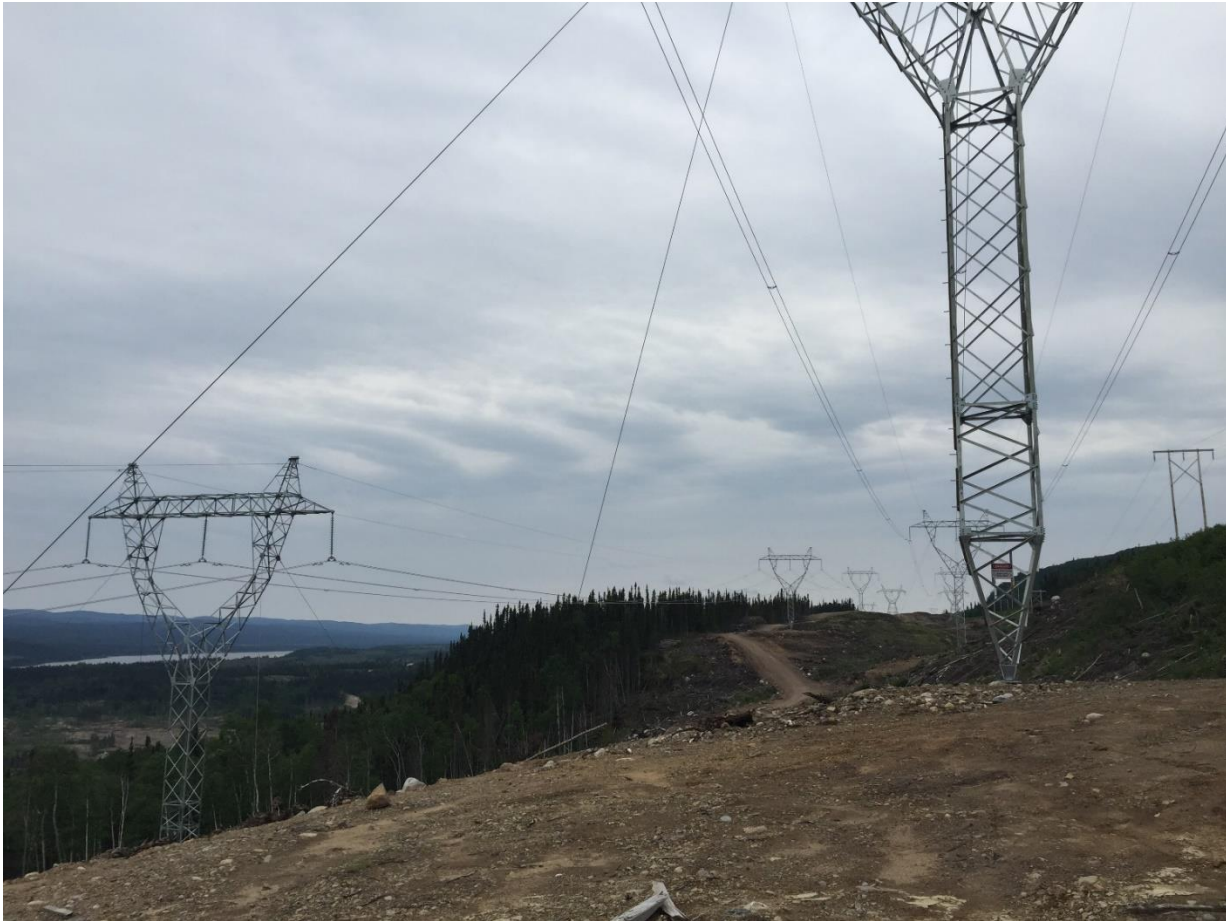
Photo 4.2 HVac transmission line clearing and clean up (*July 7, 2015*).

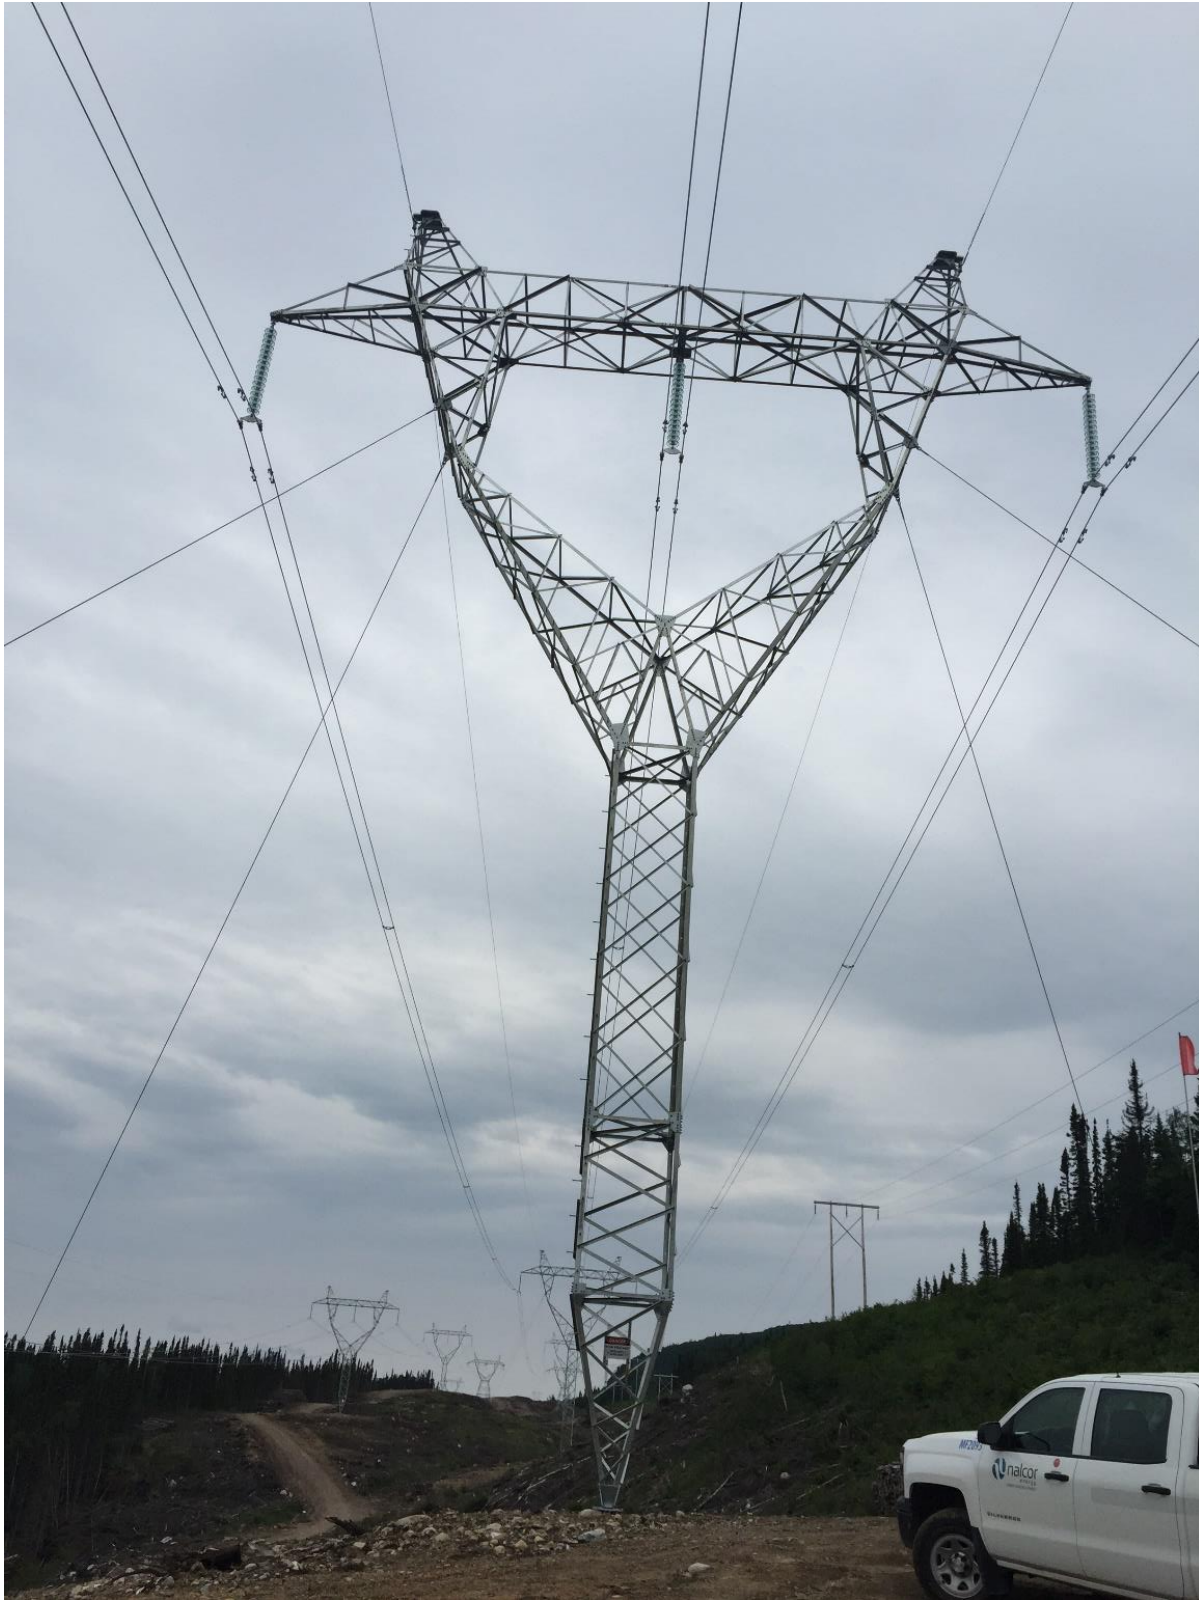
Photo 4.3 HVac transmission line erection (July 7, 2015).

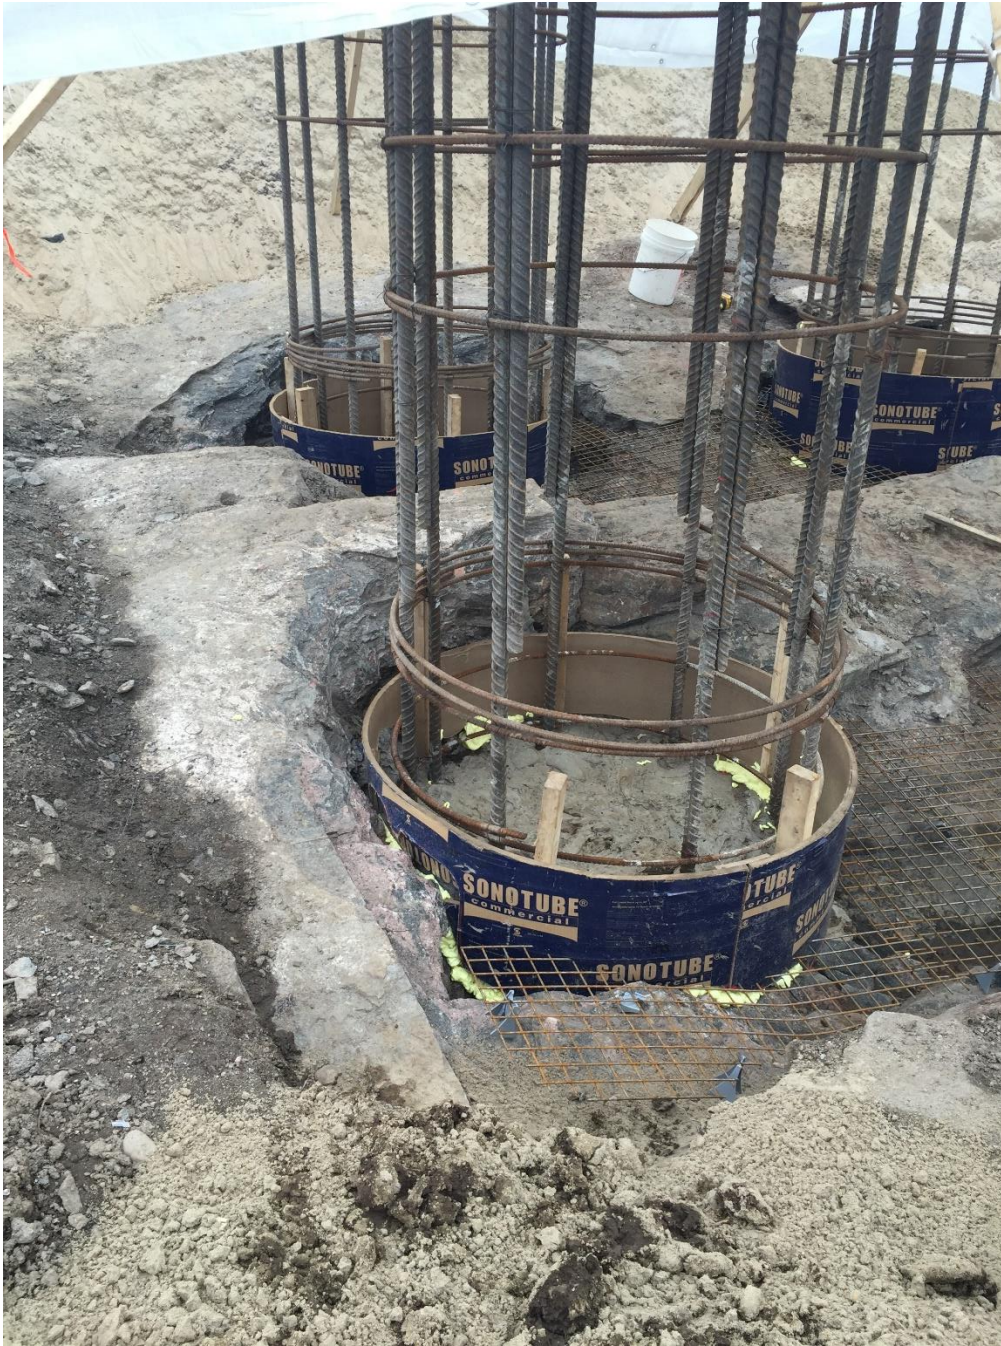
Photo 4.4 HVac transmission line – Rock foundation (July 7, 2015).

- Stringing between structure 12 and structure 165 is complete and insulator/hardware has been installed.
- The IE witnessed erection of different foundation types including rock foundation at structure 9 and concrete foundation at structure 10, 11 & 12 (Photos 4.4, 4.5 and 4.6).

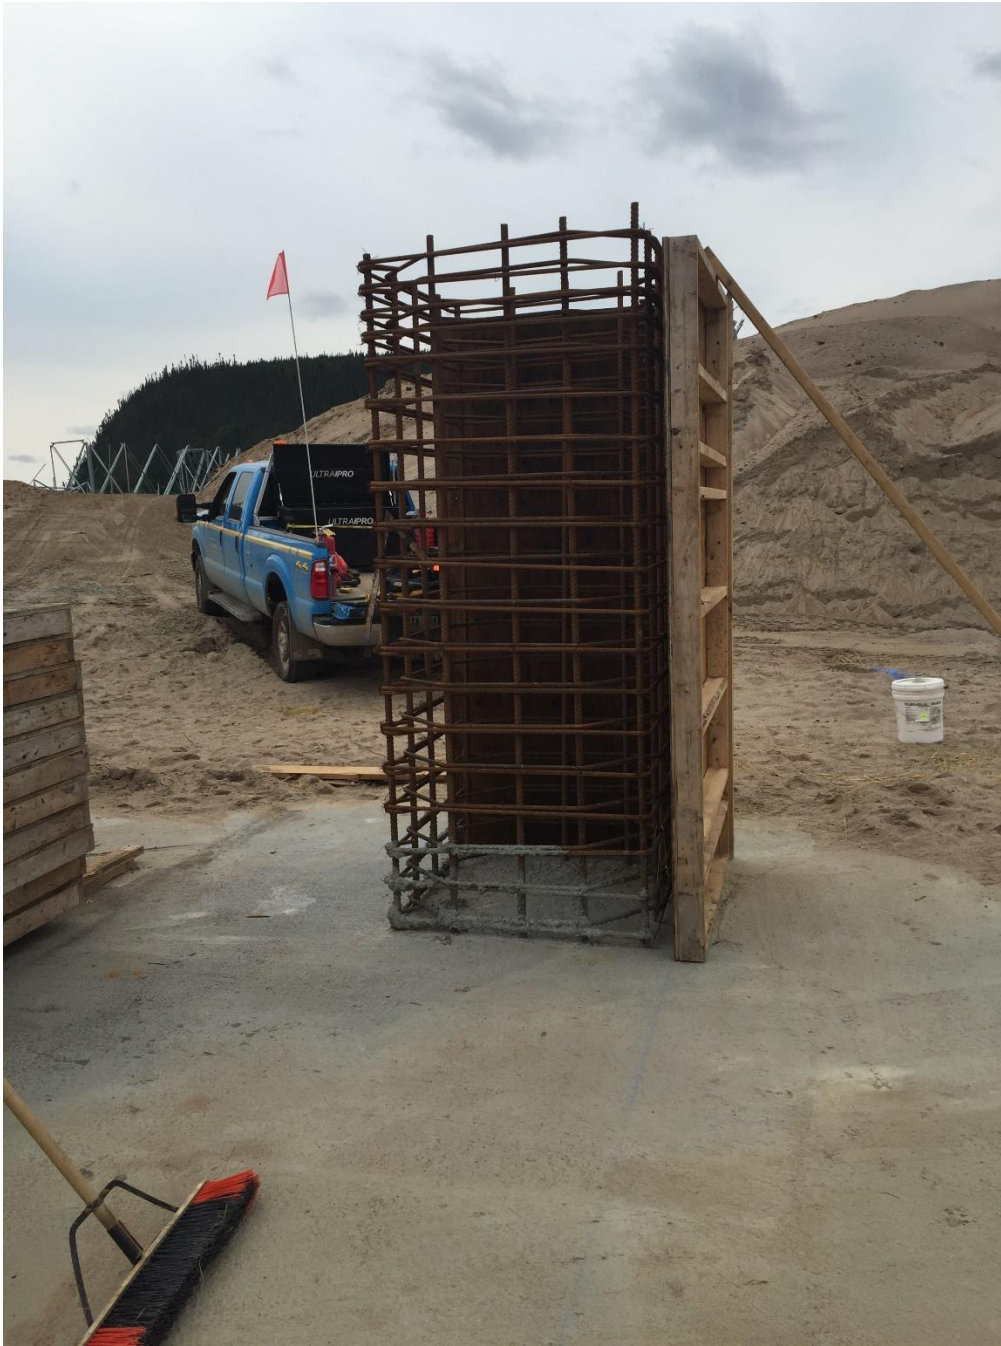
Photo 4.5 HVac transmission line – Concrete foundation (July 7, 2015).

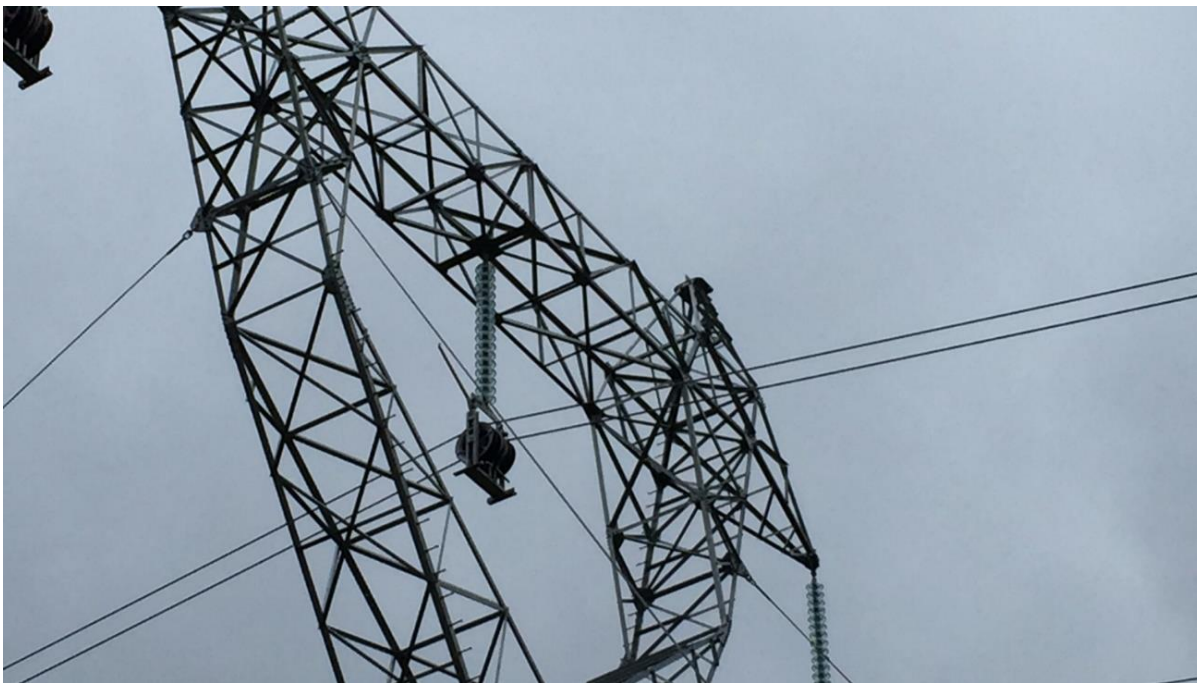
Photo 4.7 HVac transmission line – Stringing (July 8, 2015).

- The IE witnessed stringing, pulling wires and installation of implosion splices at structure 165 (Photo 4.7).
- A site visit was made to the Marshaling Yard managed directly by LCMC (Photo 4.8). Materials were well organized and marked. The operation of this yard was first class and looked able to easily keep up with progress of the transmission lines.

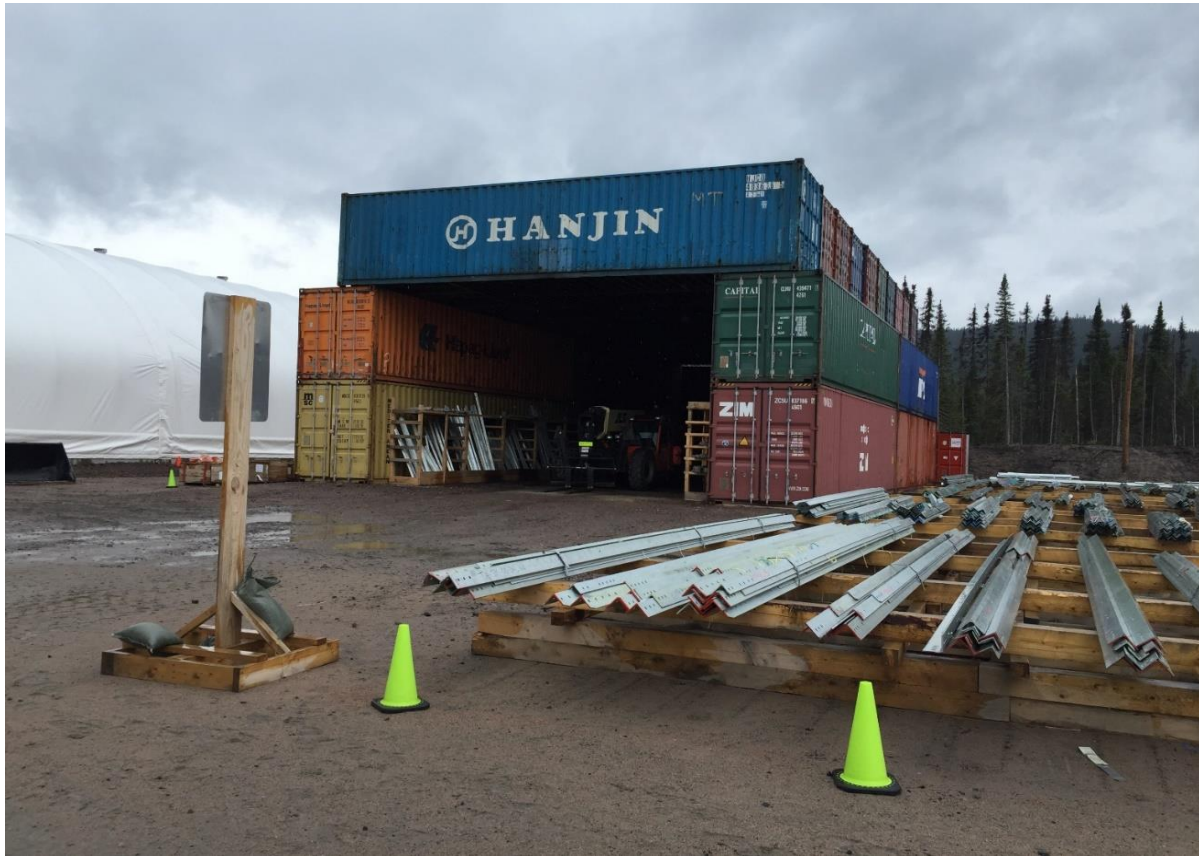
Photo 4.8 Transmission lines Marshaling Yard (July 8, 2015).

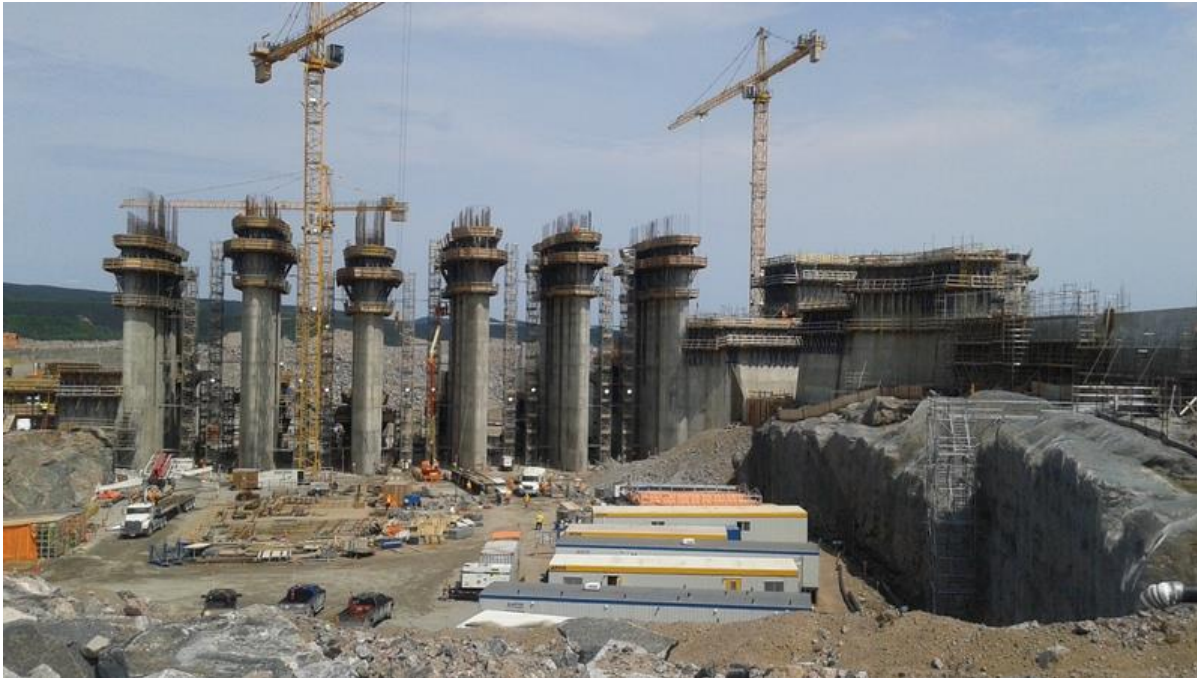
Photo 6.1 Upstream view of Spillway piers, Transition Dams and Separation Wall (July 7, 2015).

This site visit was followed by a visit to the Spillway, Separation Wall and Transition Dams (Photos 6.1). The completion of this portion of the work is key to enable the river diversion to happen as scheduled in July 2016. The Contractor Astaldi is back on schedule. The IPS Analysis shows a planned progress of 49.5% vs. an actually earned progress of 44.9%. The main spillway piers are constructed in three blocks. The downstream blocks were already completed. The concrete at the upstream blocks was at level ten (10) with formworks at level eleven (11). The remaining three lifts up to the final level fourteen (14) are planned to be completed by the end of August 2015. The middle blocks were at level six (6) with level ten being the top (crest) level. The middle blocks are to be completed shortly after completion of the upstream blocks. Both North and Central Transi-

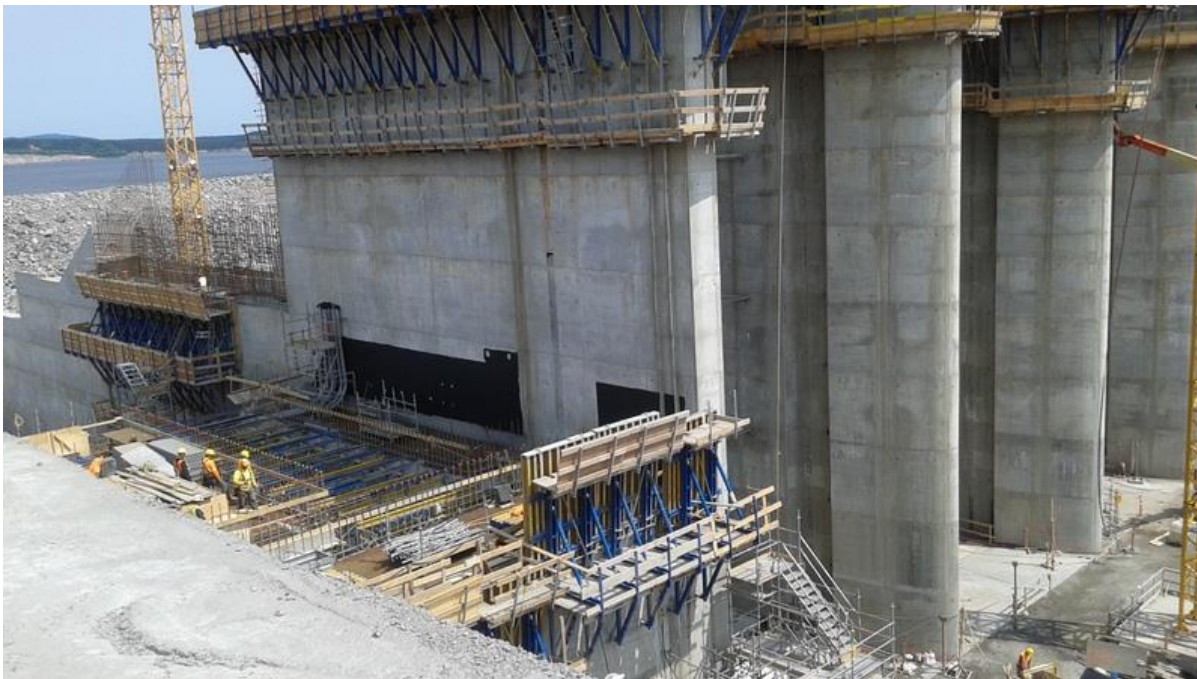
Photo 6.2 Upstream view of Spillway piers and North Transition Dam (July 7, 2015).

tion Dams (Photos 6.2 and 6.3) as well as the Separation Wall (Photo 6.4) are planned to be completed by the end of August 2015 as well. It appears that the Contractor will be able to turn over the work area to the Spillway Gates Contractor, Andritz, in time to meet the River Diversion Milestones.

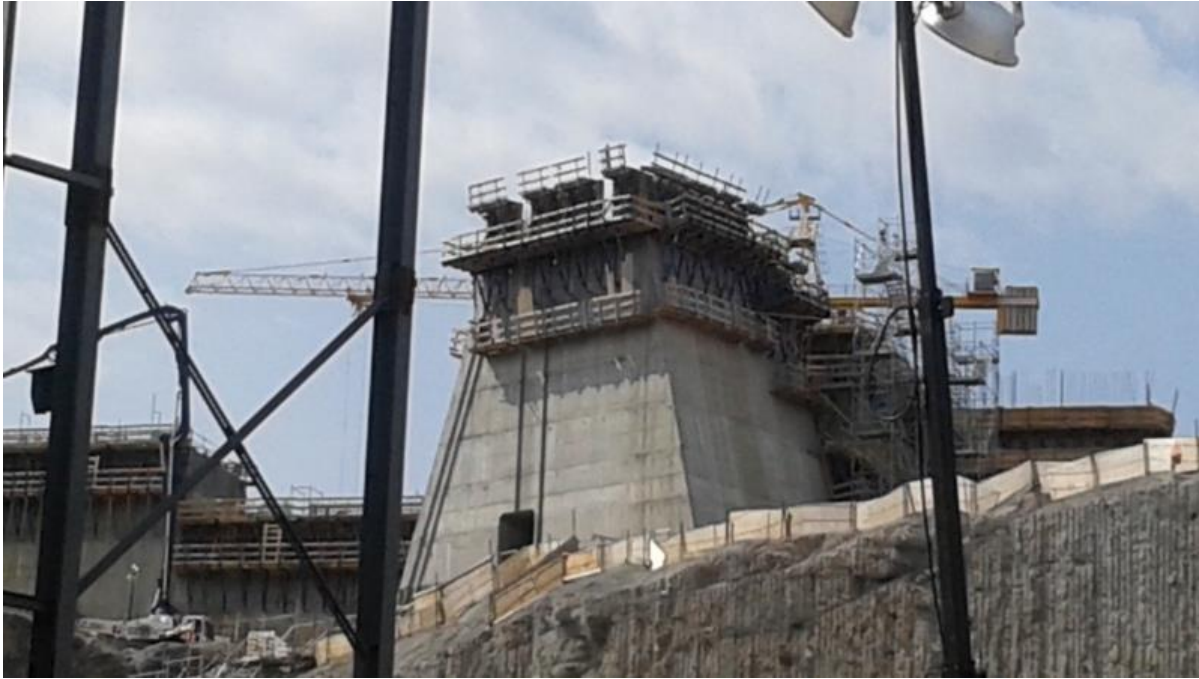
Photo 6.3 Upstream view of Central Transition Dam (July 7, 2015).

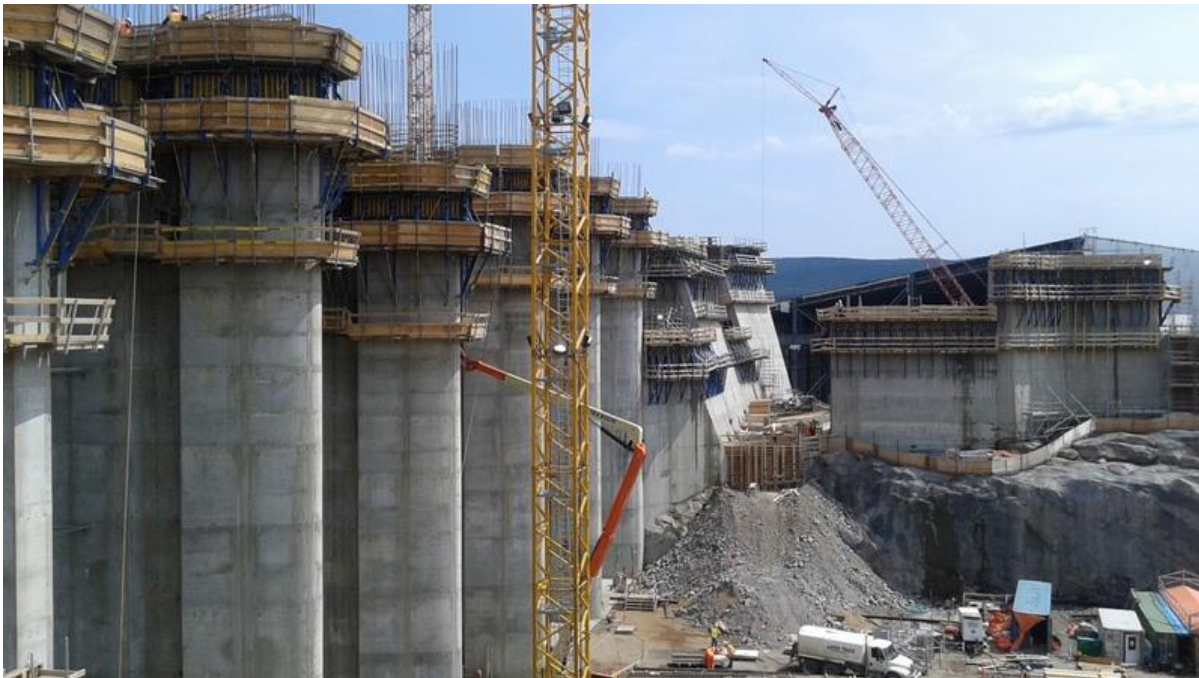
Photo 6.4 Side view of Spillway piers, Central Transition Dam and Separation Wall (July 7, 2015).

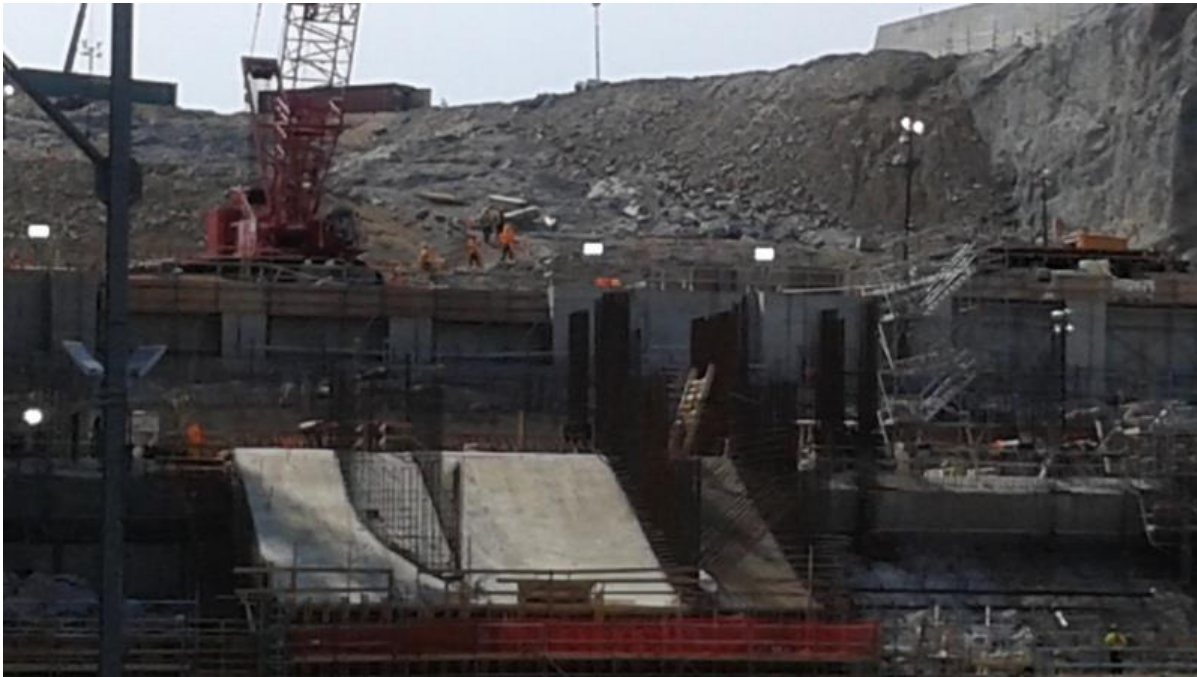
Photo 7.1 Unit 3 – Intake invert slab completed with central pier reinforcement dowels in place (July 7, 2015).

This site visit was then followed by a visit to the Powerhouse and Intake area. The IPS Analysis shows a planned progress of 36.6% vs. an actually earned progress of 13.7%. This portion of the project, also constructed by Astaldi, is significantly behind schedule. Small concrete blocks of the invert slabs have been placed in Units 3 and 4 Intakes (Photos 7.1 and 7.2). Powerhouse concreting was mostly at base slab levels with only draft tube invert slab completed for Unit 1. Preparation for erection of formwork of Unit 1 draft tube was in progress (Photo 7.3). Work on the Powerhouse / Intake structure will proceed in earnest upon completion of the Spillway concreting in early September 2015.
