Conductor Proud Stranding Investigation

ClaimsPro Briefing, 18-Oct-2016

Boundless Energy

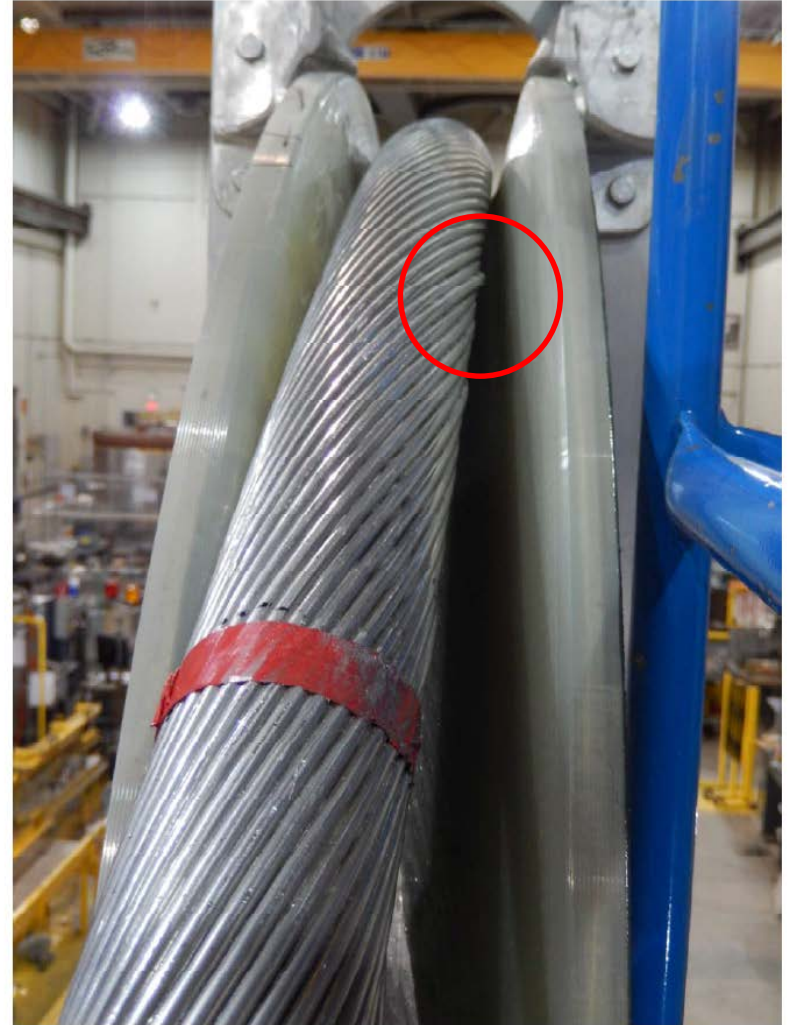
Sheave test reveals anomaly; slight proud stranding

Figure 3b Slight protruding strand of the Conductor after Completing Sheave Test 2b
(Note: the strand is just outside of the test section)

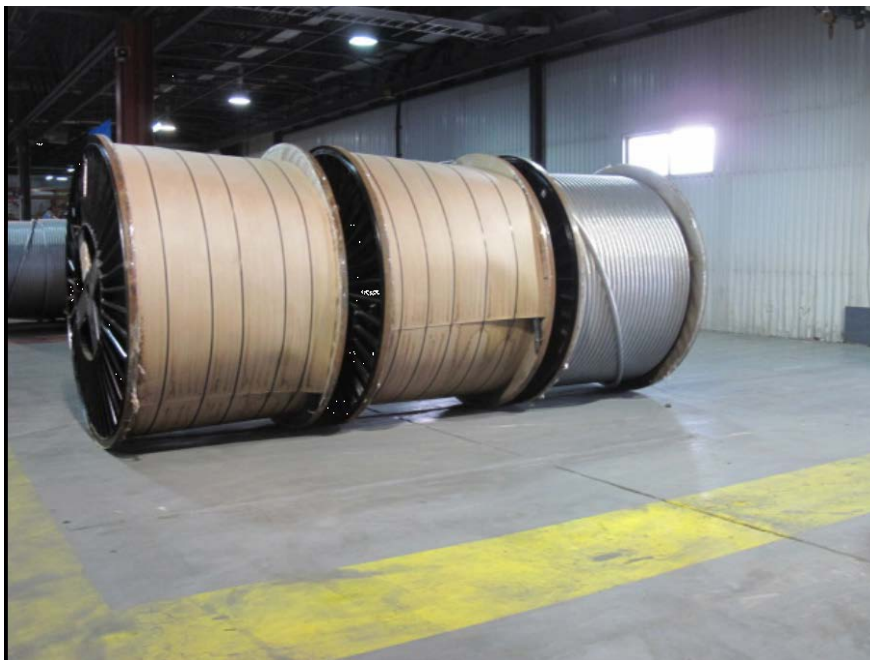
Typical Reels at GCC Plant
(1350m each)

In total ~1,700 in-spec reels were delivered by GCC in 2015

A Closer Examination
Note no Proud Stranding

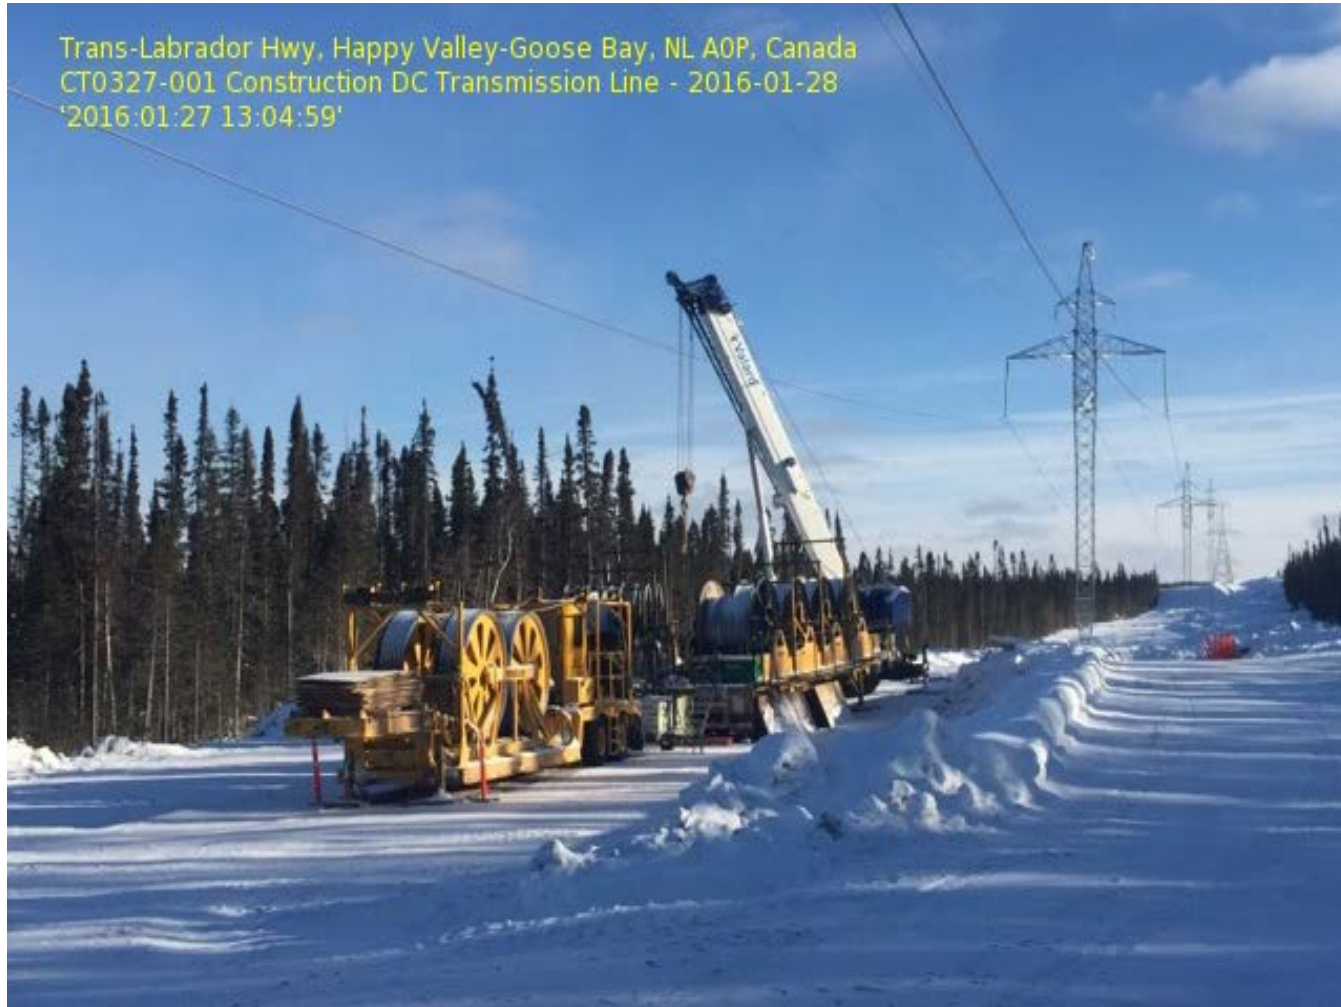
Installation commences November 2015

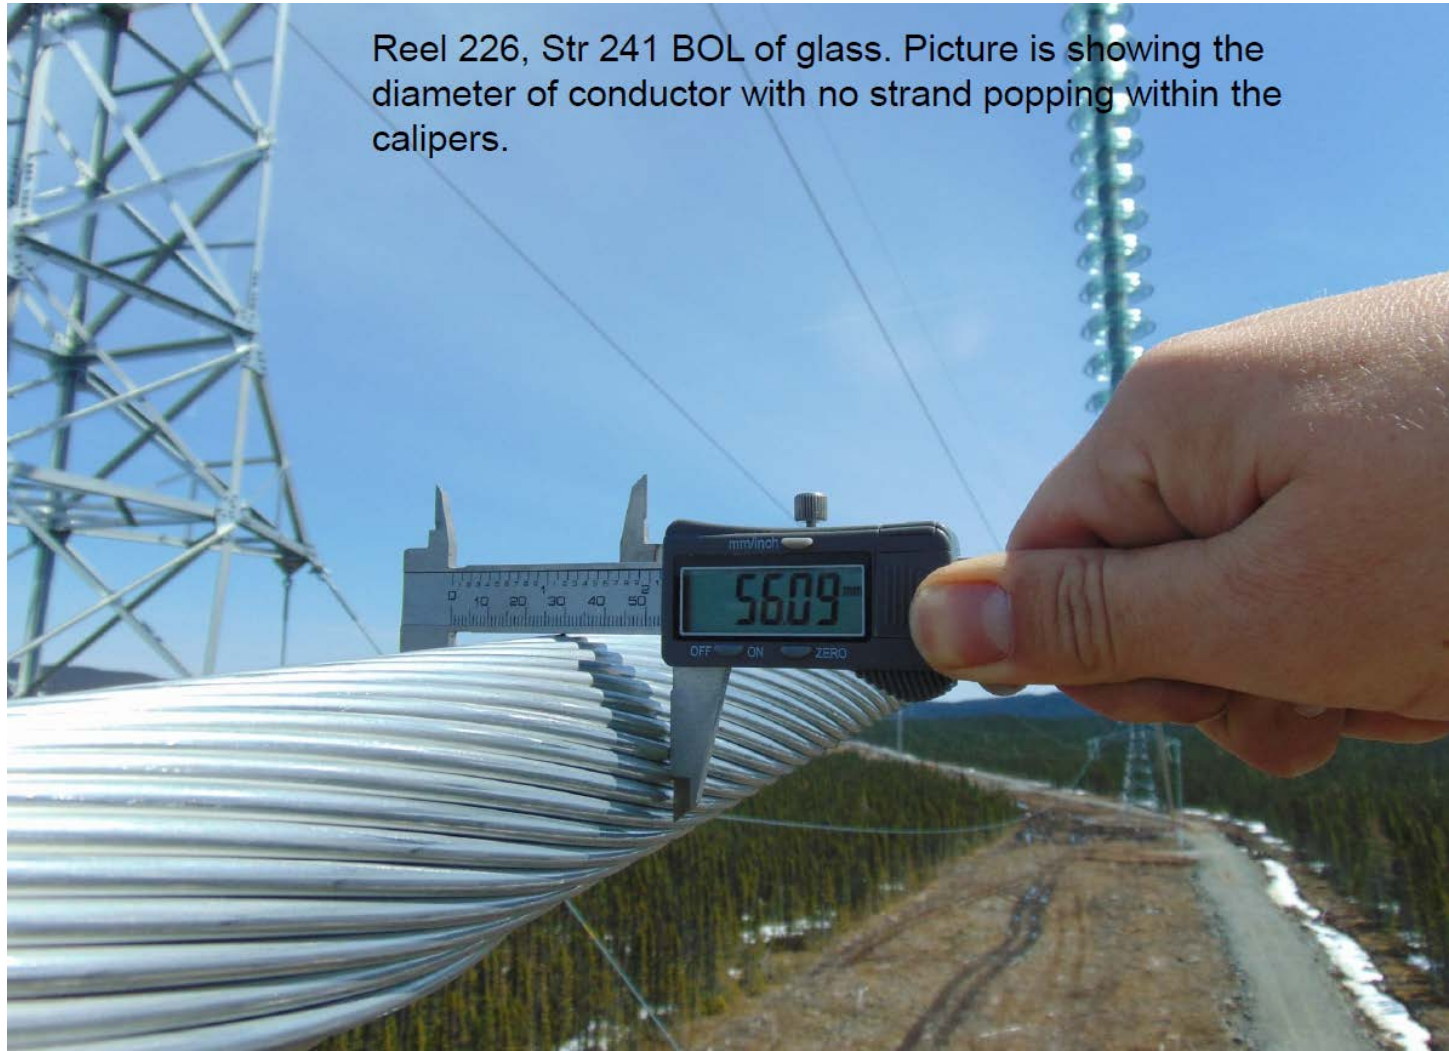
Typical as-installed condition with Conductor in a tension state in a section without proud stranding

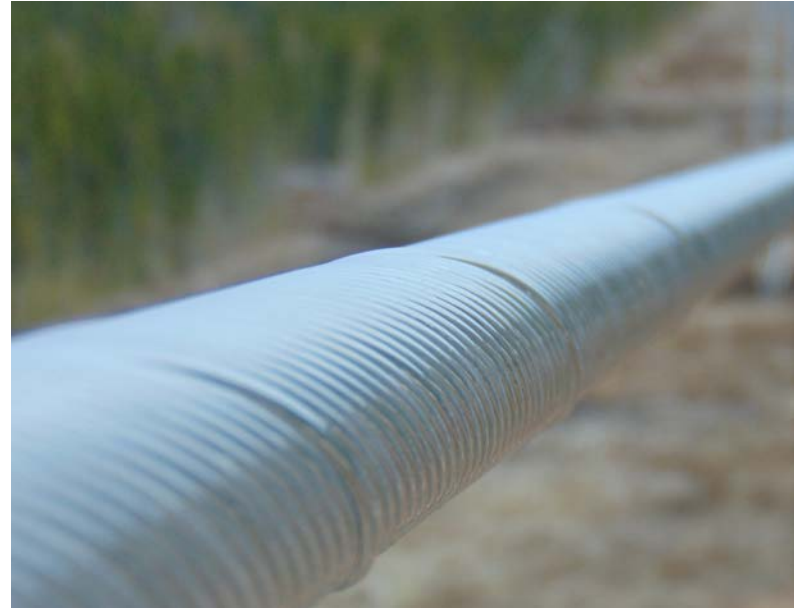
In summary, following installation, conductor outer surface condition is out of specification

Post Installation (typical)

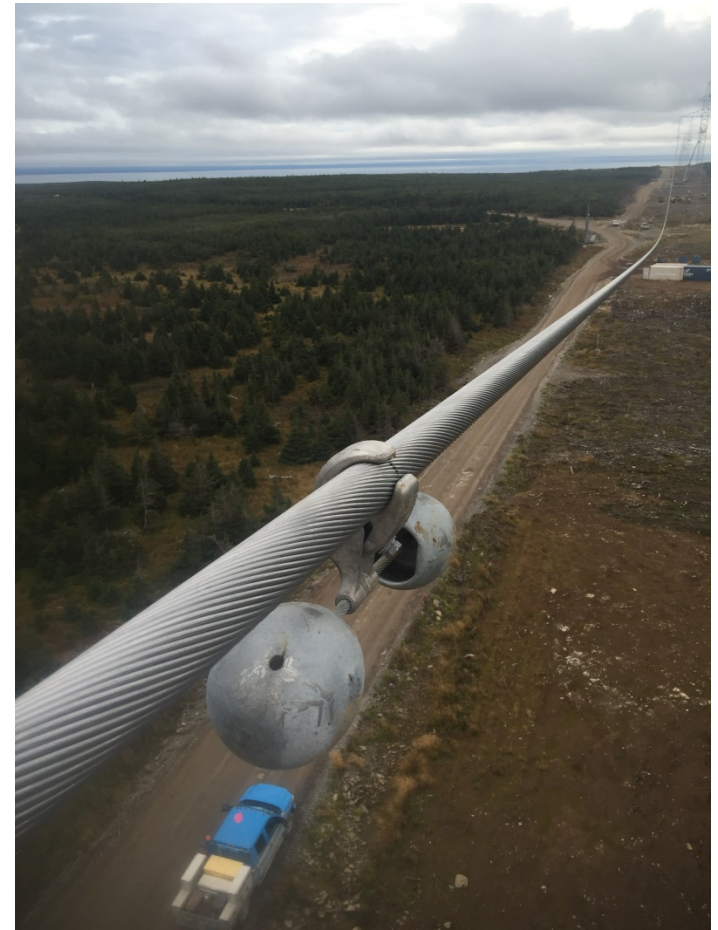
Investigation has identified corrective measures to prevent proud stranding post installation

- Modified conductor with removal of one (1) outer strand (109/7) works
- Supports our need to find a solution to support our construction schedule
- Approximately 60km installed (2 poles) without observation of proud stranding
