CHO-010 Request for Compensation – May 16, 2017

Andritz Hydro Canada Inc.

MUSKRAT FALLS HYDROELECTRICAL
Lower Churchill Project – Labrador, Canada

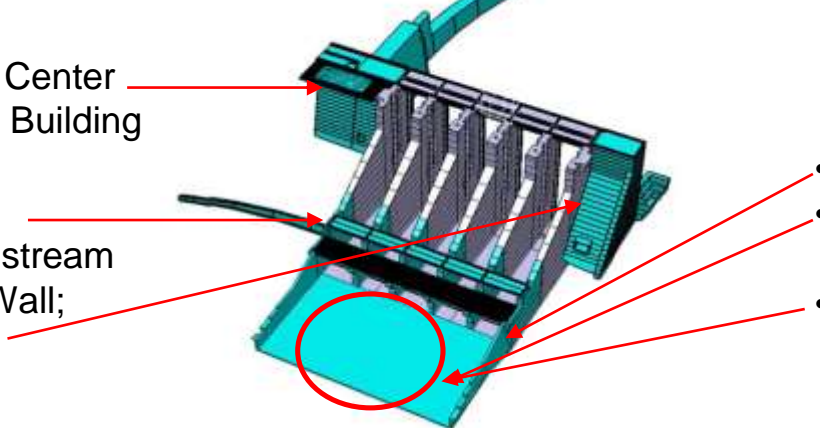
- I1B
 - Completion of Northern 2 Monoliths of Center Transition Dam including the Electrical Building Platform;
 - Completion of Spillway piers and walls (downstream 1/3) including both Downstream Bridges and Access Ramp Retaining Wall;

- Completion of North Transition Dam;
 - Completion of Separation Wall;
 - Completion of Spillway concrete Discharge Channel Phase 1;
 - Spillway Discharge Channel free for CH0032 occupation.

- A 3D perspective rendering of a dam structure, likely a spillway or transition dam. The structure is shown in a light blue/cyan color. It features several vertical piers or monoliths. Red arrows point from the text on the left to specific parts of the dam: one points to the top of a monolith, another to the spillway piers, and a third to the base of the structure. A red circle highlights a rectangular area on the base of the dam. On the right side, three red arrows point from the text to different parts of the dam structure, including the separation wall and discharge channel.

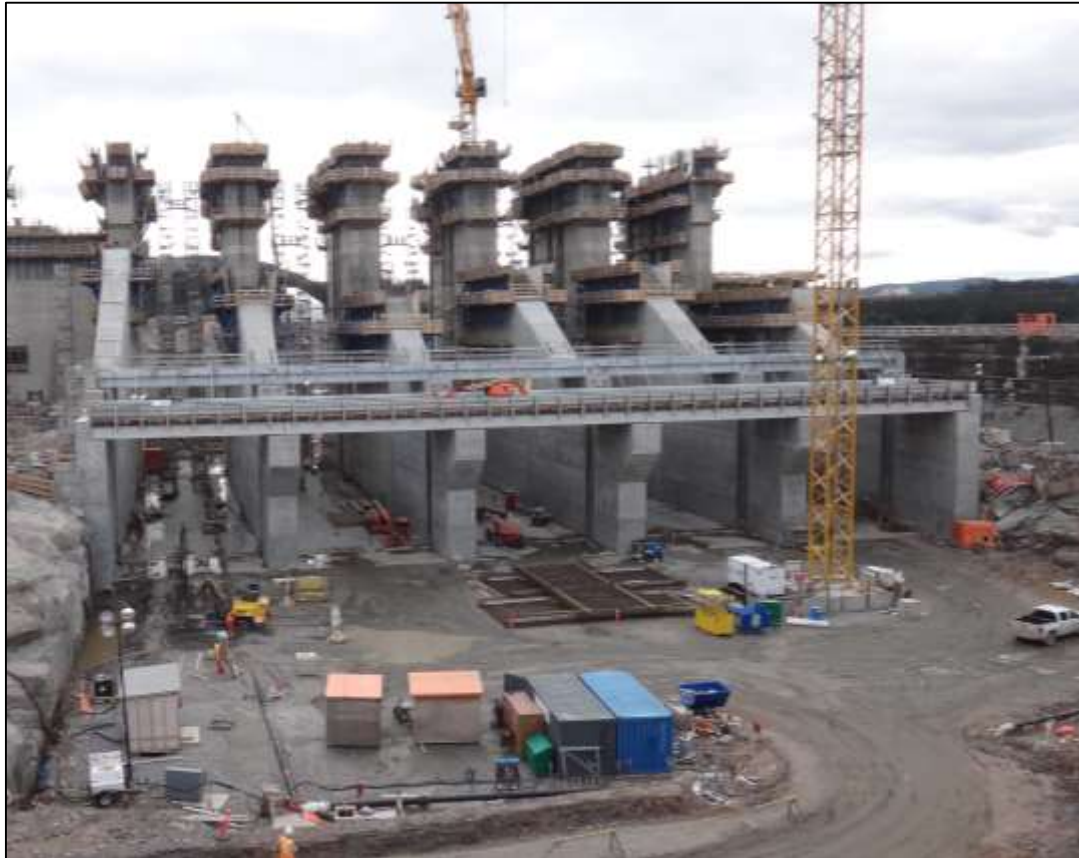
September 1st, 2015
0 of 6 conditions met

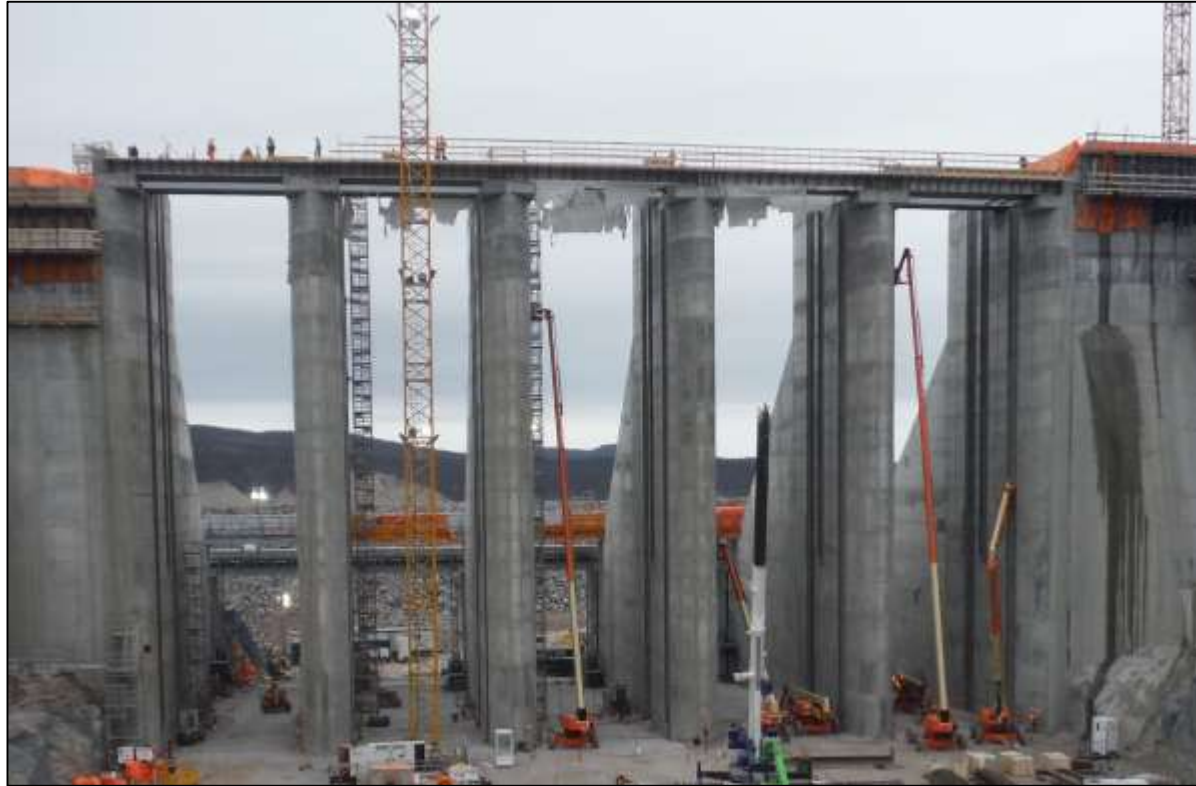
November 3rd 2015
0 of 3 conditions met

- As of October 31st 2016
- Upstream bridge only completed after River Diversion (TCM Rails)
- Other Contractor presence continuous during the execution period
- Water flowing through Spillway

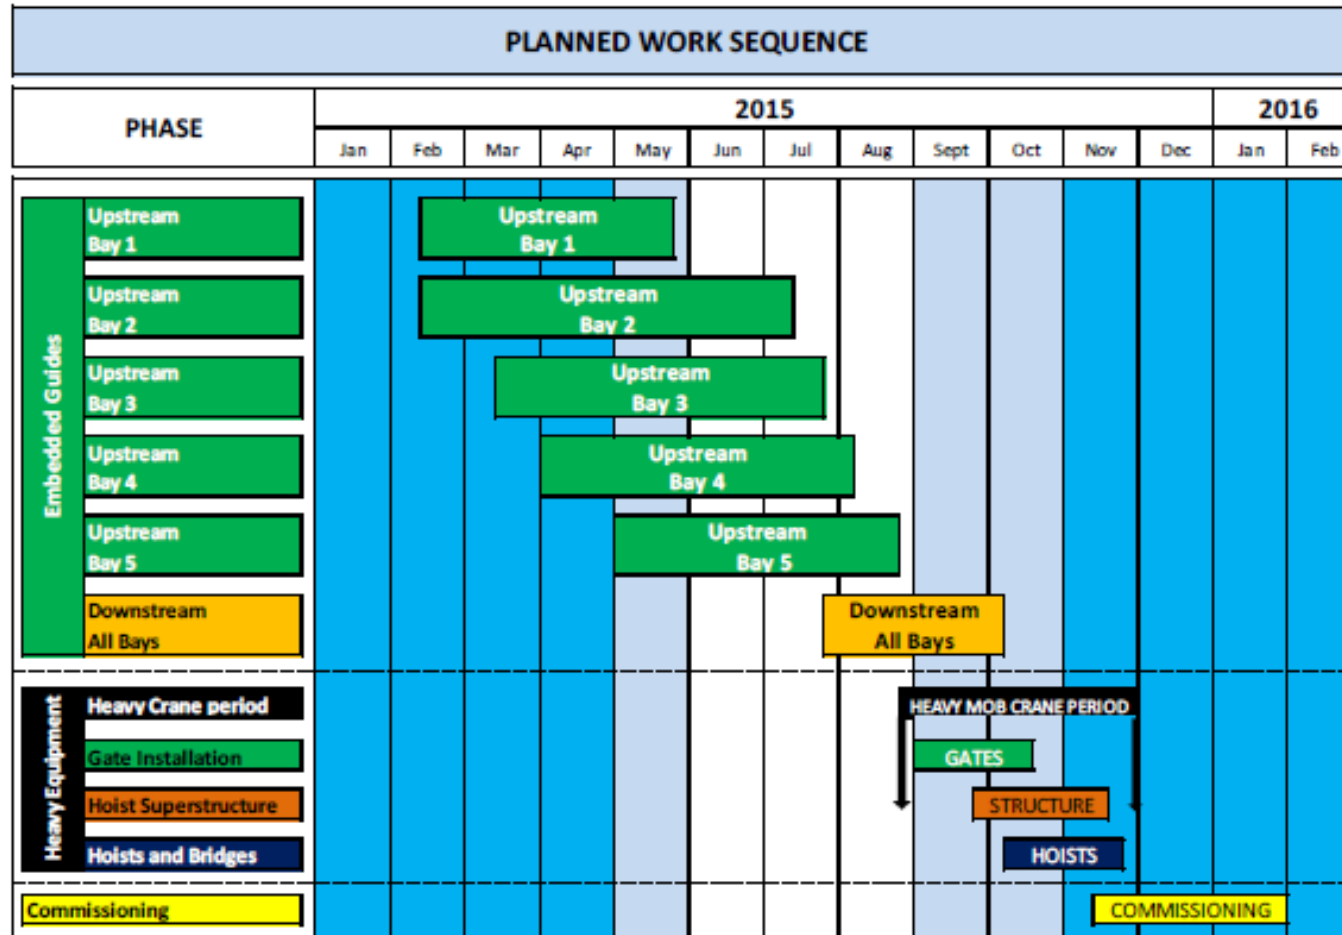
Planned Work Sequence:

1. Installation of Embedded Guides
2. Heavy Equipment (Gates, Hoists and Hoist Superstructures)
3. Start-up and Commissioning

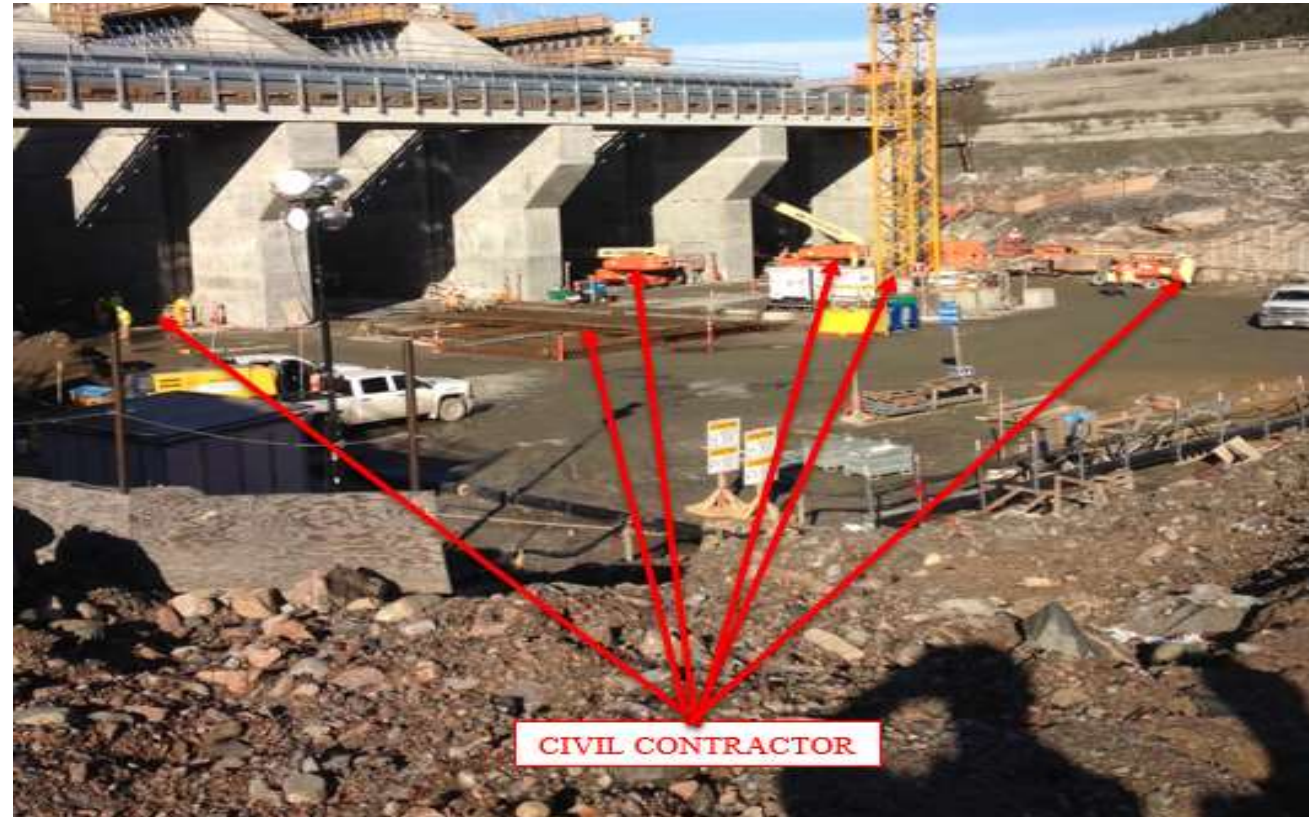
This picture taken on September 4th, 2015, shows multiple pieces of equipment, such as a tower crane, vehicles, raw materials and a man lift, belonging to Company's civil contractor and that were still interfering with Canmec's Work in the spillway discharge channel.

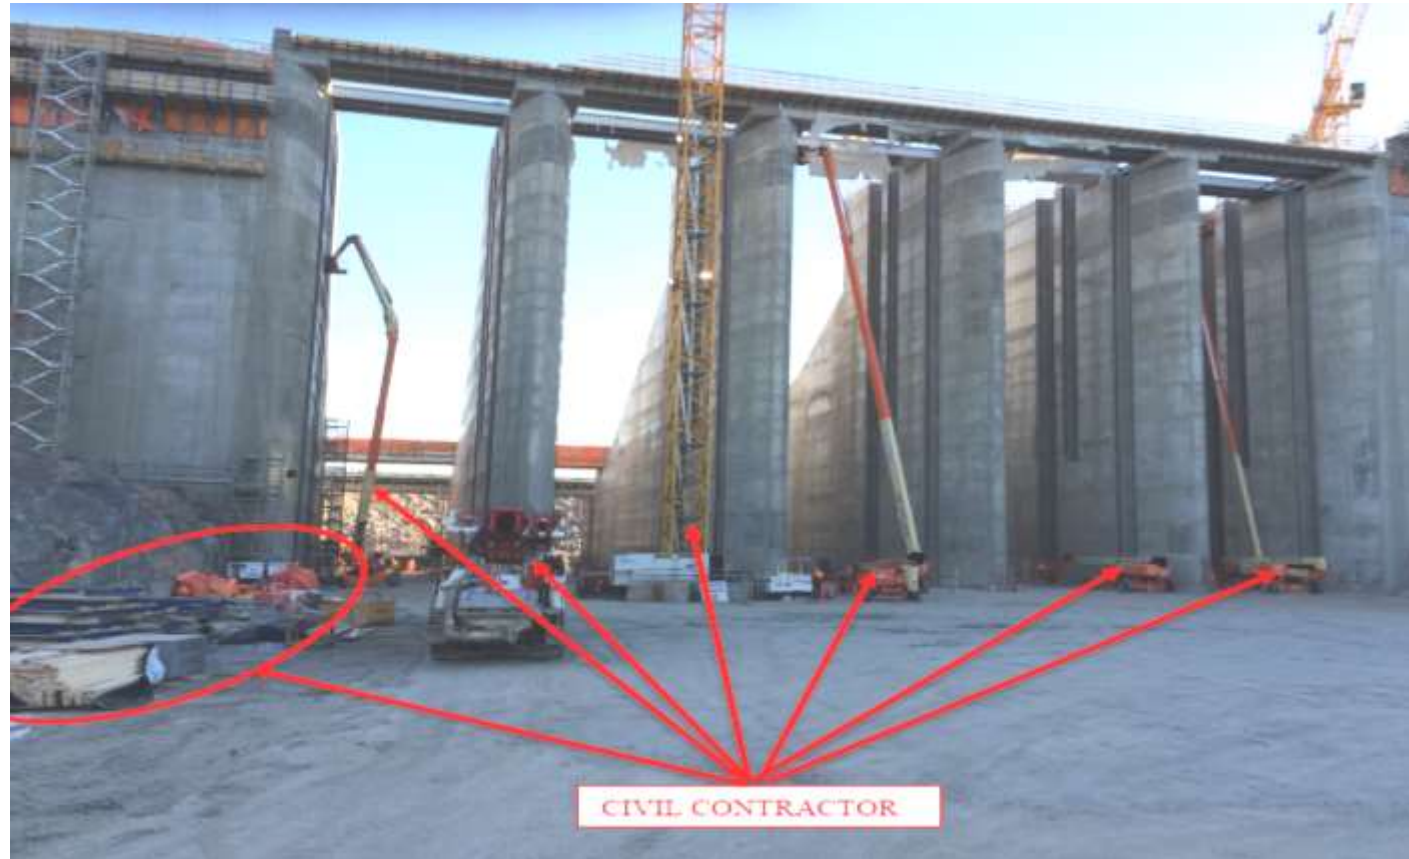
This picture taken on November 1st, 2015 shows the presence of Company's civil contractor in all five bays in the upstream area. The work executed by Company's civil contractor in the man lift was creating a potential overhead work situation for Canmec, with high HSE risks, thus preventing Canmec from starting its activities upstream.

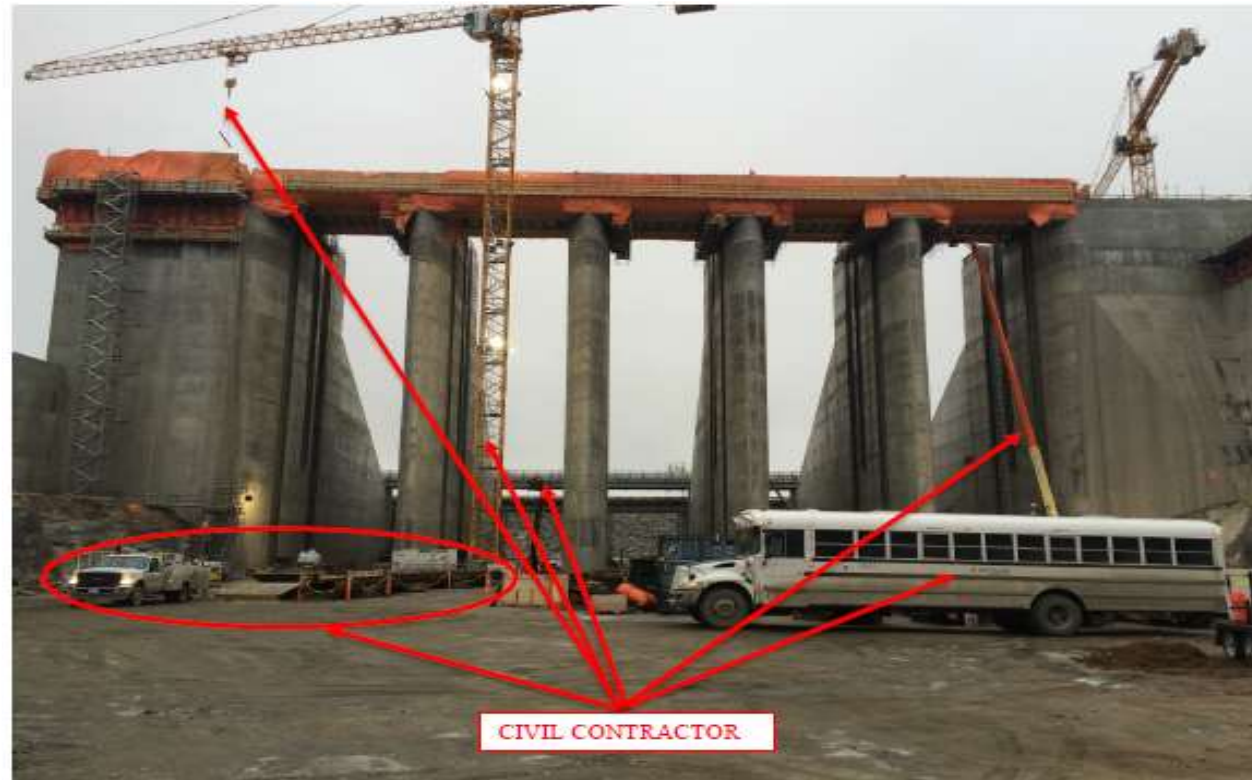
This picture, taken on November 22nd, 2015, shows the presence of much equipment, belonging to Company's civil contractor, such as a bus, light vehicle, tower crane and man lift. Also, the orange tarps on top of the piers indicate that there is still overhead work being performed by Company's civil contractor, adding HSE risks to Canmec's working area, thus preventing Canmec from progressing as planned.

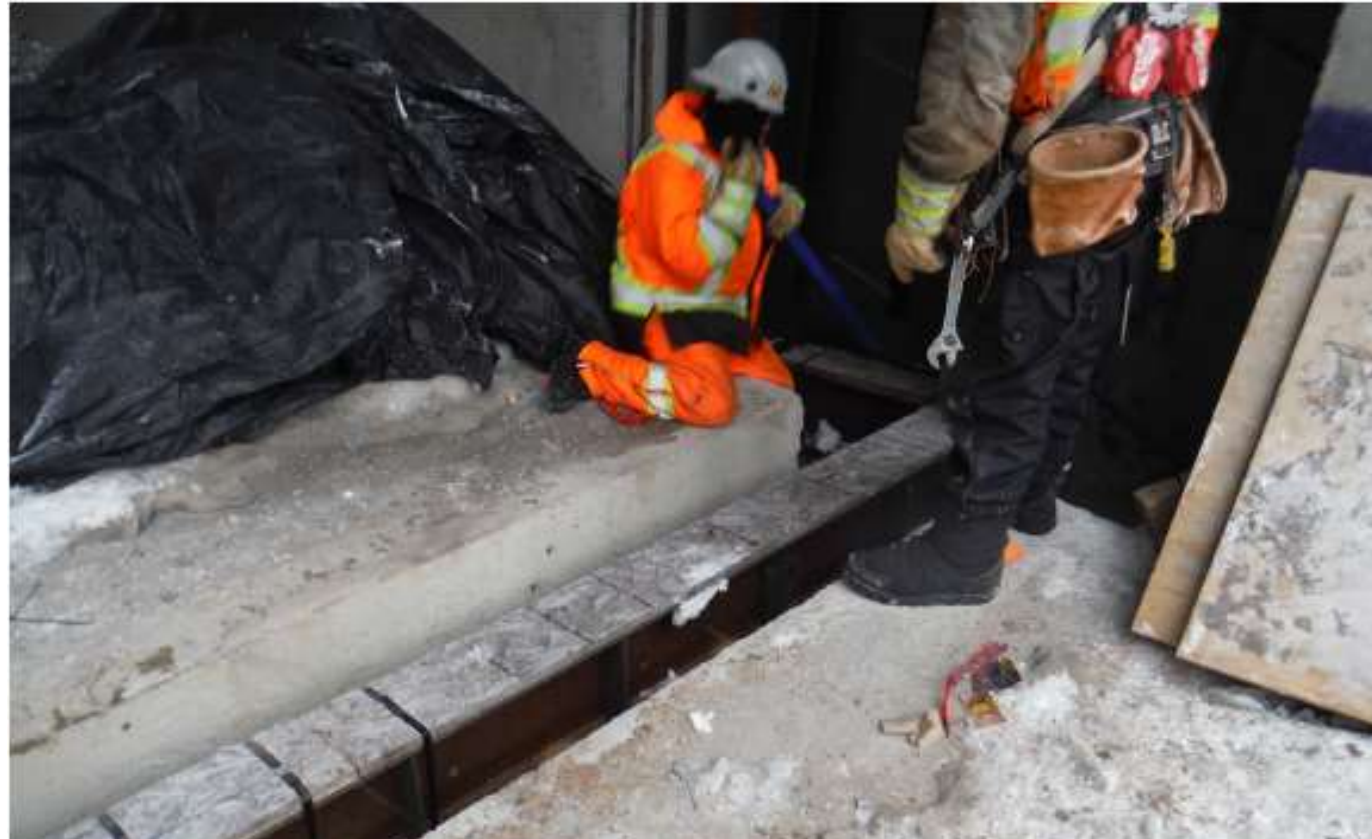
This picture, taken on January 31st 2016, shows workers trying to install a sill beam in its dedicated recess obstructed with ice and snow that was there prior to hoarding installation. This kind of situation creates HSE hazards and directly affects worker productivity, thus delaying progress.

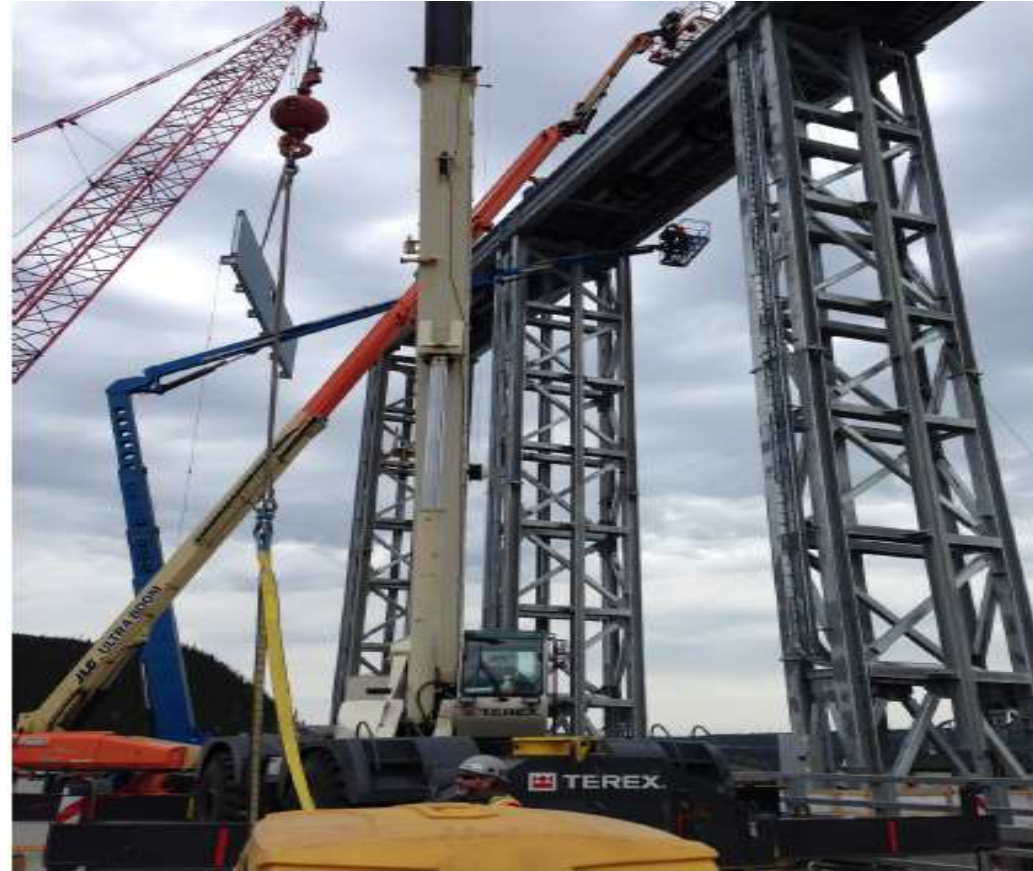
This picture, taken in June 2016, shows an example of work on multiple fronts. In order to respect the acceleration directive, Canmec simultaneously executed multiple activities, thus creating congestion in the working area, adding HSE risks and ultimately affecting productivity.

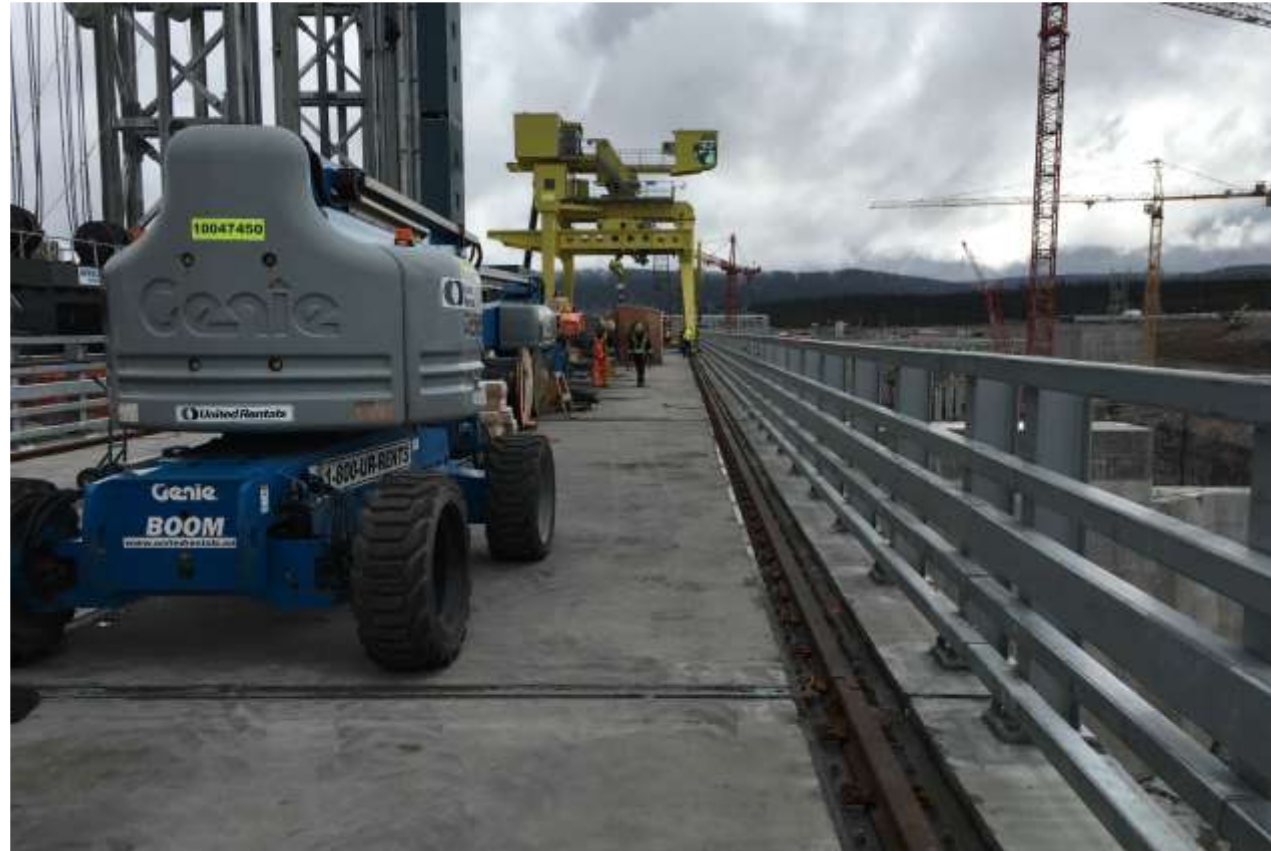
After the river diversion, Canmec and Andritz's other sub-contractors had no other choice but to use the permanent bridge, creating congestion in the working area as shown on this picture, taken in September 2016.
