Final Report

Examination of 2017 Ice Jam Event

MFA-HE-CD-2000-CV-RP-0011-01

Nalcor Energy - Lower Churchill Project
 Examination of 2017 Ice Jam Event
 H354838

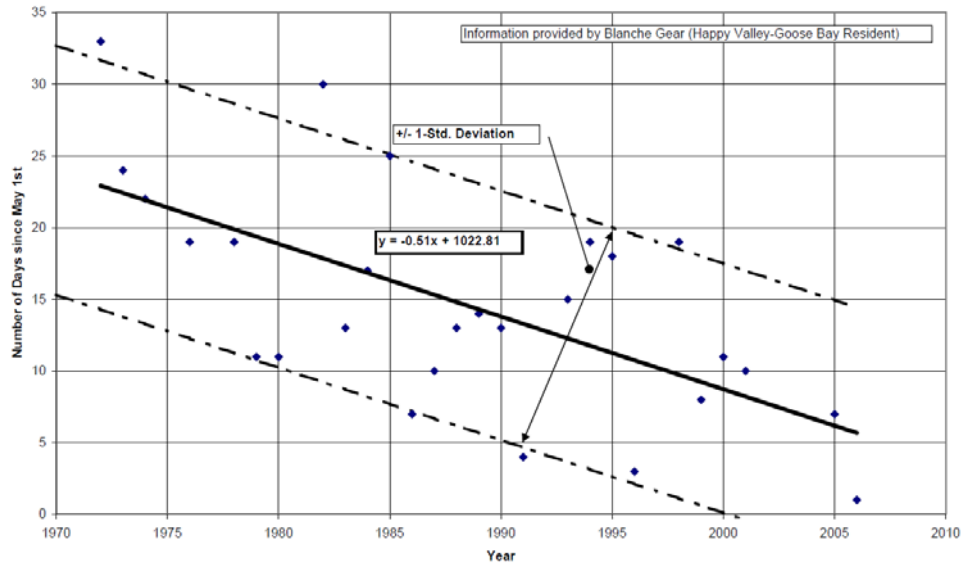
Figure 2-2: Date of First Ice Movement at Goose Bay

The ice in Goose Bay and Lake Melville will eventually weaken to the point of releasing. Residents in the area have maintained records of the date at which the Churchill River adjacent to the community of Happy Valley - Goose Bay has become ice free. This information is reported in the ice dynamics report, but has been reproduced for reference in **Figure 2-2**. It is interesting to note that records seem to indicate the ice release date has steadily decreased since records were first kept – possibility an indication of climate change induced impacts on ice release dates in these more northern environments.

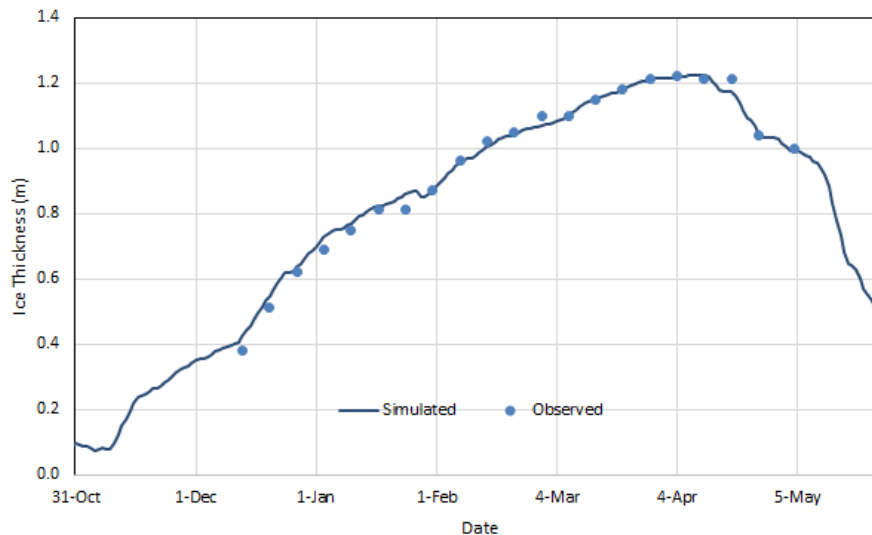
Figure 2-3: Sample Comparison Between Observed and Simulated Ice Thickness (1985/86)

The model was tested and validated in earlier studies – **Figure 2-3** illustrates the match obtained with actual ice growth on Goose Bay for a particularly severe winter in 1985/86.

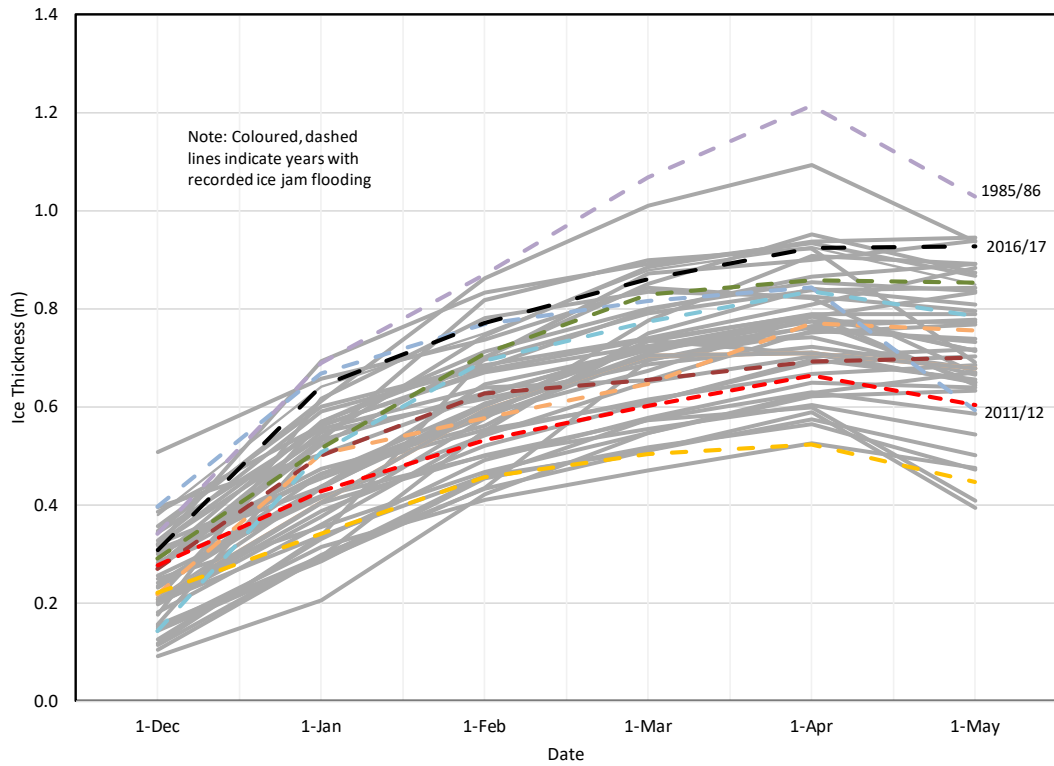
Figure 2-4: Summary of Goose Bay Ice Thicknesses

Figure 2-4 illustrates the expected or computed thickness of ice for all winters since 1958. This figure provides a good summary of the range of thicknesses that can be expected on Goose Bay, and how variable it can be. The estimated thickness for 2017 has been highlighted as a heavy dashed black line since it represents the recent flood event. As shown the 2017 winter was particularly harsh, and predicted ice thicknesses are near the upper end of the historical range. In the early part of the winter, snow cover was quite light and this led to rapid thickening of the ice through most of December. This was similar to what happened in 1985/86 (dashed purple line), which represents the thickest estimated cover since records were being taken. In 2017, the continued cold weather through April also reduced the amount of degradation of the ice. Based on this assessment, it is felt that the Goose Bay ice was likely quite thick and competent at beginning of rapid melt period. It was estimated to be at a 1 in 20 year thickness. This heightens the chance that ice may jam at the river outlet.

In 2017, the spring was marked by an abnormally cold April – the average temperature recorded by the Goose A MSC gauge was only -2.8 degrees C in 2017. This is almost 2 degrees lower than the historical average temperature of -1.1 degrees C for April. This delayed the melt and ripening of the snowpack, and also led to a reduced amount of degradation of the thick Goose Bay ice cover (**Figure 2-4**).

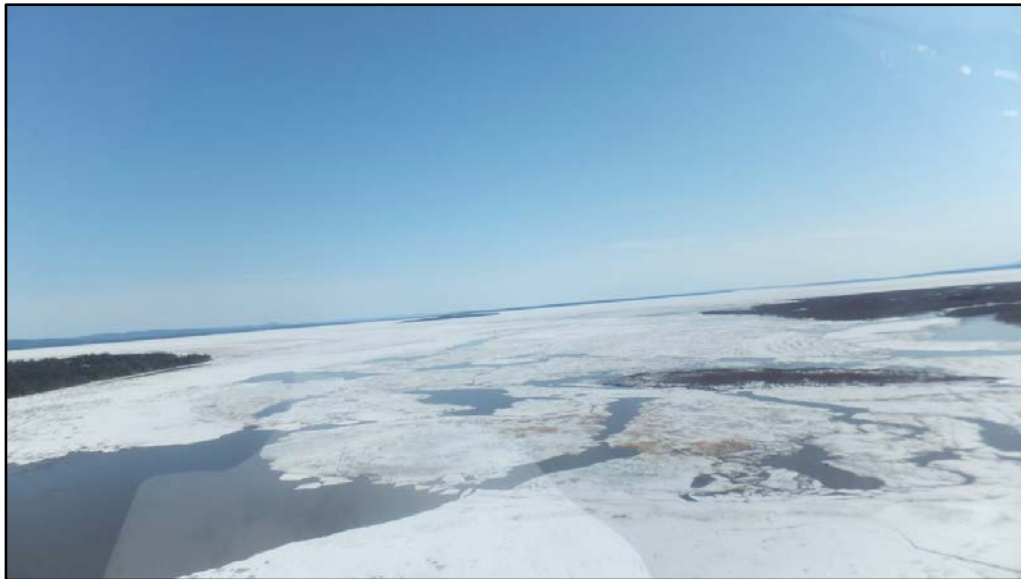
Figure 3-3: May 15, 2012 – Photo at English Point Looking Downstream

Figure 3-3 shows a photo taken at approximately the location of English Point looking downstream towards Goose Bay, and **Figure 3-4** shows a photo taken looking upstream. In both cases the ice cover is beginning to show signs of melt and degradation.

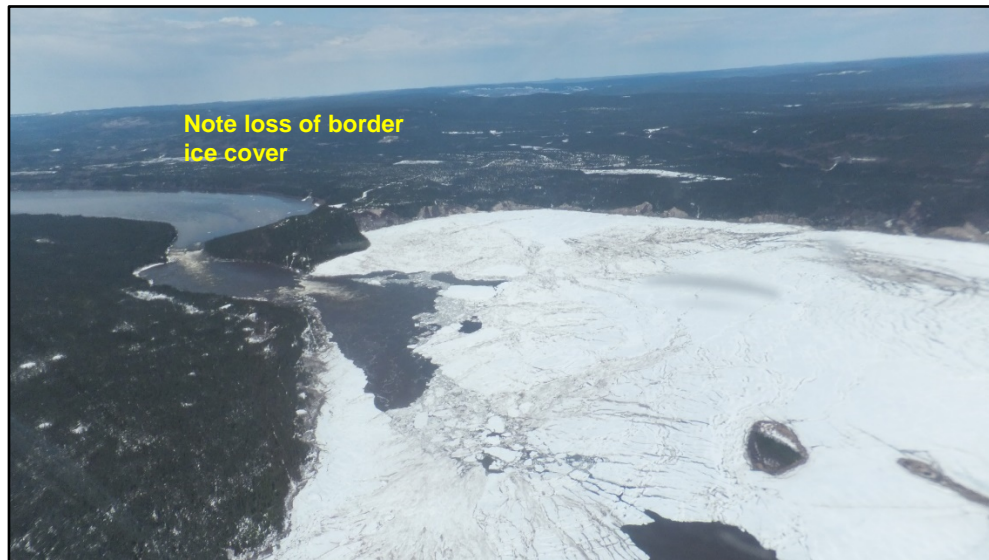
Figure 3-6: May 15, 2012 – Photo Looking Upstream at Muskrat Falls

Finally, **Figure 3-6** shows a photo taken downstream of the Muskrat Falls site, looking upstream towards the falls. The photo clearly shows i) that the ice dam remained in place below the falls, and ii) that the ice that would have formed upstream of the falls had already mobilized and flushed downstream through Muskrat Falls prior to the ice jam event.

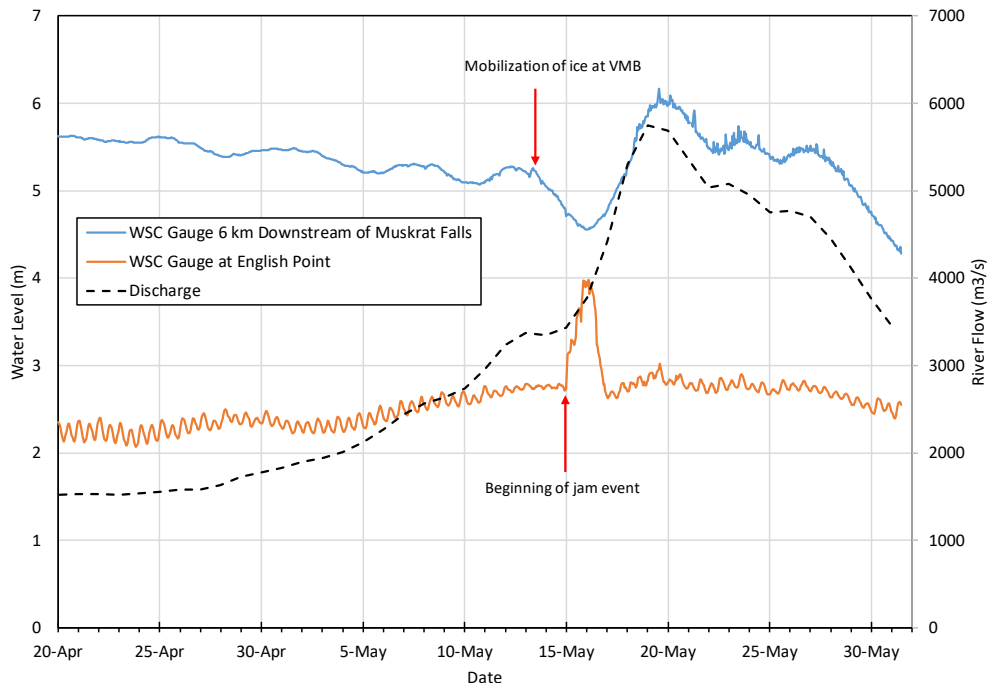
Figure 3-7: Summary of Flows and Water Levels During Spring in 2012

- As noted in this figure, the runoff associated with the spring freshet began at the end of April, and continued to climb throughout the first three weeks of May. The peak flow of 5960 m³/s reached on May 19 represents a flood with a return period of approximately 1 in 20 years. Therefore, this was a relatively high runoff year, driven in large part by the abnormally high snowpack in the basin.

- Considering the water level trace at WSC Gauge 03OE014, the ice front appears to have begun moving downstream past the gauge location, and past the Veteran Memorial Bridge (VMB), by May 13. There is a relatively noticeable drop in water level at this time, despite the fact that flows are continuing to increase. The satellite image taken on May 15th of this year (shown in **Figure 3-5**) shows that the ice front had indeed moved past the bridge by May 15. The subsequent rise in level observed at this gauge after the ice jam event had released was due to the very high flows associated with the passage of the spring freshet.

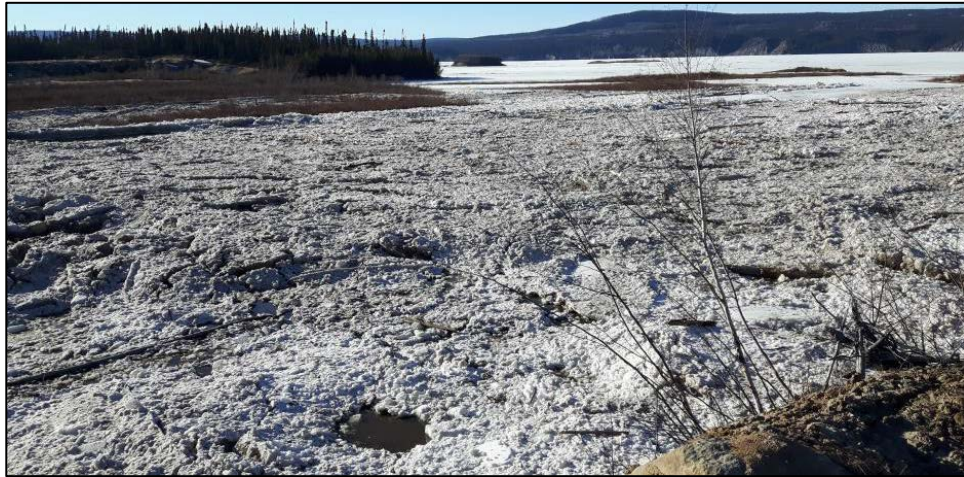
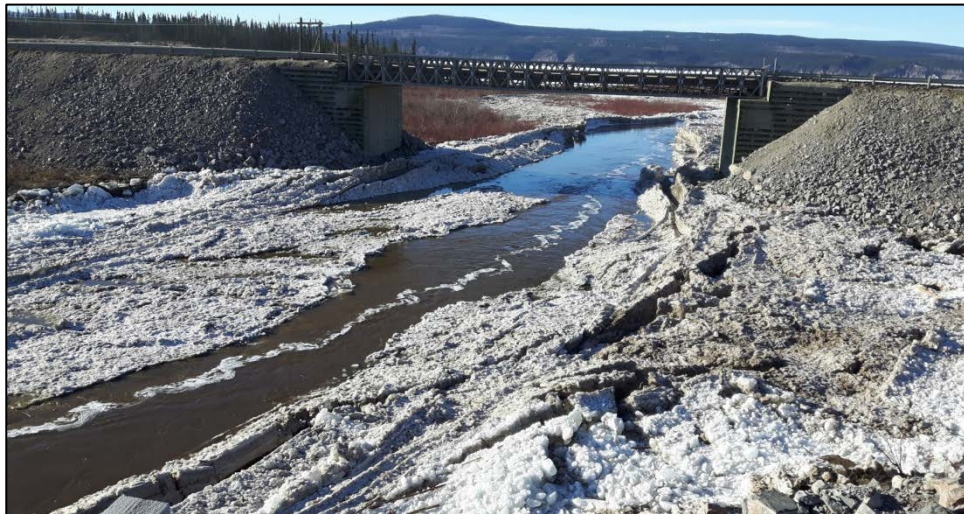
Figure 4-11: McKenzie River Ice Jam Event, May 14, 2017

Prior to the jam event occurring on May 16 on the lower Churchill River, there were similar jam events that occurred on both McKenzie River and on Goose River. **Figure 4-11** and **Figure 4-12** show images of the McKenzie River ice jam event, while **Figure 4-13** shows images of the Goose River event. The McKenzie River ice run was observed on May 11, 2017, after daily air temperatures had risen and small rivers responded relatively quickly with increasing flow. Likewise, Route 520 was flooded on May 13 as result of an ice jam on the Goose River near the outlet to Goose Bay. The photo shown in **Figure 4-13** depicts a section of the ice jam on the Goose River on May 14. These events occurred just days before the larger ice jam event on the lower Churchill River and were completely natural events.

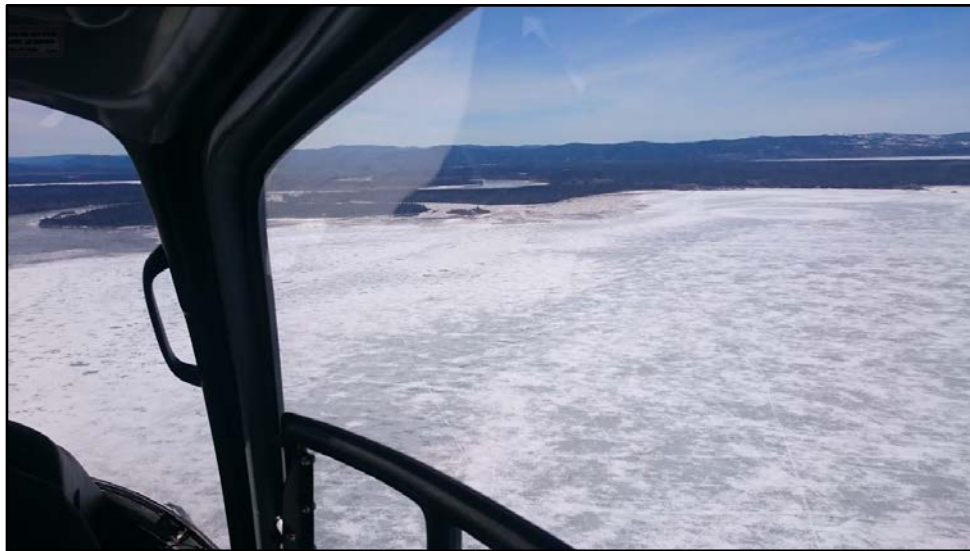
Figure 4-15: Looking Upstream Towards Mud Lake (1 km) – May 15

- Ice in the area looked to be quite solid, with minimal degradation. **Figure 4-15** and **Figure 4-16** illustrate the condition of the ice in the Mud Lake area. As shown, it looks to be quite strong, and agrees with numerical ice calculations which indicated it would still be quite thick and competent.
- **Figure 4-16** also shows some lateral and longitudinal cracks in the cover. This suggests it had been subjected to some stage increases with rising flow before May 15.

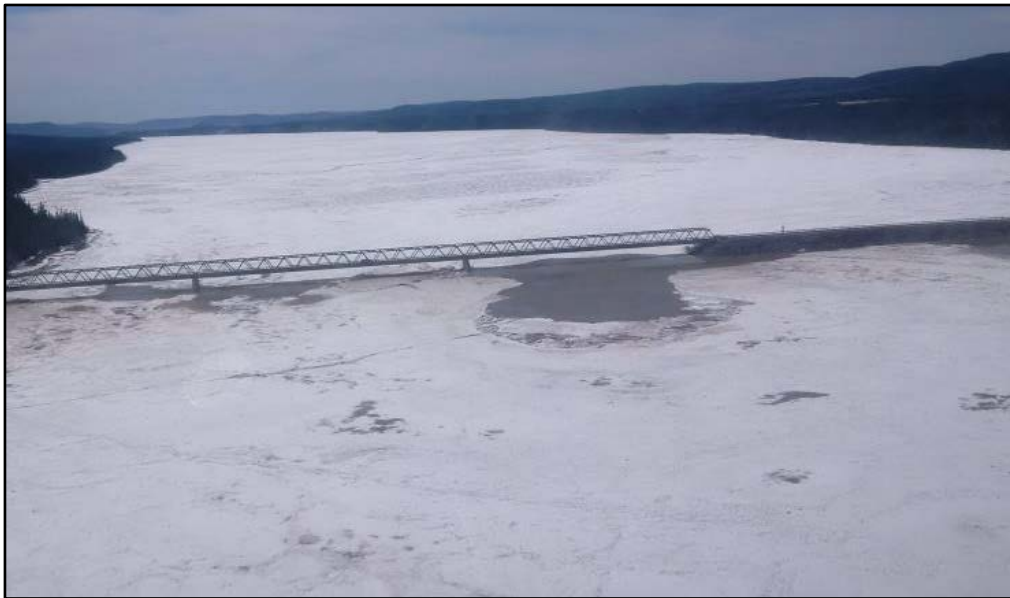
Figure 4-17: Looking Upstream Towards Memorial Bridge (23 km)

- The ice cover was still very much intact upstream of the Veteran Memorial bridge. Some consolidation of the cover can be seen upstream of the bridge in **Figure 4-17**. **Figure 4-18** actually shows some rafting of ice on the upstream causeway. Both photos suggest the cover was beginning to move downriver with the increased flow and drag associated with the high flows of the freshet.

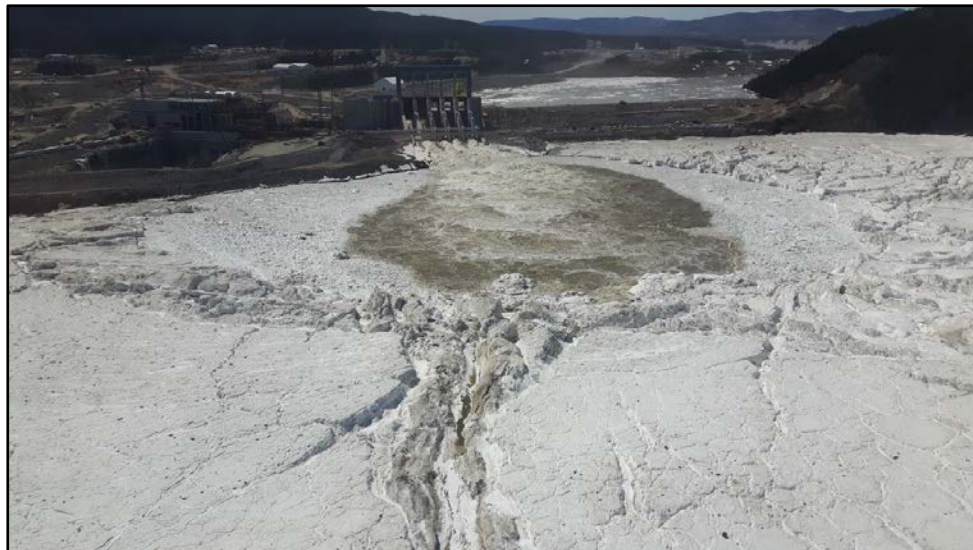
Figure 4-21: Looking Upstream Towards Muskrat Falls (42 km)

- **Figure 4-21** shows that the Muskrat Falls ice dam remained intact. Of interest, one can see in this photo the remnants of some of the upstream forebay ice that was passed through the spillway. The marked bands of accumulated ice that can be seen next to the open water lead area were not present in earlier photos – evidence that much of this ice was likely retained within the ice dam.

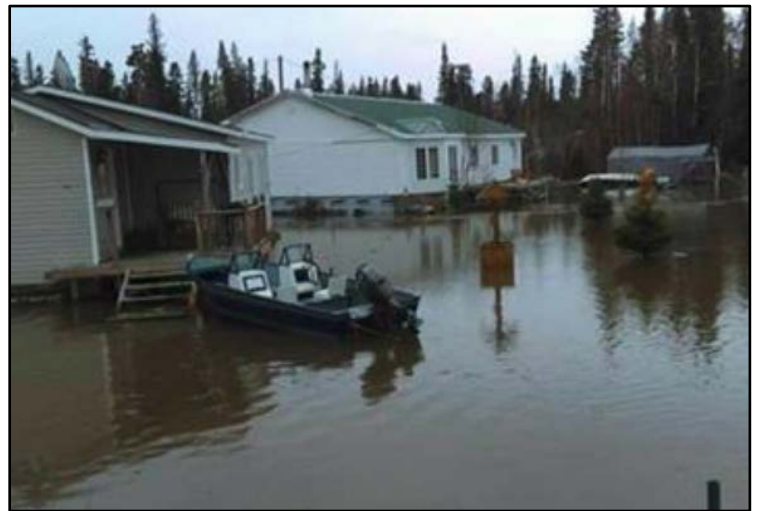
Figure 4-29: Comparison of 2012 and 2017 Photos

To aid in this comparison, **Table 4-1** has been prepared to summarize some of the key characteristics of each event, and **Figure 4-27** and **Figure 4-28** were prepared to compare the water levels and flows associated with each event. Finally, **Figure 4-29** compares photographs taken from similar vantage points during the two different flood events. Of interest, the water levels in the two photographs appear to be very similar.

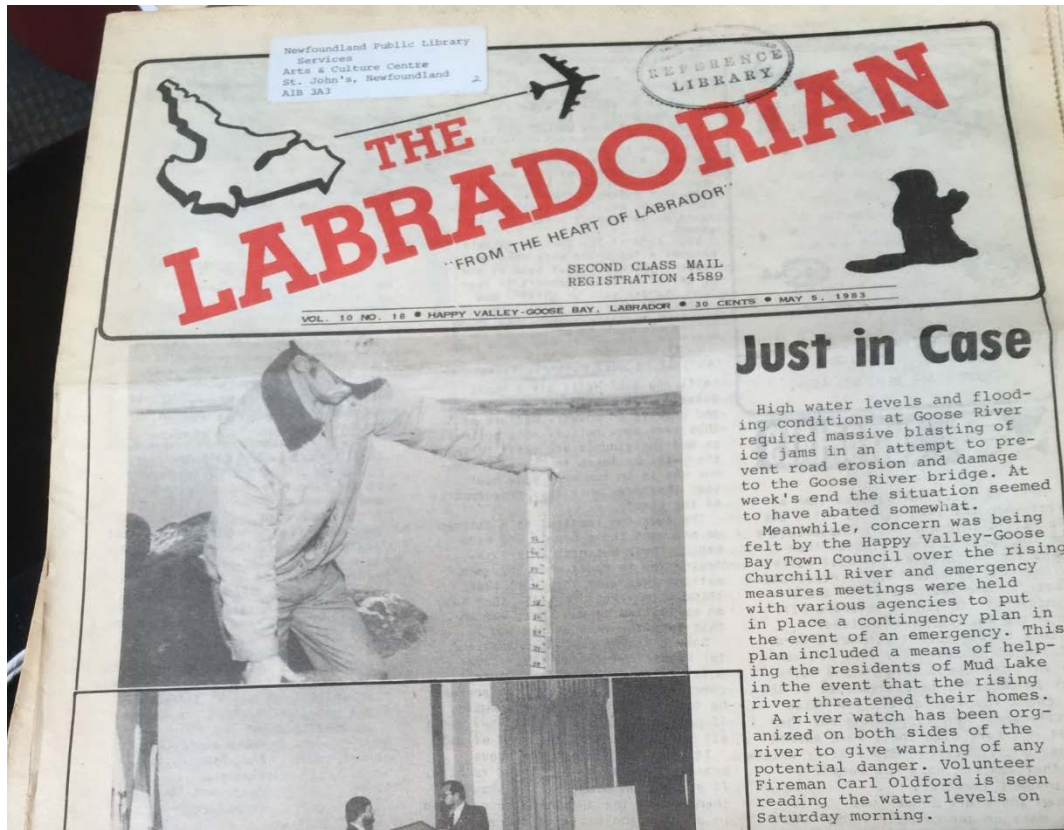
The Labradorian – May 5, 1983

In early May of 1983, flooding conditions were observed at Goose River which required massive blasting of the ice jam to prevent damage to the Goose River Bridge and erosion of the road. Emergency measures meetings were held by the Happy Valley-Goose Bay town council and various agencies to put in place a contingency plan which included a means of helping residents of Mud Lake if flood conditions threatened their homes.
