Nalcor Energy - Lower Churchill Project  
St. John's, NL

Cold Eye Review of Design and  
Technical Specifications, North Spur  
Stabilization Works

Final Report

MFA-HE-CD-2800-GT-RP-0001-01  
Rev. B1  
January 8, 2014

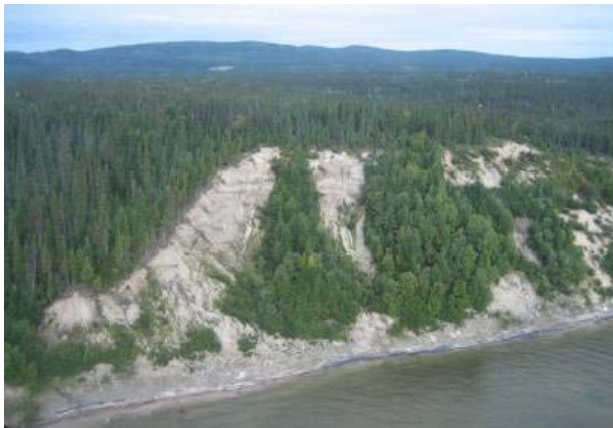
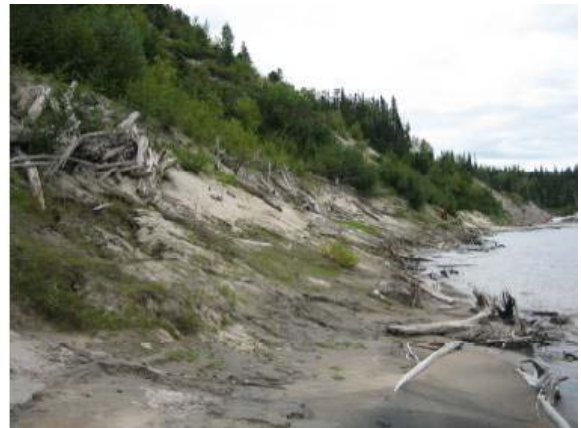
- The spur, between the north bank and the "rock knoll" is composed of stratified sensitive clays interbedded with granular deposits that create complex geological and hydrogeological conditions.
- The spur is fed by groundwater from upstream and from the north bank which, prior to the installation of the presently operating dewatering system, led to high phreatic surfaces on the downstream slope.
- In the past, turbulent eddies from the Falls have eroded and still erode the toe of the spur and the river banks causing slides.

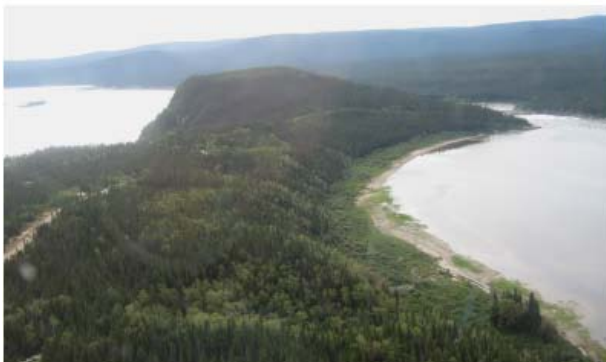
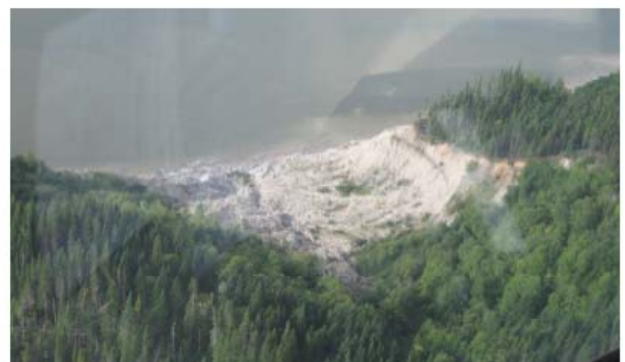
### Instabilities along the North Spur

- In the spring of each year, a hanging ice dam is created downstream of the lower falls which causes a raised tailwater level. When the dam collapses, a rapid drawdown condition is created at the toe of the downstream slope.
- The effect of the rapid drawdown plus the high groundwater plus the erosion has produced very large slides.
- A slide in 1978 reduced the width of the top of the neck by half.
  - ◆ following this, the dewatering system was installed and no large slides were observed from that time. Small erosion triggered events still occur.
