Muskrat Falls Generation

Independent Dam Safety Review and Audit

Audit #1

January 29 to February 2, 2017

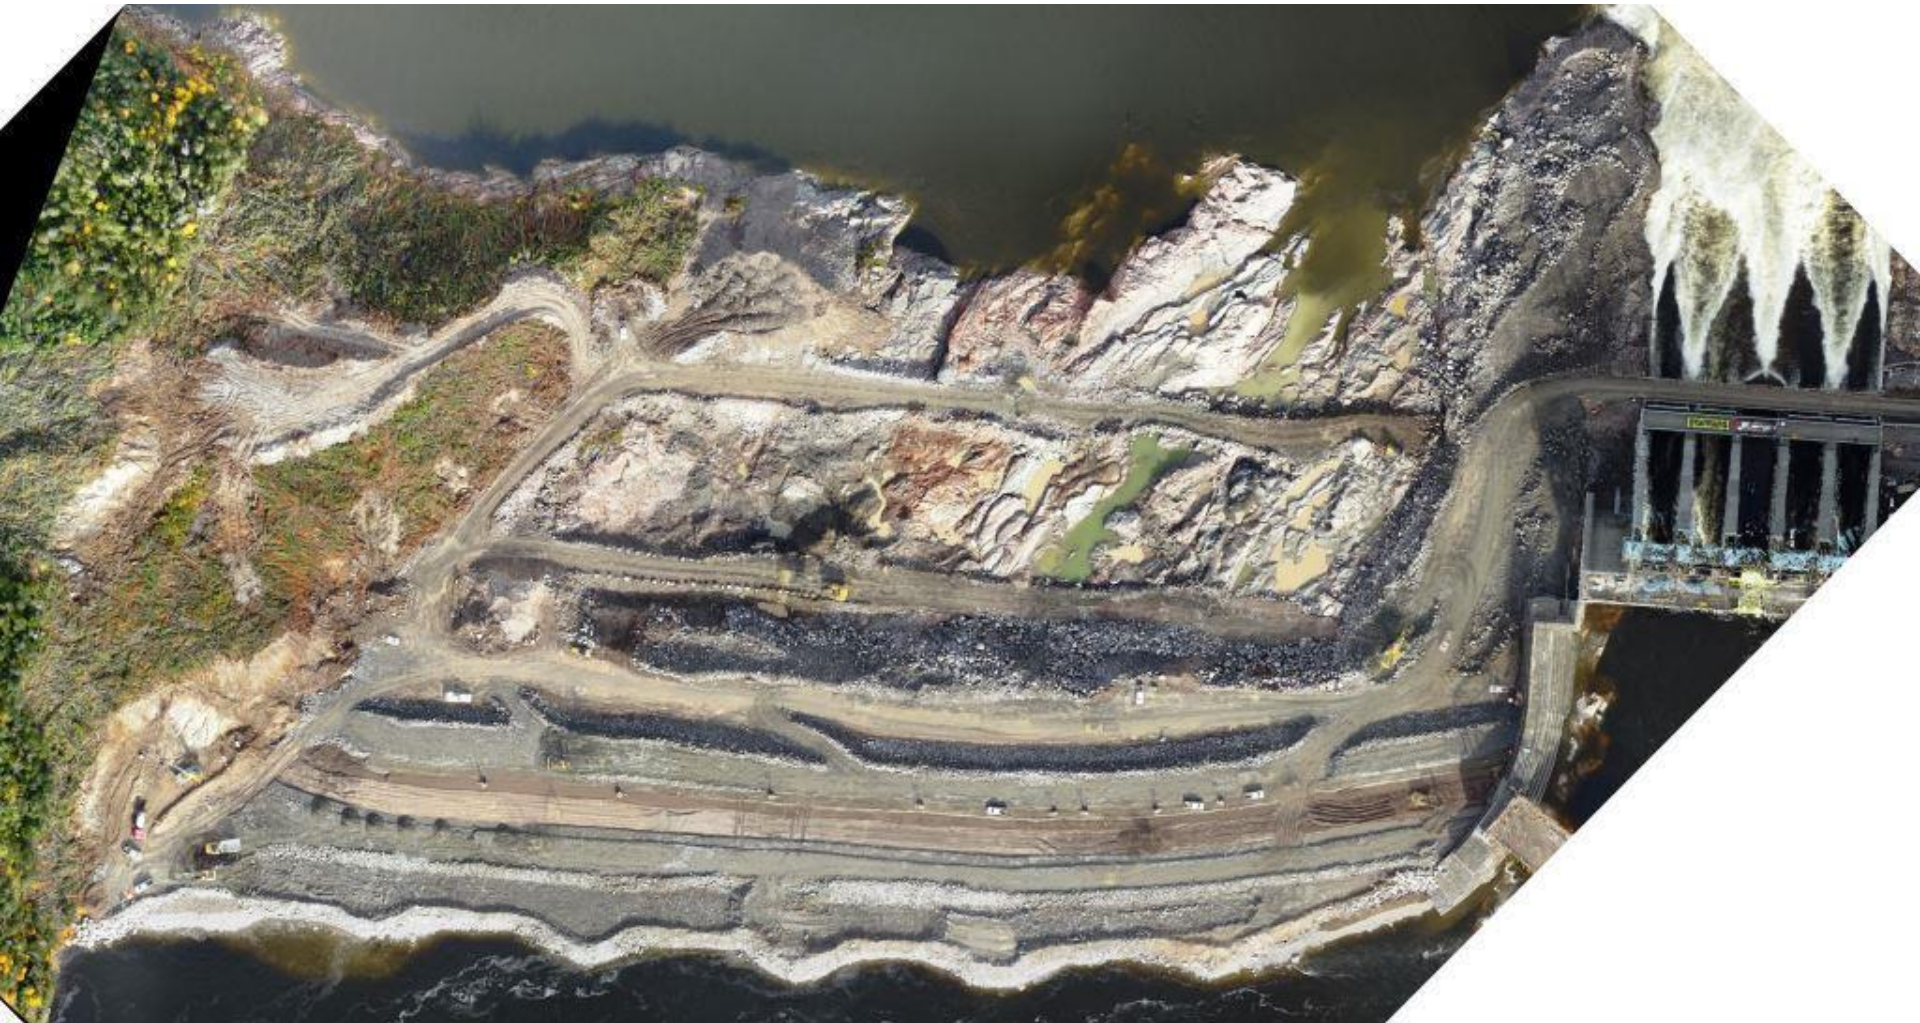
Upstream Cofferdam

- Upstream/downstream cofferdams
 - Current levels of leakage in line with what would be expected for a cofferdam of this type
 - Remediation program underway to deal with increased leakage that occurred on first impoundment
 - Measures are appropriate and appear to be effective
- Intake cofferdam (very minor leakage)
- Separation wall (very minor leakage)
- RCC cofferdam (minor leakage)

- The remedial works program is well organized and well conceived
- The work appears to be rectifying the root cause of the issues that resulted in increased seepage and turbid discharges during the initial impounding
- Adequate instrumentation has been installed to monitor cofferdam response
- The instruments are read and evaluated on a timely basis
- The reservoir level can be held or reduced if instrumentation anomalies are observed
- The cofferdam design is robust such that catastrophic failure of the structure would not be expected
- The upstream cofferdam is safe for continued impoundment following the established protocols.

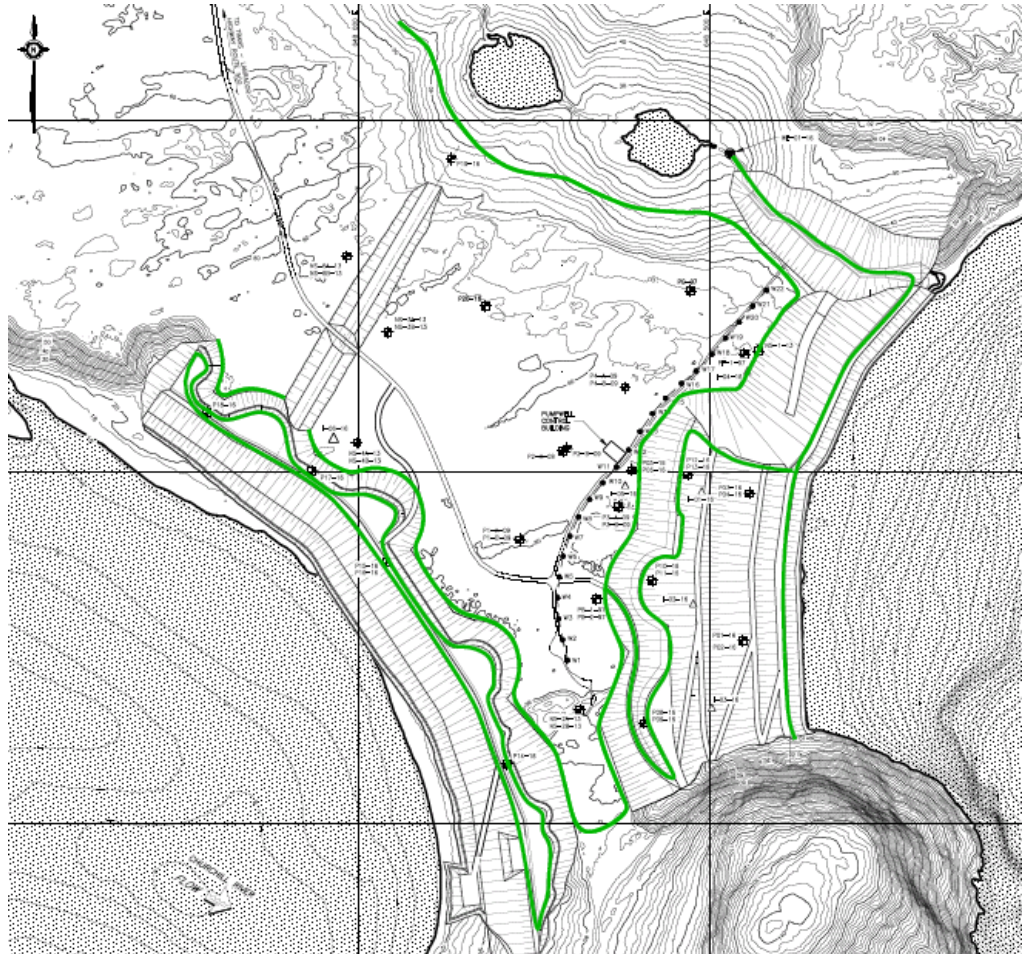
General Arrangement and location of Instrumentation

- 40 piezometers
 - 3 in lower aquifer
 - 7 upstream
 - 6 NW cow
 - 24 downstream
- 6 inclinometers
 - 5 downstream
 - 1 upstream
- 1 flow meter
 - Kettle lake outlet
