LOWER CHURCHILL PROJECT

SITE VISIT REPORT JULY 14 TO 23, 2014.

Prepared for: Natural Resources Canada and Nalcor Energy

Date: September 19, 2014

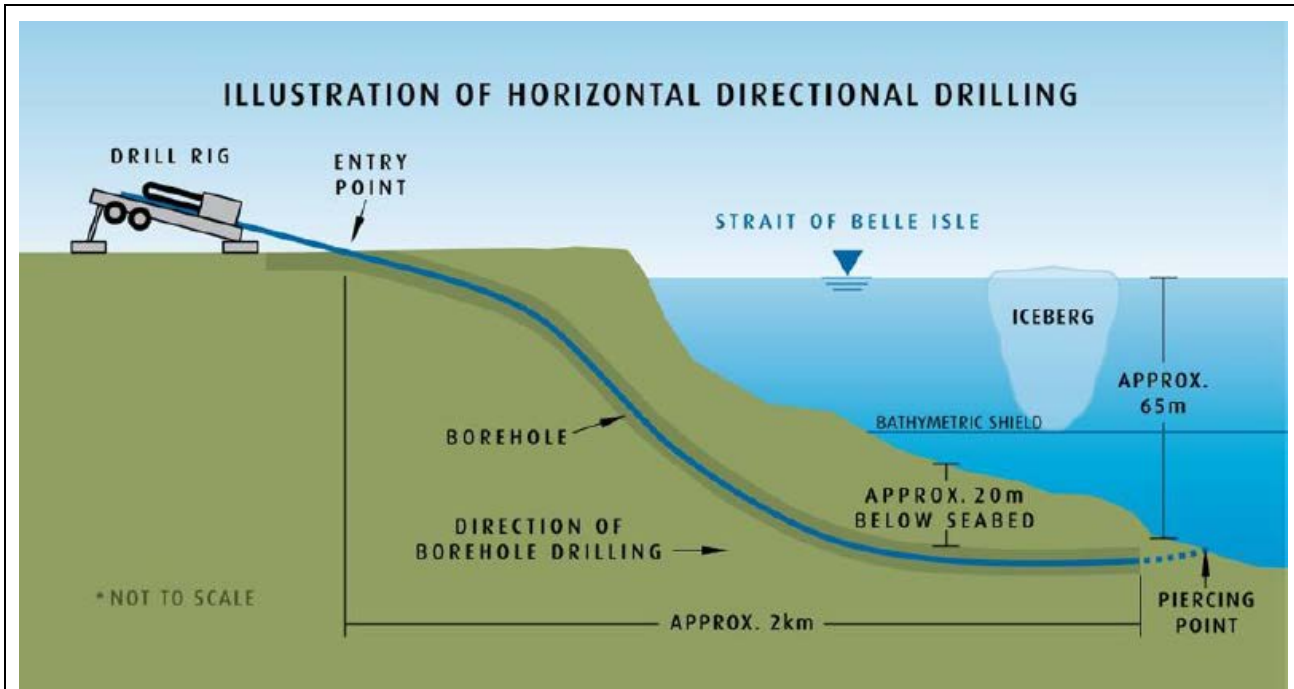
Figure 2.1: Schematic profile showing direction drilling on the shores of the Strait of Belle Isle.

At the time of the site visit the directional drilling rig (Photo 2.1 in Appendix A), owned and operated by Direct Horizontal Drilling was set up on drill hole Forteau 2. The holes at this site are collared in competent, layered sandstone that has subhorizontal to gently inclined bedding (Photo 2.2 in Appendix A). As shown in Photo 2.3, the hole is collared near surface with 30 inch casing installed in a 36' boring. Inserts of 24" and 14" casing are telescoped into this and advanced in the hole as needed until sound bedrock is encountered. The main portion of the hole is drilled with a 14 3/4 " bit. The hole orientation and route are guided by a steerable bit that is oriented by compass guided instrumentation in non-magnetic rods (tool), 20 m behind the drill bit.
