# MEETINGS IN ST. JOHN'S AND VISITS TO LOWER CHURCHILL PROJECT SITES, NOVEMBER 24 TO 27, 2014

Prepared for: Nalcor Energy

Date: January 28, 2014

Photos  
Muskrat Falls Site Visit - November 25 and 26, 2014

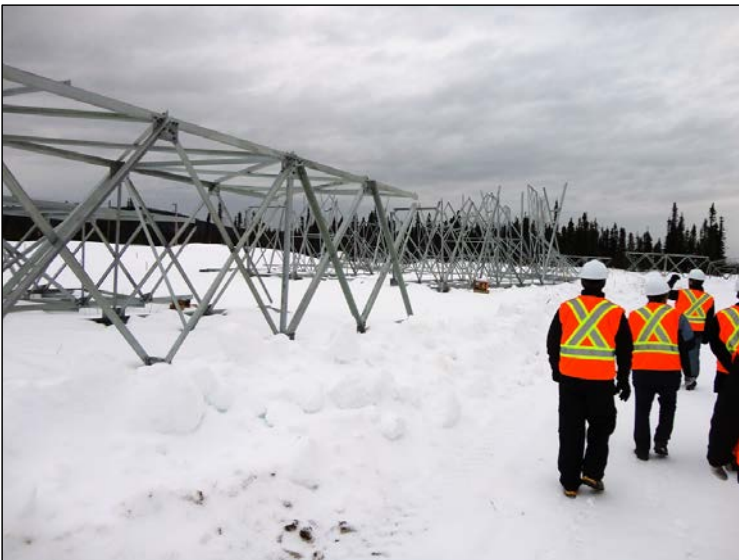
Photo 3.2: Assembling a HVacAC transmission tower near the North Spur. (November 25, 2014)

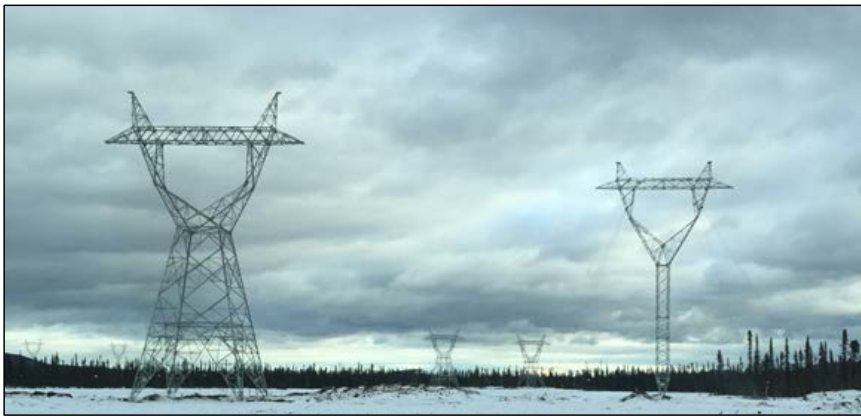
- A large number of foundations (approximately 300) have been completed.
- 56 HVac towers (Photos 5.1a, b, c and 5.1d) had been erected at the northern end of the line by the time of the site visits.

Photo 5.1c: HVac transmission line – erected Structures – Looking South toward both Lines. (November 26, 2014)

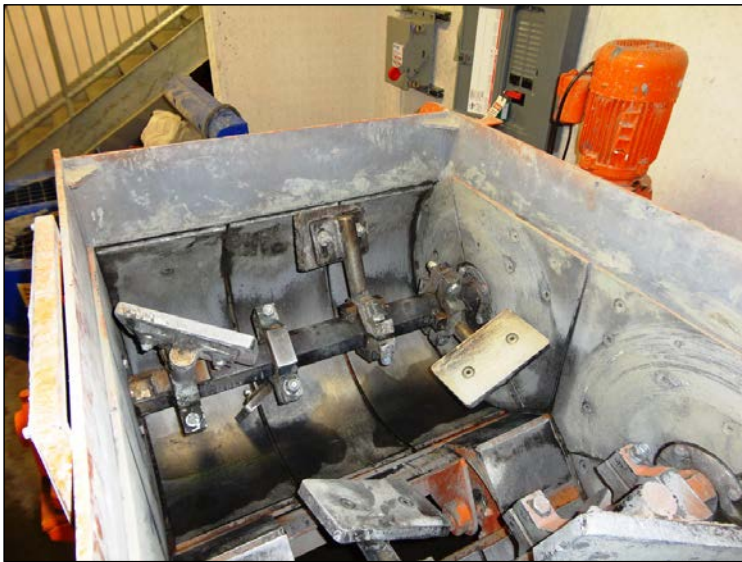
Photo 6.2: Site laboratory; mixer for concrete mix design. (November 25, 2014)

The IE inspected the soils and concrete testing laboratory on November 25, 2014. This facility is operational to carry out soil mechanics testing on fill samples and concrete testing. A program of concrete and RCC mix design is currently underway (Photos 6.1 – 6.5). A full range of soils mechanics and various concrete aggregate quality testing is carried out on aggregate and fill samples. It is understood that this facility is utilized by all contractors when confirming compliance with various technical specifications. The facility is well equipped, albeit a bit on the small size for a project of this magnitude.

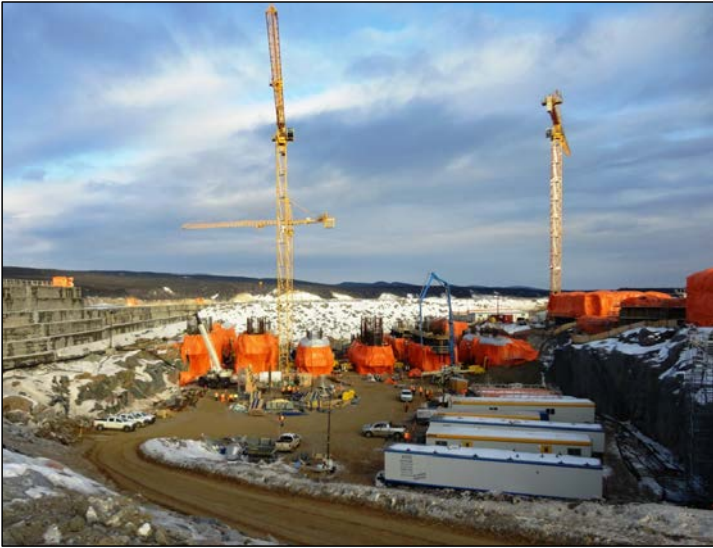
- Formwork erection and concrete placement work were underway in both abutments and all piers of the spillway structure (Photos 7.1 to 7.9). All works were enclosed in temporary shelters and heated with forced air heaters (Photos 7.6 to 7.9). This work is being carried out to a good standard and the shelter/heating arrangements are satisfactory for continuation of the work throughout the upcoming winter months.
- Steel rebar erections (Photos 7.5, 7.8 and 7.9) were observed in the various works and were of a good standard.
- A recently green cut horizontal construction joint was in Pier 3 as shown in Photo 7.9. This work was seen to be satisfactory.
- While it is understood that there has been schedule slippage, the activities and construction works observed during the site visit were all in accordance to good construction practice standards.

Photo 7.1: Spillway; view looking downstream towards the piers. RCC cofferdam is visible on the left side and the orange tarp covered transition dam is on the right. (November 26, 2014)

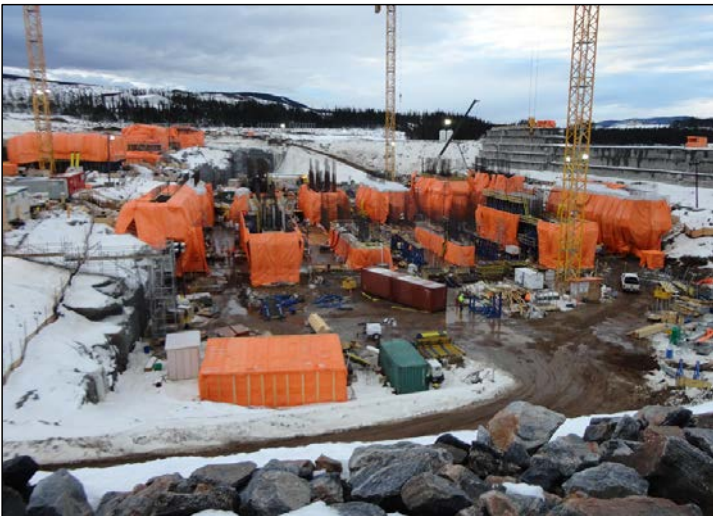
Photo 7.2: Spillway; view looking upstream towards the piers. RCC cofferdam is visible on the right side and the orange tarp covered transition dam is on the left. (November 25, 2014)

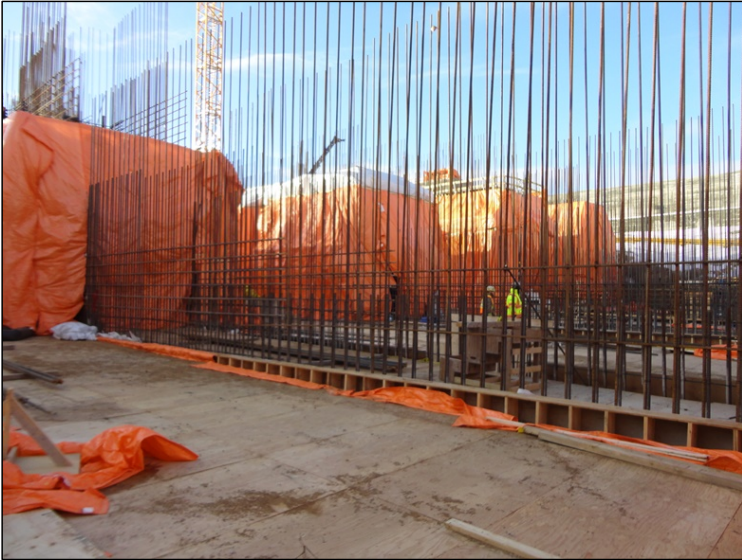
Photo 7.5: Spillway, rebar installation for Pier 3. (November 26, 2014)

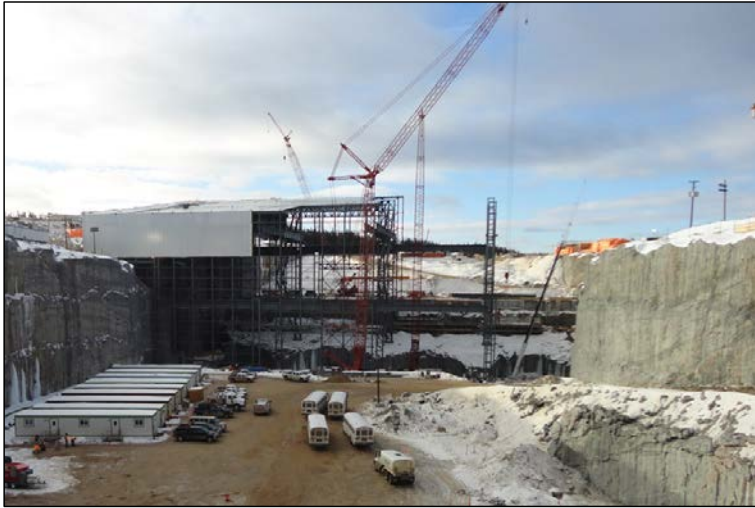
Photo 8.1: Powerhouse ICS looking upstream. Units 1 and 2 framework erection and first roof covering are substantially complete and almost half of the wall cladding has been erected. At Unit 3 the framework and first roof covering are substantially complete but no progress has been made on the wall cladding. No progress with the ICS in the area of Unit 4. . (November 26, 2014.)

- Astaldi ~~Canada's~~ progress on the Integrated Cover System (ICS) (shelter structure) for the powerhouse construction is considerably behind schedule. At the time of the IE site visit the ICS structure was partially completed over two of the four bays (minus much of the wall cladding - Photos 8.1 to 8.5). It was understood that closed-in shelter will be provided for Bays 1 and 2 by January and additional shelter will be provided over Bay 3 shortly after. As seen during the site visit, it was assumed no shelter will be available for the Unit 4 area during early winter.

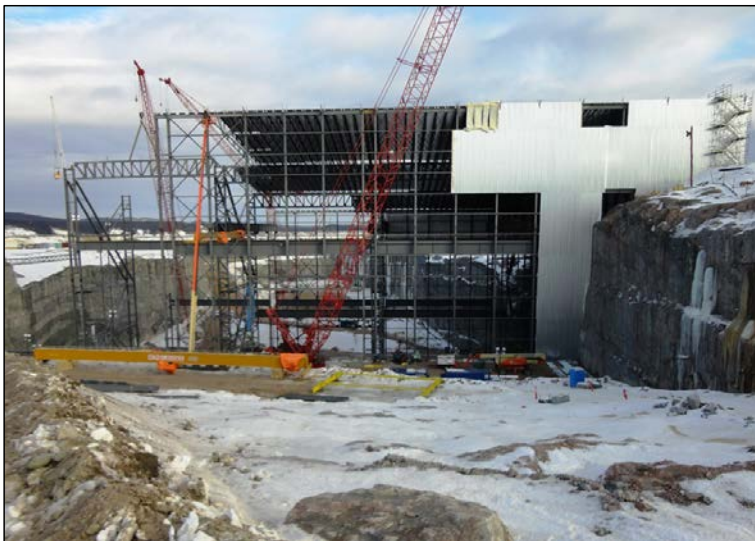
Photo 8.2: Powerhouse ICS looking downstream. Framework and cladding in Units 1, 2 and 3 can be seen. (November 26, 2014.)

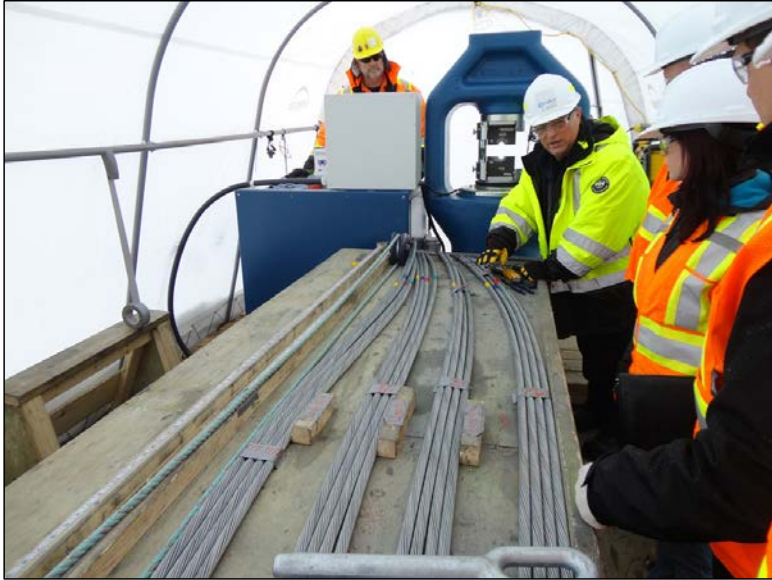
- A site visit was made to the guy wire assembly facility (Photos 2.1 and 2.2) and typical guy wire attachment installations were viewed (Photo 4.3).
- Tower assembly work (Photo 3.2) at each tower site was continuing at the time of the site visit. A significant number of units (approximately 300) have been completed and are ready for erection.

Photo 2.2: Laydown and preparation of guy cables for HVacAC transmission towers. (November 25, 2014)

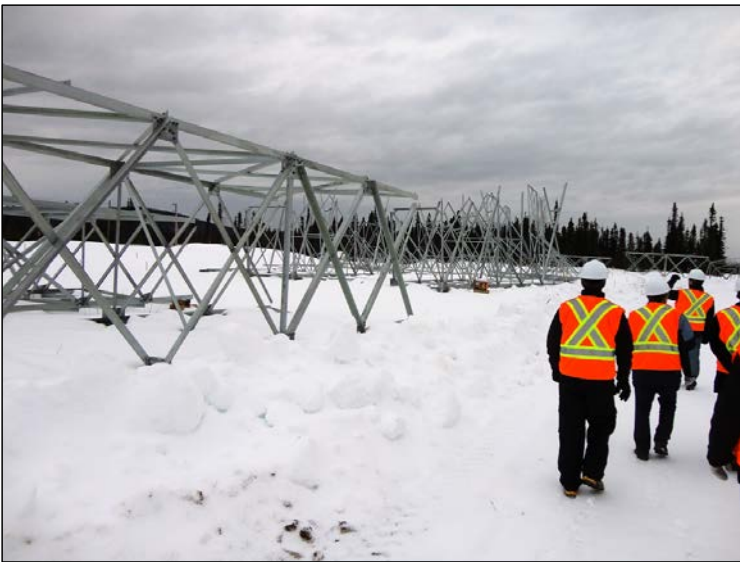
Photo 3.2: Assembling a HVacAC transmission tower near the North Spur. (November 25, 2014)

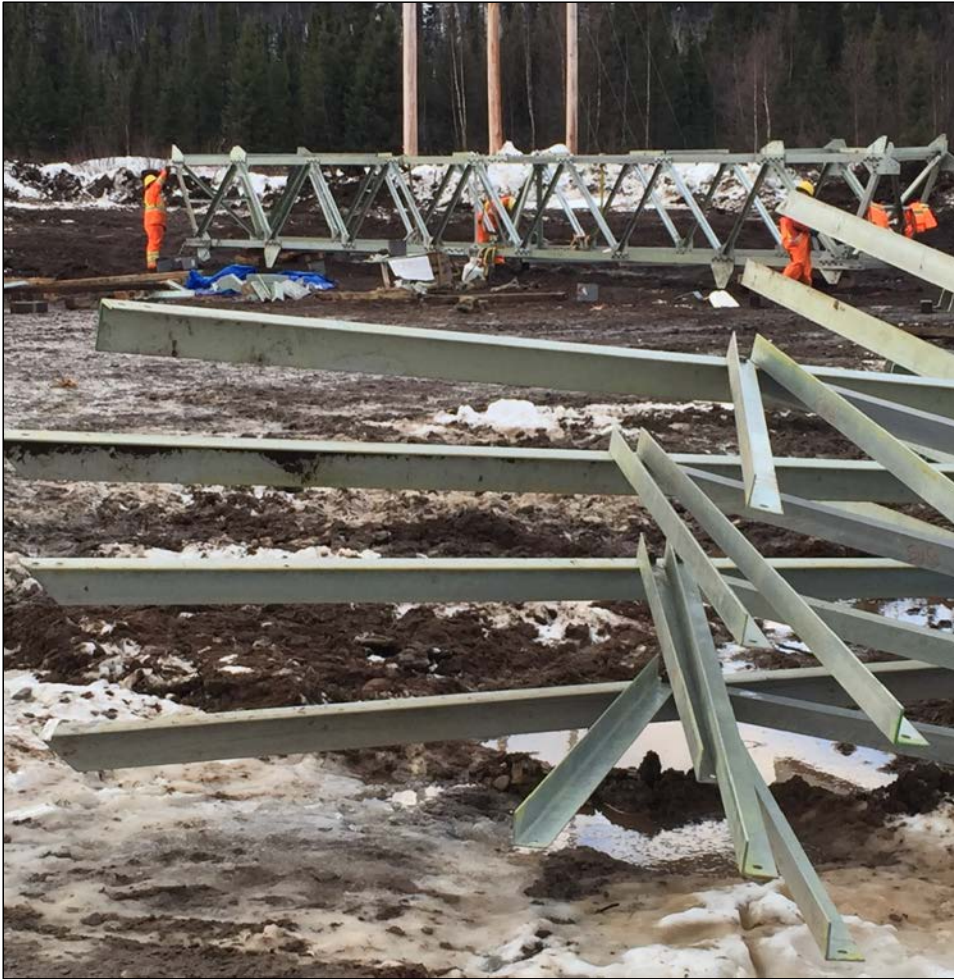
Photo 3.3: HVac transmission line structure assembly, November 25, 2014

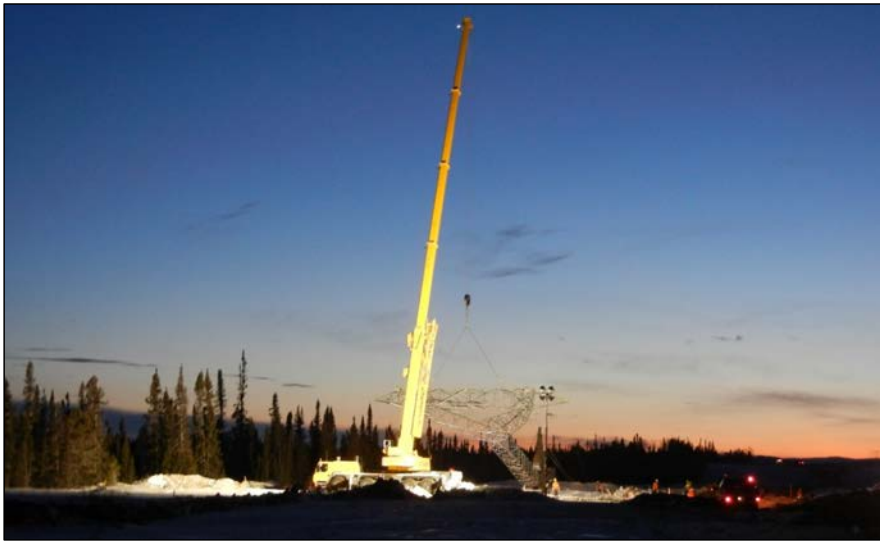
- No stringing or insulator/hardware has been installed yet.
- The IE witnessed the night time erection of a single foundation tower (Photos 4. 1, 4. 2a and b). The total time for the crew to move onto the site and erect the tower with a crane was just over one hour. When the IE team departed the site, crews were starting to secure to guy wires to the previously installed ground anchors.

Photo 4.1: HVac transmission line – structure erection, November 26, 2014

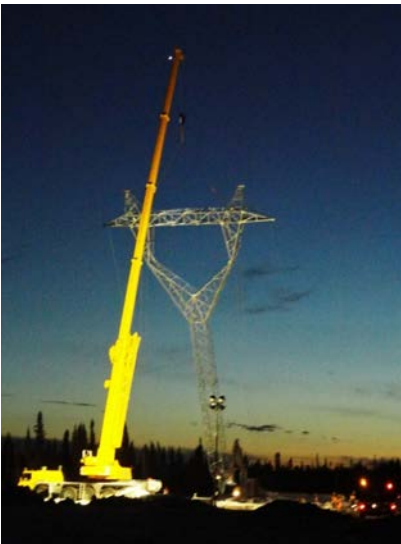
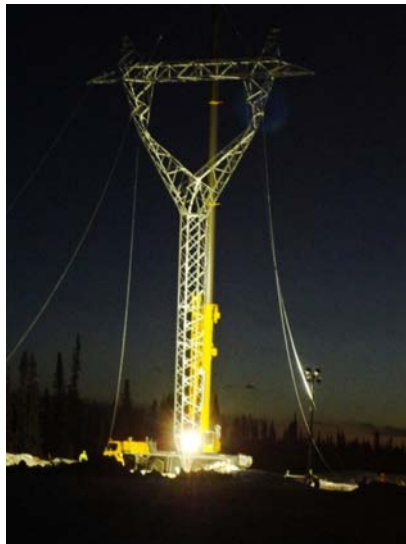
Photo 4.2 a (left) and b (right) : Erection of HVac Transmission Tower 58 at sundown. (a) tower being hoisted into place with crane and excavator and (b) in final position, still suspended from the crane; note untethered guy wires at this stage of erection. (November 26, 2014)

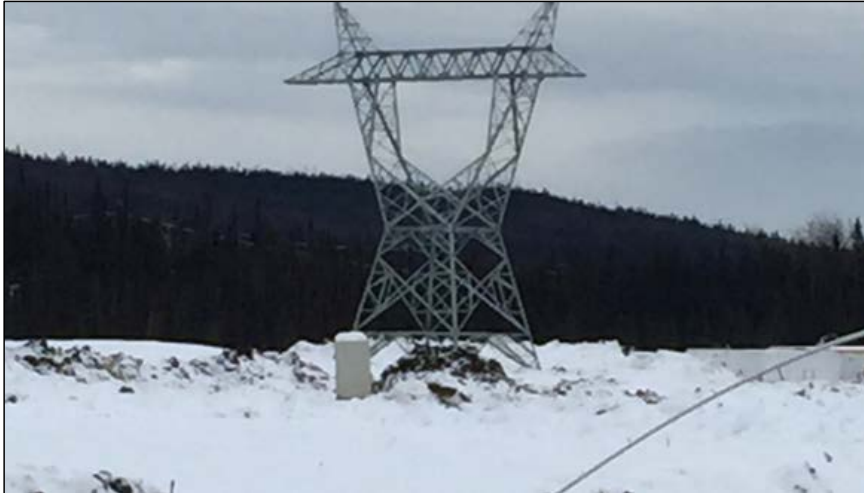
Photo 5.1b: HVac transmission line – erected Self Supporting Structure. (November 26, 2014)

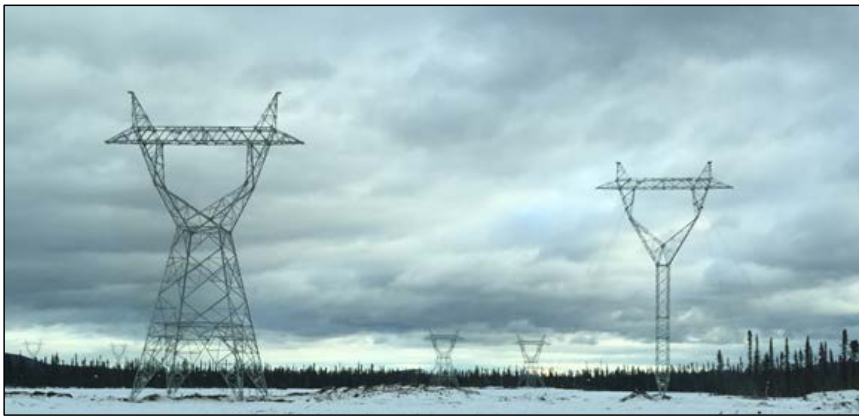
Photo 5.1c: HVac transmission line – erected Structures – Looking South toward both Lines. (November 26, 2014)

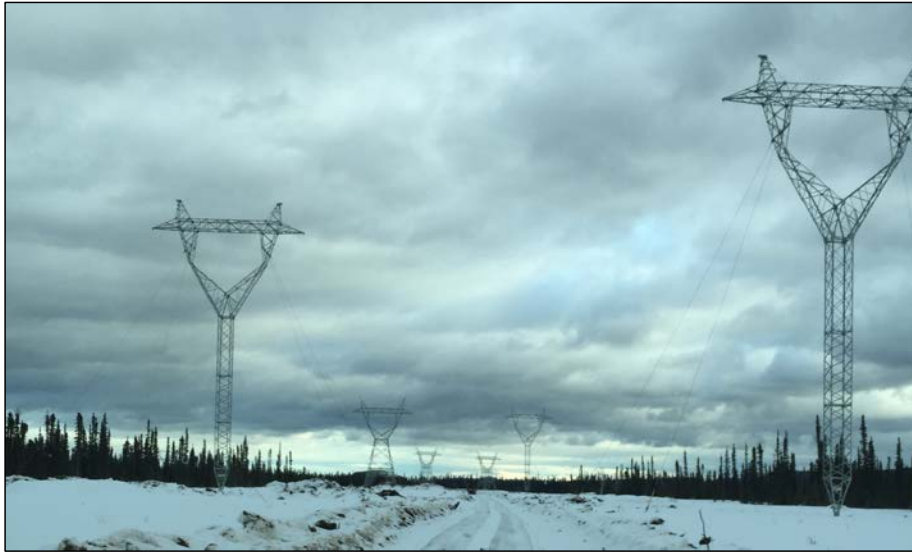
Photo 5.1d: HVac transmission line – erected structures – Looking South toward both Lines, November 26, 2014

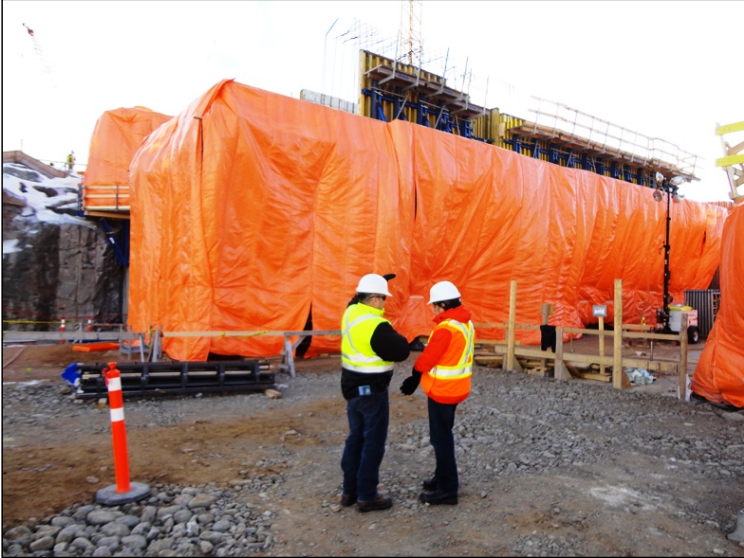
Photo 7.3: Right side of the spillway. Transition dam is visible at the top of the photograph. (November 26, 2014)

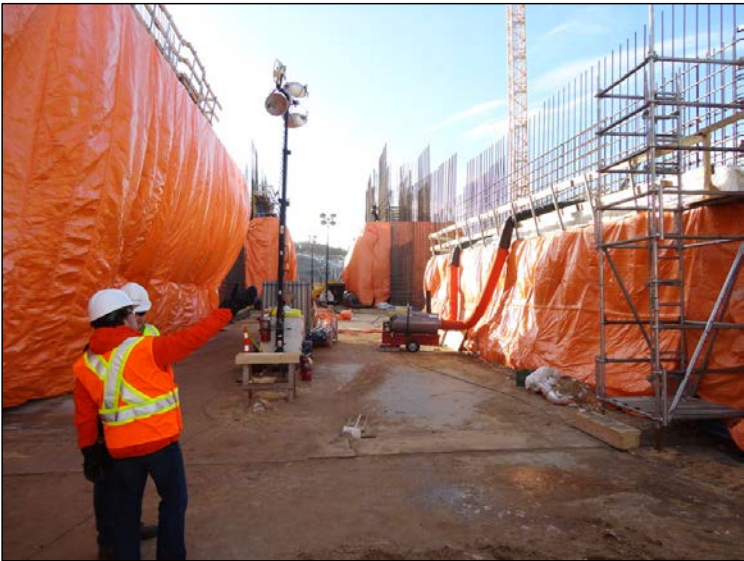
Photo 7.4: Spillway; view looking upstream between North Piers and Pier 1. (November 26, 2014)

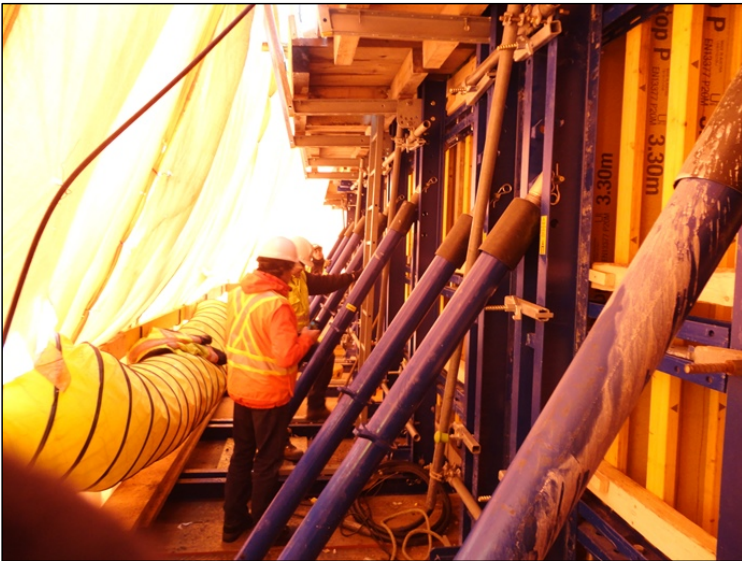
- Formwork erection and concrete placement work were underway in both abutments and all piers of the spillway structure (Photos 7.1 to 7.9). All works were enclosed in temporary shelters and heated with forced air heaters (Photos 7.6 to 7.9). This work is being carried out to a good standard and the shelter/heating arrangements are satisfactory for continuation of the work throughout the upcoming winter months.
- Steel rebar erections (Photos 7.5, 7.8 and 7.9) were observed in the various works and were of a good standard.
- A recently green cut horizontal construction joint was in Pier 3 as shown in Photo 7.9. This work was seen to be satisfactory.
- While it is understood that there has been schedule slippage, the activities and construction works observed during the site visit were all in accordance to good construction practice standards.

Photo 7.6: Spillway; shrouded and heated formwork. (November 26, 2014)

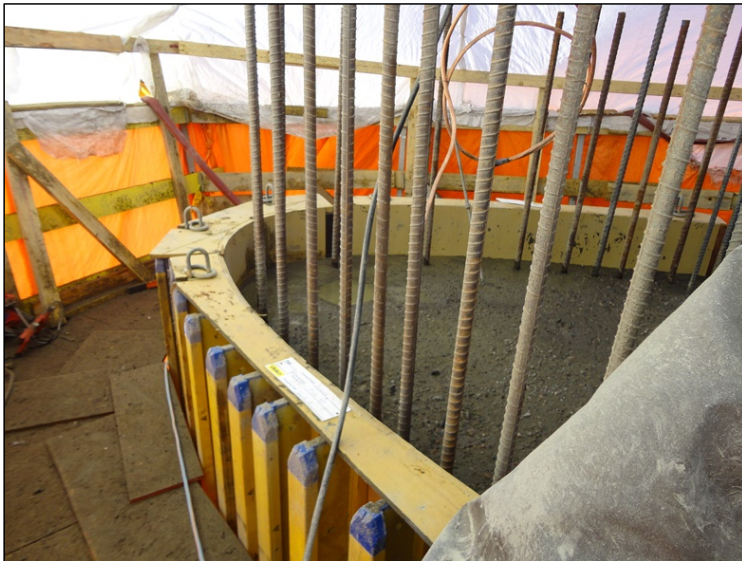
Photo 7.8: Spillway; Upstream nose of Pier 3. (November 26, 2014)

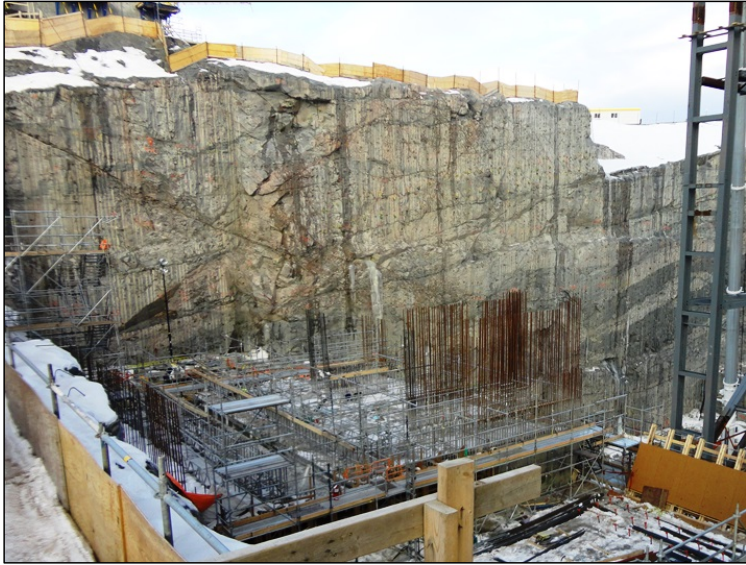
- A relatively small block of permanent concrete has been placed in Unit 4 of the intake (Photo 8.11). No further work is planned on the intake concrete works in the immediate future. Work on this structure will proceed in earnest when there has been more progress in the Powerhouse construction.

Photo 8.11 Powerhouse, Bay 4. Permanent concrete at base of intake structure at Bay 4. This is the only permanent concrete in the powerhouse/intake structures. (November 26, 2014)

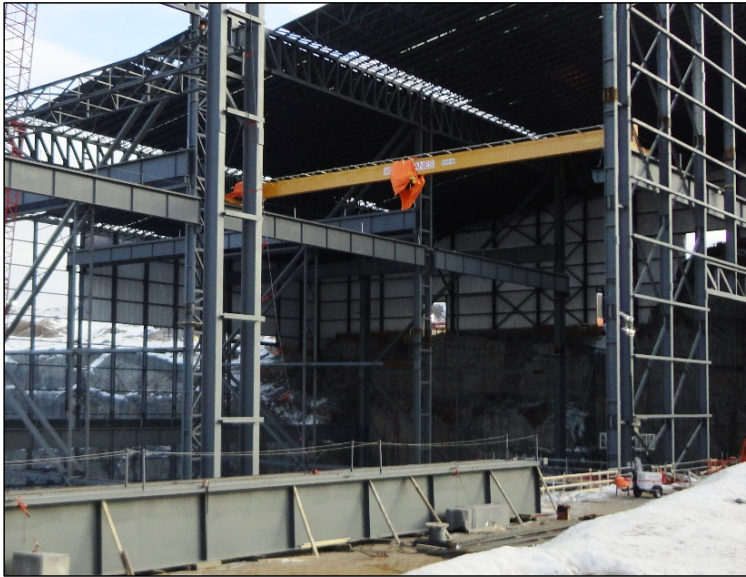
- Erection and concrete placement facilities are being installed. As seen in (Photos 8.10 and 8.12), an overhead crane and beam have been laced over the Unit bay. A Putzmeister concrete pump has been erected on a fixed swivel mounting between Bays 2 and 3 in the Powerhouse (Photo 8.13). Additional pumps and rail cranes will be installed throughout the Powerhouse to make sure that all areas can be reached.

Photo 8.12: Powerhouse ICS. Beam crane above Unit 2. (November 26, 2014)
