Lower Churchill Project

Final Engineering Assessment Report of Draft Tube 2 Formwork/Falsework Failure

February 24, 2017

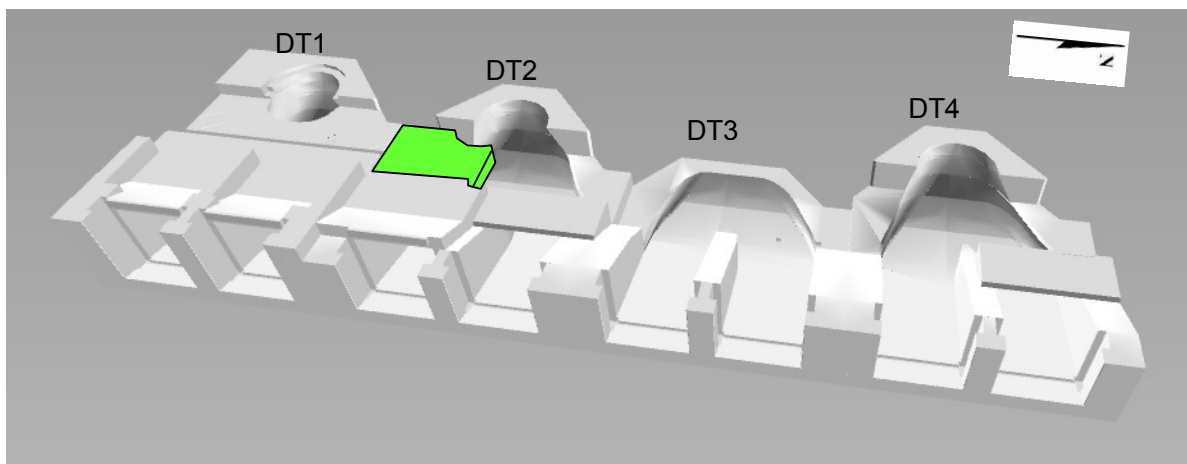
At the time of ILF’s arrival on site, powerhouse construction had been suspended and the status of respective draft tubes were as depicted in Figure 2 DT 1 was the most advanced of the four draft tubes, with three levels (lifts) of pours in place. DT 2 was the second-most advanced with some outlet roof pours complete. DT 3 was the least advanced with 2 lifts of draft tube concrete complete and outlet roofs unpoured.

Figure 2: Work progress in the power house June 2, 2016. Failed D2ESB-03 in Green

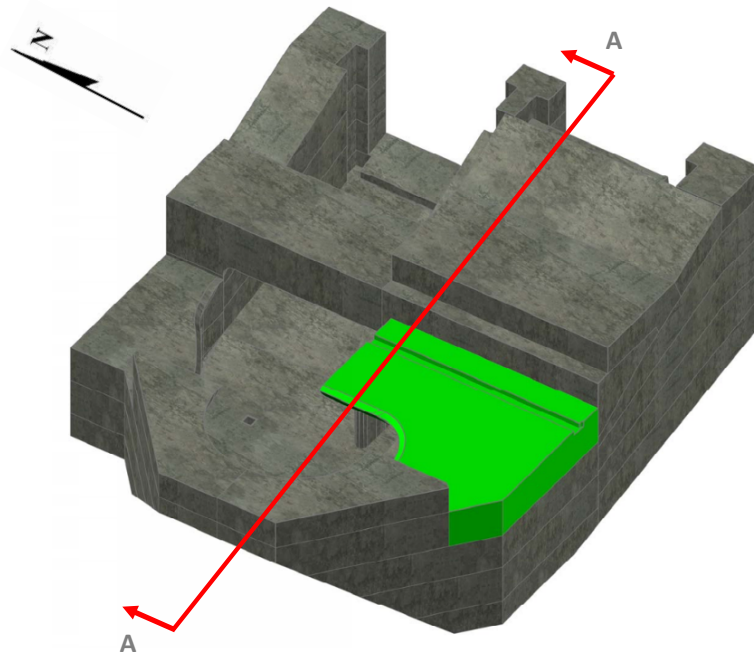
Figure 3: Draft Tube Unit 2 isometric; failed D2USB-03 pour in green

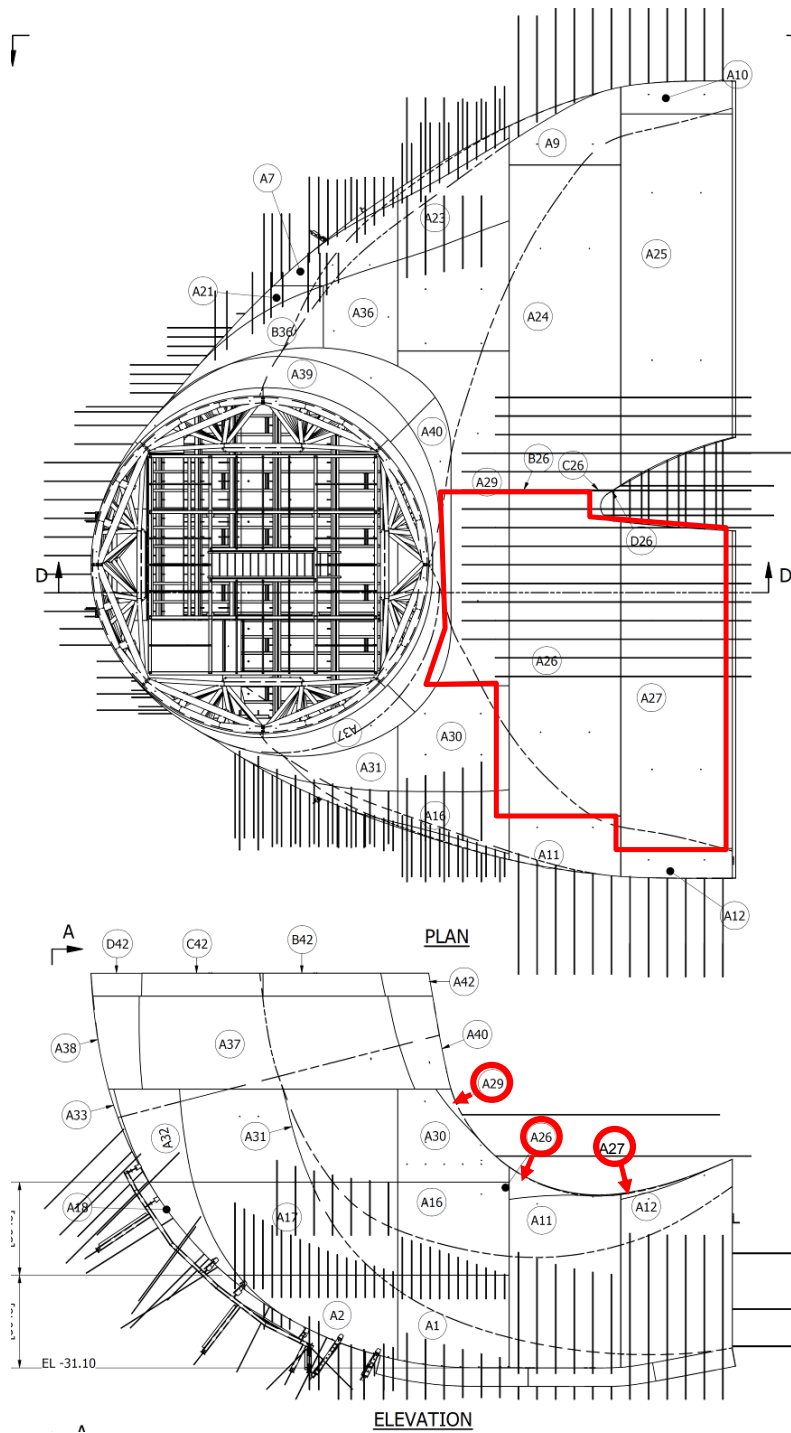
Figure 6: CEI formwork modules involved in collapse

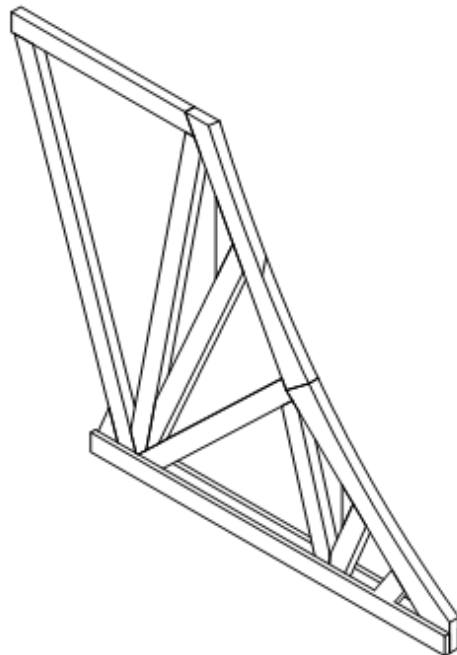
Figure 30: Rib C29 of Panel A29 from CEI shop drawing MFA-AT-SD-3310-CS-D04-0048-01

CEI's use of eight two-dimensional rib models to represent the entirety of the draft tube formwork is not reasonable and does not represent employment of sound engineering judgement. This was especially evident in using the calculations of rib G24 to represent panels A24, A25, A26, A27, and A29. The geometry of these panels varies significantly rib to rib and panel A29 has significantly different geometry and loading when compared to the other panels. Panel A29 has lateral coil rod ties to resist the horizontal loading but that was not represented in the rib G24 analysis. The material impact of this approach is that numerous ribs lacked adequate representation in the design. Based on the complex geometry and variation between adjacent ribs, many structural members were not checked for appropriate loads, load paths, interaction with the formwork skin, and joint connections.

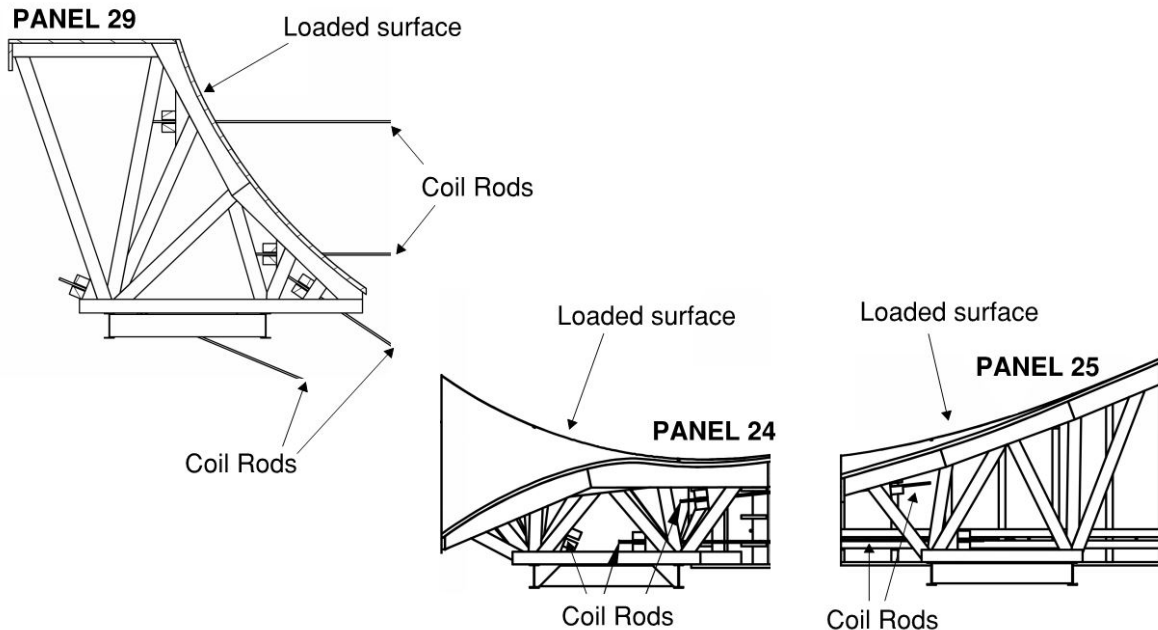
Figure 32: Draft Tube Roof Panel Geometry

Figure 32 provides indication of the differences in the loading and geometry of modules A24, A25 and A29. Modules A26 and A 27 are similar to A24 and A25, respectively. Note the difference in geometry of the module sections and consider CEI modeled all three of these formwork modules using one rib (rib G24) from module A24. CEI's analysis did not consider the difference in applied concrete loading (mostly lateral for A29, mostly vertical for A24) due to formwork curvature nor were connecting forces from coil rods represented in their calculation package. The reactions of the coil rods produce localized stresses and global deflections in the formwork system that result in higher utilization of multiple members.

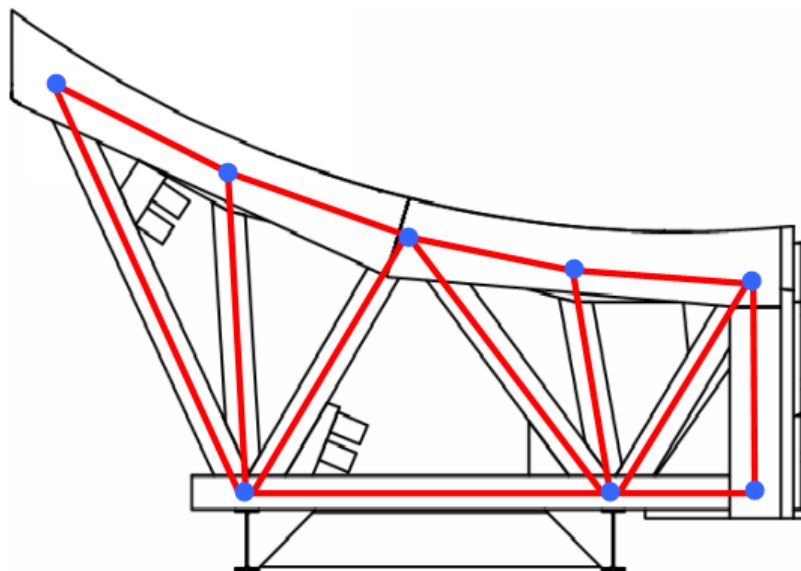
Members with utilization ratios of 1.00 to 1.20 were acceptable due to the difference between the center to center span in the RISA model and the as-built clear span of the members. Members in RISA were modelled to centerline of supporting members, versus the actual clear span in the field taking into account support member sizes and plywood gusset plate sizes. Figure 35 indicates how the stick and node models used in RISA overestimate the unbraced lengths, for reasons described above. Stick and node are indicated as red lines and blue dots, respectively.

Figure 35: Comparison of stick and node to actual geometry

Reinforcing and bracing with dimensional lumber and plywood were required for members with utilization ratios over 1.20 to achieve acceptable member capacities. Modifications were generally limited to discrete members of formwork module ribs and could be carried out in the field with on-hand materials. Details for the strengthening/bracing of formwork were issued for construction via site instructions and engineered drawings submitted through Astaldi’s document control system. See Table 2 below for a summary of modules with overstressed members.

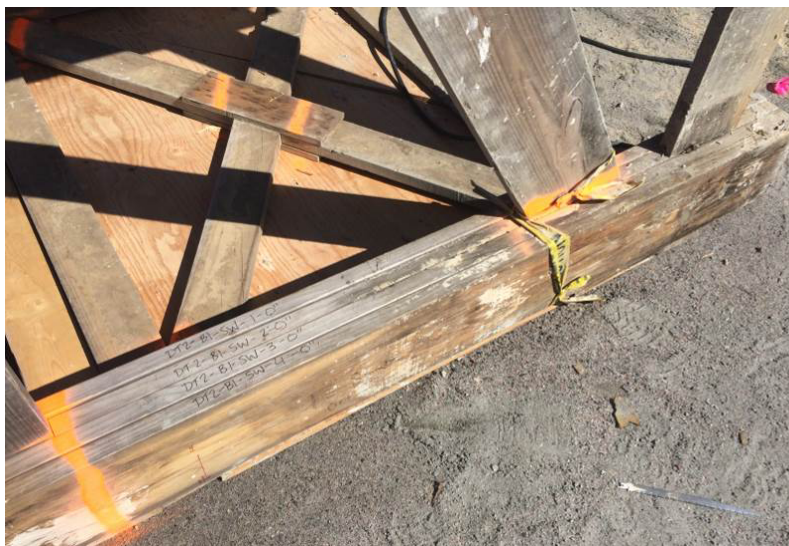
Figure 39: SW Tower Leg of B2 recovered from DT2, submitted for testing

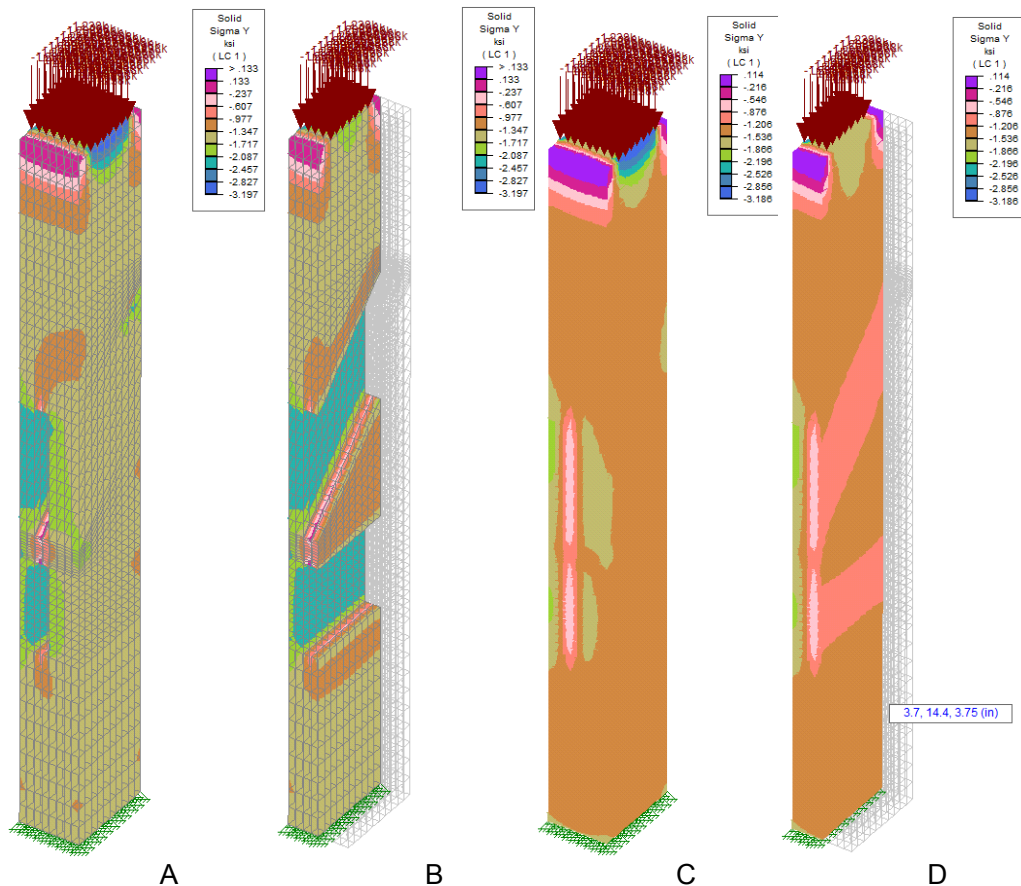
ILF performed 3D structural modeling of the tower legs at brace locations to examine the effects of discontinuities in plies of the built up members. The model consists of solid elements representative of the 4-ply 2x10 leg with a 78 kip (Ref. CEI calculations) axial load applied. The results presented in Figure 46 represent two conditions. Figure 46A and Figure 46B represent a void where the braces penetrate the leg. This assumption comes from the observation of gaps in butt joints (see photographs below) that may not adequately transfer vertical loading. Figure 46C and Figure 46D represent the braces modeled as a weaker material, assuming material properties for wood compressed perpendicular to the grain.

Figure 46: 3D model of Tower leg at bracing interface

Both modeling assumptions show significant stress increases at the bracing interface. A vertical stress of 1.4 ksi is developed in the continuous portion of the leg model as would be expected from a simple force per area calculation. At the discontinuities vertical stress increases to 2.5 ksi for the void model and 2.2 ksi for the weaker material model. This is a stress increase of 78% that was not considered in CEI's calculation package. The model is intended to be representative of conditions that should have been explored by CEI during original design, given fabrication methods later used by CEI.

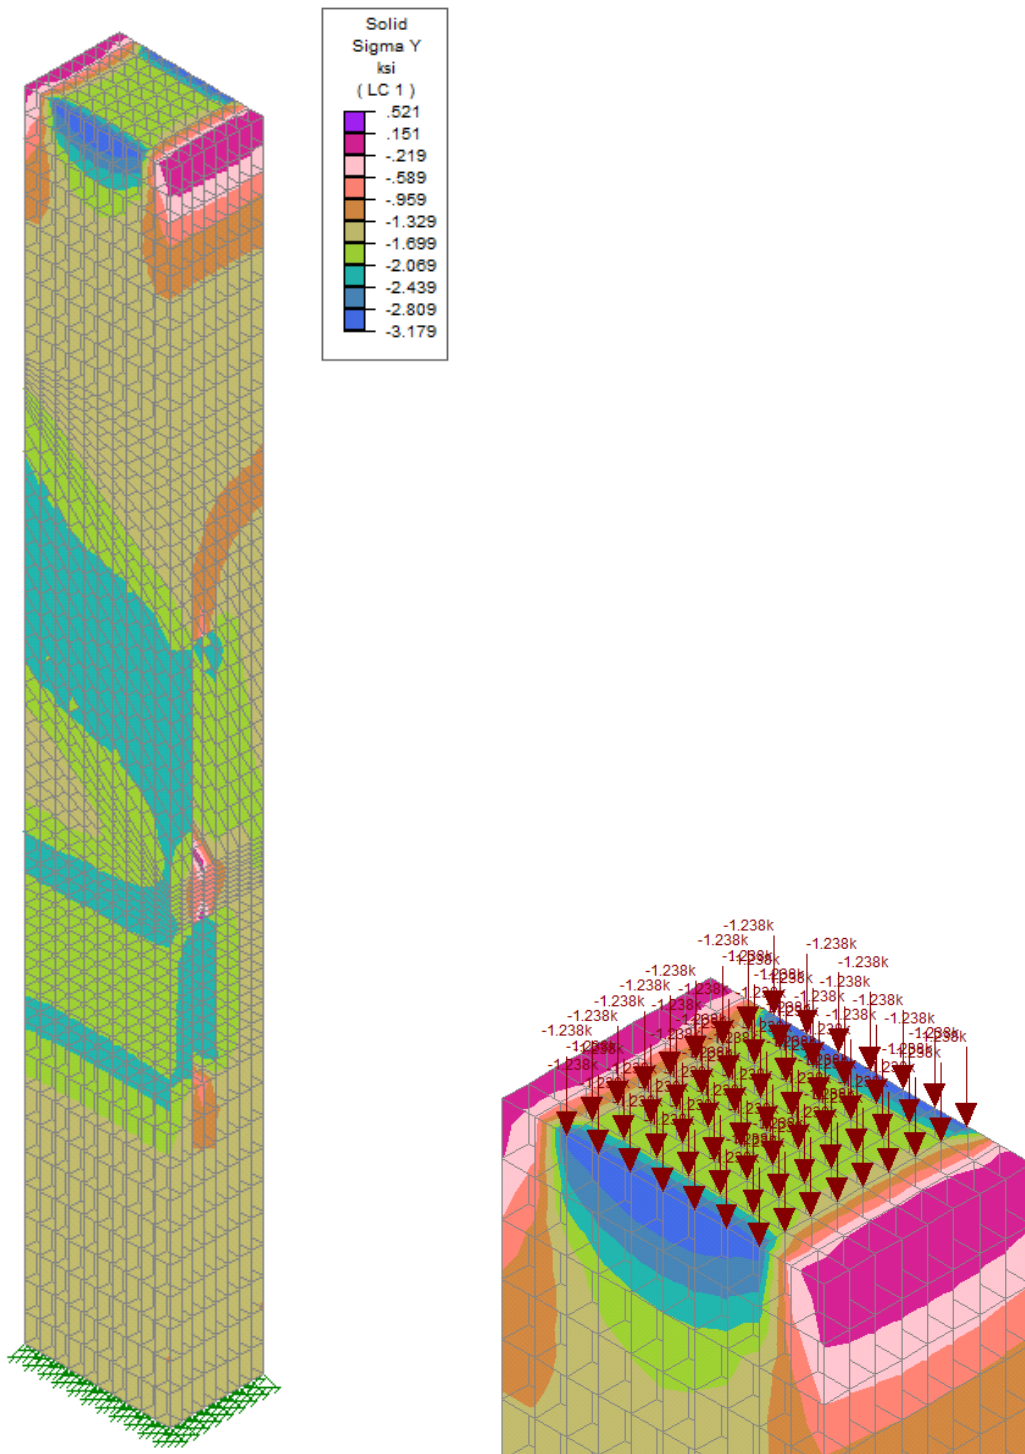
Figure 47: Vertical Stress Analysis - Load applied uniformly over all plies

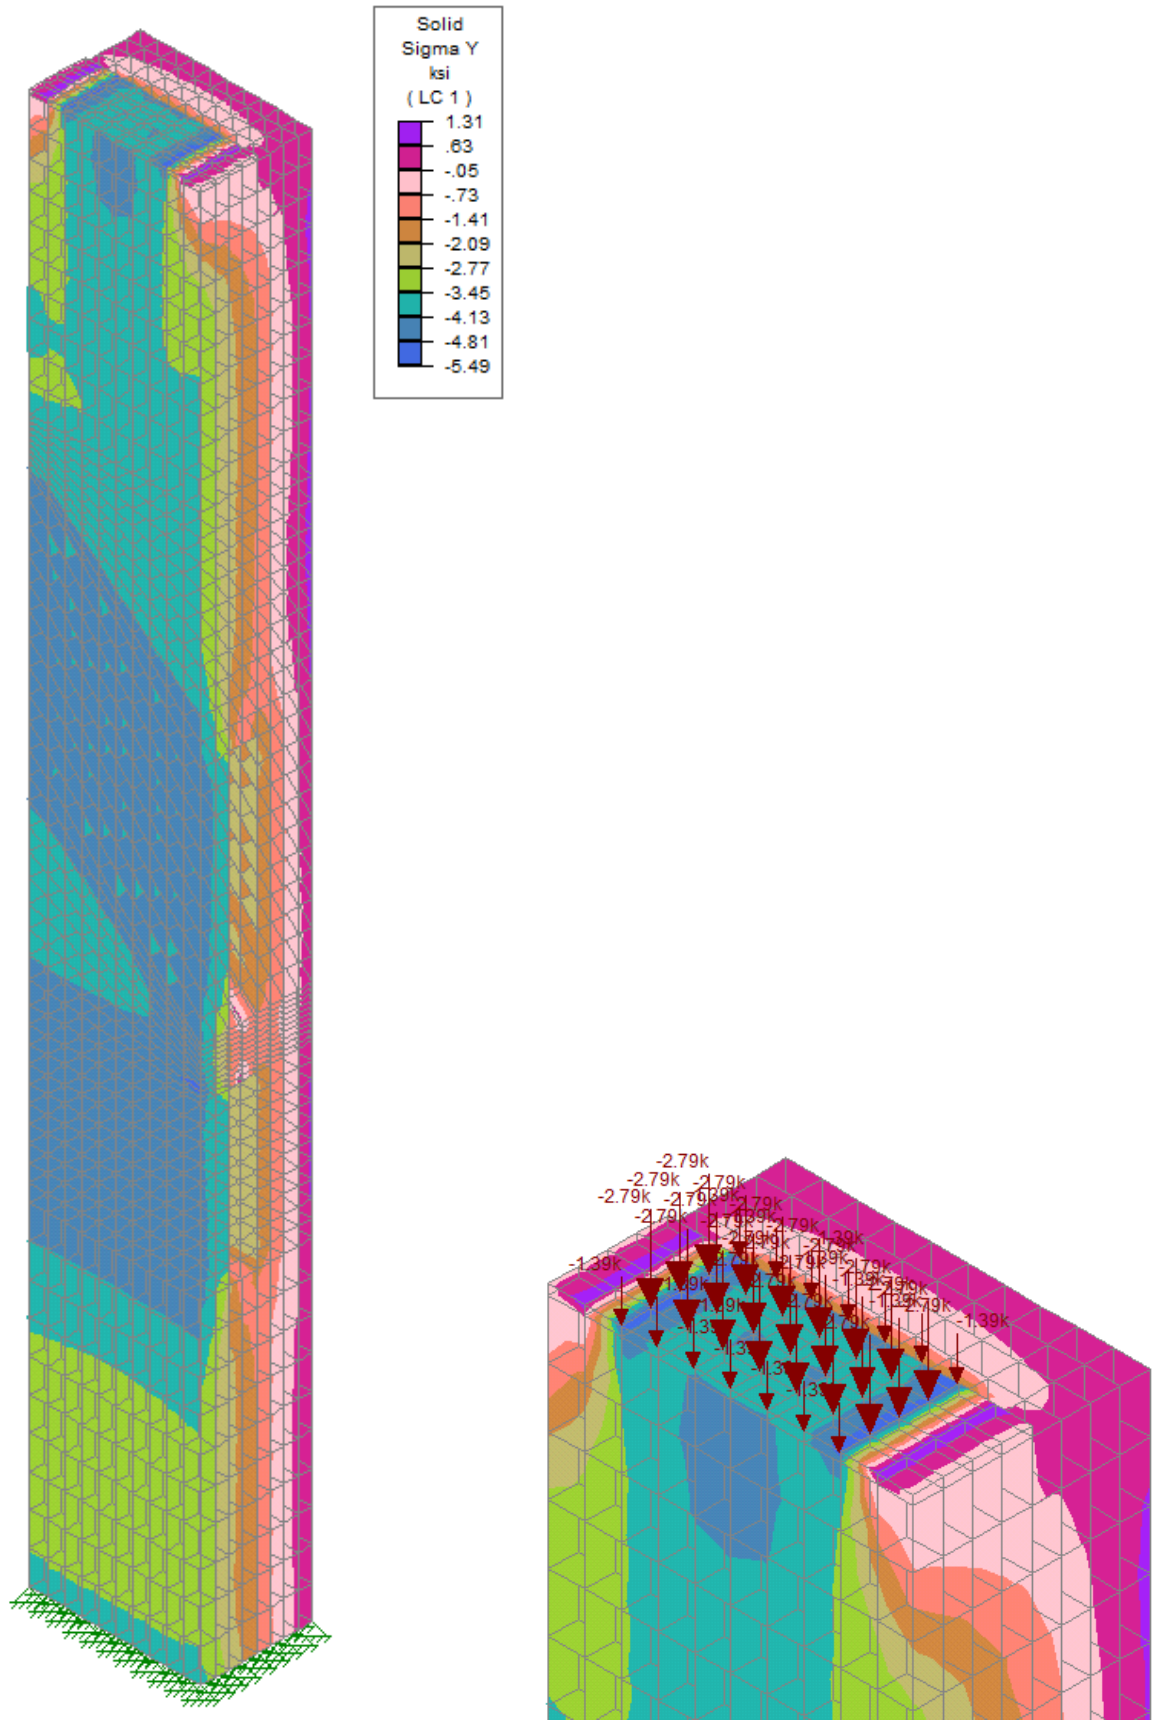
Additional 3D models were created by ILF to examine the effects of uneven loading at top of falsework legs. The purpose of this is to examine the effects of tower legs where the plies are not flush at the top and lacked a bearing plate. Figure 48 illustrates a loading condition where two adjacent plies are taller than the others. Figure 49 depicts alternating taller plies. The results of both simulations indicate significant overstressing of portions of the tower leg. Stress concentrations develop at the loading areas and voids caused by the penetrating bracing members. These stress concentrations greatly exceed the nominal (unadjusted design value) Compression Parallel to Grain Design value of 1.85 ksi.

Figure 48: Vertical Stress Analysis – Load applied to two adjacent plies

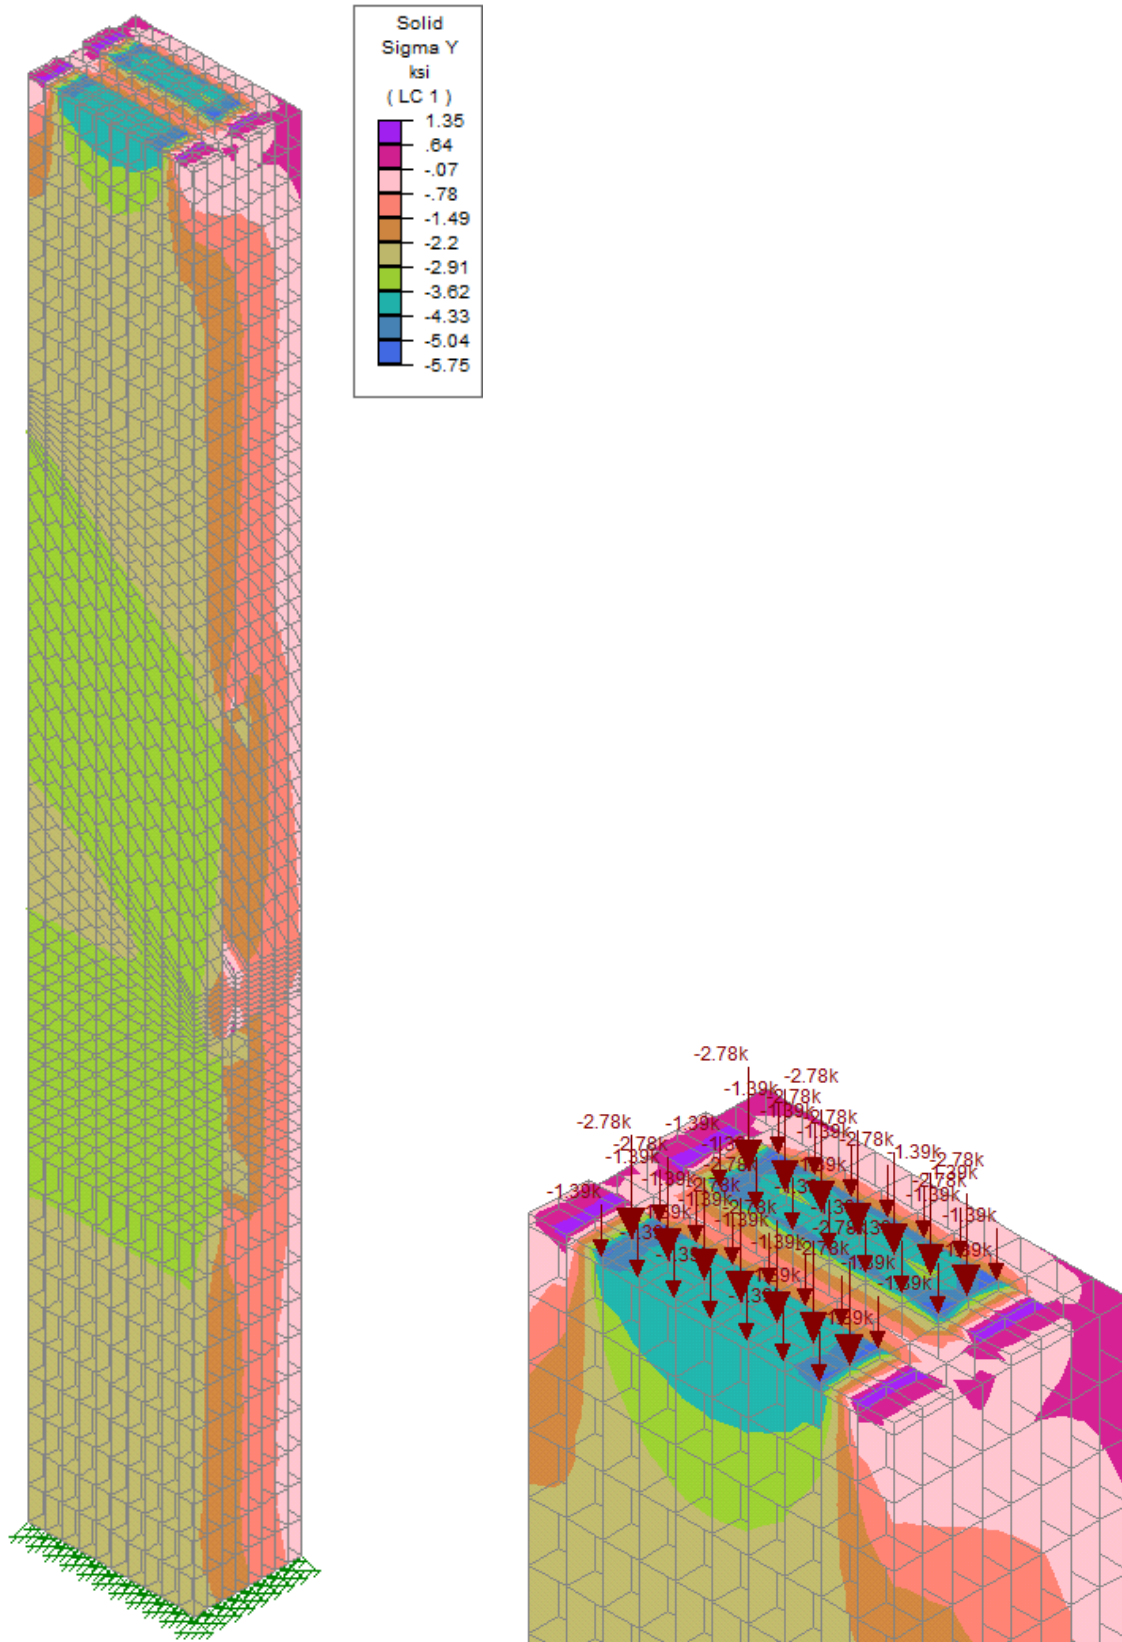
Figure 49: Vertical Stress Analysis – Load applied to two alternate plys
