Muskrat Falls Generation Project
 Unit #2, Pour D2ESB-03, Draft Tube Formwork
 Collapse Investigation Report

Prepared for:
 Nalcor Energy Lower Churchill Project

Project No.160450

Date: April 20, 2017

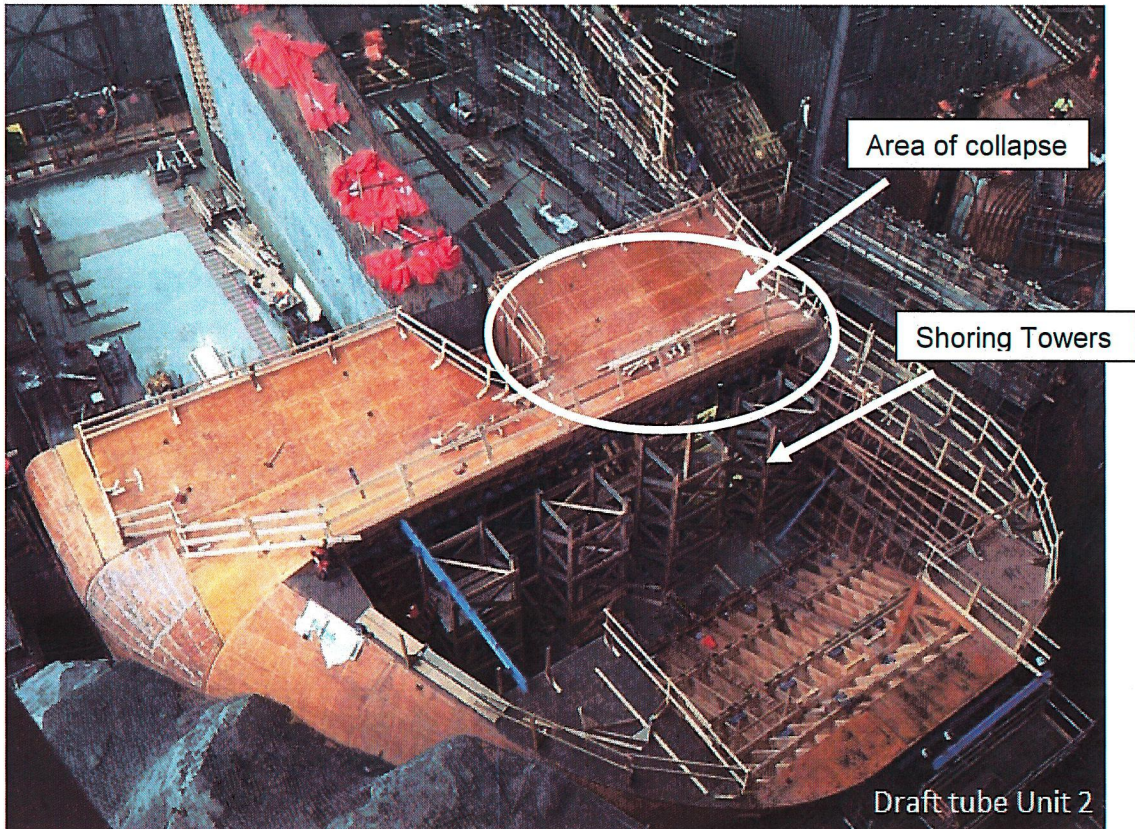
Figure 6: Unit 2 draft tube on October 10, 2015

The catastrophic formwork failure covered a large area. Six shoring towers at Row B and Row C that supported the load of concrete were completely destroyed.

Once the formwork collapsed, the freshly poured concrete flowed downstream into the Unit 2 draft tube southern outlet. As a result, the bottom of the four downstream shoring tower rows that were constructed with DOKA supplied formwork and shoring were severely bent and damaged. Once the concrete settled, it covered the lower portion of nearby shoring tower legs. During the site visit, no evidence of destabilizing sideways movement of the draft tube formwork was found as the failure appeared to be vertical in nature.

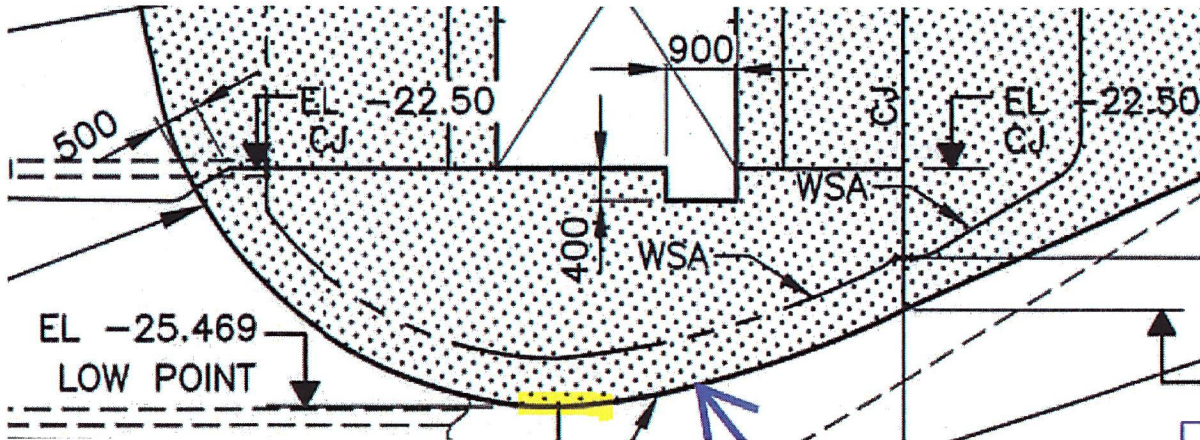
Figure 9: Design concrete pressure based on lift 3 thickness

Structural drawings provided by SNC indicate that lift 3 above the draft tube has the largest concrete thickness at approximately 9.74 ft. The design pressures for this analysis were derived by taking into account the thickness of lift 3. This concrete thickness represents approximately 1,461 psf of concrete. Concrete density is assumed to be 150 lbs/ft³.

The design pressures for the tower leg capacity calculation consists of the combined load of concrete, formwork, and access loads. Access load, per CSA standards, is 40 psf. Formwork load, per CEI drawings for panel weights, is 22 psf. For lift 3, this design pressure is therefore 1,523 psf, which is approximately the maximum permissible applied concrete pressure per CEI's general notes in the erection drawing.

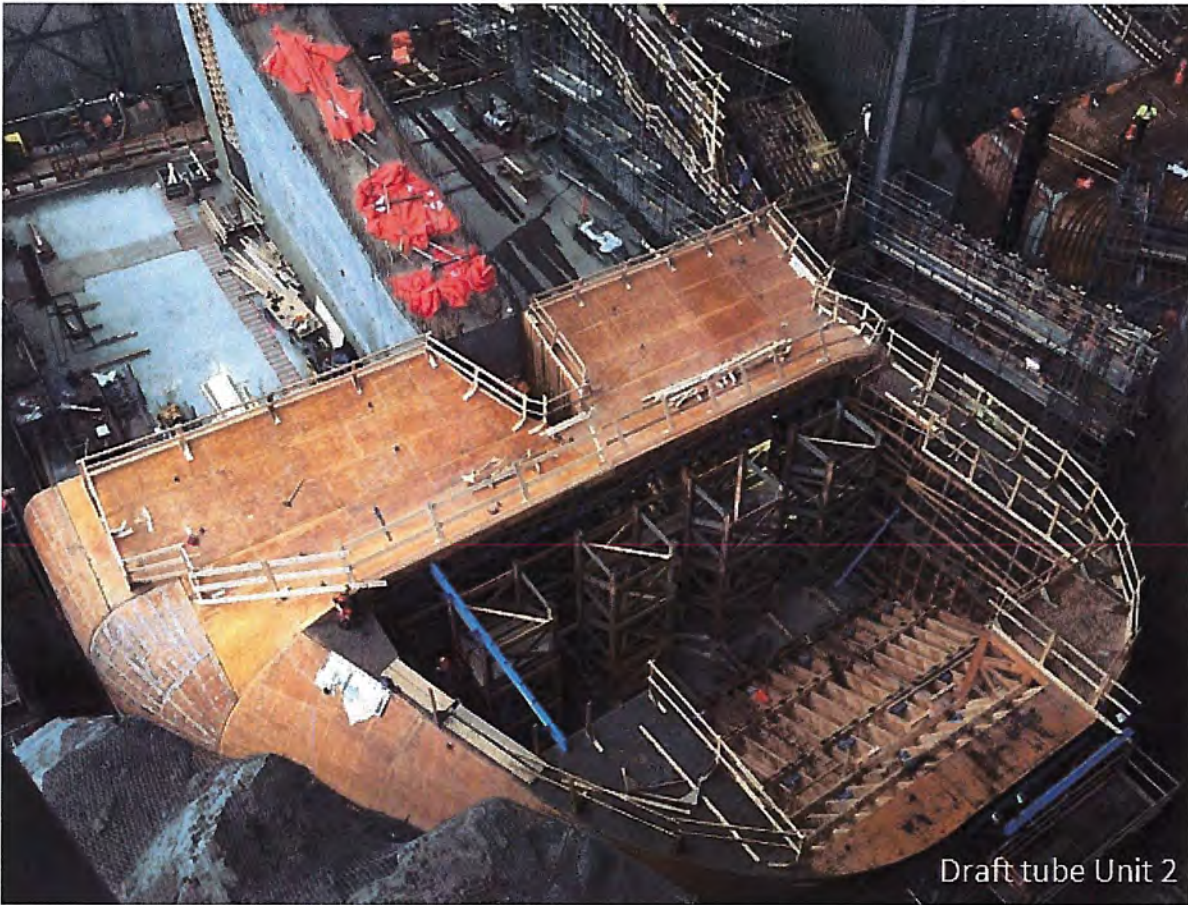
Draft Tube Unit 2
Picture from Nalcor
Taken October 10, 2015

In our opinion, from the time the formwork modules arrived on-site, to the time the formwork modules were installed and concrete was poured around the formwork, the modules were exposed to the elements and were not protected adequately.
