# MEETINGS IN ST. JOHN'S AND VISITS TO LOWER CHURCHILL PROJECT SITES, JULY 11 TO 15, 2016

Prepared for: Natural Resources Canada and Nalcor Energy  
 IE Point of Contact: Nik Argirov  
 Date: November 2, 2016

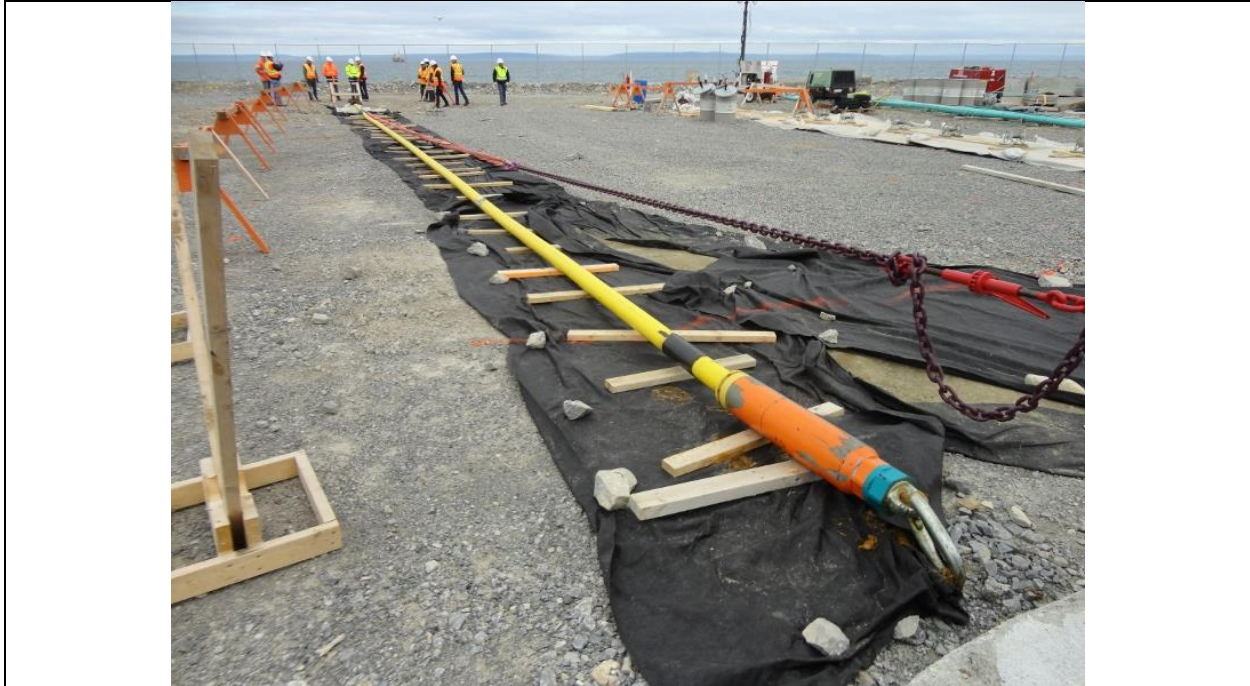
**Photo A.1:** Land end of Cable No. 1 on the Shoal Cove shoreline. (July 12, 2016)

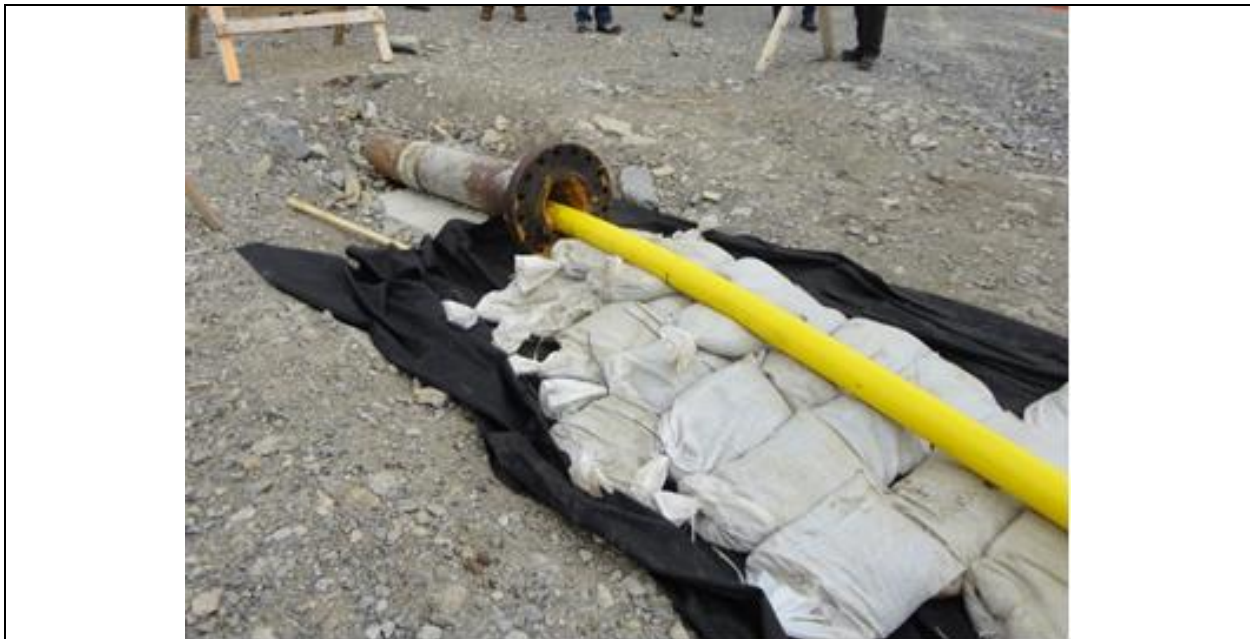
**Photo A.2:** Cable No. 1 at Shoal Cove; exit from the inclined borehole on the Shoal Cove shore. (July 12, 2016)

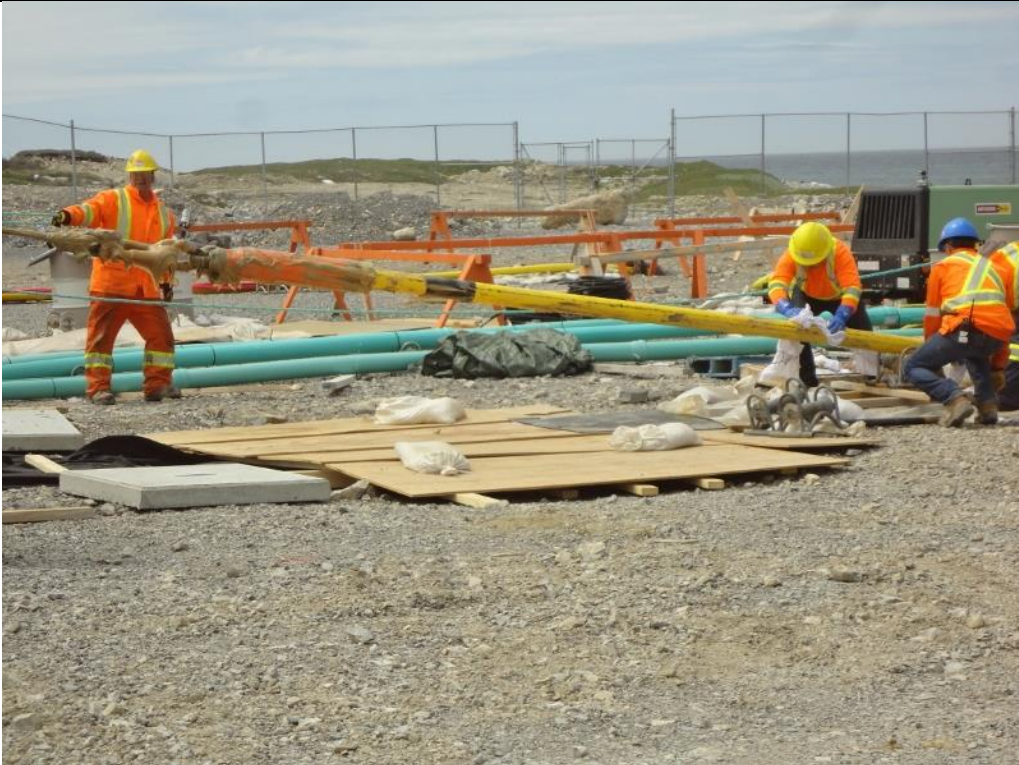
**Photo A.3:** Cable No 2 emerging from the casing of the inclined borehole. Note coating of lubricant grease. (July 12, 2016)

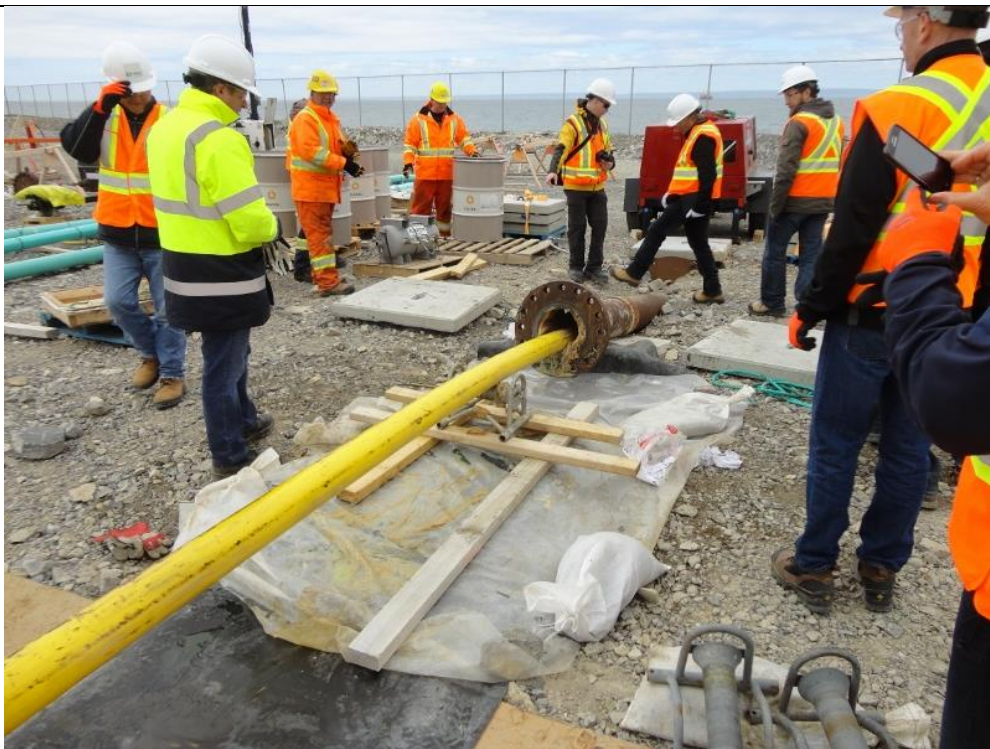
**Photo A.4:** Cable No 2 emerging from the casing of the inclined borehole. (July 12, 2016)

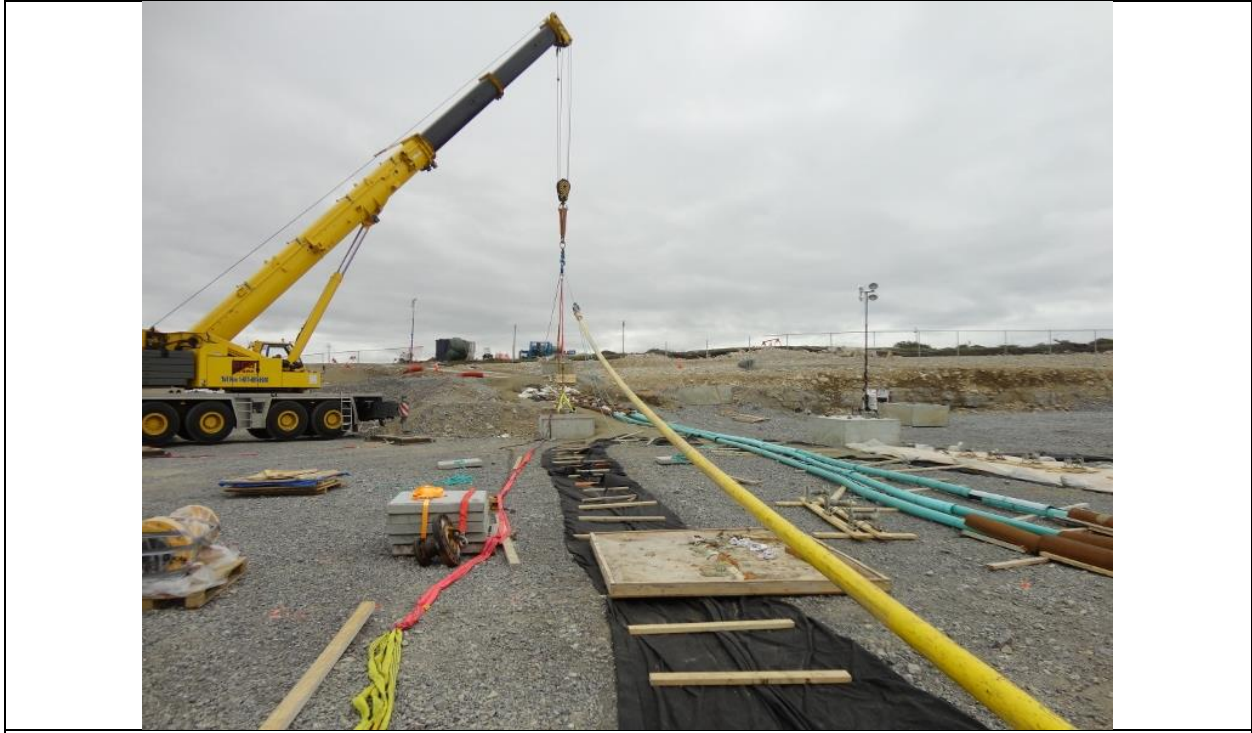
Photo A.5: Cable No.2; final pull work to emplace the cable along the Shoal Cove shoreline work area. (July 12, 2016)

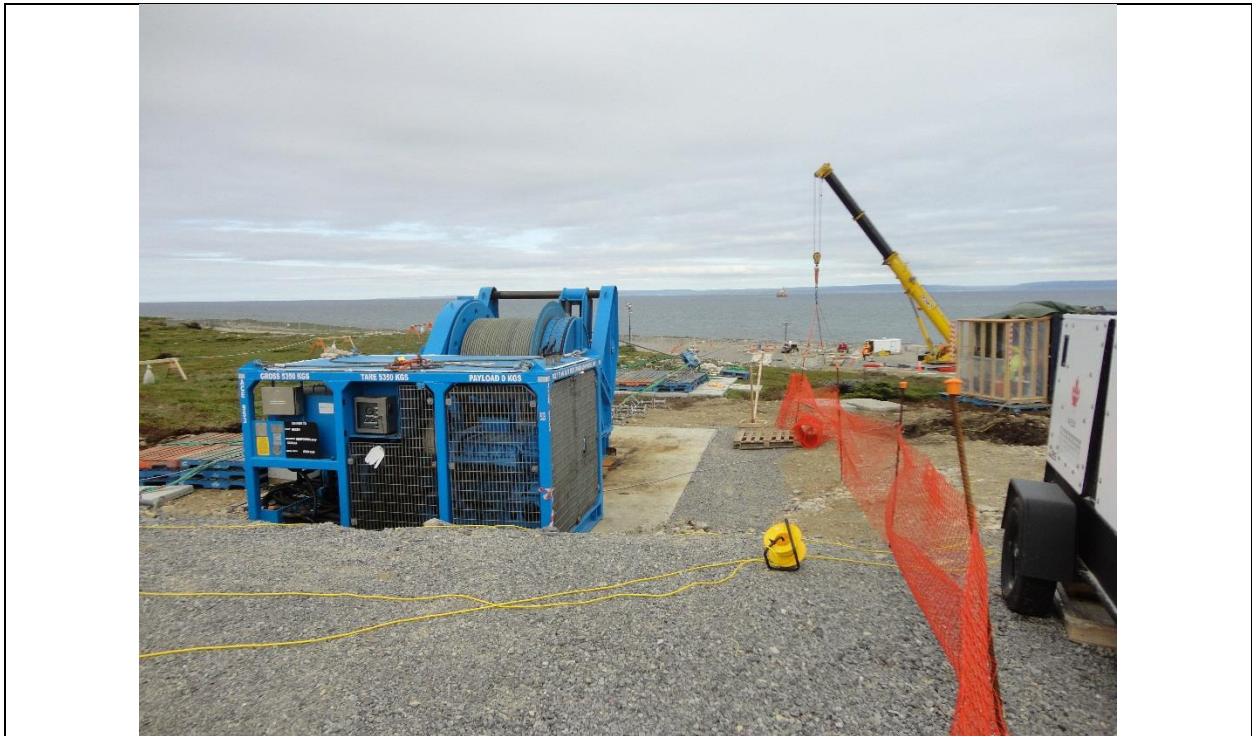
Photo A.6: Winch pulling Cable No 2. (July 12, 2016)

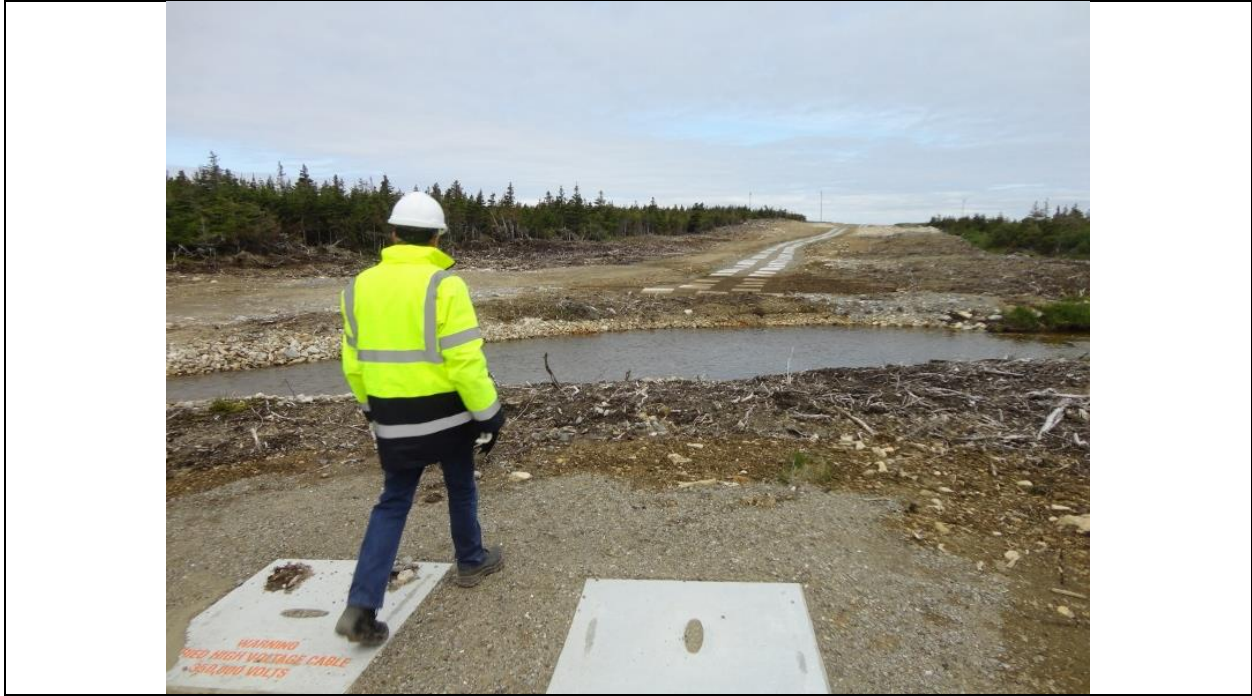
**Photo A.7:** Creek crossing over the buried cables near the midway point. Further erosion control works are planned to protect the buried cables. (July 12, 2016)

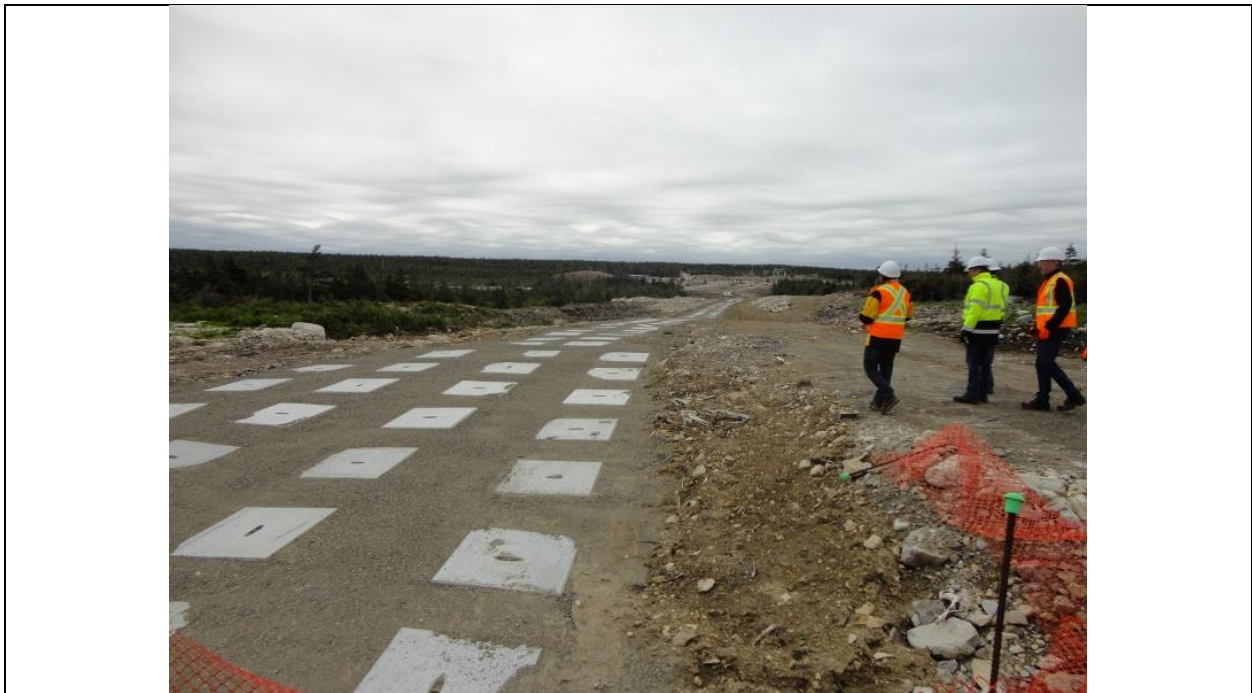
**Photo A.8:** View looking eastwards along the buried cables line. (July 12, 2016)

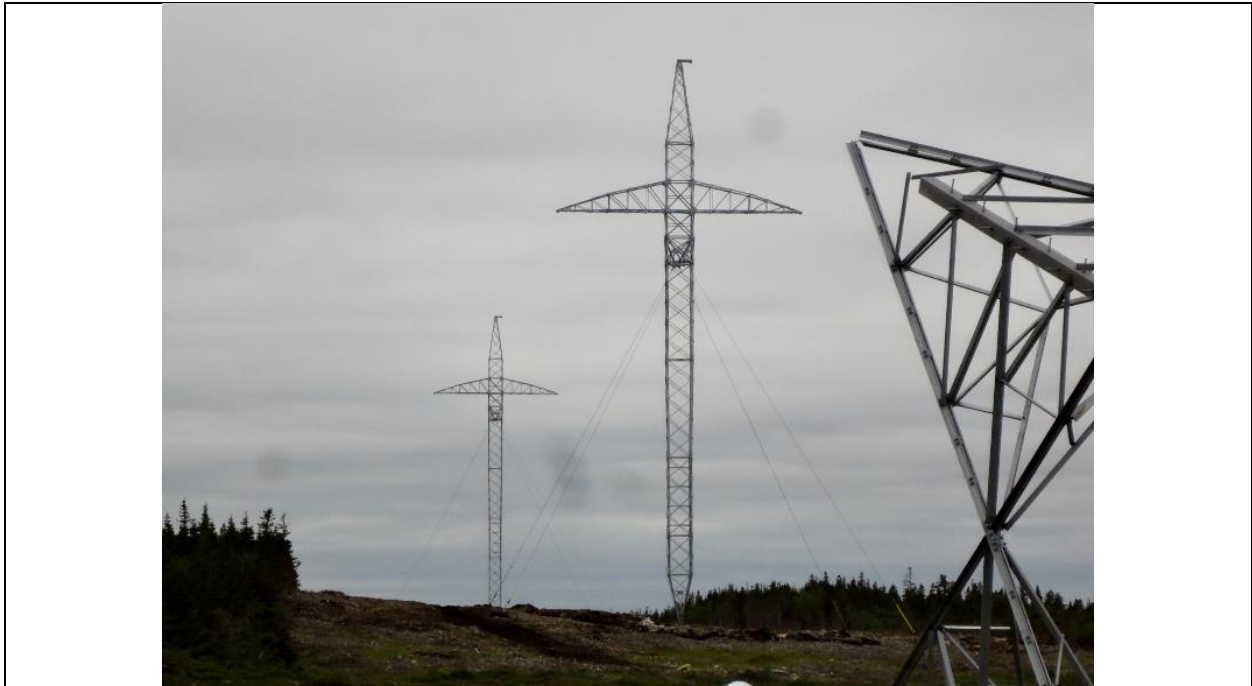
Photo A.9: DC transmission towers immediately east of the Shoal Cove facilities. (July 12, 2016)

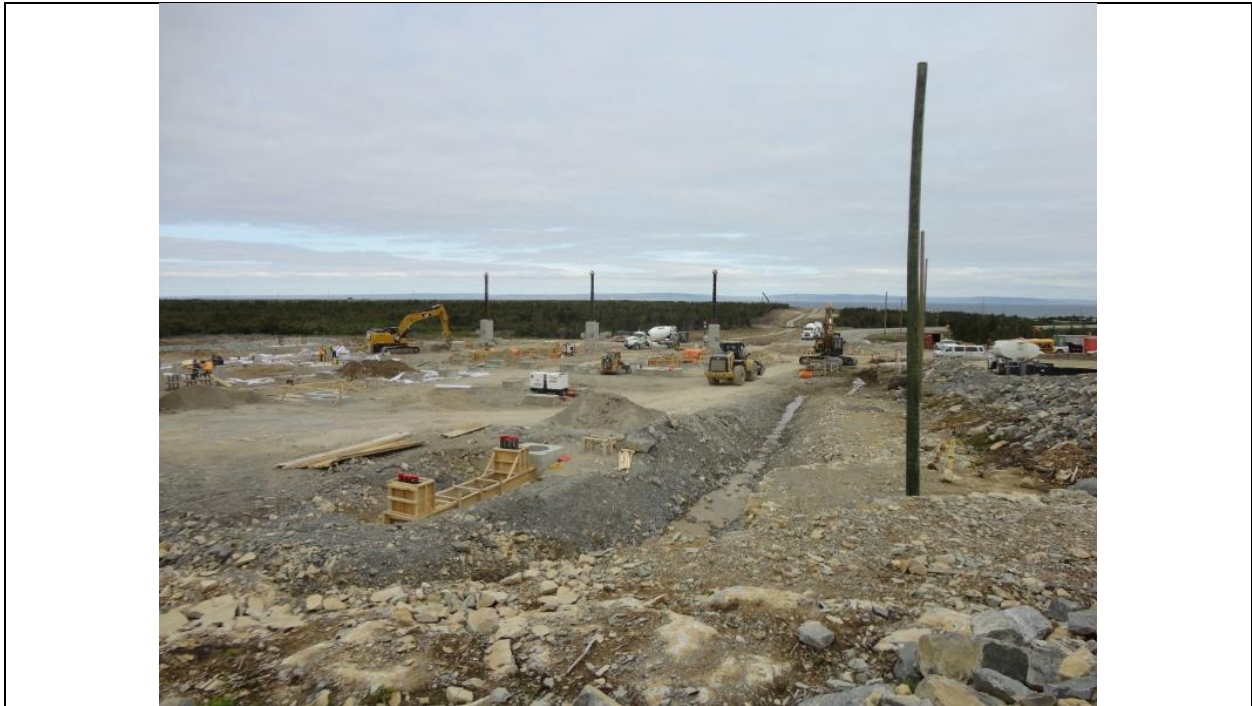
Photo A.10: Shoal Cove Transition compound preparatory works. (July 12, 2016)

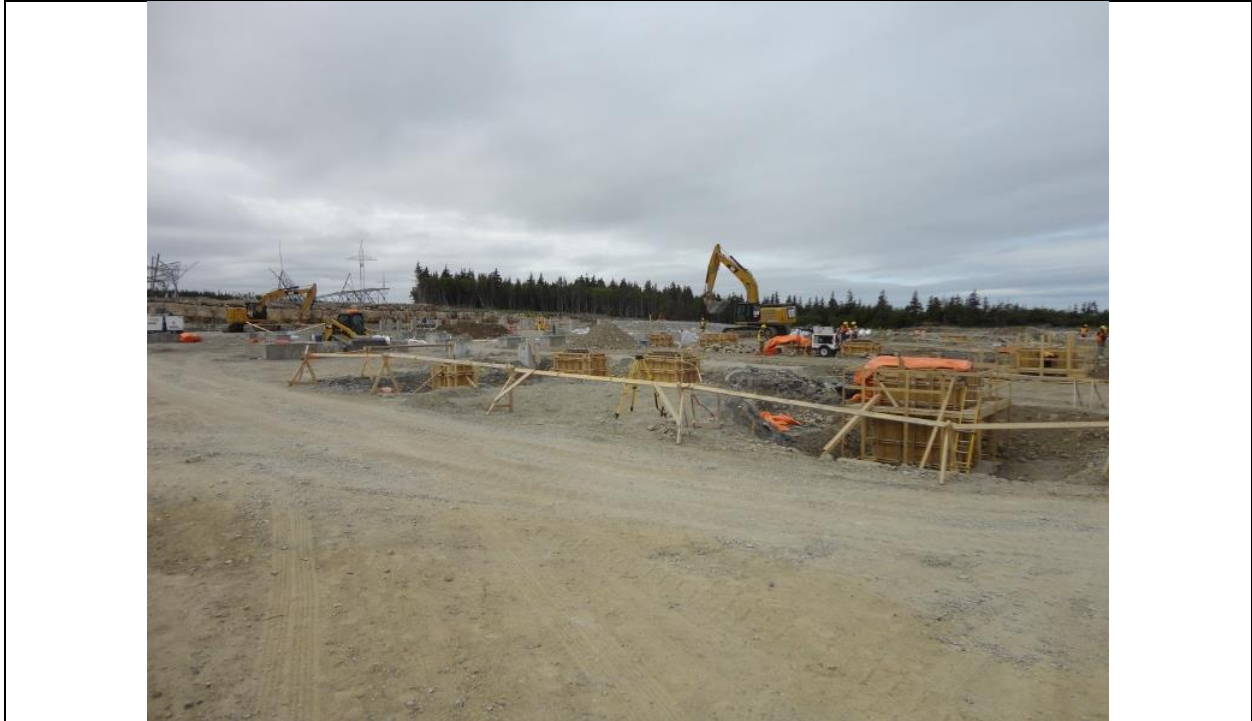
**Photo A.11:** Shoal Cove Transition compound preparatory works. (July 12, 2016)

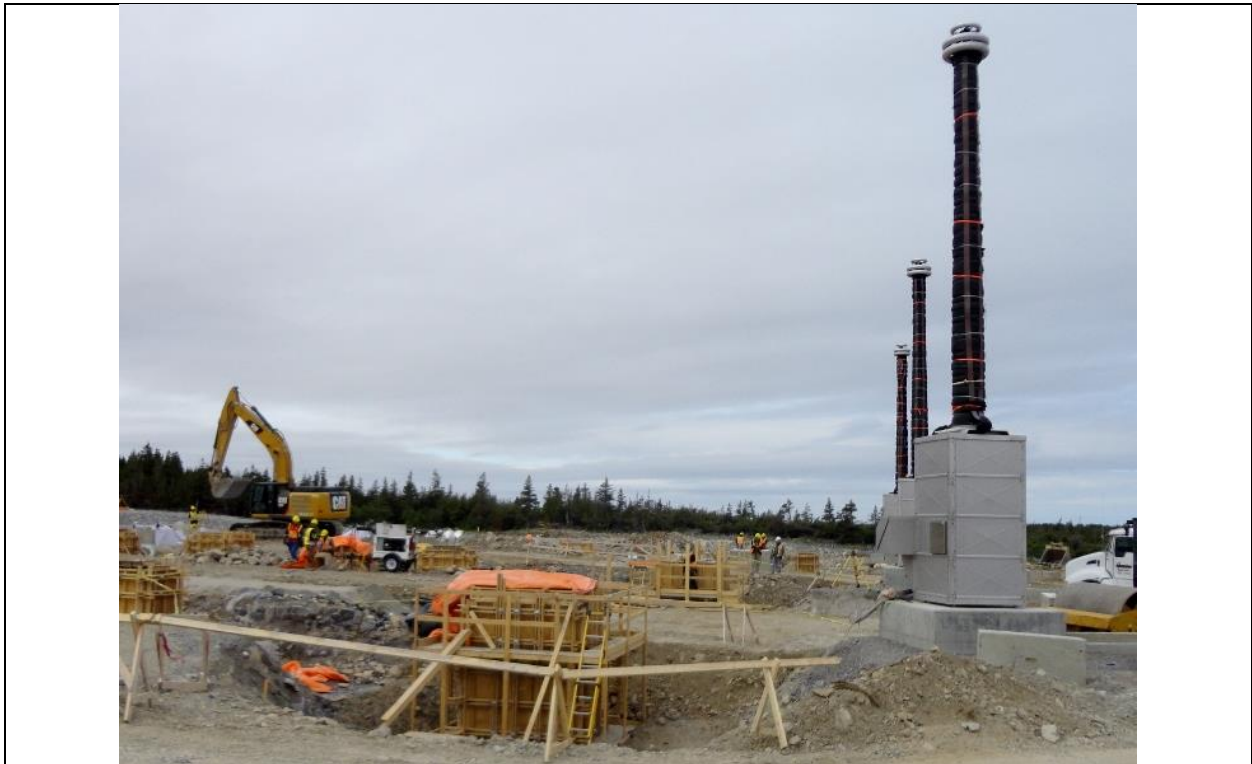
**Photo A.12:** Shoal Cove Transition compound – buried land cables termination points. (July 12, 2016)

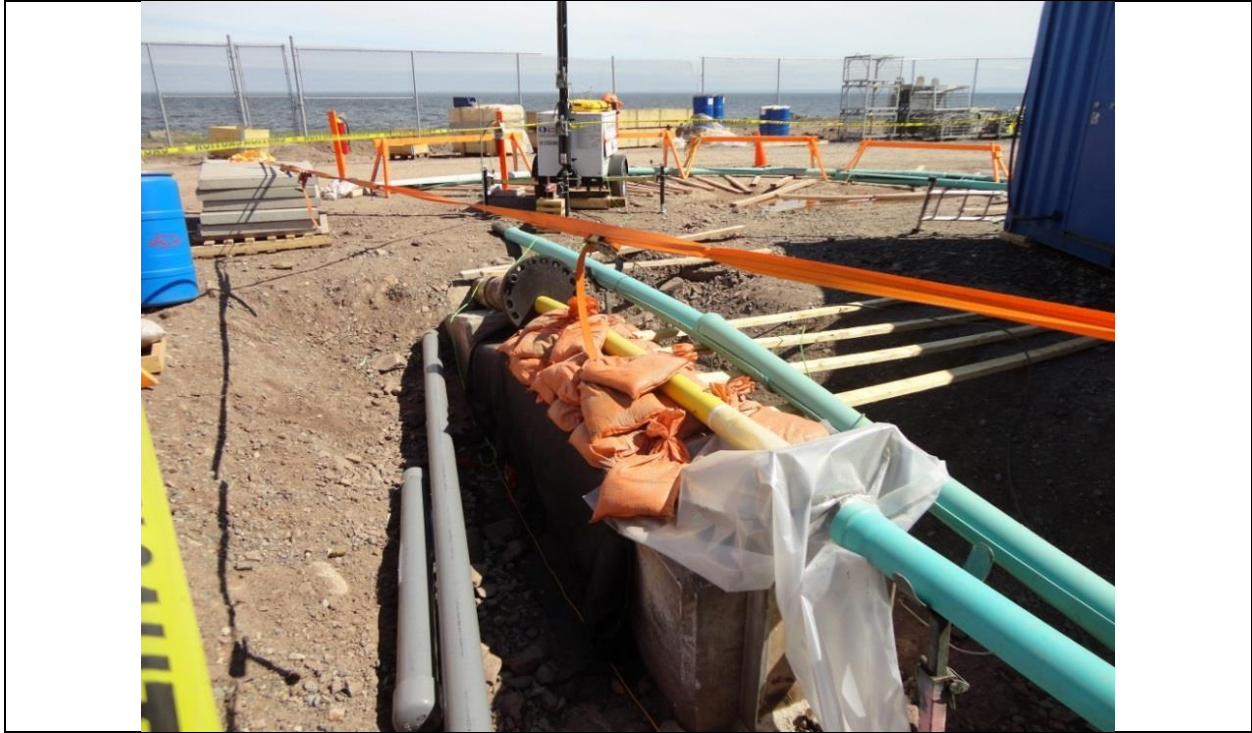
Photo B.1: Cable #1 (yellow cable) at the inclined borehole and anchor point. (July 12, 2016)

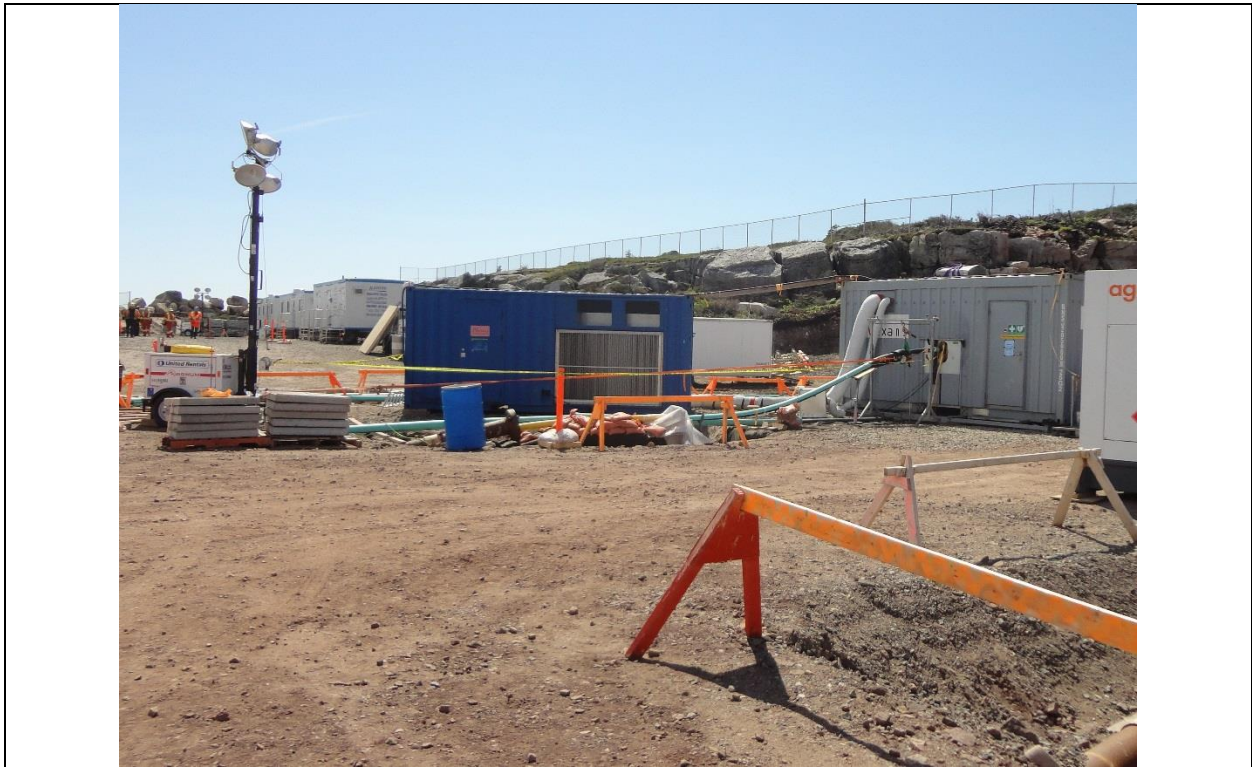
Photo B.2: Cable #1 at the cable jointing facility. (July 12, 2016)

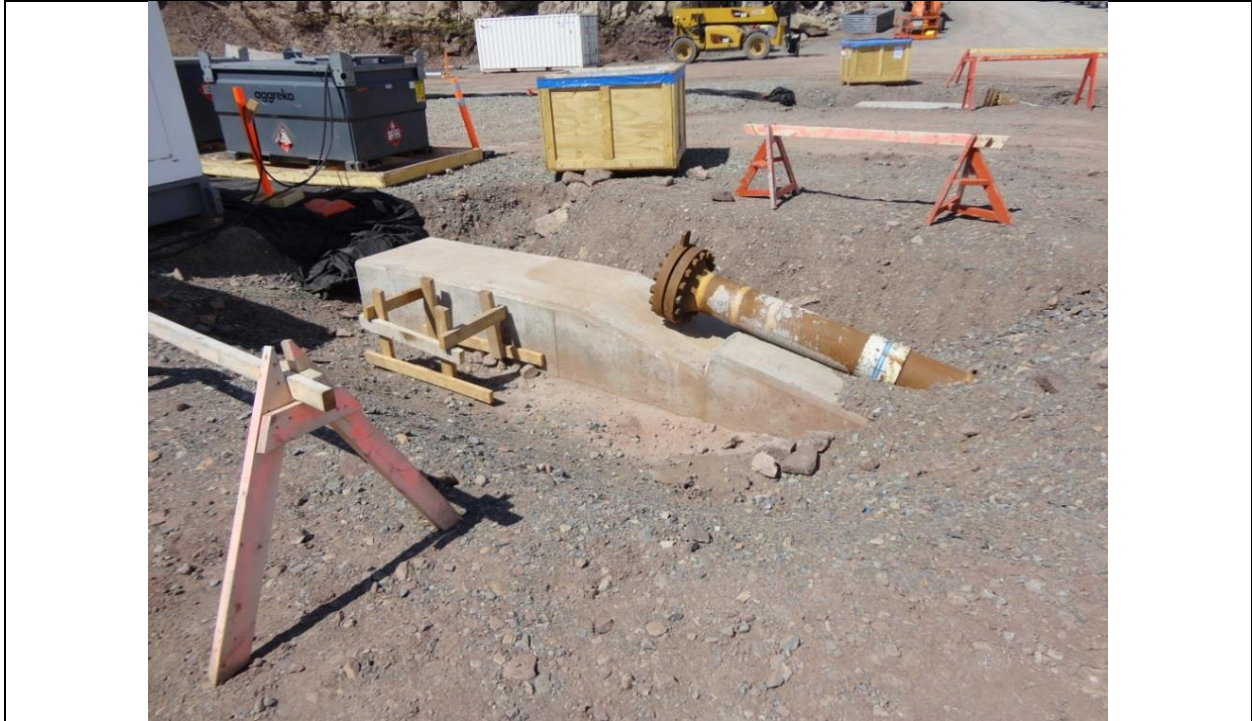
**Photo B.3:** Anchor point for Cable #2. (July 12, 2016)

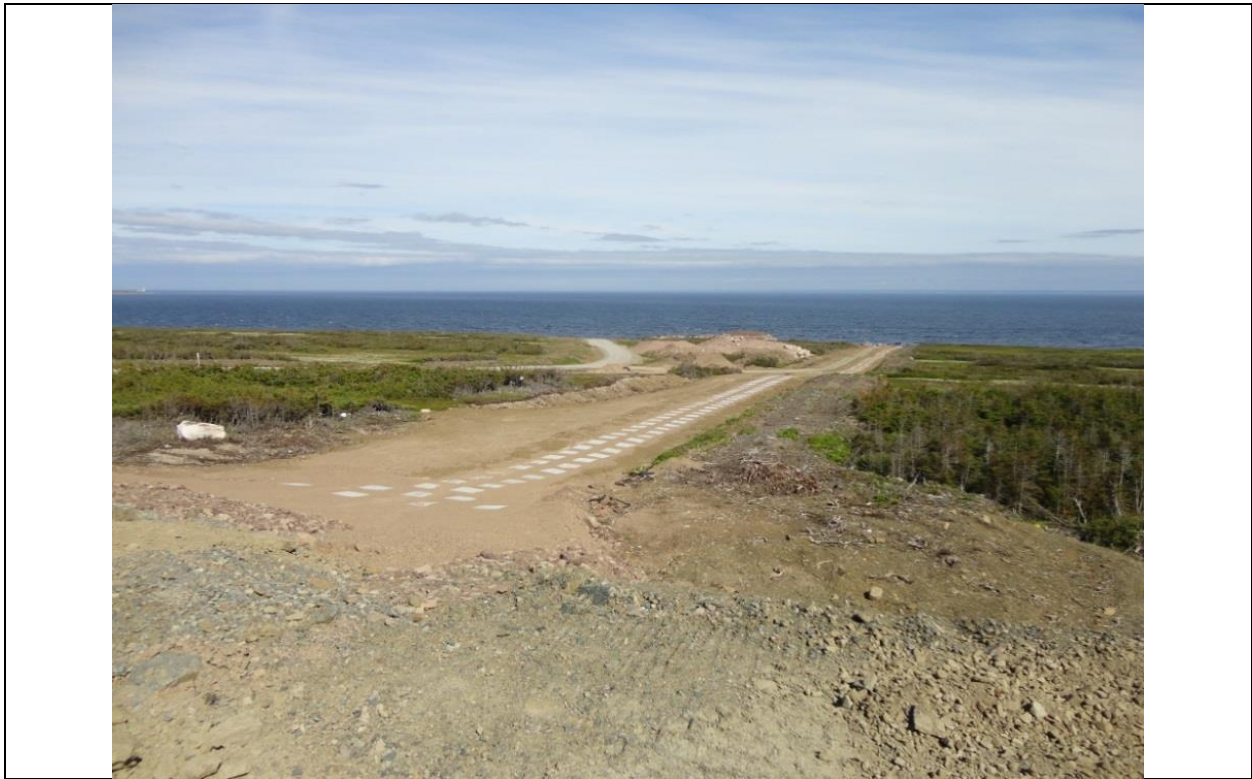
**Photo B.4:** View looking eastwards along the buried land cables line. (July 12, 2016)

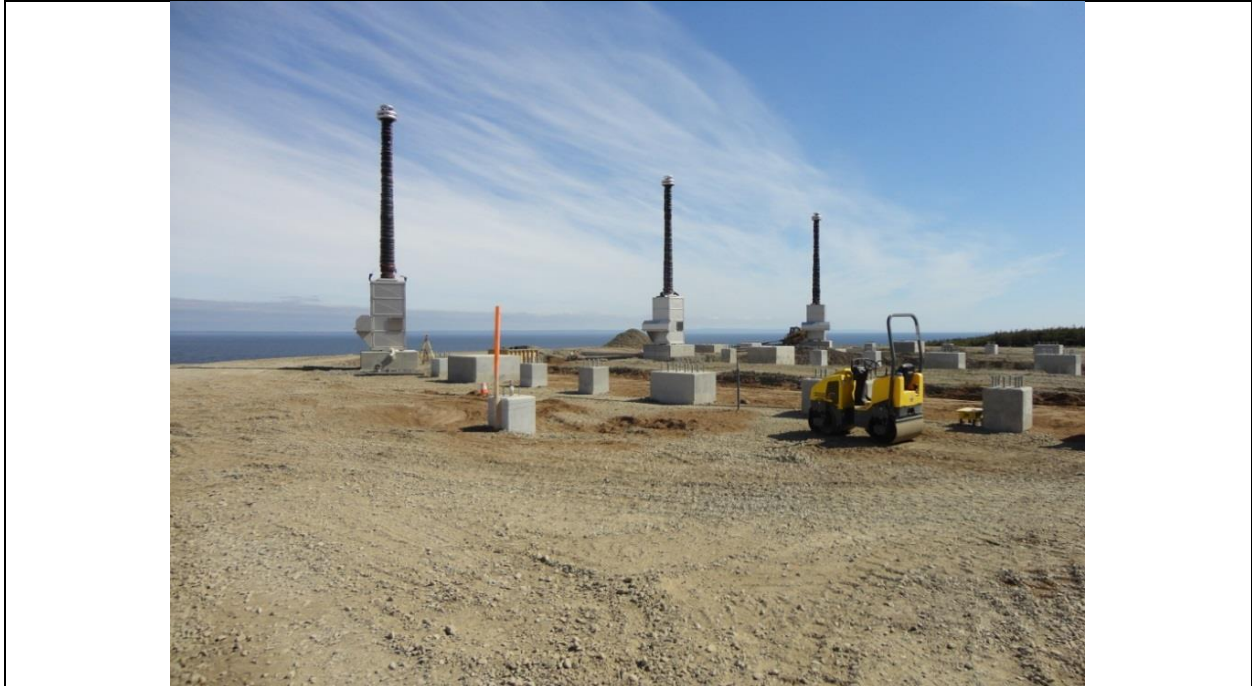
**Photo B.5:** Transition compound - buried land cables termination points. (July 12, 2016)

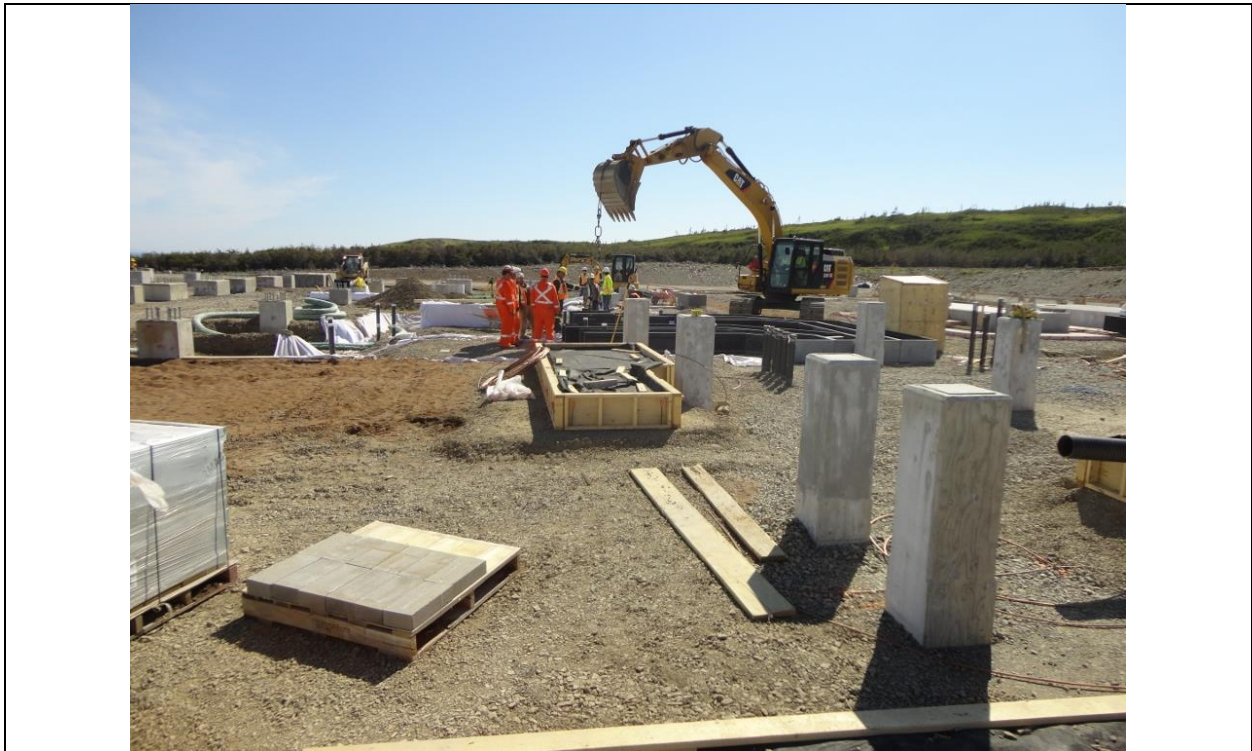
**Photo B.6:** Transition compound – ongoing work on concrete foundations for gantries and equipment. (July 12, 2016)

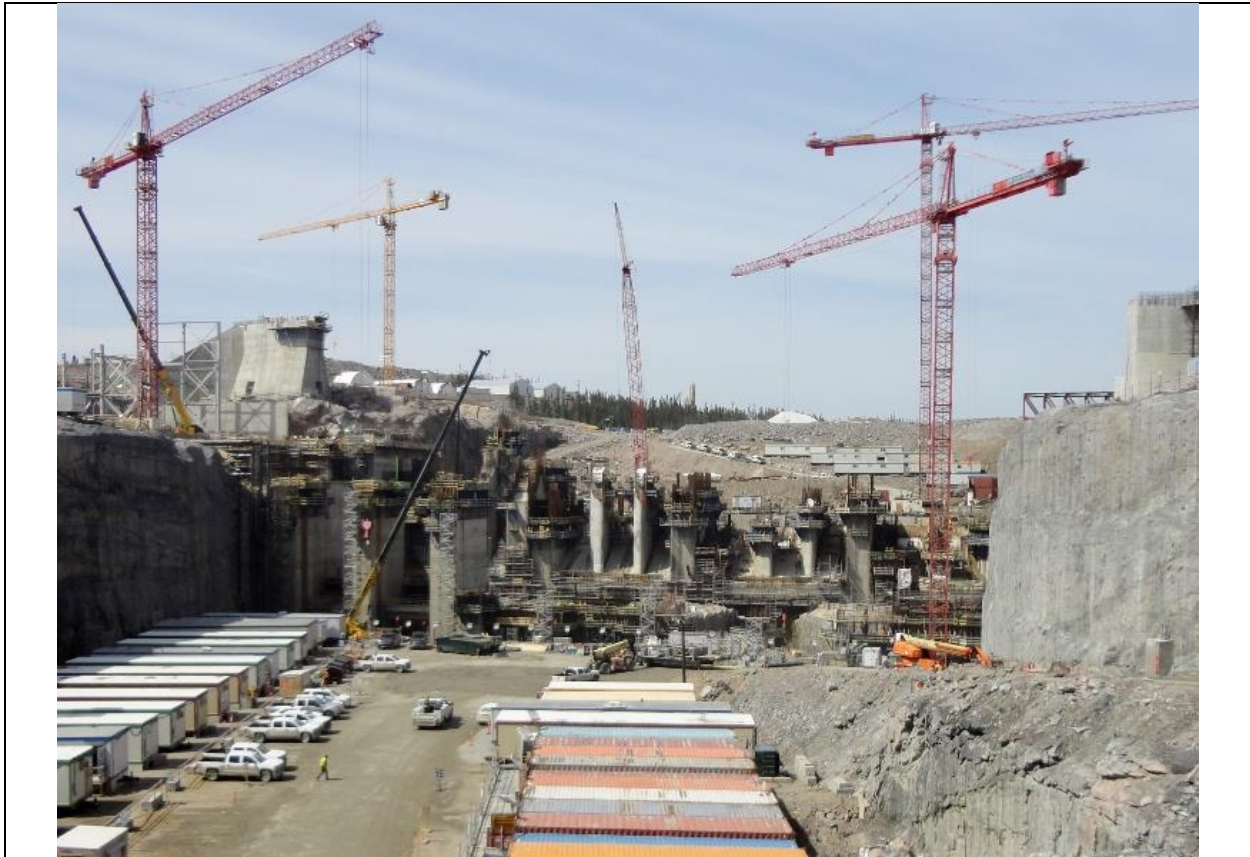
Photo C.1: Downstream face of the powerhouse. (July 13, 2016)

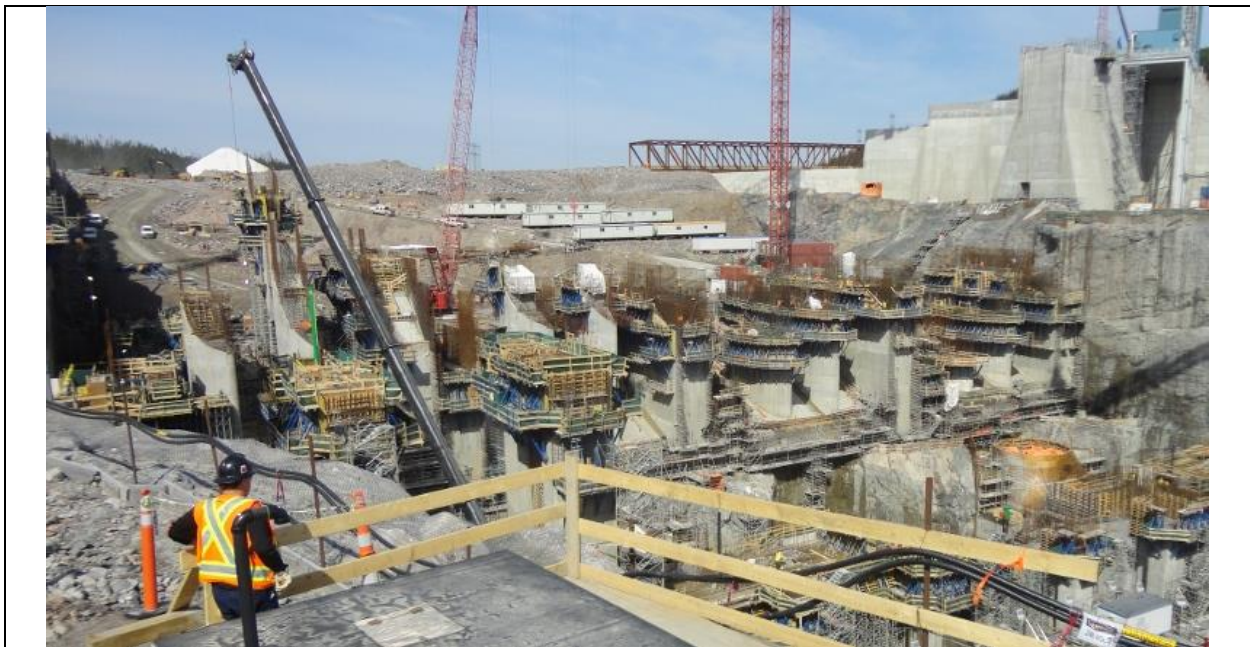
Photo C.2: View of powerhouse looking northwest. (July 13, 2016)

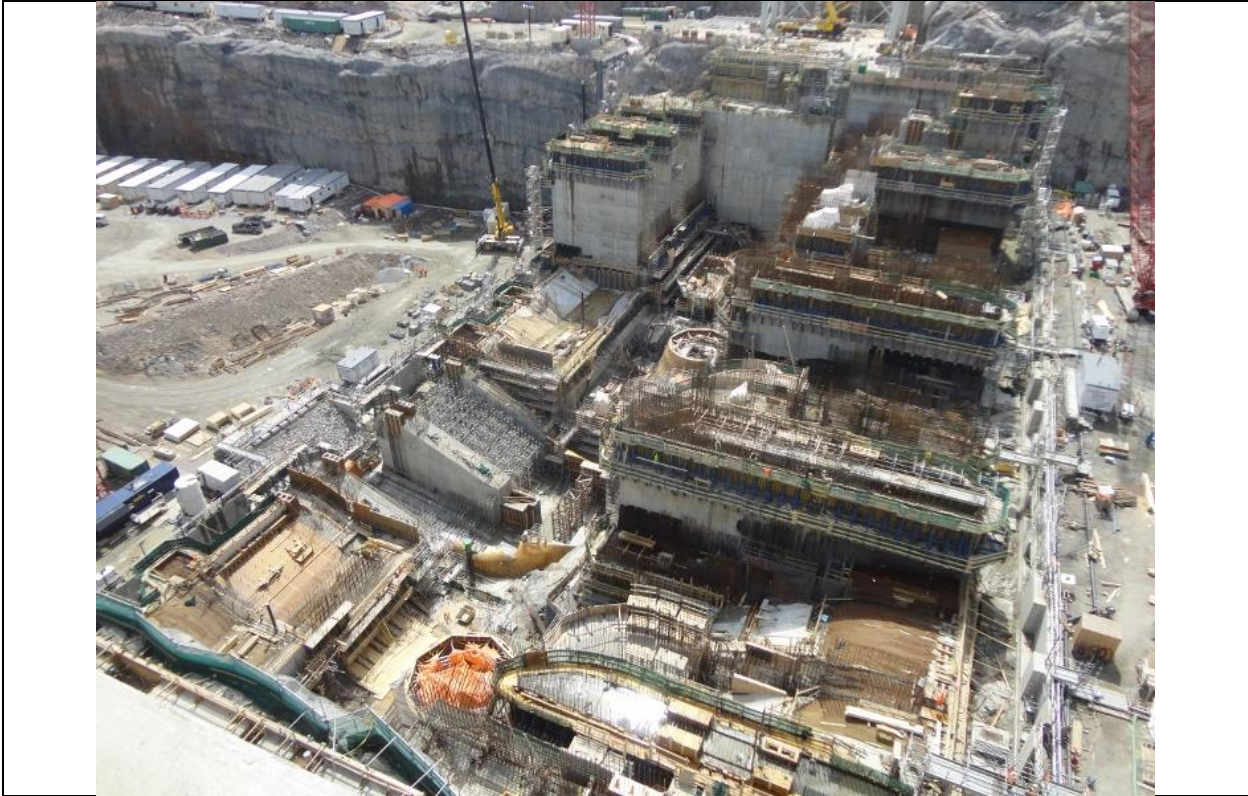
Photo C.3: View of powerhouse from spillway area looking south. (July 13, 2016)

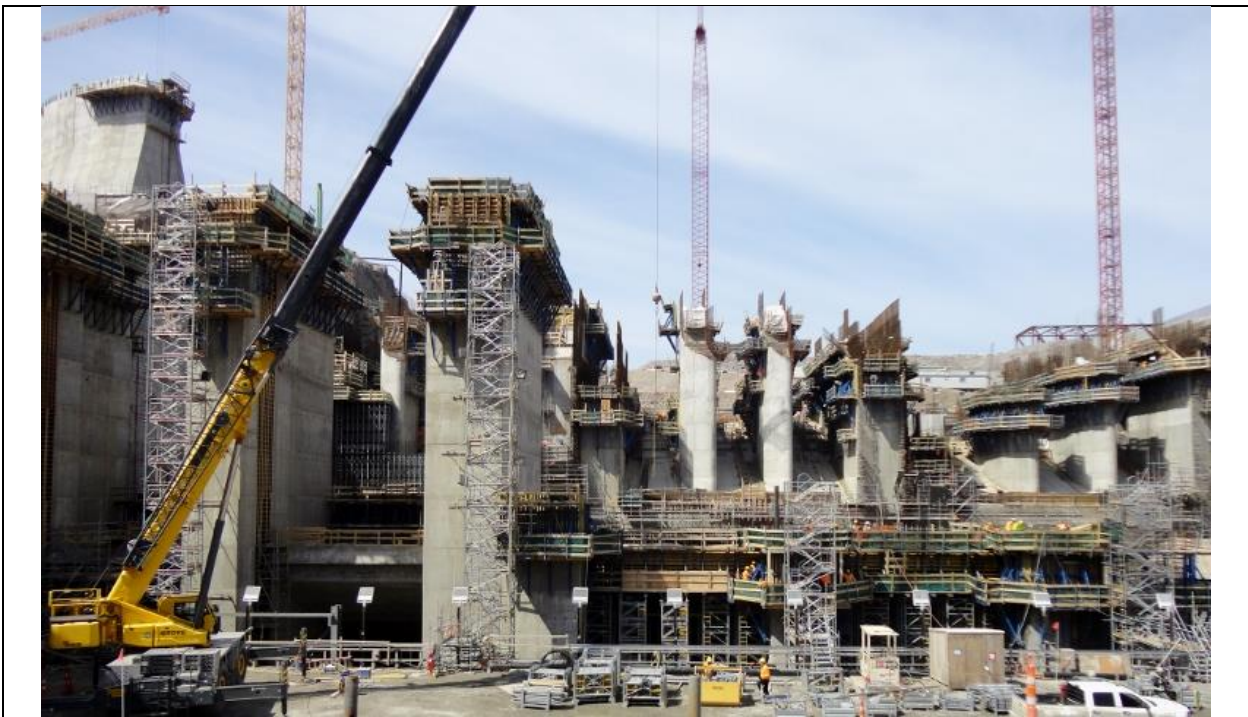
Photo C.4: Units 1, 2 and 3, view looking upstream. (July 13, 2016)

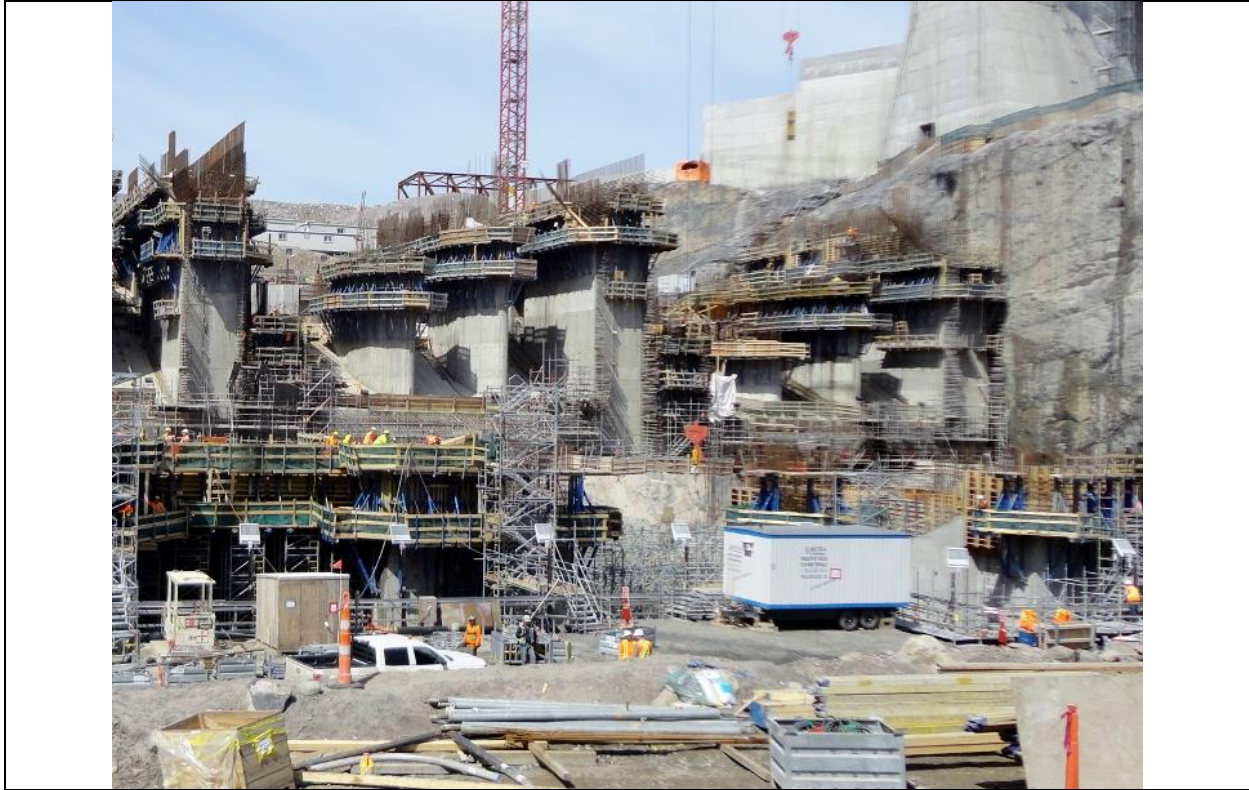
Photo C.5: Units 3 and 4, view looking upstream. (July 13, 2016)

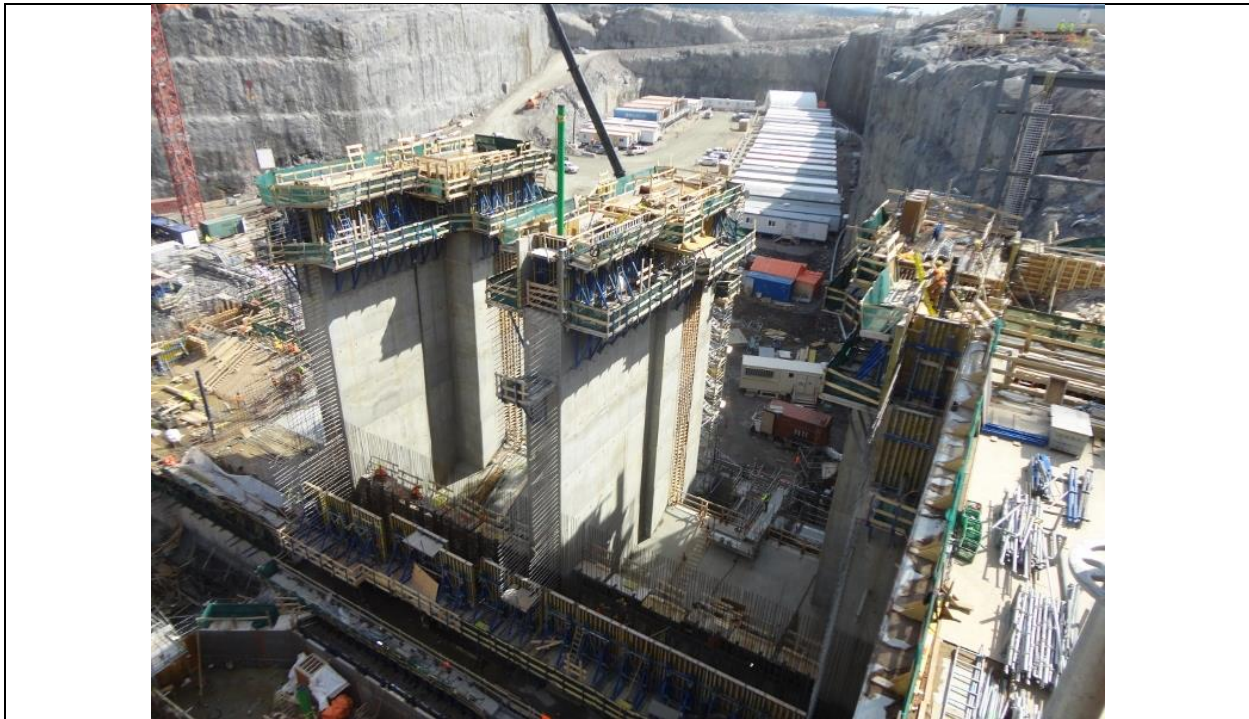
Photo C.6: Concrete walls at intake of Unit 1, view looking downstream. (July 13, 2016)

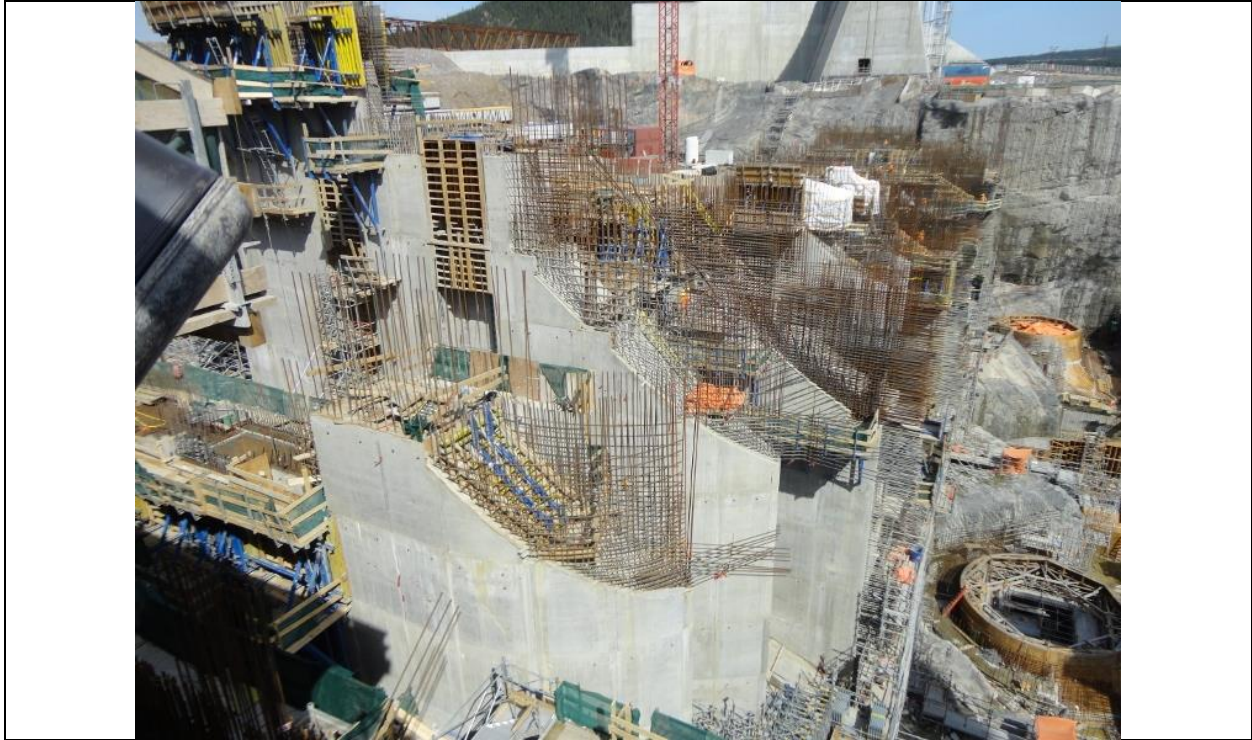
Photo C7: Downstream end of intake piers of Units 1 and 2, view looking north. (July 13, 2016)
