# MEETINGS IN ST. JOHN'S AND VISITS TO LOWER CHURCHILL PROJECT SITES, JULY 11 TO 15, 2016

Prepared for: Natural Resources Canada and Nalcor Energy  
 IE Point of Contact: Nik Argirov  
 Date: November 2, 2016

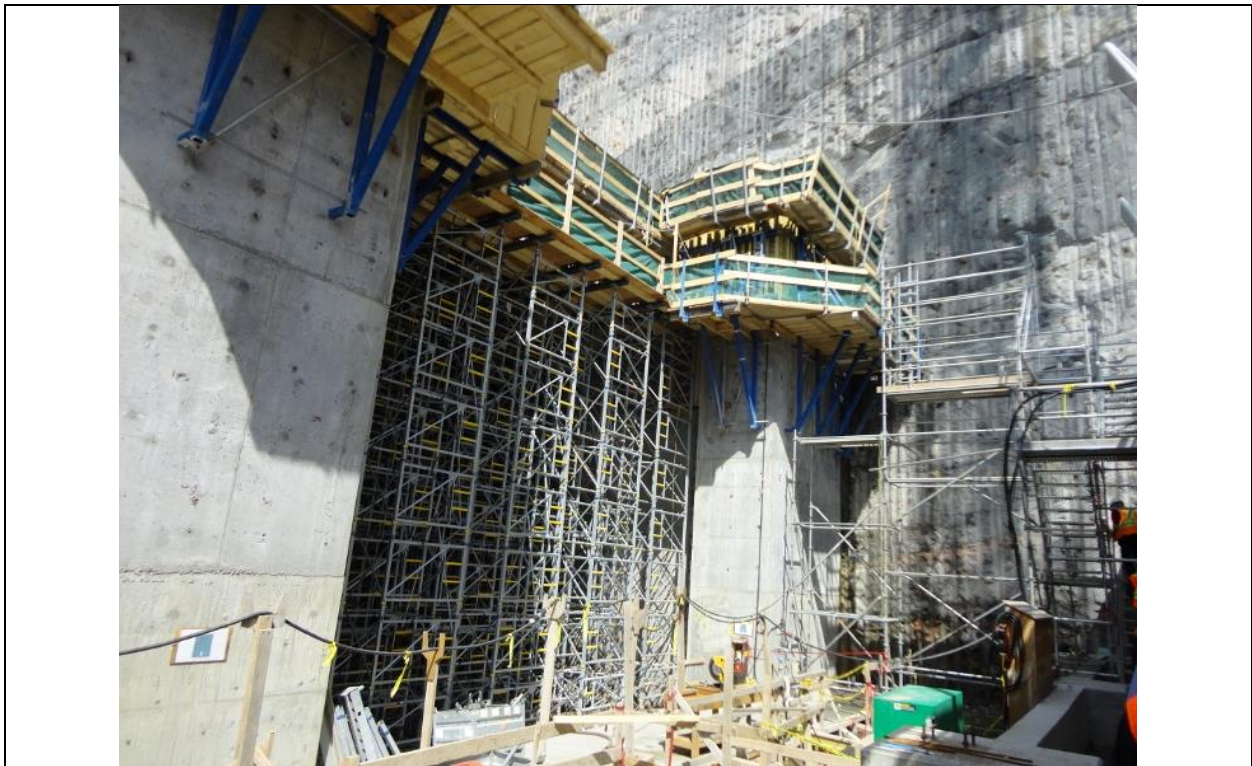
Photo C.8: Intake face for Unit 1. (July 13, 2016)

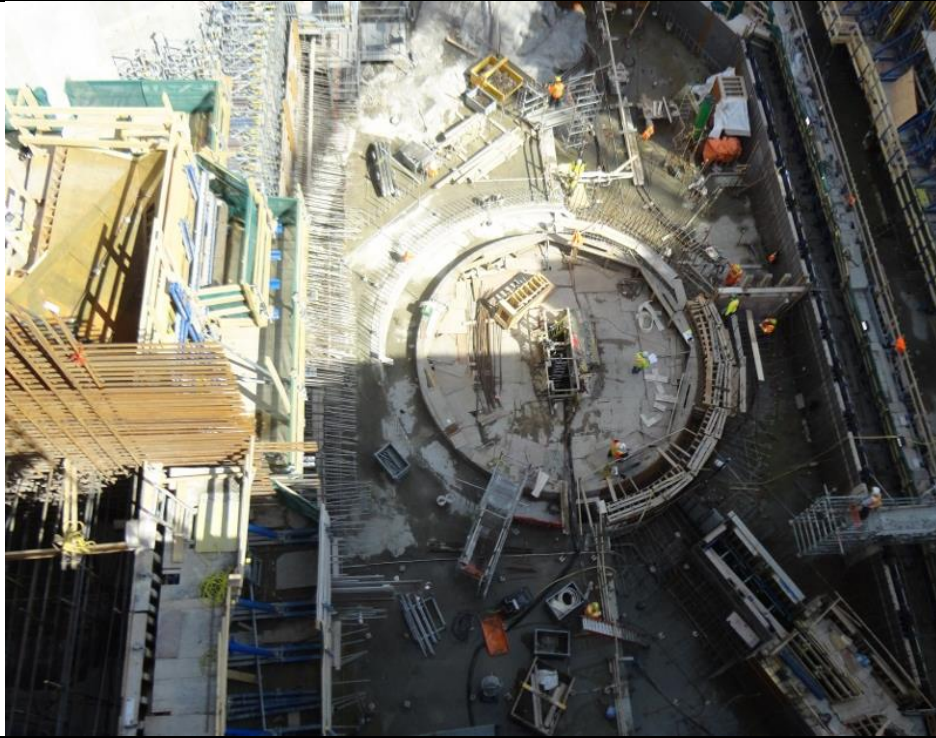
Photo C.9: Unit 1, Draft tube formwork. (July 13, 2016)

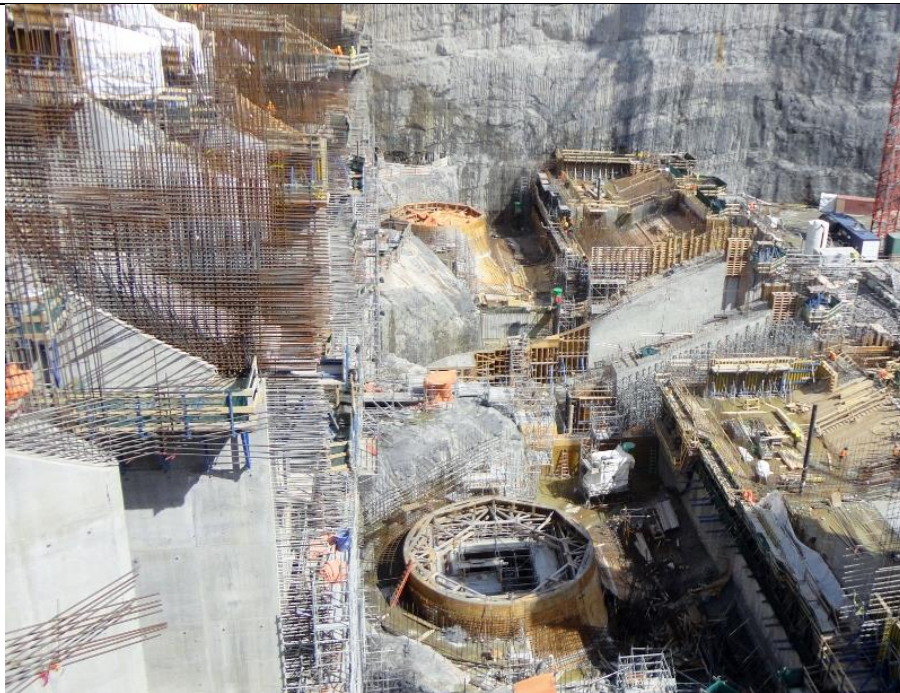
Photo C.10: Units 2, 3 and 4. (July 13, 2016)

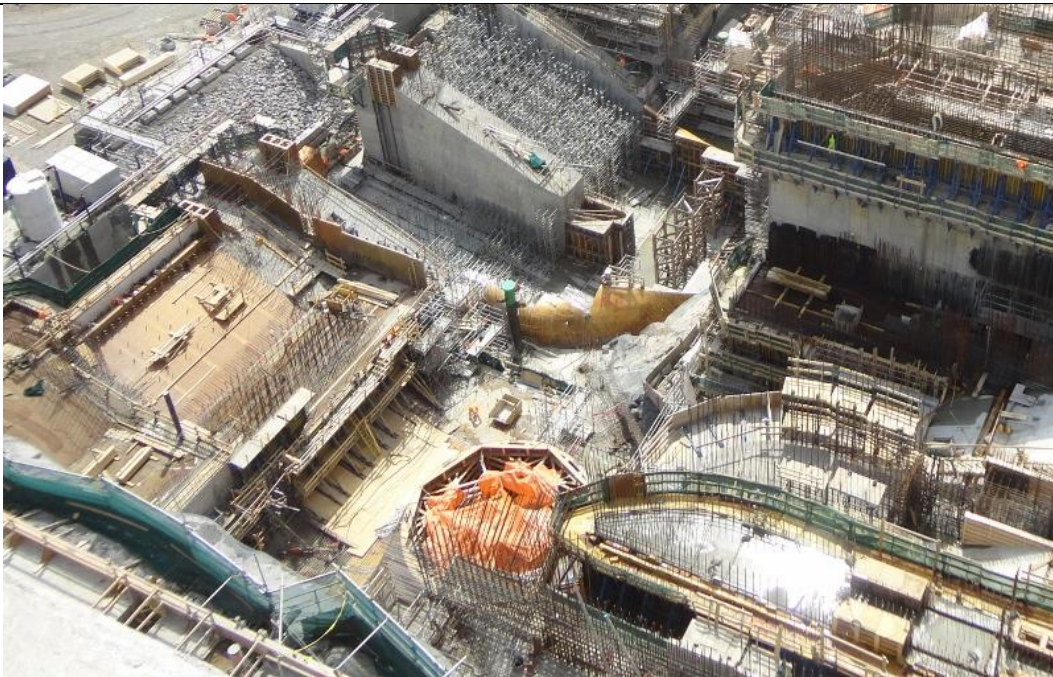
**Photo C.13:** Units 4 and 3, view looking east; Unit 4 is nearest the camera. (July 13, 2016)

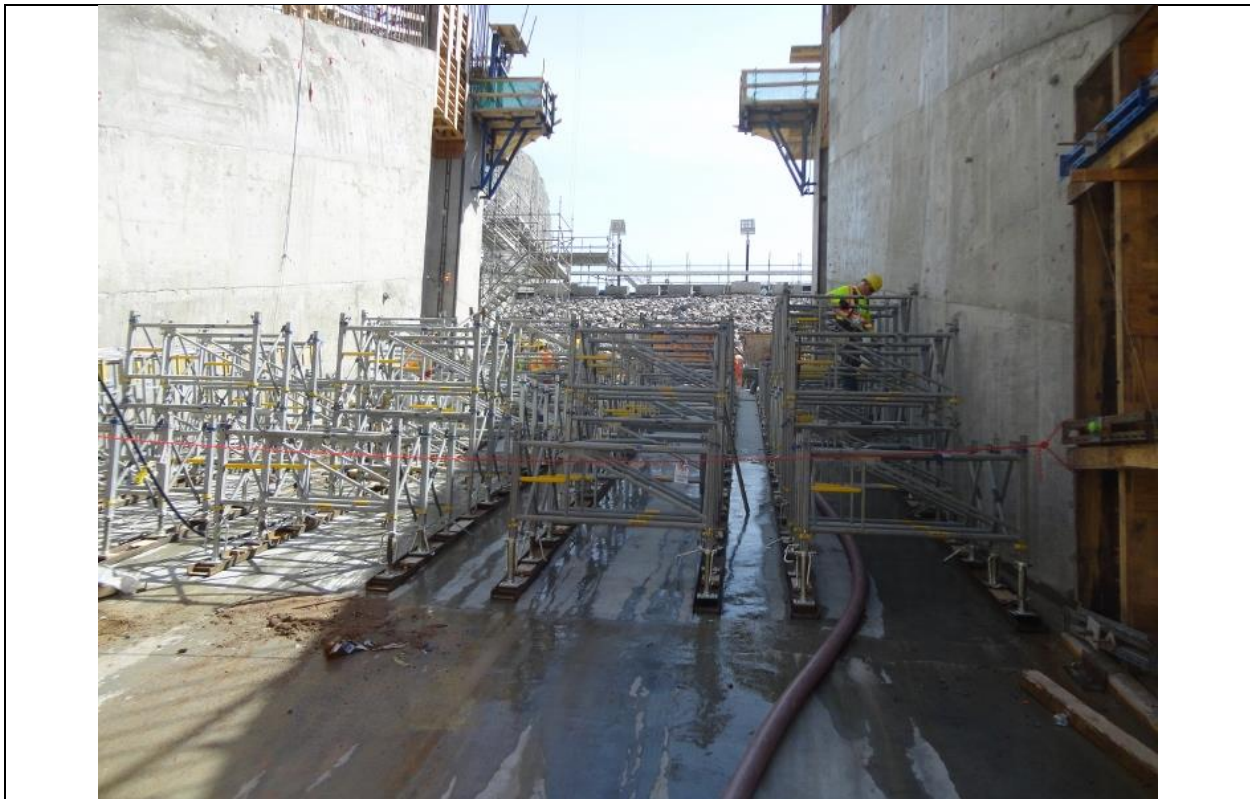
Photo C.15: Unit 3 intake chute, view looking upstream. (July 13, 2016)

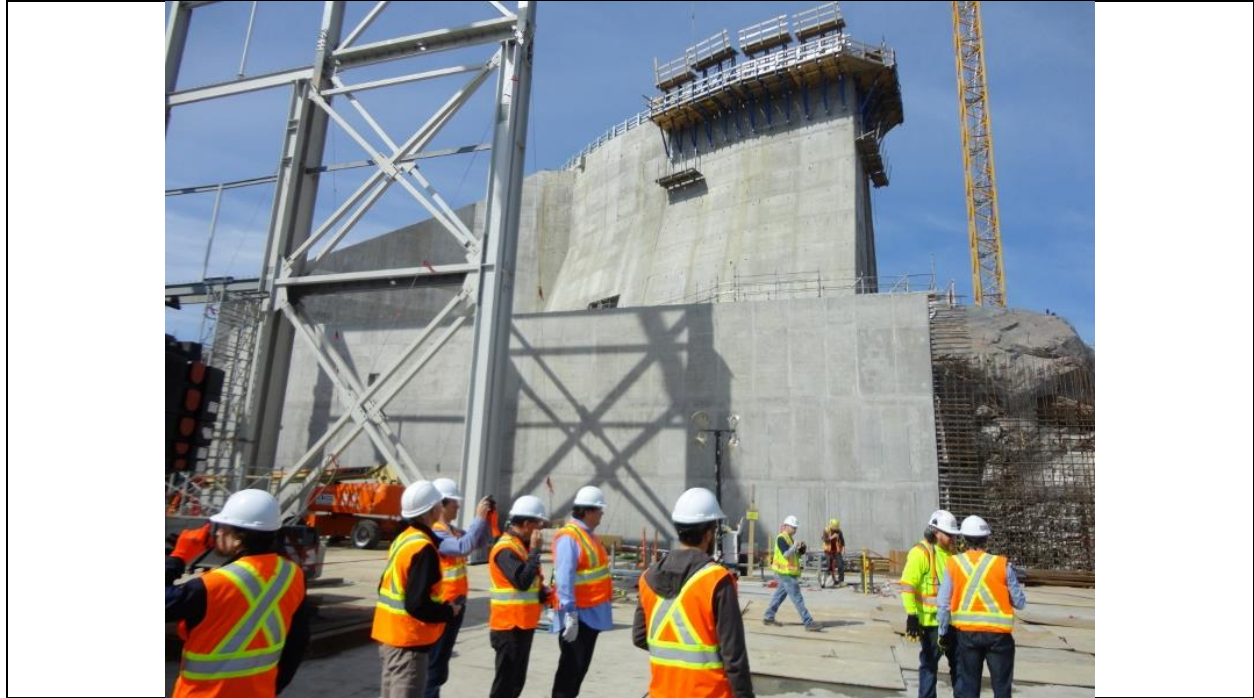
Photo C.16: Powerhouse south service bay with a view towards Central Transition Dam. (July 13, 2016)

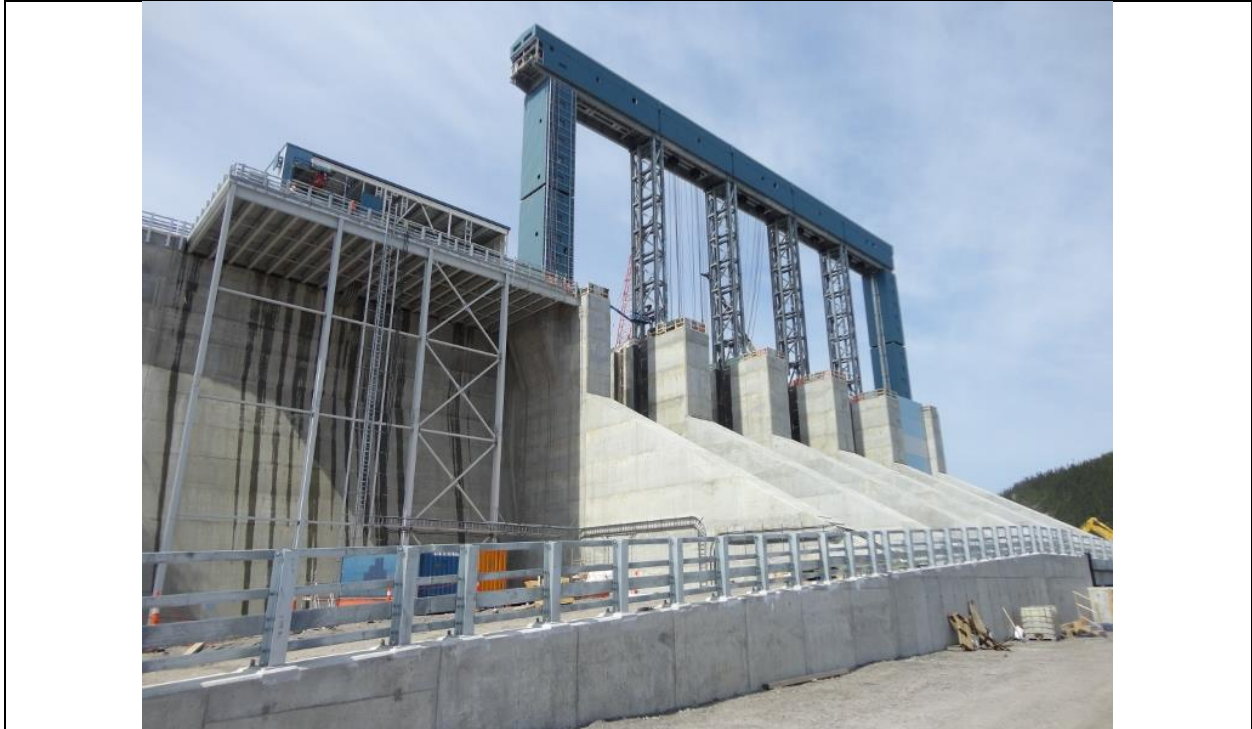
Photo D.1: Downstream view of the spillway gate structure. (July 13, 2016)

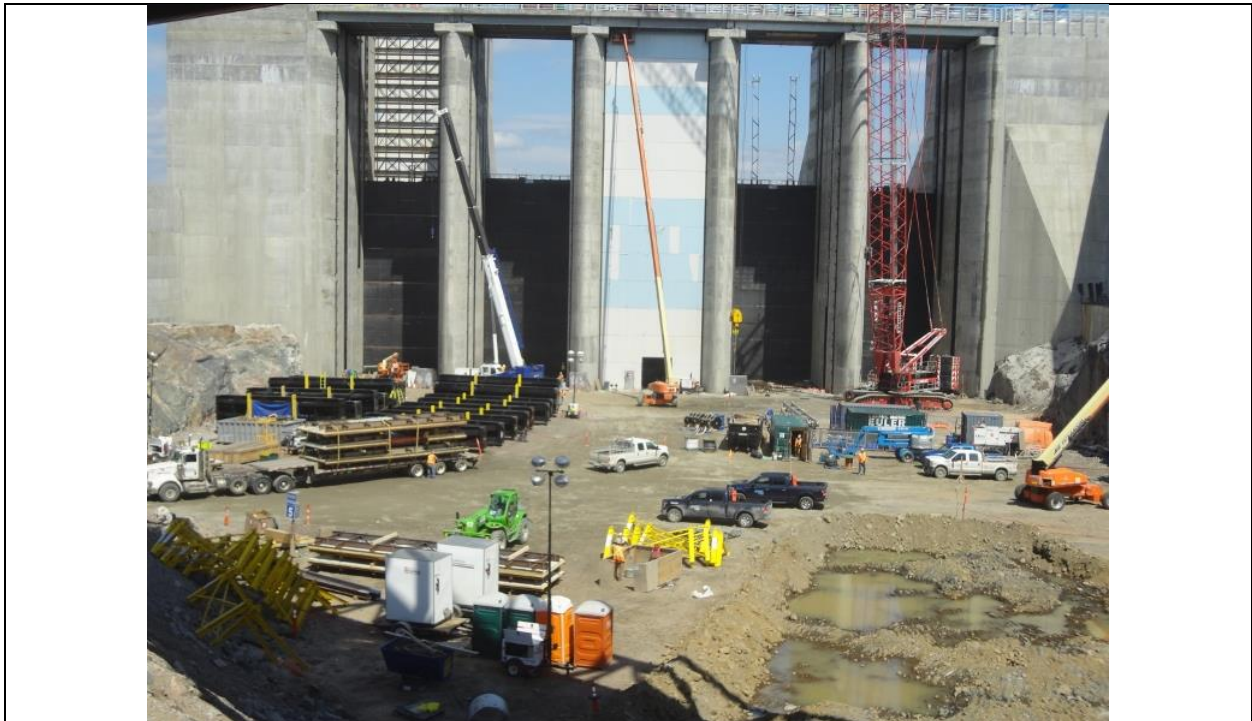
Photo D.2: Upstream view of the spillway gates. (July 13, 2016)

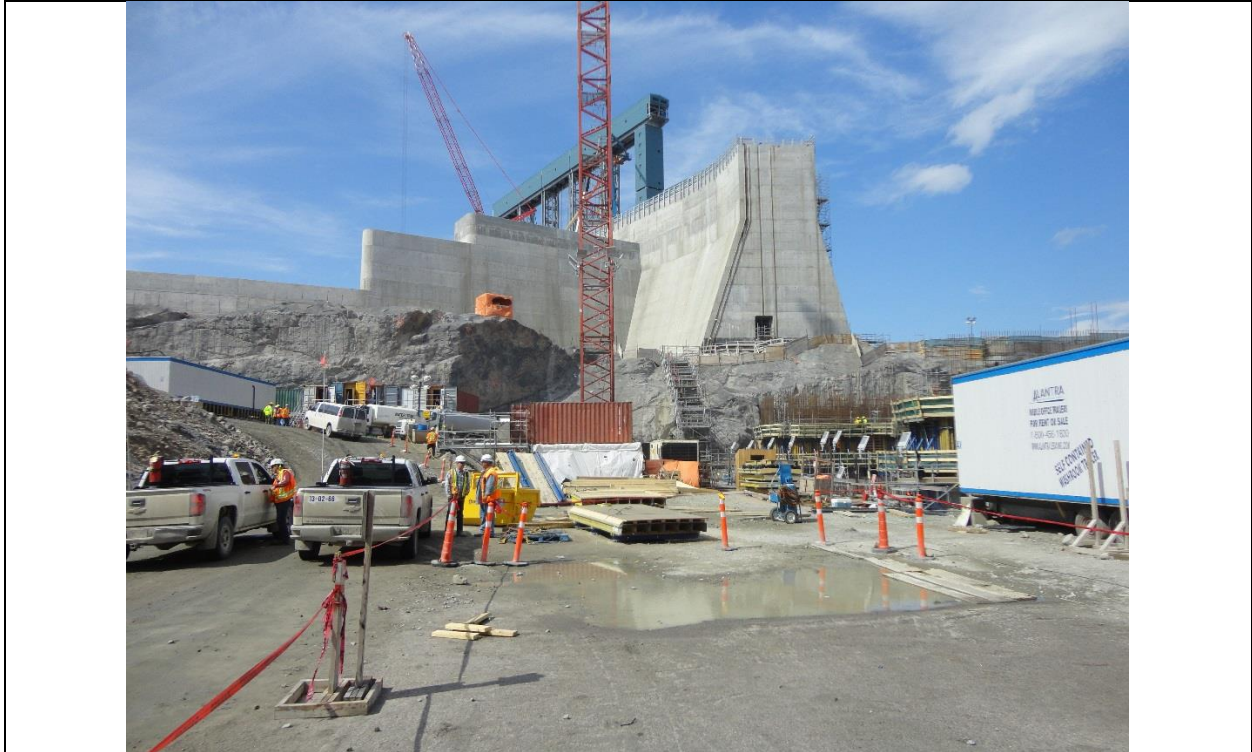
Photo D.3: South side of spillway, Powerhouse/Transition dam shown on the right. (July 13, 2016)

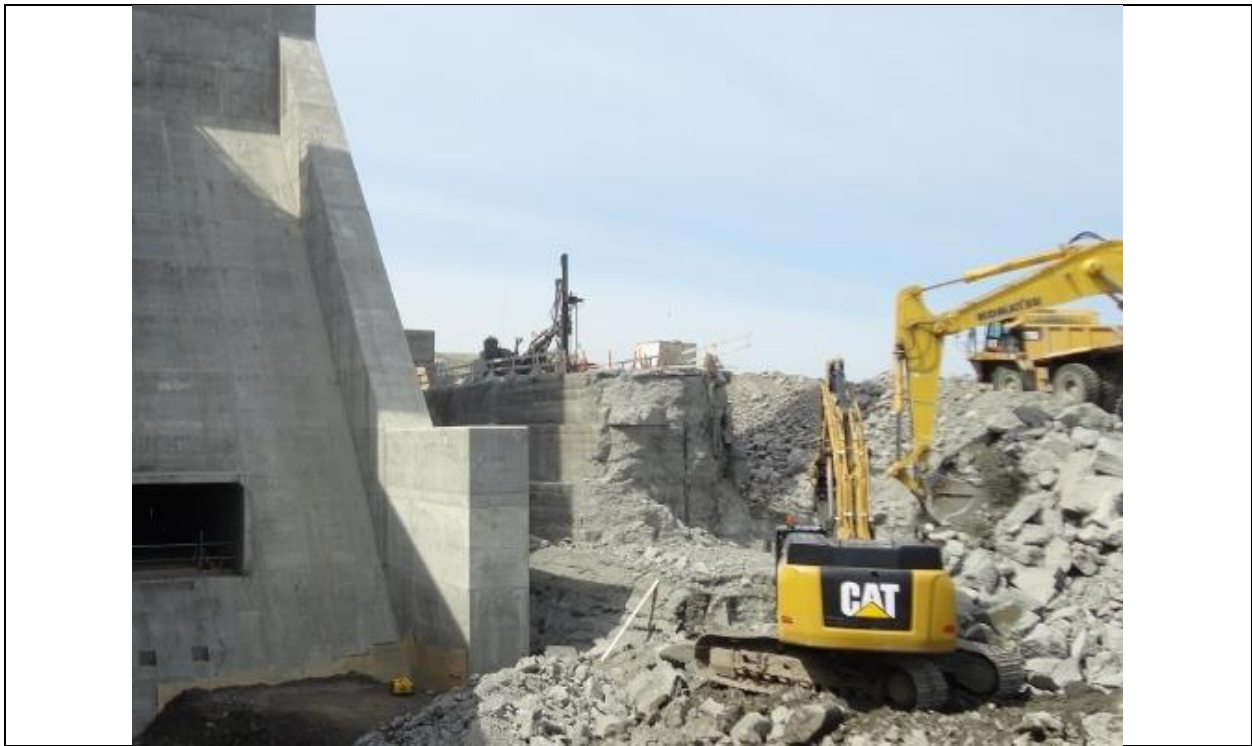
Photo D.4: RCC cofferdam being demolished with a hydraulic hoe ram. (July 13, 2016)

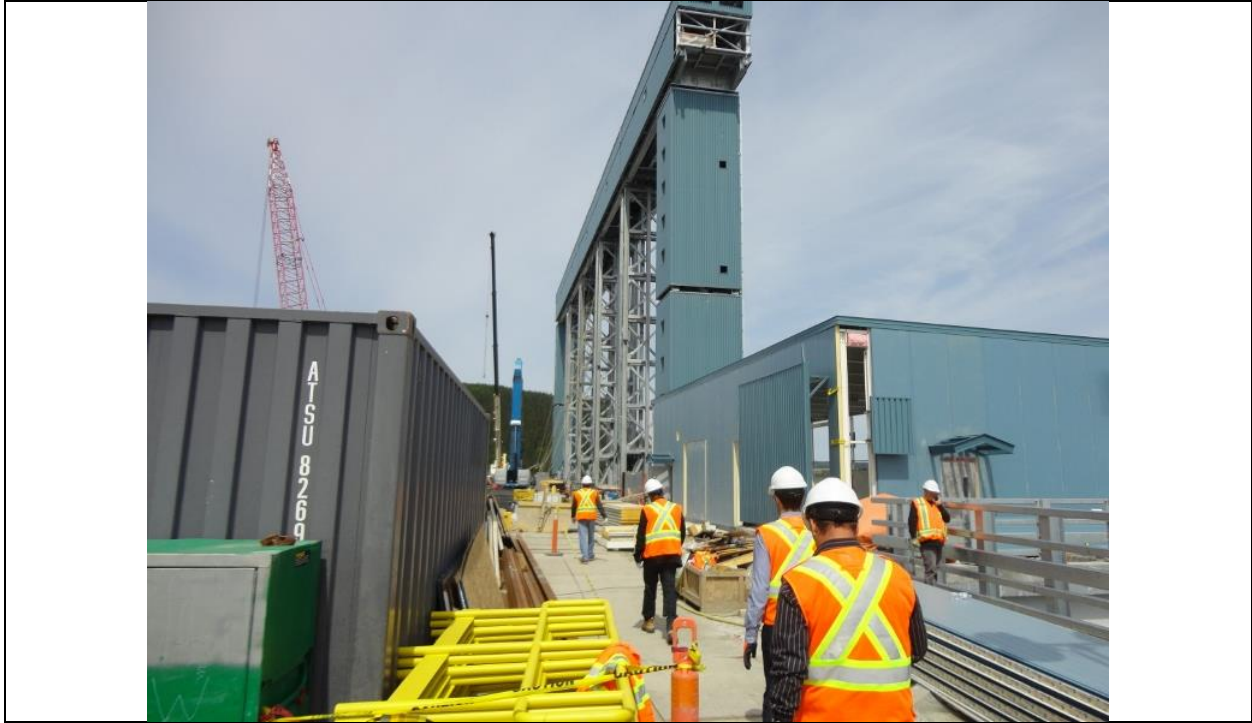
Photo D.5: Deck on top of the spillway gate structure. (July 13, 2016)

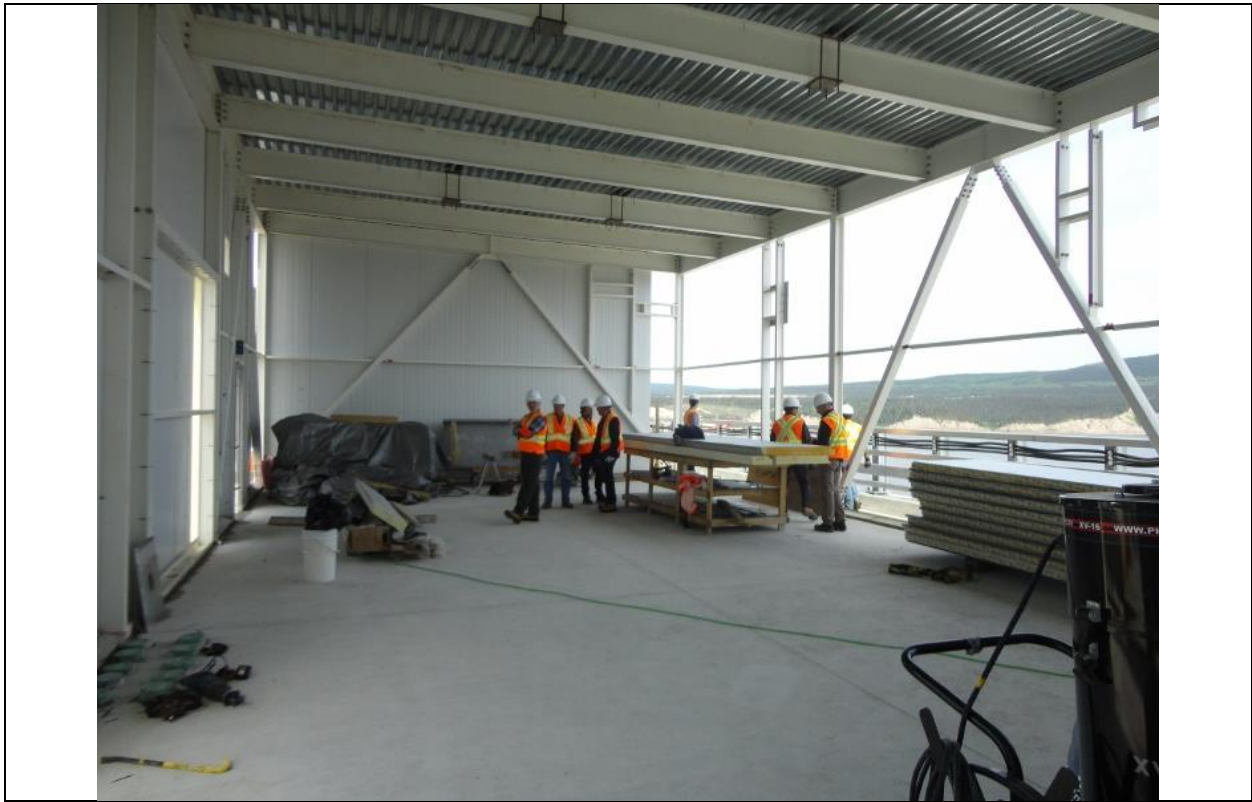
Photo D.6: Control room on top of the spillway gate structure. (July 13, 2016)

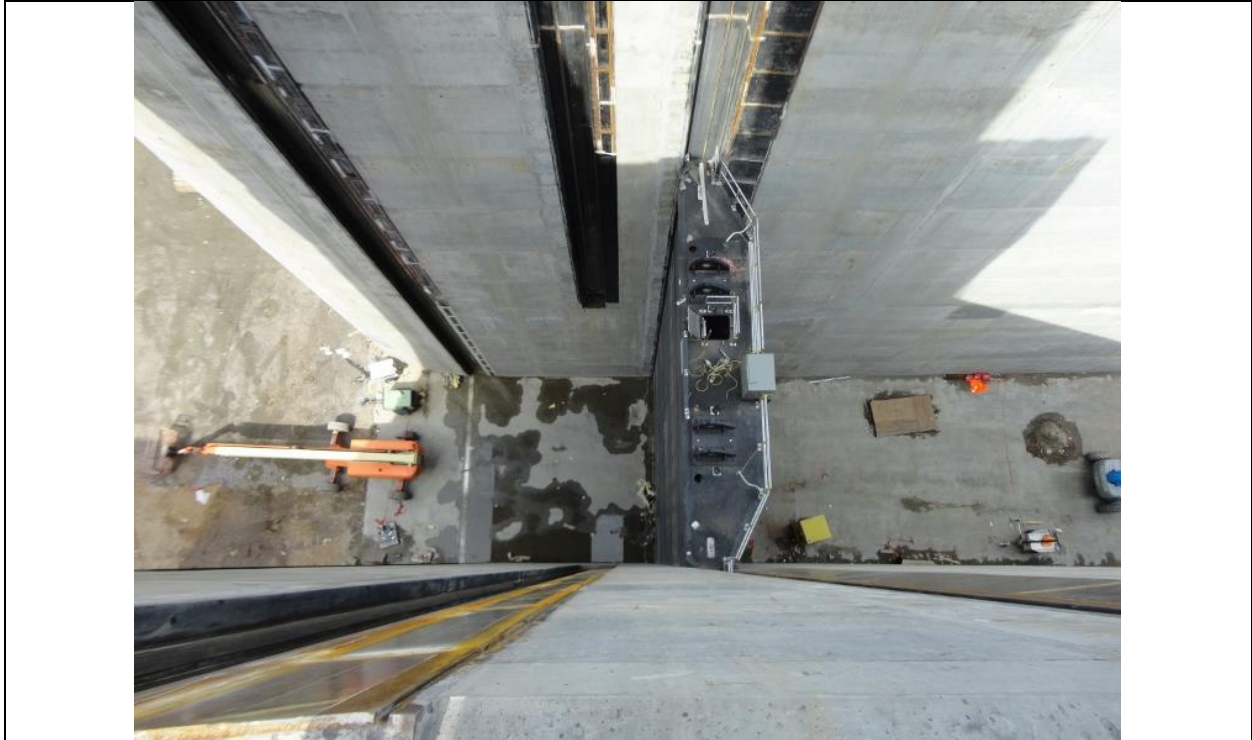
Photo D.7: Top of gate No. 1, view from the top of the spillway gate structure. (July 13, 2016)

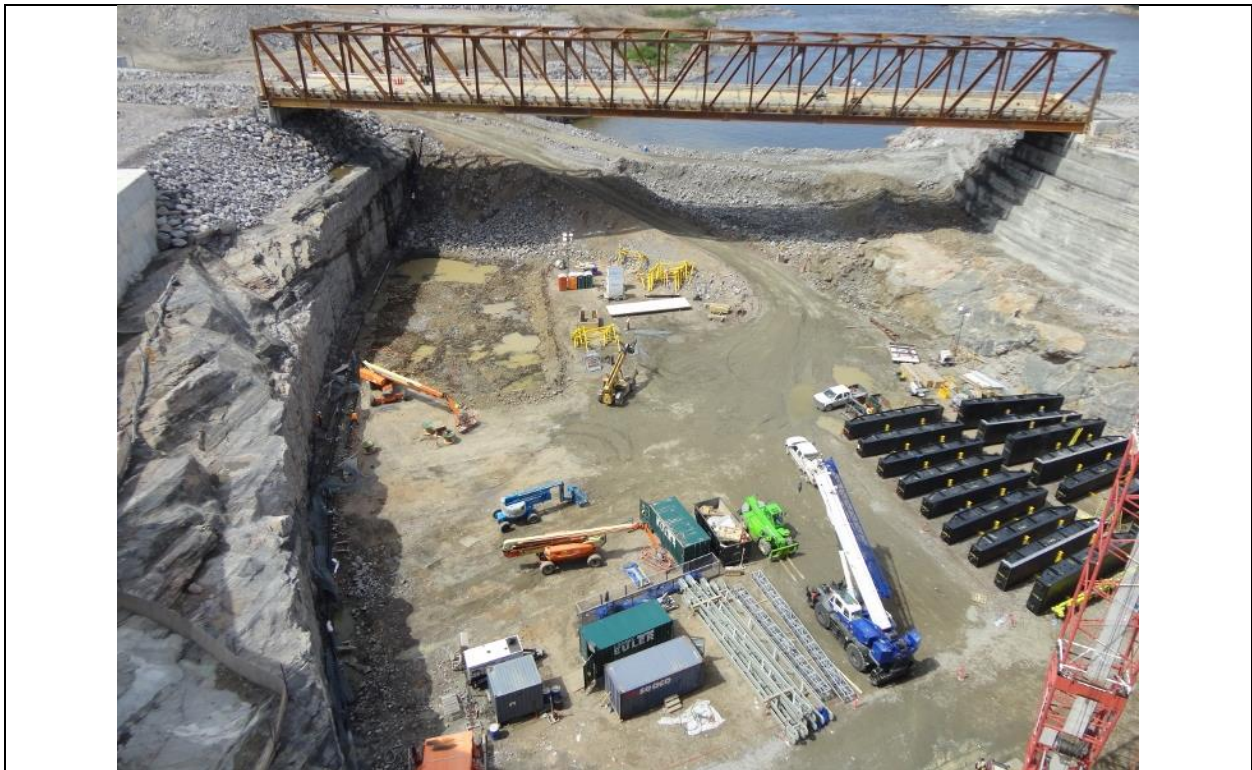
Photo D.8: Spillway intake channel and temporary bridge. View looking towards upstream. (July 13, 2016)

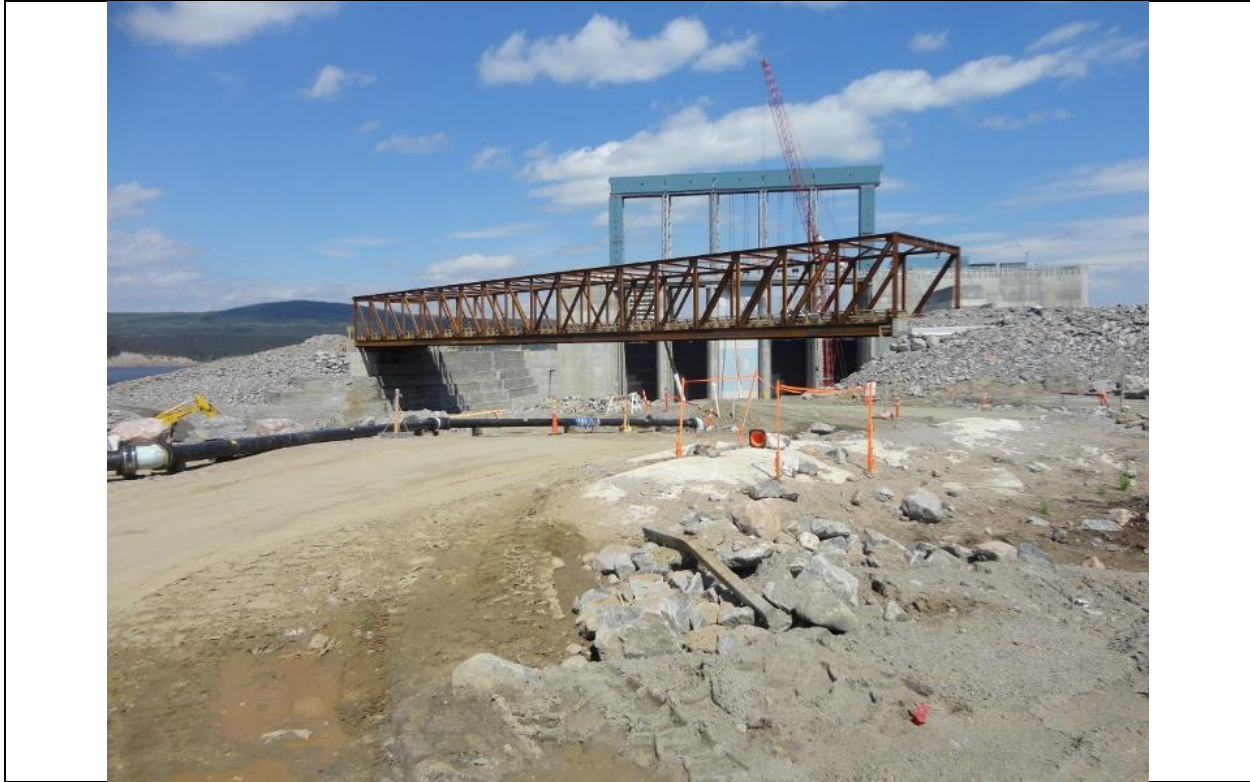
**Photo D.9:** Spillway intake channel and temporary bridge. View looking downstream. (July 13, 2016)

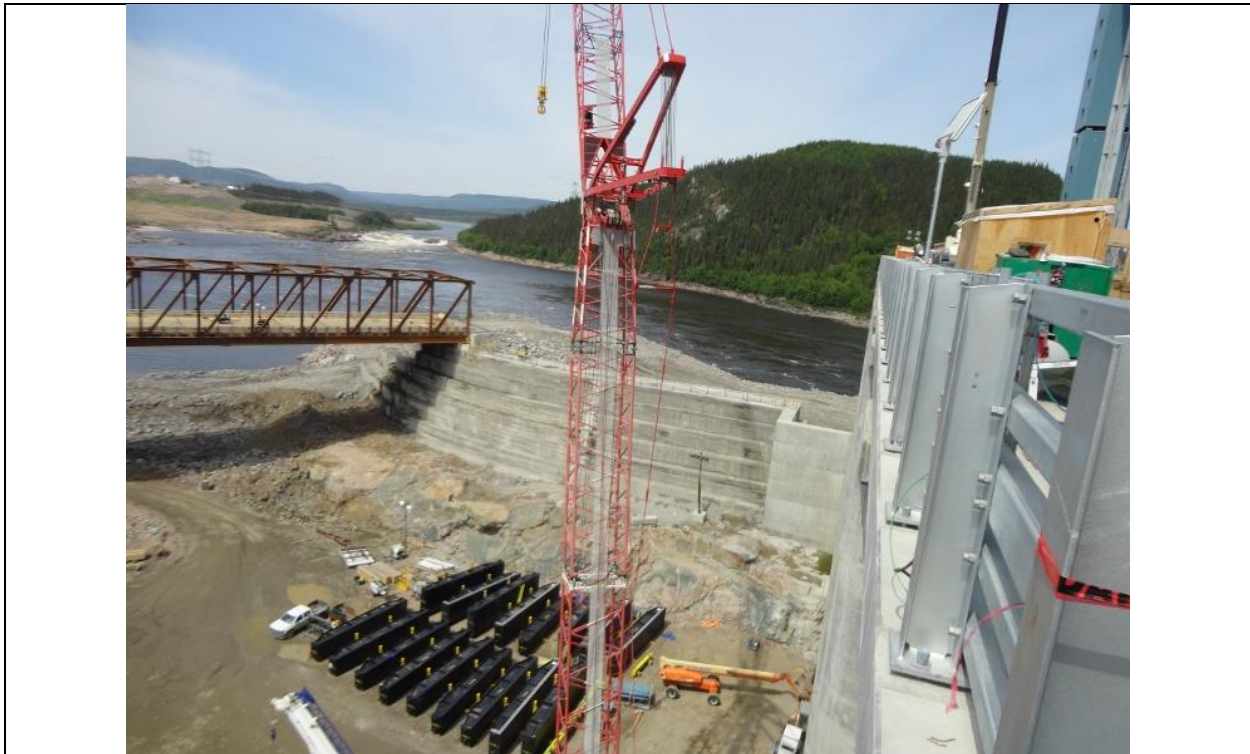
**Photo D.10:** Left side of the spillway intake channel. Note the black stop log segments stored on the bases of the channel in the foreground. (July 13, 2016)

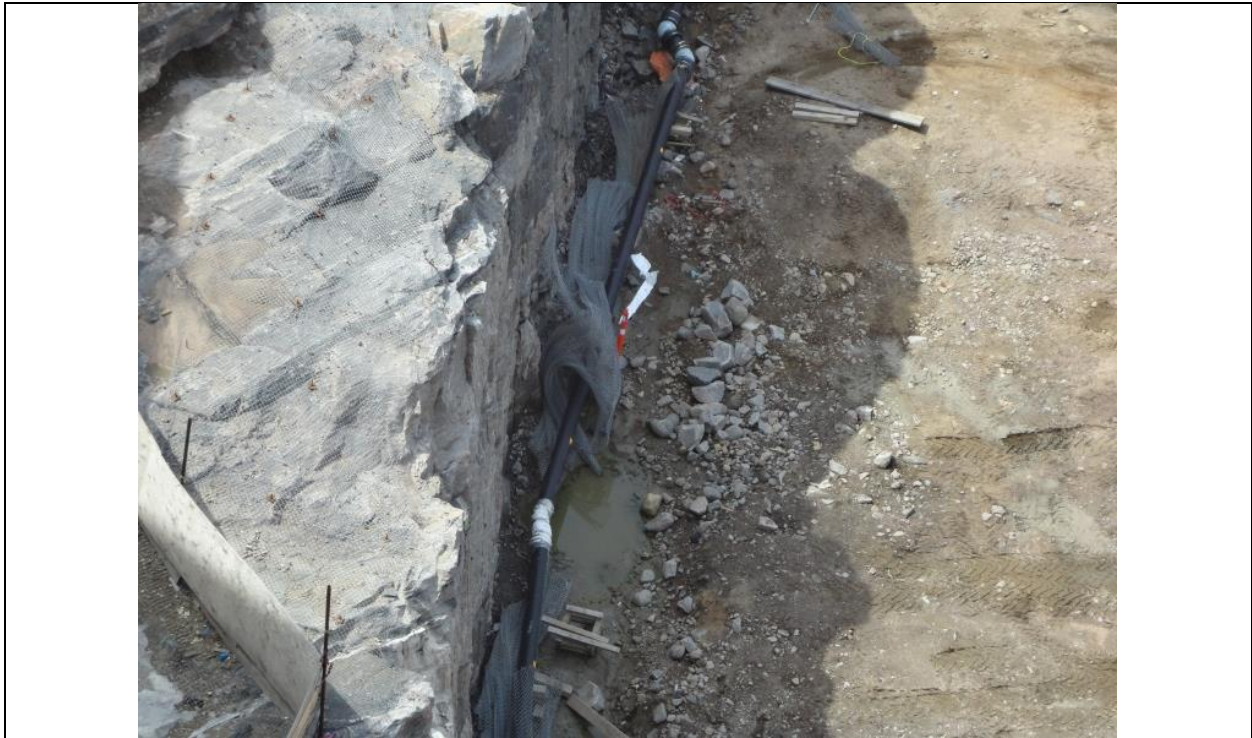
Photo D.11: Spillway approach channel. Removal of steel mesh from the left side rock face. (July 13, 2016)

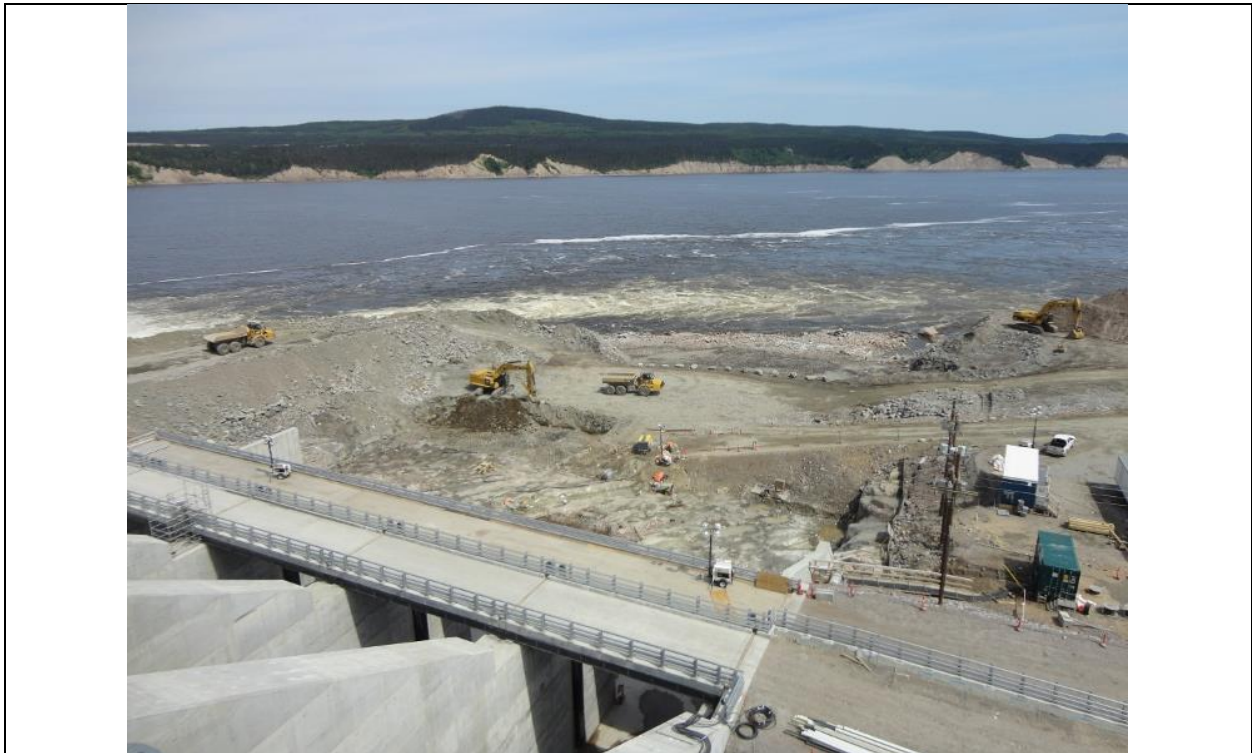
Photo D.12: Spillway apron, removal of cofferdam and preparation of the apron surface. (July 13, 2016)

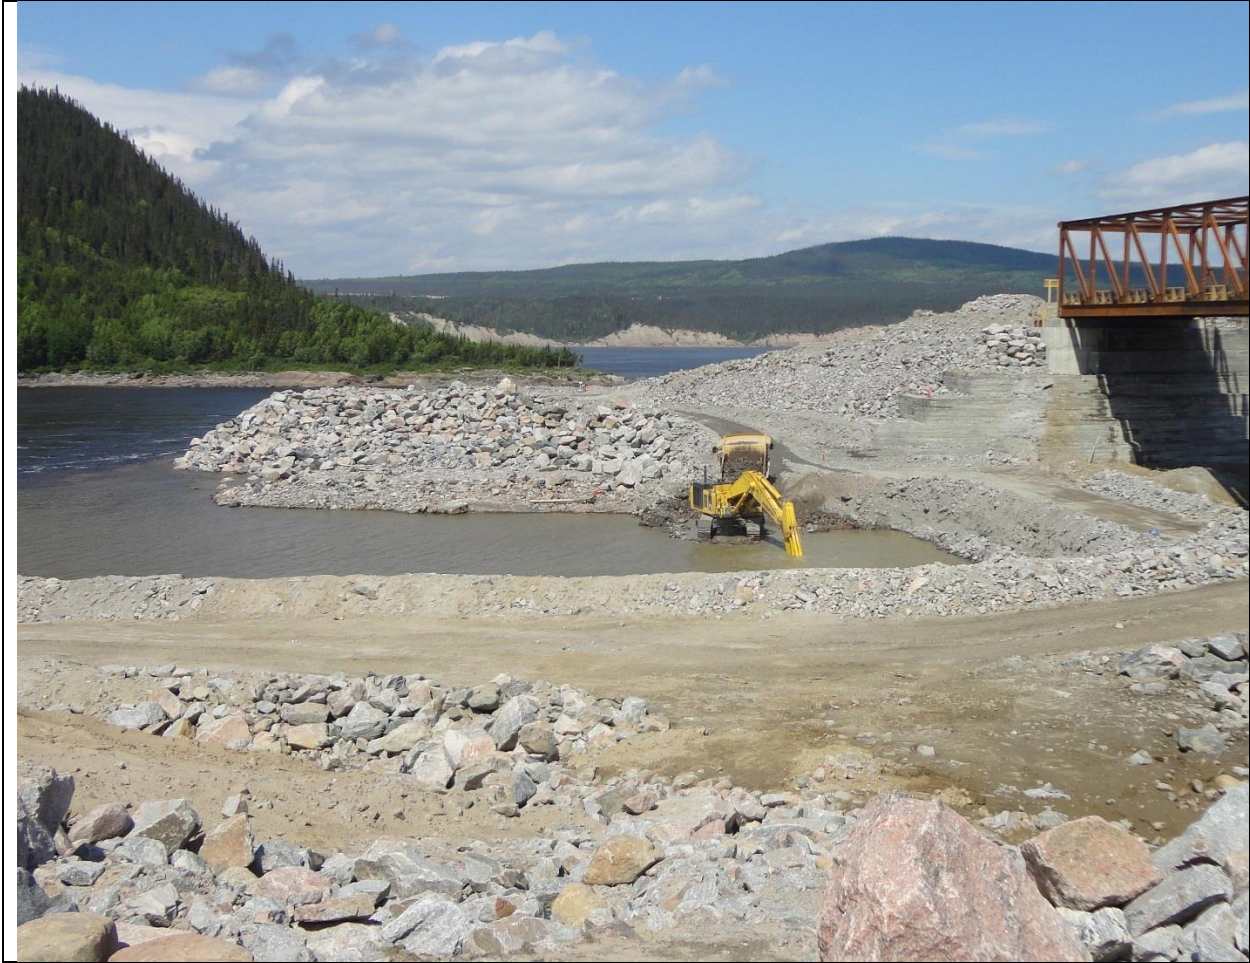
**Photo D.15:** Preparation of the left starter dyke of the Upstream Cofferdam. (July 13, 2016)

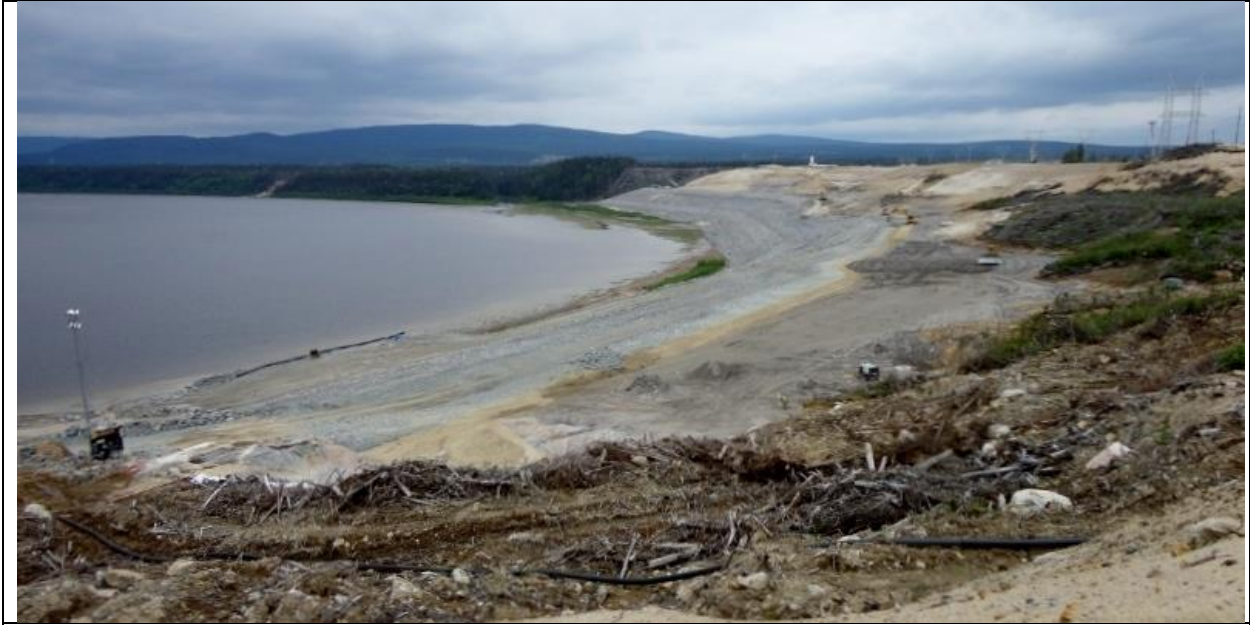
Photo E.1: North Spur, upstream slope. (July 14, 2016)

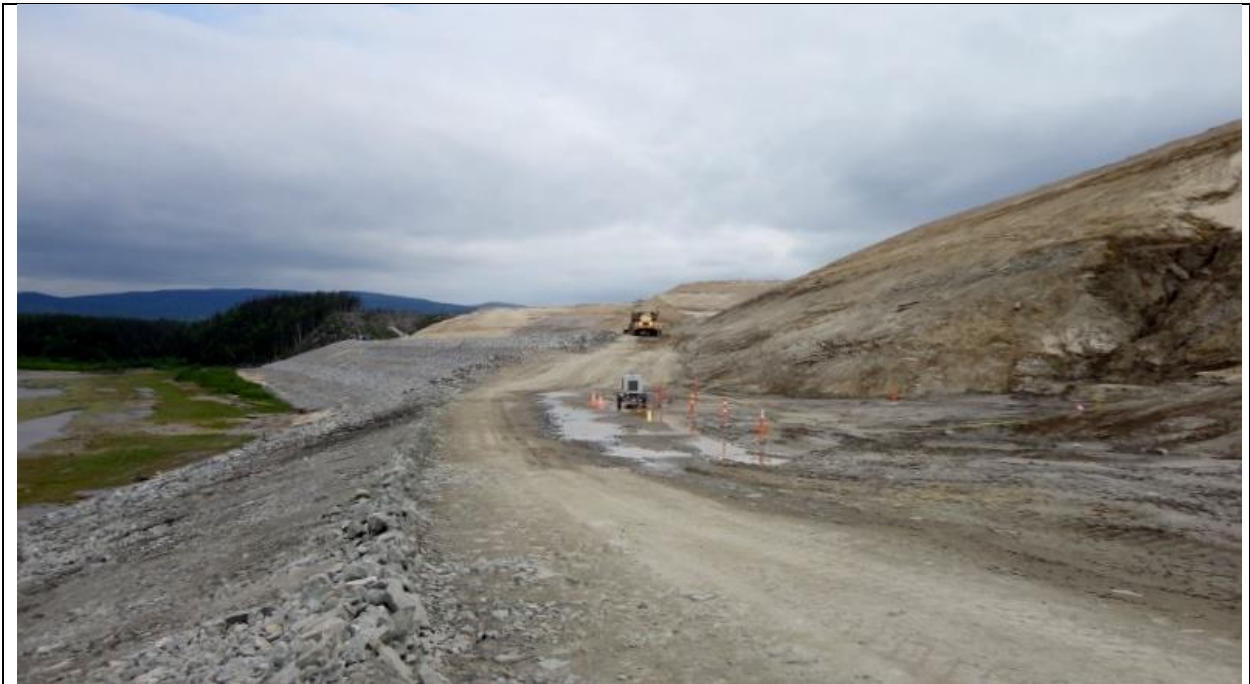
Photo E.2: North Spur, upstream slope. North end, view looking north.. (July 14, 2016)

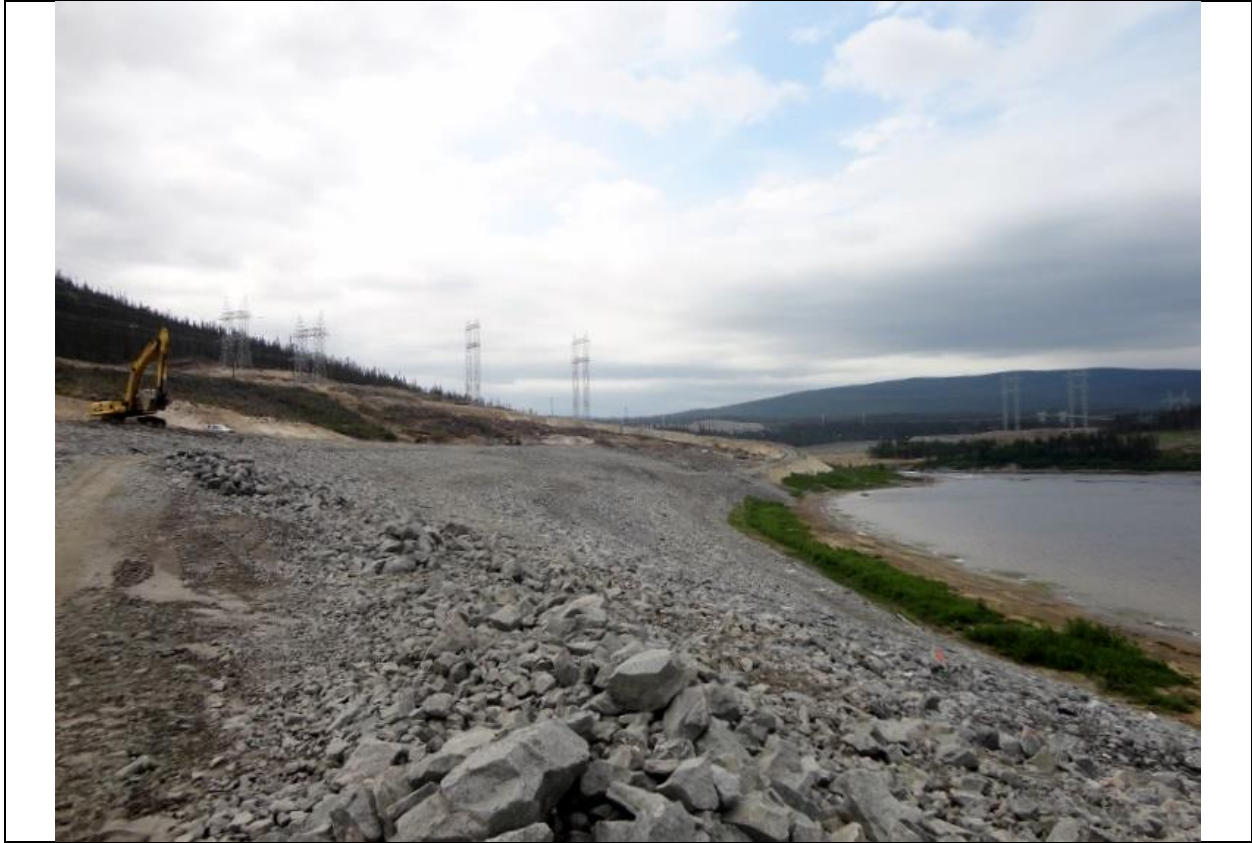
Photo E.3: North Spur, upstream slope. View looking south. (July 14, 2016)

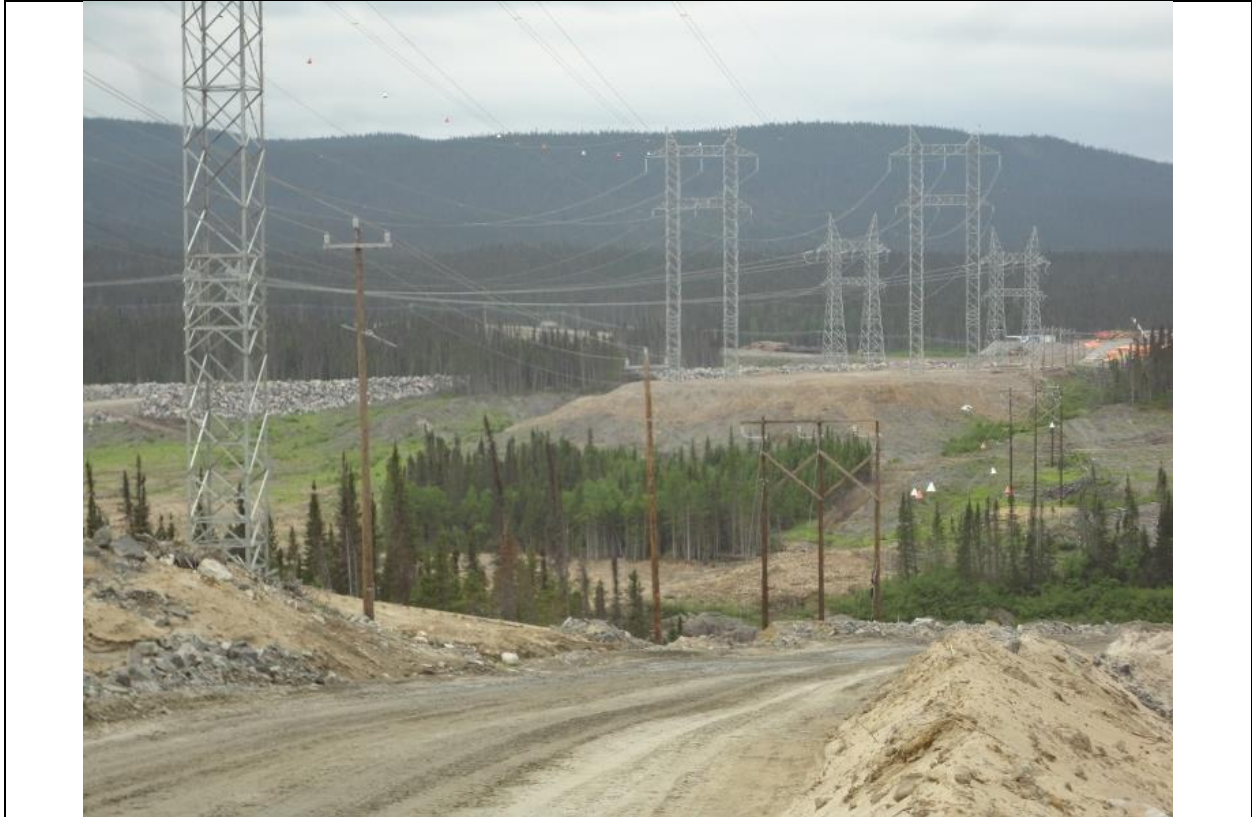
**Photo E.7:** North Spur. View looking north at the HVac transmission line along the top of the North Spur. (July 14, 2016)

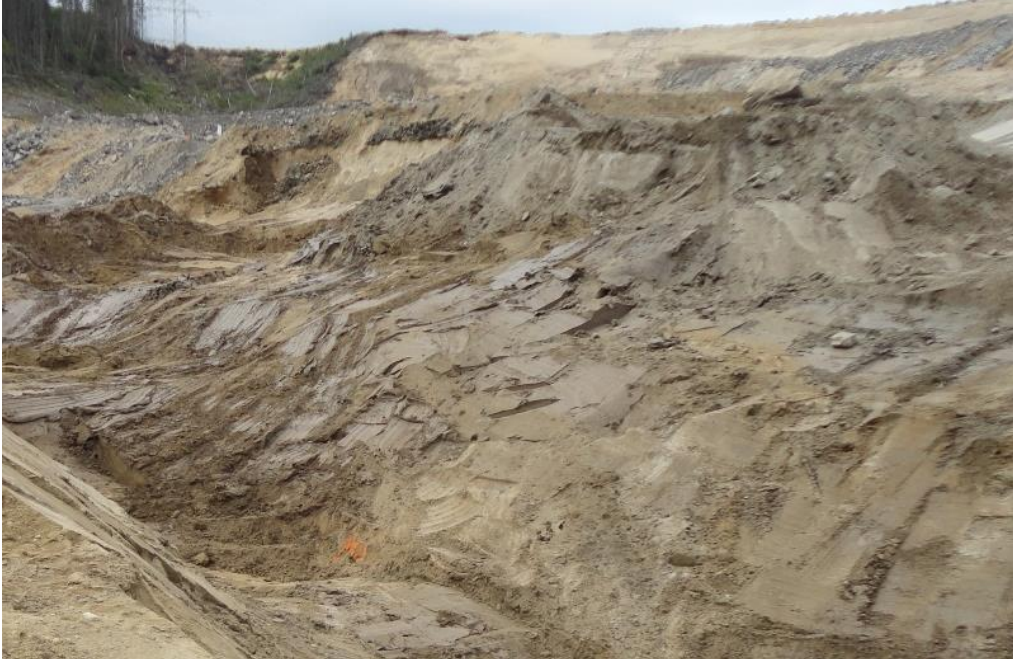
- As reported in our previous November 2015 visit report, NALCOR and site engineering staff have indicated that very few manifestations of high sensitive or “quick clay” behavior in clay/silt materials have been reported during excavations of the North Spur. In most cases, it was observed by geotechnical site staff that excavated material adhered together in clumps, even after dumped into the haul trucks. This is unlike typical “quick clay” materials which would normally lose cohesion and liquefy to slurry after such rough handling. Also, the north-west cut-off wall trench panels were stable during excavation in the upper sands and stratified drift and no liquefaction of materials was noted during excavation works.

**Photo E.11:** North Spur, downstream slope. Exposure of plastic silt/clay with interlayered fine sand of the Upper Stratified Drift. This location is near in the southern area at the base of the downstream slope. No evidence of liquefaction properties could be seen at this location. (July 14, 2016)
