# MEETINGS IN ST. JOHN'S AND VISITS TO LOWER CHURCHILL PROJECT SITES, JULY 11 TO 15, 2016

Prepared for: Natural Resources Canada and Nalcor Energy  
 IE Point of Contact: Nik Argirov  
 Date: November 2, 2016

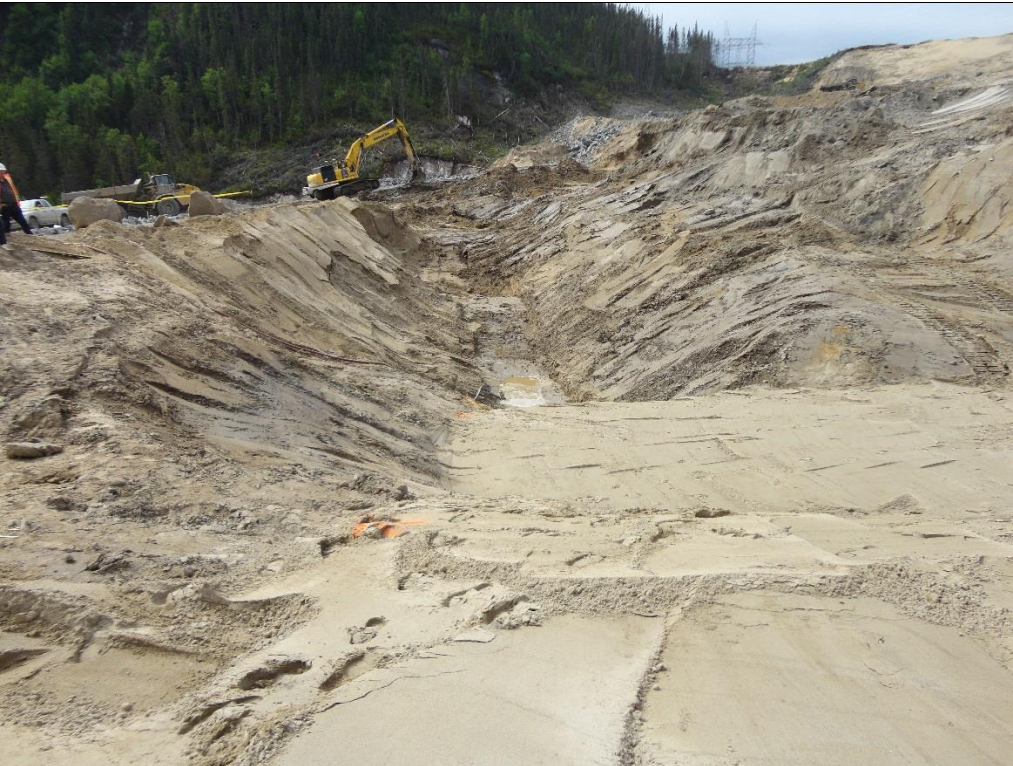
**Photo E.12:** North Spur, downstream slope. Sloping finger drain. (July 14, 2016)

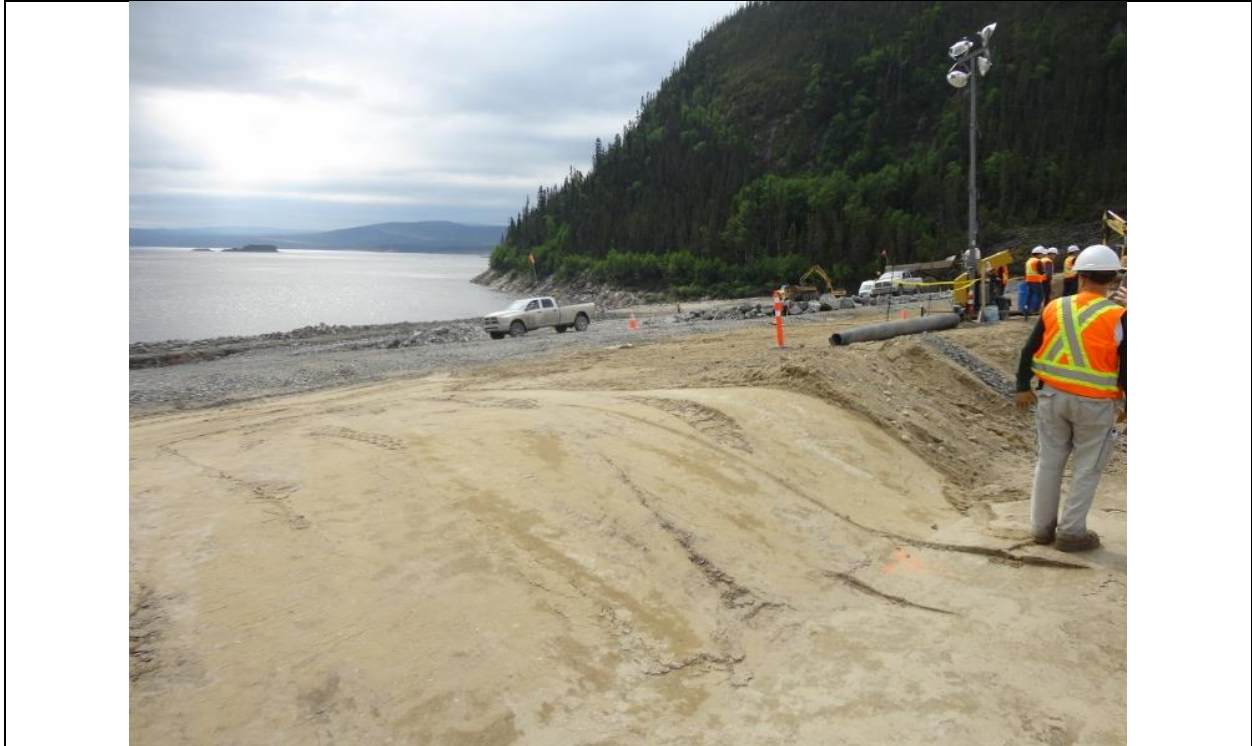
**Photo E.13:** Excavation and fill placement for finger drain at the south end of the downstream slope. (July 14, 2016)

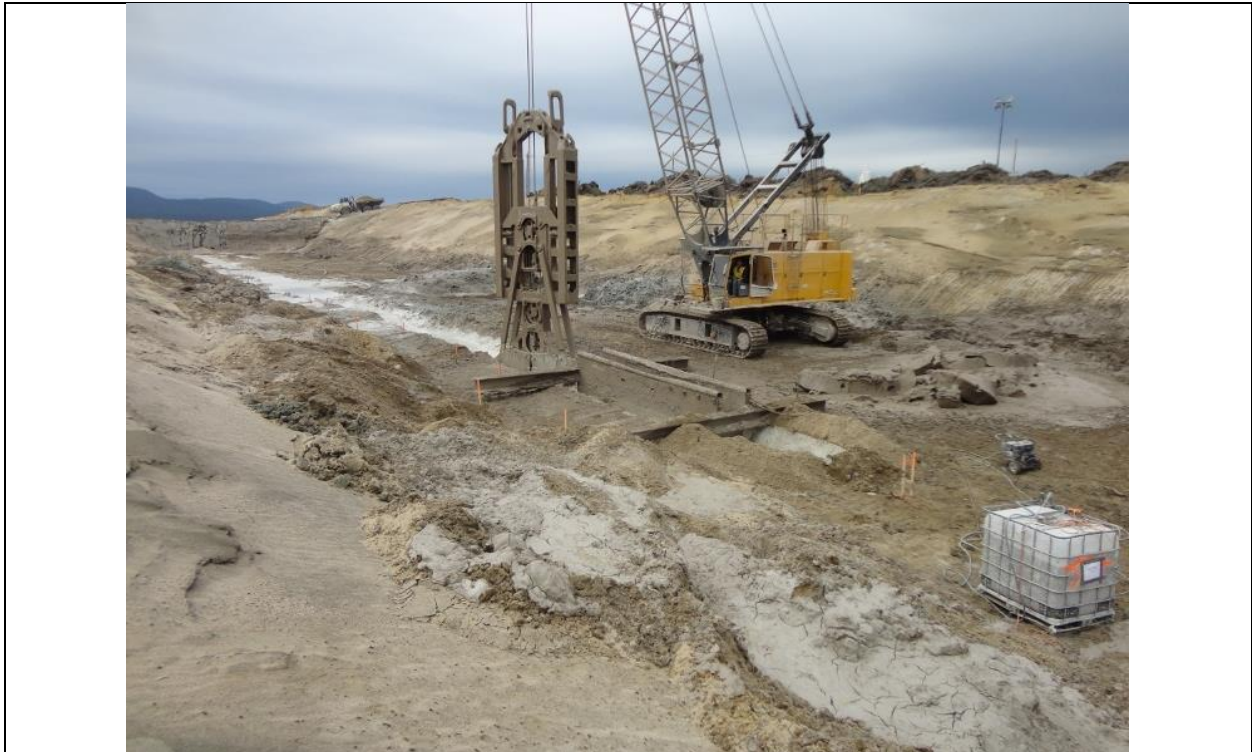
**Photo E.14:** Excavation of the North Cut-off, in the area east of the road crossing. (July 14, 2016)

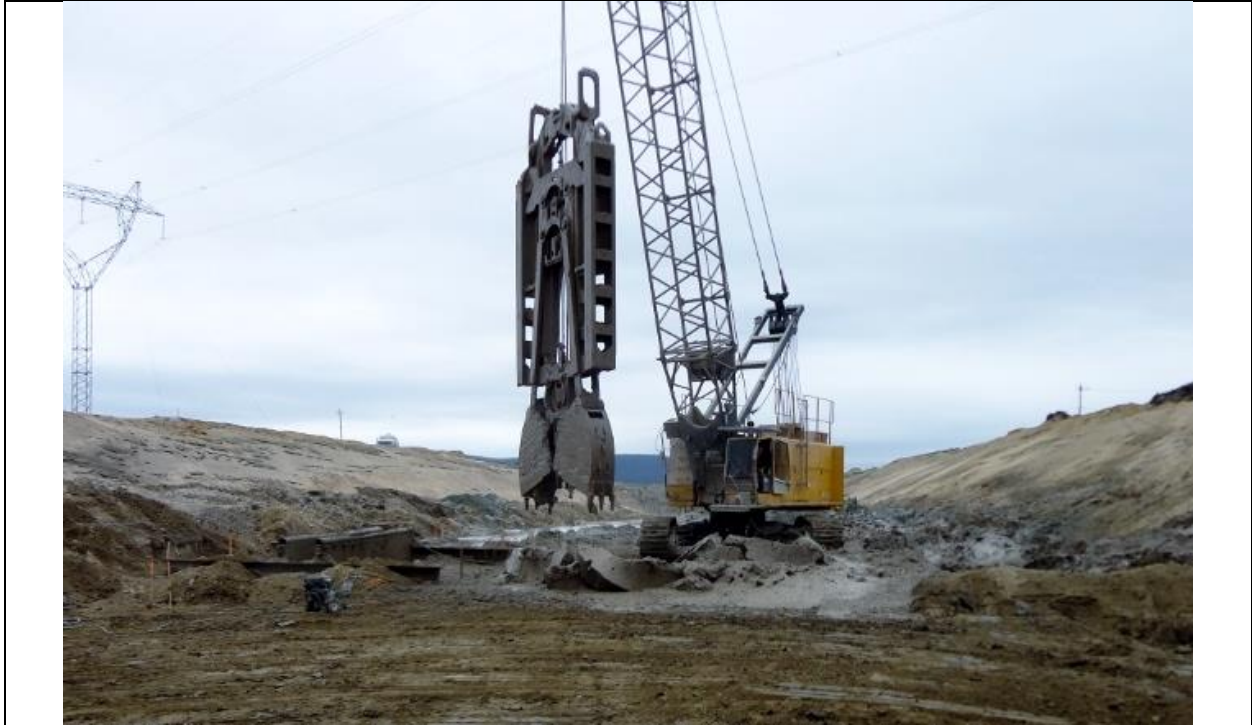
Photo E.15: Dumping of clay material from the North Cutoff. (July 14, 2016)

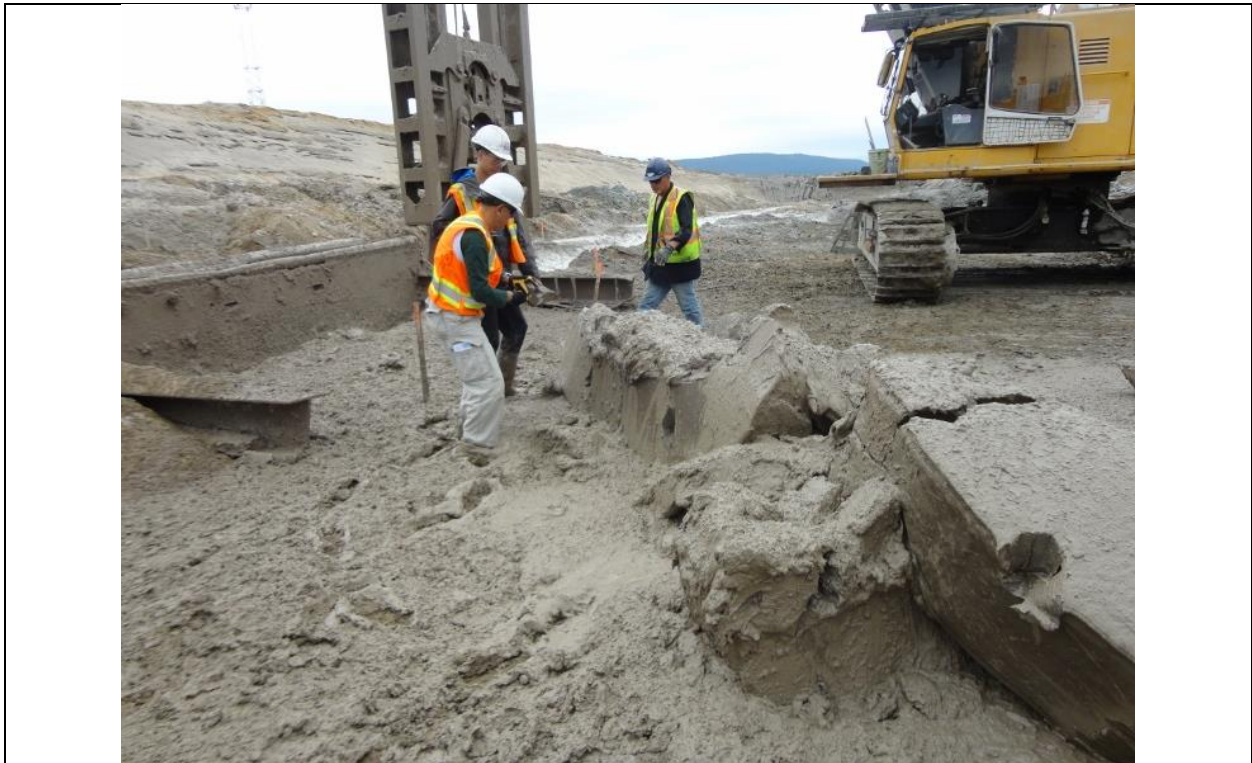
Photo E.16: Plastic "lower clay" from the base of the north Cutoff. (July 14, 2016)

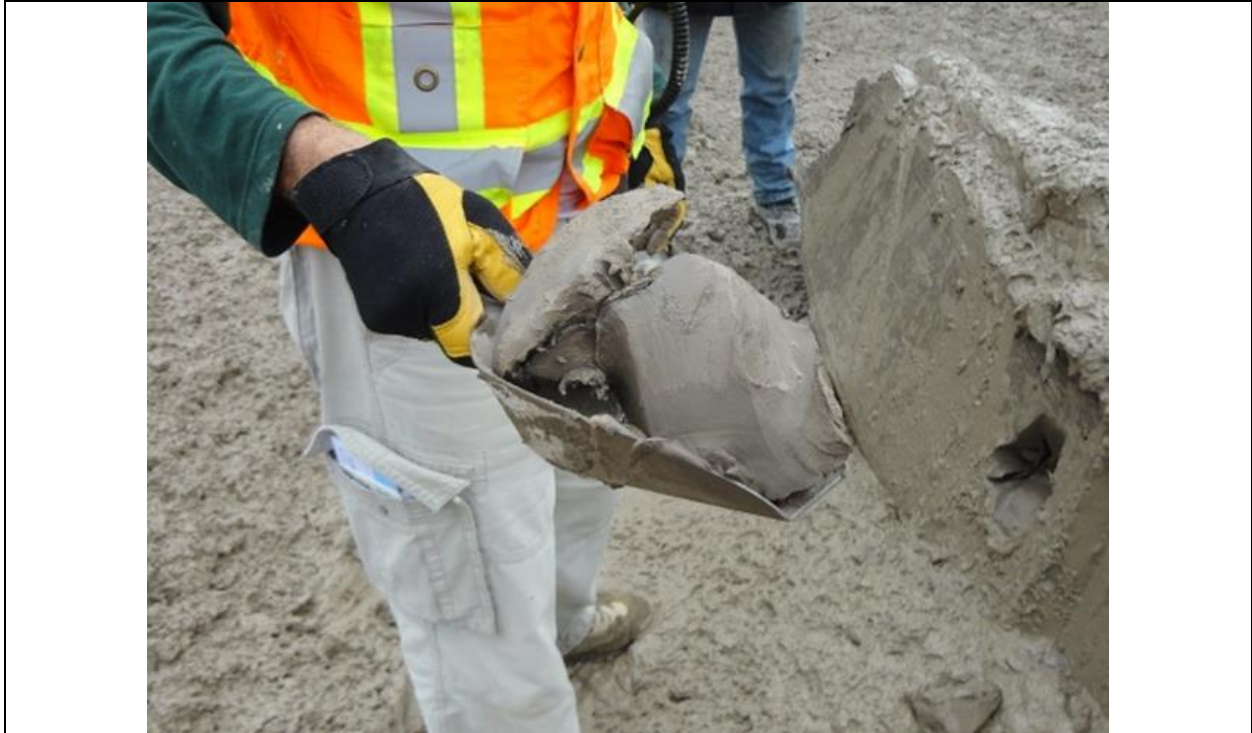
**Photo E.17:** Sample of cohesive, plastic "lower clay" from the base of the North Cutoff. (July 14, 2016)

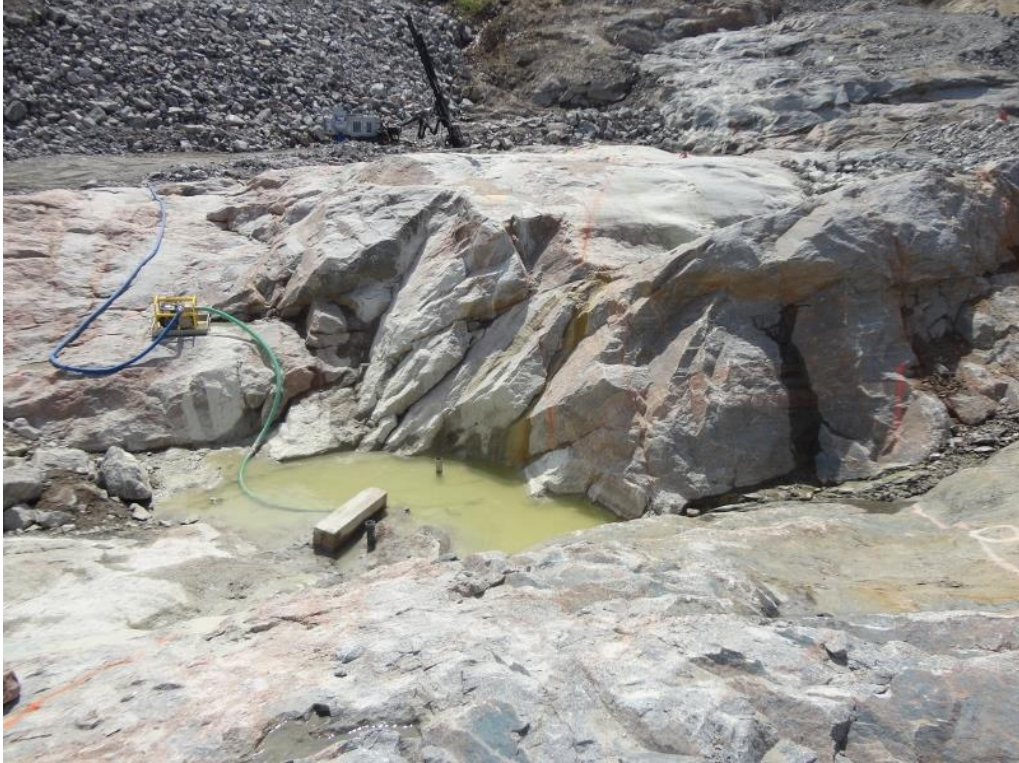
**Photo F2:** South Dam foundation, cleaned rock along the impervious core footprint. View looking north down the abutment. (July 14, 2016)

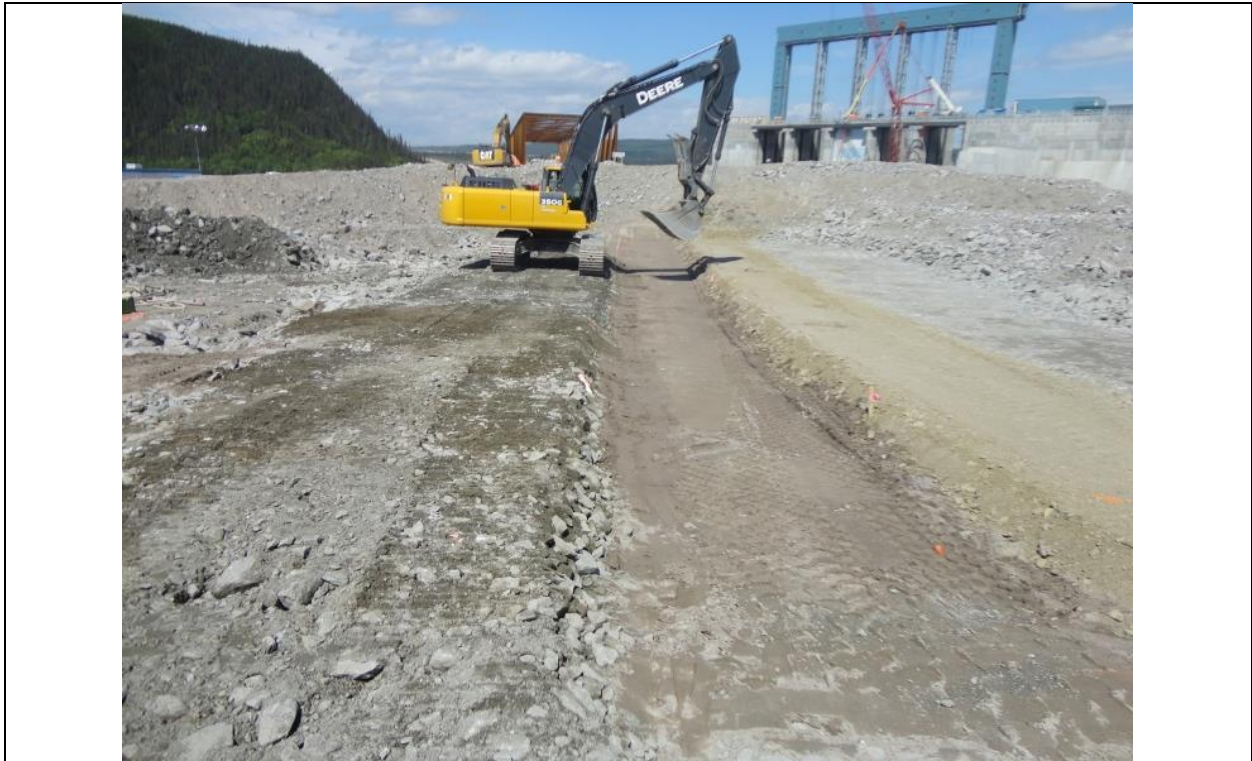
**Photo F.4:** North end of the South Dam foundation. Cleaned, irregular granitic gneiss in foreground and the south end of the concrete transition dam is in the background. (July 14, 2016)

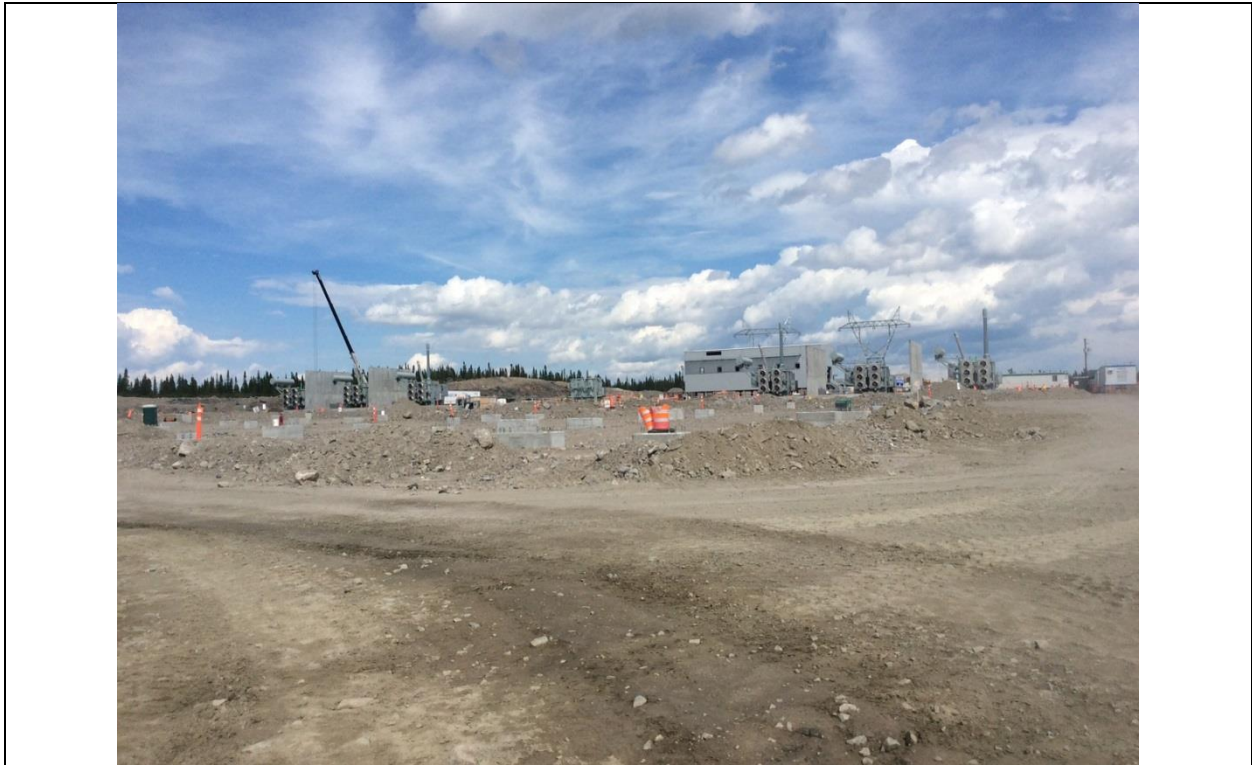
- At the Converter Station, all concrete interior works were completed. Valve hall pole 1 and 2 were substantially completed with minor punch list items remaining. The roofing installation was completed at the valve halls and was in very advanced stage at the control room. All transformer pads and containment pits for Pole 2 were completed and those for pole1 were in very advanced stage with completion scheduled for the end of July'16. Work on the fire walls for both, Pole 1 and 2 was underway (Photos G.1 and G.2).
- GIS building foundation repair work was near completion. The steel frame of the building was half way in place. The balance of the structural steel was to be erected upon completion of the foundations' repair work (Photos G.3, G.4 and G.5).
- The neighbouring Control Building concrete foundations were in advance stage of completion (Photo G.6).

Photo G.6: Control building foundations ready for the pre-engineered building erection. (July 13, 2016)

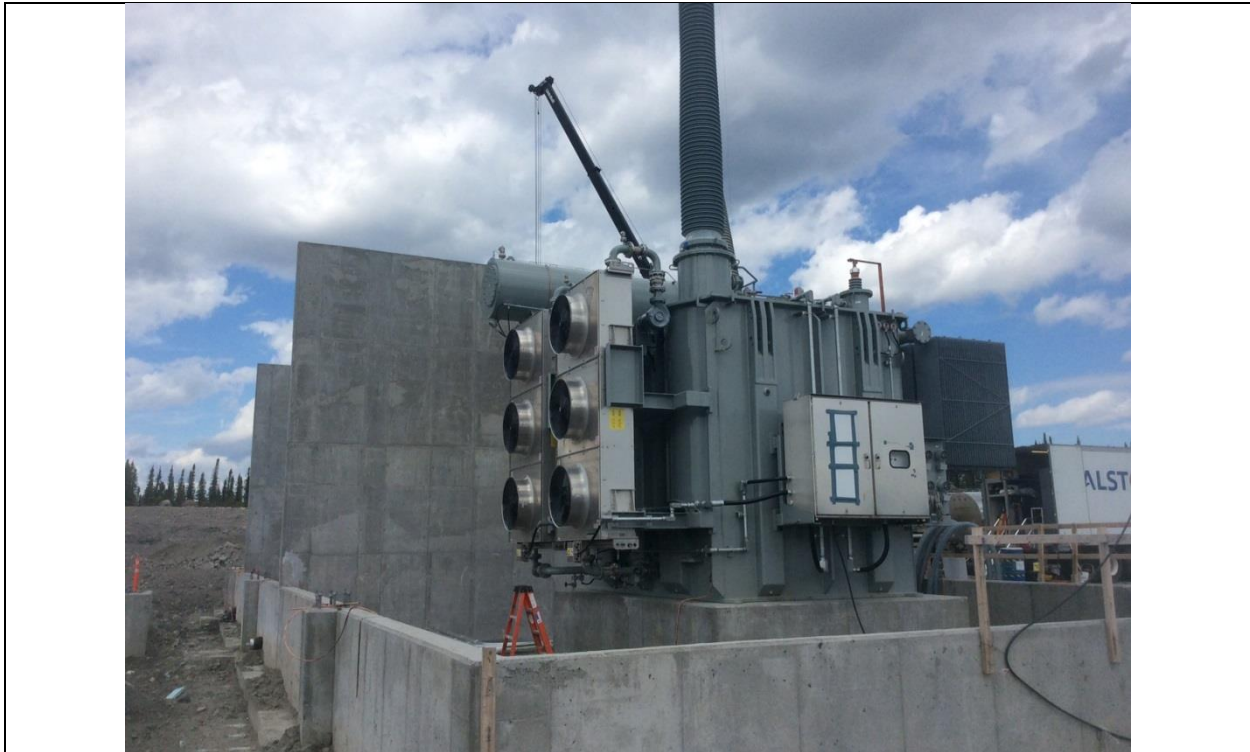
**Photo H.3:** Transformers already installed on concrete pads within containment pits complete with fire walls. (July 14, 2016)

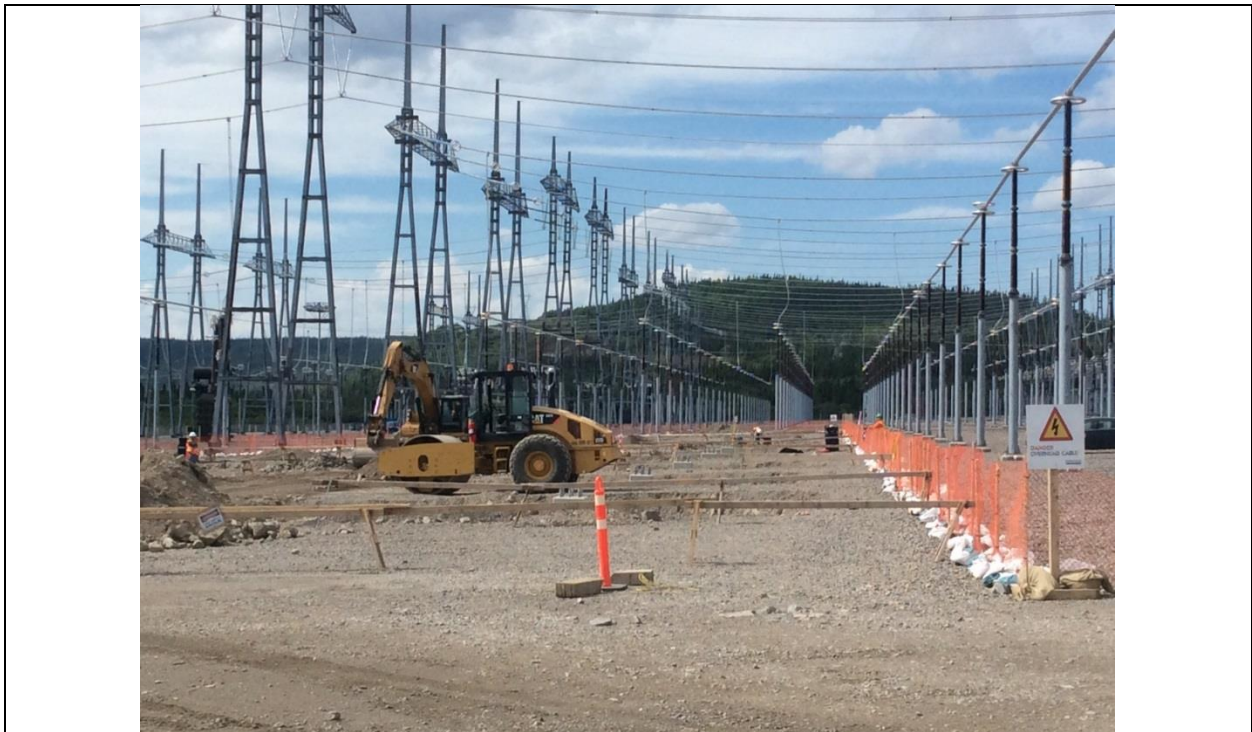
**Photo H.9:** Extension of the new Switchyard for interconnection to the existing Churchill Falls Switchyard. (July 14, 2016)

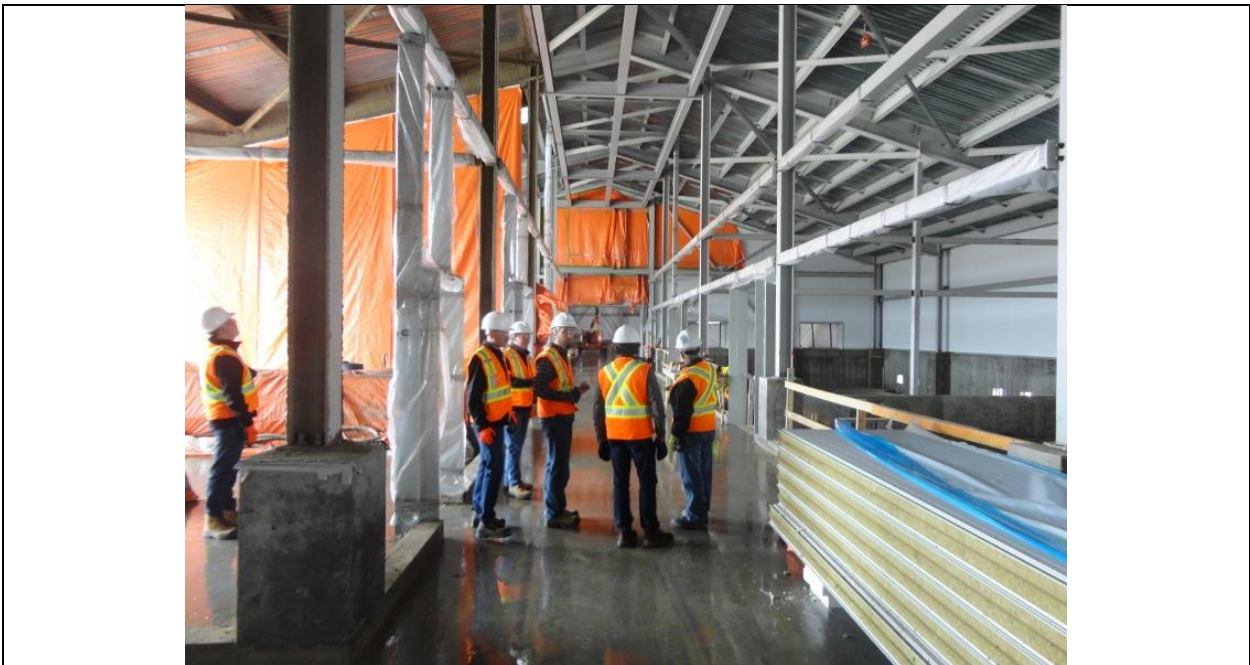
Photo I.1: Soldiers Pond - Converter Station and HVdc yard. (July 15, 2016)

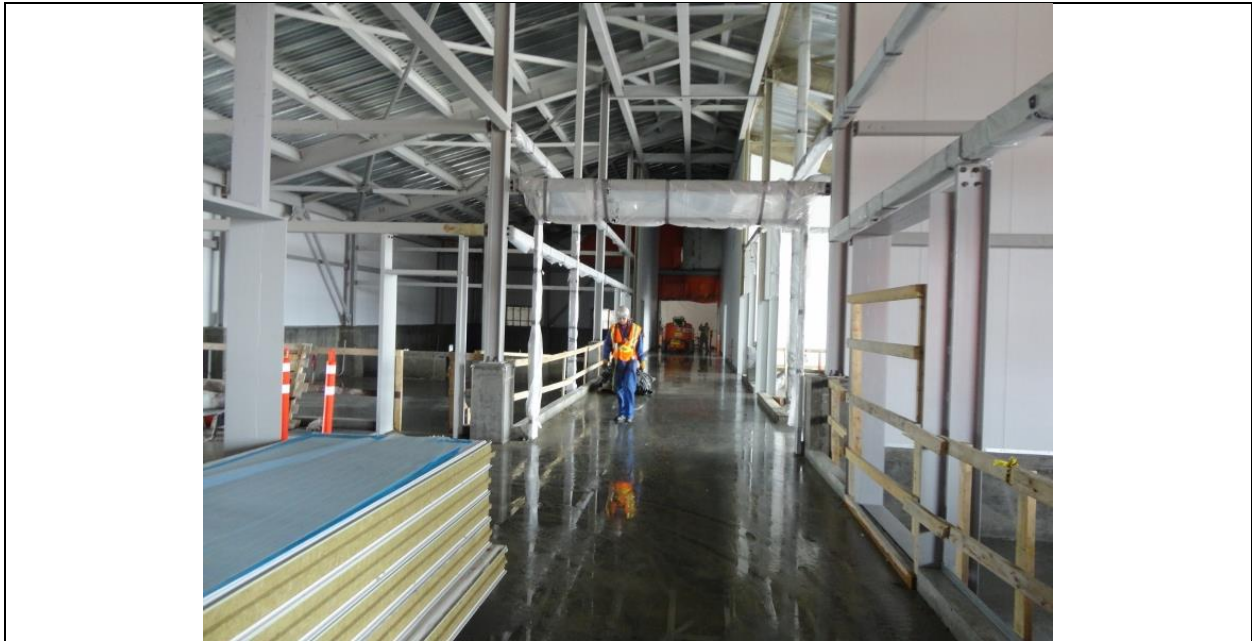
Photo I.2: Soldiers Pond – Converter Station control room interior. (July 15, 2016)

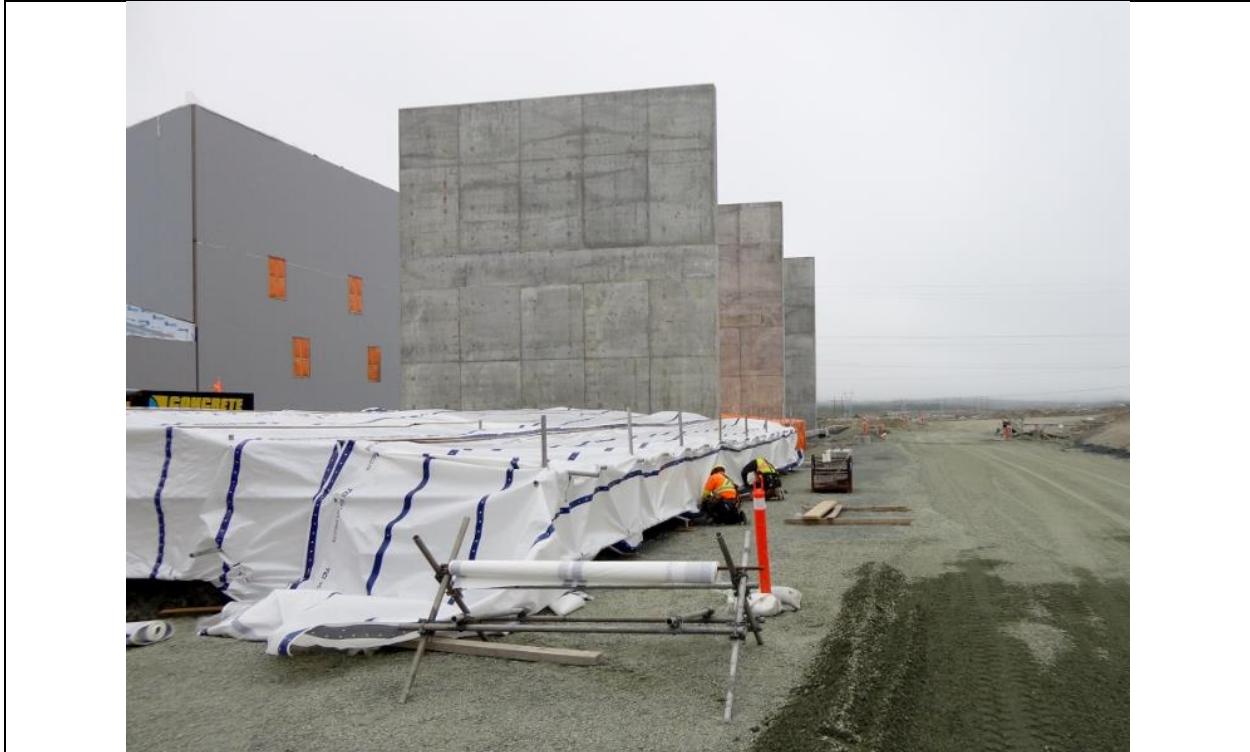
**Photo I.4:** Soldiers Pond Converter Transformers fire walls. (July 15, 2016)

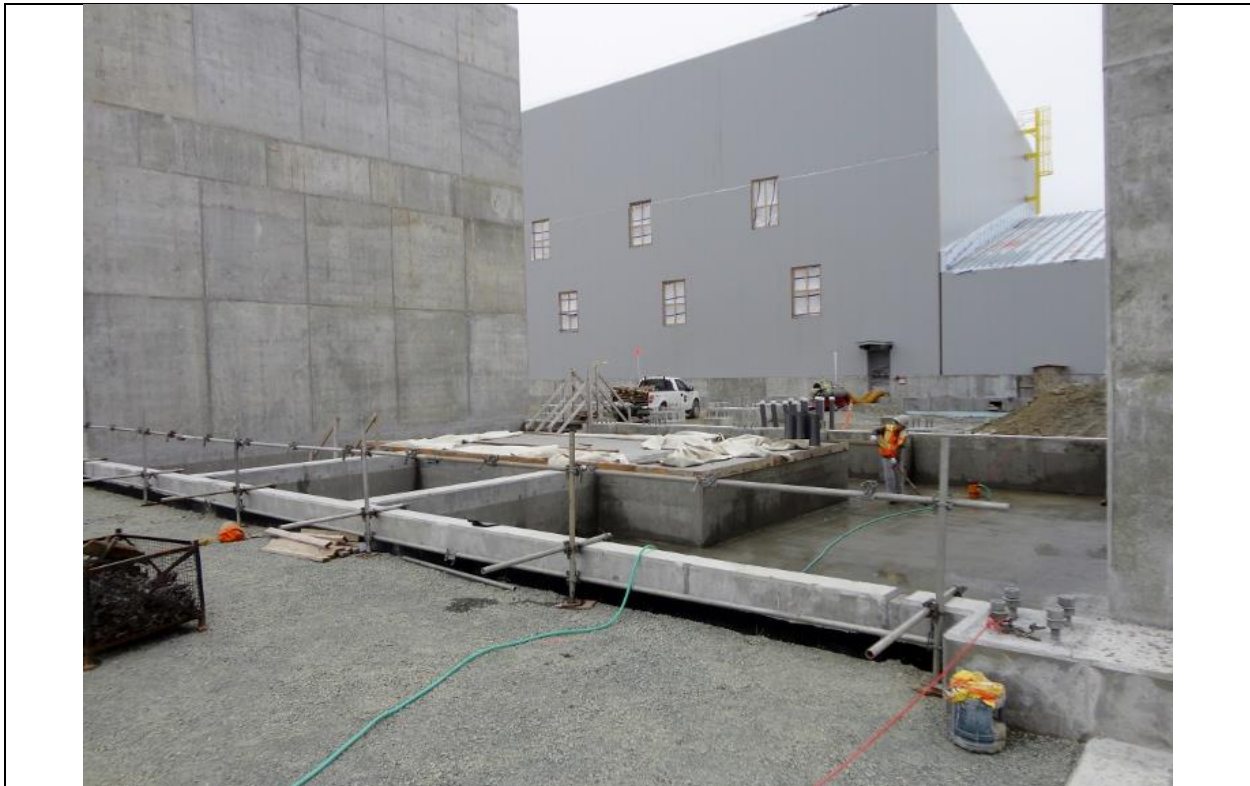
**Photo I.5:** Soldiers Pond – Converter transformer containment pit covered for curing the finished protective coating of the pit floor and walls. Separation fire walls and Converter Station on the background. (July 15, 2016)

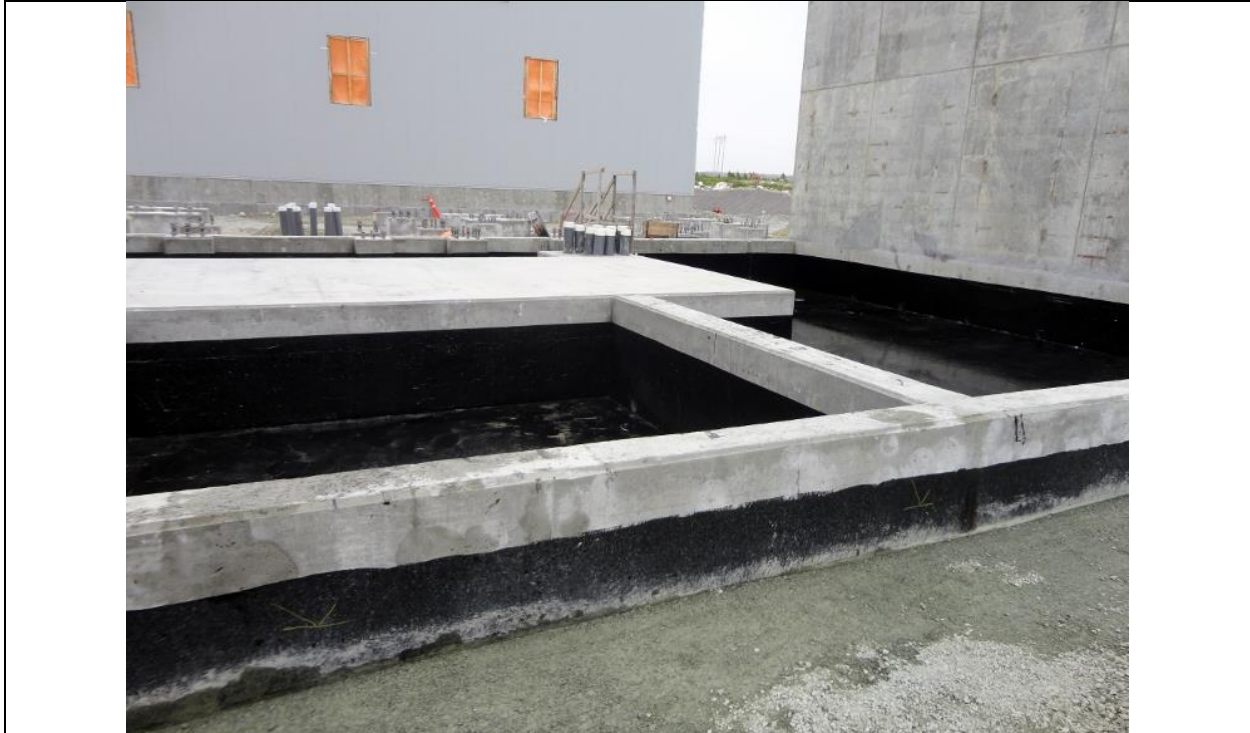
**Photo I.6:** Soldiers Pond – Converter transformer pad, fire walls and containment pit in preparation for final protective coating application. (July 15, 2016)

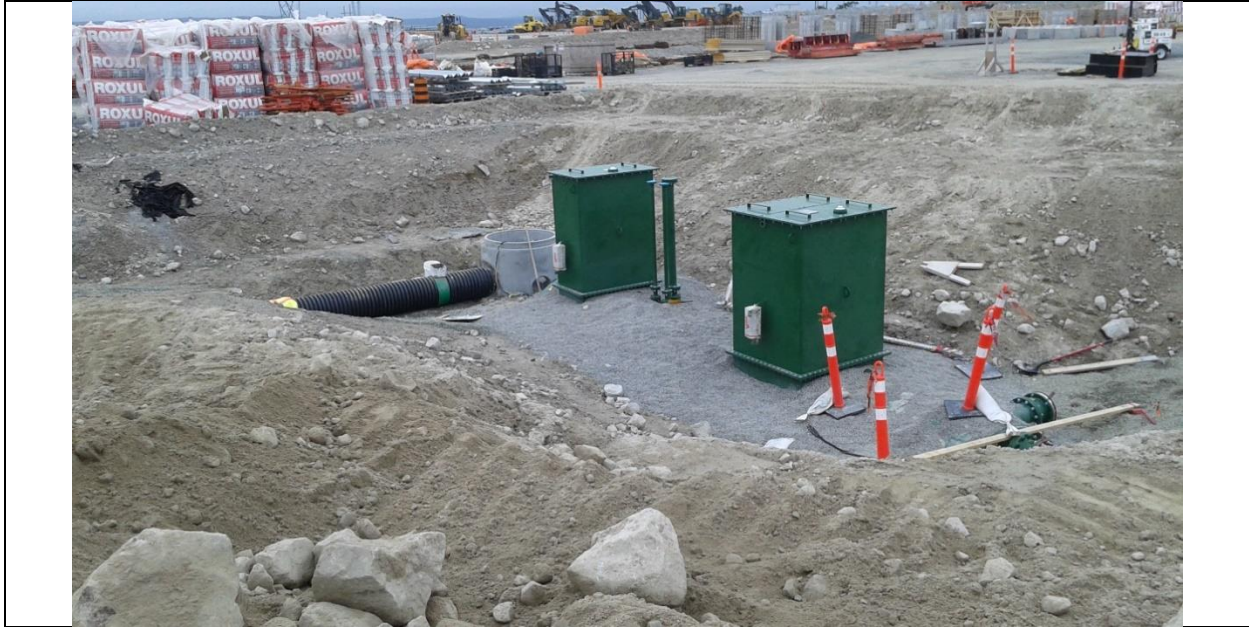
- Works on the three SC Exciter Transformer concrete foundations were ongoing and nearing completion (Photo I.16).
- Testing of the oil/water separator has been completed and the tank was partially backfilled (Photo I.17).

**Photo I.16:** Soldiers Pond – Synchronous Condensers transformers and the building on the background. (July 15, 2016)
