**RELIABILITY STUDY
OF TRANSMISSION LINES
ON THE AVALON AND CONNAIGRE PENINSULAS**

Asim Haldar, Ph.D., P. Eng.
Sr. Engineer
Technical Support,
TRO Engineering

April, 1996

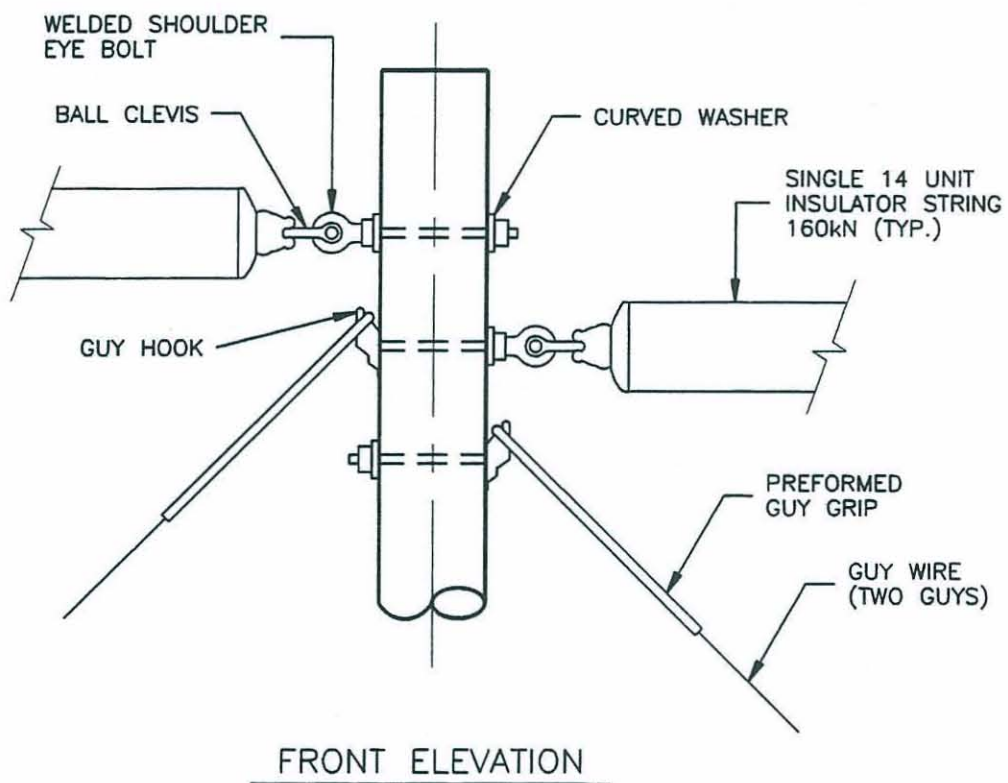
During this sleet storm, a number of lines that failed are detailed in Table 2.3. TL201 failed due to significant movement of a guying arrangement at a large angle structure location and this guying arrangement was subsequently modified (refer Fig. 2.7) under Work Order No. 5092 and implemented at various locations by Hydro forces in 1985. Failure of TL217 was also caused due to the collapse of a large angle (self-supported) structure (C-Type) thus causing a severe cascading failure. TL237 failure was primarily caused due to the conductor breakage in tension under 1.60 inches (41 mm) radial ice load. In all areas, ice load far exceeded the original design criteria and more than 2.0 inches (50 mm) of radial ice was observed at various places (refer Photos #2.1 and #2.2).

230kV TANGENT DEADEND ARRANGEMENT
(ORIGINAL DESIGN)

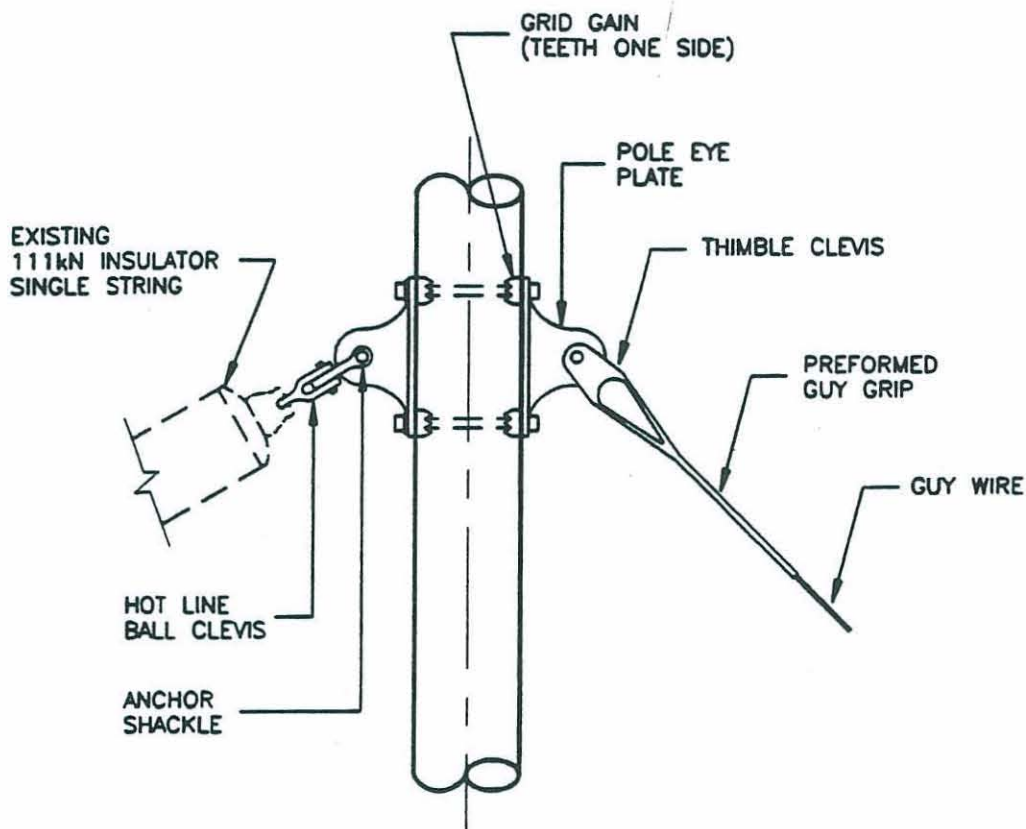
POLE EYE PLATE ARRANGEMENT ON
230kV ANGLE STRUCTURE TYPE "C" - TL201 & TL203
(REPLACES EXISTING GUY HOOK & BALL LINK EYE BOLT ARRANGEMENT)

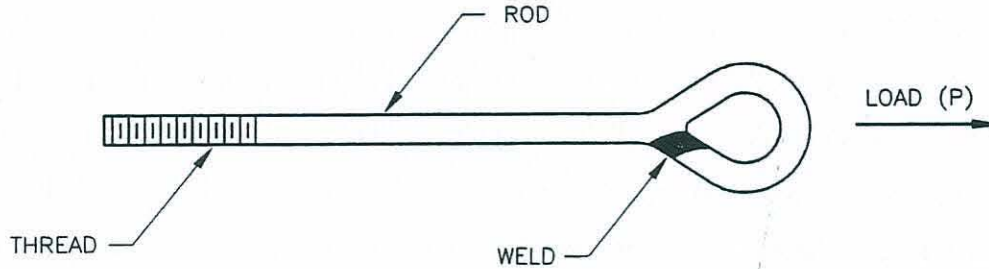
FIGURE 3.1

Eye bolts received from the failed line were taken to the strength laboratory of Memorial University and a direct pull test was performed on each bolt sample. Fig. 3.1 depicts the direction of the pull with the Table 3.2 presenting the mean value and standard deviation of the rated strength. Minimum guaranteed rated strength of this bolt should be approximately 25,000 lb (based on 3 standard deviation) with a coefficient or variation of 5%. One (1) failure out of four (4) tests occurred at the weld where it opened prematurely. Strength reported under Test No. 5 was not carried out at the laboratory rather estimated based on the strength coordination of heavily loaded iced conductor with the failure of the welded eye bolt. In this case, conductor did experience approximately 1 1/2 ~ 2.0 inches (38 mm - 50 mm) radial ice on December 8, 1994 (refer Photo #2.5) between structure #2 and #3 with a span of 2039 feet (620 meters). It is estimated that conductor tension will be approximately 24,000 lb under this load which is very close to the strength of these bolts considering the failure occurring at weld.

WELDED EYE BOLT

To improve the strength of the conductor hardware assembly, it is recommended that all welded eye bolts should at least be replaced by forged eye bolts where the strength of the bolt will only be governed by failure occurring at the threaded root. However, this still will not provide adequate strength when ice load on the conductor is being exceeded. TL201 and TL217, in general, have experienced 4 major failures (combined) in the past 30 years (Table 2.11), with an average failure rate of 1 failure in 7.5 years. TL201 alone has experienced 2 major failures in the past 30 years i.e.: 1 failure in 15 years (Table 2.9). Table 4.6 provides information on probability of encountering an ice storm as 49% (third storm) which is quite high when compared to a 50-year load which is only 5%. As these lines were designed with ice load as 1.0 inch (25 mm) radial which has been underestimated severely with regard to a real 50-year load, probability of a line failure, in future, is extremely high. Therefore, standard dead-end assembly shown in Fig. 5.3 is strongly being recommended in view of Item (d) in Section 5.4.1. To improve the strength of the conductor itself, several discussions were held with Aluminum Company of Canada (ALCAN) (Ref. 14) and it was suggested that a high strength special alloy conductor (equivalent to "Drake" 795 ACSR 26/7 in ampacity) be used for re-conductoring option. Strength of this 804 kcmil conductor is twice that of "Drake" and Table 5.6

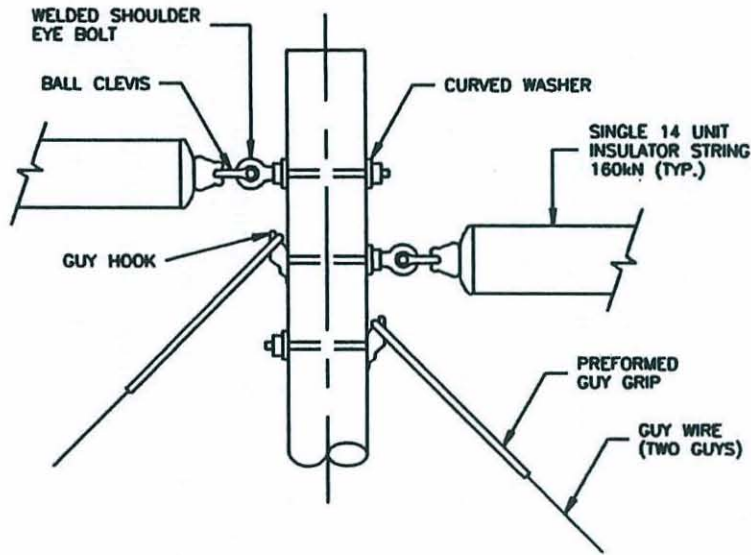
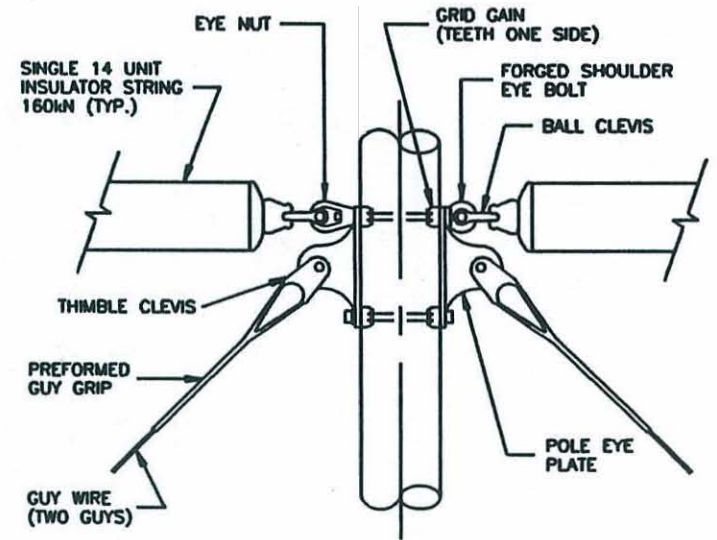
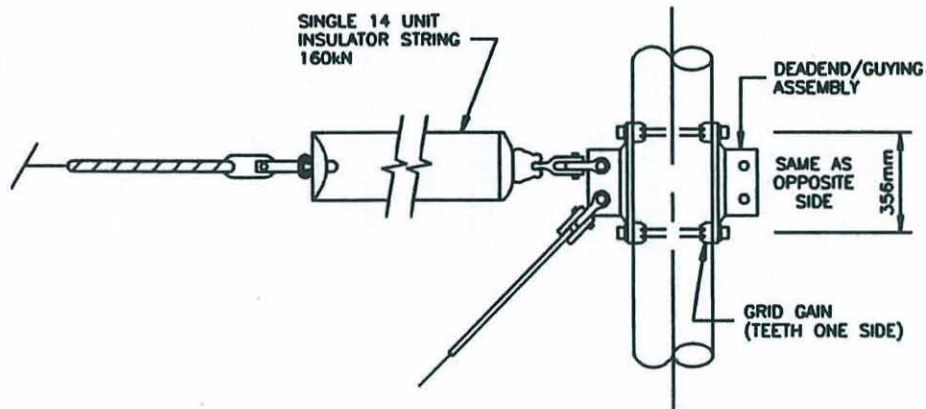
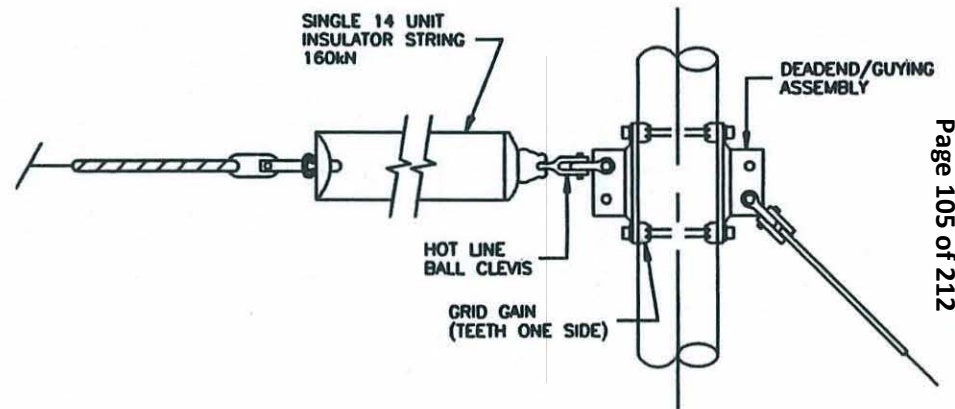
FIGURE 5.3

230kV TANGENT DEADEND ARRANGEMENT
(ORIGINAL DESIGN)

230kV TANGENT DEADEND ARRANGEMENT
(MODIFIED DESIGN - 1987)

230kV TANGENT DEADEND ARRANGEMENT
(SINGLE INSULATOR STRING - CURRENT STANDARD)

230kV ANGLE DEADEND ARRANGEMENT
(SINGLE INSULATOR STRING - CURRENT STANDARD)

This option includes implementation of all works associated with installation of full dead-end assembly on all existing dead end structures (Fig. 5.3). These are 19 on TL201, 43 on TL203 and 11 on TL236 respectively. In addition, scope of work includes installation of pole eye plates (Fig. 5.5 and 5.6) on light and medium angle wood pole structures (11 structures on TL201 and 1 structure on TL203, respectively) and replacement of fifteen (15) type F structures (uplift structures) on TL201, six (6) on TL203 by dead-end. Under this option, six (6) dead-end (anti-cascading) structures on TL201, two (2) on TL203 and eleven (11) on TL236 will be added to wood pole lines with particular reference to security containment. For steel tower lines, one (1) structure on TL207, three (3) structures on TL237, four (4) structures on TL217 and two (2) structures on TL218 will be added as anti-cascading towers with particular reference to security containment. Even though reliability increase will be marginal, security will be improved substantially.

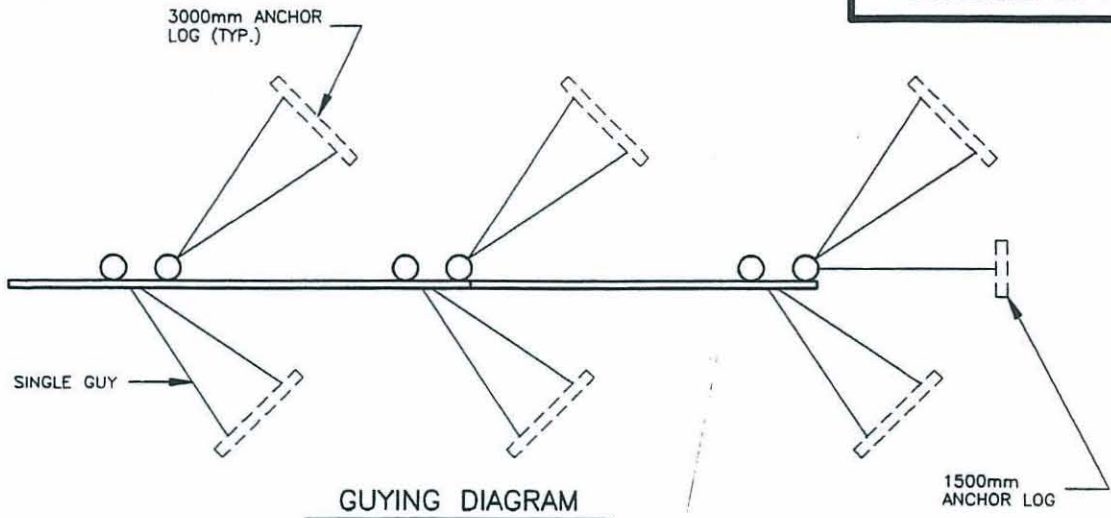
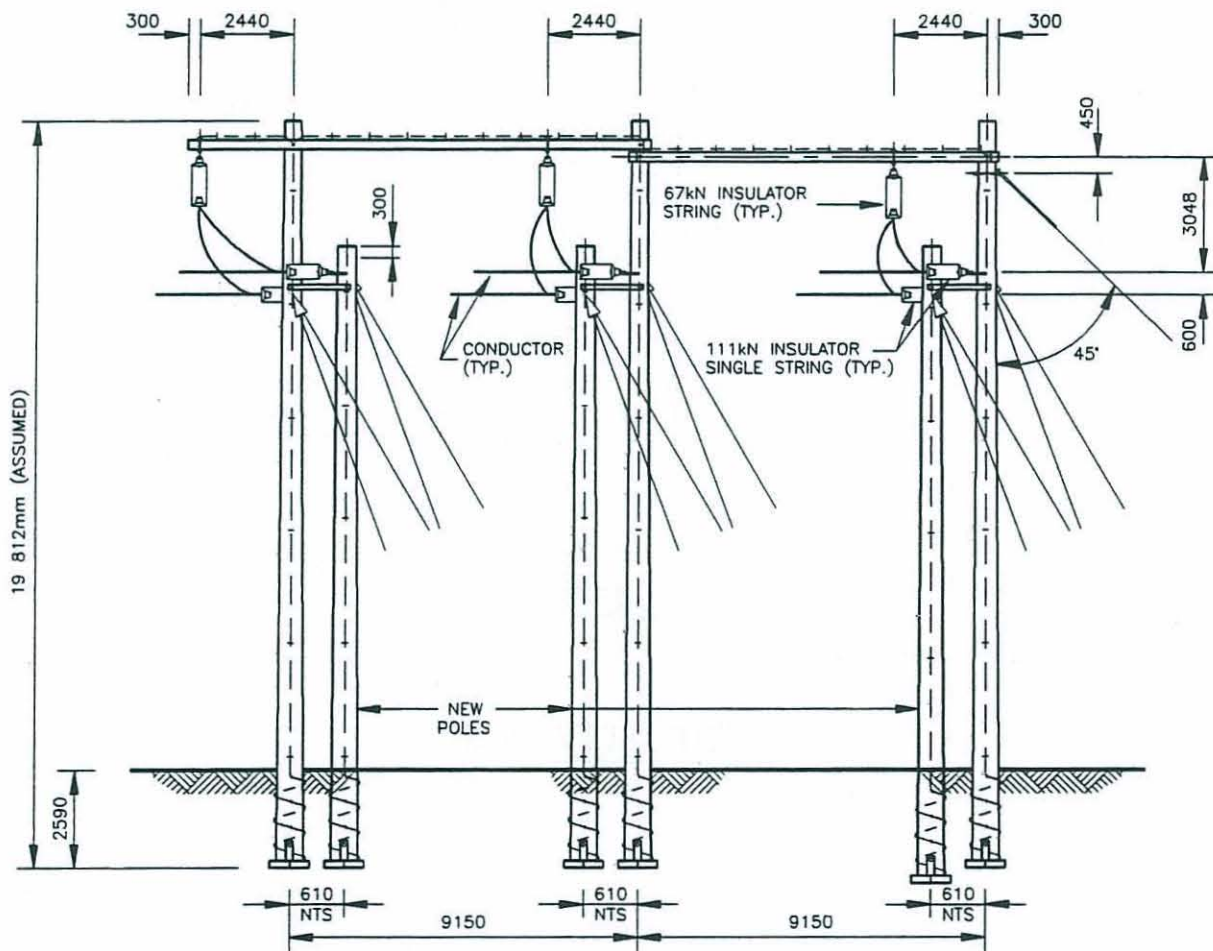
FIGURE 5.5

One of the weaknesses that has generally been observed in lines on Avalon Peninsula is minimum protection against failure containment loads (security requirements) particularly with regard to wood pole lines such as TL201. There may have been more than seventy (70) structures placed in "series" without any

TYPICAL 230kV STRUCTURE TYPE "D"
 UPGRADED TO 6 POLE DEADEND
 (ANGLE DEADEND - NORMAL ZONE - TL201)

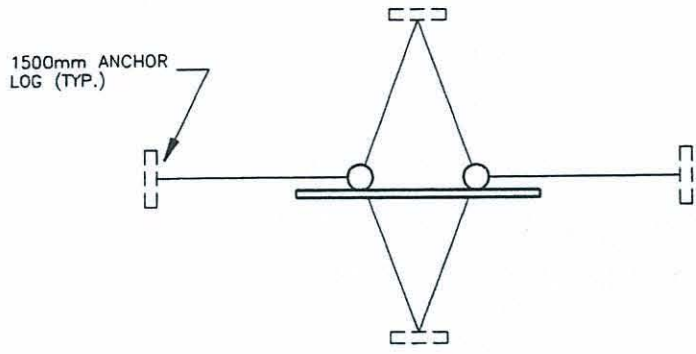
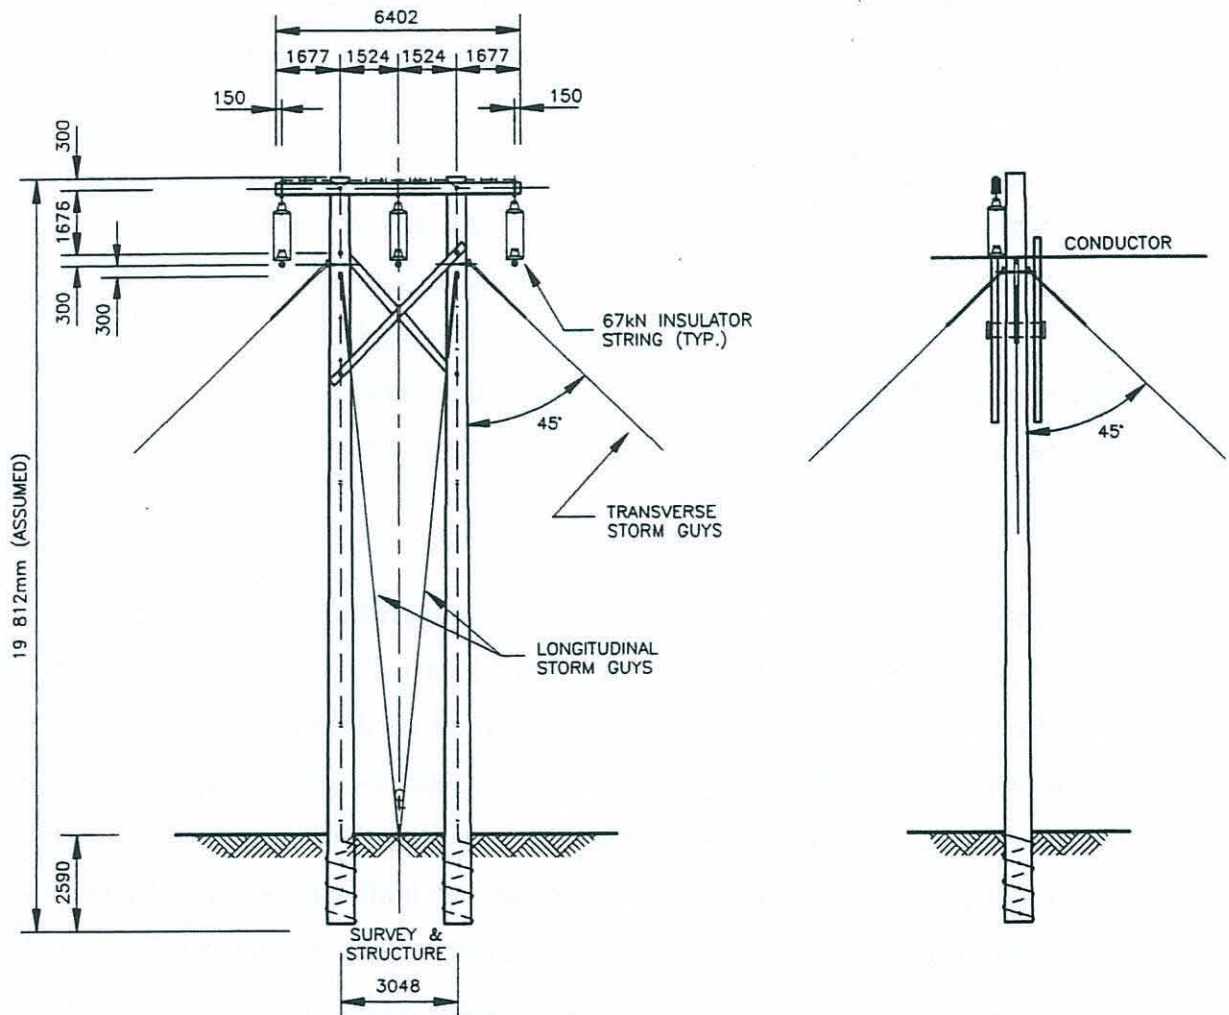
FIGURE 5.7

EXISTING 69kV STRUCTURE TYPE "A"
WITH STORM GUYS ADDED

(TANGENT - TL220)

The suggested improvement of TL220 is based on upgrading and/or building a new section of the line to revised 50-year, return period load as 2.0 inches radial (refer Table 4.10). Conductor was chosen as a 559 Kcmil Alloy conductor and typical structure would be wood pole H-Frame. Upgrading would include re-conductoring 17 km section from Str. #89 to English Harbour station by installing double crossarms on every structures, strengthening 3-pole dead-end structures etc; building new line sections would include approximately 18 km to 35 km of lines depending on the particular option selected. Details of these various options are discussed further in Section 7. Due to one (1) wind storm damage earlier, Fig. 5.7 presents the typical storm guying arrangement that needs to be implemented on TL220.
