Muskrat Falls Generation

Independent Dam Safety Program Audit

Audit #3

November 27 to 30, 2017

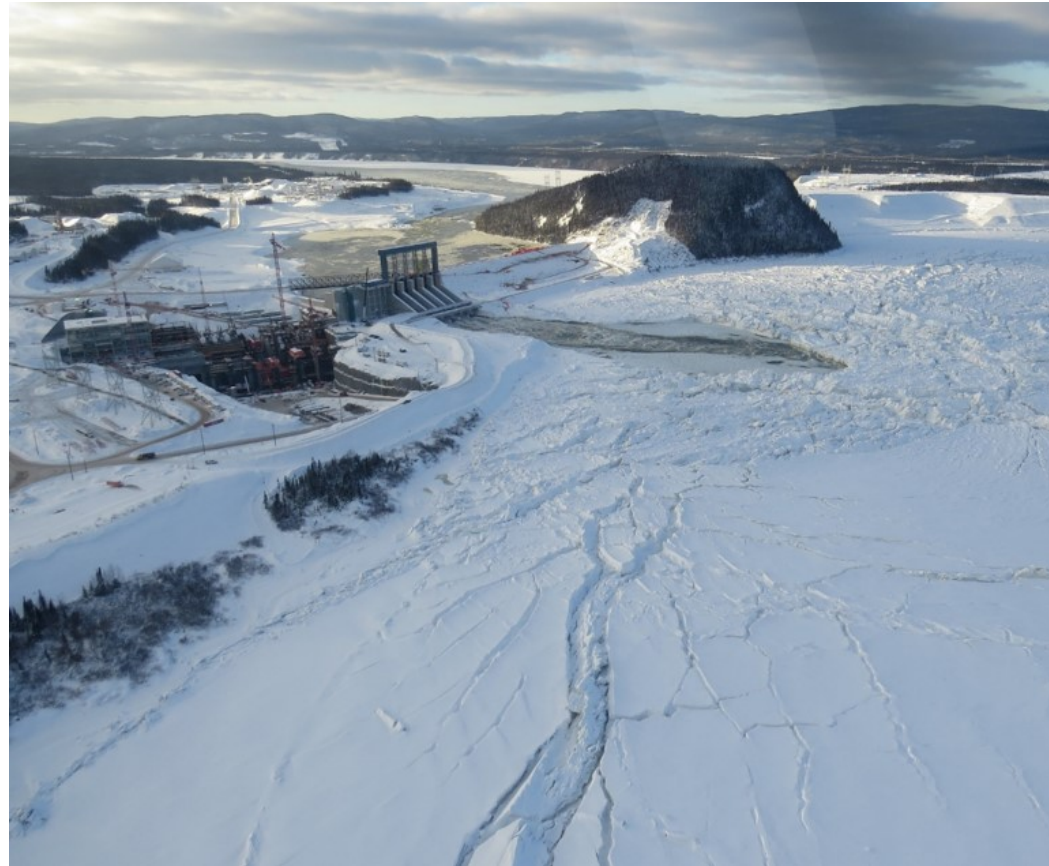
- South Dam
- Intake/Powerhouse
- **Spillway**
- North Dam
- **North Spur**
- **Transition Dams**
 - North
 - South
 - Centre
- **Separation Wall**

Highlighted structures have water impounded against them to el. 22.5 m

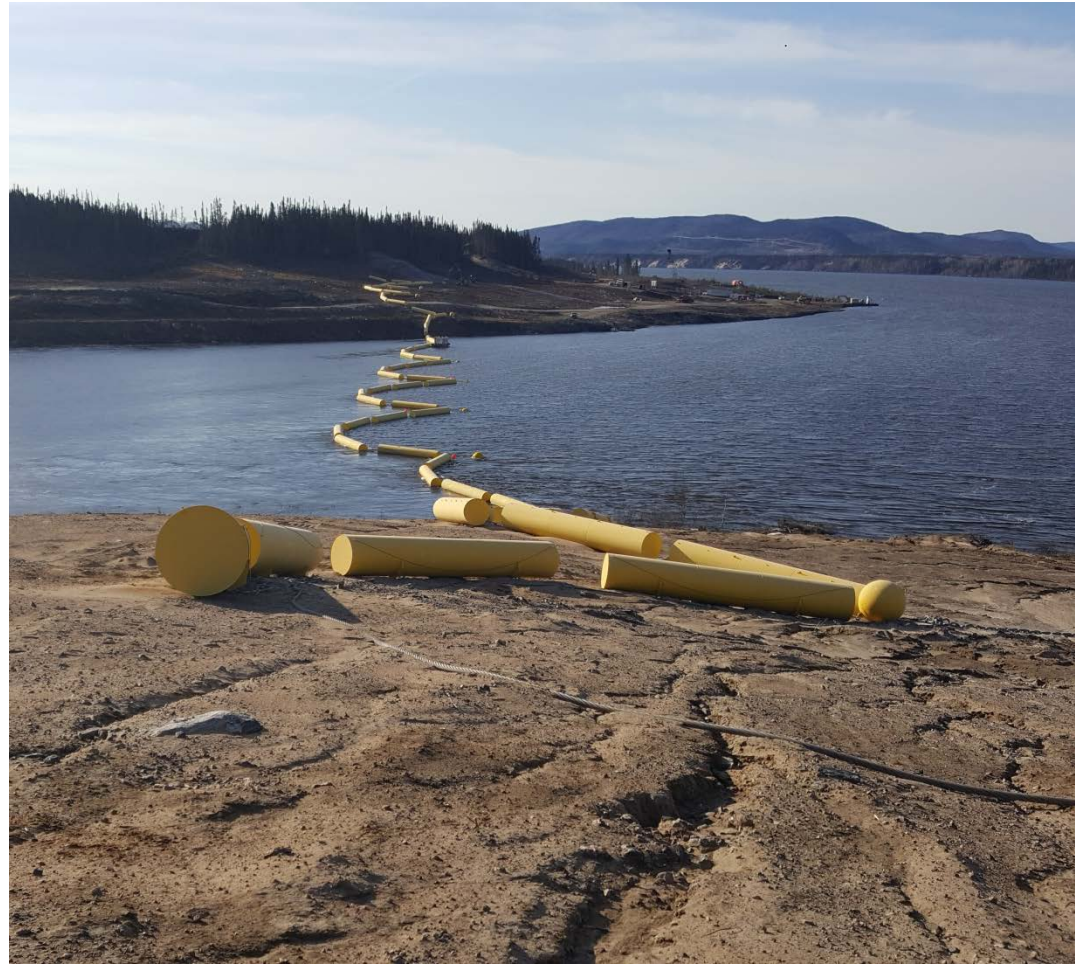
The ice/safety/debris boom

- Installed October 2017
- Permanent structure located 1.2 km U/S of the Spillway
- 12 spans of highly visible yellow steel pontoons
- Extension for full supply phase completed
- Promote formation of stable ice cover
- Visual safety warning to public users on the river
- Self-rescue mechanism
