Is the North Spur dam safe?

I have written several articles about my concerns regarding the safety of the North Spur dam, concluding in my last article that the dam was not safe. However, on undertaking a more detailed analysis of the NALCOR reports, I have changed my mind, and now believe the dam to be safe.

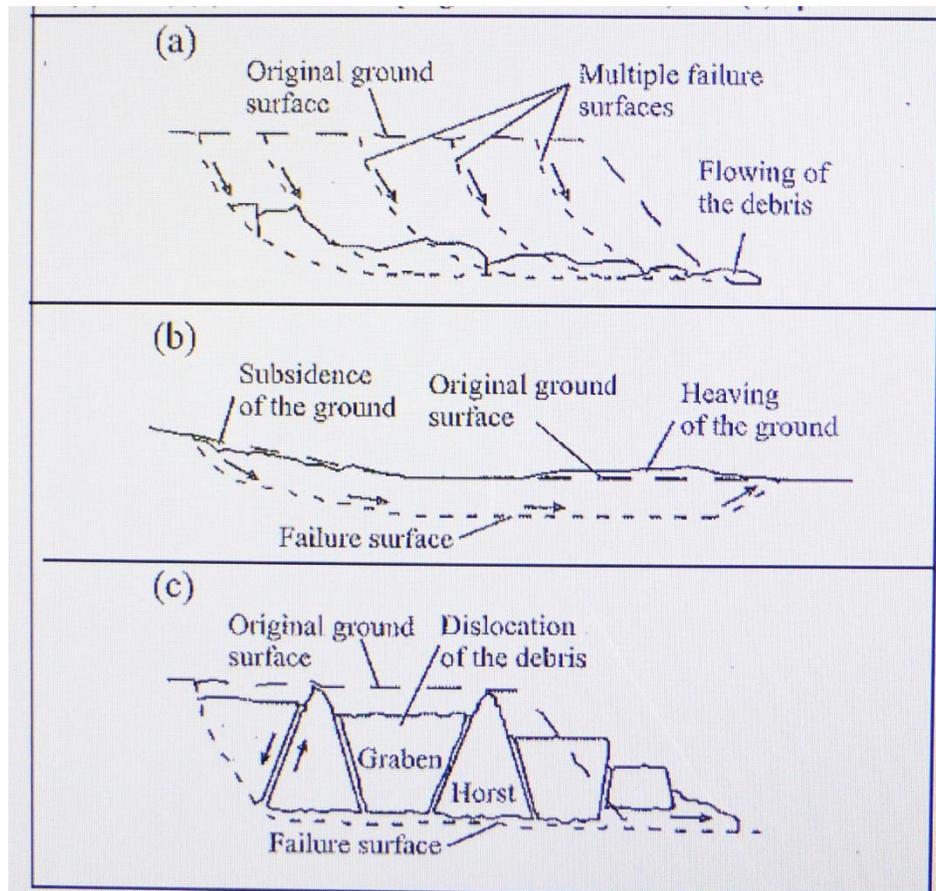
Figure 1.

(a) Flowslide (b) Downhill progressive landslide. (c) Uphill progressive landslide.

Source Dr. Ariane Locat, Serge Leroueil, Stig Bernander, Denis Demers, Hans Petter Jostad, Lyes Ouehb . “Progressive failures in Eastern Canadian and Scandinavian sensitive clays” Canadian Geotechnical Journal, 2011. 48 (11).

My initial concerns centered on the report by Dr. Bernander identifying many progressive landslides in the river valley near the North Spur. What is a progressive landslide – it is a landslide which can occur in soft (quick) clays where the land mass slides downhill on failure of a weak zone below the surface, as shown in Figure 1, sections (b) and (c).

Dr. Bernander, after inspecting the river banks and the North Spur shoreline, concluded “For the most recent large slide in the North Spur, in 1978, Nalcor’s own engineers found that the silty clay layer **had developed multiple failure surfaces and liquefied over a long lateral distance**”. Sources Bernander 2015 report, pages 7. No such statement could be found in the NALCOR 2015 report, on liquefaction in the 1978 landslide. In fact, the landslide is identified as being of the flow type – see Figure 1 (a) – “The slide involved a block movement triggered by weak layers

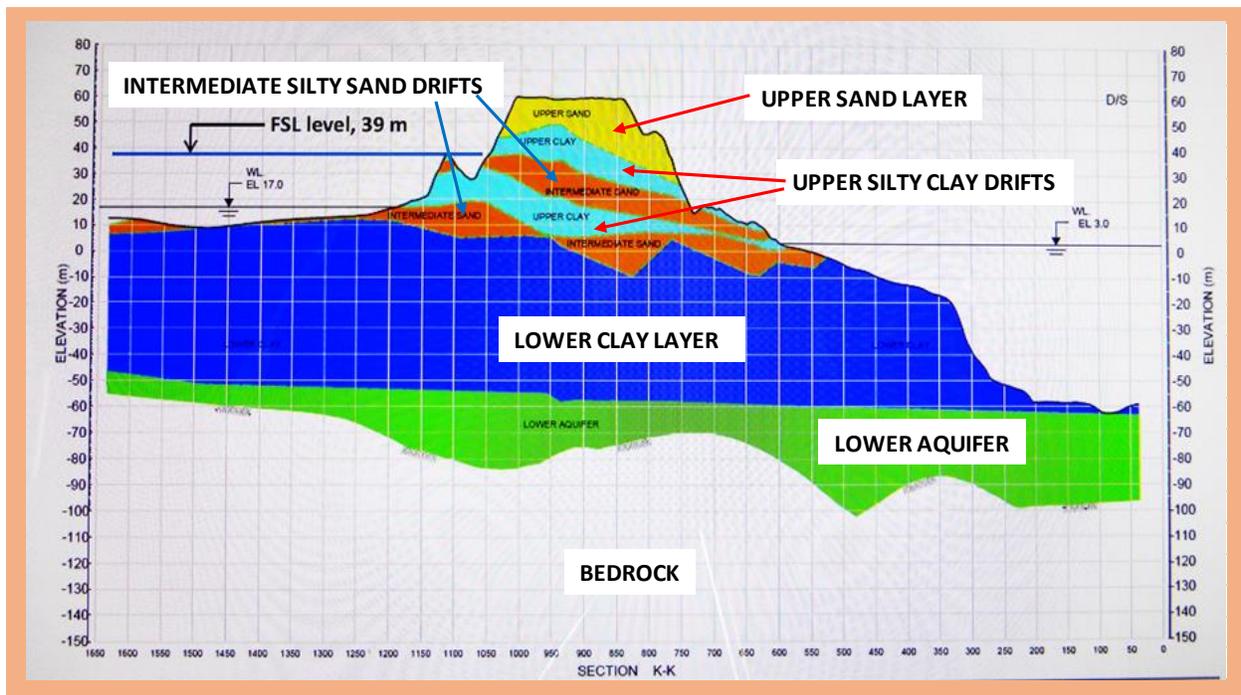
Figure 2.

Section through the North Spur – vertical scale exaggerated for clarity. Shows the layers of sands and clays within the Spur. Source – North Spur Updated, Independent Engineer, 21.7.14.

A few tests on soil samples retrieved from the two "Upper Silty Clay Drifts" – see Figure 2 have indicated the presence of soft clays. The sensitivity ranged from 1 to 36 in 43 samples, with an average of 10. Source NALCOR 2016 report. Page 91. This is not soft enough to be considered "quick", according to Carlton U. Moreover, during the excavation work required to re-shape the North Spur, there were no instances of liquefaction nor small landslides. All clay removed by shovels and dumped into trucks remained in clumps. This indicates that the pockets of quick clay (if any) were far too small to cause landslides.

Dr. Bernander also reviewed the data available on the lower clay layer (See figure 2). This layer provides the foundation for all the soils above water level in the North Spur. Again, Dr, Bernander concludes *"... that layers with high sensitivity also occur in the Lower Clay formation – a fact that allows the possibility of developing a progressive failure"*. Source Bernander 2016 report, page 8.
