Nalcor Energy - Lower Churchill Project

North Spur Dam Break Analysis

Final Report

MFA-HE-CD-2800-CV-RP-0001-01 Rev. B1 June 26, 2015

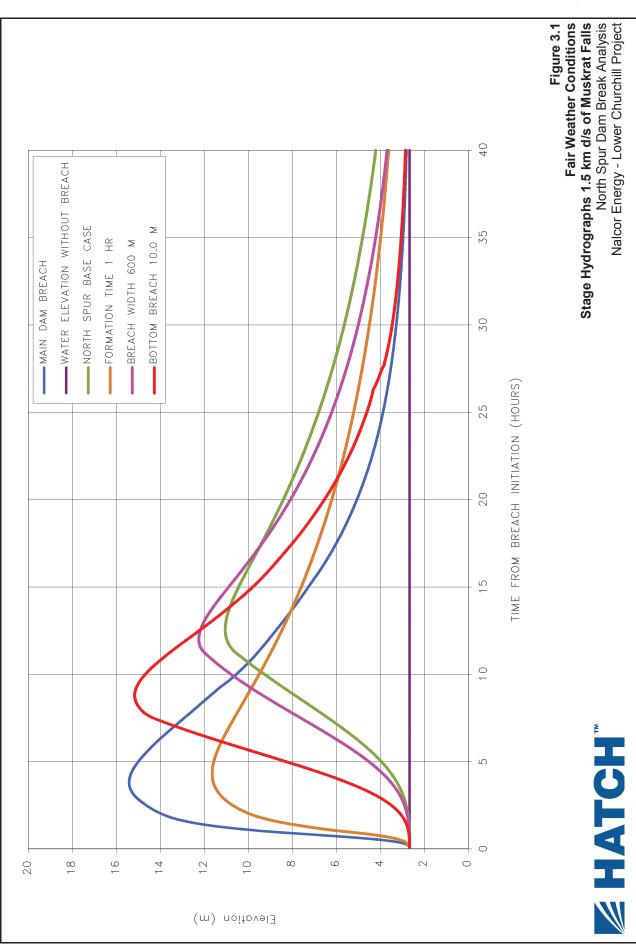
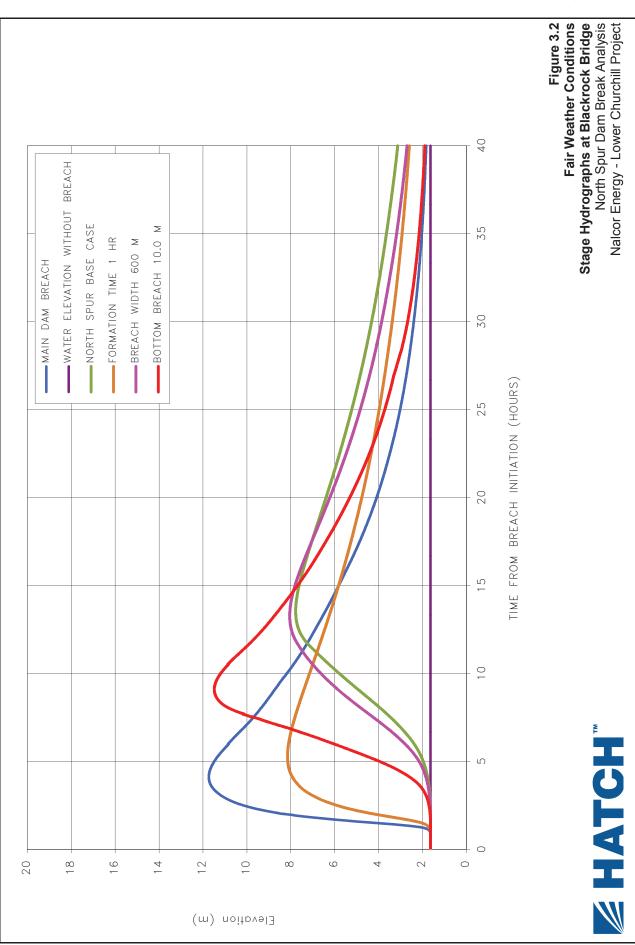
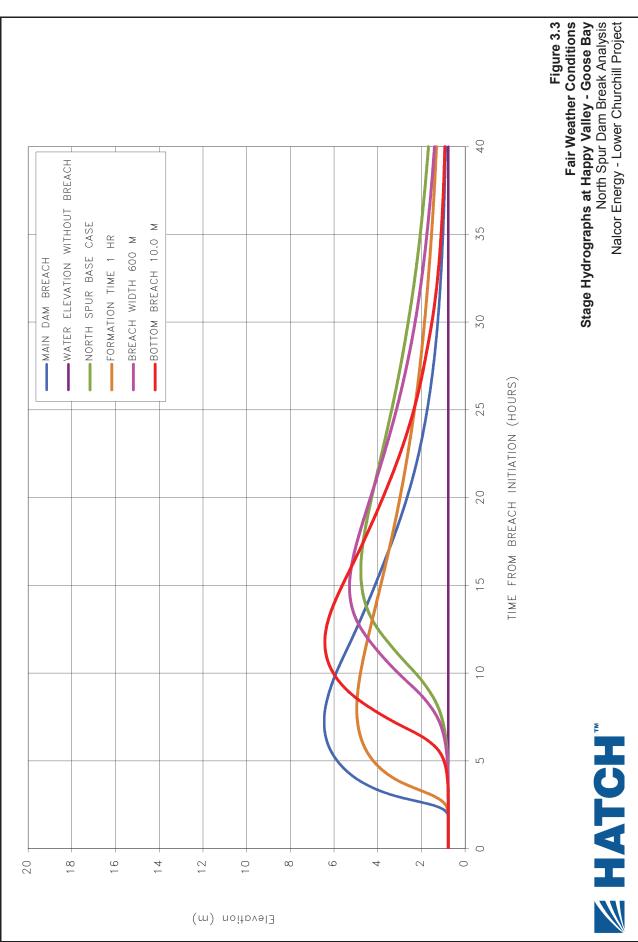
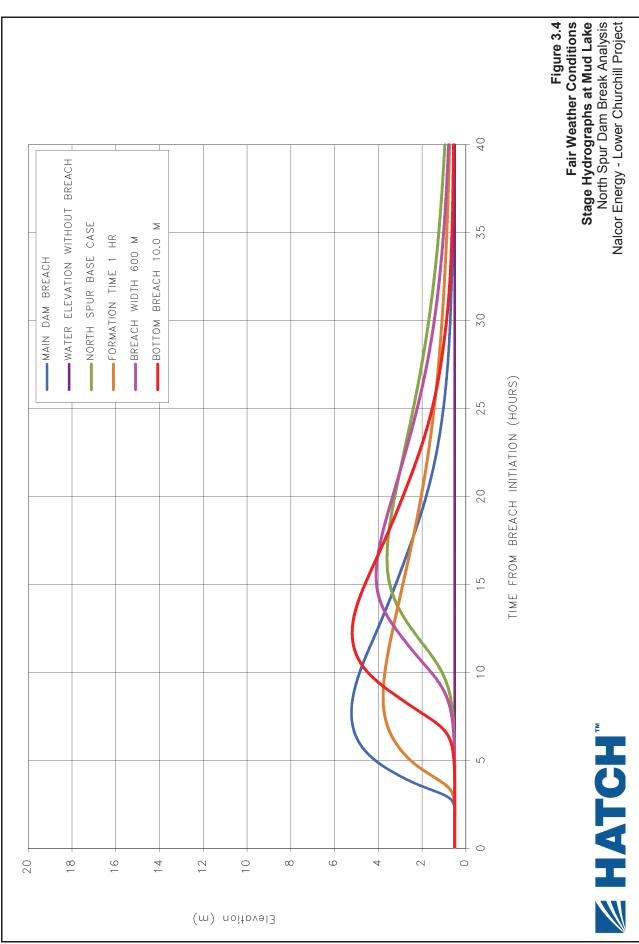
Simulations were undertaken to estimate the impacts of a hypothetical breach of the North Spur on downstream water levels during "fair weather" conditions. The analysis included simulations to test the sensitivity of the results to variations in individual parameters. Table 3-1 below summarizes the results for a number of key downstream locations. For comparison, results from MF1330 for a hypothetical breach of the North Dam are included. Figures 3.1 to 3.4 present the stage hydrographs for key locations, and Figures 3.5 to 3.8 present the flow hydrographs.

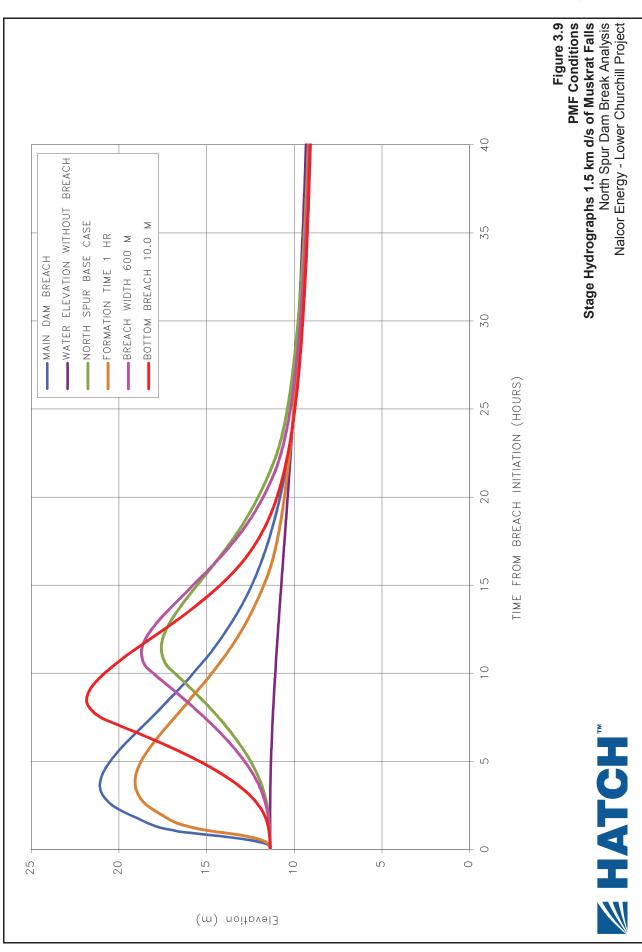
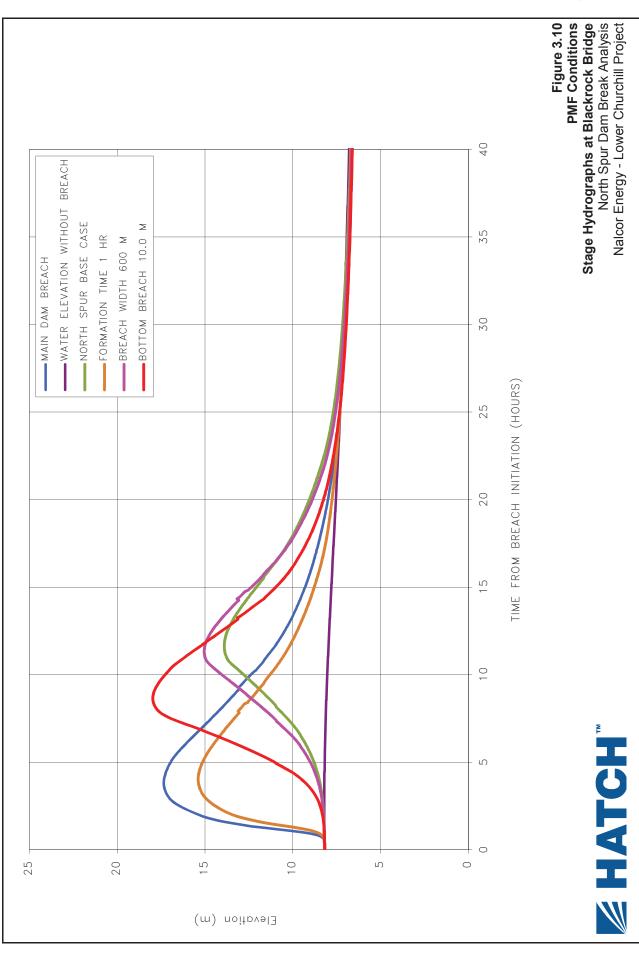
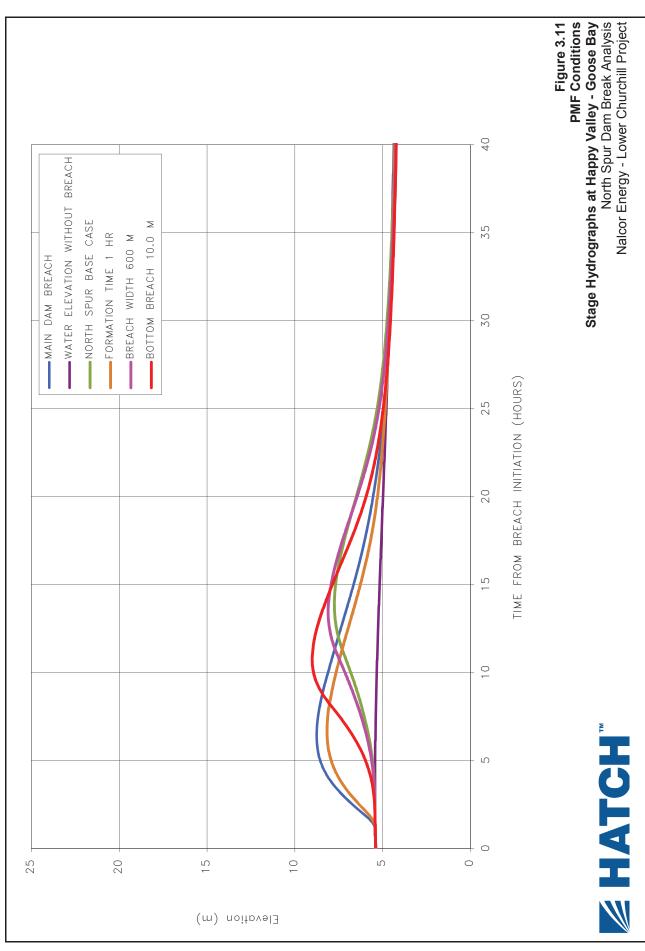
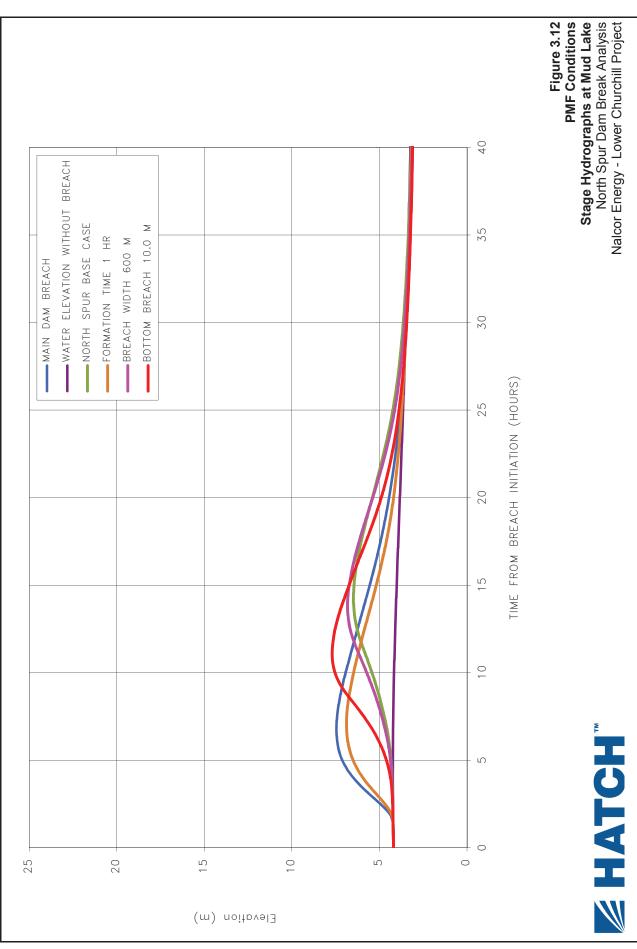
Simulations were undertaken to estimate the impacts of a hypothetical breach of the North Spur on downstream water levels during PMF conditions. The analysis included simulations to test the sensitivity of the results to variations in individual parameters. Table 3-2 below summarizes the results for a number of key downstream locations. Figures 3.9 to 3.12 present the stage hydrographs for key locations, and Figures 3.13 to 3.16 present the flow hydrographs.
