Lower Churchill Project

ENGINEERING REPORT

North Spur Stabilization Works

Progressive Failure Study

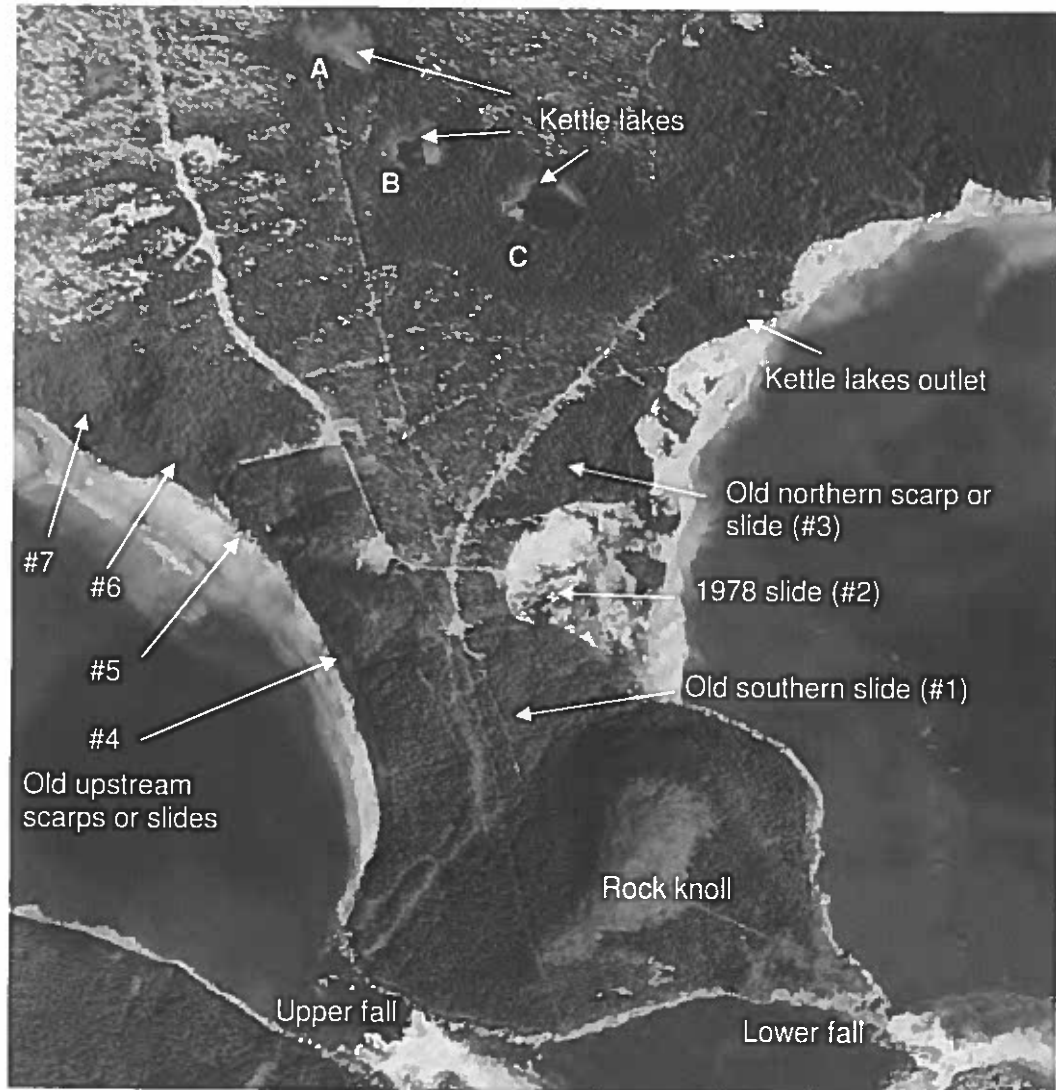
Figure 1-1 : Aerial photo of the North Spur (1988)

On the downstream side of these sections where landslides have already occurred (see Figure 1-1 and 3-1), the slope is gentler and the presence of slide debris in the toe area has a stabilizing effect. On the upstream side of the spur, the height of the slope relative to the toe elevation is lower and the presence of the reservoir will have a stabilizing effect. Based on previous seepage analyses, after the completion of the stabilization works, the normal water level below the crest is expected to be at an elevation of 25 m at a distance of 20 m from the crest as illustrated on Figure 2-5; a conservative water table elevation of 30 m was assumed in the analyses.

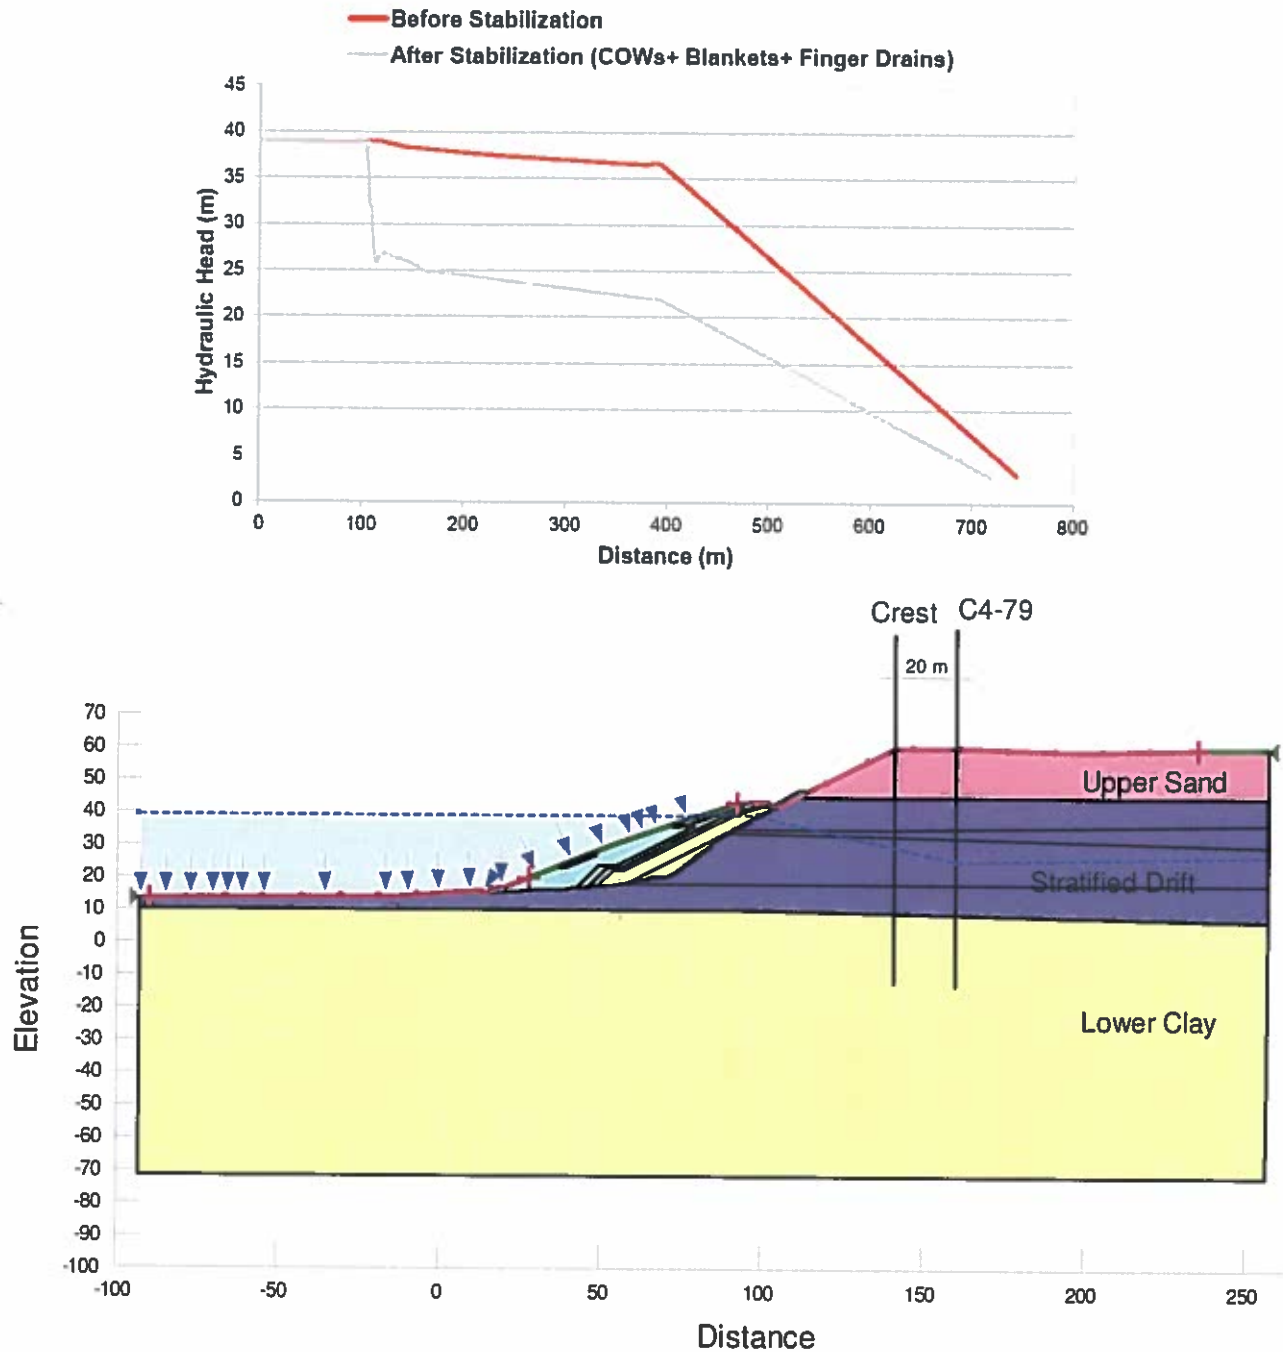
Figure 2-5 : 3D Hydrogeological Study (Hatch, 2015) Results for Full Reservoir Impoundment

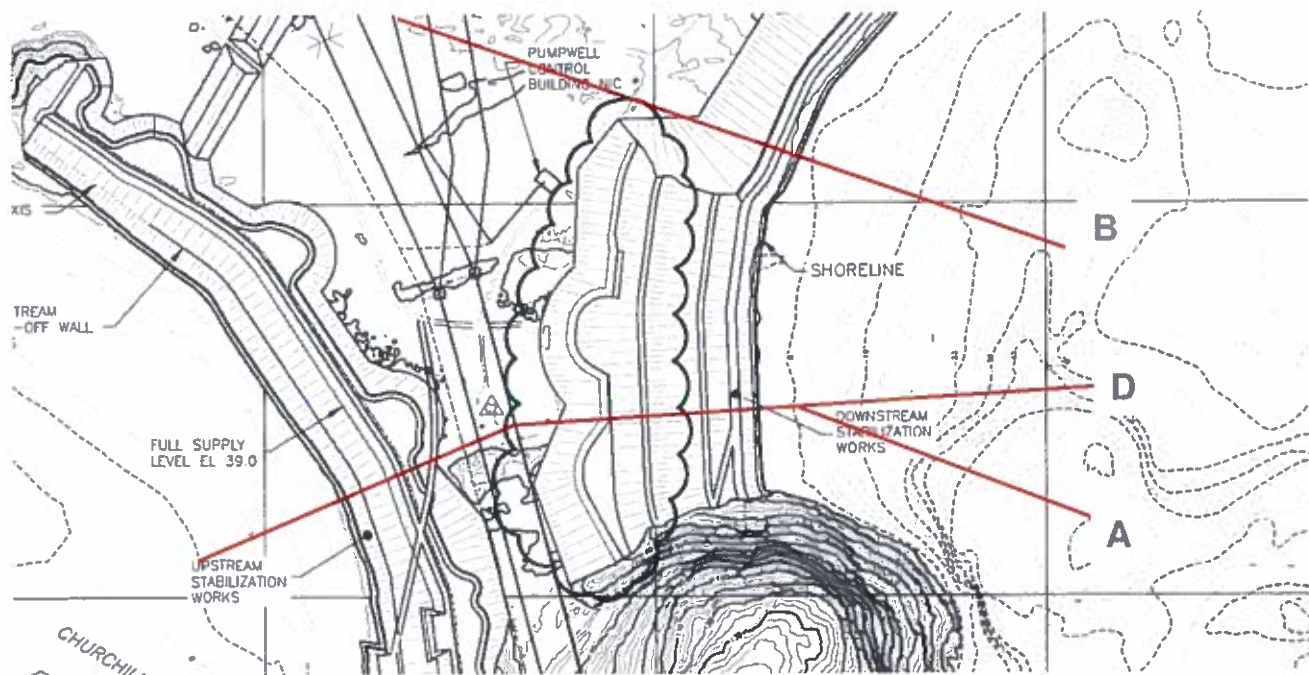
Figure 5-4 : Localization of Sections Analysed for Stabilized Conditions

Three cross-sections were selected in the southern portion of the Spur where the crest is already narrow due to past landslides. These sections are located in plan on Figures 5-1 (present conditions) and 5-4 (stabilized conditions) and are shown on the figures of Appendix A:

- Section C-C shown on Figure 5-4 was also analyzed but not retained because it was judged less representative than Section D-D.

The narrow sections illustrated on Figure 5-4 were analysed using the same methodology and the results are illustrated on the figures of Appendix C. Section D-D was selected as representative of the narrow part of the Spur with the steepest stabilized slope (see localisation on Figure 5-4). The results of analyses for Section D-D are presented on Figure 7-10. Three conditions were analysed: before stabilization, after stabilization and after reservoir impoundment at elevation 39 m. The model predicts that the stabilization works will produce no significant reduction of the shear stresses on the upstream side of the Spur but a 25% reduction on horizontal plane -10 m in the Lower Clay on the downstream side. This reduction is relative to the conditions before stabilization for which the maximum horizontal shear stresses are already more than 20% below the undrained shear strength measured in CPT and Vane tests.

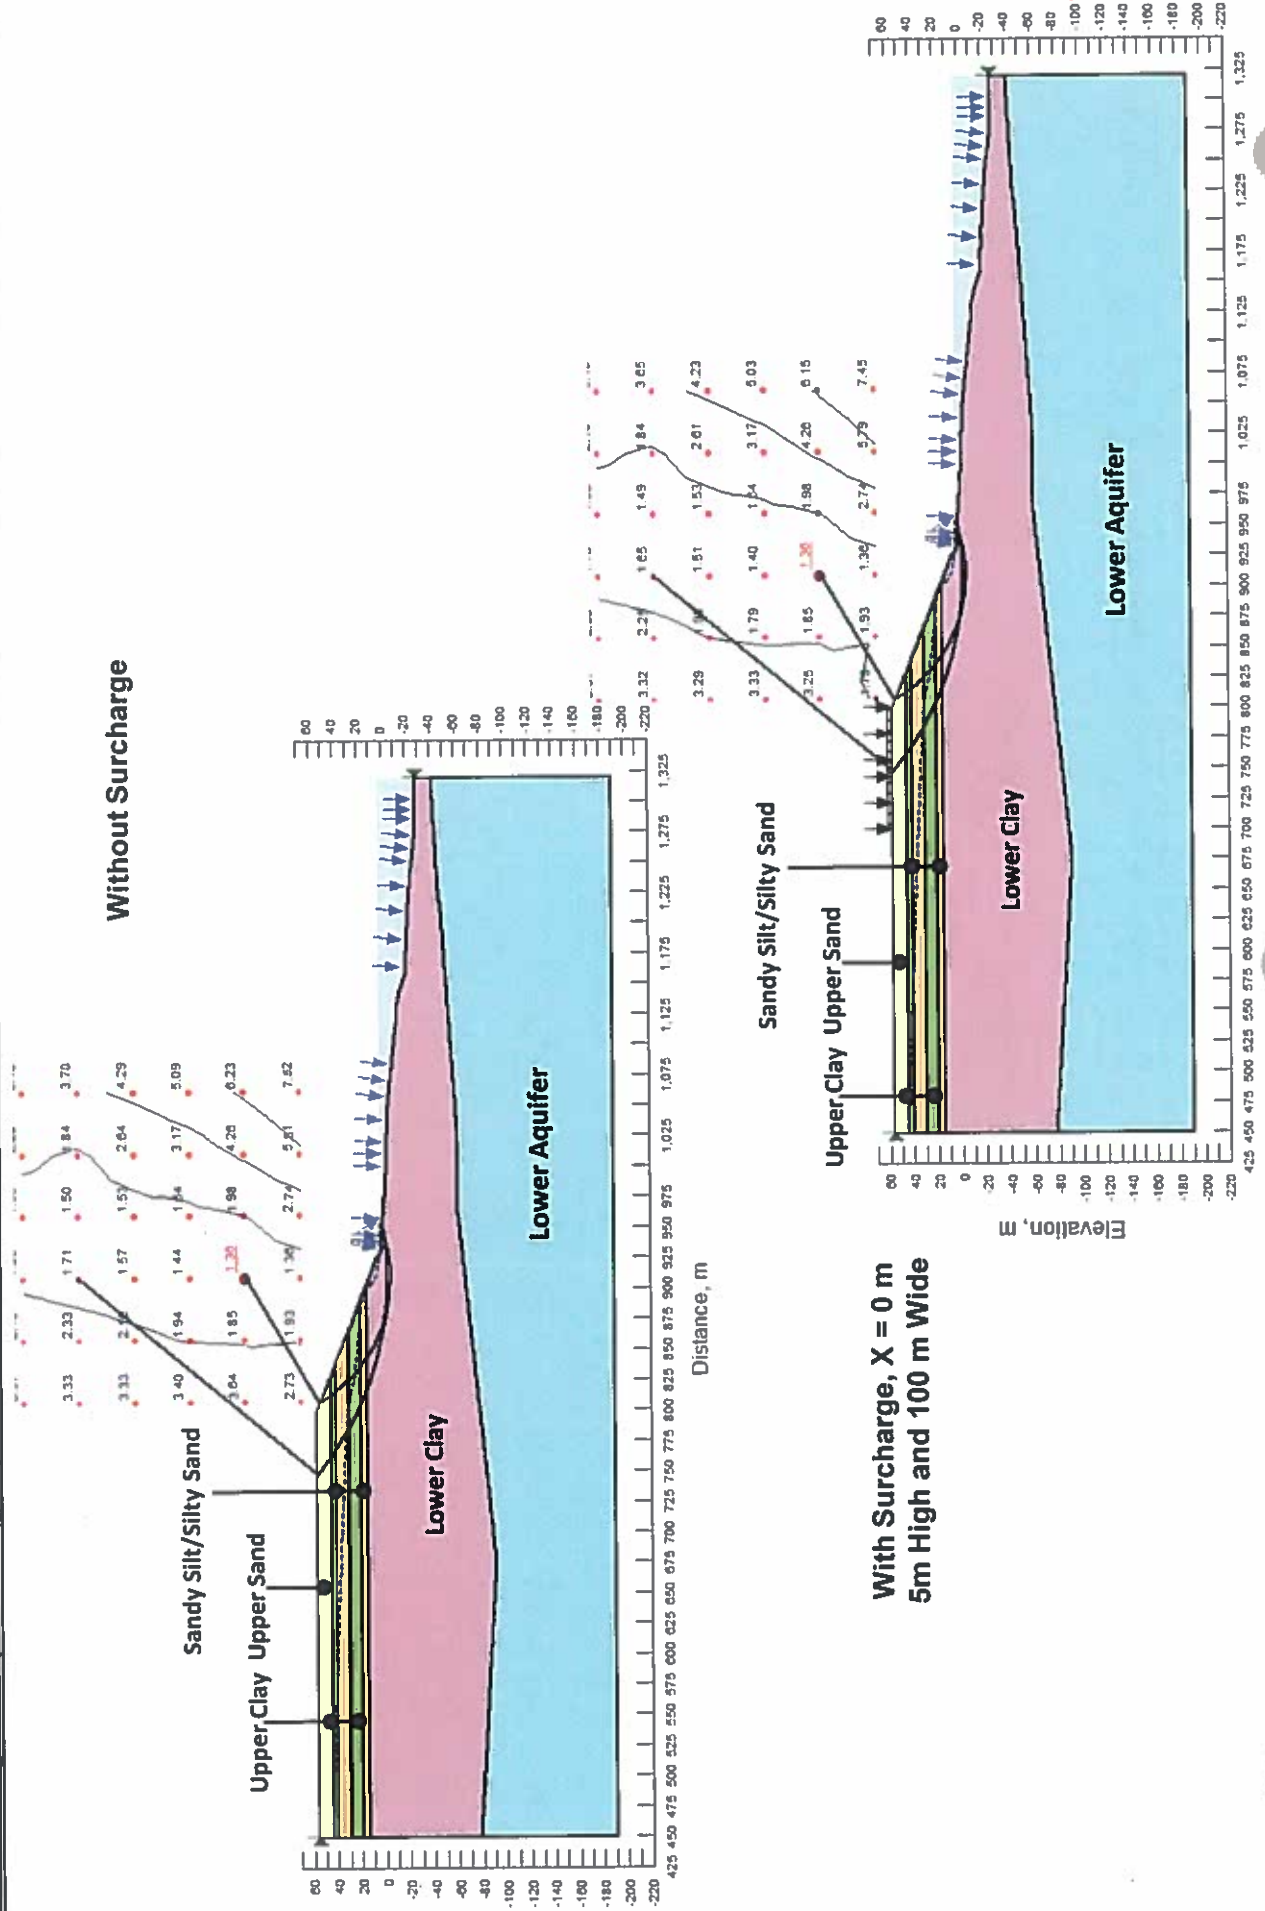
SNC • LAVALIN	NORTH SPUR STABILIZATION WORKS - Progressive Failure Study		Revision
	Nalcor Doc. No. MFA-SN-CD-2800-GT-RP-0001 Rev. A1	SLI Doc. No. 505573-3281-4GER-0001-PB	Date
	Figure C-47	SECTION B-B - EFFECT OF A SURCHARGE – STABILITY ANALYSES	16-JUN-2015
