JIM GORDON'S FINAL COMMENTS ON THE NORTH SPUR

THE NORTH SPUR – MY FINAL COMMENTS

Guest Post by James L. Gordon P.Eng.(Retired)

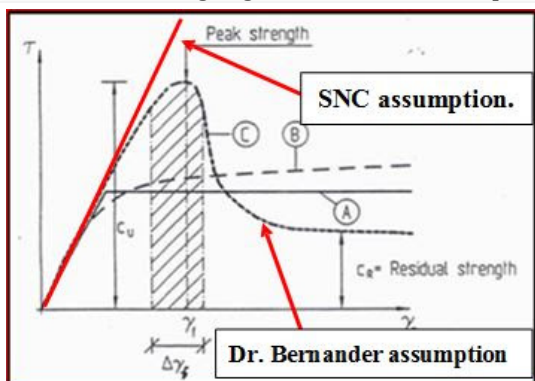
1. The results of stress-strain tests on the soils. This is where Dr. Bernander and the consultant SNC-Lavalin depart in their expectation of the soil strength. SNC-Lavalin have assumed a linear relationship with a softening factor, whereas Dr. Bernander assumes a loss of strength at relatively low levels of strain, as shown in the following diagram extracted from his report.

There is a reference to the strength reduction in the report as follows - *Recent research in Norway (refs. (29) and (30)) recommends the use of the LEM approach in practice for the analysis of slope stability in sensitive and quick clays, with the addition of a correction factor, called $F_{softening}$, to account for the reduction of the clay shear strength after the peak shear strength has been reached, and to partially account for strain compatibility on the failure surface. (Report page 15)*

The report then states - *As an example of the effect of the mitigation measures for a slope on the Eastern side of the North Spur, the critical factor of safety was increased from 1.0 to 1.6. This is a 60% increase in the stability of the slopes, and within the reduction associated with $F_{softening}$, if one should use the results of some of the most recent researches.*

However, there is no discussion on how the $F_{softening}$ factor was determined for the soils in the Spur. It has been assumed from other studies. Since the safety of the Spur is so critical, stress-strain test results should be available for the North Spur soils.

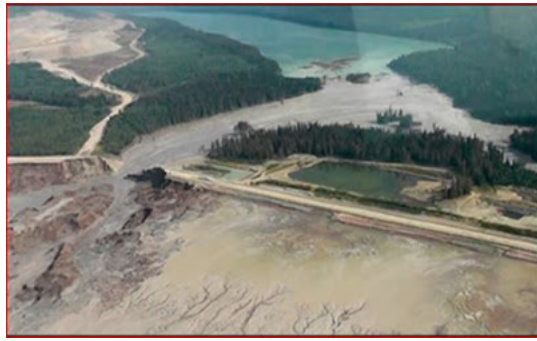
Mount Polley dam in BC. The downstream slope failed on August 14th, 2014.

Report extract - *(The) Independent Expert Engineering Investigation and Review Panel concluded that the dominant contribution to the failure resides in the design. The design did not take into account the complexity of the sub-glacial and pre-glacial geological environment associated with the Perimeter Embankment foundation. As a result, foundation investigations and associated site characterization failed to identify a continuous (soft) layer in the vicinity of the breach and to recognize that it was susceptible to undrained failure.*

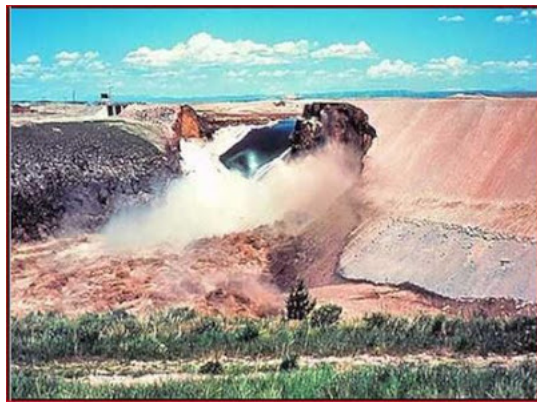
Teton Dam failure due to excessive seepage on first filling. June 5th, 1976. This was the unexpected event which started the dam safety campaigns in North America.
