## **Lower Churchill Management Corporation**

## Muskrat Falls Dam Related Emergency (Full Supply Construction Phase) – Emergency Preparedness Plan

Nalcor Doc. No. MFA-PT-MD-0000-EN-PL-0003-01

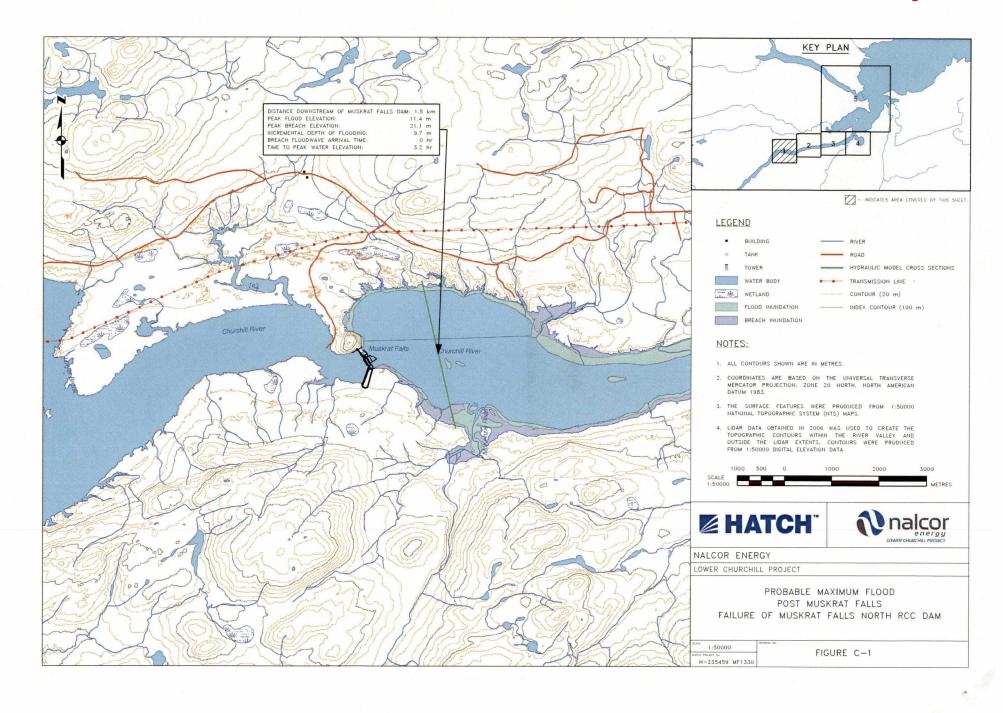
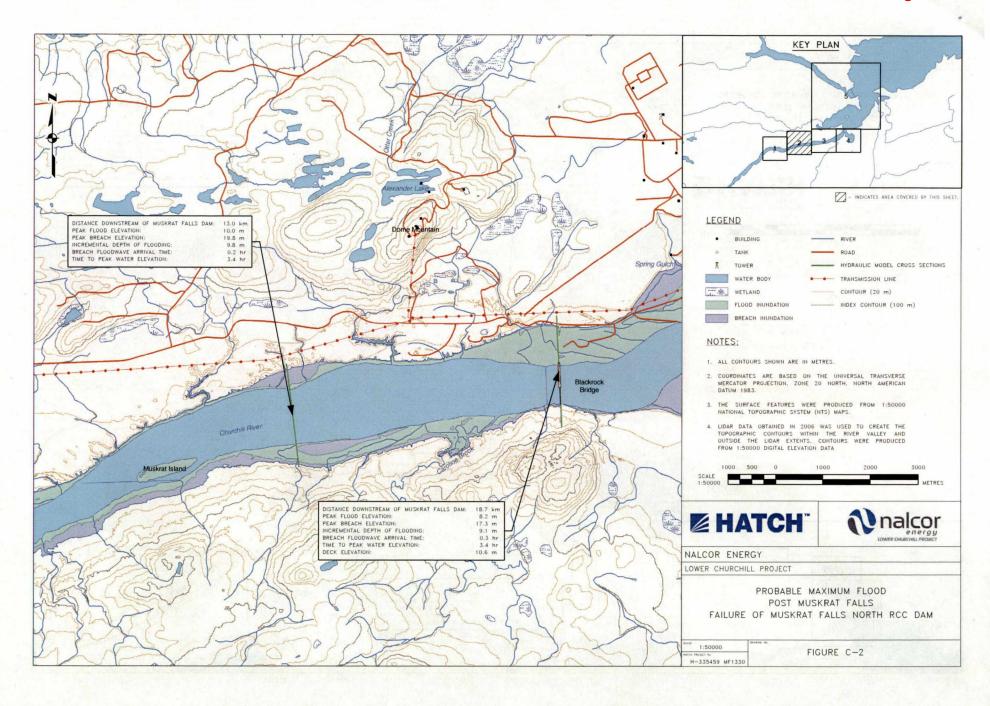
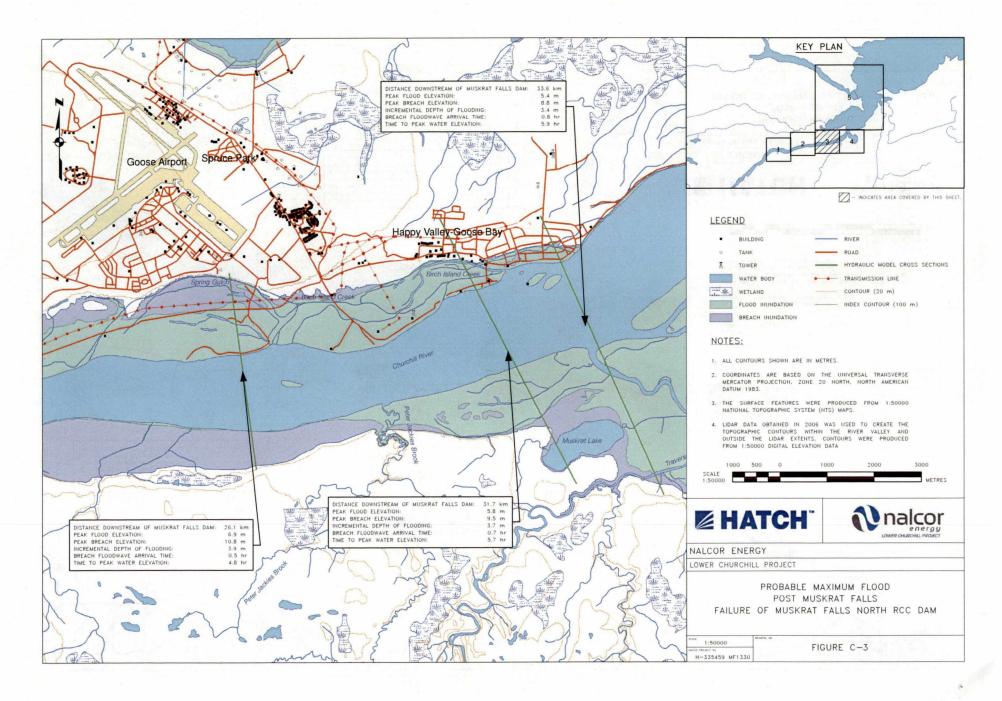
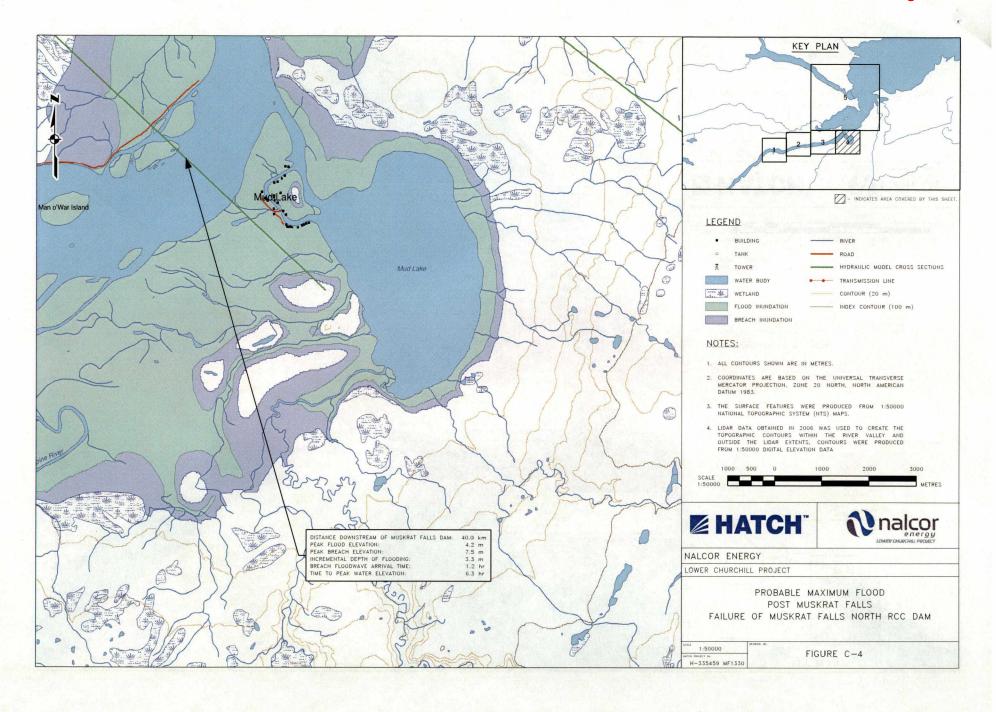
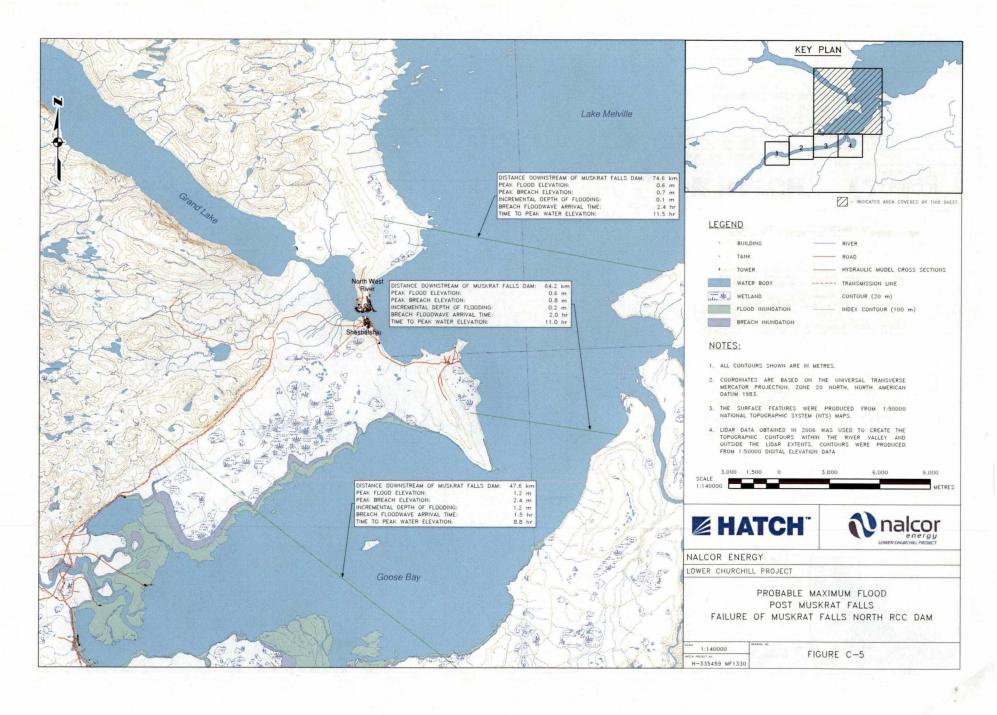
Appendix B

**PMF Inundation Mapping**

Tables 4-1 and 4-2 summarize the estimated floodwave arrival times, peak water level, time to peak water level, and incremental water depths at key downstream locations for failure of the North Dam under fair weather and PMF conditions, respectively. The incremental increase in water depth is the increase above the natural river level because of the dam failure. Inundation mapping for fair weather and PMF failures is included in Appendices A and B, respectively. Due to the potential for erosion and model limitations, it is recommended that communities delineate evacuation zones beyond the inundation mapping.
