Lower Churchill Project
ENGINEERING REPORT
North Spur – Post Construction Assessment

SLI Document No. 505573-3281-4GER-0010 00

Nalcor Reference No. MFA-SN-CD-2800-GT-RP-0010-01B1

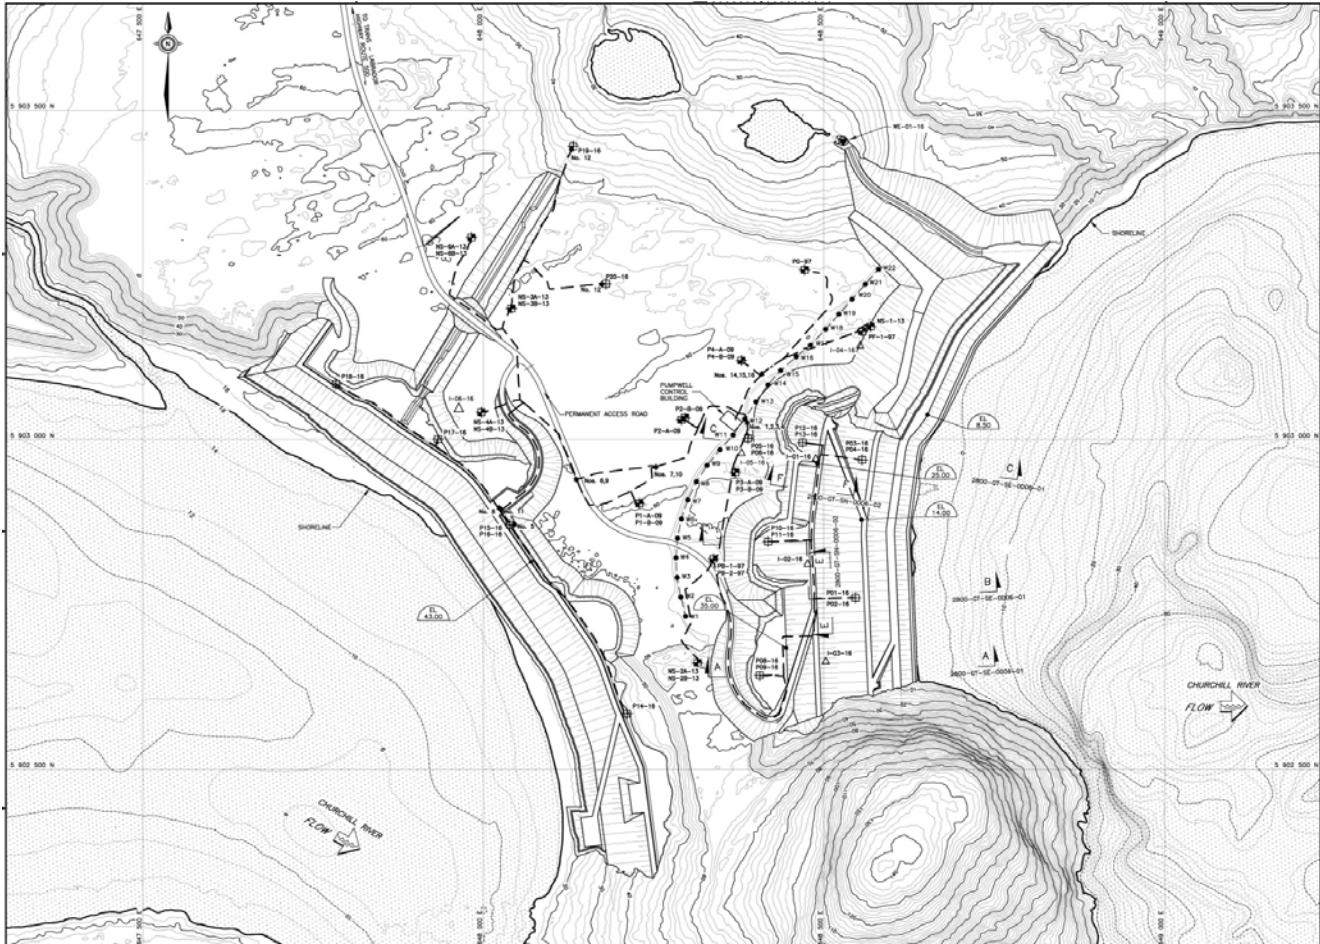
Figure 5-1: Instrumentation
