JAMES L. GORDON,

HYDROPOWER CONSULTANTPhone 514 695 [REDACTED]
e-mail jim-gordon [REDACTED]**March 14th, 2019****Minister Siobhan Coady
Minister of Natural Resources
Natural Resources Building
50 Elizabeth Avenue
P. O. Box 8700
St. John's, AIB 4J6
Canada****Minister Coady**

THE NORTH SPUR – MY FINAL COMMENTS

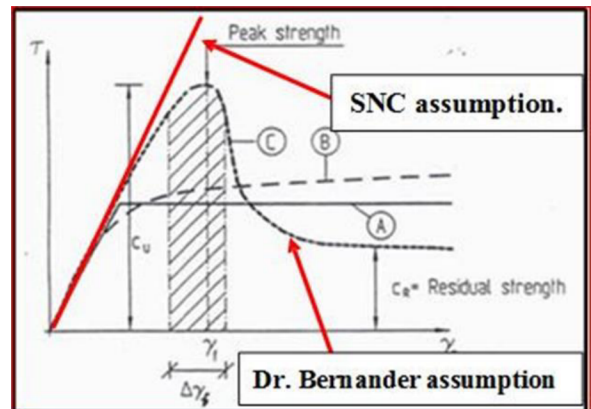
There is a reference to the strength reduction in the report as follows - Recent research in Norway (refs. (29) and (30)) recommends the use of the LEM approach in practice for the analysis of slope stability in sensitive and quick clays, with the addition of a correction factor, called $F_{softening}$, to account for the reduction of the clay shear strength after the peak shear strength has been reached, and to partially account for strain compatibility on the failure surface. (Report page 15)

The report then states - As an example of the effect of the mitigation measures for a slope on the Eastern side of the North Spur, the critical factor of safety was increased from 1.0 to 1.6. This is a 60% increase in the stability of the slopes, and within the reduction associated with $F_{softening}$ if one should use the results of some of the most recent researches.

However, there is no discussion on how the $F_{softening}$ factor was determined for the soils in the Spur. It has been assumed from other studies. Since the safety of the Spur is so critical, stress-strain test results should be available for the North Spur soils.
