HVdc TL: Geotechnical Risk Review

Background, Current Situation, Action Going Forward

30-Mar-2016

Boundless Energy

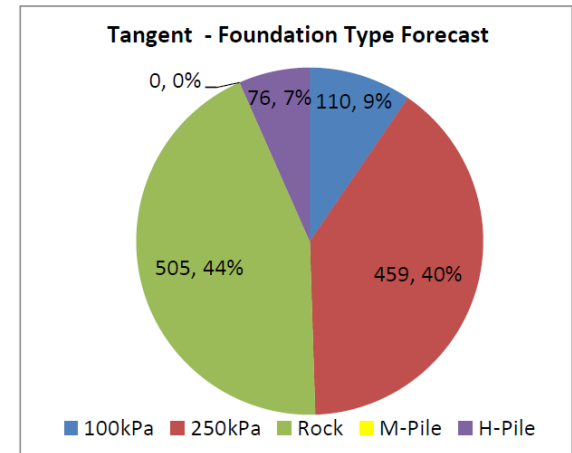
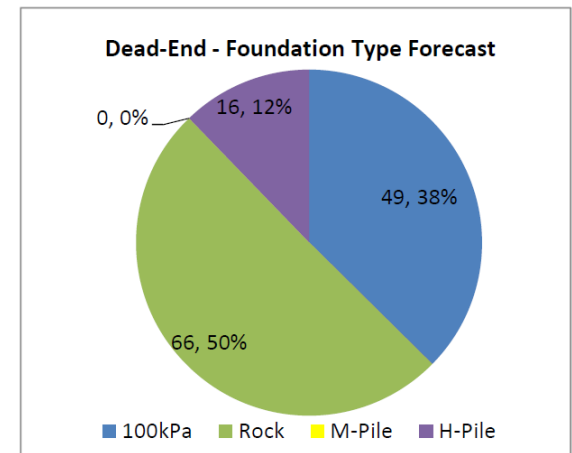
Installation Trends – Segments 1 & 2 ⁽¹⁾

- **Segments 1 & 2 are indicating more grillage than rock, in particular for tangent structures**
 - Grillage: Plan = 33%; Forecast 49%
- **Quantity projections of 1% Pile not consistent with field conditions, or Baseline Geotechnical Report wherein it stated that rock or grillage is expected to be used at 95% of locations, while the remaining 5% soft, sandy soil of significant depth where alternate foundation solutions (H-Pile, cribbing, etc.)**

(1) Data current as of 13-Mar-2016 as collected and interpreted by LCMC’s Field Engineers

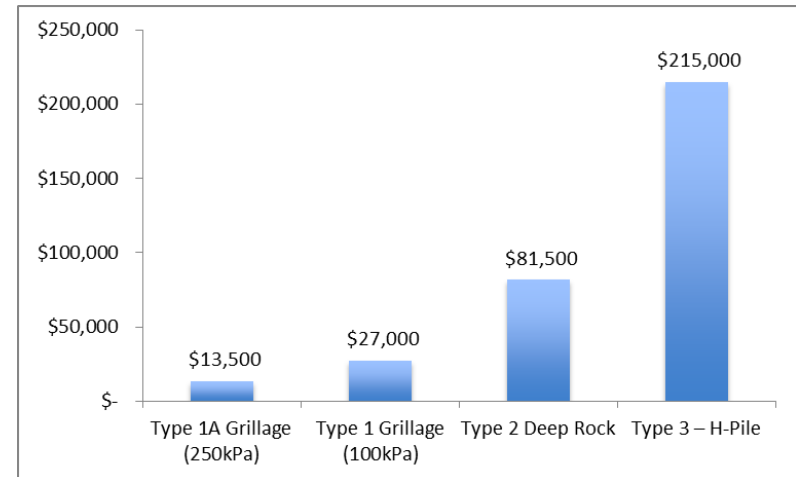
Contract Unit Prices – Segments 1 & 2

- Quantity used in contract reflects final as-designed structure staking list
- Unit price for grillage is more cost effective than rock
- Cost risk exists when “native” backfill not suitable for re-use
 - Requires borrowing and trucking backfill outside the tower box area
- Provisions for alternate foundation type exist (H-pile, caisson / crib), however are costly

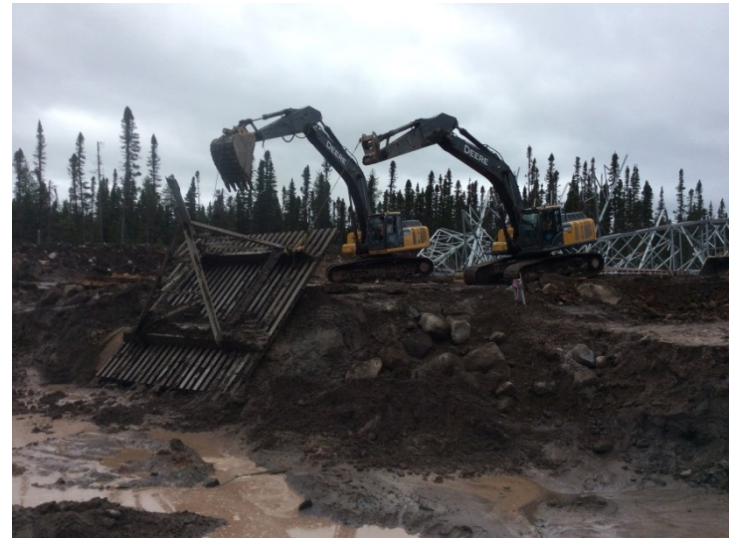
- Several installed grillage foundations in Segment 1 experienced settlement
 - S1-24, 54, 70, 86, 105 & 112
- Contractor positioning that settlement due to soils not suitable for grillage
- Geotechnical investigation to remove uncertainty and strengthen LCMC's position that settlement due to poor workmanship.
- Investigations have confirmed that sites are suitable for application of grillage foundations

S1-70 Leg C, reclamation of grillage footing, saturated founding base and backfill

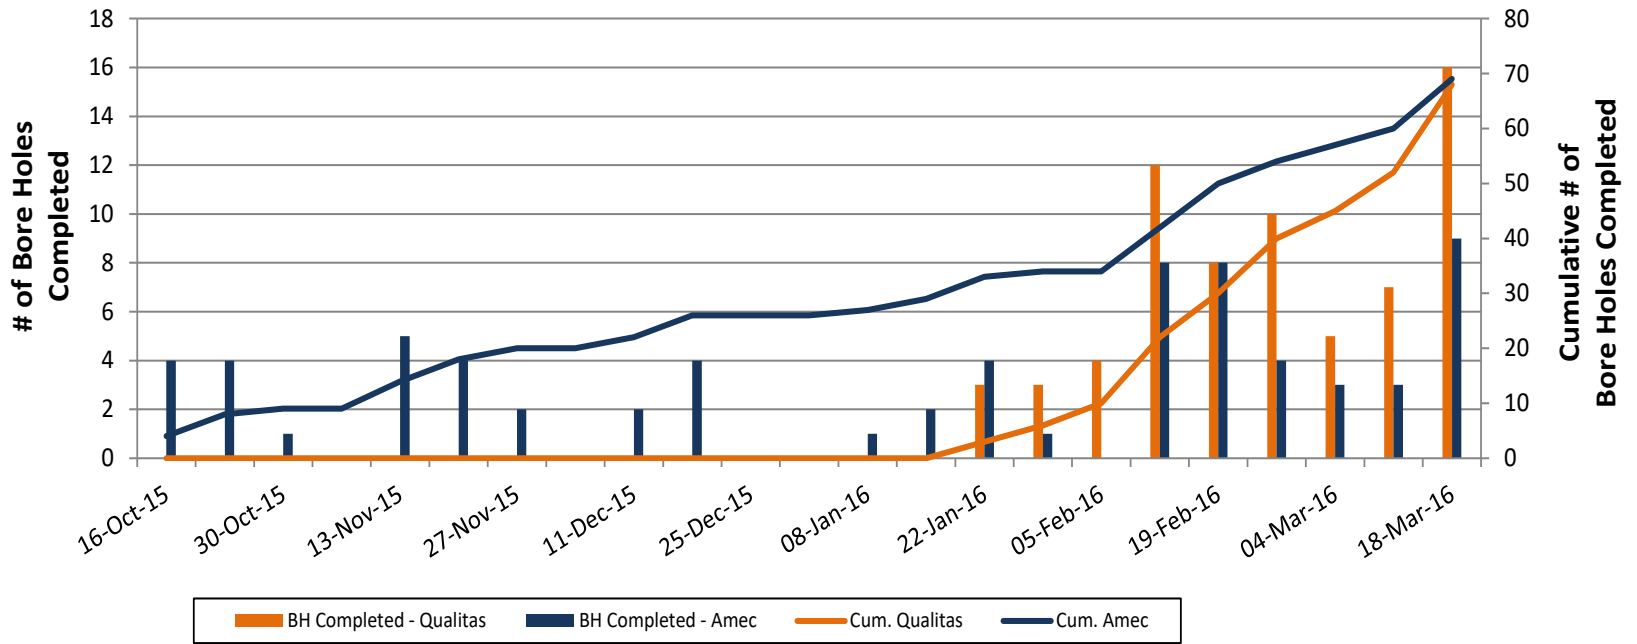
Graph 2 - Borehole Program - # of Boreholes Drilled

3 ~137 boreholes completed in Segments 1 & 2

Note: Qualitas BH Program started 01-Jan 2016

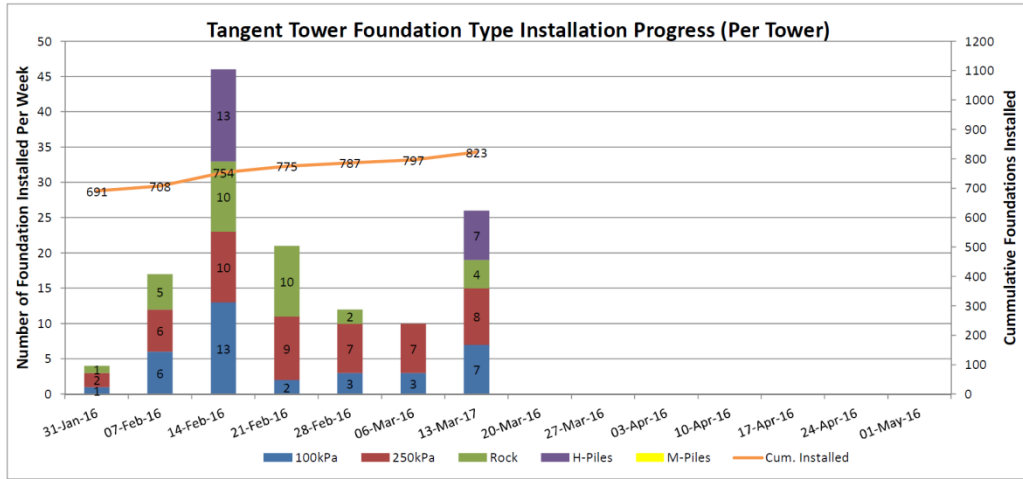
Segment 1 and 2 Tangent and Self-Supporting Tower Progress

Valard's installation progress steadily improving due in part to the benefits of geo program

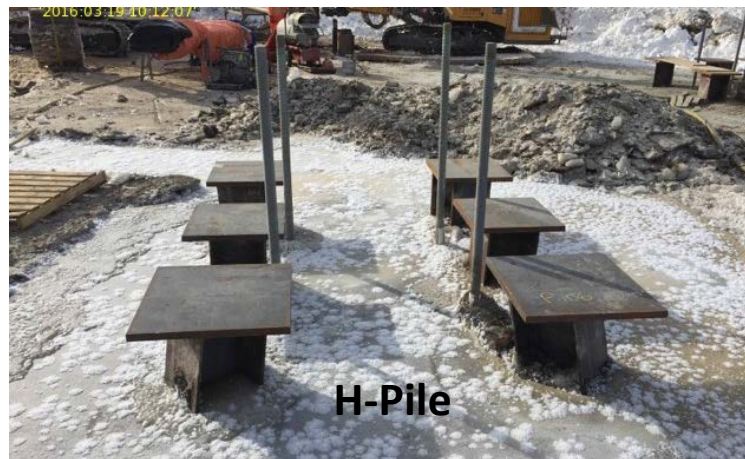
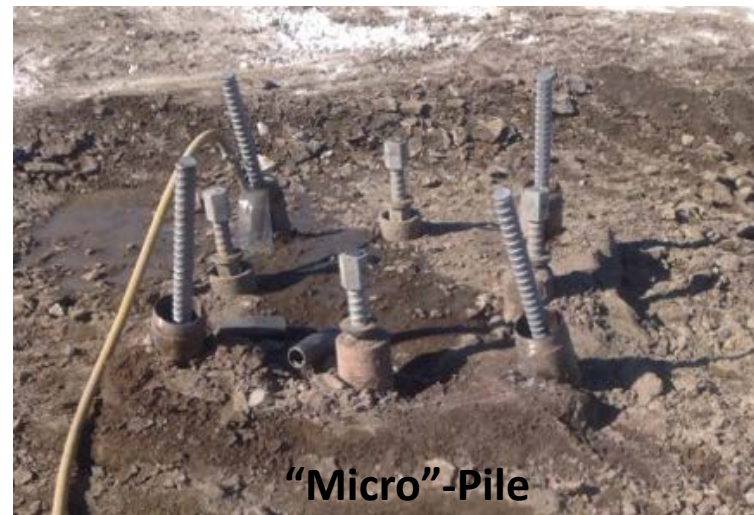
Where grillage doesn't work, micro-pile being trial tested over H-Pile

- Currently forecasting approximately 90 locations that are unsuitable for grillage foundation
- H-Pile design available and field proven, but is costly
- Micro-pile concept viewed as more cost effective solution given the reduction in materials, large pile caps and extension welding
- LCMC approved Valard to undertake design in Q4-2015 at a cost of \$150k, Initial field installation on T&M basis at S1-167 which was recently completed.
- Unit price proposal expected from Valard in the near term.

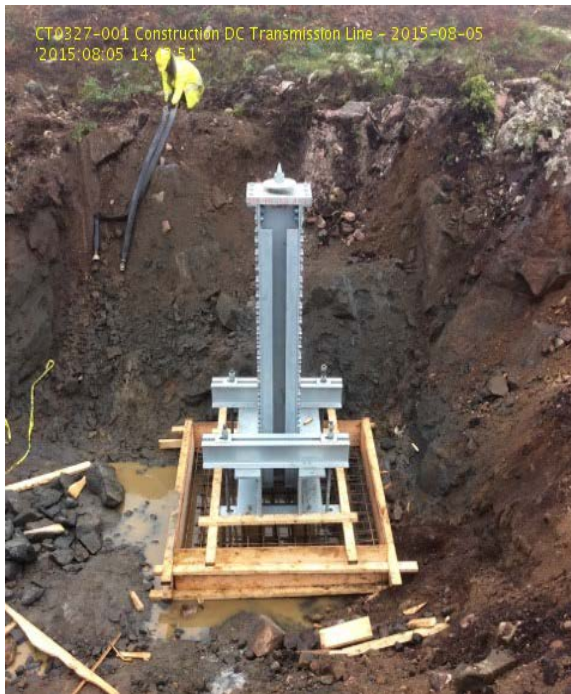
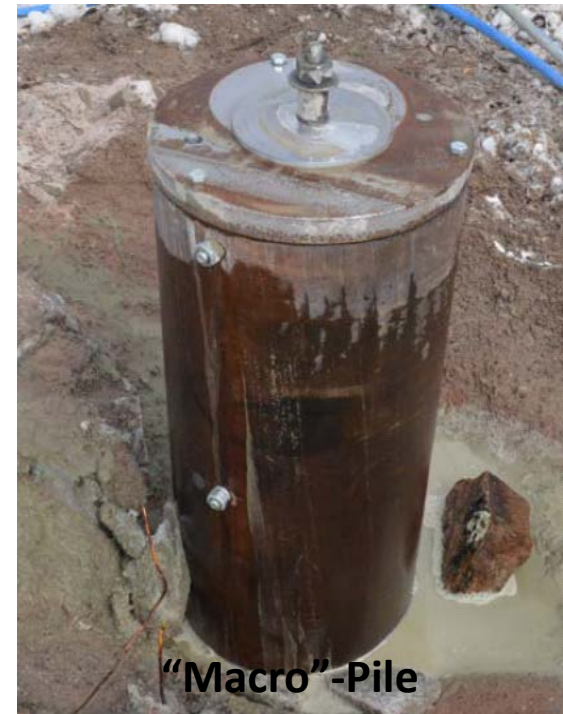
4 Alternate rock foundation design being explored in order to explore potential cost savings

- Current rock foundation is expensive, in particular for deep rock applications, requiring both significant excavation, rock leveling, and concreting
- Team currently with Valard to explore alternate design for rock depths up to 4m (i.e. Macro-Pile) currently being installed by LEG for Hydro Quebec. Design funded at \$150k.
